# Assessment of Environmental Qualification Practices and Condition Monitoring Techniques for Low-Voltage Electric Cables

Condition Monitoring Test Results

Brookhaven National Laboratory

U.S. Nuclear Regulatory Commission  
Office of Nuclear Regulatory Research  
Washington, DC 20555-0001

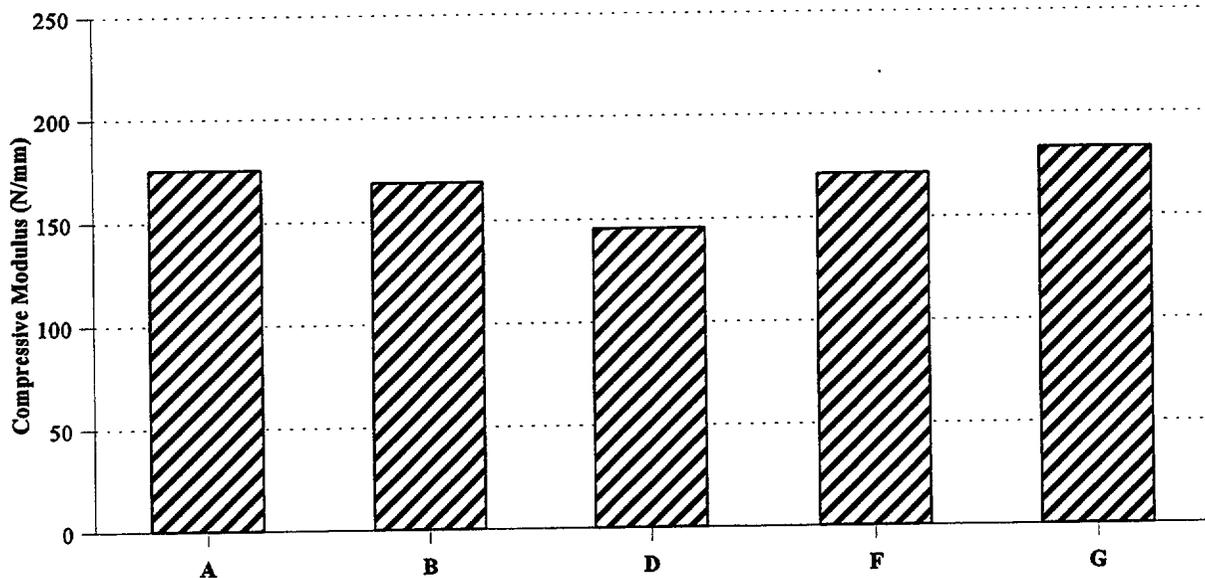
**Figure 4.32 Compressive Modulus versus pre-aging for XLPE from Group 1.2 pre-aged to simulate cable naturally aged for 10 years**

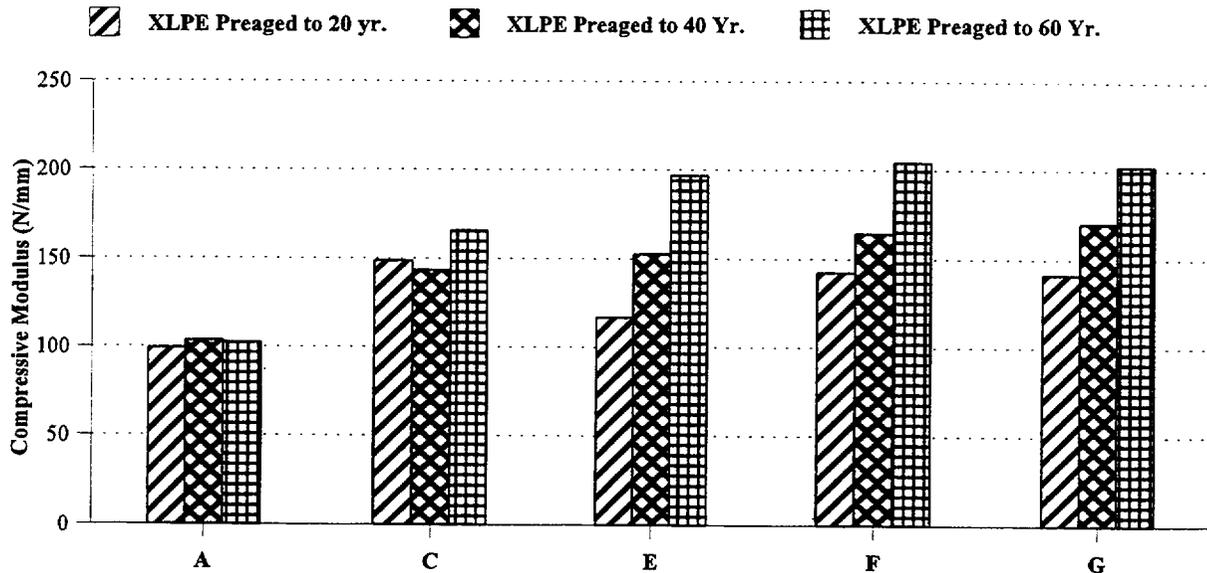
**Figure 4.33 Compressive Modulus versus pre-aging for XLPE from Groups 1.4, 3.4 and 6.2 pre-aged to 20, 40 and 60 years of qualified life**

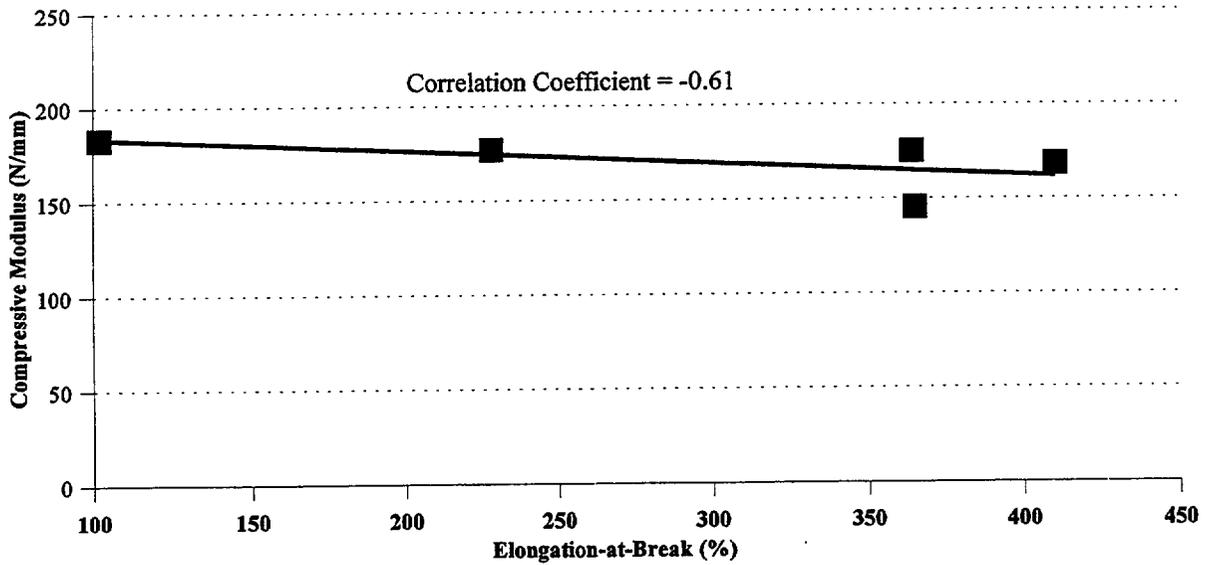
Figure 4.34 Correlation of Compressive Modulus with EAB for XLPE from Group 1.2 pre-aged to 20 years of qualified life

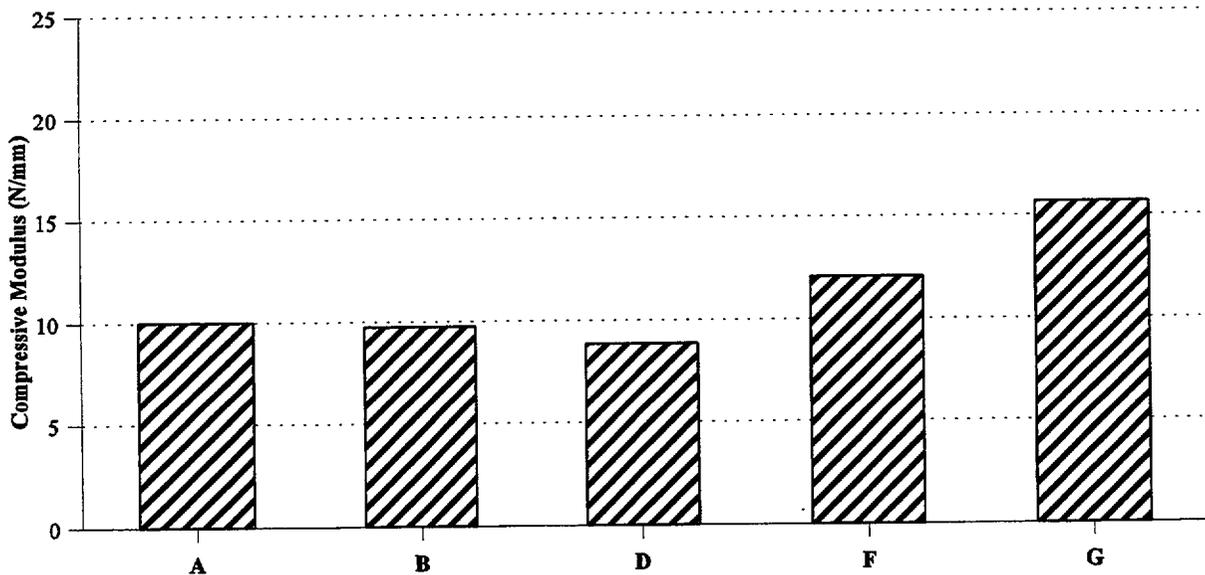
Figure 4.35 Compressive Modulus versus pre-aging for Neoprene® from Group 1.2 pre-aged to simulate cable naturally aged for 10 years

- A = Baseline
- B = Post Thermal Pre-aging
- D = Post Service Radiation
- F = Post half accident radiation
- G = Post full accident radiation

Figure 4.35 presents the compressive modulus values for the Neoprene® outer jackets on the Group 1.2 specimens from test sequence 1. A slight decrease in the modulus from the baseline value of approximately 10 N/mm (57 lbs./in.) was noted after service thermal and radiation aging. An increase in modulus was noted after exposure to accident radiation. A more significant increase in modulus was noted in the Group 1.4 specimens (Figure 4.36), which were pre-aged to the equivalent of 20 years of qualified life. Following thermal aging, the Neoprene® outer jackets were brittle, and this was reflected in the dramatic 1,900 percent increase in compressive modulus. Clearly, the predominant driver in this increase was the thermal aging.

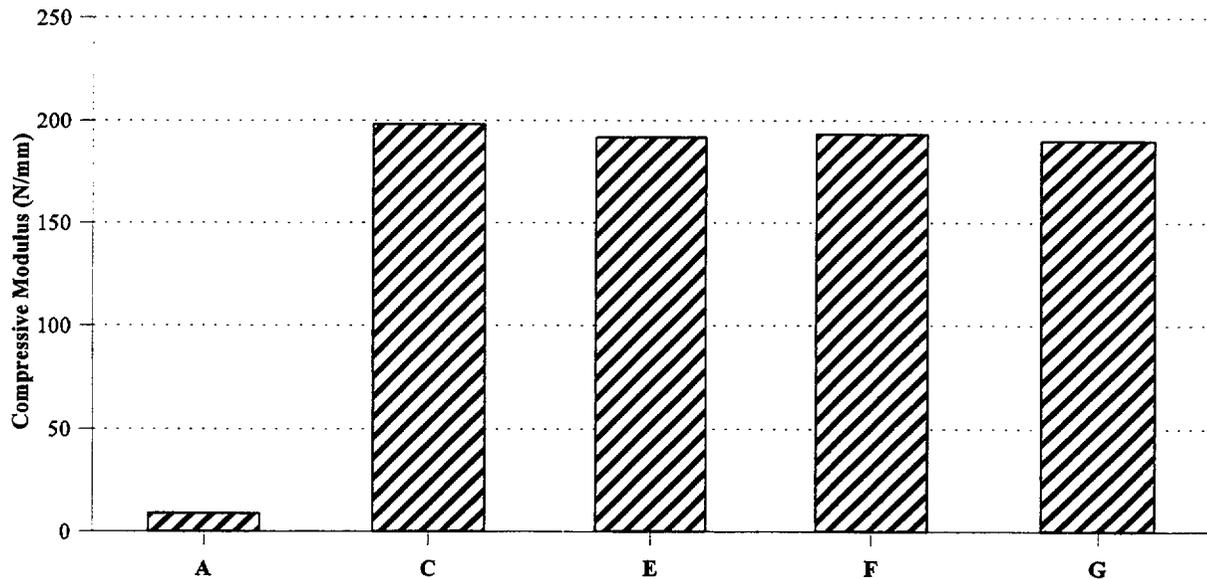
**Figure 4.36 Compressive Modulus versus pre-aging for Neoprene® from Group 1.4 pre-aged to 20 years of qualified life**

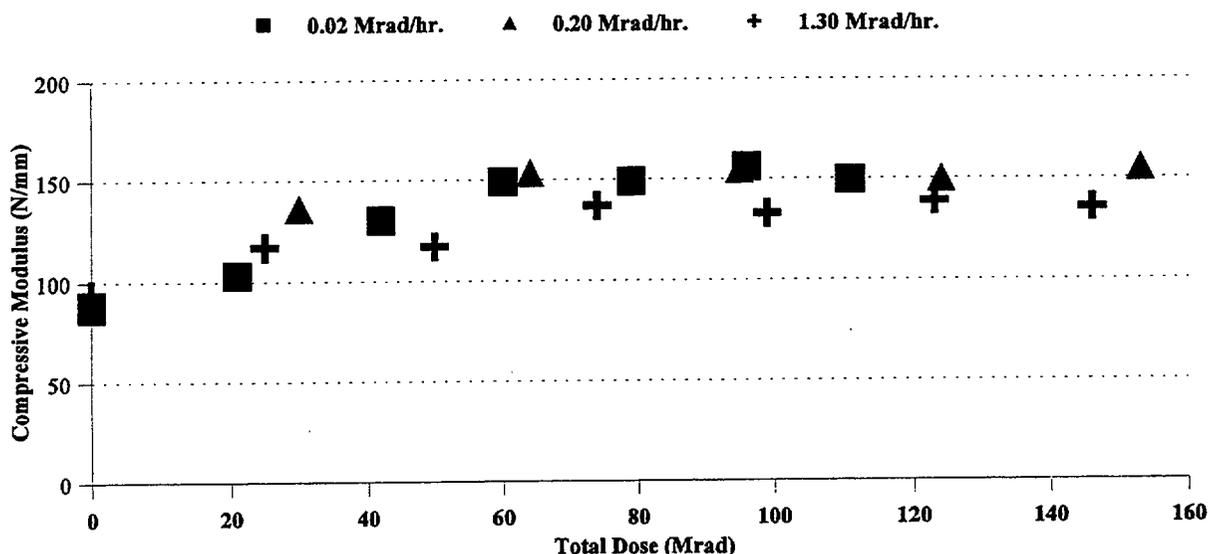
Figure 4.37 Comparison of compressive modulus versus radiation dose for XLPE as a function of dose rate

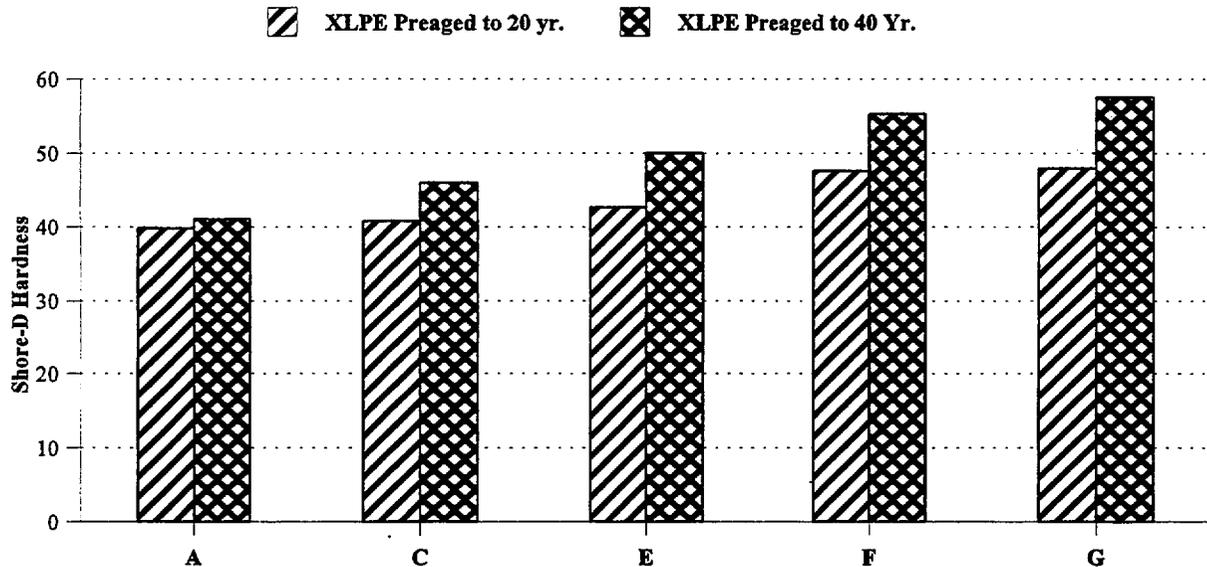
Figure 4.38 Hardness versus pre-aging for XLPE

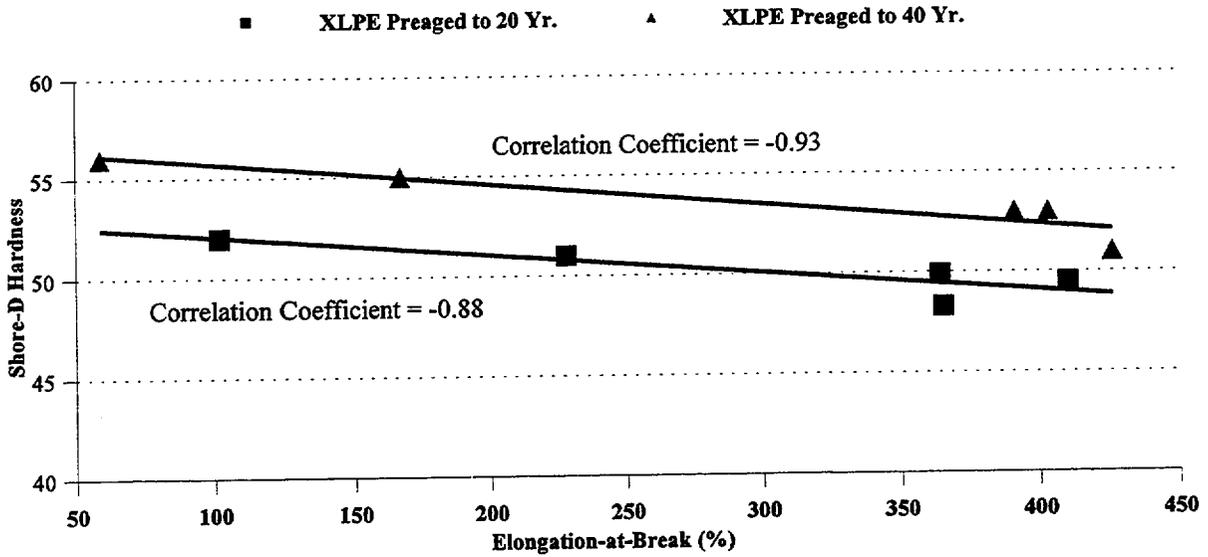
Figure 4.39 Correlation of EAB and hardness for XLPE insulation

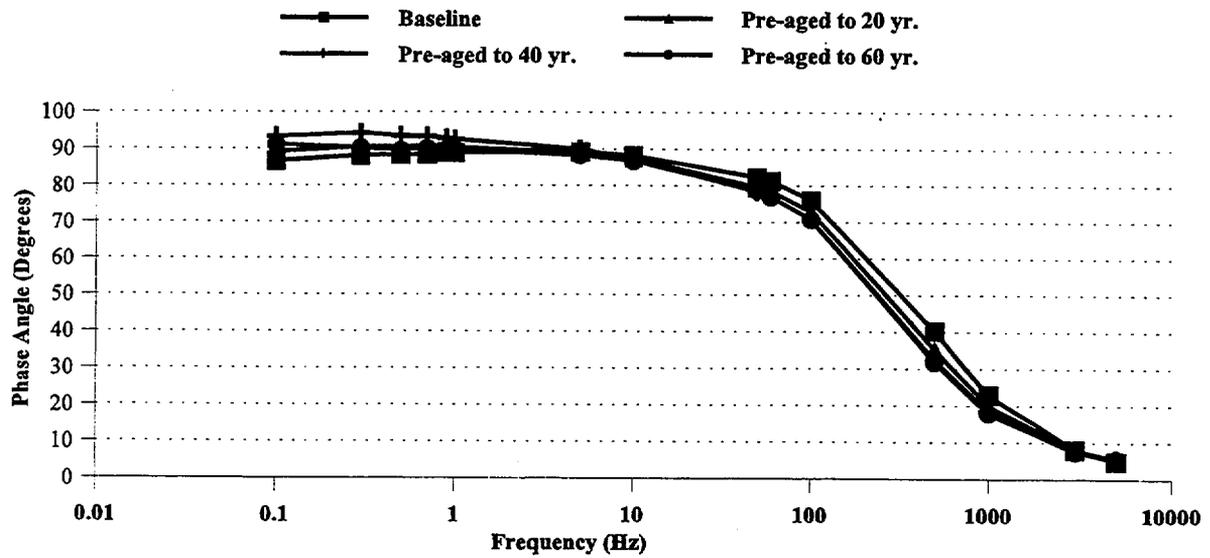
Figure 4.40 Dielectric phase angle vs test voltage frequency for aged XLPE-insulated cables

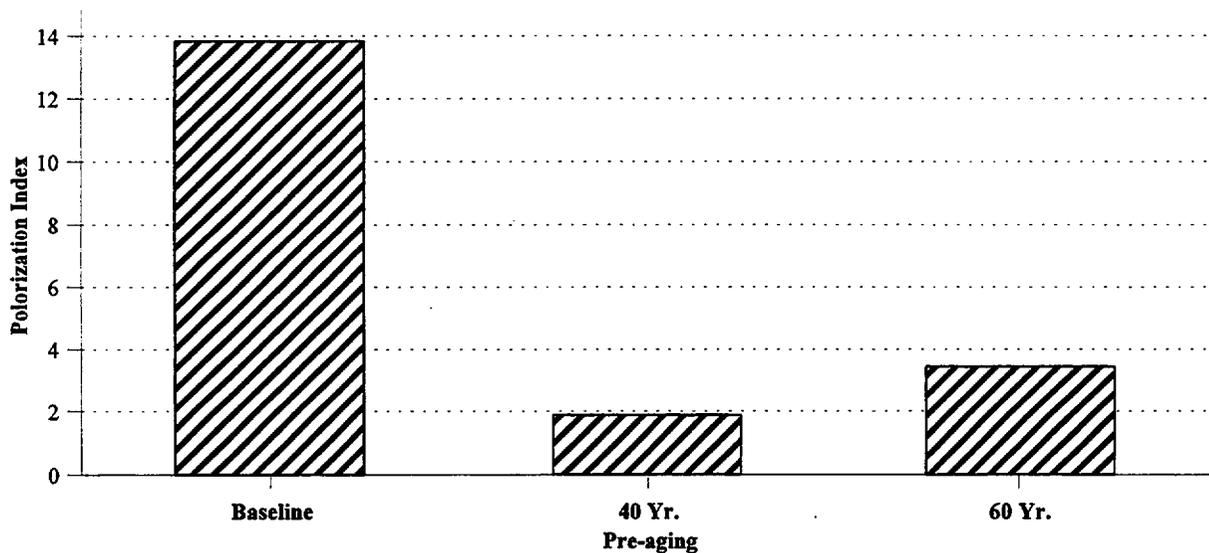
**Figure 4.41 Polarization Index for aged XLPE-insulated cables**

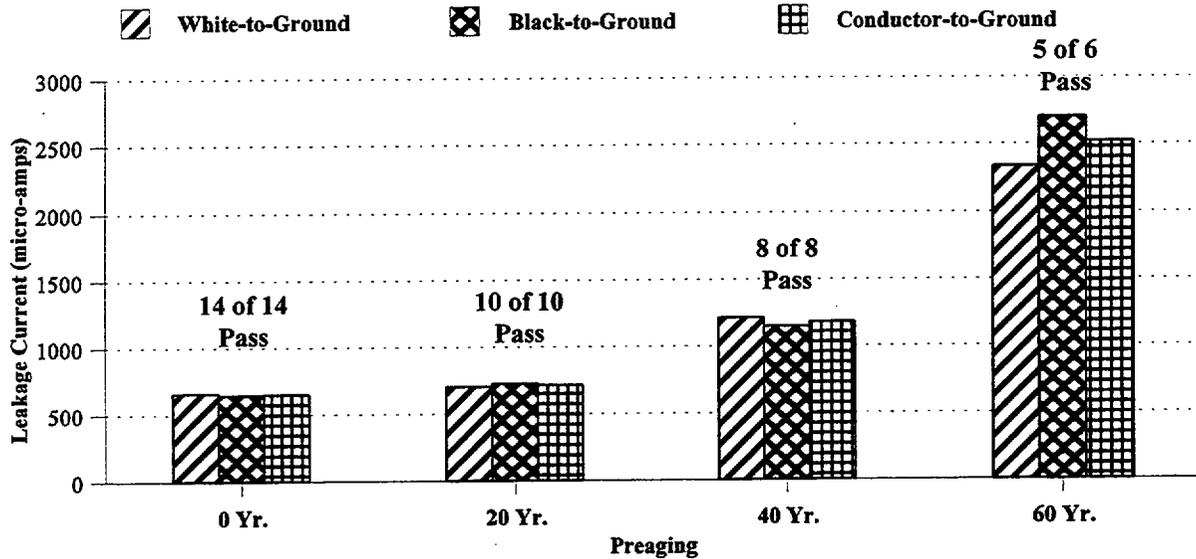
Figure 4.42 Post-LOCA submerged voltage withstand test results for pre-aged XLPE-insulated cables

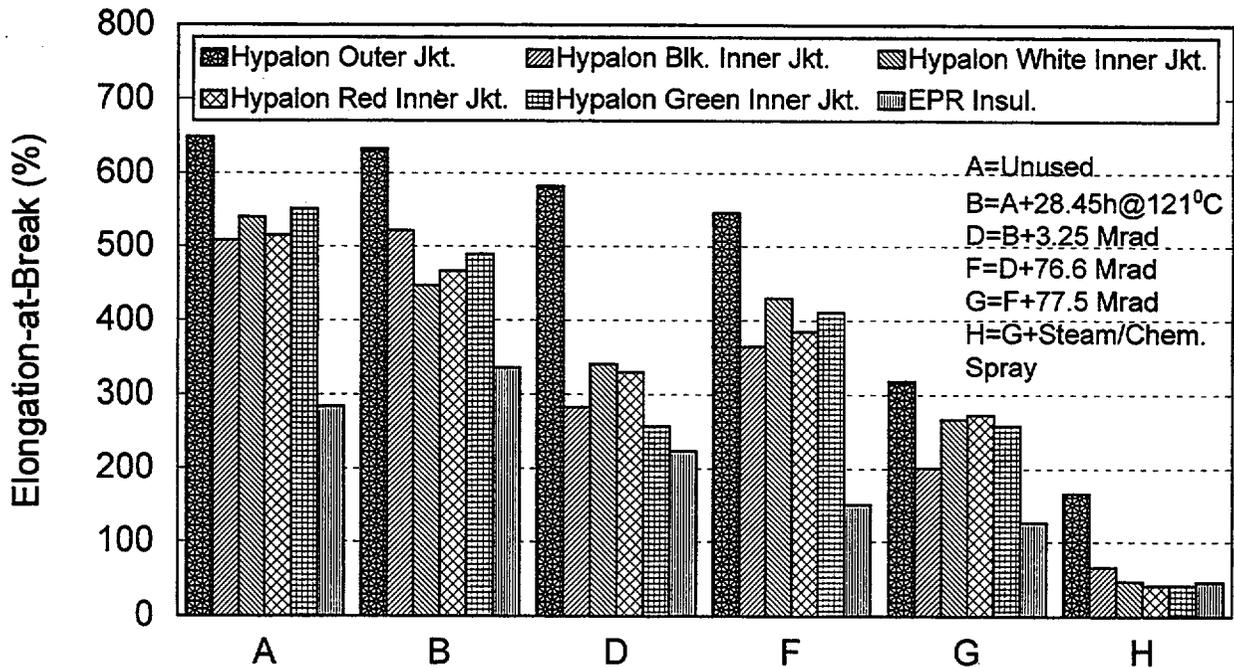
Figure 5.1 Effect of aging and LOCA testing on the EAB of AIW EPR/Hypalon® cable PNI74AI027 (Group 2.2, Specimen 0205) artificially aged to simulate Group 2.3

The AIW and Anaconda cables evaluated consisted of EPR insulation enclosed by Hypalon® individual jackets of different colors. The overall outer jacket was also made from Hypalon®. Figure 5.1 shows the changes in EAB for AIW cable that was given thermal and irradiation aging treatments (CM points B and D, respectively) to simulate the 24 years of service that had been received by the naturally-aged cable in Group 2.3. The outer jacket consistently showed a loss in EAB with each aging step and also during the LOCA radiation and steam/chemical spraying. The individual Hypalon® jackets, however, showed an increase in EAB after the first LOCA radiation (CM point F). For subsequent steps in the LOCA cycle the EAB decreased. The ductility of the individual jackets did not seem to show any consistent differences from color to color. For the EPR insulation, the EAB showed a decrease throughout the successive service aging and LOCA treatments. The one exception was for the service aging step (CM point B) for which there was a small increase in ductility. Subsequent aging and LOCA cycles consistently reduced the EAB.

In Figure 5.2, CM point A gives the EAB results for AIW cable that was naturally aged for 24 years in a nuclear power plant. The results in Figure 5.1 (CM point D) for material artificially aged to 24 years of service show that it has a lower EAB compared to the naturally-aged material. This suggests that artificially aged cable may be used to conservatively estimate aging effects in cable materials. Such a conclusion assumes that the artificially- and naturally-aged cables, which were made by the same manufacture, had the same starting properties. This is a reasonable assumption since both cables were made in the same year (1974). It is also assumed that aging while in storage was insignificant for the artificially aged cable. The naturally-aged cable materials showed decreasing ductility after the LOCA radiation and steam/chemical spraying cycles (CM point F, G, and H in Figure 5.2). In the case of the artificially-aged cable, however, the first LOCA radiation dose of 78.7 Mrad increased the EAB. Subsequent LOCA radiation and steam/chemical spraying reduced the ductility.

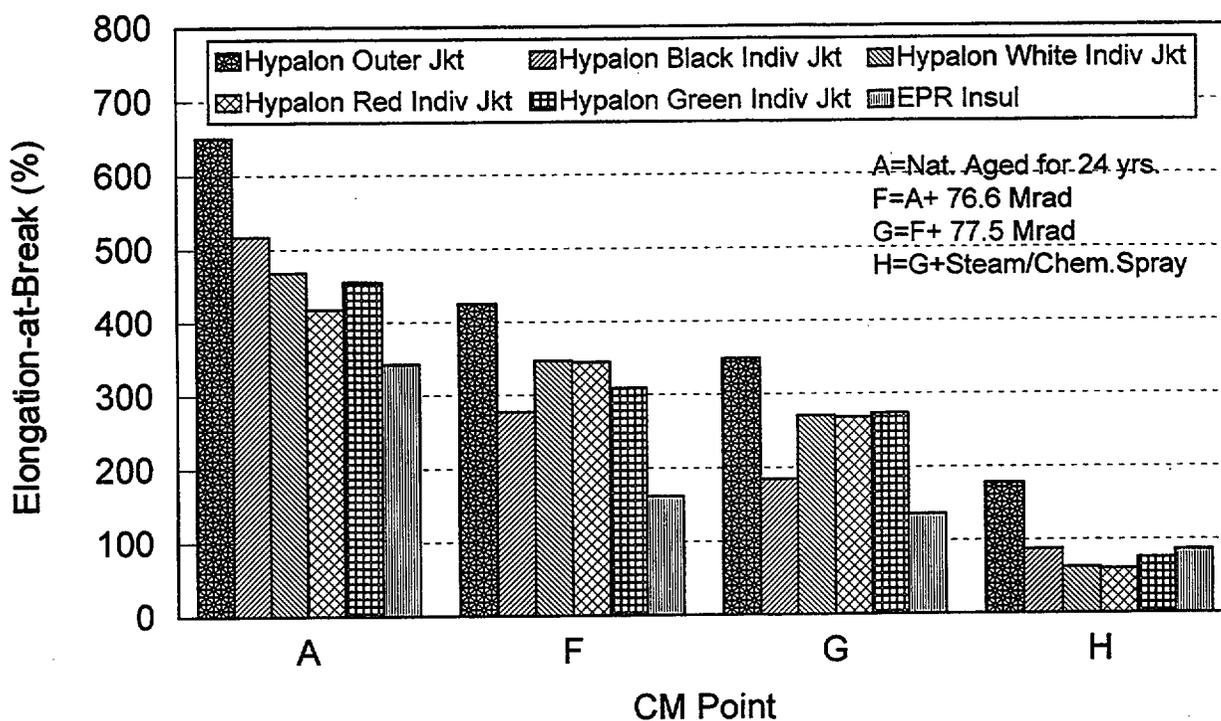
Figure 5.2 Effect of LOCA testing on the EAB of AIW EPR/Hypalon® Cable PNI74AI015 (Group 2.3, specimen 0207) naturally-aged for 24 Years

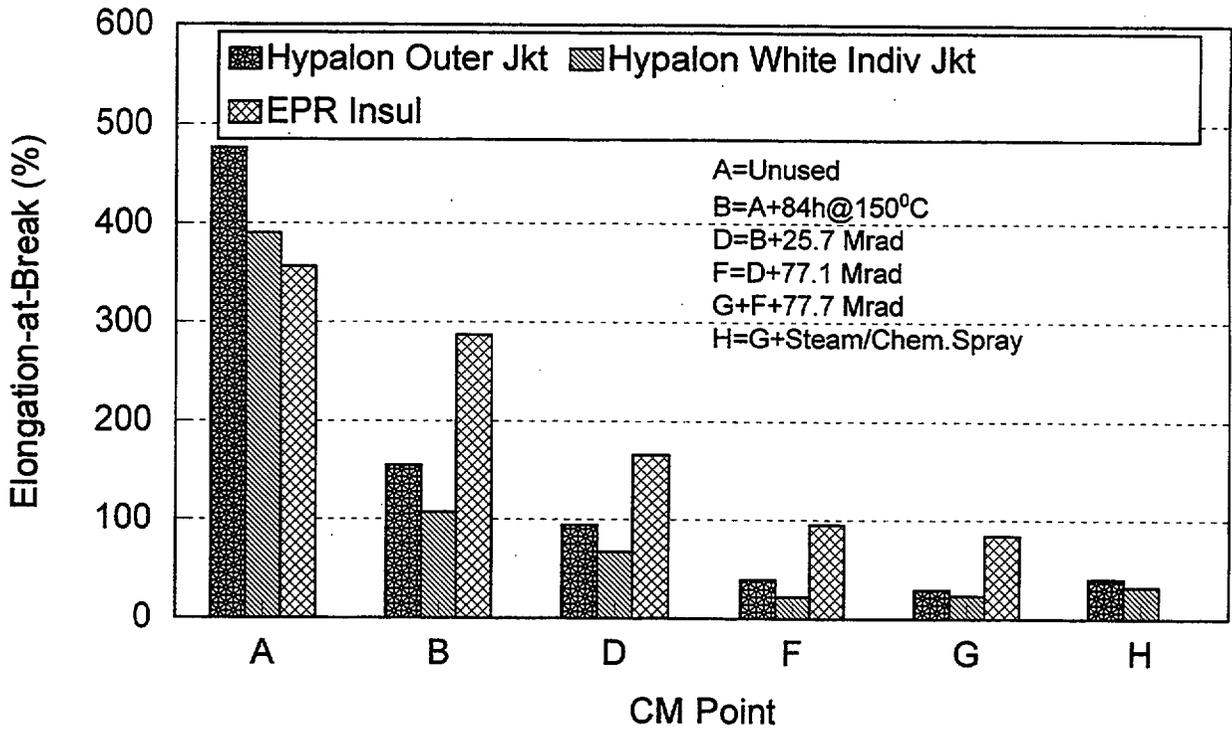
Figure 5.3 Effect of aging and LOCA testing on the EAB of Anaconda EPR/Hypalon® cable DNP78AN008 (Group 5.2, Specimen 0508)

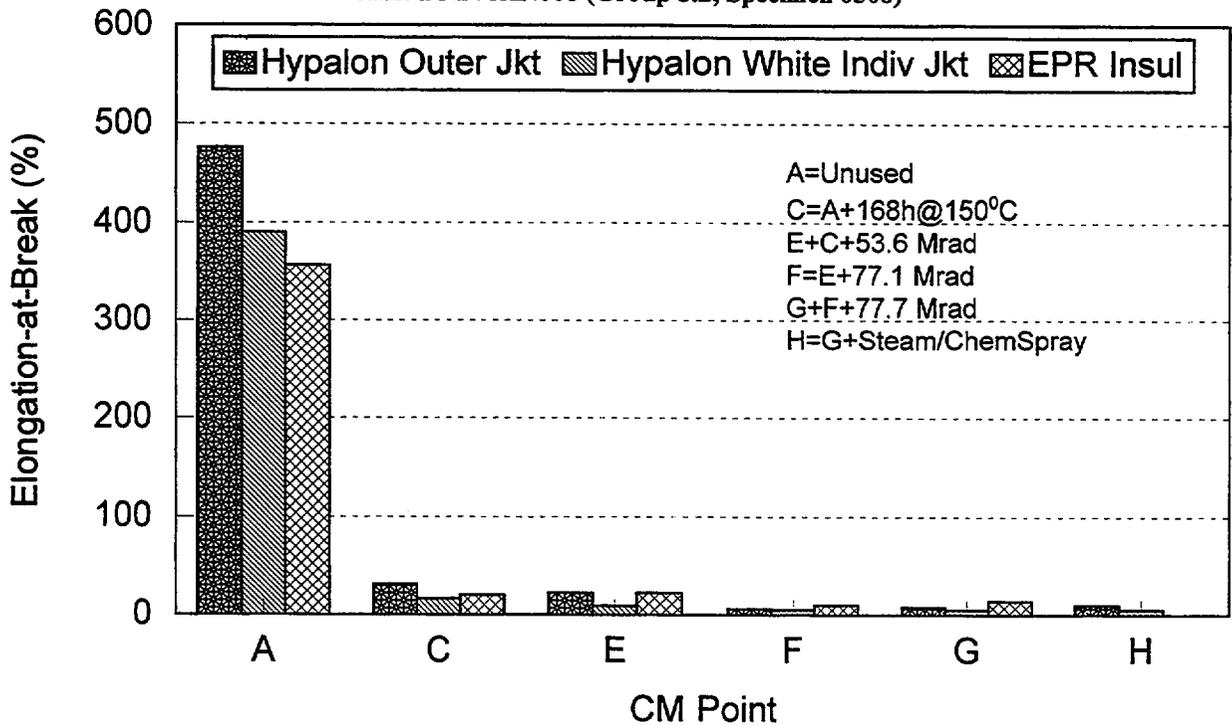
Figure 5.4 Effect of aging and LOCA testing on the EAB of Anaconda cable DNP78AN008 (Group 5.3, Specimen 0515). Specimens artificially aged to 40 Years of qualified life

EAB data for Anaconda EPR/Hypalon® cable are given in Figures 5.3 and 5.4 for materials aged for 20 and 40 years of qualified life, respectively. As expected, the insulation and jacket materials suffered a loss in ductility of

approximately 75 percent after the 20 year aging treatment (Figure 5.3, CM Point D); LOCA radiation and steam/chemical spraying caused further reductions in EAB, but the materials were not brittle. After the 40-year treatment (Figure 5.4, CM Point E) the ductility decreased to the 10-20 percent range. There were additional decreases after LOCA testing, and the materials became brittle.

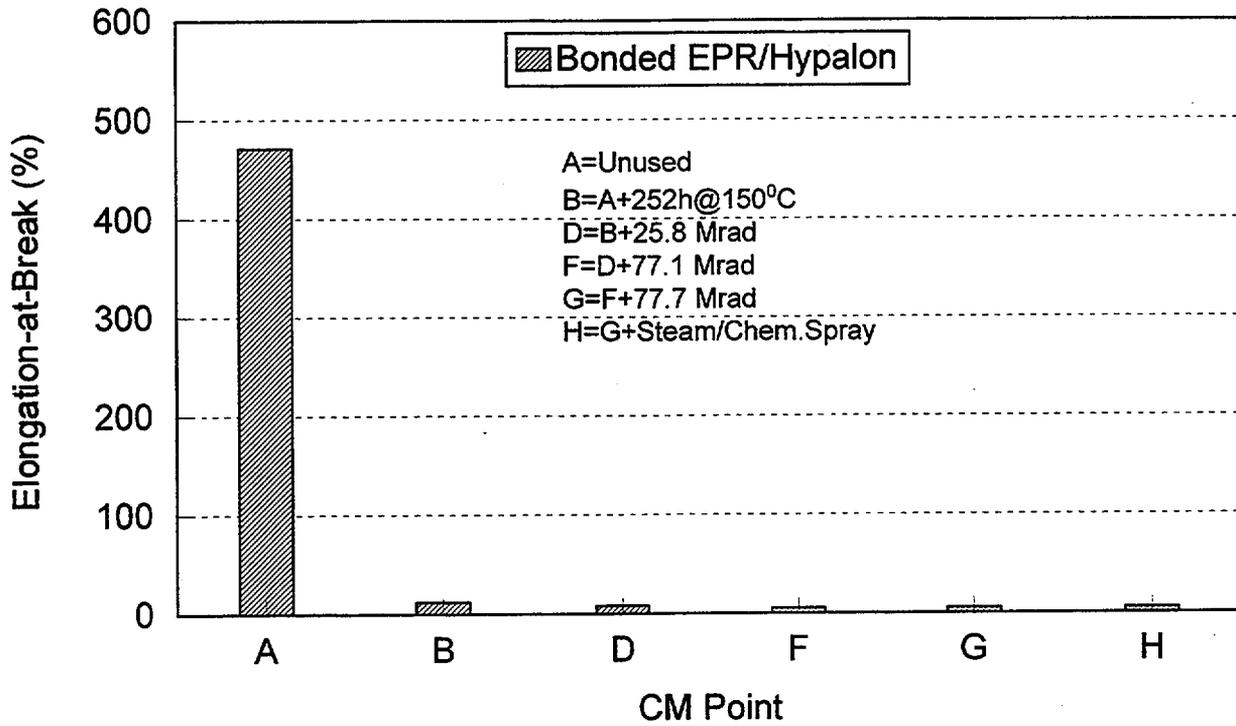
Figure 5.5 Effect of aging and LOCA testing on the EAB of Okonite EPR/Hypalon® Cable LNI81OK020 (Test 5.2, Specimen 0504)

A similar major loss in EAB was observed for Okonite® cable consisting of a Hypalon® jacket bonded to EPR insulation. After artificial aging to one-half of the manufacturer's 40-year qualification protocol, assuming a service temperature of 194°F (90°C), the EAB of the bonded Hypalon®/EPR composite specimens was reduced to approximately 8 percent (Figure 5.5, CM Point D). For the full 40-year qualification, the cable became brittle with the EAB reduced to about 5 percent (Figure 5.6).

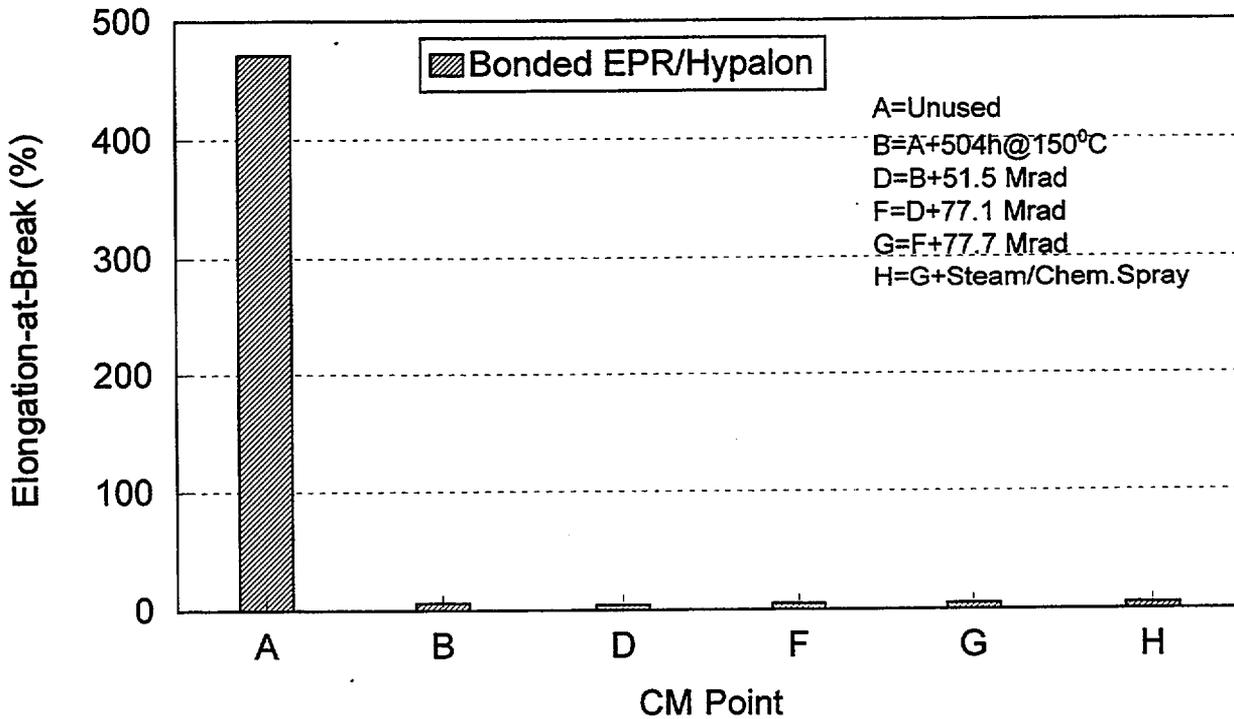
Figure 5.6 Effect of aging and LOCA testing on the EAB of Okonite EPR/Hypalon® Cable LNI81OK020 (Test 5.3, Specimen 0510)

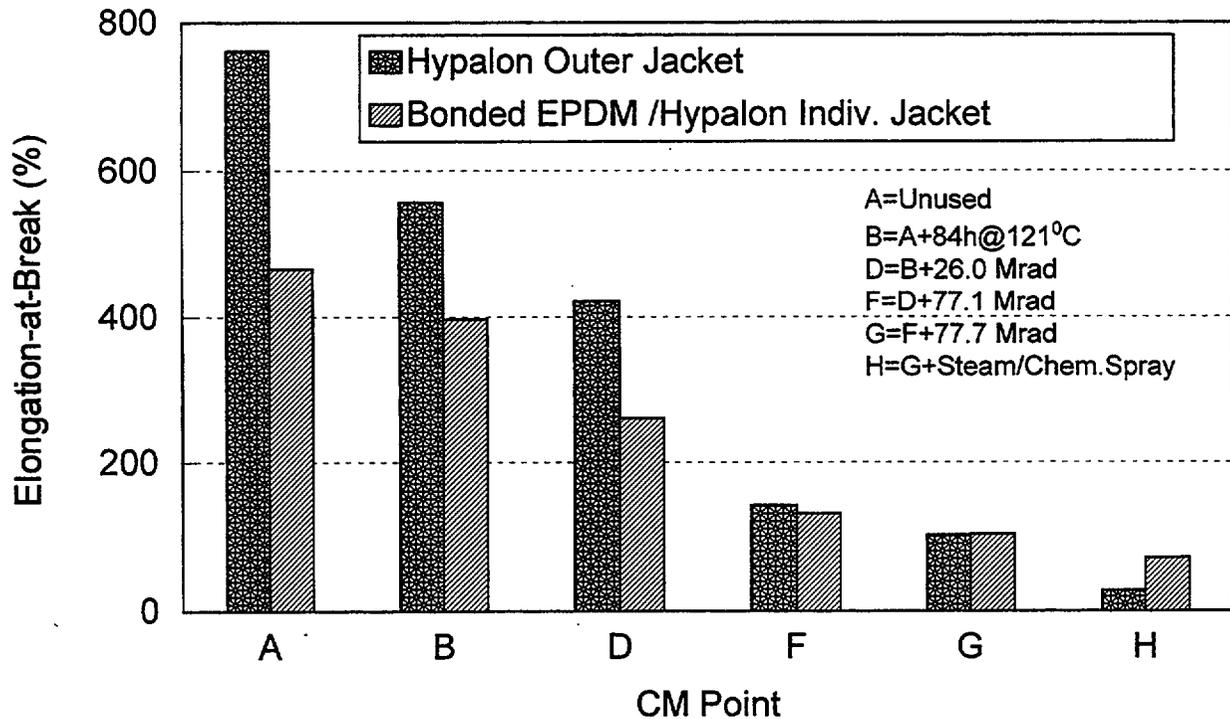
Figure 5.7 Effect of aging and LOCA testing on the EAB of Samuel Moore EPDM/Hypalon® cable PN182SM008 (Test 4.2, Specimen 0403)

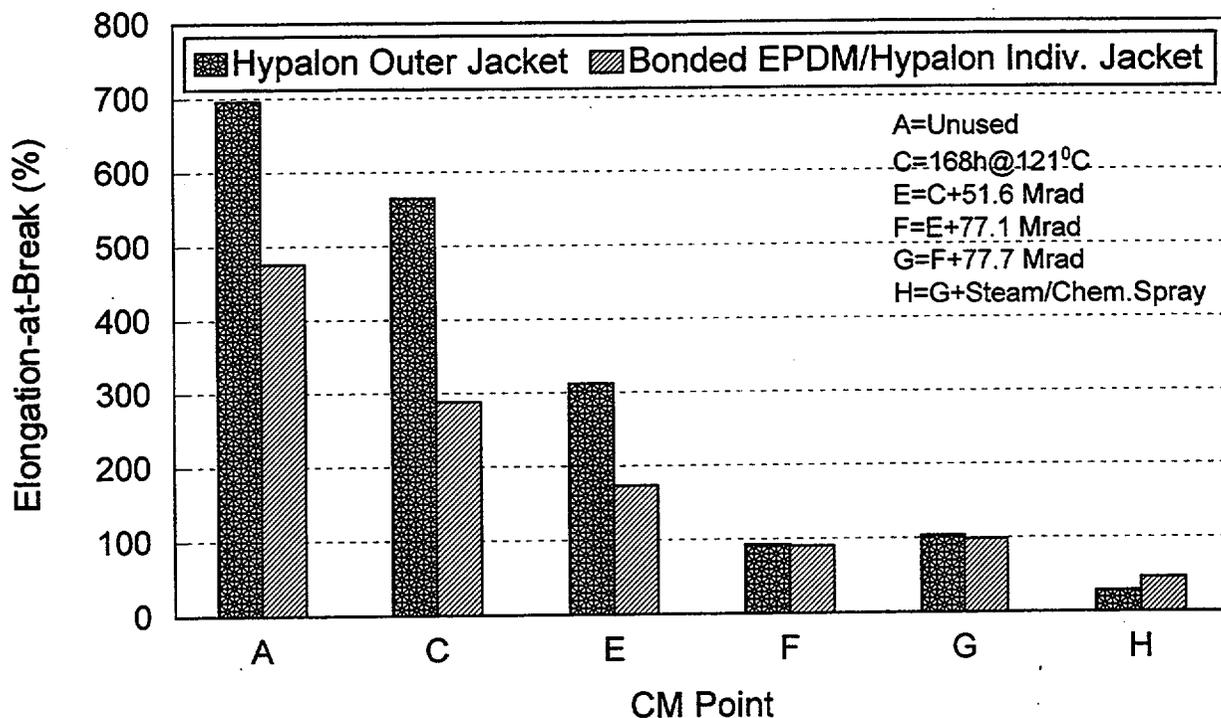
Figure 5.8 Effect of aging and LOCA testing on the EAB of Samuel Moore EPDM/Hypalon® cable PNI82SM008 (Test 4.4, Specimen 0412)

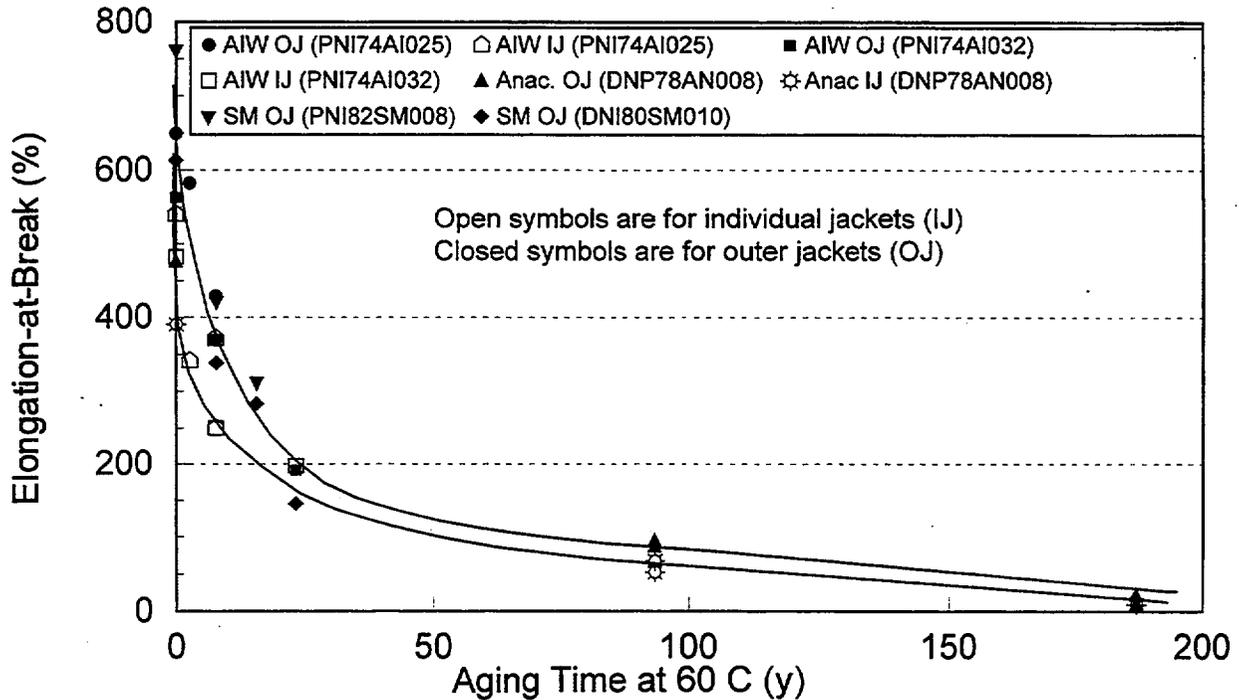
Figure 5.9 Comparison of EAB results for unbonded Hypalon® jacket material from different manufacturers

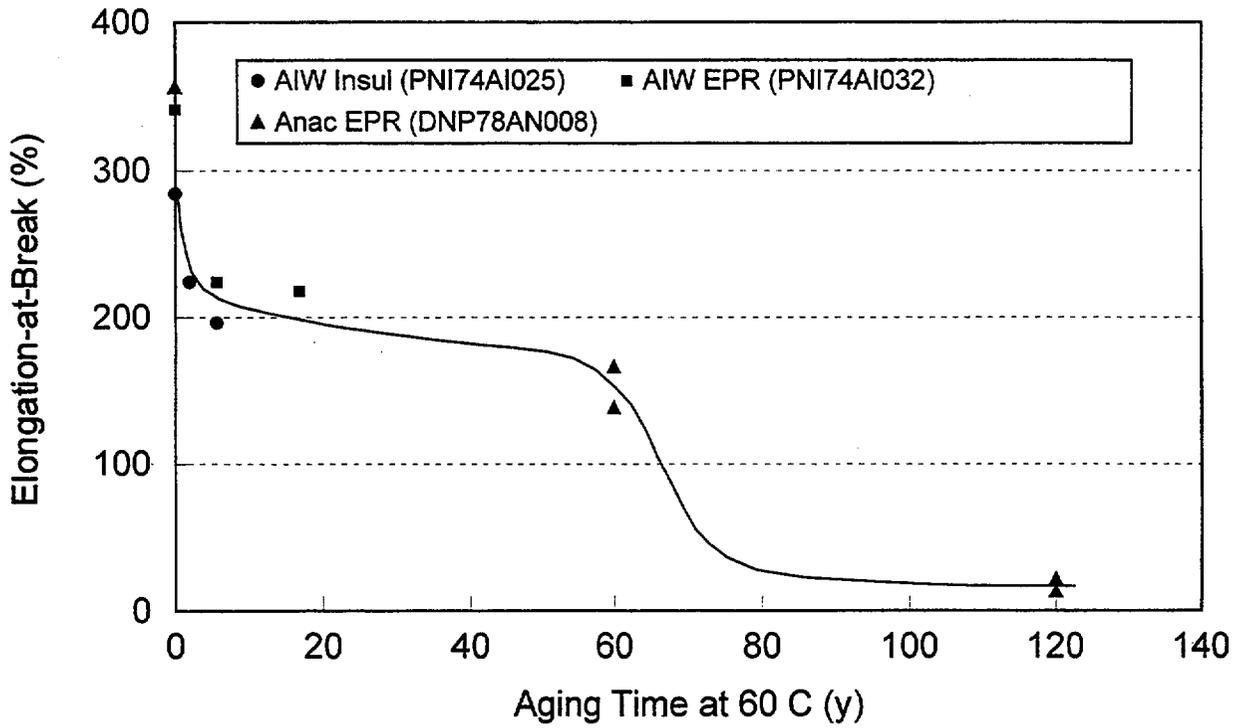
Figure 5.10 Comparison of EAB results for unbonded EPR insulation from different manufacturers

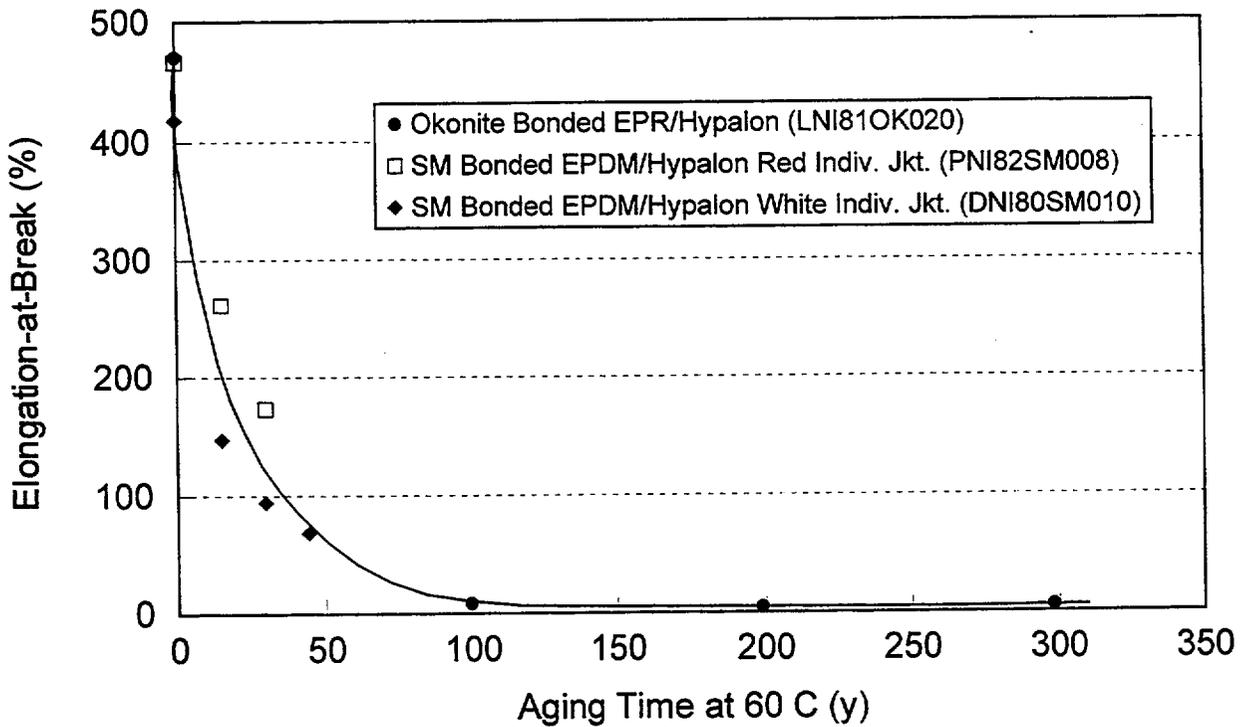
Figure 5.11 Comparison of EAB results for bonded EPR and EPDM insulation from different manufacturers.

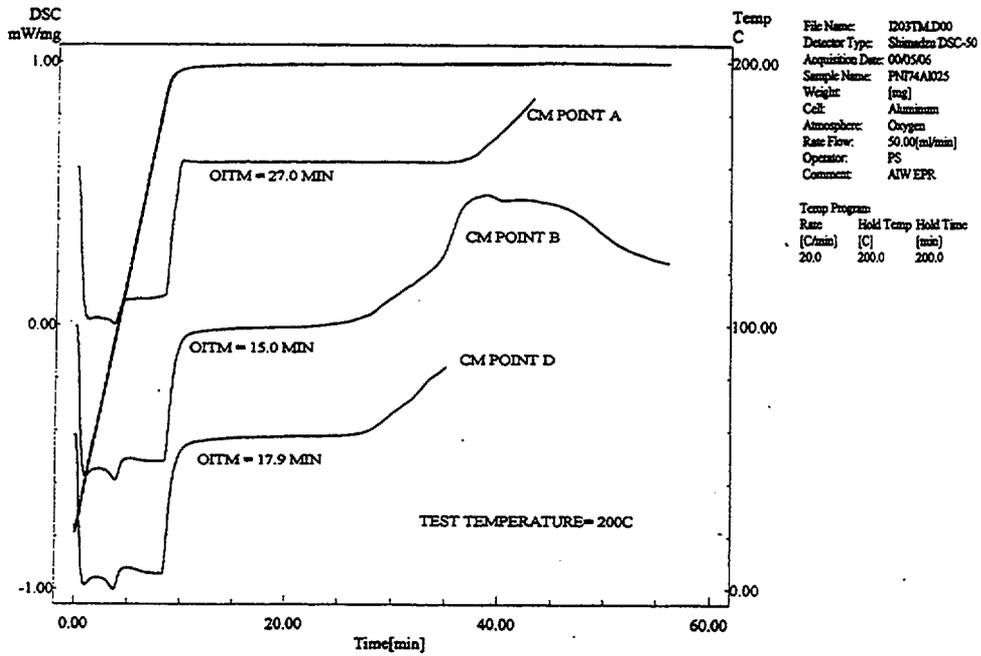
Figure 5.12 OITM Thermograms at 392°F (200°C) for AIW EPR insulation PNI74AI026 (Group 2.2, Specimen 0203)

Figure 5.12 shows typical OITM thermograms for EPR from Group 2.2 that was given an accelerated aging treatment to simulate 24 years of natural aging to match that for the naturally-aged cable in Group 2.3. Note that the flat line in the figure denotes the test temperature profile with time. The thermal aging (CM point B) consisted of oven aging for 28.45 hours at 250°F (121°C). The service radiation dose was 3.25 Mrad (CM point D). There is a large decrease in OITM after thermal aging, but a small increase after radiation.

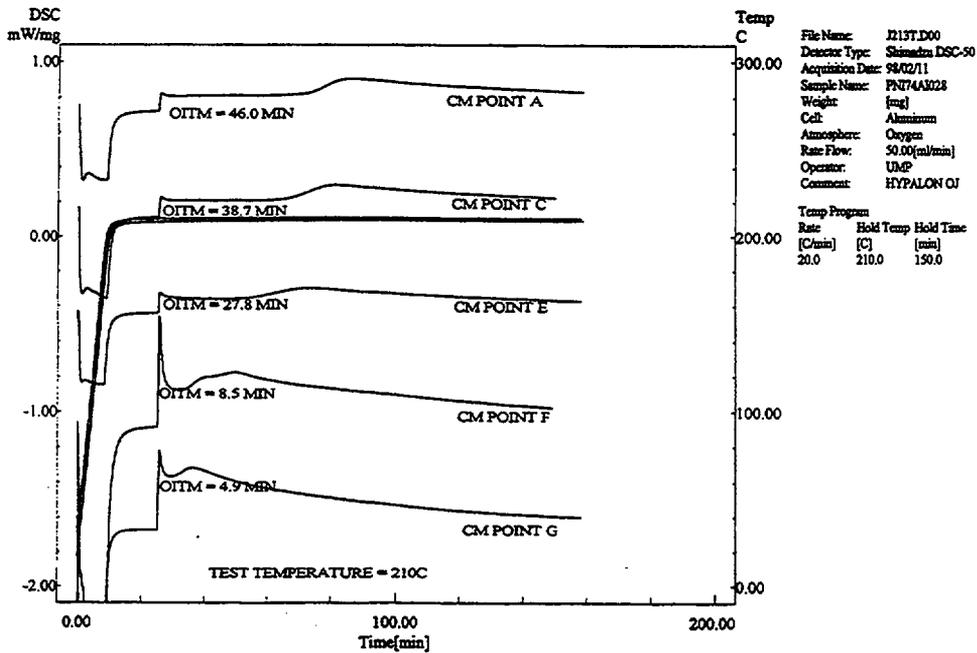
Figure 5.13 OITM Thermograms at 410°F (210°C) for AIW Hypalon® outer jackets PNI74AI028 (Group 2.4, Specimen 0213)

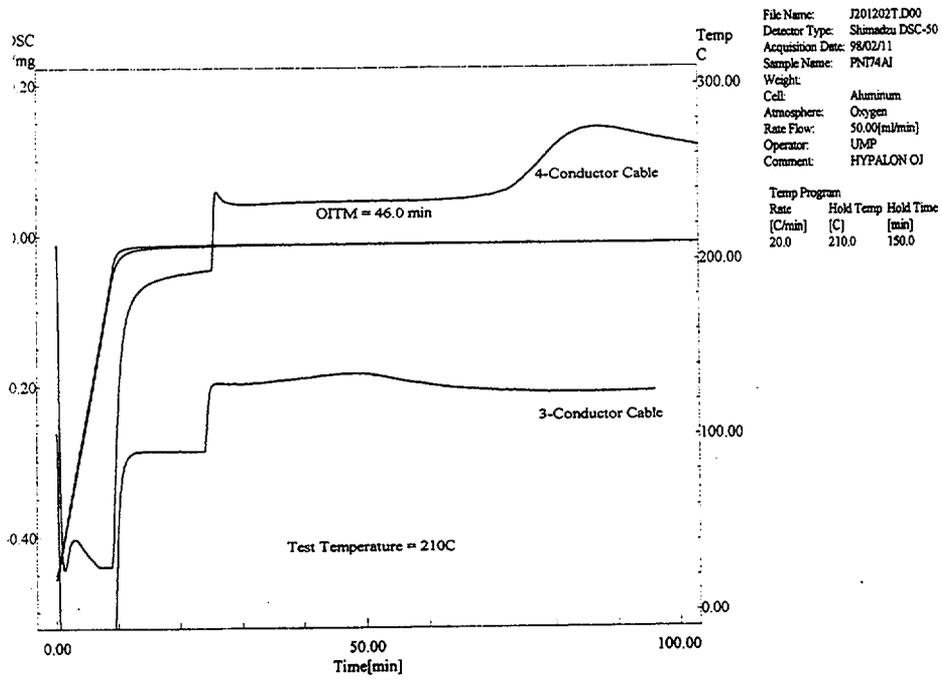
Figure 5.14 Comparison of Thermograms for Hypalon® outer jackets for unaged four- and three-conductor from AIW cable

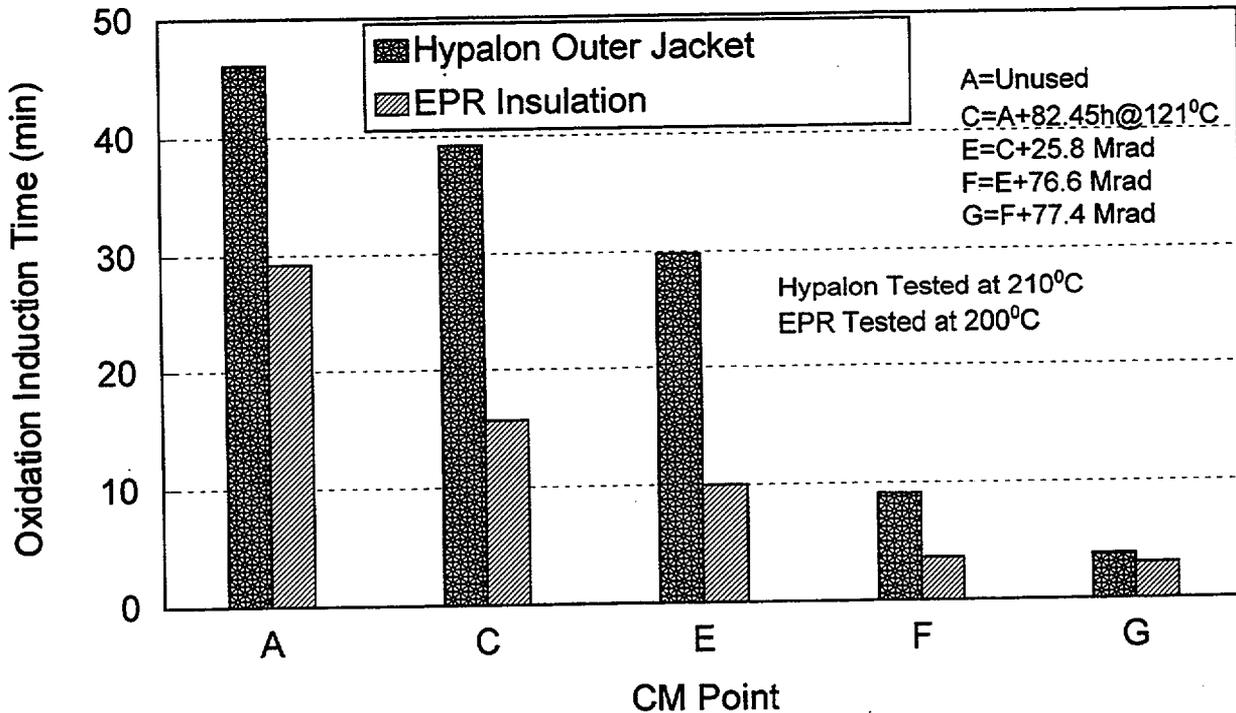
Figure 5.15 OITM for AIW four-conductor cable PNI74AI028 (Group 2.4, Specimen 0213) as a function of CM point

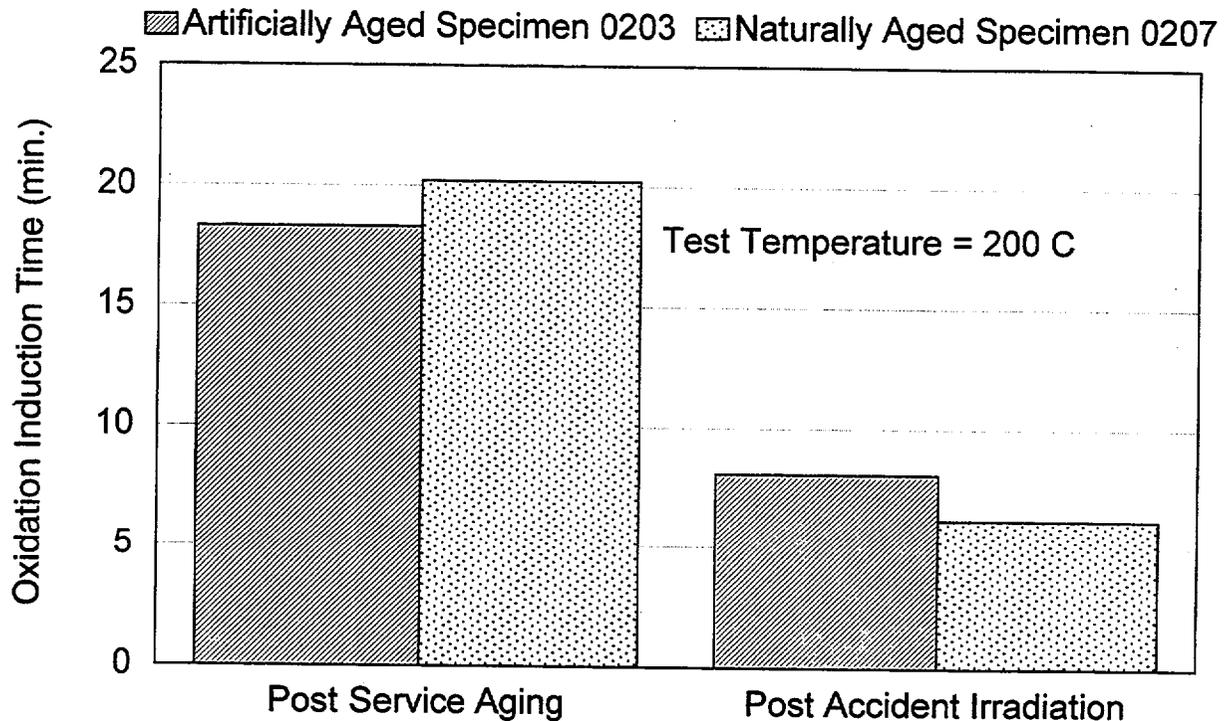
**Figure 5.16 Comparison of OITM for artificially-aged and naturally-aged EPR Insulation from AIW cable after 24-Years of service aging**
