# Assessment of Environmental Qualification Practices and Condition Monitoring Techniques for Low-Voltage Electric Cables

Condition Monitoring Test Results

Brookhaven National Laboratory

U.S. Nuclear Regulatory Commission  
Office of Nuclear Regulatory Research  
Washington, DC 20555-0001

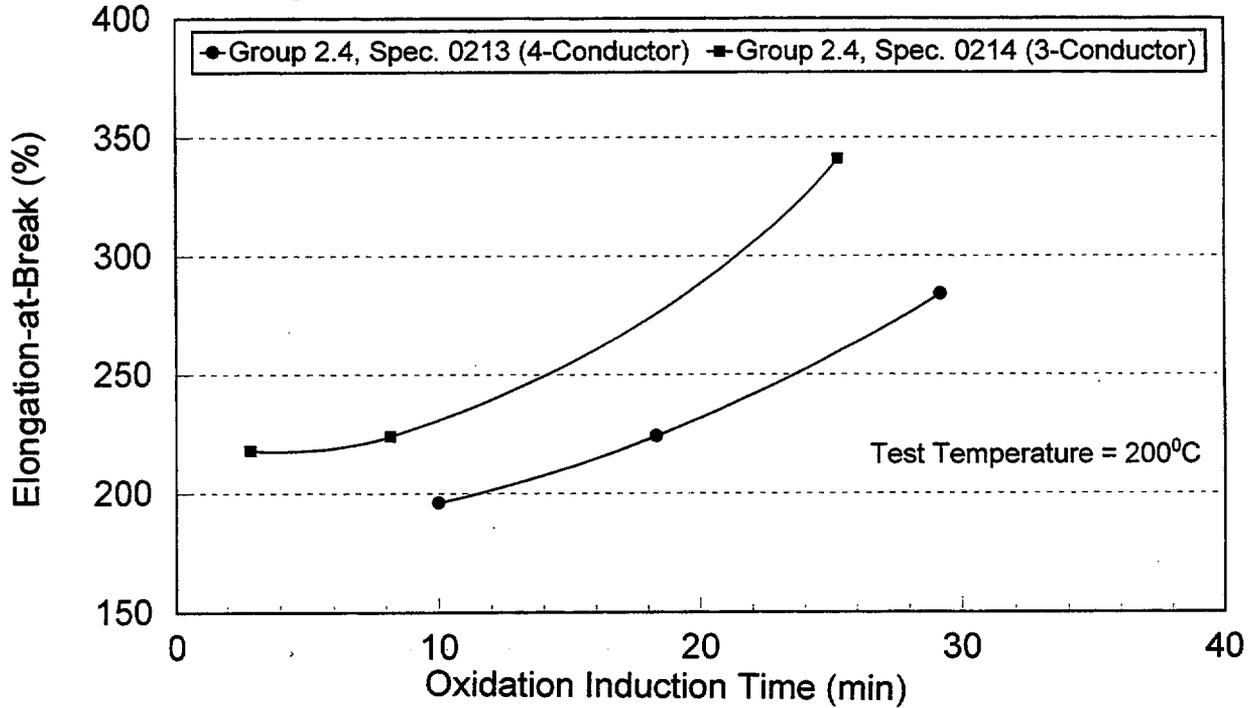
Figure 5.17 Correlation between OITM and EAB for EPR insulation from AIW cable PNI74AI028 (Group 2.4, Specimens 0213 and 0214)

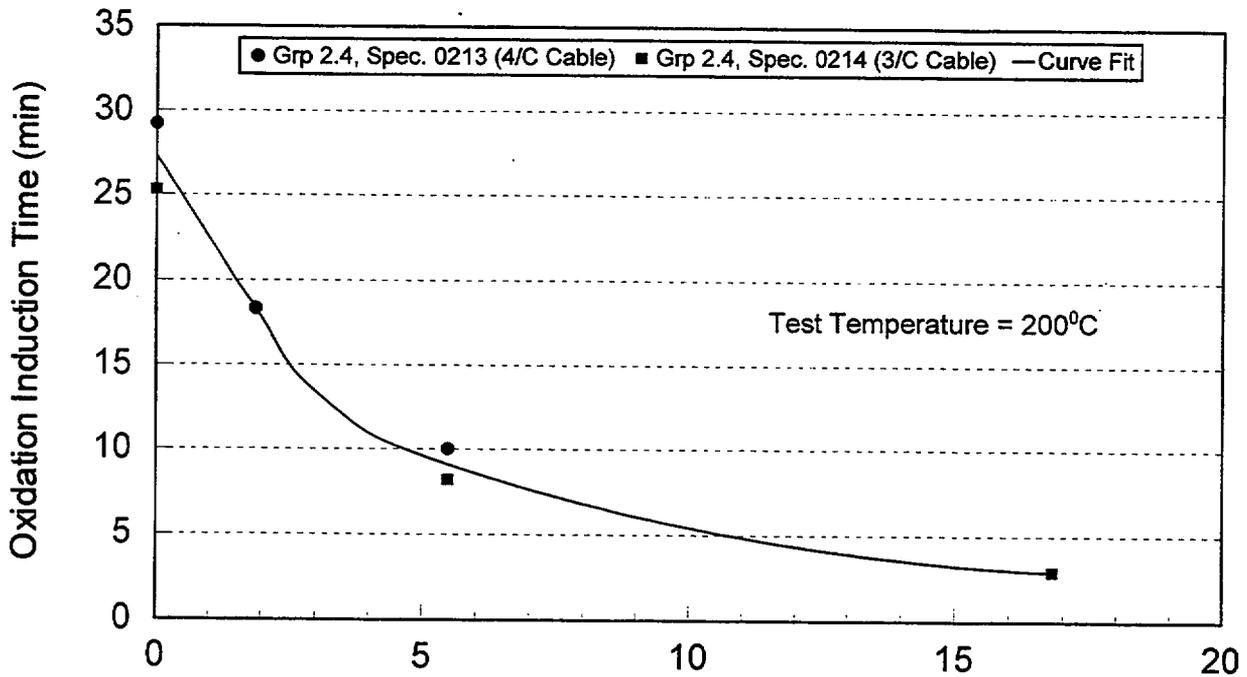
Figure 5.18 Correlation between OITM and service aging time for EPR insulation from AIW cable PNI74AI028 (Group 2.4, Specimens 0213 and 0214)

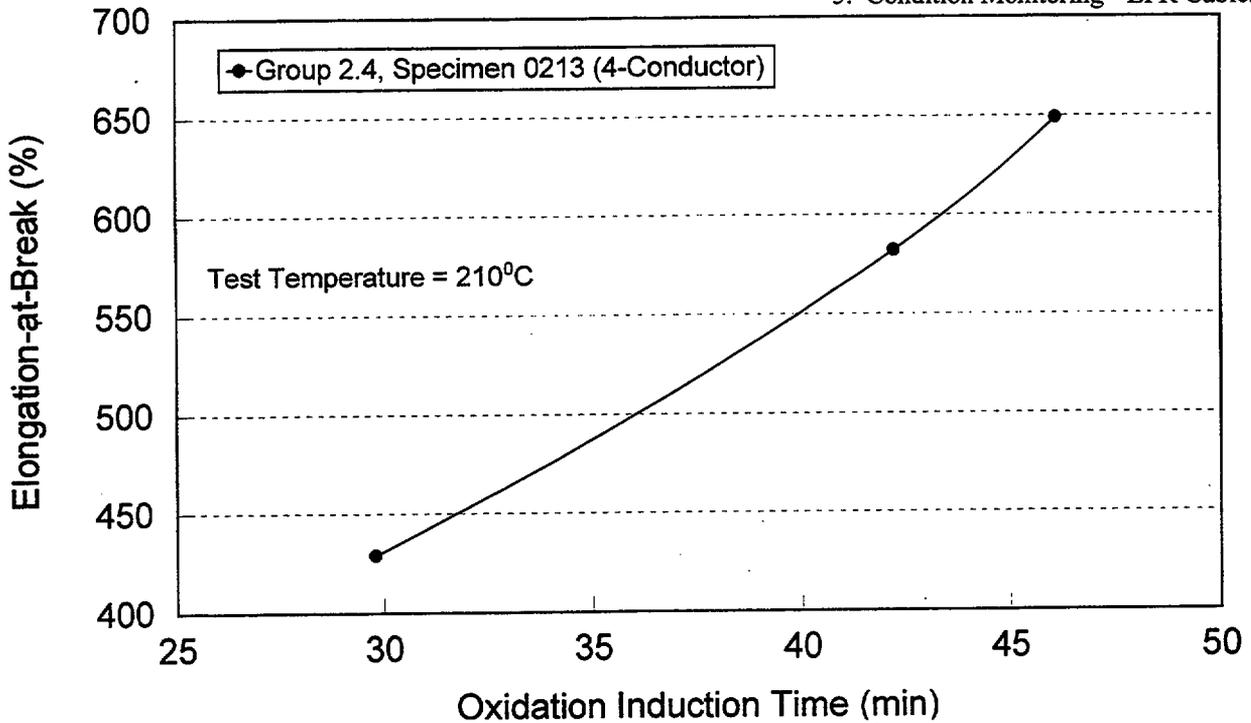
Figure 5.19 Correlation between OITM and EAB for Hypalon® outer jackets from AIW cable PNI74AI028 (Group 2.4, Specimen 0213)

Figures 5.19 and 5.20 show correlations between OITM and EAB and service aging time for Hypalon® outer jackets. Again, the data are limited but there is a clear relationship between the variables in each figure. This indicates that the OITM is a useful parameter to predict the EAB for Hypalon®.

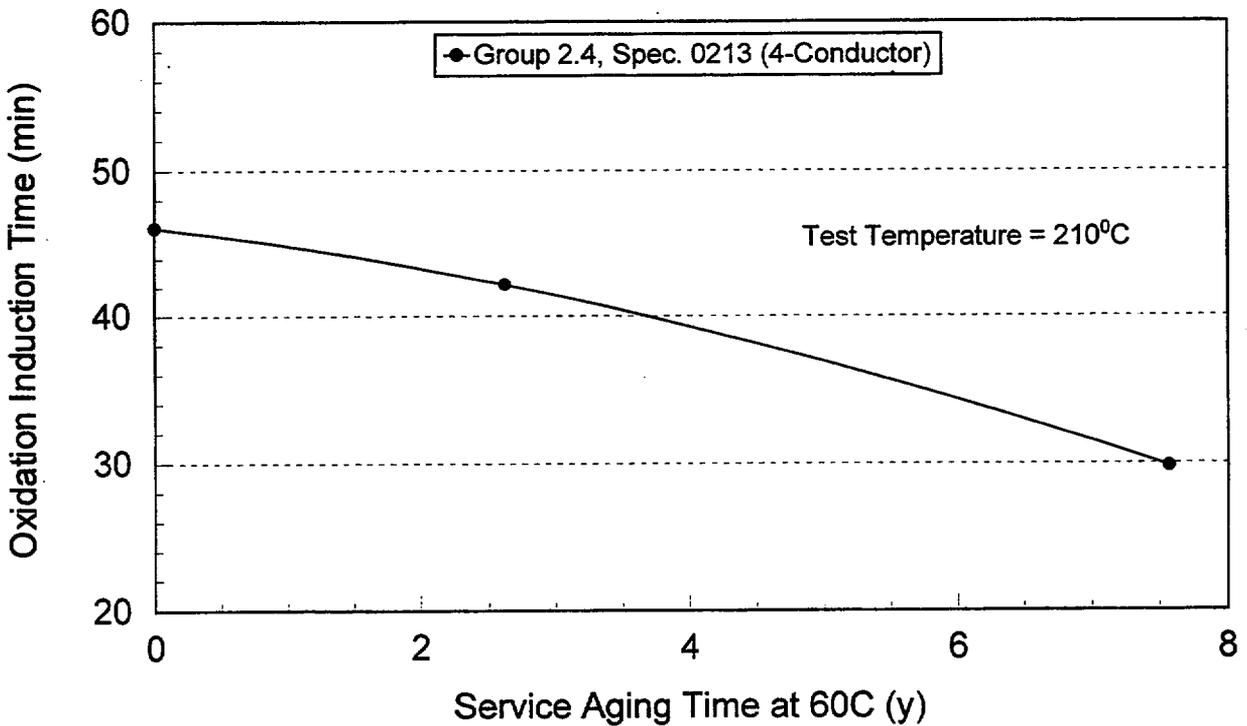
Figure 5.20 Correlation between OITM and service aging time for Hypalon® outer jackets from AIW cable PNI74AI028 (Group 2.4, Specimens 0213)

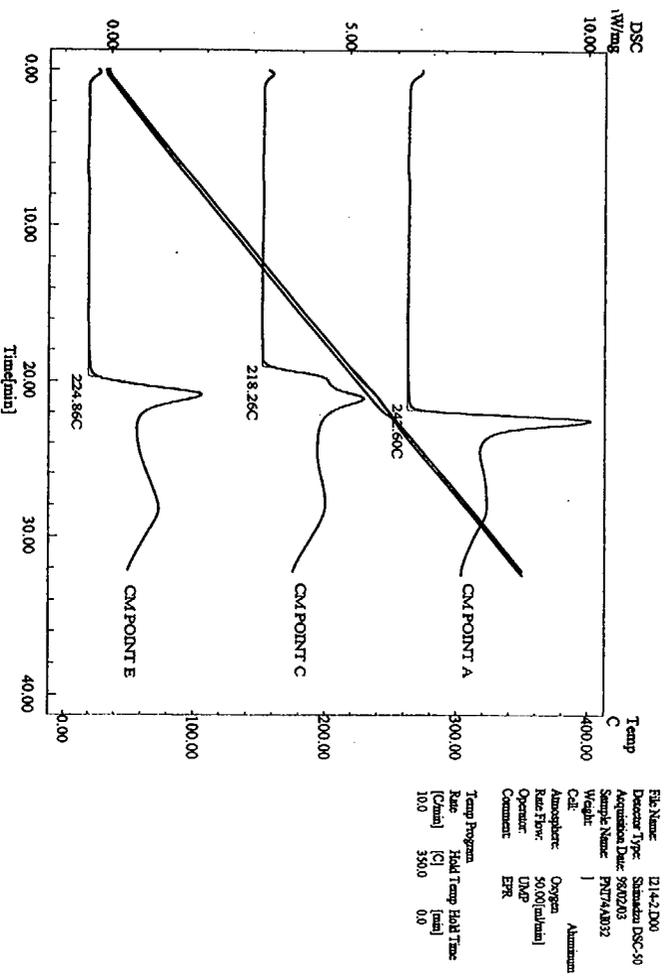
Figure 5.21 OTTP for AIW EPR (PN174A1032) as a function of service testing protocols

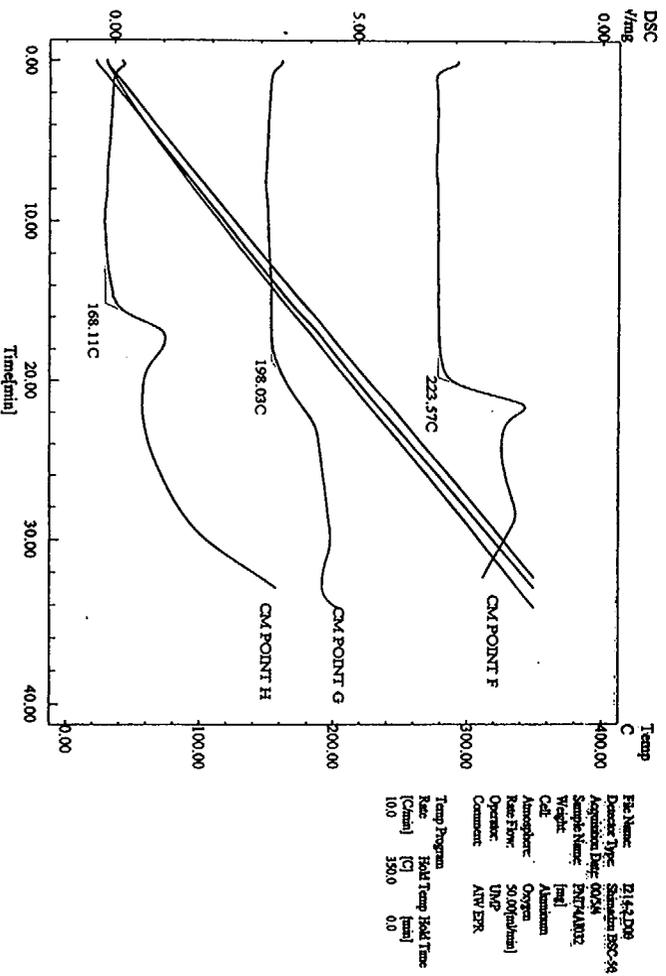
Figure 5.22 OTTP for AIW EPR (PN174A1032) as a function of LOCA testing protocols

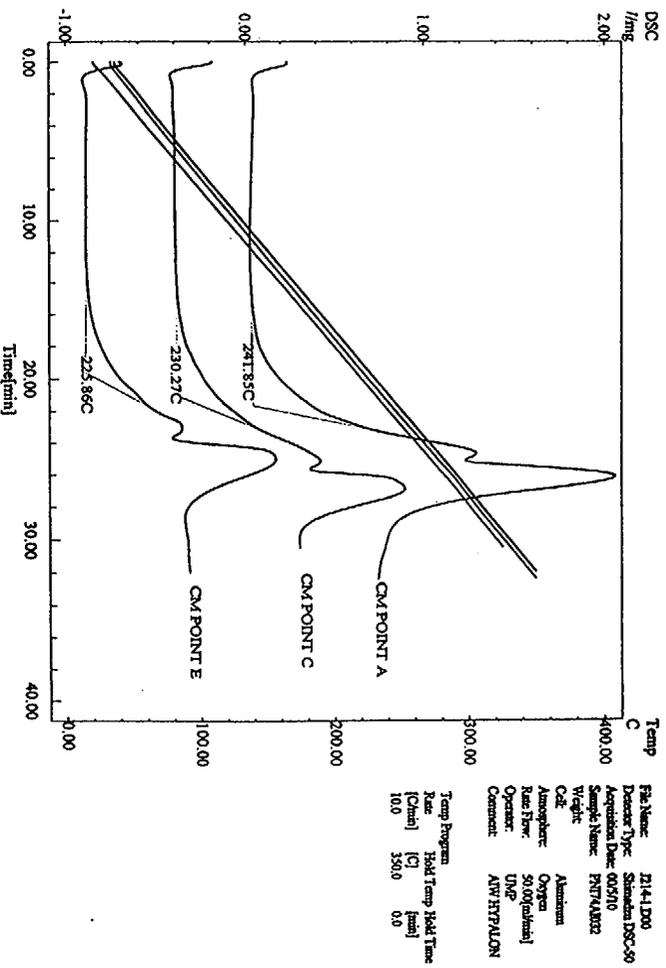
Figure 5.23 OTTP for AIW Hypalon® (PN174AI032) as a function of service testing protocols

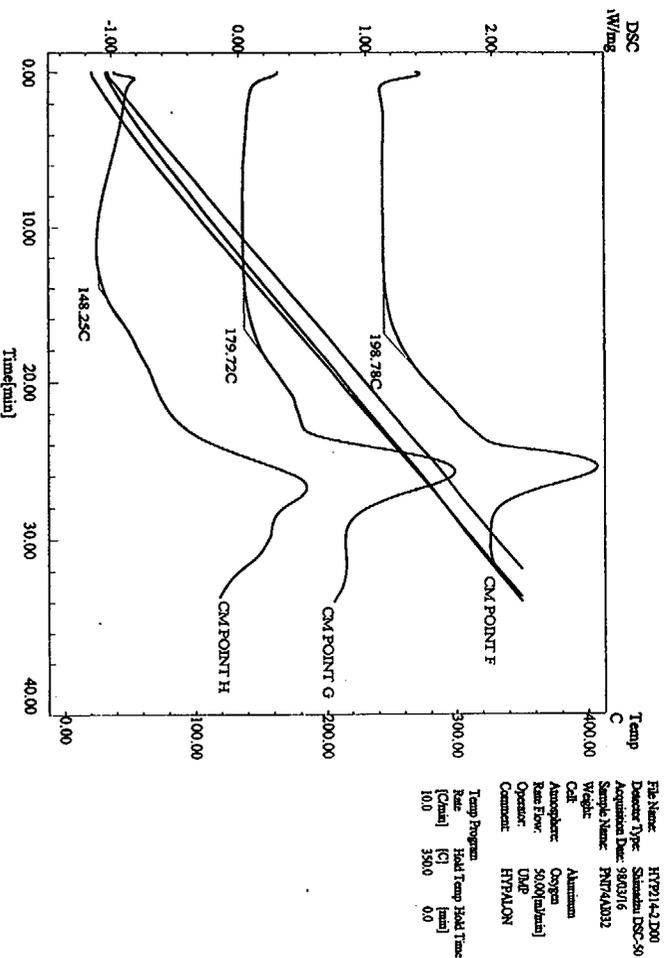
Figure 5.24 OTTP for AIW Hypalon® (PN174AI032) as a function of LOCA testing protocols

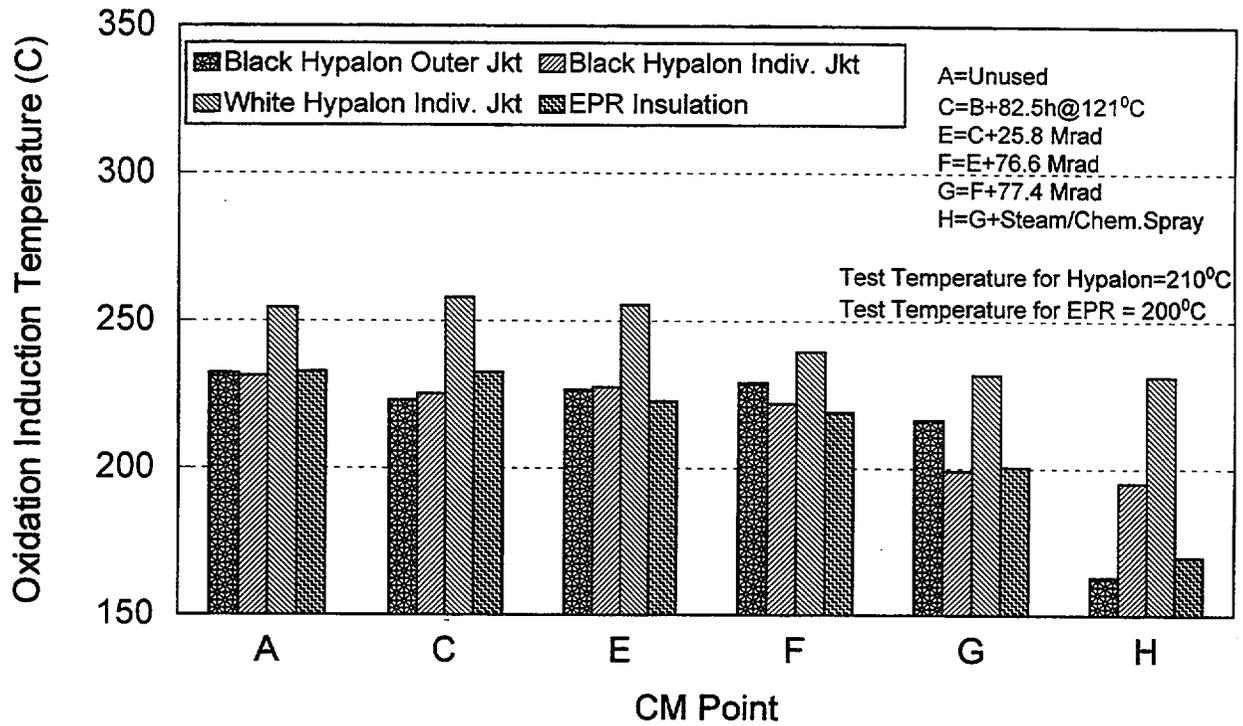
Figure 5.25 OITP for AIW EPR/Hypalon® cable (Group 2.4, Specimen 0213) as a function of CM point

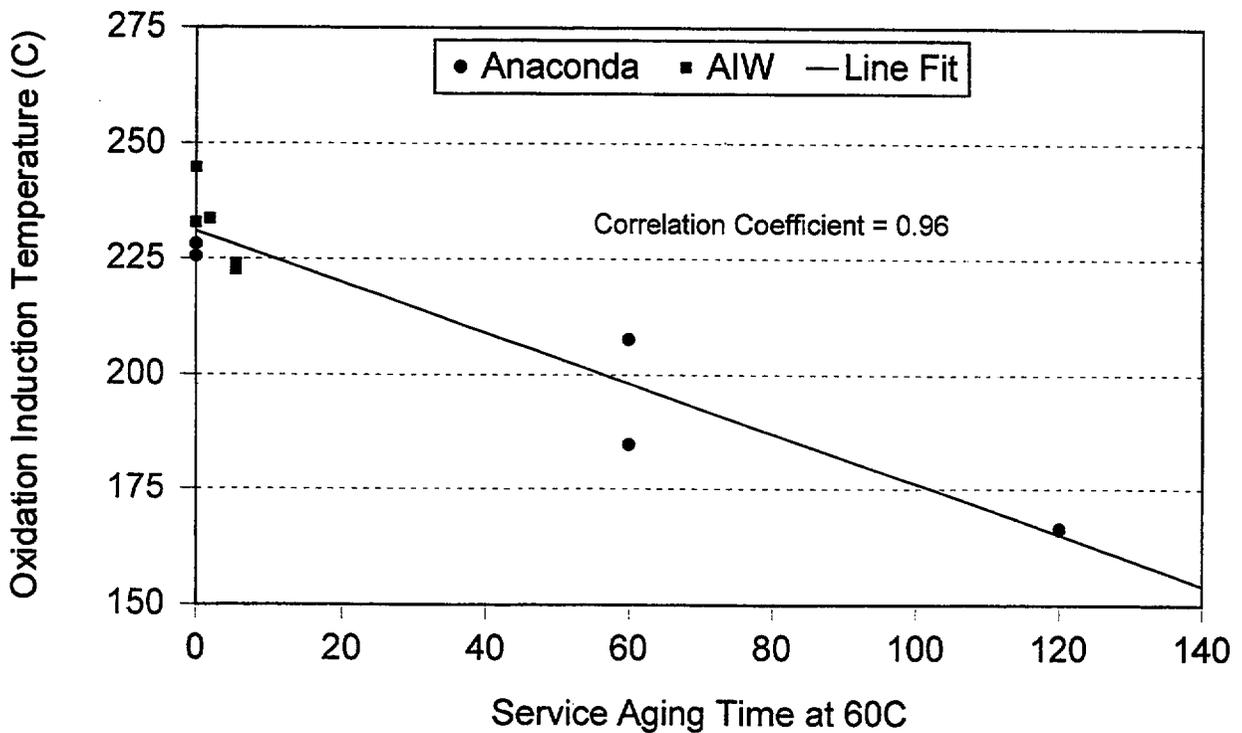
Figure 5.26 OITP for EPR insulation as a function of service aging time at 140°F (60°C)

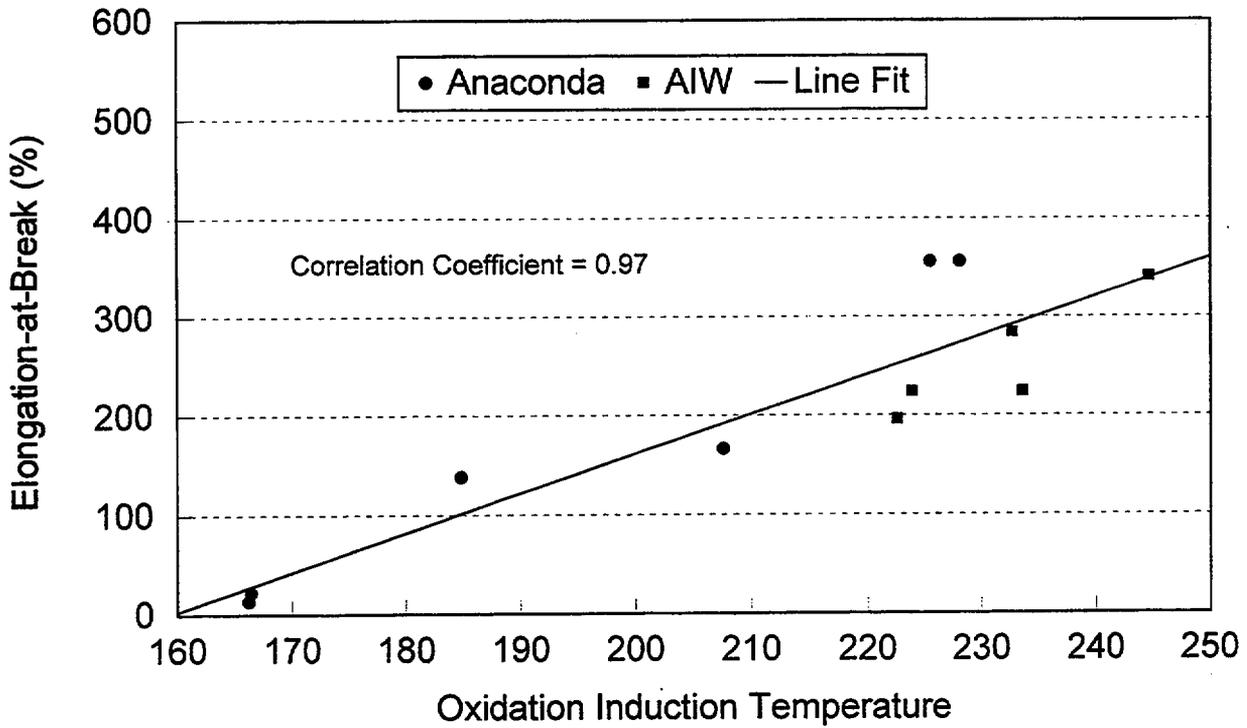
Figure 5.27 Correlation between EAB and OITP for EPR insulation from different manufacturers

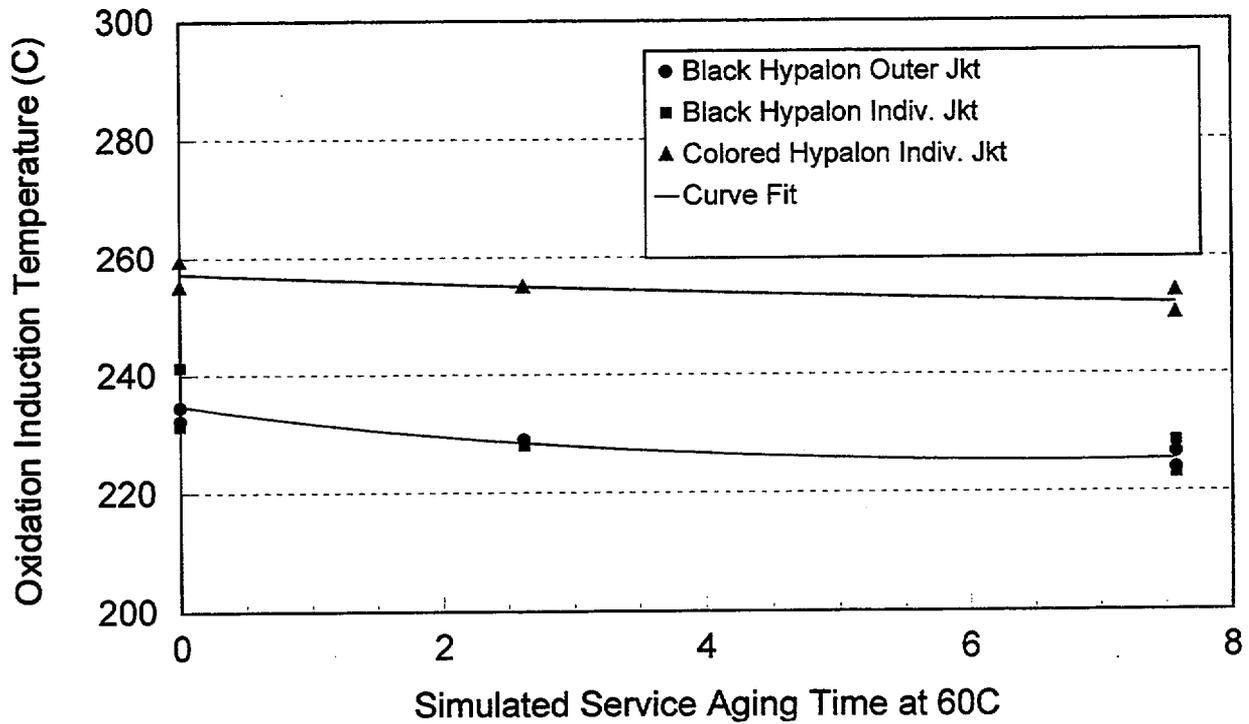
Figure 5.28 OITP for AIW Hypalon® outer and individual jackets as a function of service aging time at 140°F (60°C)

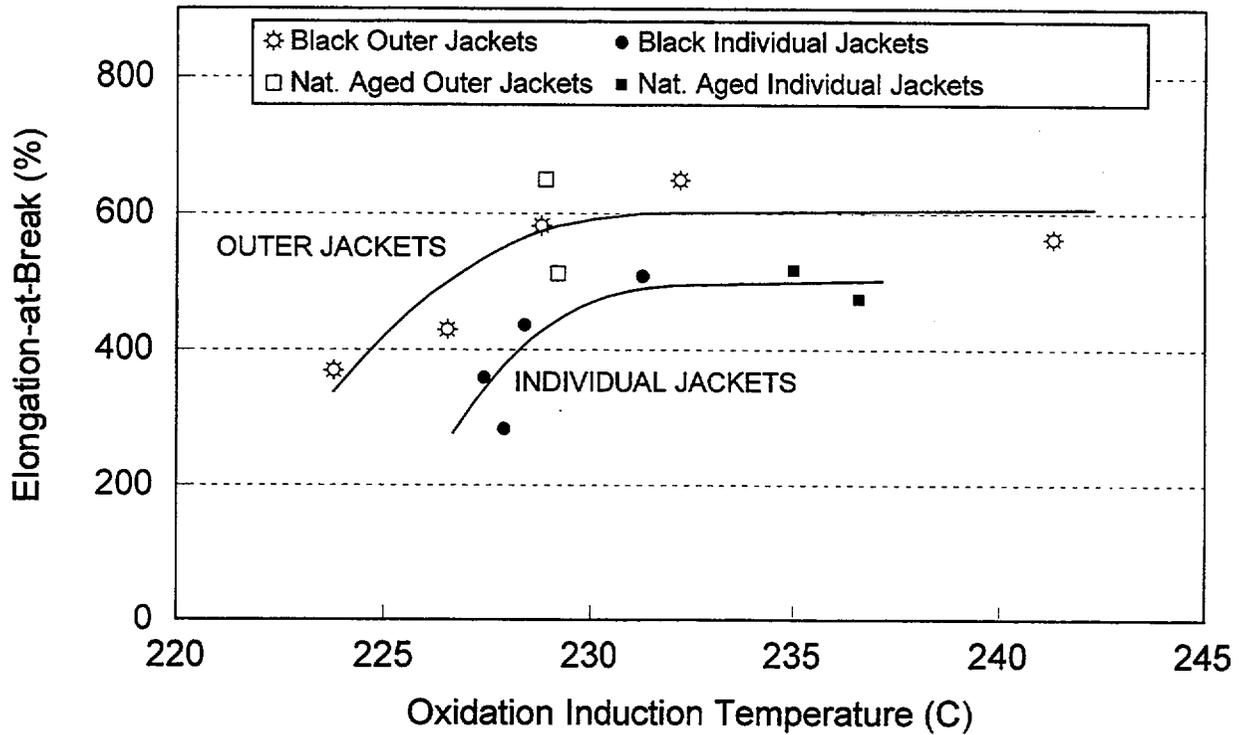
Figure 5.29 Correlation between EAB and OITP for AIW Hypalon® outer and black individual jackets as a function of OITP

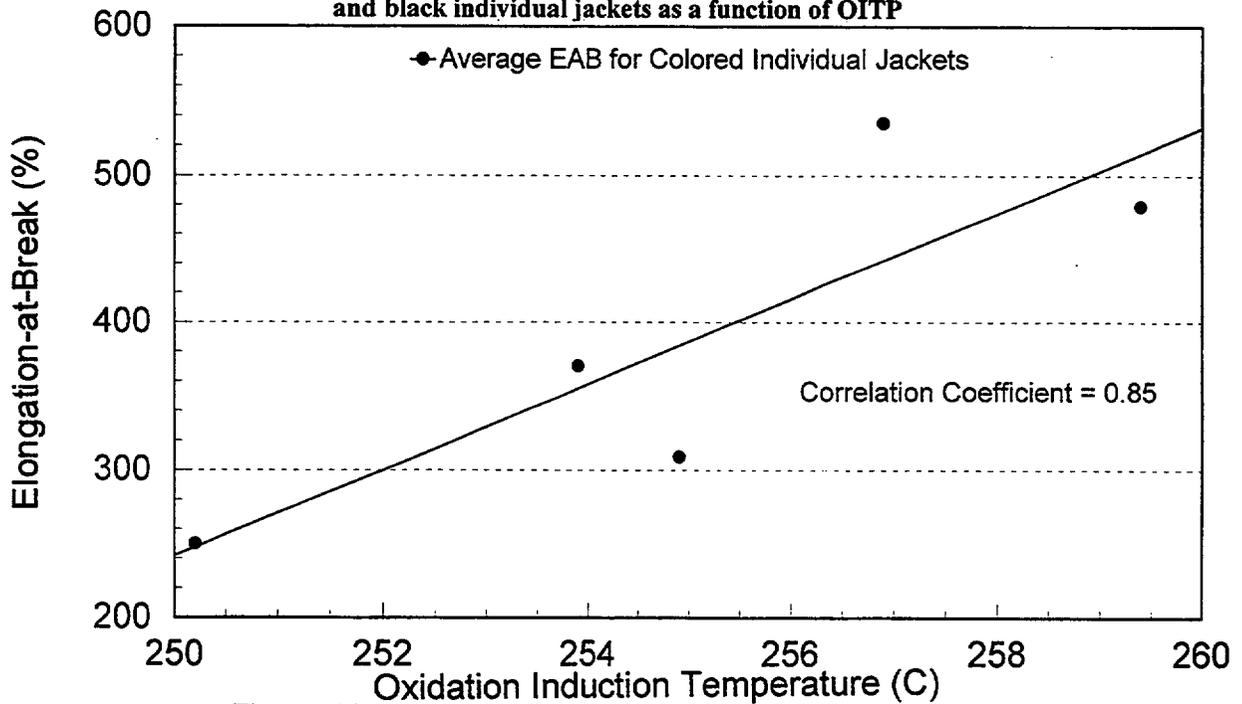
Figure 5.30 Correlation between EAB and OITP for AIW colored Hypalon® individual jackets as a function of OITP

The OITP values for the AIW outer and individual jackets are given in Table 5.4 and Figure 5.28 as a function of the service aging time. The black outer and individual jackets show similar behavior. The OITP values for the colored (non-black) individual jackets were averaged because of their similarity. It is noticed that the OITP values for the colored jackets are about 35°F (20°C) higher than those for black jackets. This shows that the colored jackets are more resistant to oxidation than the black jackets. Figure 5.29 shows that there is a correlation between the EAB and OITP for the black jackets. Therefore, in principle, the OITP may be used to estimate the residual EAB in aged black jackets. There also appears to be a correlation between EAB and OITP for the colored individual jackets, as shown in Figure 5.30 despite considerable scatter in the data.

In summary, a reasonable correlation was found between OITP and EAB, therefore, OITP is judged to be an acceptable method for estimating EAB for EPR/Hypalon® cable materials.

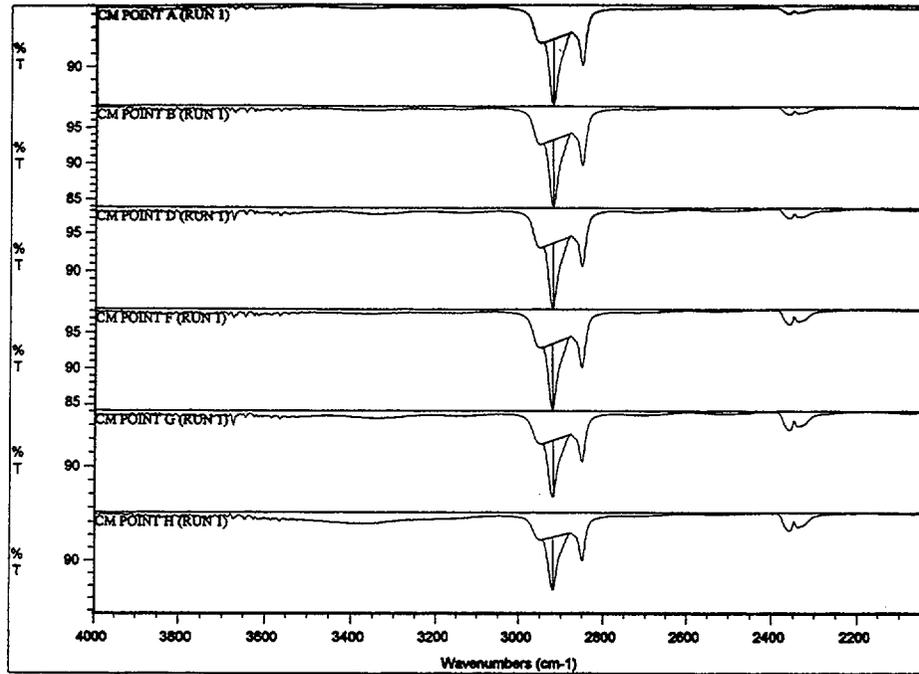
Figure 5.31 FTIR spectra for EPR insulation from AIW cable PNI74AI027 (Group 2.2, Specimen 0205) artificially aged to 20 years service

The technique used for the study of AIW EPR/Hypalon® cables is similar to that used for the XLPE/Neoprene® cables (see Sections 3.5 and 4.5 of this report). Appendix D is a tabulation of FTIR data obtained in the current program. Figure 5.31 shows FTIR spectra for EPR insulation that had received an accelerated aging protocol that simulates the aging that was received by the naturally aged cable in Group 2.3. This involved thermal aging of 28.45 hrs. at 250°F (121°C), CM point B, plus an irradiation of 3.25 Mrad, CM point D. Subsequent LOCA irradiations of 78.7 and 77.0 Mrad are given at CM points F and G, followed by steam/chemical spraying at CM point H. The EPR results, together with data for Hypalon® outer and white individual jackets, are plotted in Figure 5.32. They show that the service aging results in a small increase in transmittance for all three materials. After the second LOCA irradiation dose, the transmittance again increases slightly. When the steam/chemical spray is administered, the outer and individual jackets show a further increase in transmittance, but the EPR insulation shows a small decrease.

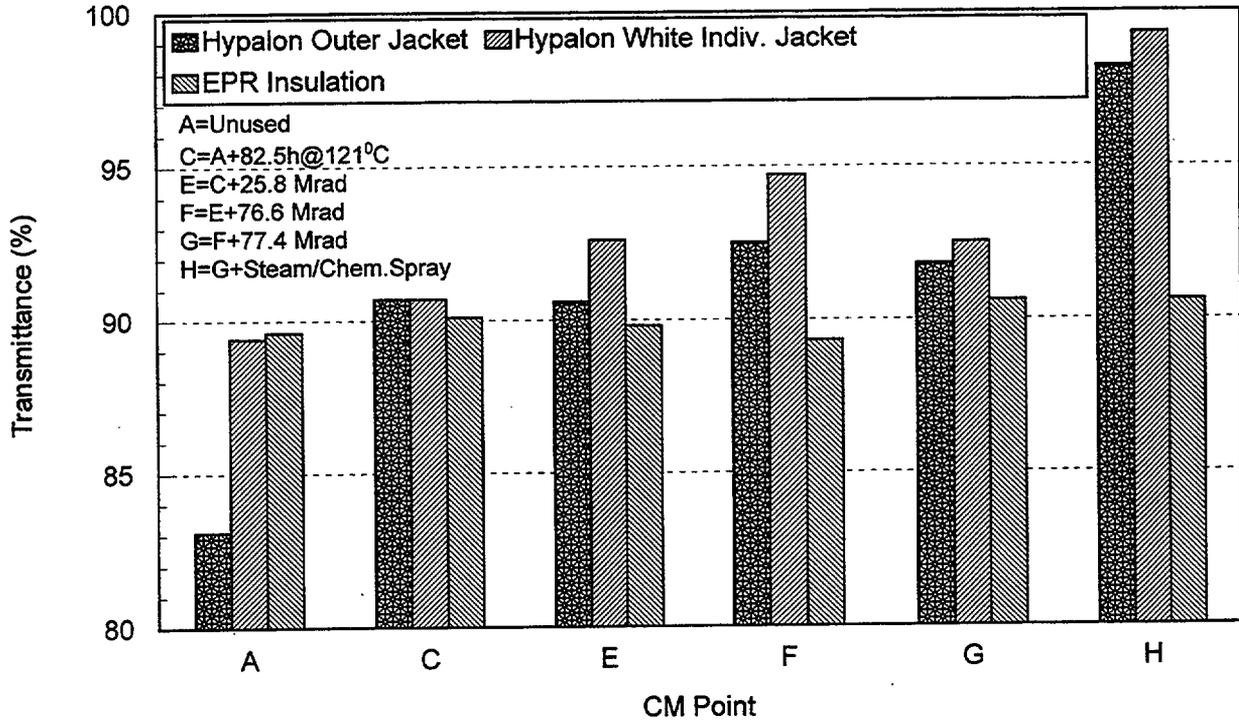
Figure 5.33 FTIR results for AIW cable PNI74AI028 (Group 2.4, Specimen 0213) artificially aged to one-half of the 40 year qualification protocol

Figure 5.33 shows data for cable that had received one-half of the 40 year qualification test protocol used by the cable manufacturer. The protocol involved a thermal aging step of 82.5 hrs at 250°F (121°C), CM point C, and an irradiation of 25.5 Mrad (CM point E). This is followed by two LOCA radiation exposures of 78.6 and 76.8 Mrad at CM point F and G, respectively. A final steam/chemical spray is administered at CM point H. The trends in transmittance for the various CM points are similar to those for the 20-year aging protocol shown in Figure 5.32.

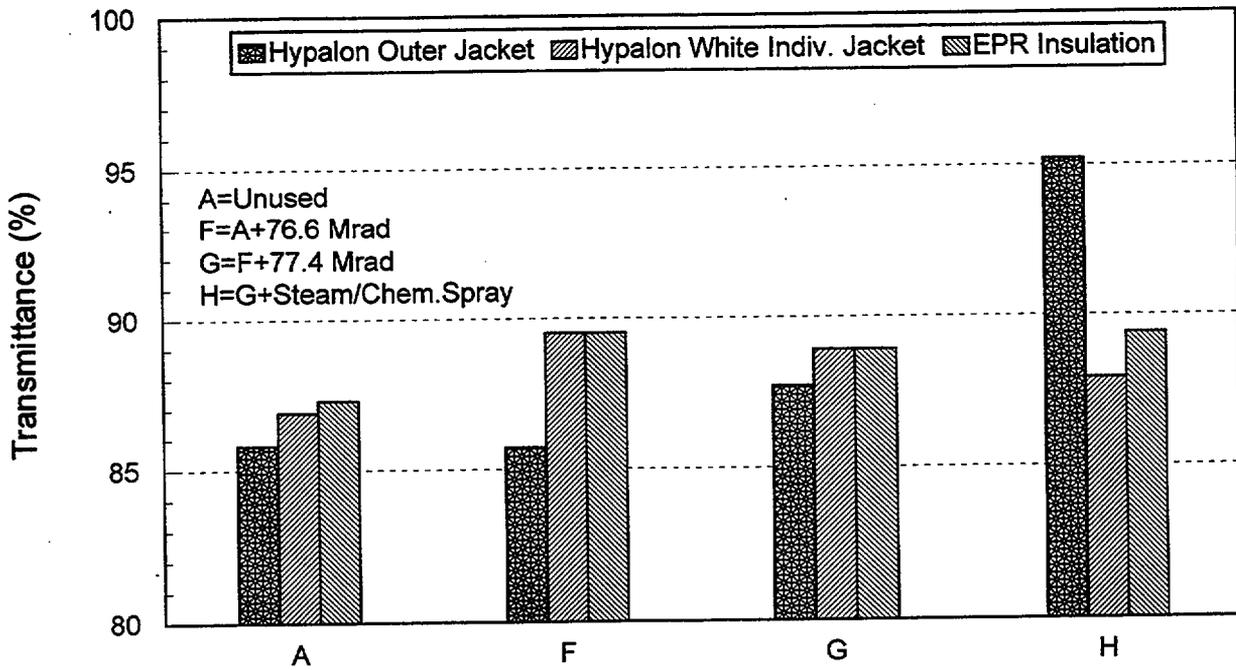
Figure 5.34 FTIR results for AIW cable PNI74AI019 (Group 2.3, Specimen 0210) naturally aged to 20 years service

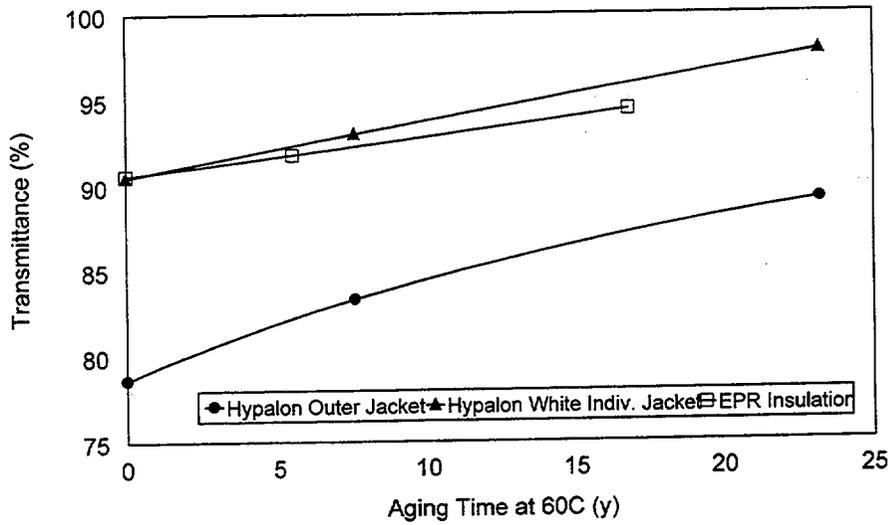
Figure 5.35 Correlation between FTIR transmittance and service aging time at 140°F (60°C) for AIW three-conductor cable

Table 5.5 shows FTIR and EAB data taken from Appendices E and B, respectively. Using this information the transmittances for three and four conductor AIW cable materials are plotted, respectively, in Figures 5.35 and 5.36 as a function of service aging time at a normalized temperature of 140°F (60°C). For both cable types, the percent increases with aging time. The one exception is for the EPR insulation for the four-conductor cable (Figure 5.36) which does not show a significant change after about 5 years of aging.

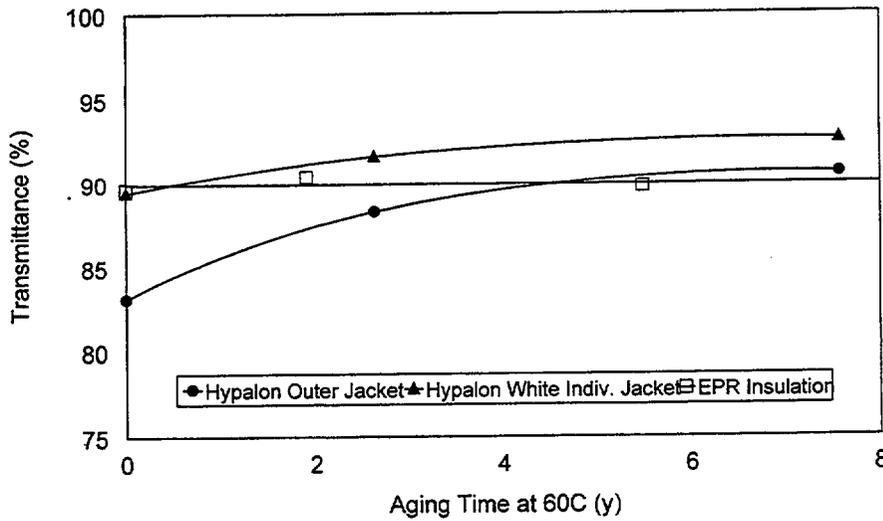
Figure 5.36 Correlation between FTIR transmittance and service aging Time at 140°F (60°C) for AIW four-conductor cable

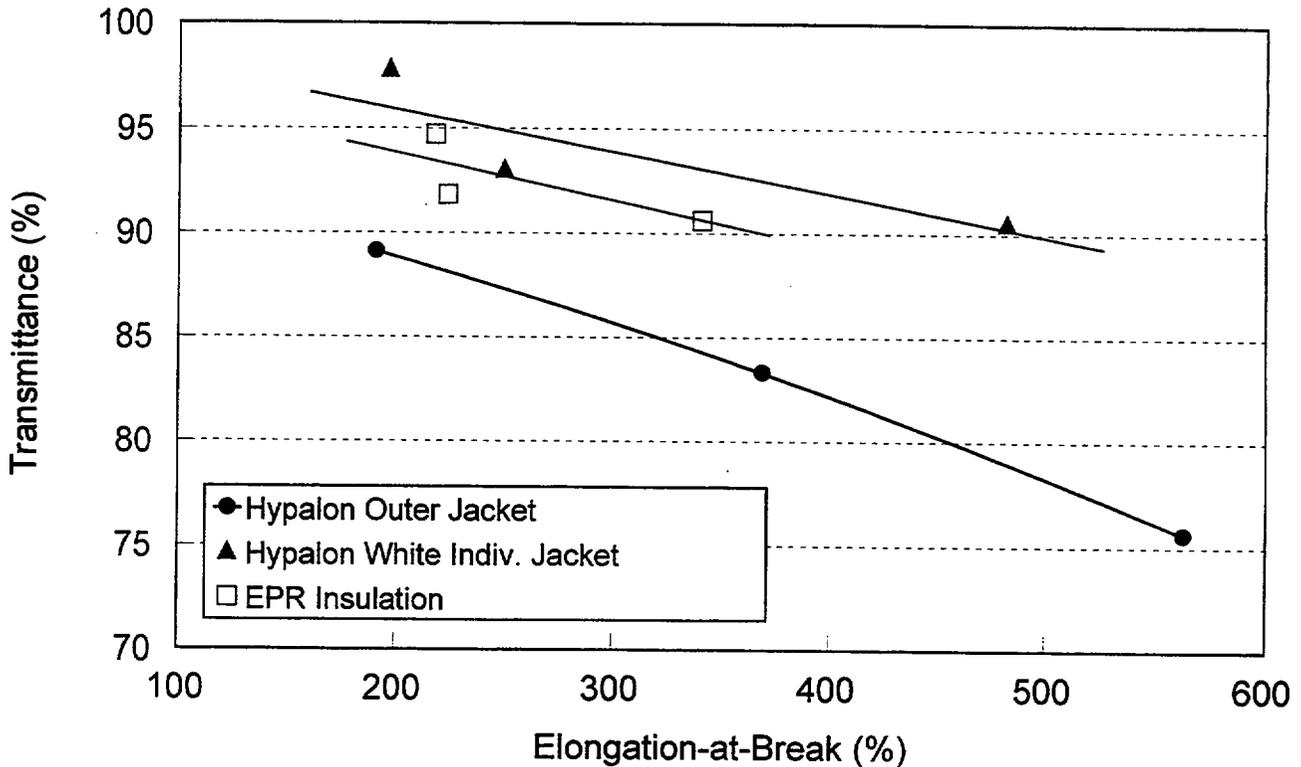
Figure 5.37 Correlation between FTIR transmittance and elongation-at-break for AIW three-conductor cable

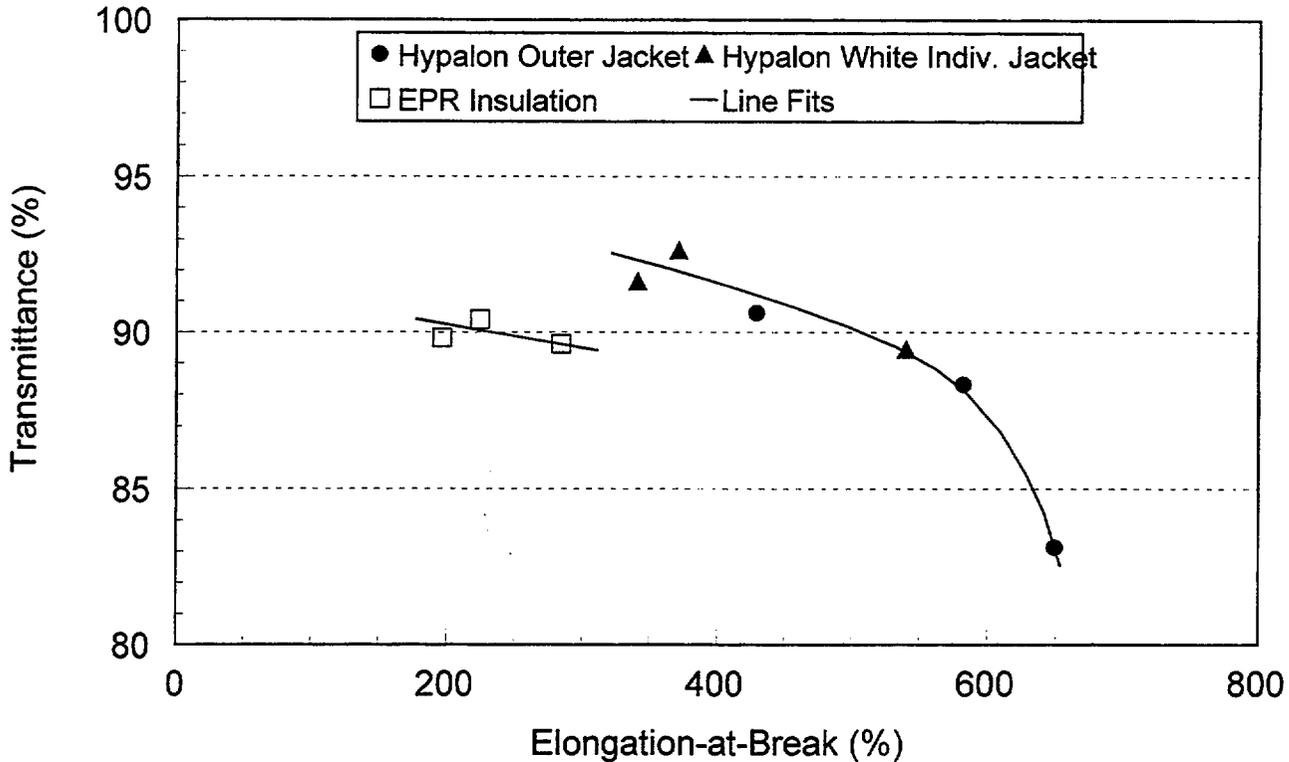
**Figure 5.38 Correlation between FTIR transmittance and elongation-at-break for AIW four-conductor cable**

Figures 5.37 and 5.38 show the FTIR transmittance as a function of the elongation-at-break for AIW three and four conductor cables, respectively. When the materials are given service aging treatments, the ductilities decrease and the transmittances increase. This is in keeping with the loss of  $-CH_2$  bonds by oxidation.

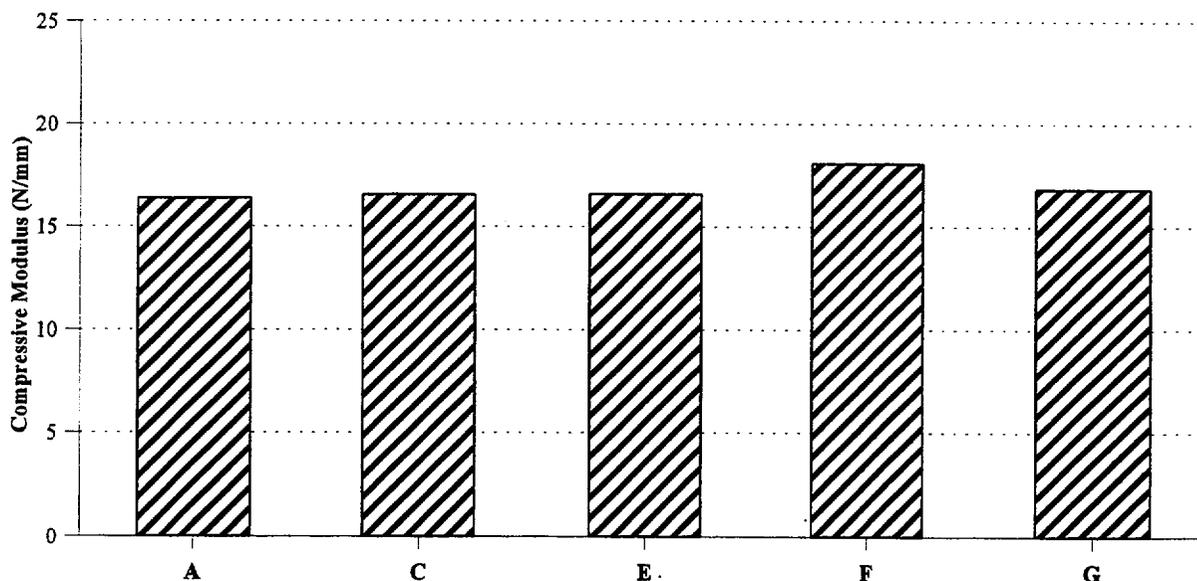
Figure 5.39 Average compressive modulus for EPR insulation from AIW specimens pre-aged to 60 yr.

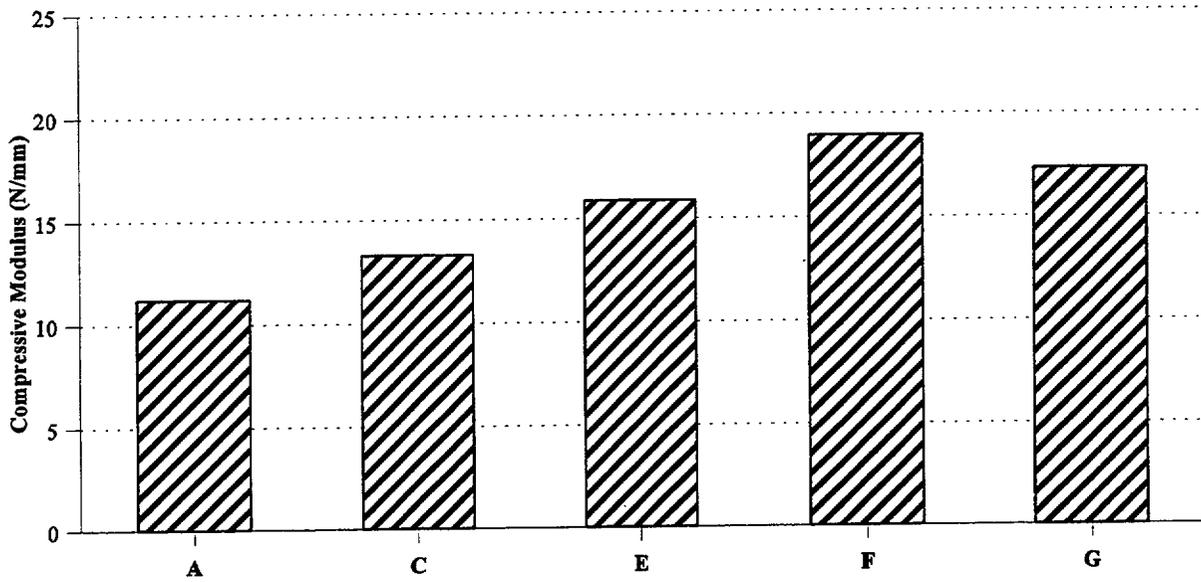
**Figure 5.40 Average compressive modulus for composite EPR/unbonded Hypalon® insulation from AIW specimens in test sequence 6 pre-aged to 60 yr.**

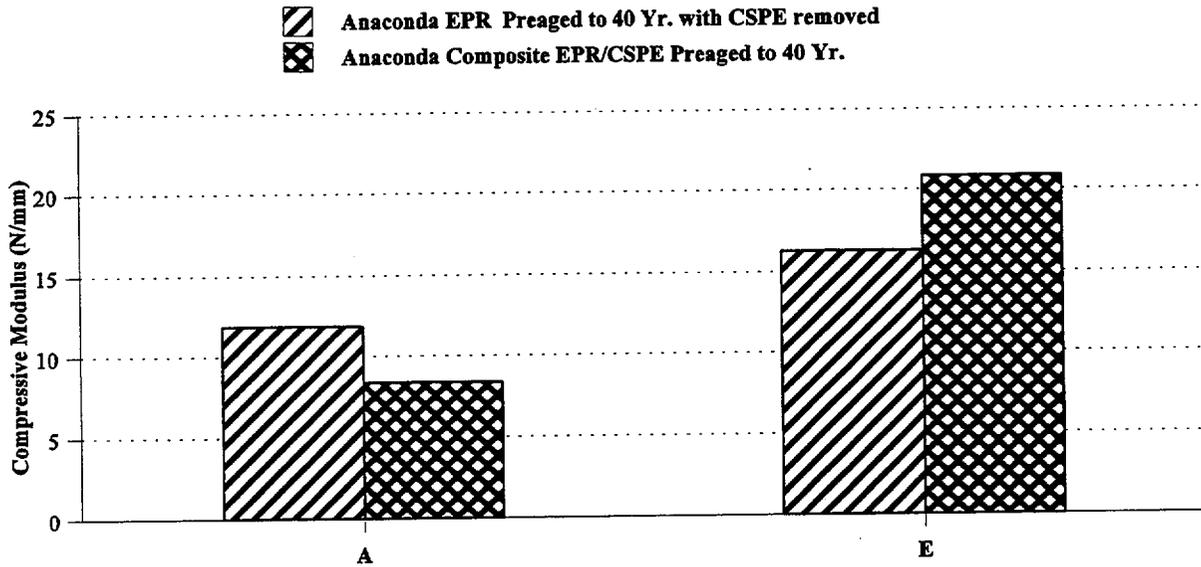
**Figure 5.41 Average compressive modulus for EPR insulation from Anaconda specimens in test sequence 4 pre-aged to 40 yr. with and without Hypalon® individual jacket**

A = Baseline                      E = Post Thermal and Radiation Service Pre-aging

To examine this further, data for EPR-insulated Anaconda specimens pre-aged to 40 years of equivalent qualified life, both with and without the Hypalon® individual jacket, were compared (Figure 5.41). As shown, the specimens with EPR alone exhibited a smaller increase in compressive modulus from their baseline value to post-service aging (overall increase of 37 percent) compared to the specimens with the composite EPR/unbonded Hypalon® individual jacket (overall increase of 149 percent). These results are consistent with those from the AIW specimens and indicate that the Hypalon® individual jacket influences the change in compressive modulus of the insulation as a function of aging degradation.

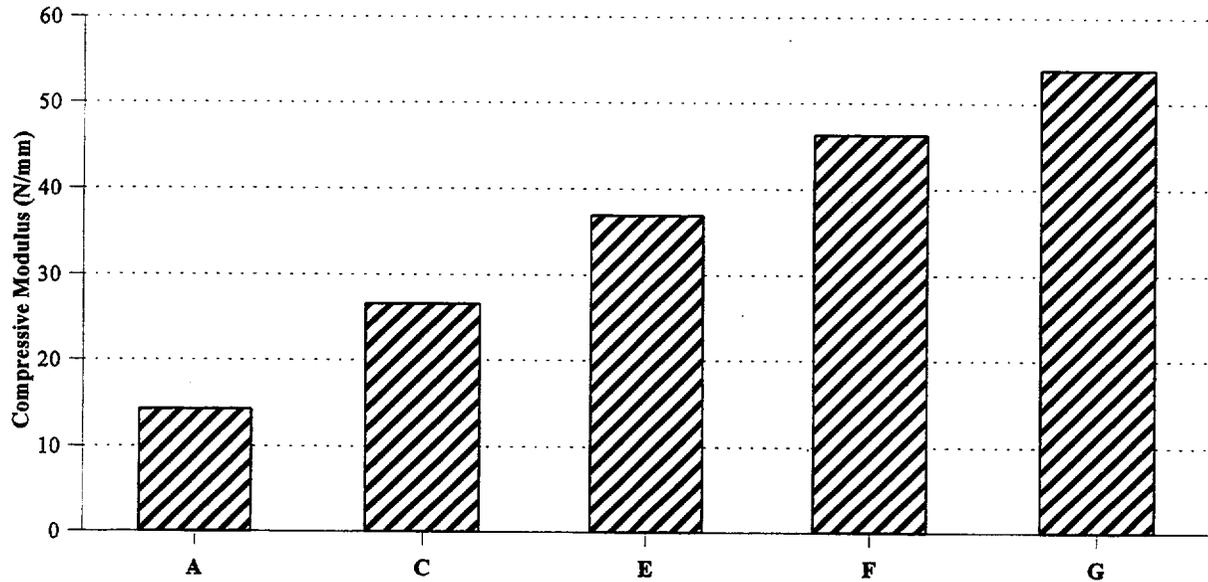
**Figure 5.42 Average compressive modulus for composite EPR/bonded Hypalon® insulation from Samuel Moore specimens in test sequence 6 pre-aged to 60 yr.**

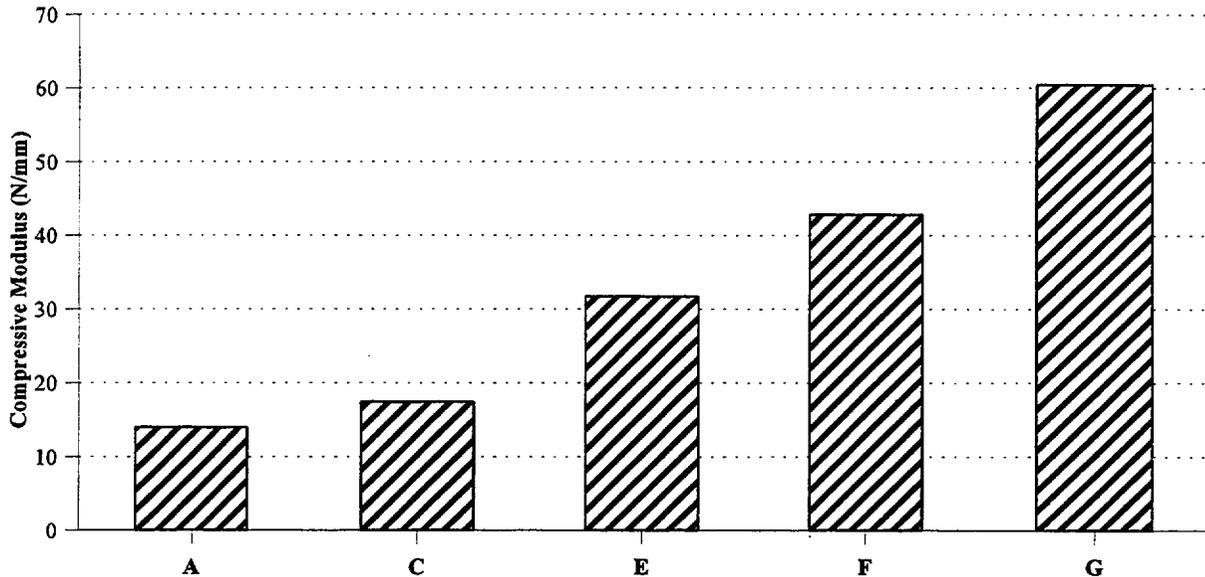
Figure 5.45 Average compressive modulus for Hypalon® outer jacket from Samuel Moore specimens in test sequence 6 pre-aged to 60 yr.

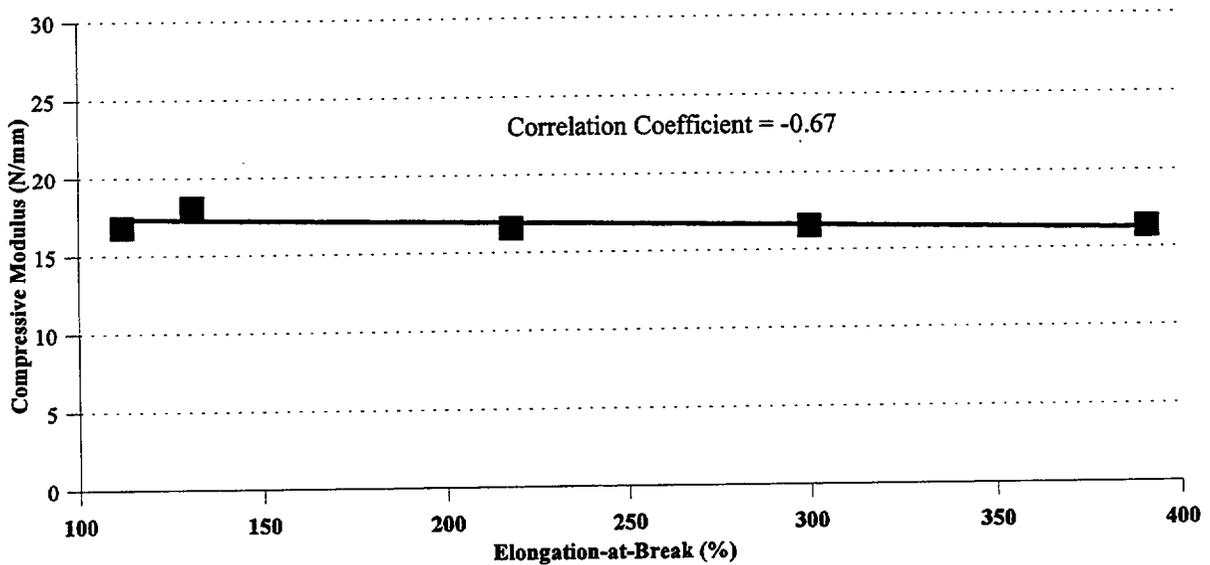
**Figure 5.46 Correlation of Compressive Modulus with EAB for EPR insulation from AIW specimens in test sequence 6 pre-aged to 60 yr.**
