# Assessment of Environmental Qualification Practices and Condition Monitoring Techniques for Low-Voltage Electric Cables

Condition Monitoring Test Results

Brookhaven National Laboratory

U.S. Nuclear Regulatory Commission  
Office of Nuclear Regulatory Research  
Washington, DC 20555-0001

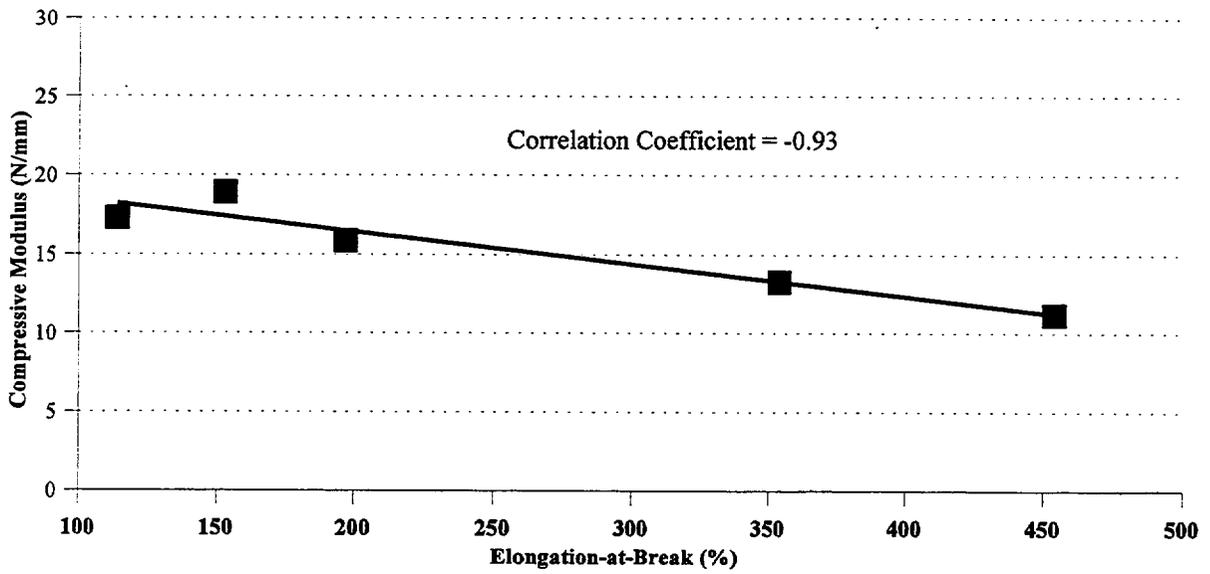
Figure 5.47 Correlation of Compressive Modulus with EAB for composite EPR/unbonded Hypalon® insulation from AIW specimens in test sequence 6 pre-aged to 60 yr.  
(Note: EAB values are for Hypalon® individual jacket alone)

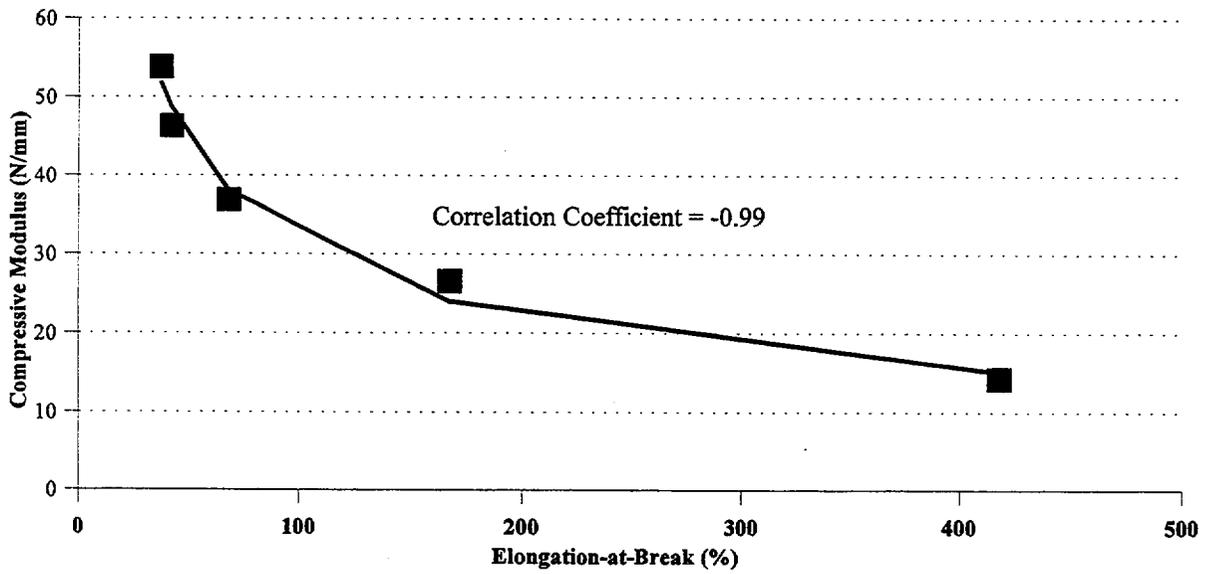
Figure 5.48 Correlation of Compressive Modulus with EAB for composite EPR/bonded Hypalon® insulation from Samuel Moore specimens in test sequence 6 pre-aged to 60 yr.

As discussed previously, EAB is often considered the standard against which the effectiveness of other condition monitoring techniques is measured. To determine how well the indenter data obtained in this study correlates with the EAB values for the materials tested, compressive modulus was plotted against EAB for several of the specimens. As shown in Figure 5.46, the EPR insulation alone did not have a very good correlation with EAB since the compressive modulus changed very little with increasing aging while the EAB continuously decreased. However, with a Hypalon® individual jacket applied to the EPR, the compressive modulus values correlated very well with EAB, as shown in Figures 5.47 and 5.48 for the AIW and Samuel Moore specimens, respectively. In both cases, an excellent correlation was found with compressive modulus continuously increasing corresponding to a decrease in EAB as aging degradation increased. Correlation of compressive modulus with EAB for the Hypalon® outer jacket was also found to be very good (Figure 5.49).

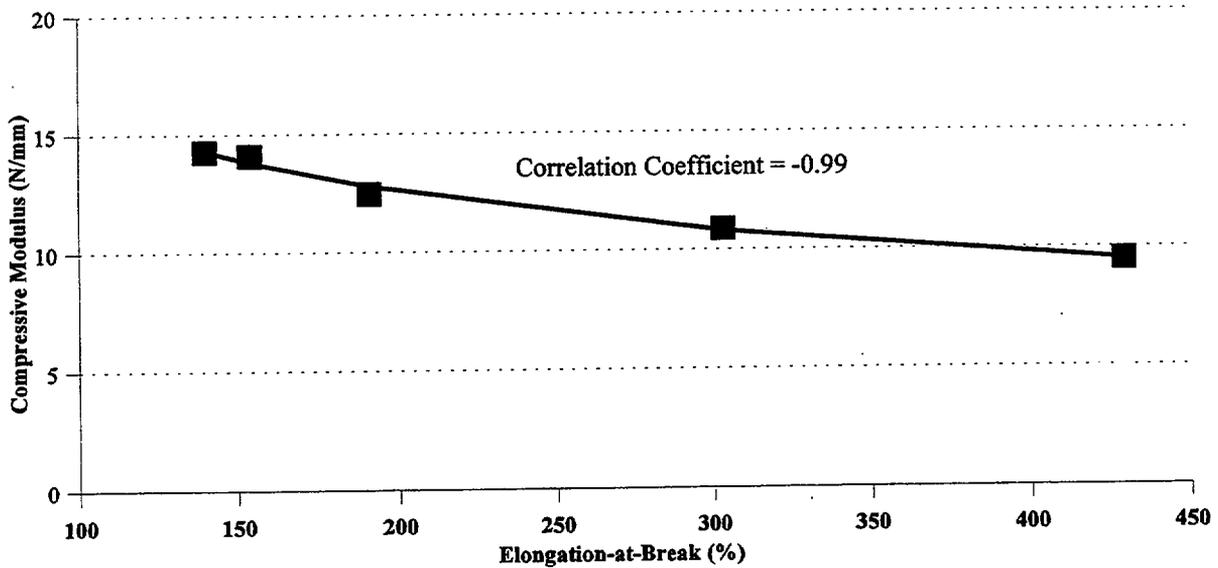
Figure 5.49 Correlation of Compressive Modulus with EAB for Hypalon® outer jacket from AIW specimens in test sequence 6 pre-aged to 60 yr.

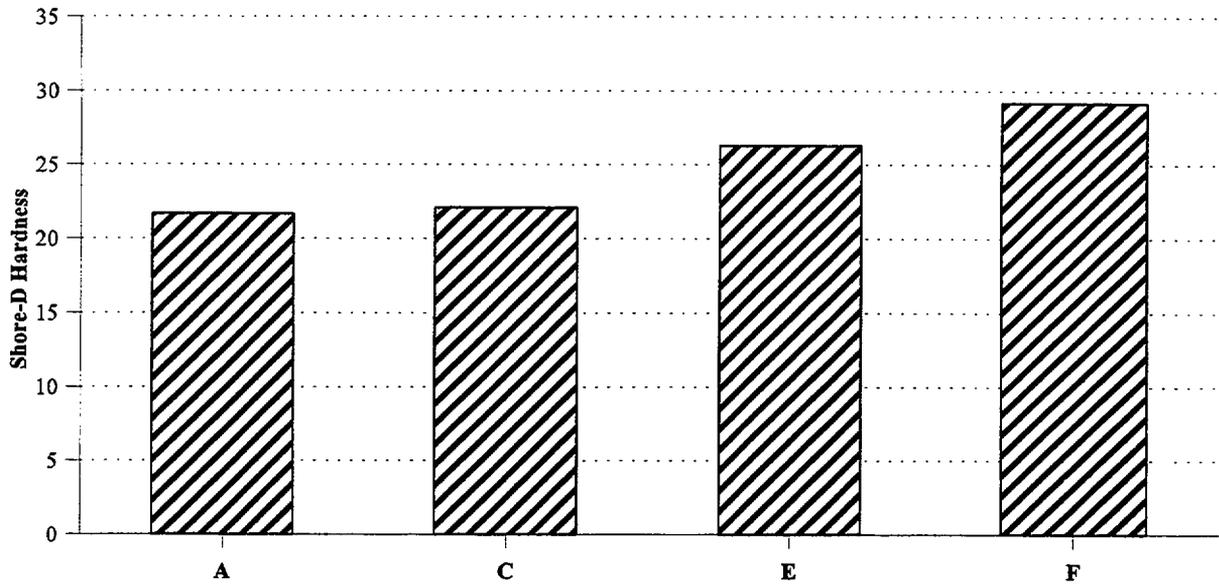
Figure 5.50 Hardness versus pre-aging for EPR material from AIW specimens in Group 2.4, test sequence 2 pre-aged to 20 yr.

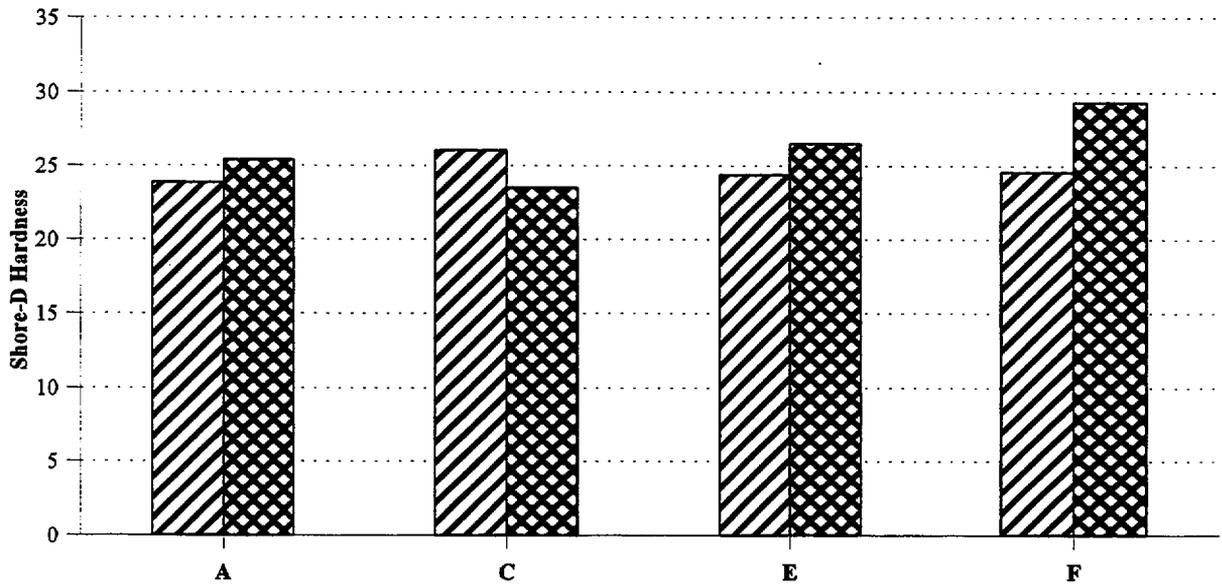
Figure 5.51 Hardness versus pre-aging for Hypalon® material from AIW specimens in Group 2.4, test sequence 2 pre-aged to 20 yr.

A = Baseline  
 C = Post Thermal Pre-aging  
 E = Post Service Radiation  
 F = Post half accident radiation

Hardness data were obtained for the AIW EPR-insulated cable specimens in test sequence 2. The average hardness results for the Group 2.4 specimens pre-aged to the equivalent of 20 years of qualified life show that none of the specimens tested in this sequence exhibited a dramatic increase in hardness (Figures 5.50 and 5.51). Figure 5.50 shows the EPR insulation experienced a 34 percent increase in hardness (21.7 to 29). The increase was continuous and would provide a means of trending degradation rate for this material.

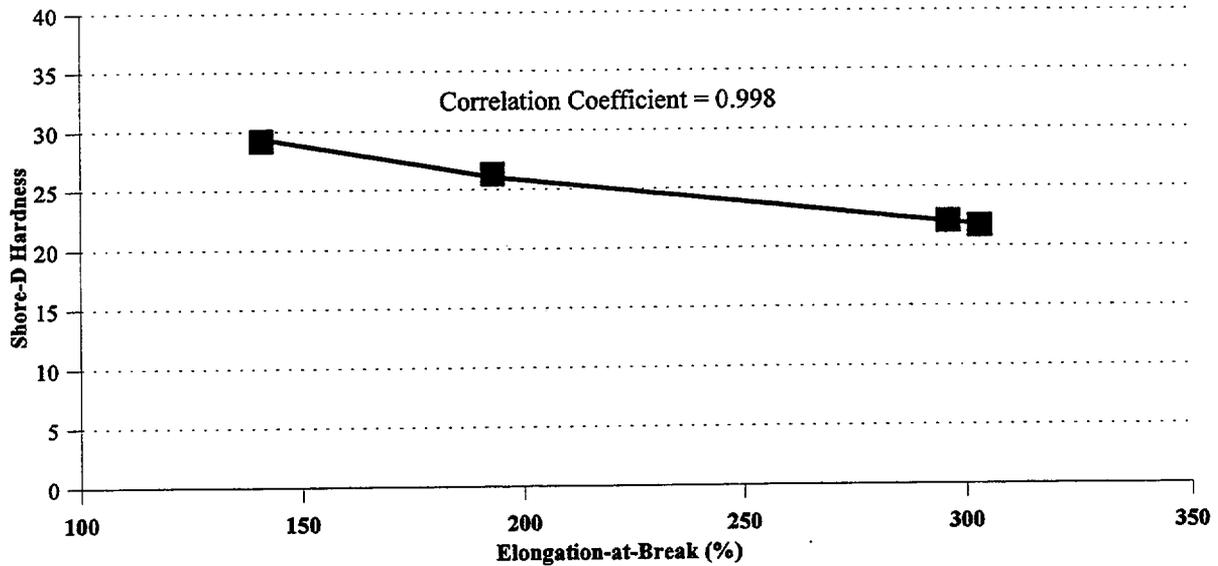
Figure 5.52 Correlation of Shore-D Hardness with EAB for EPR insulation from Group 2.4 AIW specimens pre-aged to 20 yr.

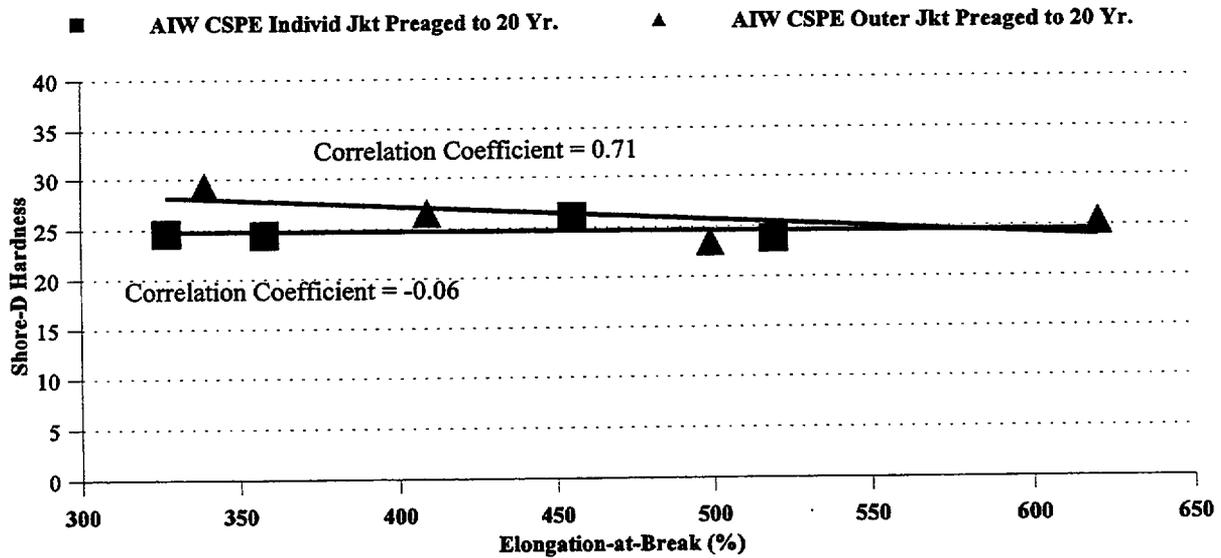
Figure 5.53 Correlation of Shore-D Hardness with EAB for Hypalon® from Group 2.4 AIW specimens pre-aged to 20 yr.

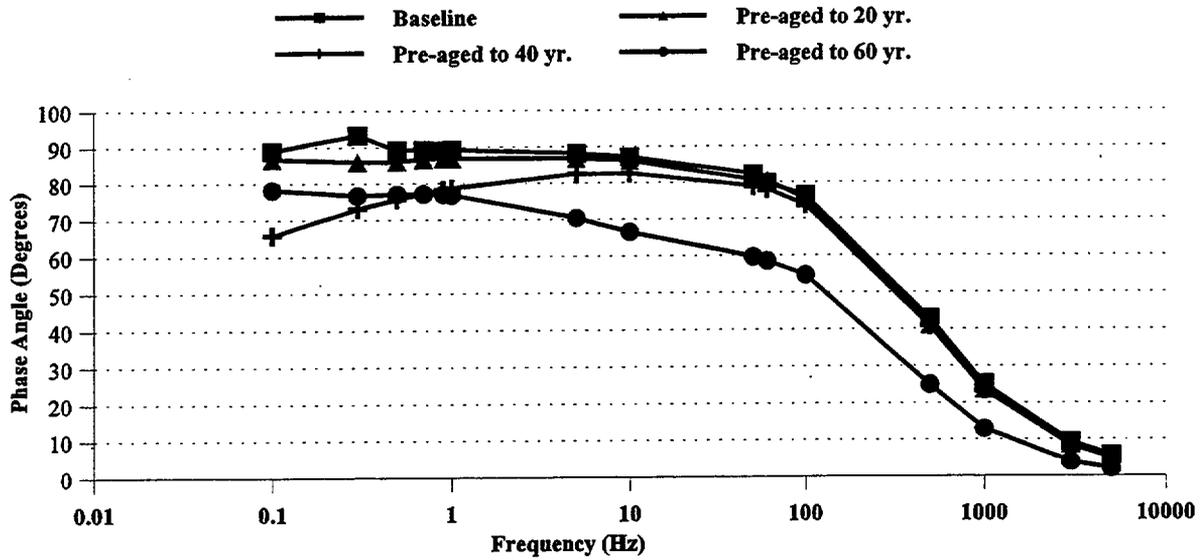
Figure 5.54 Dielectric phase angle vs test voltage frequency for aged Okonite cables

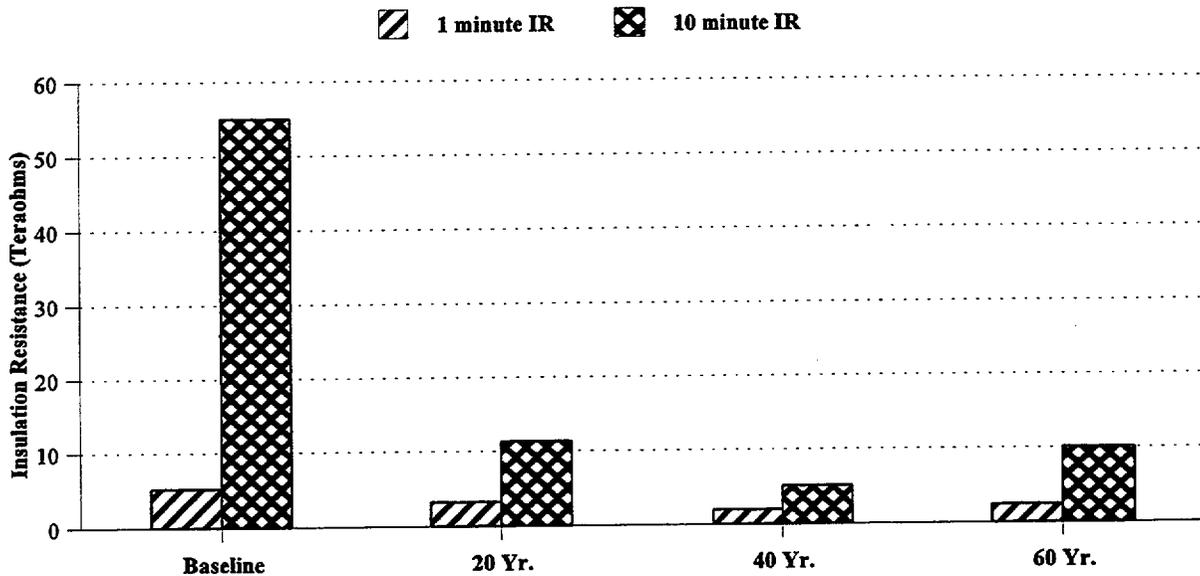
Figure 5.55 Insulation Resistance (IR) for aged EPR-insulated Samuel Moore cables

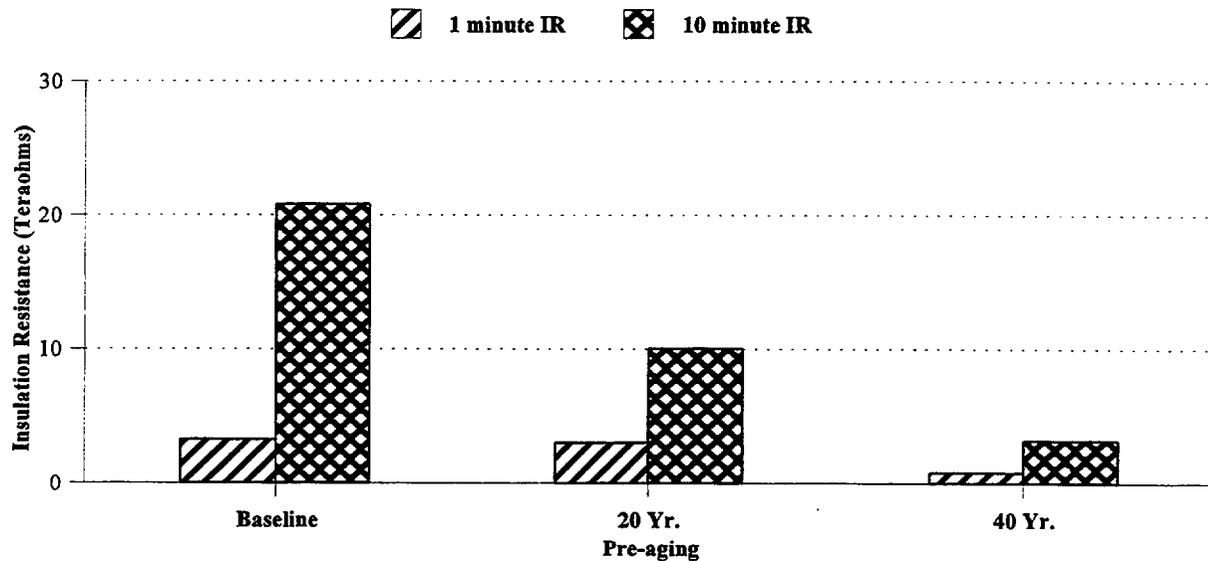
**Figure 5.56 Insulation Resistance (IR) for aged EPR-insulated Anaconda cables**
