WSRC-TR-2001-00067

**Degradation and
Failure Characteristics
of NPP Containment
Protective Coating Systems (U)
Interim Report No. 3**

SRTC Coating System No. 1
(Phenoline[®] 305 epoxy-phenolic topcoat,
Carbozinc[®] 11 primer, carbon steel substrate)

Savannah River Technology Center
Westinghouse Savannah River Company
Aiken, SC 29808

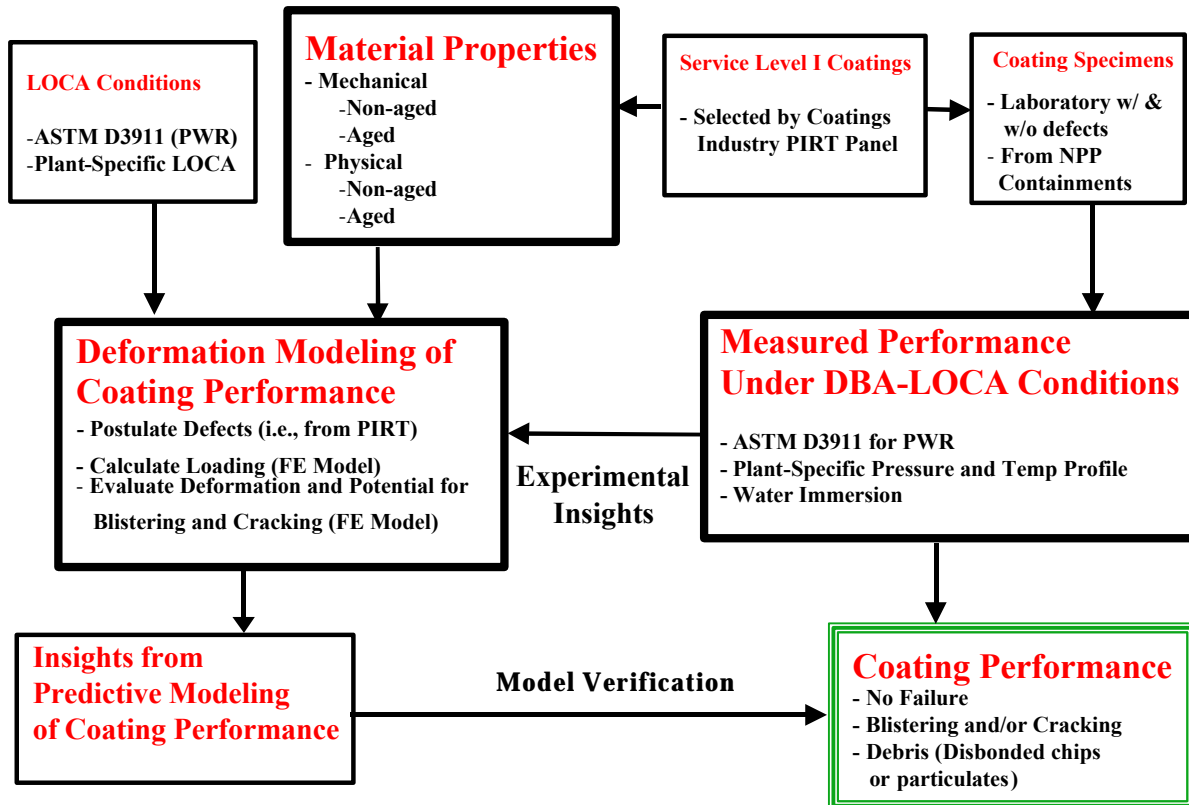
Figure 2-1. Task Logic Diagram for SRTC Project

The Savannah River Technology Center coatings research program is designed to investigate the potential degradation and failure of Service Level I protective coatings under postulated LOCA conditions. The key program elements and interactive paths are shown in Figure 2-1. The program goal is to evaluate the performance of “qualified” coating systems exposed to DBA-LOCA conditions. Coating response could range from “no failure,” to minor blistering and/or cracking, to production of debris through

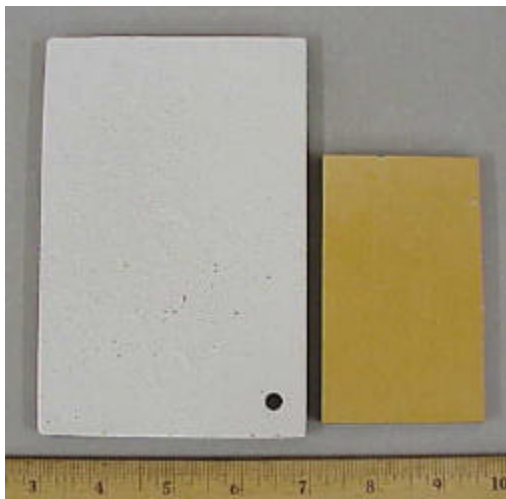
Figure 2-3. System 1 Laboratory Specimens before (left) and after (right) exposure to 10⁹ Rad per ASTM D4082-95

The specimens also were fabricated to contain a Type 1 defect at the IOZ/steel substrate interface. Type 1 defects were created by either attaching 0.472-in.- (12 mm) diameter, 0.005-in.-thick glass discs to the steel, or by applying polytetrafluorethylene (Teflon®) on the steel in well-defined locations, prior to application of the IOZ primer.

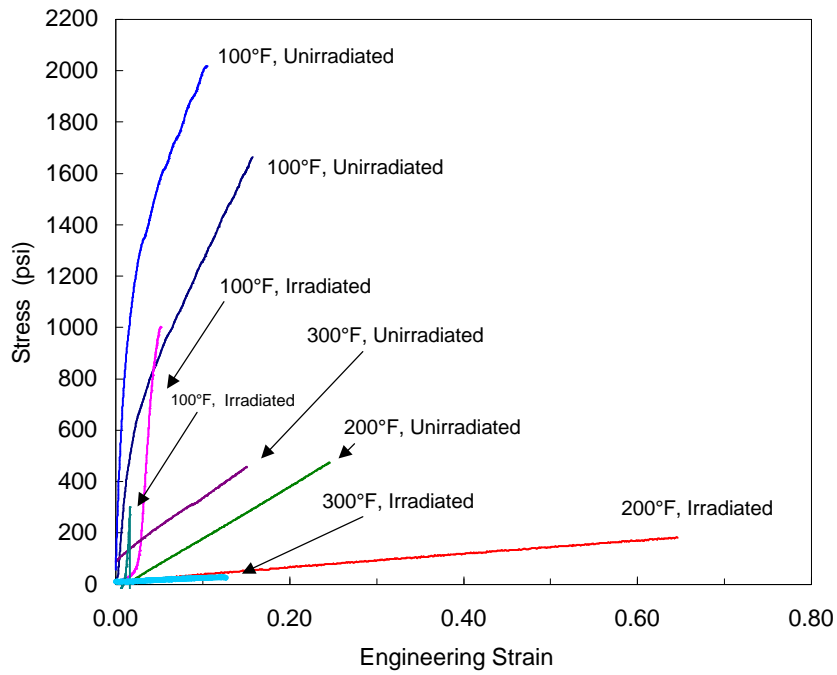
Figure 3-1. Free-film tensile test results for Phenoline[®] 305 in the dry condition

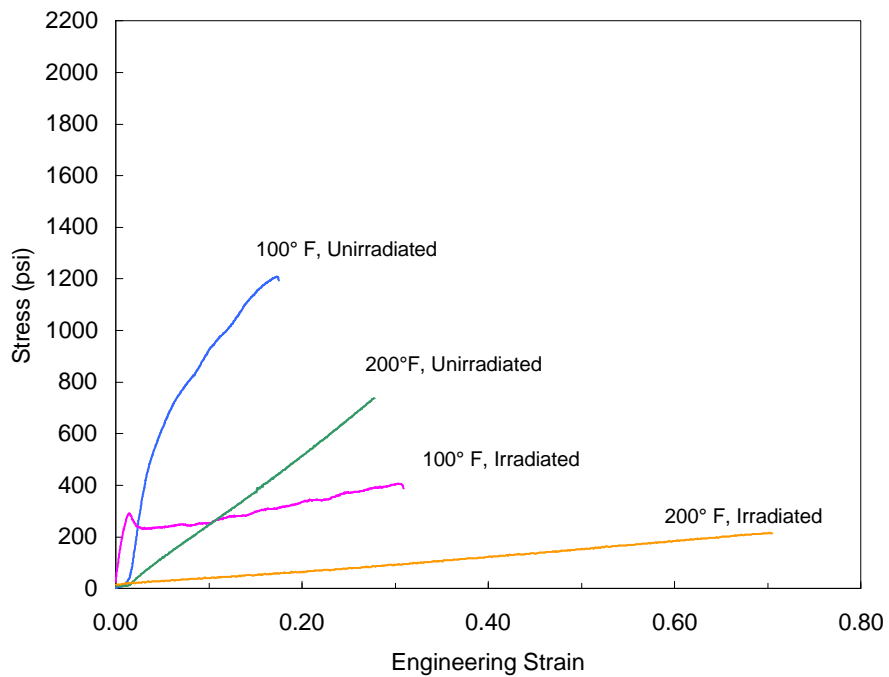
Figure 3-2. Free-film tensile test results for Phenoline[®] 305 in the wet condition

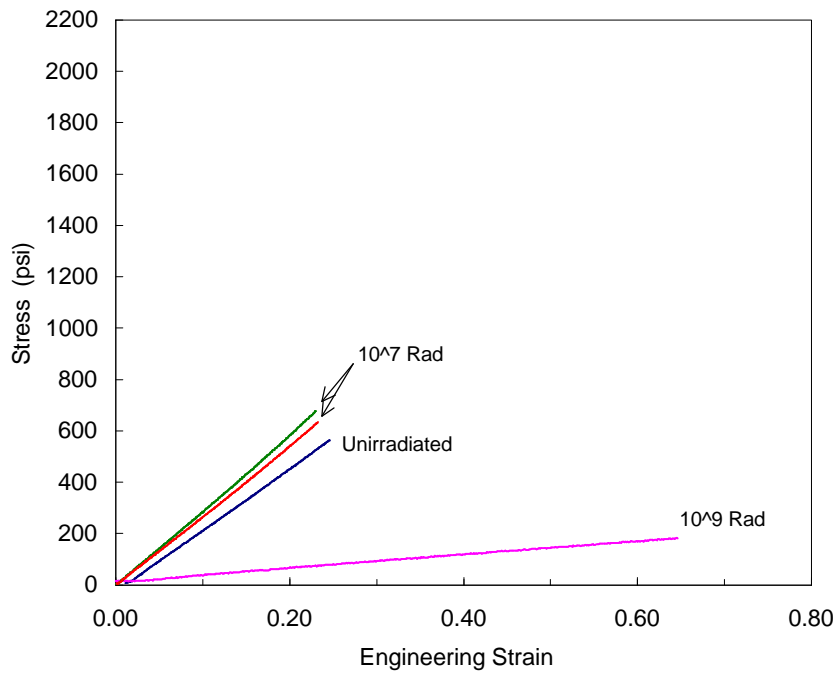
Figure 3-3 . Free-film tensile test results for Phenoline[®] 305 at 200°F in the dry condition

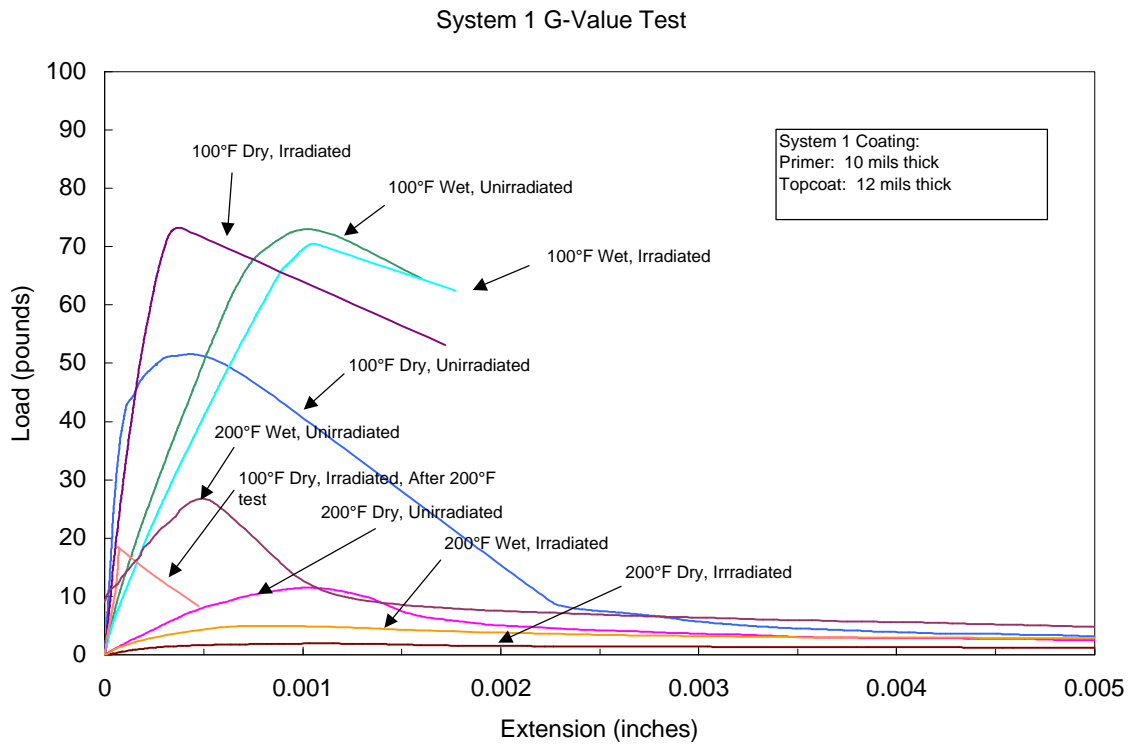
Figure 3-4. Adhesion G-value test results for System 1

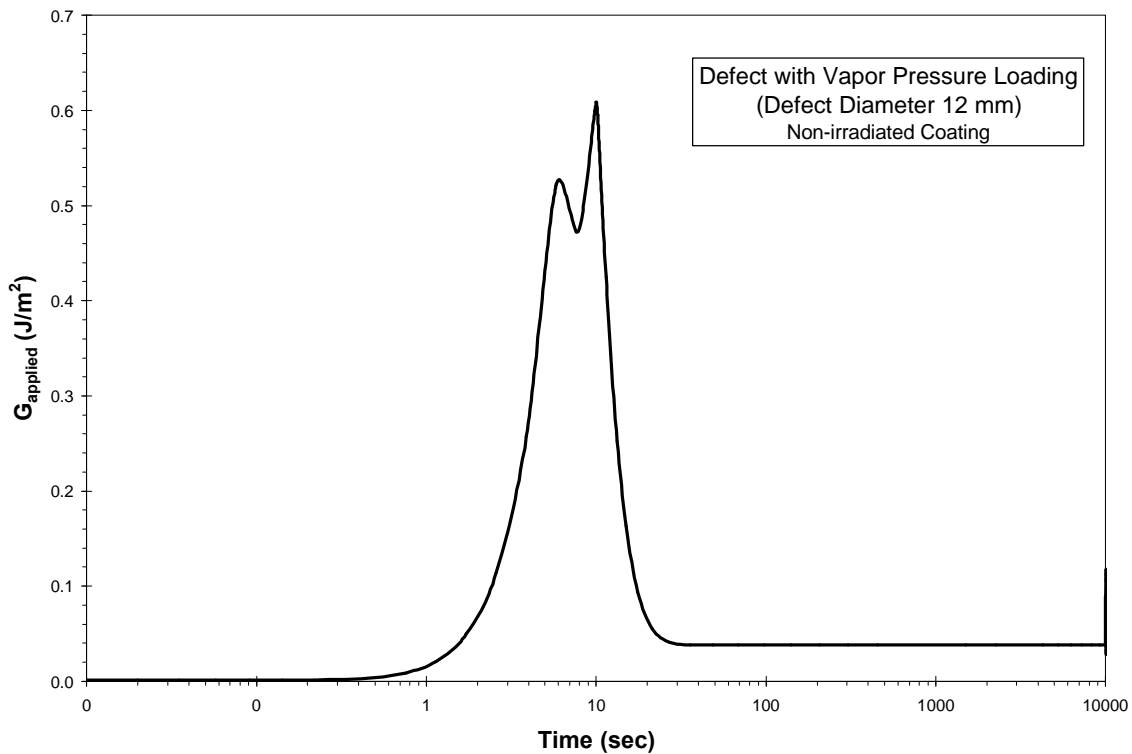
Figure 3-7. Applied G-Values at the Edge of a dry Defect (Diameter 12 mm) during DBA Test (Logarithmic Time Scale)

A Type 1 defect with diameter 12 mm was placed between the primer and the steel substrate. The J-integral option in the finite element code (ABAQUS) was used to evaluate the applied G-values for this defect with and without vapor pressure due to trapped water in the defect. When there is no vapor pressure present inside the defect, the applied G-value is mainly due to the thermal expansion mismatch. The maximum applied G-value (0.6 J/m^2) occurs about 0.1 seconds after the initial heating is complete (10 seconds and at 307°F), as shown in Figure 3-7. It can be seen that the peak value of the applied G-value is insignificant compared to the material G-values in Table 3-8 (98 J/m^2), and thus no delamination would occur. It can be concluded that this defect will not grow under the condition in which there is no trapped water in the defect.

The analysis results are consistent with the DBA tests in which no coating failures were observed.

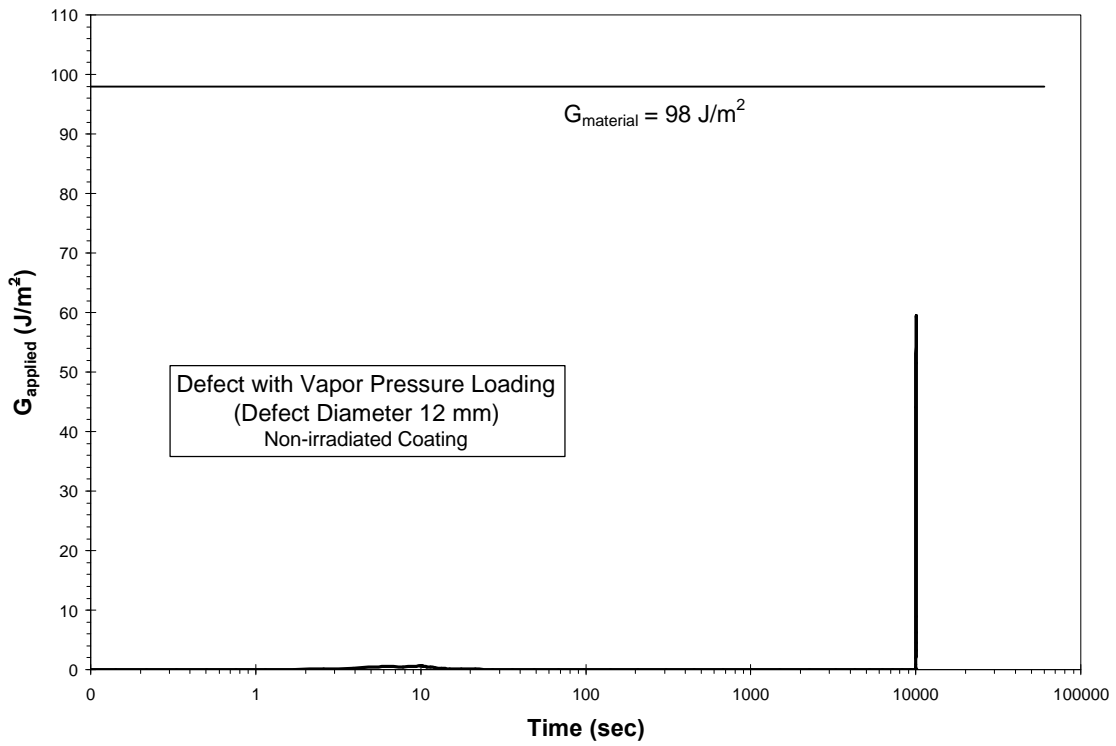
Figure 3-8. Applied G-Values at the Edge of a Vapor Pressurized Defect (Diameter 12 mm) during DBA Test (Logarithmic Time Scale)

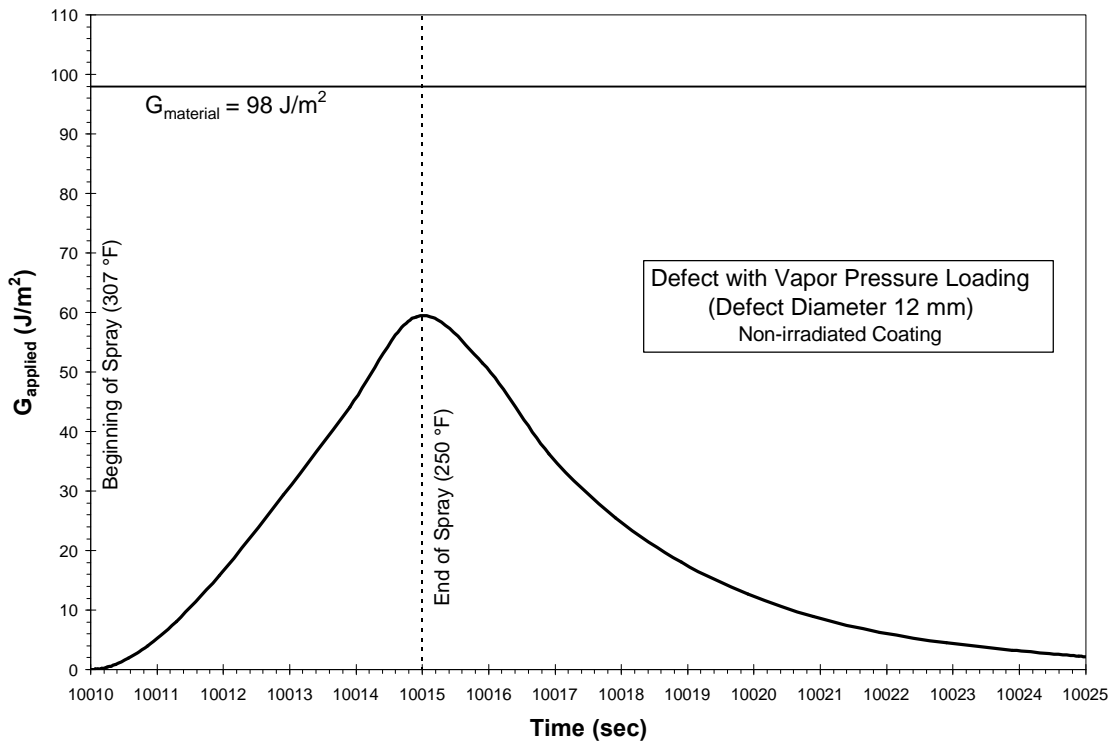
Figure 3-9. Applied G-Values at the Edge of a Vapor Pressurized Defect (Diameter 12 mm) during Cooling Phase in DBA Test (Linear Time Scale)

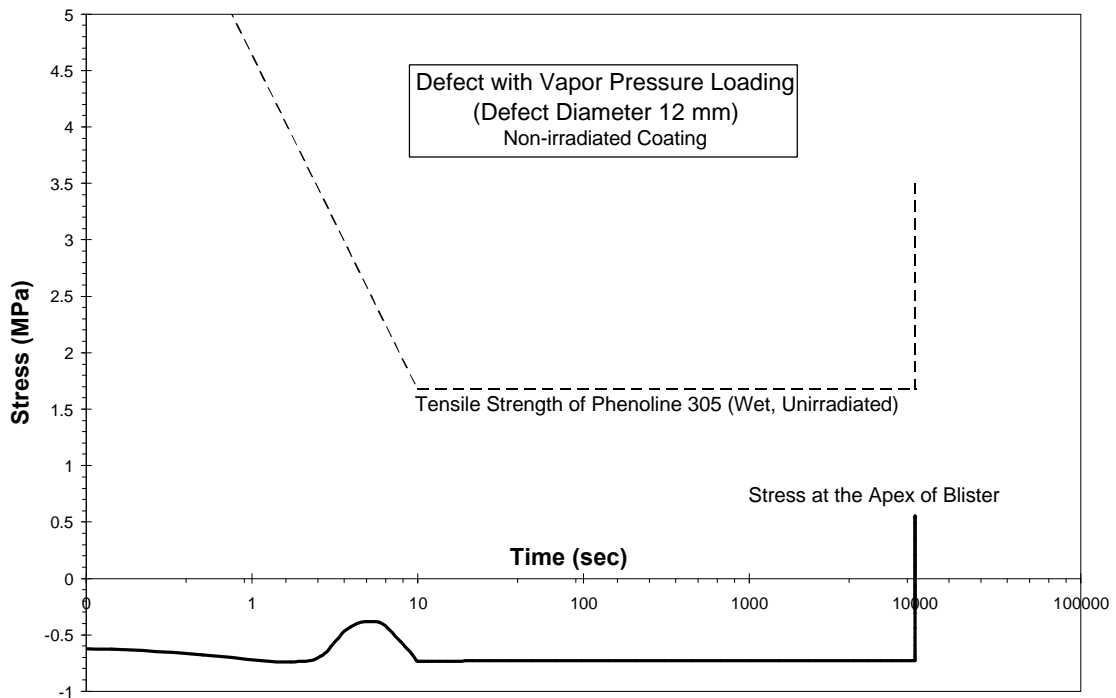
Figure 3-10. Failure Assessment of Type 1 Defects Using the Peak Tensile Stress Criterion (Entire Time History with Logarithmic Time Scale)

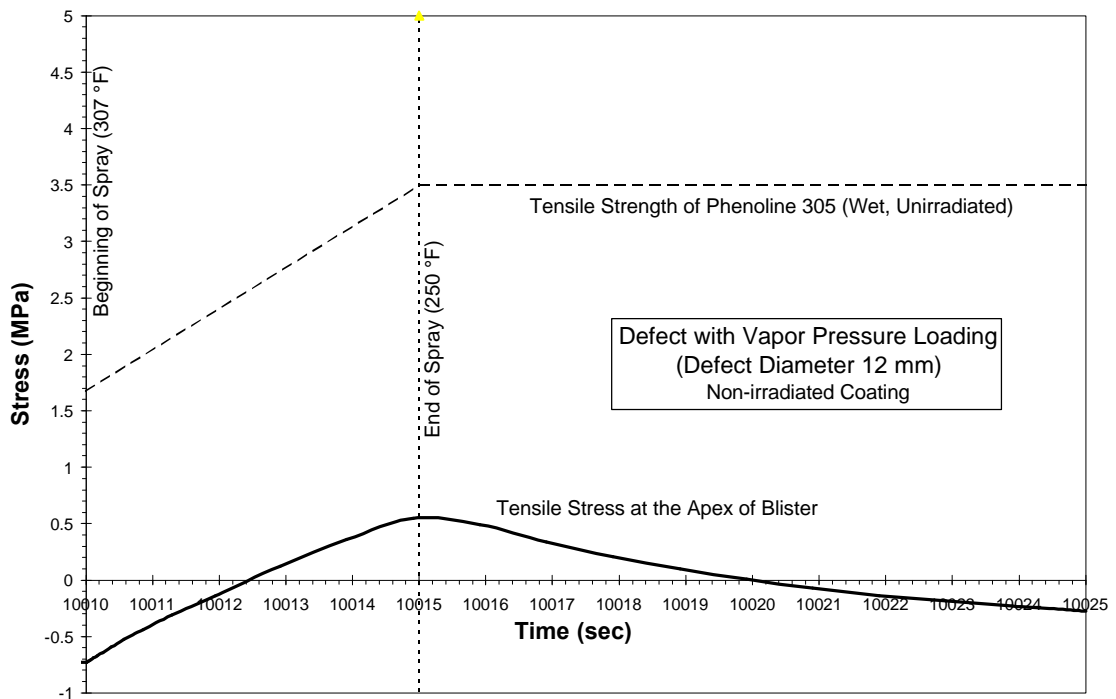
Figure 3-11. Failure Assessment of Type 1 Defects Using the Peak Tensile Stress Criterion (Cool-down Phase with Linear Time Scale)

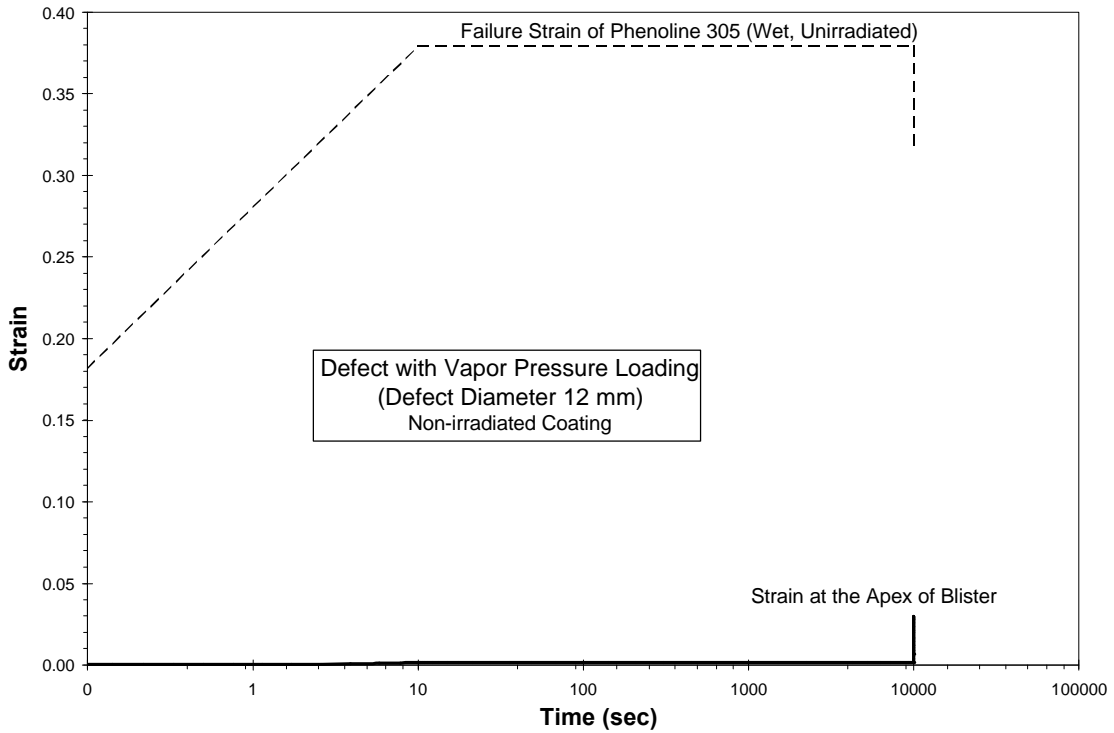
Figure 3-12. Failure Assessment of Type 1 Defects Using the Failure Strain Criterion (Entire Time History with Logarithmic Time Scale)

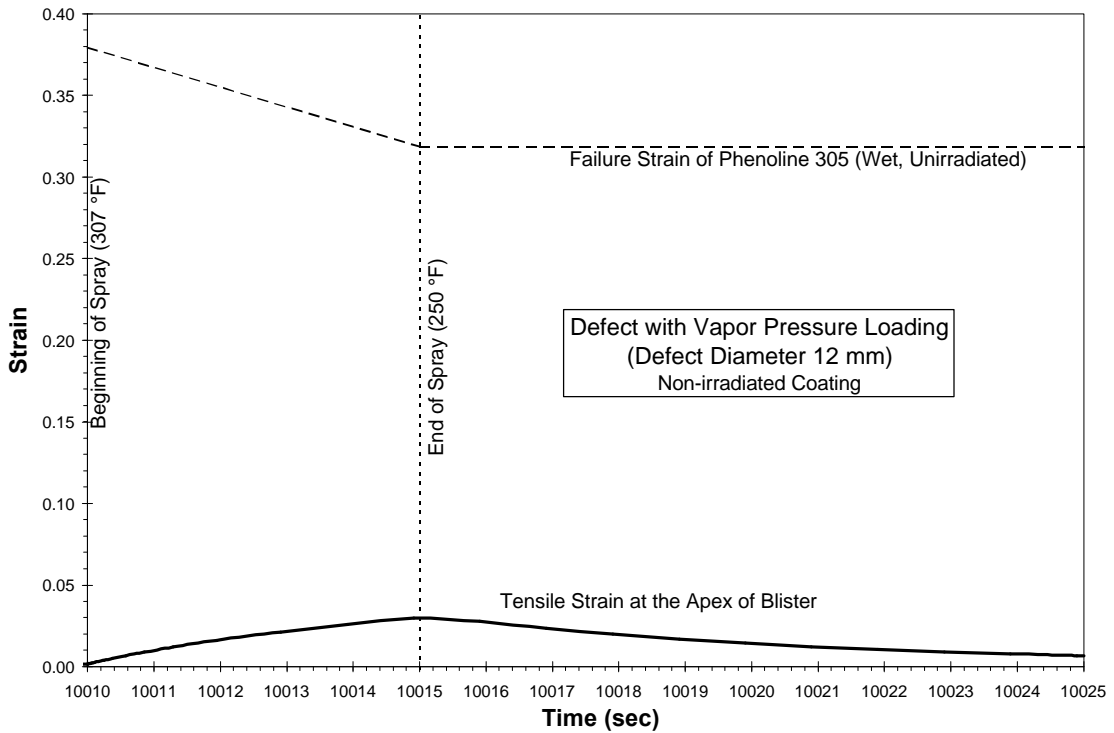
Figure 3-13. Failure Assessment of Type 1 Defects Using the Failure Strain Criterion (Cool-down Phase with Linear Time Scale)

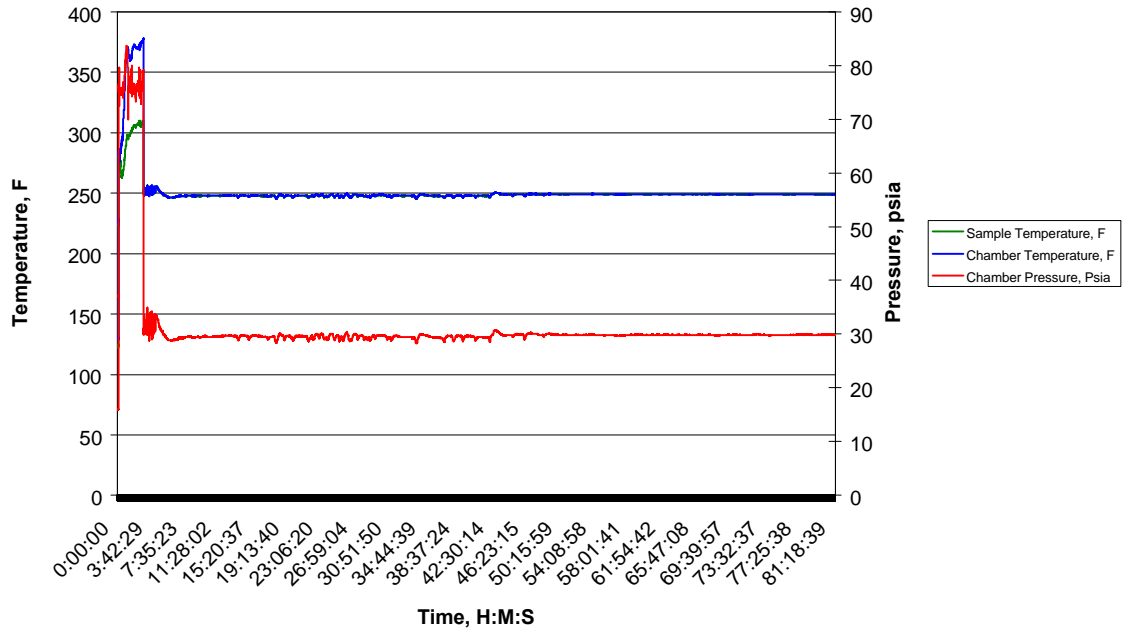
Figure 3-15. Typical Temperature-pressure Profile from SRTC System 1 D3911 DBA-LOCA Test

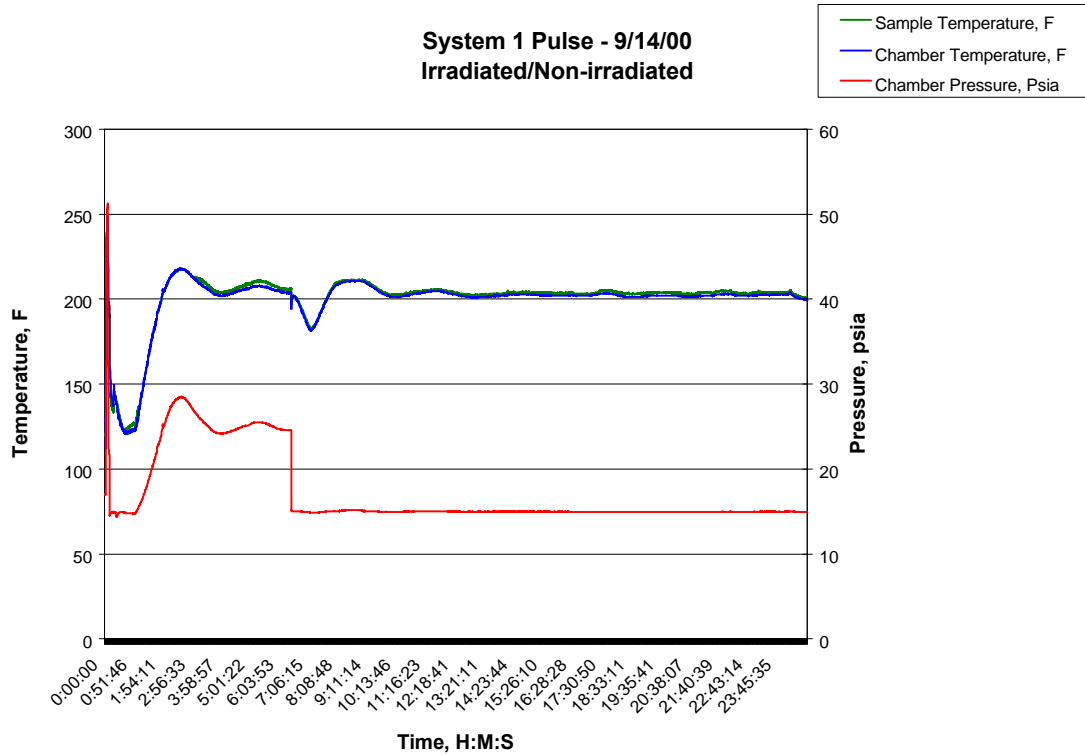
Figure 3-16. Temperature-Pressure Curves from Plant-specific LOCA Test

plant-specific LOCA event, the SRTC coatings performance evaluation system was used to subject aged and non-aged System 1 specimens to a rapid temperature-pressure pulse (Figure 3-16).

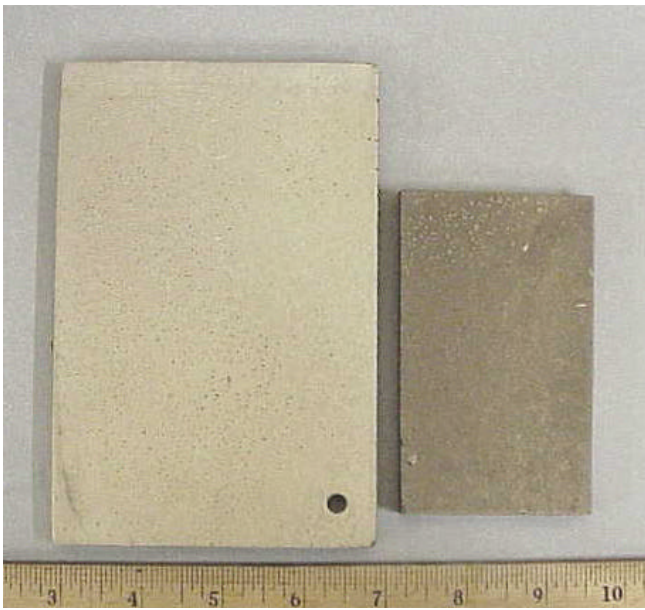
Figure 3-22. Overall views of System 1 specimens after DBA/LOCA testing according to ASTM D3911-95

Significant blistering was not observed in irradiated coating specimens during DBA-LOCA testing performed in accordance with ASTM D3911-95 (Figures 3-22 and 3-23). However, microscopic examination of the surface of the irradiated specimens following testing revealed evidence of coating softening and the presence of numerous pores in the coating (Figure 3-24). A cross-section of the irradiated coating made after DBA-LOCA testing (Figure 3-25) verified the pores are confined to the outermost layer of the topcoat. Therefore, it is possible any gases which formed in the topcoat during irradiation were released from the coating during the high-temperature steam exposure, which occurs during the first 2.8 hours of the DBA test cycle. During this time, the specimen is heated with 75 psia steam to 307°F. At this temperature, the coating may become so soft, and the gases so mobile, that the gas pressure is relieved through the coating without forming large blisters. It is probable, however, that small debris particles were released from the coating at this time, although this speculation has not been confirmed.

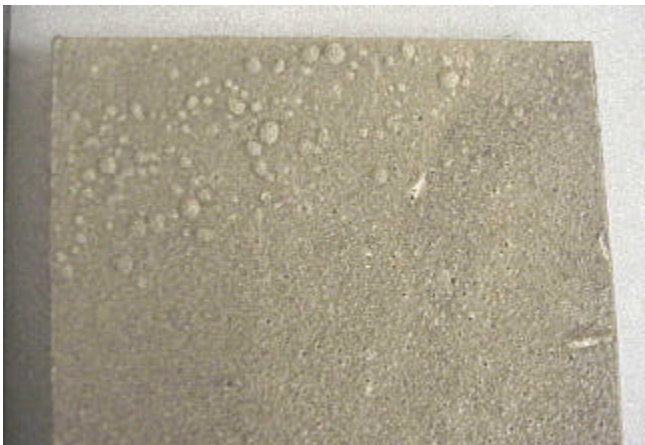
Figure 3-23. Detail of the surface of the irradiation-aged specimen after DBA testing. Note the presence of intact blisters in the coating.

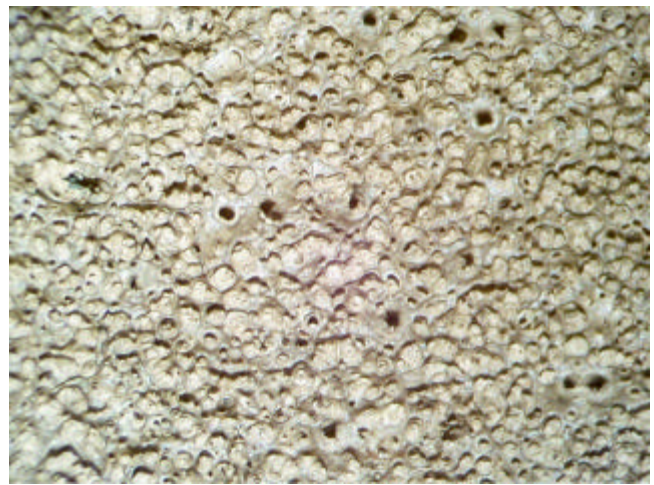
Figure 3-24. Microscopic view of the surface of the irradiation-aged specimen after DBA testing illustrating evidence of coating softening and formation of pores. Original magnification 7x

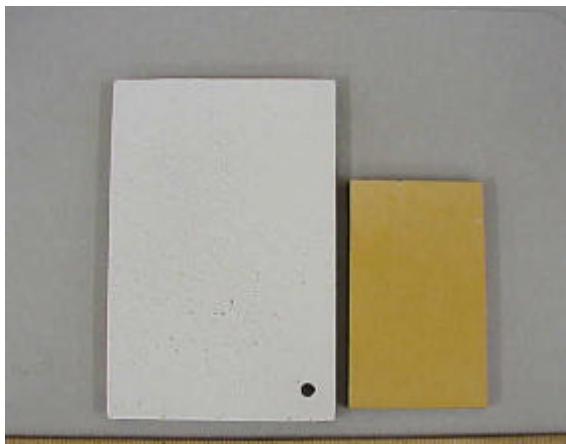
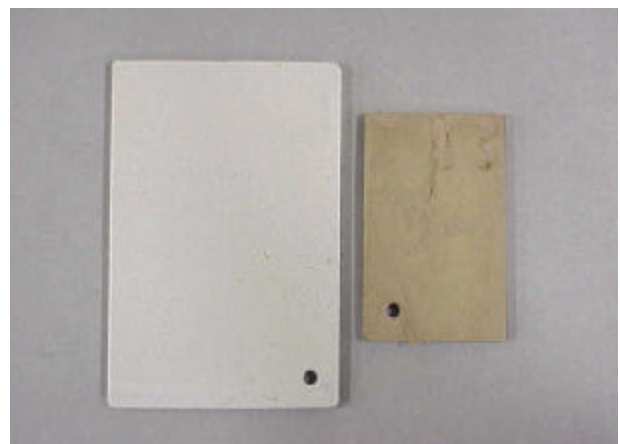
Figure 3-26. Overall view of the non-aged (left) and irradiation-aged (right) System 1 specimens before (left photo) and after (right photo) a plant-specific DBA/LOCA test. The specimens in the left-hand photo are not the specimens used in the plant-specific test, but were identical specimens used in the full LOCA test and included here for illustration. The actual test specimens in the right-hand photo are oriented as they were during testing.

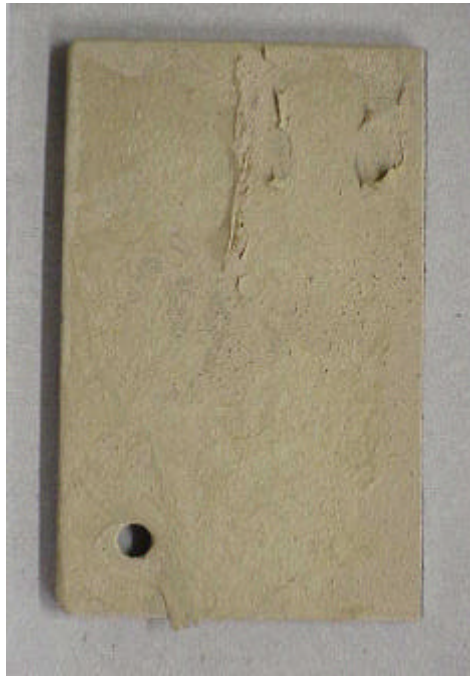
Figure 3-27. Overall view of the irradiation-aged System 1 specimen, revealing blistering and sloughing of the topmost layer of the topcoat

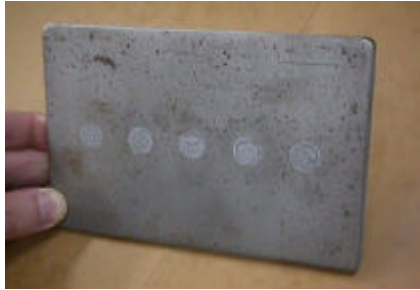
PTFE discs on steel coupon

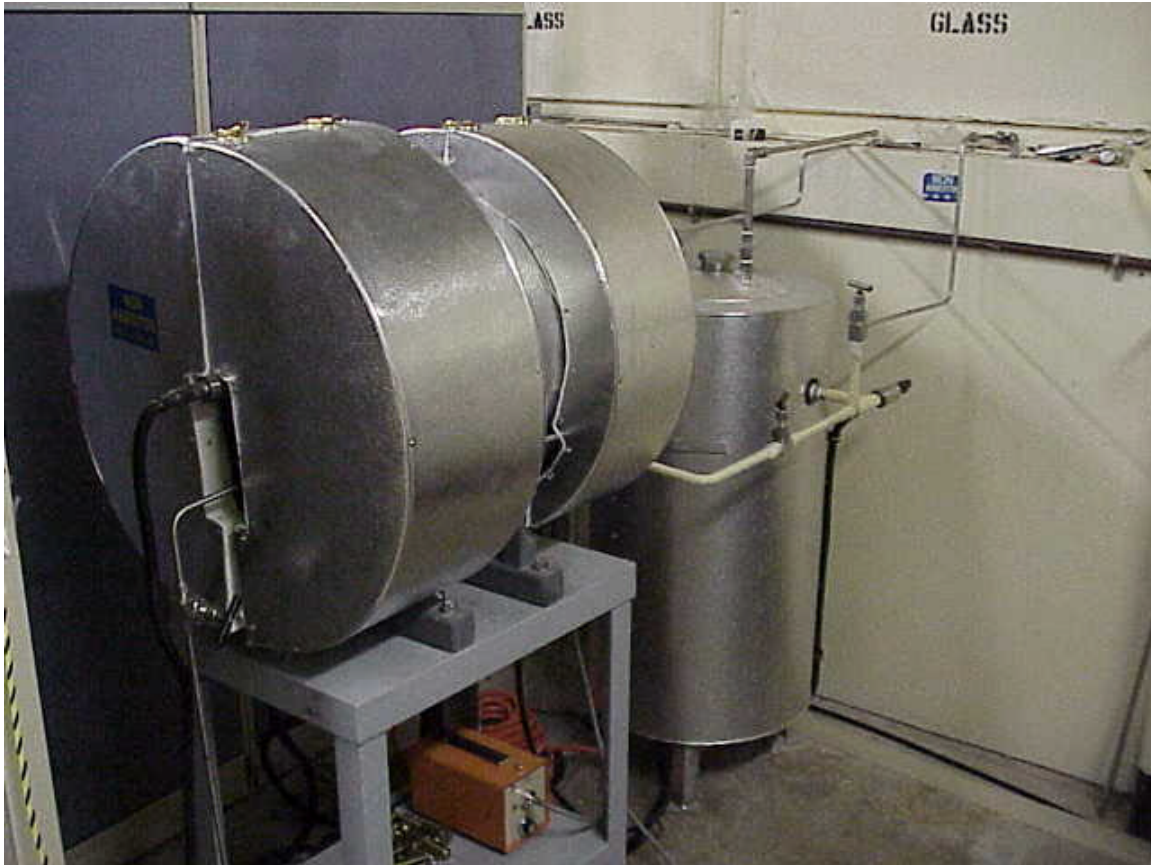
Figure D-1. SRTC Coatings Performance Evaluation System. Insulated environmental test chamber is shown on the left, the 10 gallon steam generator is on the right.

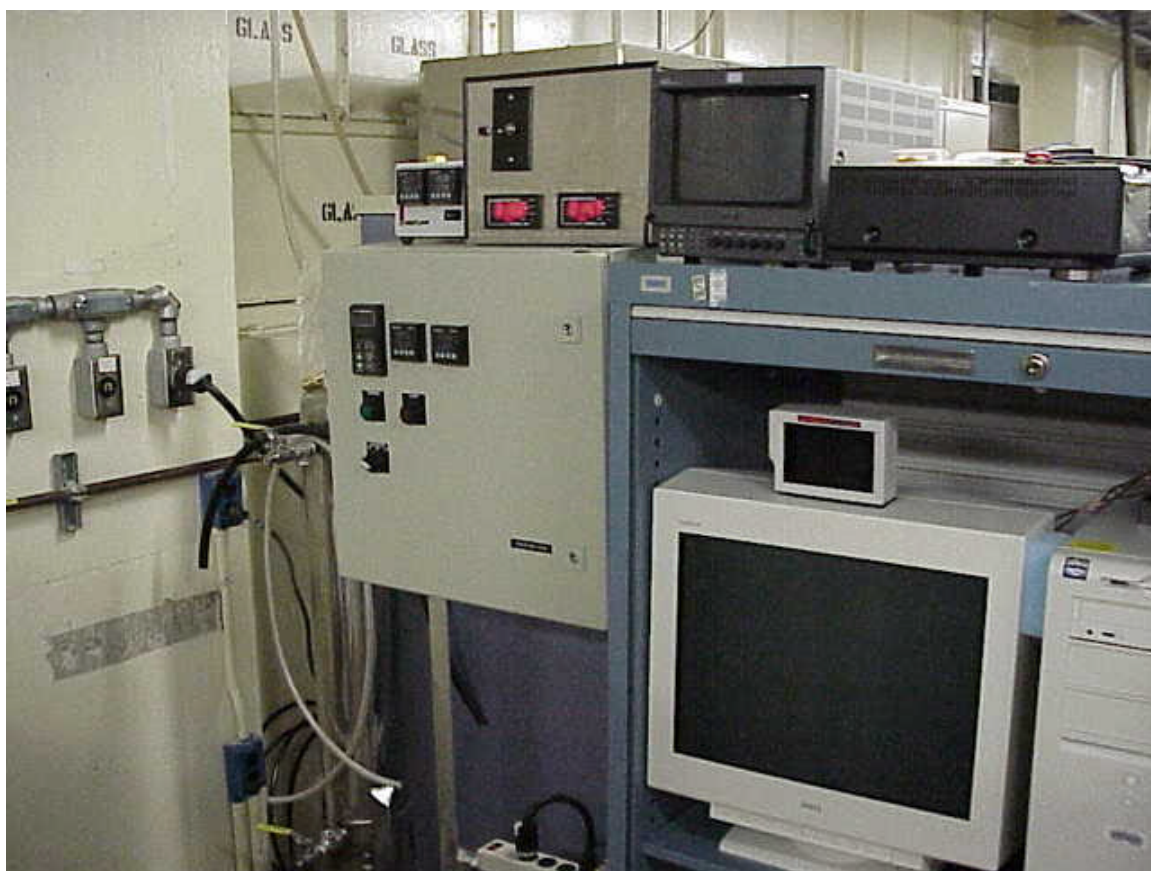
Figure D-2. Overall view of the heater control console and the video monitoring and data acquisition systems for the SRTC Coatings Performance Evaluation System

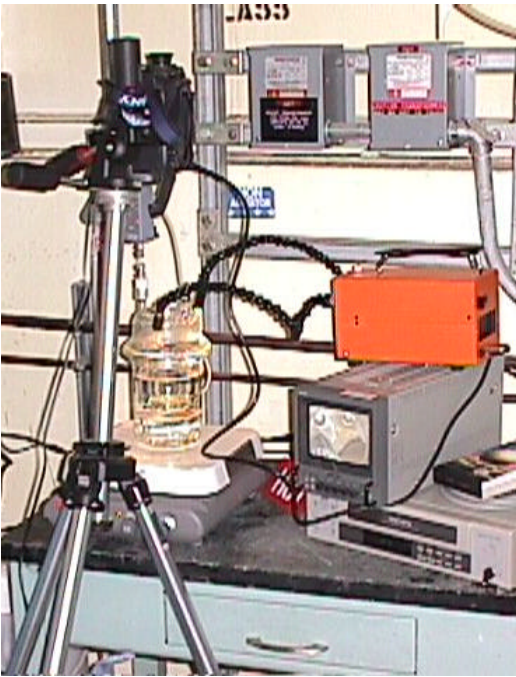
Figure D-9. Overall view of soak test system, illustrating video camera (on tripod), fiberoptic lighting system (orange box), time-lapse video recorder, and video monitor

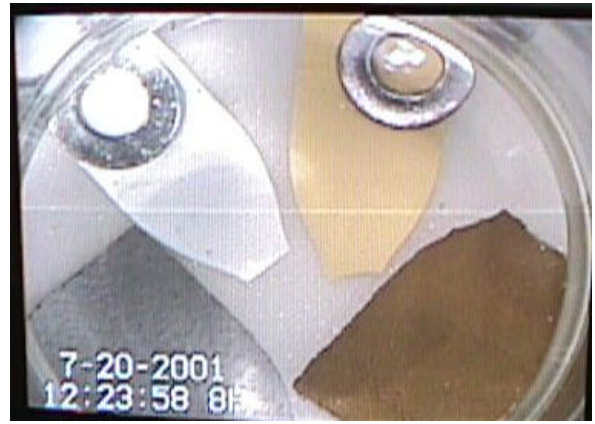
Figure D-10. Video image of specimens at the beginning of testing, as recorded

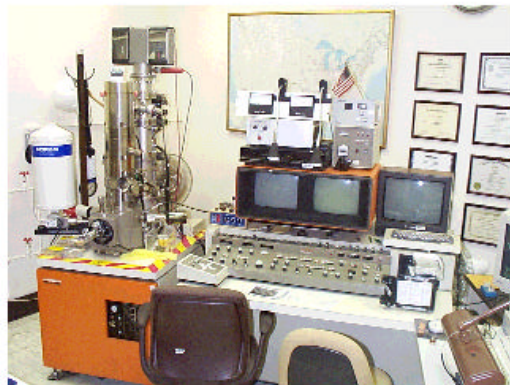
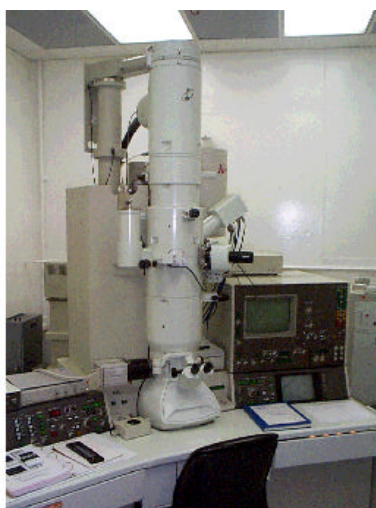
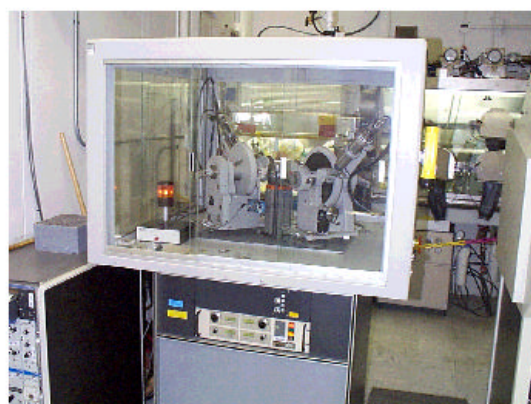
Figure F-1. SRTC Analytical Capabilities: Scanning Electron Microscope (top), Transmission Electron Microscope (middle), and X-ray Diffraction Unit (bottom)

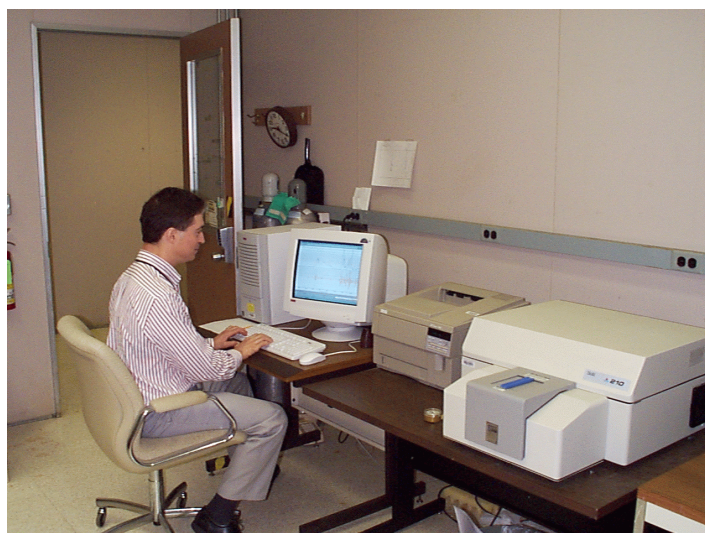
Figure F-2. FT-IR Spectrophotometry Equipment

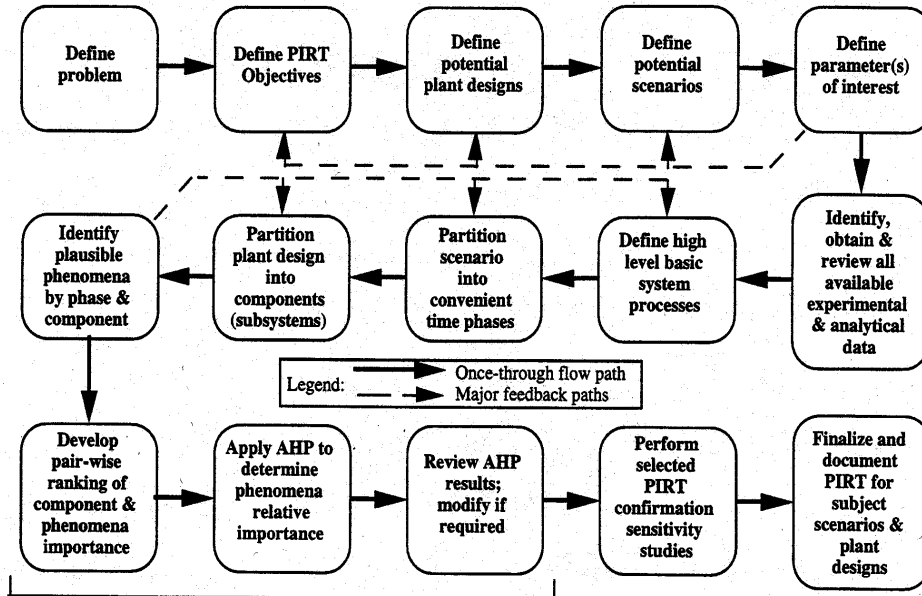
Figure G-1. PIRT Process
