Subject: Long-Term Surveillance Plan for the Sherwood, Washington, Title II Site

**Long-Term Surveillance Plan**

**Sherwood Project (UMTRCA Title II) Reclamation Cell  
Wellpinit, Washington**

February 2001

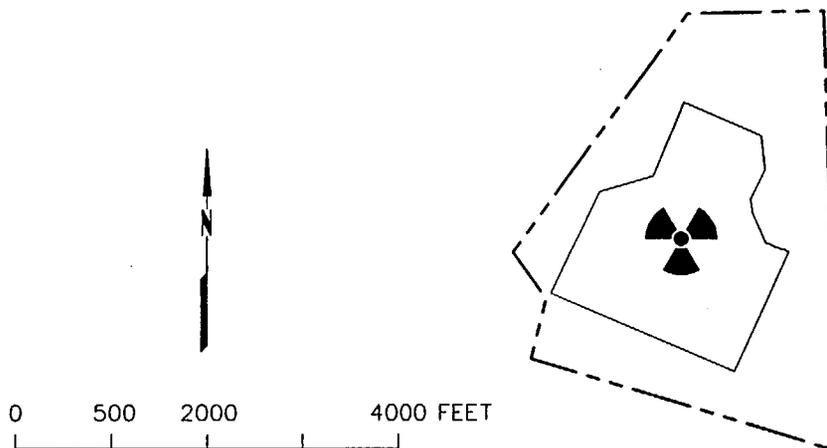
Figure 2-4. Site Marker at Sherwood, Washington, Disposal Cell Site

DATE OF CLOSURE: DECEMBER 1996  
TONS OF TAILINGS: 2,900,000  
RADIOACTIVITY: 470 CURIES, RA-226

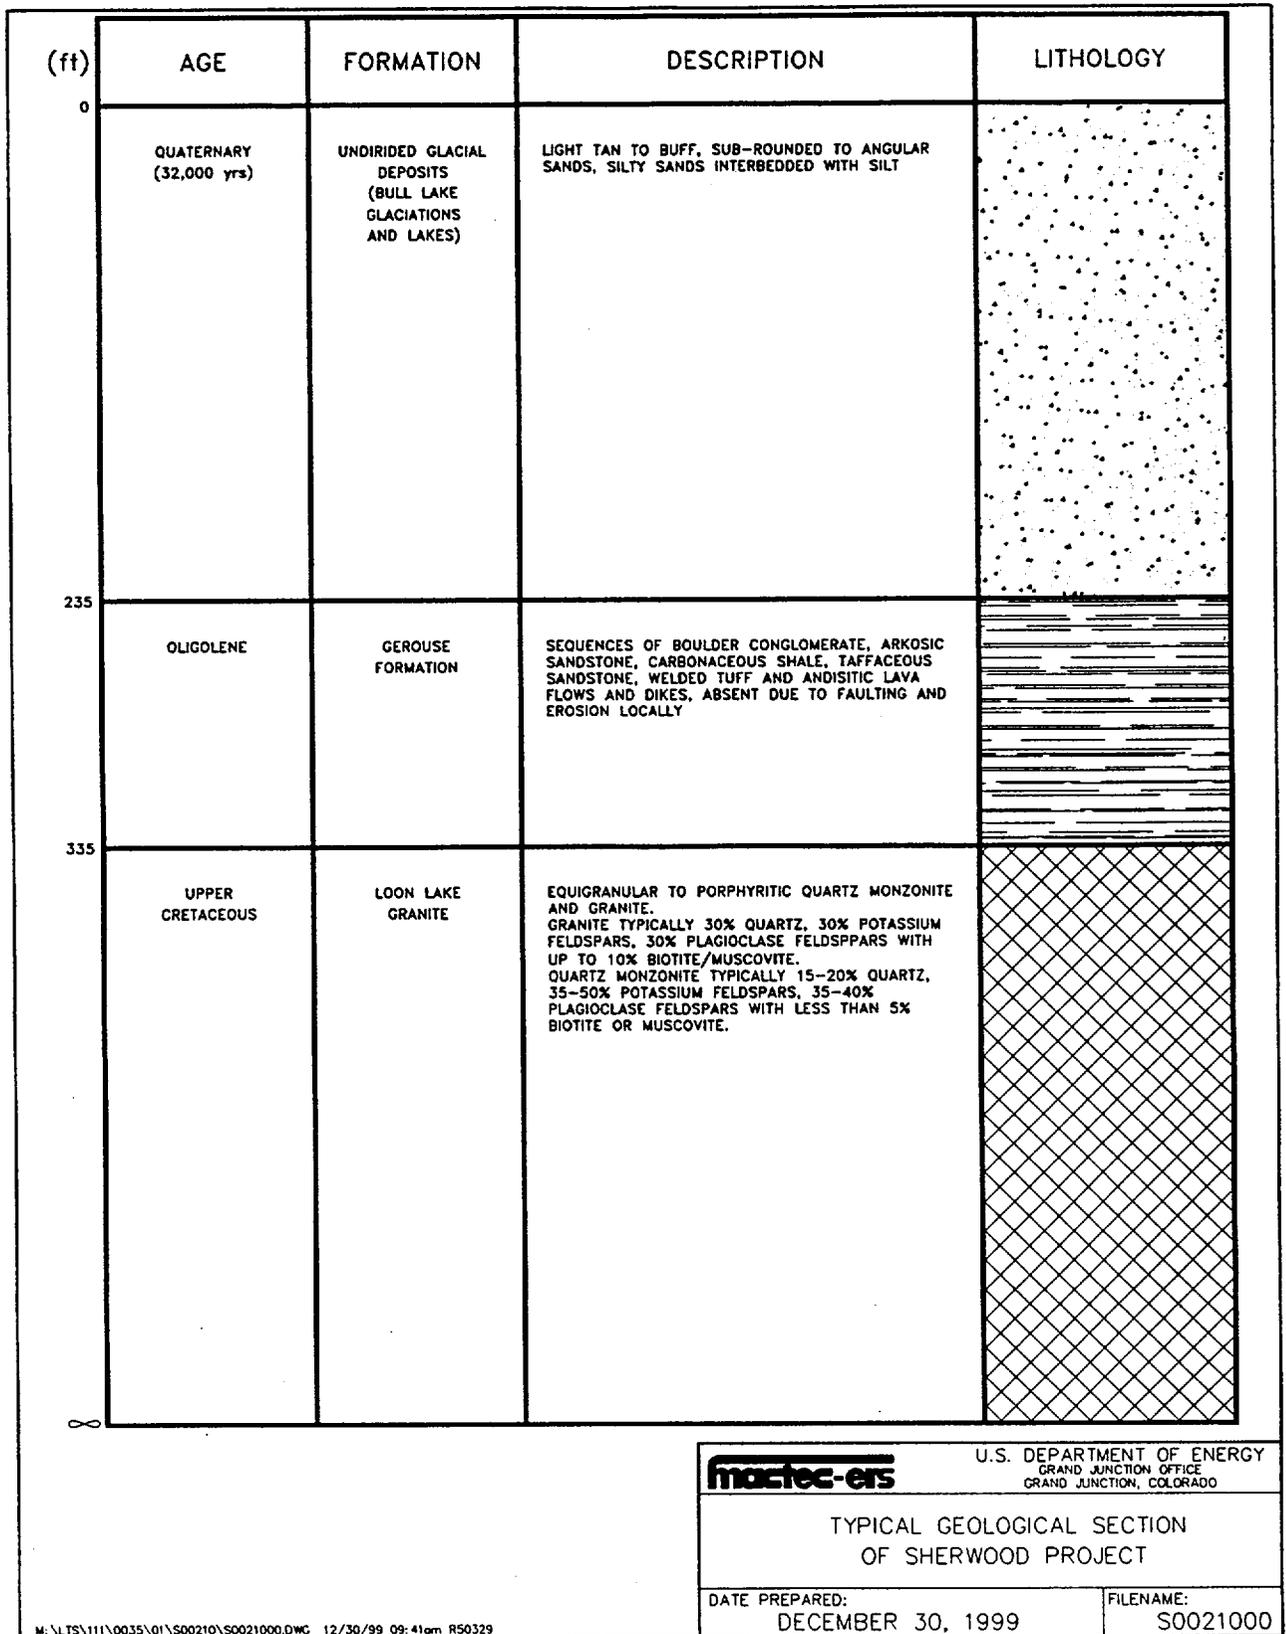
Figure 2-6. Typical Geological Section of Sherwood, Washington, Disposal Cell Site

The oldest and most widespread bedrock unit is porphyritic quartz monzonite of the Cretaceous Loon Lake granite formation (BIA 1976). Overlying the quartz monzonite is a variable thickness of glacial outwash (BIA 1976). See Figure 2-6 for typical geologic section. Variability in soil depth is attributable to the intermittent distribution of shallow bedrock and changes in slope (BIA 1976). Soil depths vary from zero at the northern extreme of the reclamation cell to approximately 200 feet at the ground water monitor wells immediately downgradient of the repository.

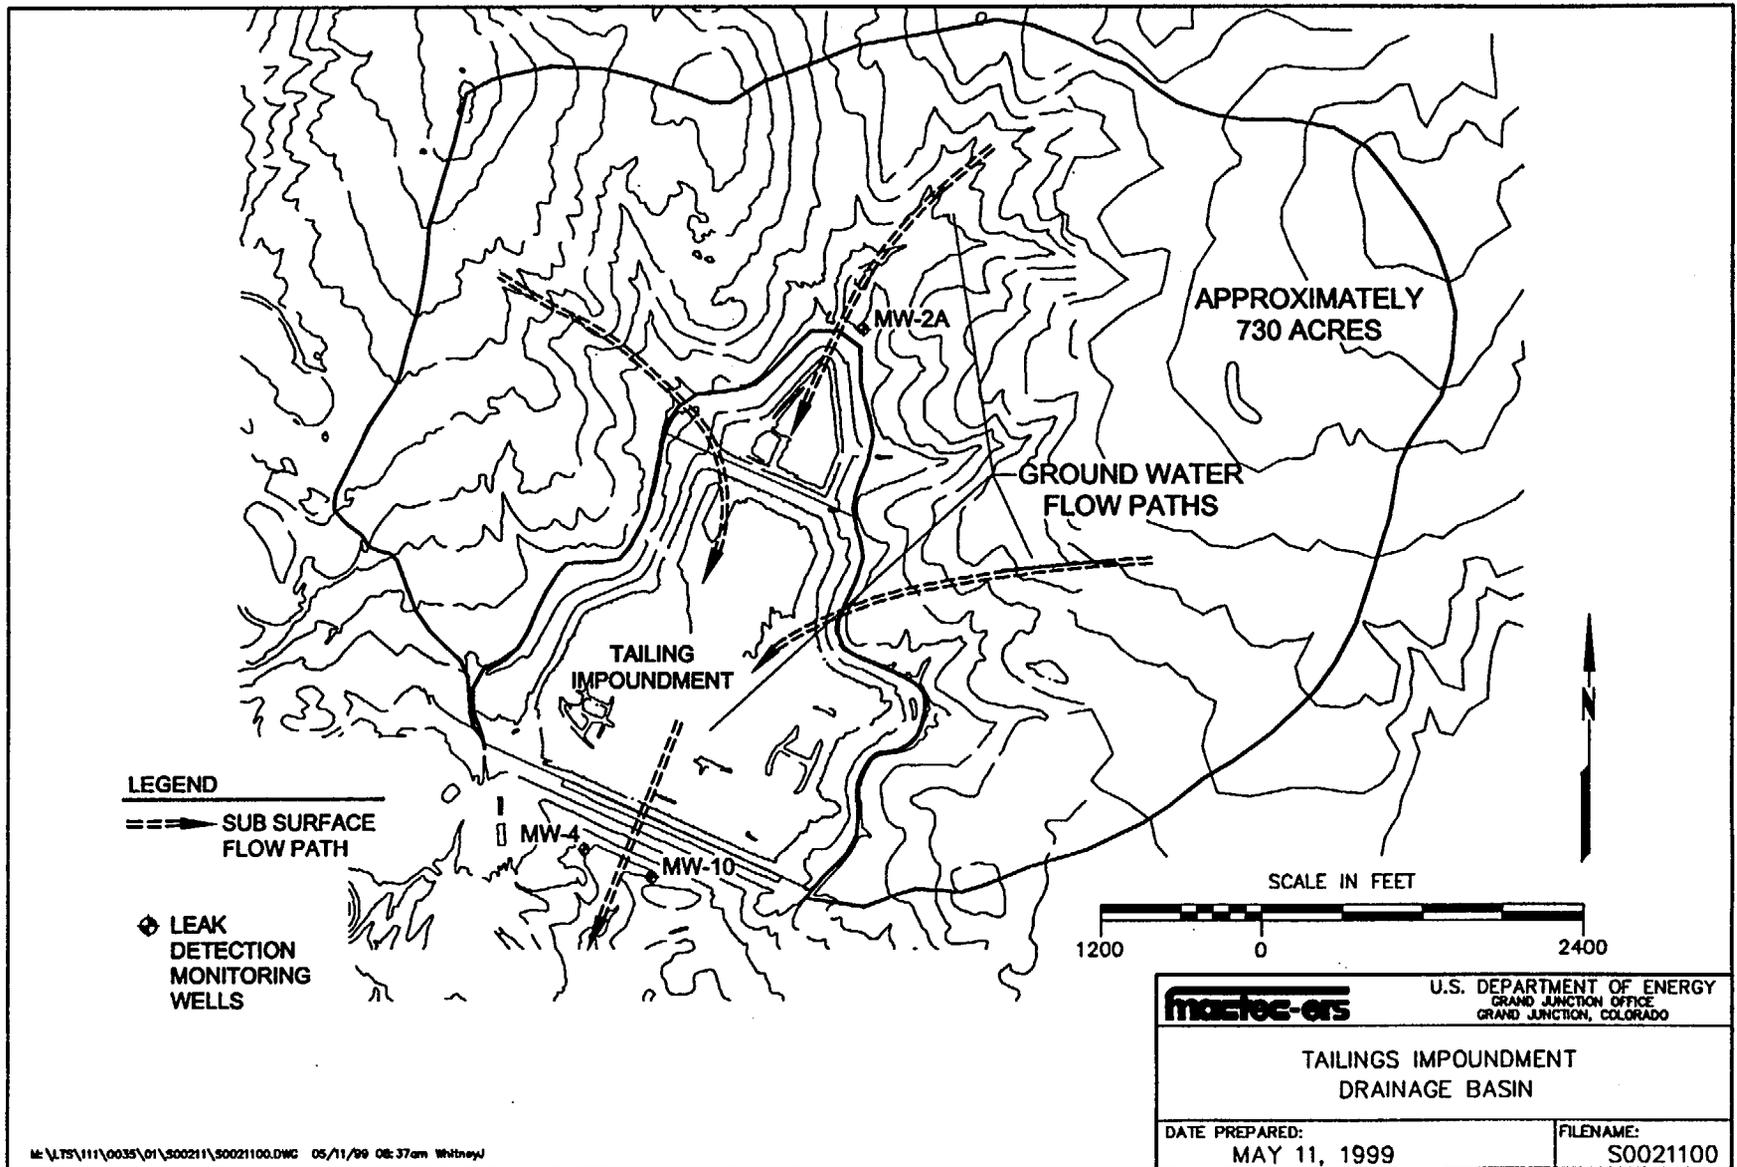
Figure 2-7. Tailings Impoundment Drainage Basin at Sherwood, Washington, Disposal Cell Site

The reclamation cell is situated in approximately the center of a 730-acre drainage basin (BIA 1976). The basin, which is closed to the north, east, and west sides by high bedrock, drains to the south (see Figure 2-7) (WNI 1994a). Local relief is approximately 300 feet, and the drainage basin has low erosion potential due to vegetative or rock armor cover (BIA 1976; WNI 1997b). The reclamation cell is underlain by sandy alluvial outwash soils ranging in depth from zero (an interface with bedrock) to approximately 200 feet (WNI 1994a).

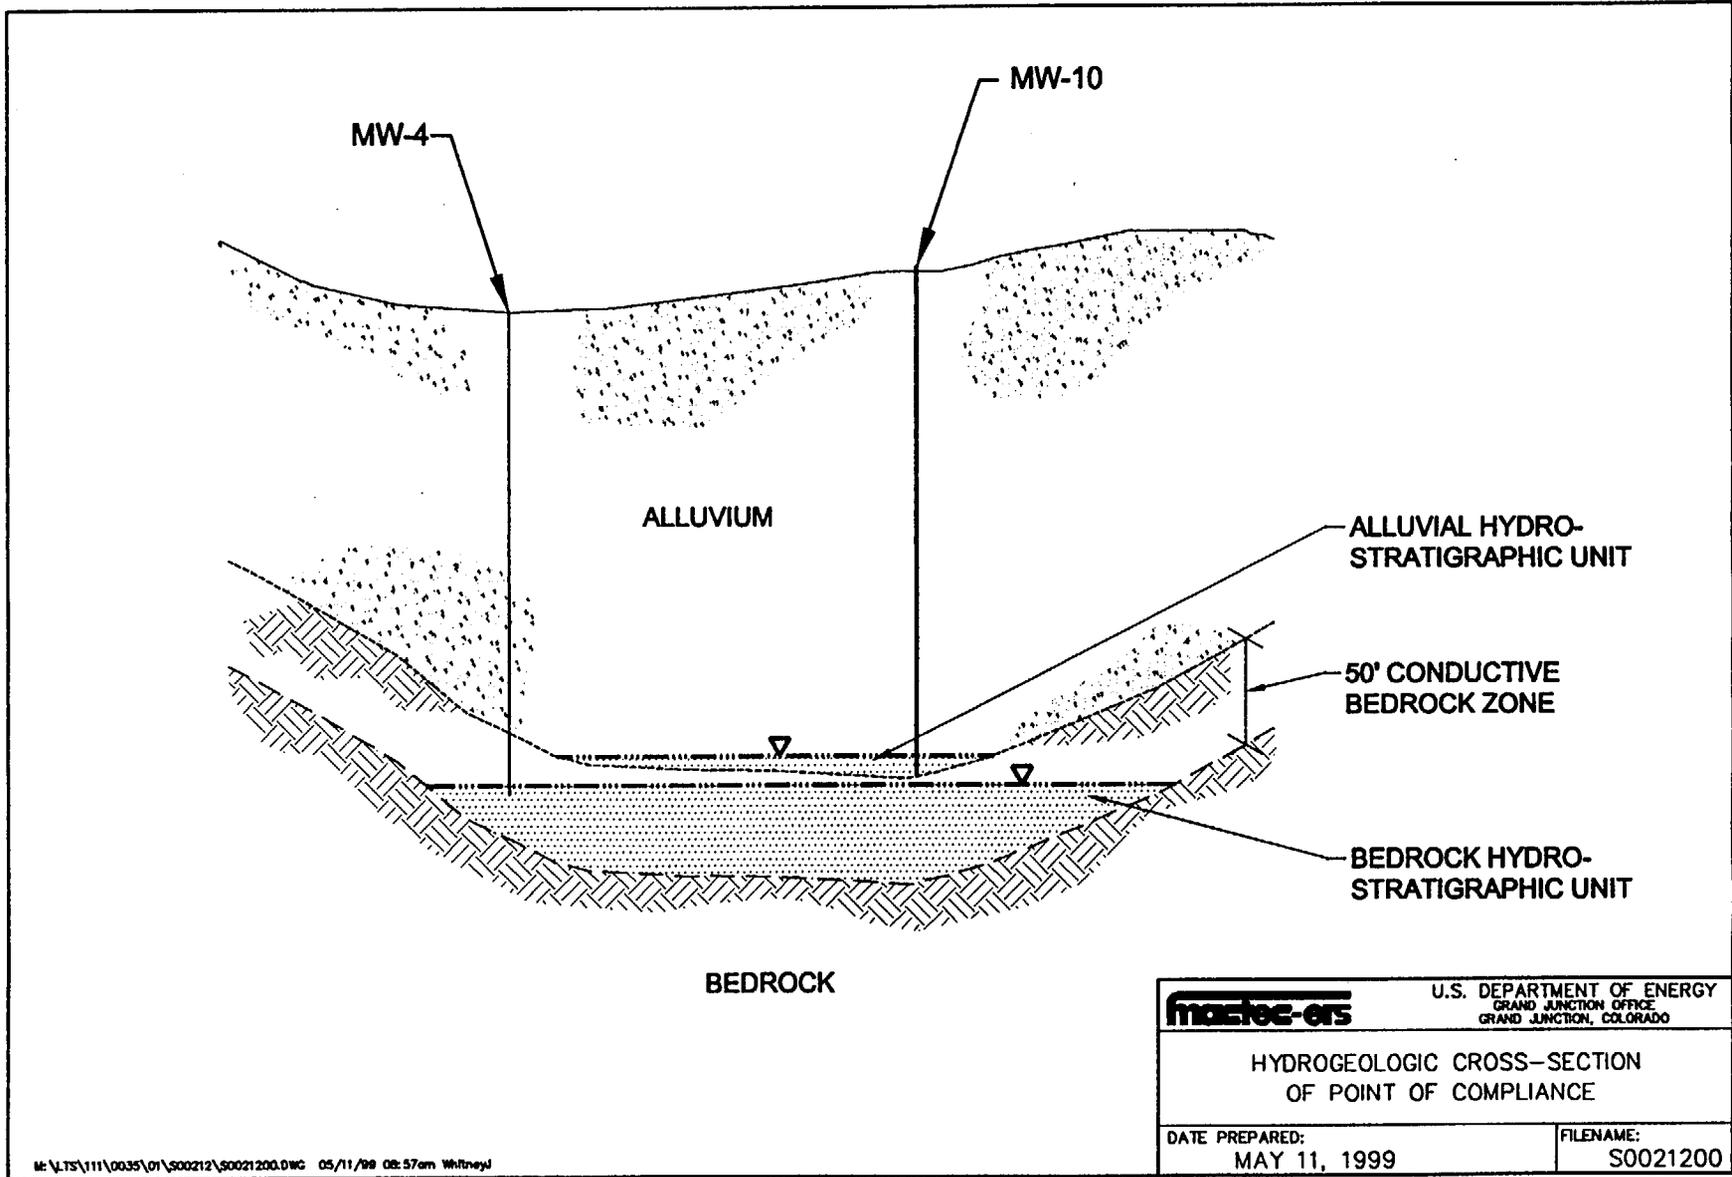
Figure 2-8. Hydrogeologic Cross-Section of Point of Compliance (POC) at Sherwood Washington, Disposal Cell Site

Infiltrating waters percolate vertically through the basin soils (alluvium) until bedrock is encountered (WNI 1994a; WNI 1995b). The ground water then flows in the two hydro-stratigraphic units: (1) the alluvium, which lies on top of the bedrock surface; and (2) the conductive bedrock zone (see Figure 2-8) (WNI 1994a; WNI 1995b).

Ground water in the alluvium flows parallel to the bedrock surface and toward the south (WNI 1994a). Ground water in the conductive bedrock zone, which is the upper 50 feet of bedrock consisting of hydraulically conductive weathered and fractured bedrock, also flows parallel to the bedrock surface and toward the south (WNI 1994a). Flow in the conductive bedrock zone occurs at a slower rate due to the lower hydraulic conductivity of this bedrock unit (WNI 1994a).

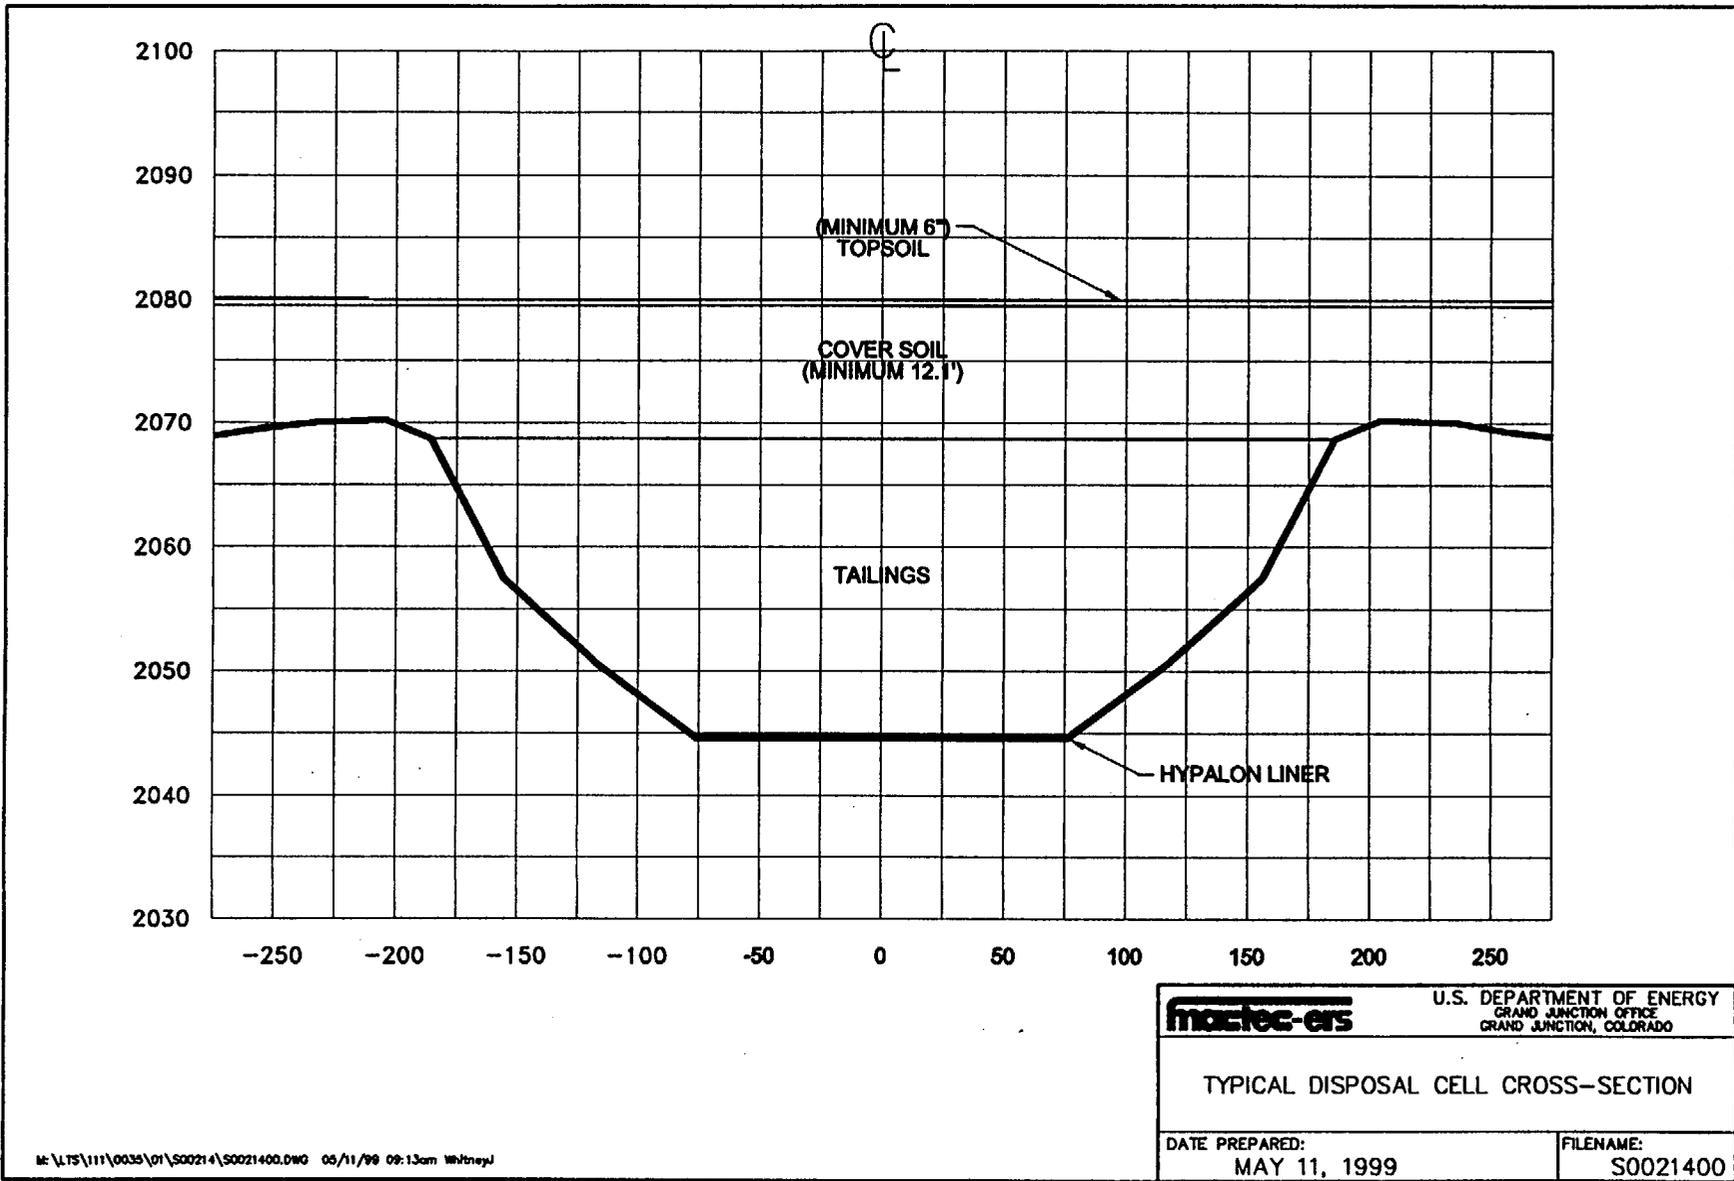
Figure 2-10. Typical Disposal Cell Cross-Section

A reclamation cover system, consisting of uncompacted local sandy to clayey-sandy soils and of vegetation, was placed over the wastes to control radon flux and infiltration into the repository (WNI 1995a). The cover consists of 12.6 to 20 feet of uncompacted local soils (WNI 1997b). The reclamation cover, which includes a minimum of 0.5 foot of topsoil, was revegetated with native grass, forbs, shrub and tree species (WNI 1997b). The vegetation is self-sustaining and natural succession caused by fire and other natural mechanisms has been anticipated (WNI 1995a). The range of vegetation communities that will occur over time will provide the necessary protection and evapotranspiration. A typical disposal cell cross-section is shown in Figure 2-10. The uncompacted cover was designed to be "self-healing" with regard to impacts from freeze-thaw, bio-intrusion, and settlement (WNI 1995a).

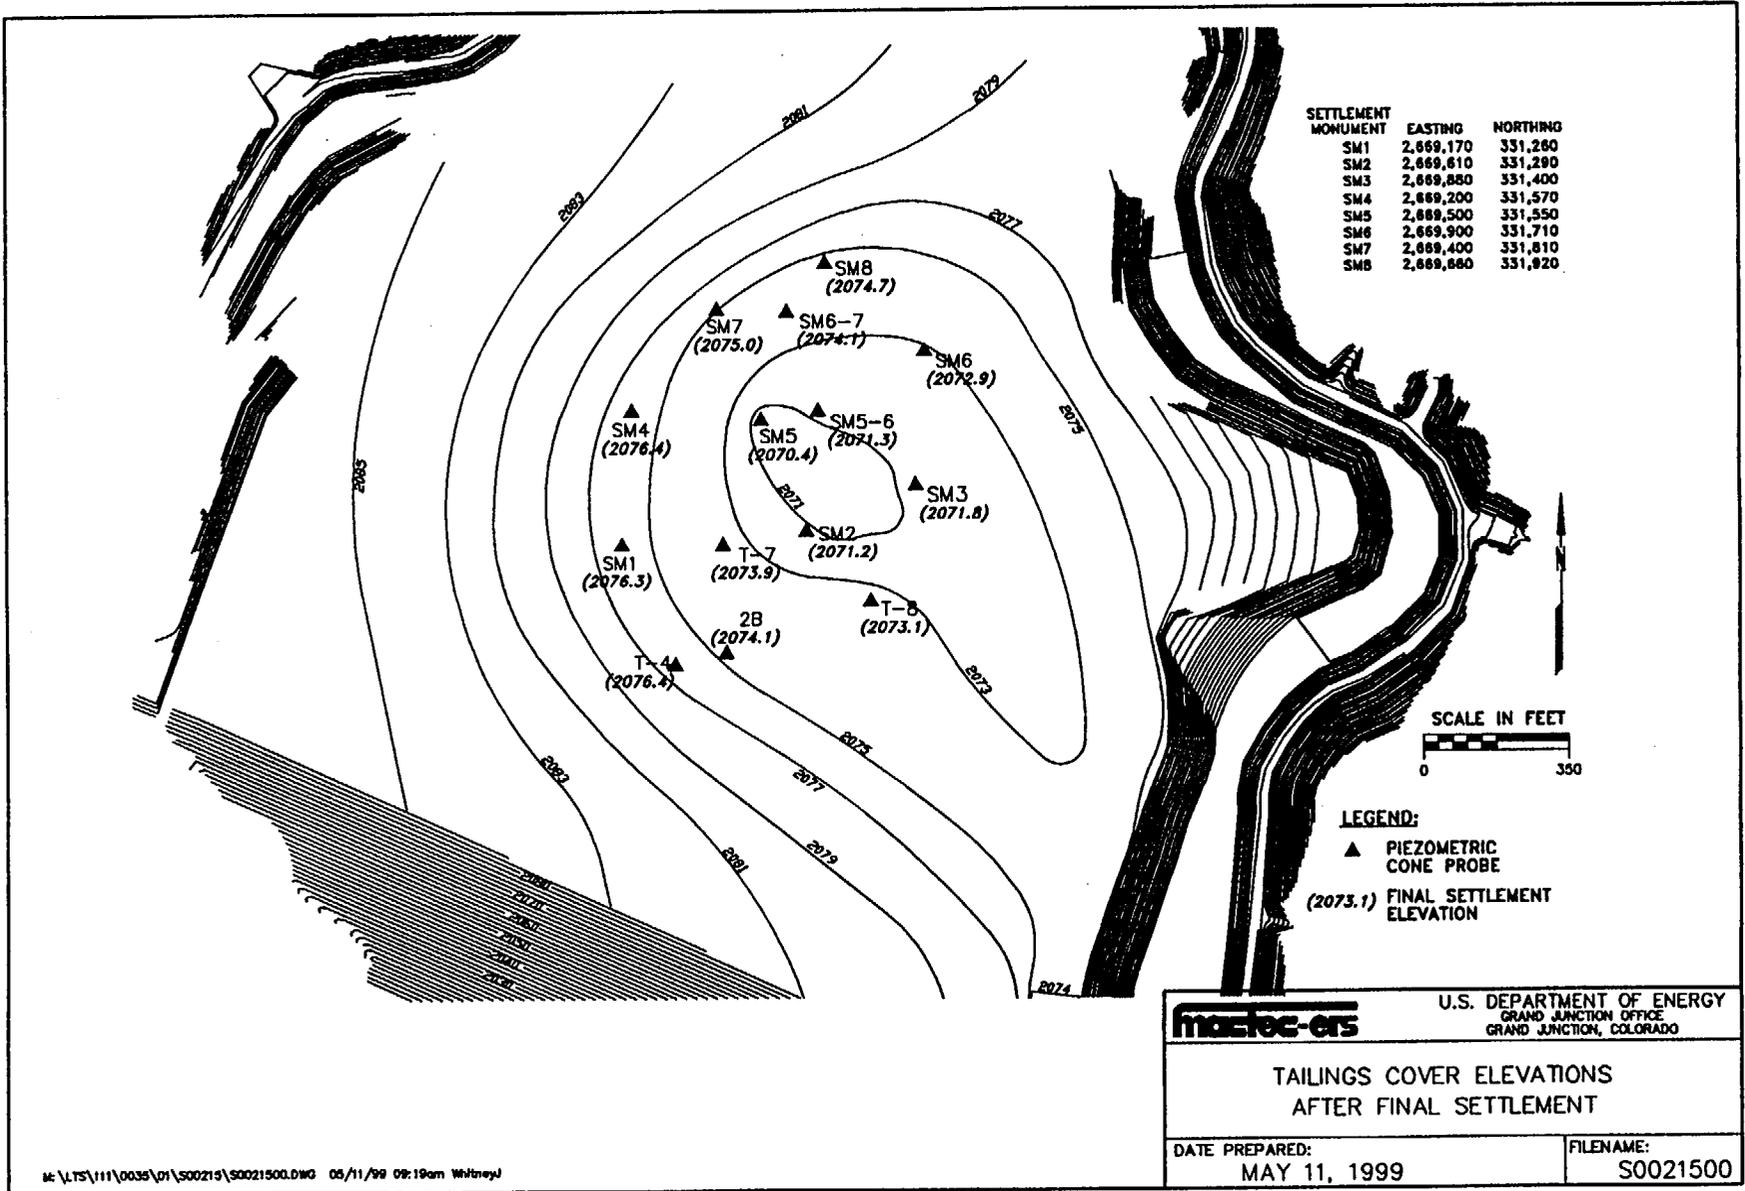
Figure 2-11. Tailings Cover Elevations After Final Settlement

Although the reclamation cell cover design predicted that up to 10 feet of settlement could potentially occur, a significant portion of the projected settlement occurred during placement of the reclamation cover (WNI 1995a). Short-lived, localized, wetter areas will develop; however, adverse impacts on the performance of the vegetated reclamation cell are not anticipated (WNI 1995a). Wetter areas will lead to a different density or type of vegetation (WNI 1995a).

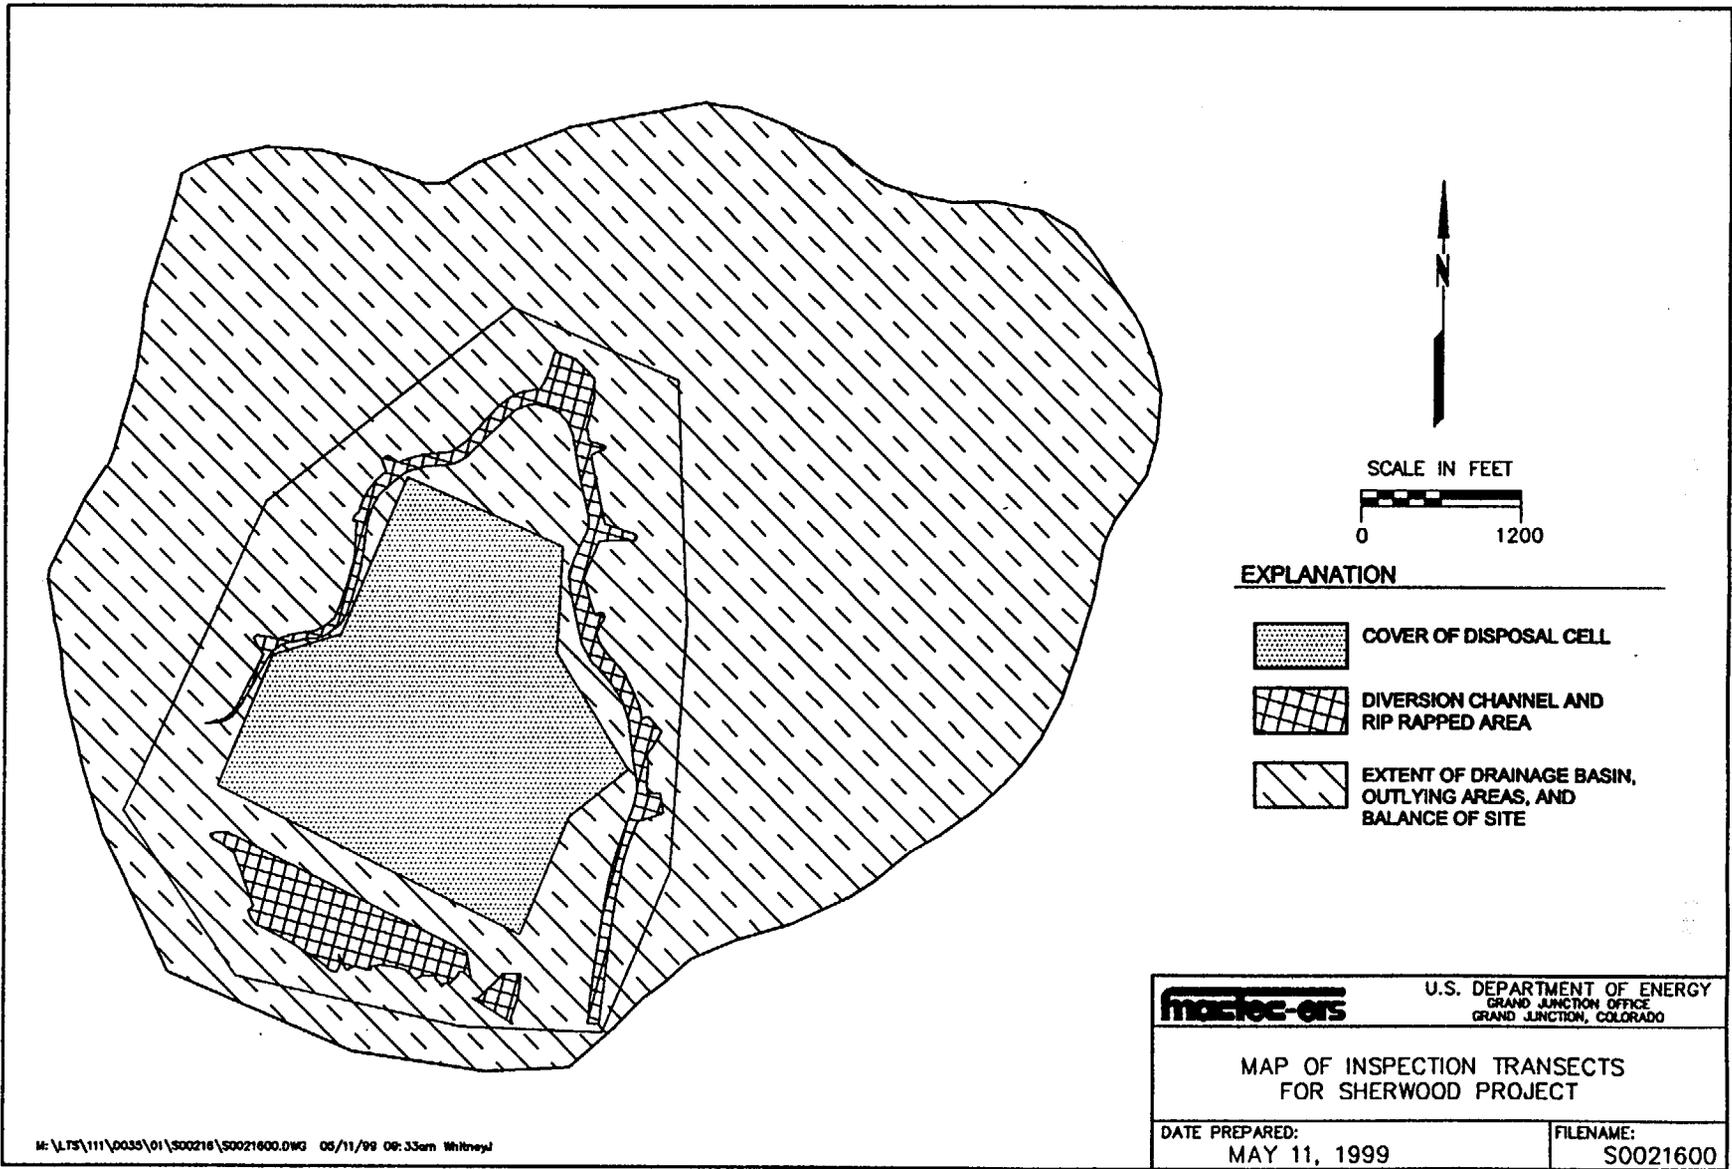
Figure 3-1. Map of Inspection Transects for Sherwood, Washington, Disposal Cell

Annual inspections will be a visual walk-through. The primary purpose of the inspection will be for evidence of cover cracking, wind or water erosion, structural discontinuity of the containment dam, maintenance of vegetation, and animal or human intrusions that could result in adverse impacts.

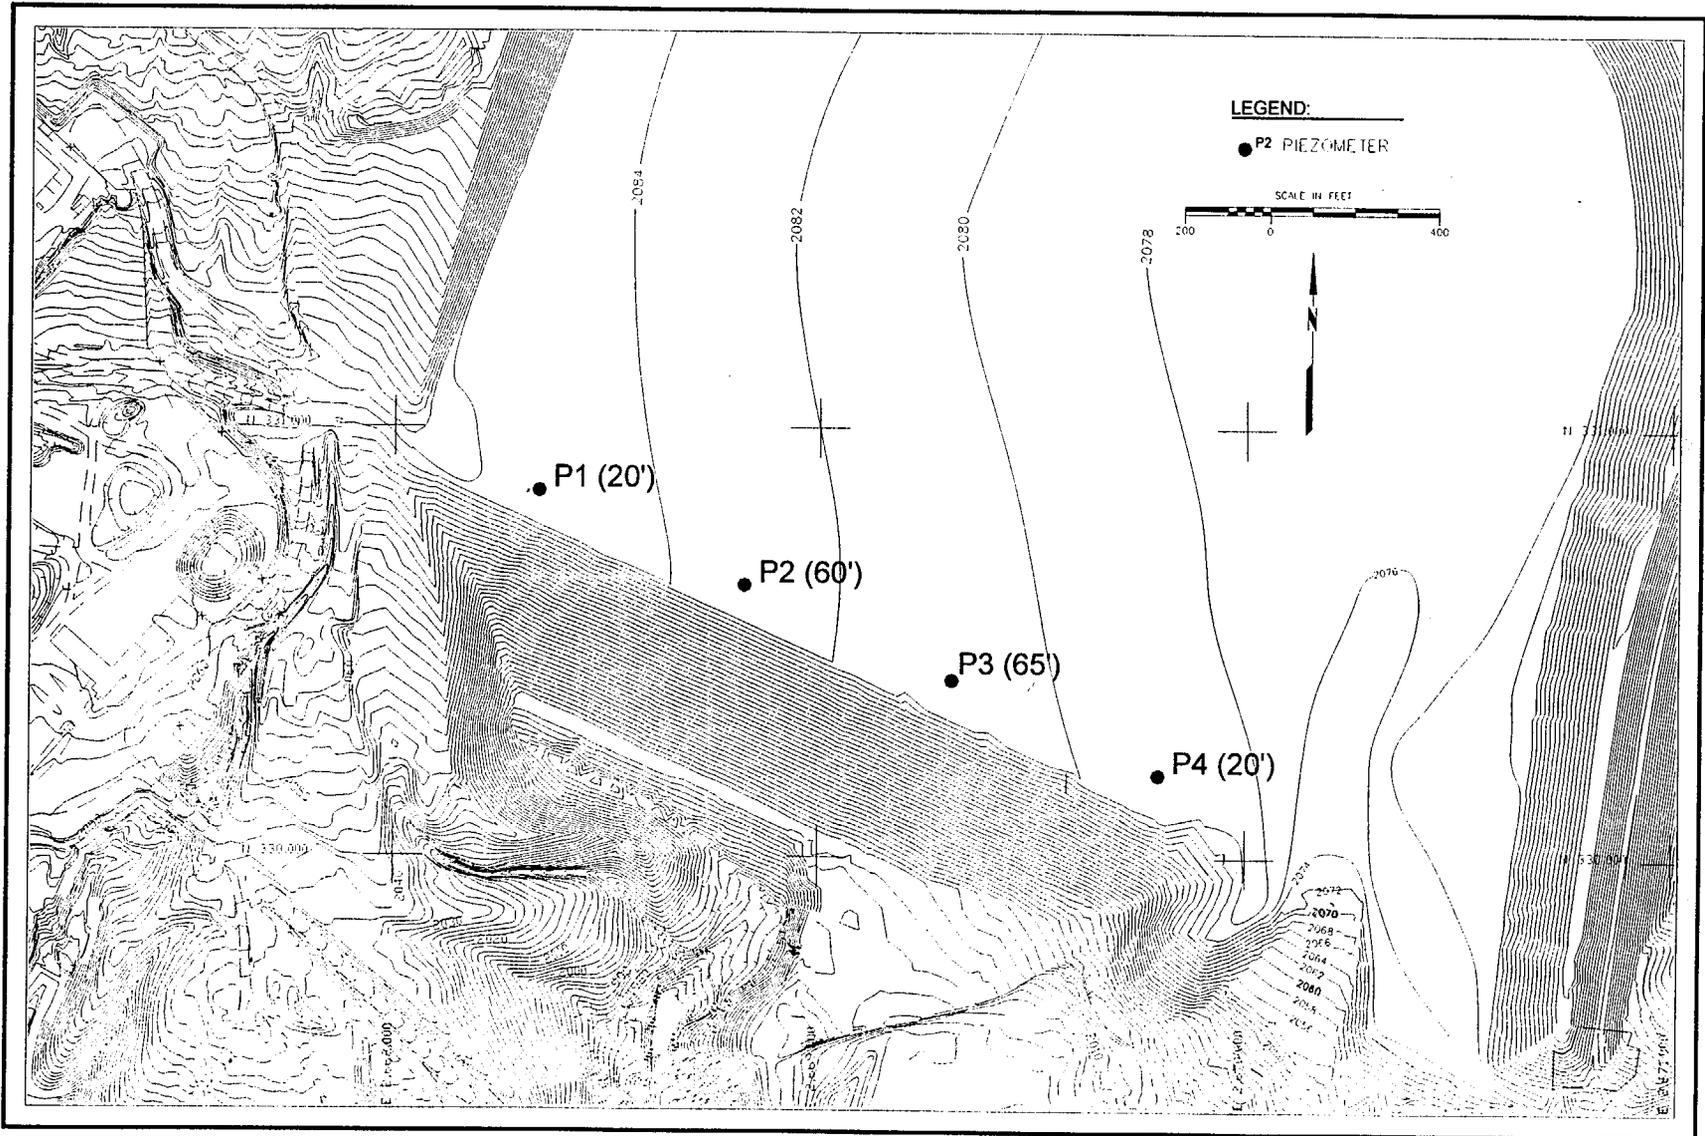
**FIGURE 3**  
**PIEZOMETER LOCATIONS**

Four piezometers have been installed along the alignment of the tailings dam crest to provide the long-term custodian with a direct means of determining dam moisture conditions. The positions of the piezometers are shown in Figure 3 and piezometer completion details are provided in Figure 4.
