VOGTLE ELECTRIC GENERATING PLANT RESPONSE TO NRC BULLETIN 2001-01

VOGTLE ELECTRIC GENERATING PLANT, UNIT 1 AND UNIT 2 RESPONSE TO NRC BULLETIN 2001-01 CIRCUMFERENTIAL CRACKING OF REACTOR PRESSURE VESSEL HEAD PENETRATION NOZZLES

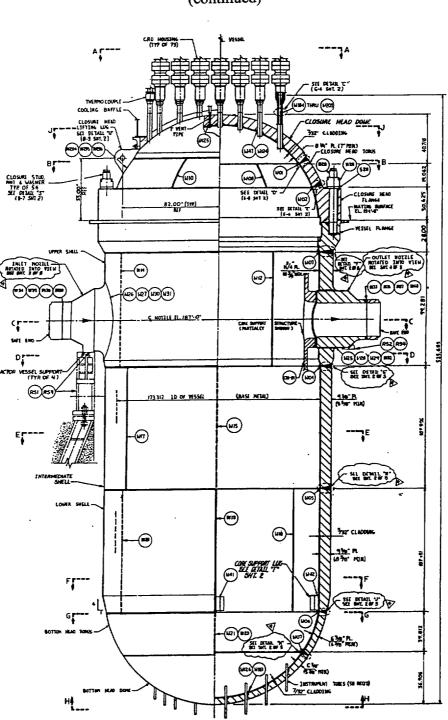
EXCERPT-VOGTLE ISI DWG. ISI-11201-V6-001, SHT. 1 OF 5 FIGURE 1 - WESTINGHOUSE 4-LOOP REACTOR PRESSURE VESSEL

Parameter	Data
Head Fabricator	Combustion Engineering
Design Diametral Nozzle Interference Fit (mils)	0.0 - 3.0
Number of CRDM Nozzles	78
Outside Diameter of CRDM Nozzles (inches)	4.000
Inside Diameter of CRDM Nozzles (inches)	2.750
Number and Size of J-Groove Head Vent Nozzles	1 - 1" Sch. 160
Minimum Horizontal Distance Between VHP Nozzles	11.973"

Refer to Figure 1 for a depiction of the RPV.

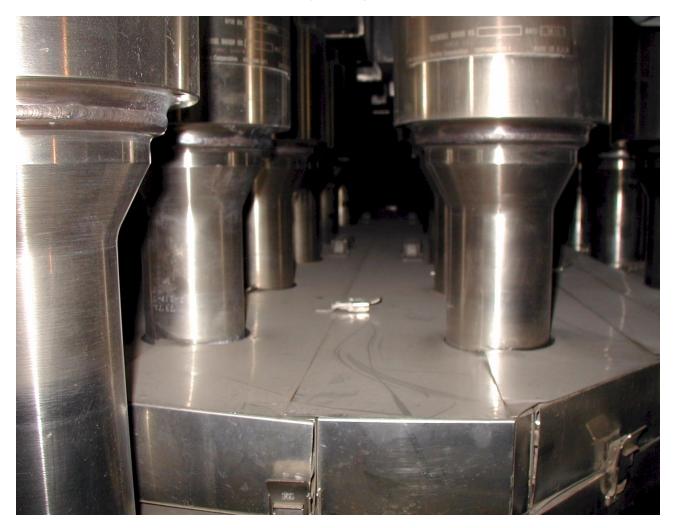
FIGURE 2 - RPV CLOSURE HEAD INSULATION AROUND CRDM NOZZLES

The RPV closure head insulation used at VEGP Unit 1 and Unit 2 is reflective (mirror) stepped insulation fabricated by Transco, Inc. It is 3" in thickness and is removable. Refer to Figure 2 for a depiction of the RPV closure head insulation. Typically, the insulation remains in place since it is part of the integrated head package used on each of the VEGP units. The RPV closure head insulation may be accessed through manways located in the shroud assembly that is also part of the integrated RPV closure head package. Refer to the response to Bulletin Item 1.e for a general description of the integrated RPV closure head package. Figures 4 and 5 are photographs of the VEGP integrated head package.

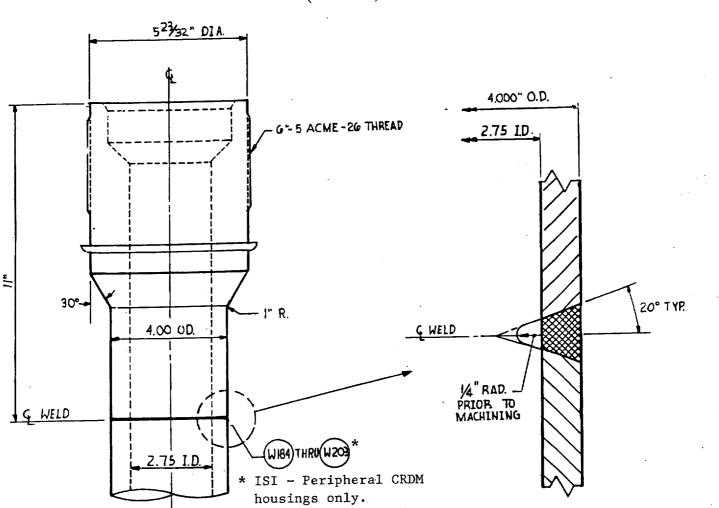
EXCERPT-VOGTLE ISI DWG. ISI-11201-V6-001, SHT. 2 OF 5

FIGURE 3 - CRDM HOUSING WELD

The most recent examination of the CRDM housing welds at VEGP was performed in excess of four years ago during maintenance/refueling outages 1R5 (Fall 1994) and 2R5 (Fall 1996) for Unit 1 and Unit 2, respectively. During those outages, the American Society of Mechanical Engineers (ASME) Section XI Code-required percentage of these Category B-O, Item B14.10 welds were examined using surface means (liquid penetrant), thereby fulfilling the examination requirements for the first ten-year inservice inspection interval. Ten percent (10%) of the peripheral CRDM housings were required to be examined and include the following welds:

performed by nondestructive examination (NDE) personnel certified to the requirements of the American Society of Nondestructive Testing (ASNT) document SNT-TC-1A for liquid penetrant examination. No Recordable Indications (NRI) were identified. Relevant indications are required to be recorded and include: (1) mechanical discontinuities, (2) linear indications in which the length is equal to or greater than three times the width, and (3) rounded indications that are circular or elliptical with the length less than three times the width. Refer to Figure 3 for a depiction of the CRDM housing weld.

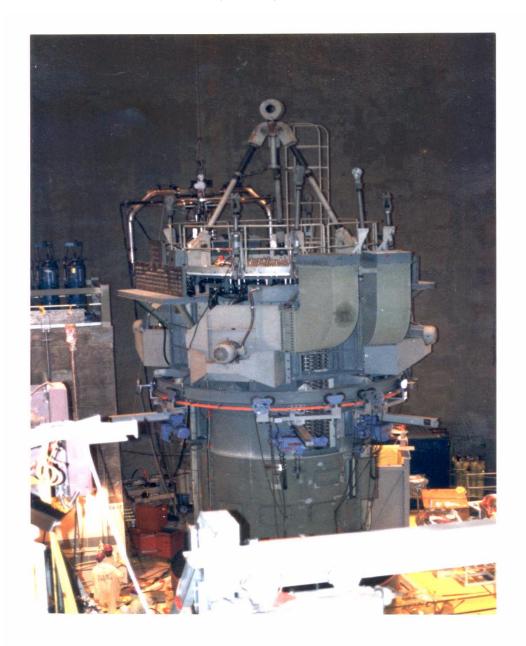
FIGURE 4 – VOGTLE INTEGRATED RPV CLOSURE HEAD PACKAGE (UPPER PORTION)

As noted in the response to Bulletin Item 1.c, Unit 1 and Unit 2 use an integrated RPV closure head package. The integrated RPV closure head package is a system that combines the head lifting rig, seismic platform, lift columns, reactor vessel missile shield, CRDM, Digital Rod Position Indication (DRPI) coils, forced-air cooling system, and electrical and instrumentation cable routing into a single, efficient design package. This system provides for the following during maintenance/refueling outages:

The overall height of the integrated RPV closure head package is approximately 41'-2" from the mating flange, i.e., the RPV flange, to the top of the lifting rig, inclusive of the shroud assembly. From the RPV flange to the bottom surface of the missile shield is approximately 29' - 2".

Refer to Figures 4 and 5 for a depiction of the integrated RPV closure head package.

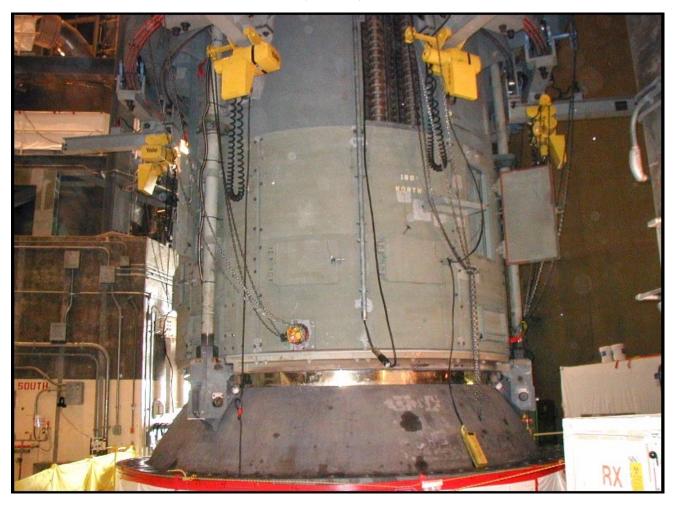
FIGURE 5 – VOGTLE INTEGRATED RPV CLOSURE HEAD PACKAGE (LOWER PORTION)
