TDR-EBS-MD-000017 REV 00

Seismic Tomography Technology for the Water Infiltration Experiment

Prepared for:
U.S. Department of Energy
Yucca Mountain Site Characterization Office
P.O. Box 30307
North Las Vegas, Nevada 89036-0307

Prepared by:
Bechtel SAIC Company, LLC
1180 Town Center Drive
Las Vegas, Nevada 89144

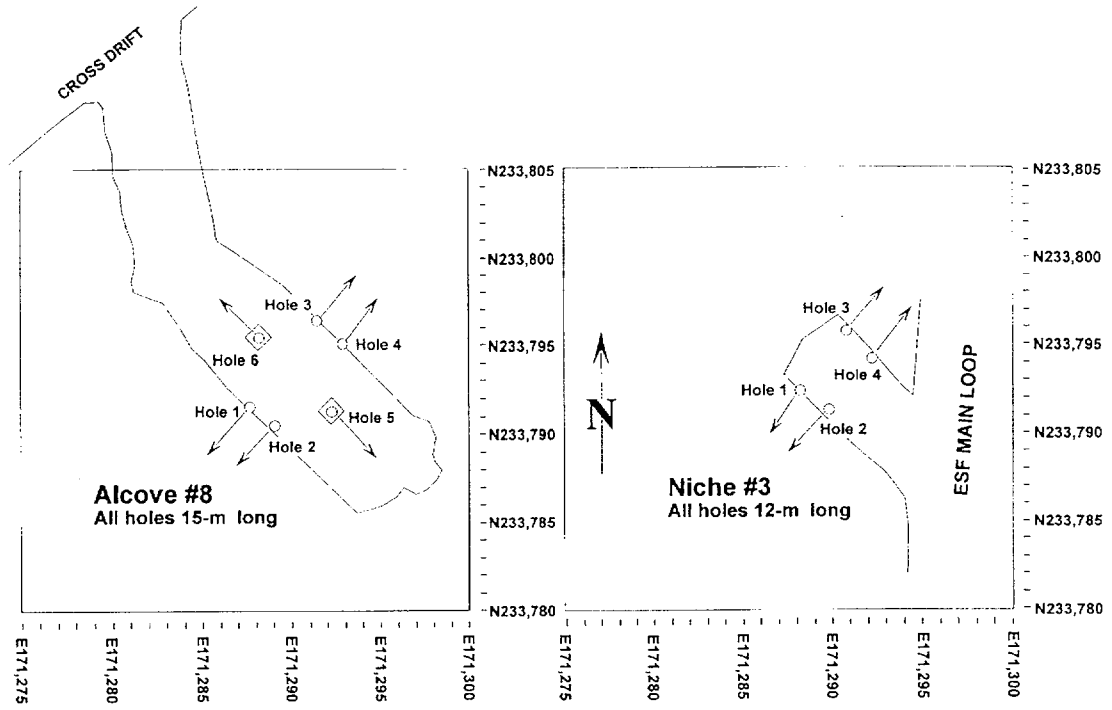
Figure 4. Plan view of Alcove #8 and Niche #3 with borehole locations and directions.

The test as planned consisted of seismic tomographic imaging of the rock volume between Niche #3 in the ESF main loop drift and Alcove #8 in the overlying ECRB cross drift. Figure 1 shows the proposed location of the test site within the ESF and ECRB, and Figures 2 and 3 show three-dimensional representation of the test area including several boreholes that were drilled prior to the test. The six angled holes drilled downward from Alcove #8 and the four holes drilled upward from Niche #3 are to be used for data collection; the imaged area roughly corresponds to the rock volume enclosed by these 10 boreholes. The vertical distance between the two levels is approximately 23 m (75.5 ft). Figure 4 shows plan views of the hole collar locations within Alcove #8 and Niche #3.

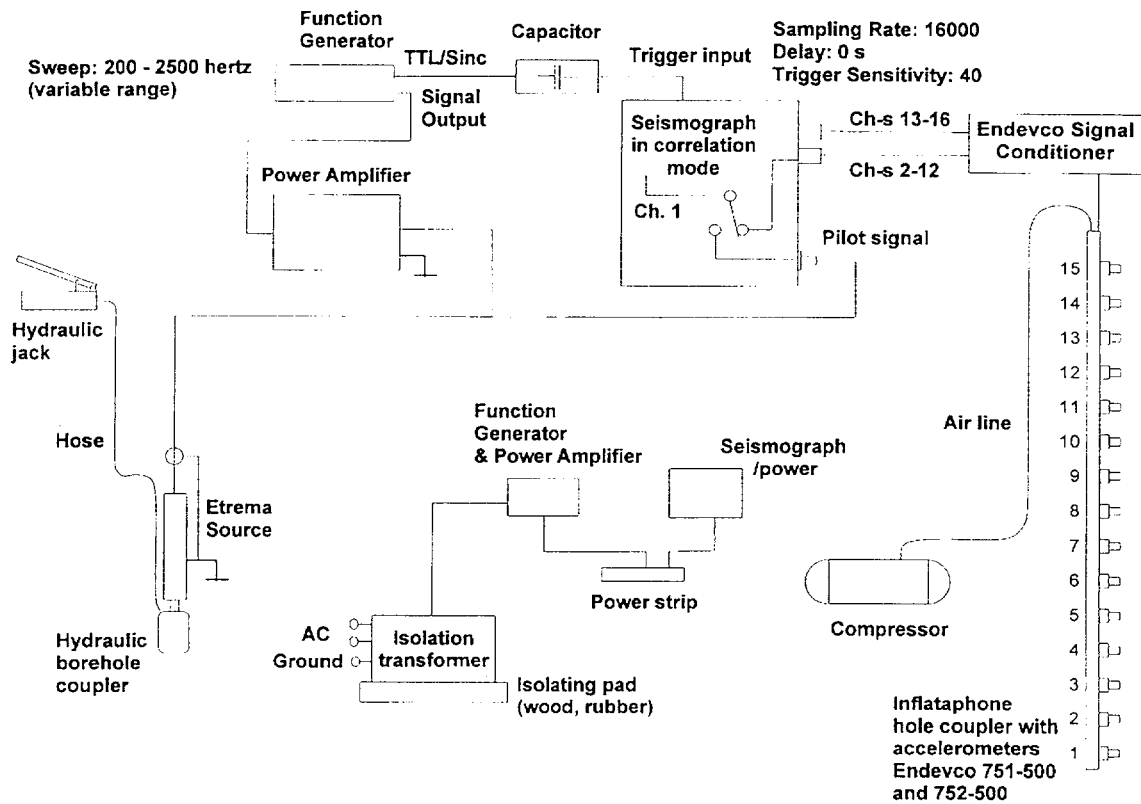
Figure 5. Block schematic showing components of the tomographic survey installation.

Figure 5 shows a schematic diagram of the data collection equipment and system connections. The primary seismic signal source is an Etrema magnetostrictive actuator inserted into a borehole and coupled to the rock with a hydraulic mechanism. A function generator provides a variable frequency signal that triggers data acquisition, controls seismic output from the source, and improves detection of seismic waves recorded by an array of receivers. The receivers are accelerometers that are mounted at regular intervals on a tube inserted into a borehole and forced against the rock surface with an inflatable bladder inside the tube. The signals are recorded by a high-resolution digital seismograph and saved as data files, which are subsequently processed using the RockVision3D™ software. The system was evaluated, and appropriate components were calibrated by the Standard and Calibration Laboratory of Bechtel Nevada Corporation. Serial numbers of equipment are listed in the *NSA Engineering Tomographic Survey Scientific Notebook* (Kramer 2000). Details of selected equipment are described below:

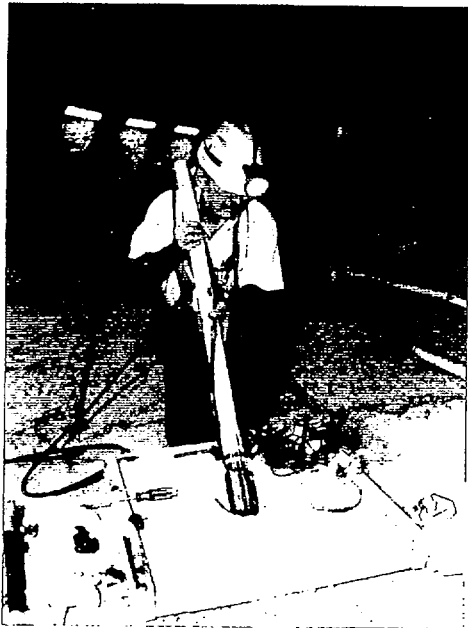
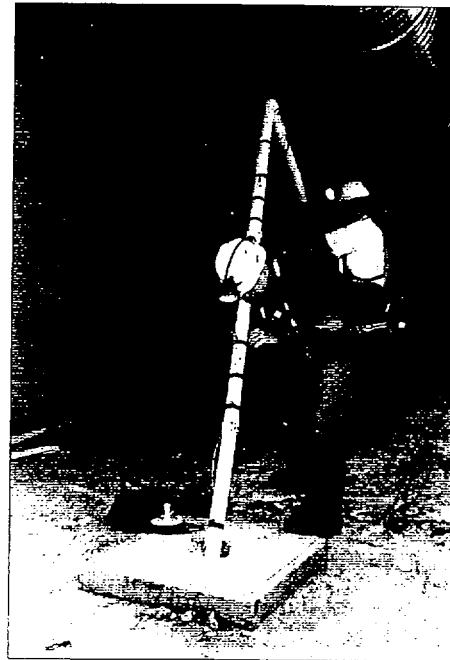
Project: Phase II - Tomographic Survey in Alcove#8 and Niche #3
	Project engineer: J. M. Descour
	Figure 7
	Date: October 2000

Seismic Source

Accelerometers - Inflataphone Probe Assembly

The receiver probe consists of fifteen Endevco accelerometers (models 751-500 and 752-500) mounted on sectional lengths of PVC tubing that is inserted into the borehole to the required depth. The accelerometers are forced against the borehole wall using air pressure of 105 kPa (15 psi) to inflate a line hose extending through the tube assembly. The accelerometers are spaced 1 m (3.28 ft) apart, and the tubing sections are indexed to ensure that the receivers are aligned and oriented properly in the borehole. The output from the receivers is processed by an Endevco signal conditioner to provide an amplified input to the seismograph.

Small adjustments to the original design of the Etrema source installation tubes and clamping device were required to enhance field operations; however, the basic functions were unchanged. These adjustments included: replacement of the original cables with lighter ones, strengthening of the PVC pipe joints, and adding an expansion limiter (Kramer 2000). Figure 7 illustrates the actual installation of source and receivers.
