WCAP-15753 NON-PROPRIETARY VERSION OF WCAP-14118,
“STRUCTURAL INTEGRITY EVALUATION OF REACTOR VESSEL UPPER HEAD
PENETRATIONS TO SUPPORT CONTINUED OPERATION:
D. C. COOK UNITS 1 AND 2”

INDIANA MICHIGAN POWER COMPANY (I&M) SUMMARY OF
WESTINGHOUSE ELECTRIC CORPORATION
WCAP-14118, REVISION 4

October 2001

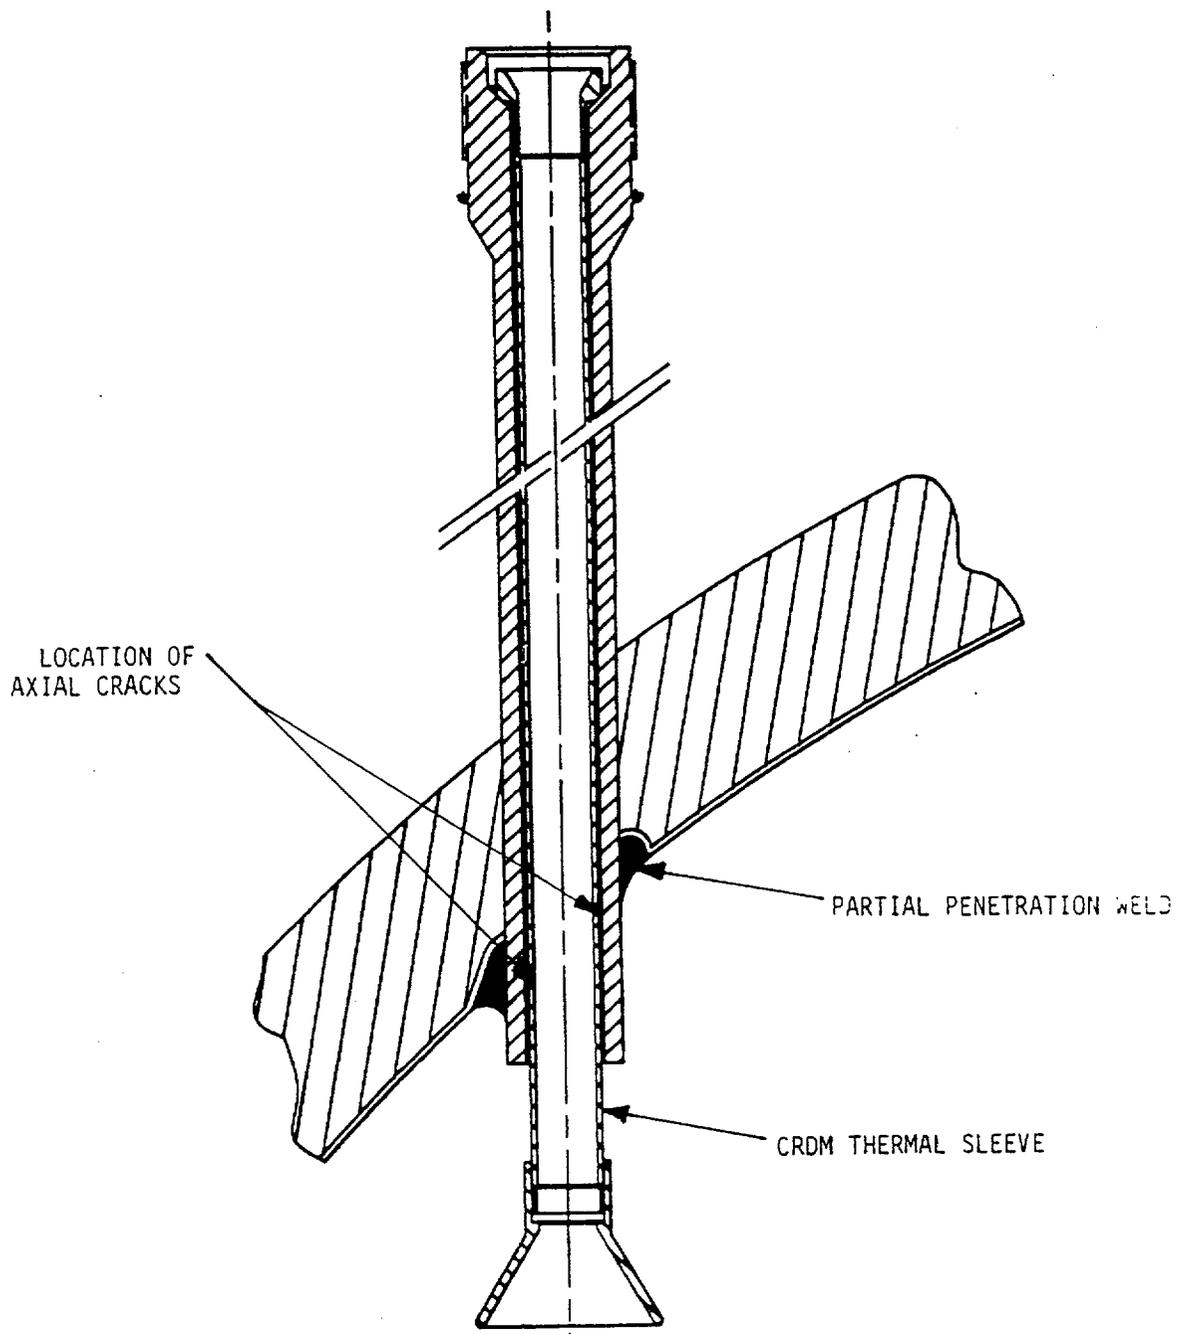
FIGURE 1-1
REACTOR VESSEL HEAD ADAPTER PENETRATION TUBE, SHOWING LOCATIONS OF
AXIAL CRACKS FOUND IN SOME PLANTS

In September of 1991, a leak was discovered in the reactor vessel control rod drive head penetration region of an operating plant. This has led to the question of whether such a case could occur at D. C. Cook Unit 1 or 2. The geometry of interest is shown in Figure 1-1.

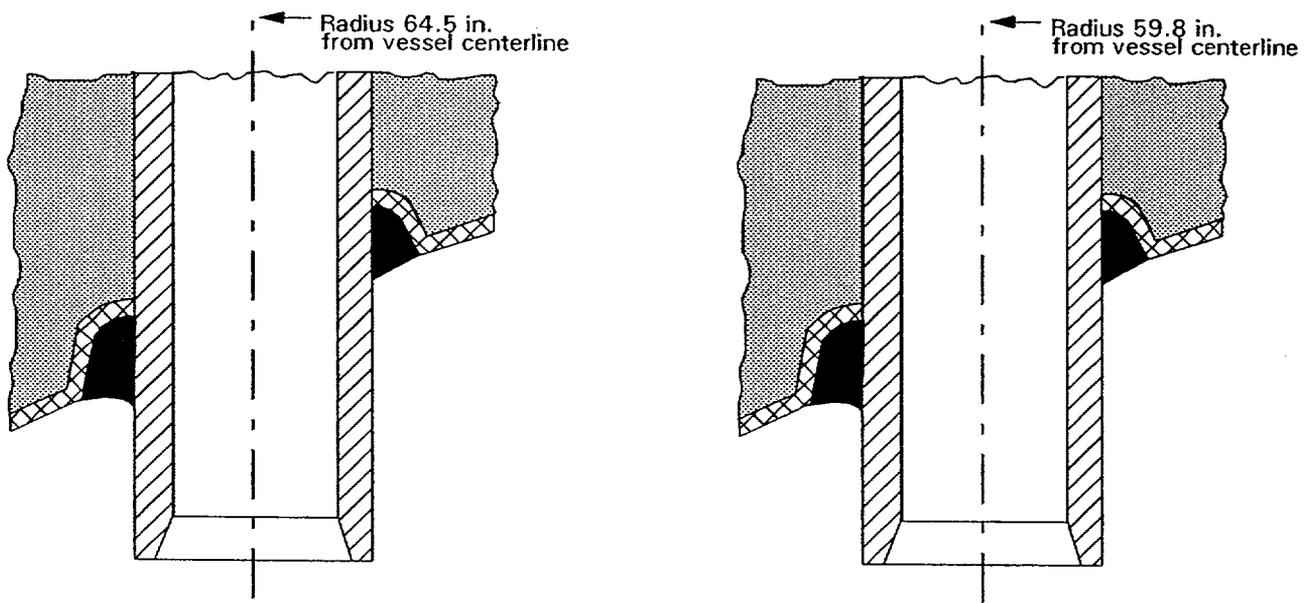
FIGURE 1-2
GEOMETRY OF THE HILLSIDE PENETRATIONS ANALYZED

The basis of the analyses was a detailed three dimensional elastic-plastic finite element analysis of the two penetration locations, as described in detail in Section 5. The geometry of the hillside penetration analyzed is shown in Figure 1-2.

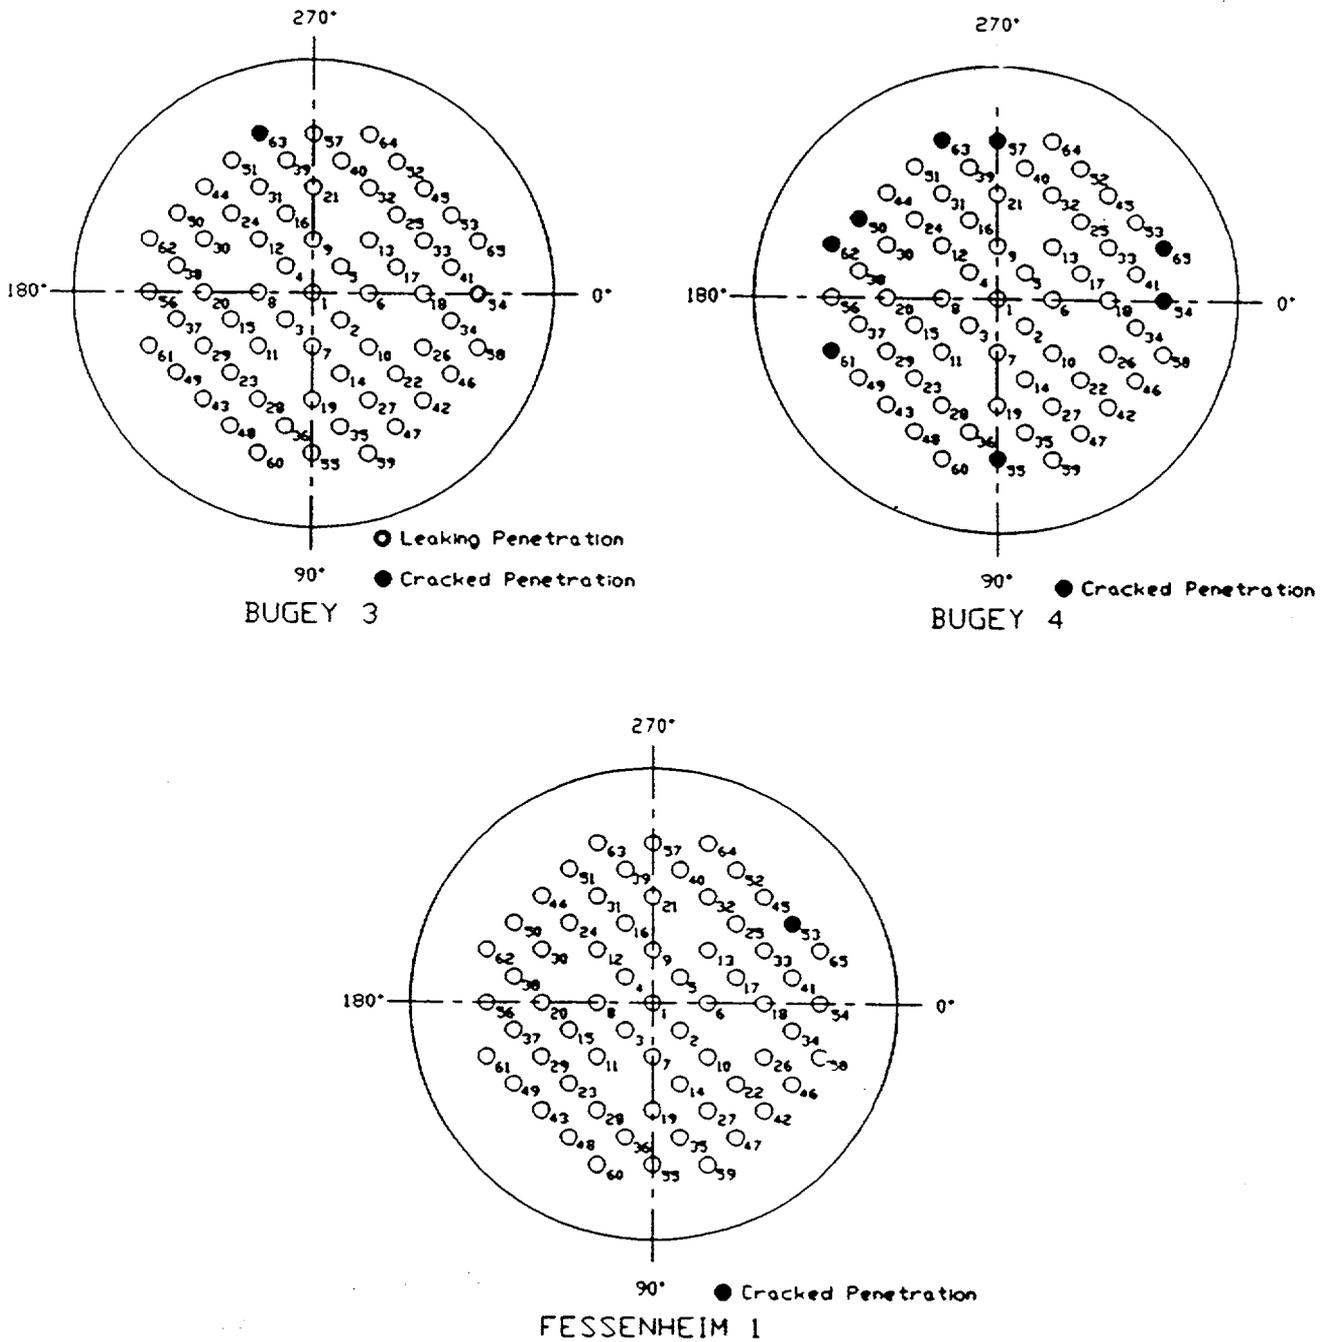
FIGURE 2-1

FRENCH R/V CLOSURE HEAD PENETRATION CRACKING
EdF PLANTS - PENETRATIONS WITH CRACKING

In September of 1991, leakage was reported from the reactor vessel head penetration region of a French plant, Bugey Unit 3. Bugey 3 is a 920 megawatt three-loop PWR which had just completed its tenth fuel cycle. The leak occurred during a post ten year hydrotest conducted at a pressure of approximately 3000 psi (204 bar) and a temperature of 194°F (90°C). The leak was detected by metal microphones located on the top and bottom heads, and the leak rate was estimated to be approximately 0.7 liter/hour. The location of the leak was subsequently established on a peripheral penetration with an active control rod (H-14), as seen in Figure 2-1.

As a result of this finding, all of the control rod drive mechanisms and thermal sleeves at Bugey 3 were removed for inspection of the head penetrations. Only two penetrations were found to be cracked, as shown in Figure 2-1.

At Bugey 4, eight of the 64 penetrations examined were found to contain axial cracks, while only one of the 26 penetrations examined at Fessenheim 1 was cracked. The locations of all the cracked penetrations are shown in Figure 2-1. None of the 17 penetrations inspected at Paluel 3 showed indications of cracking, at the time, but further inspection of the French plants have confirmed at least one crack in each operating plant.

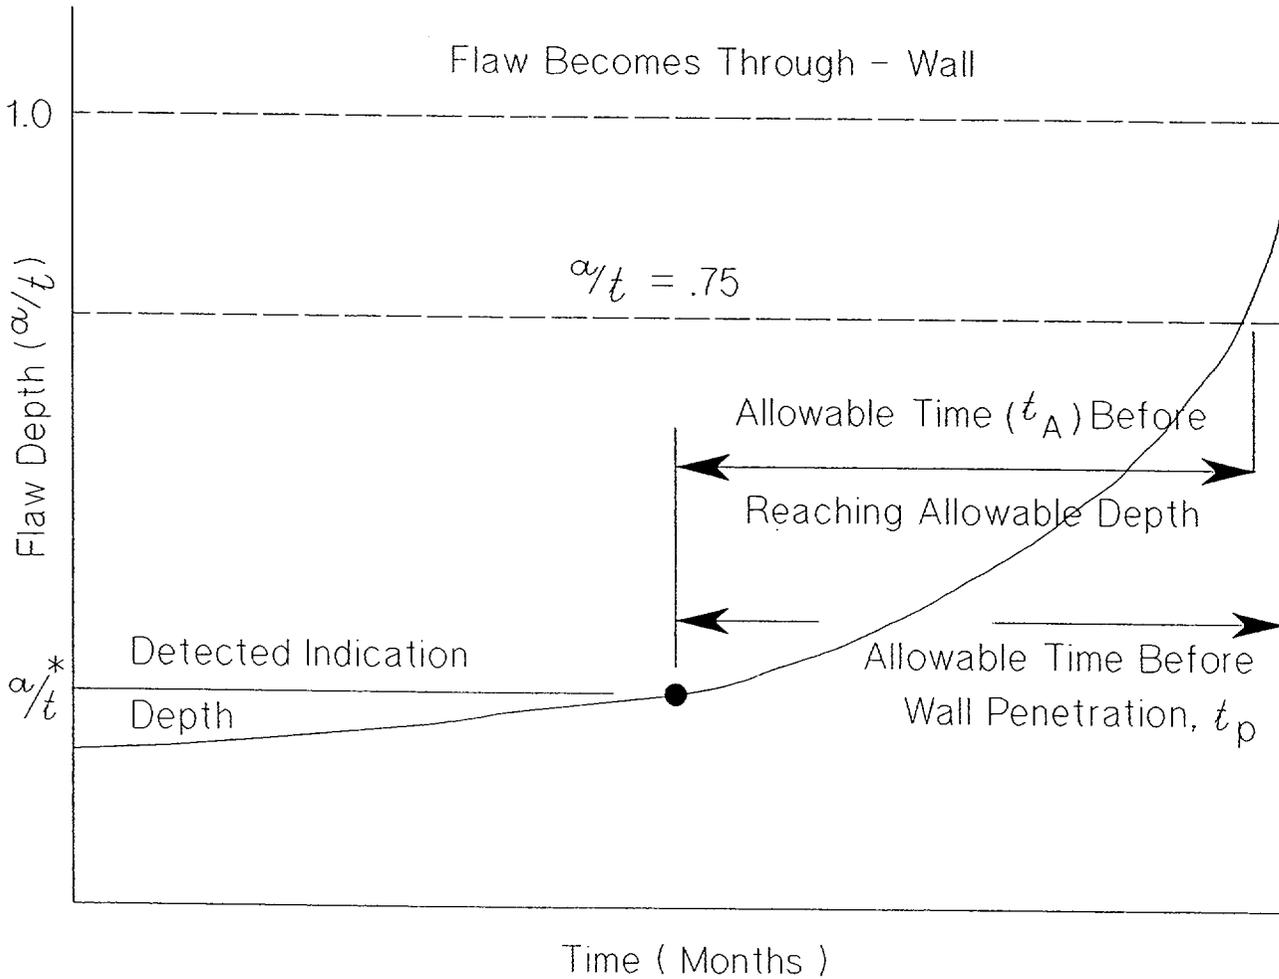
FIGURE 3-1
 SCHEMATIC OF A HEAD PENETRATION FLAW GROWTH CHART FOR
 PART THROUGH FLAWS

Schematic drawings of the head penetration flaw tolerance charts are presented as Figures 3-1 and 3-2. These two types of charts can be used to provide estimates of the time which remains before a leak would develop from an observed crack. For example, if a part-through flaw was discovered, the user would first refer to Figure 3-1, to determine the time (t_p) which would be remaining before the crack would penetrate the wall or reach the allowable depth (t_A) (eg $a/t=.75$). Once the crack penetrates the wall, the time (t_B) required to reach an allowable crack length would be determined from Figure 3-2. The total time remaining would then be the simple sum:

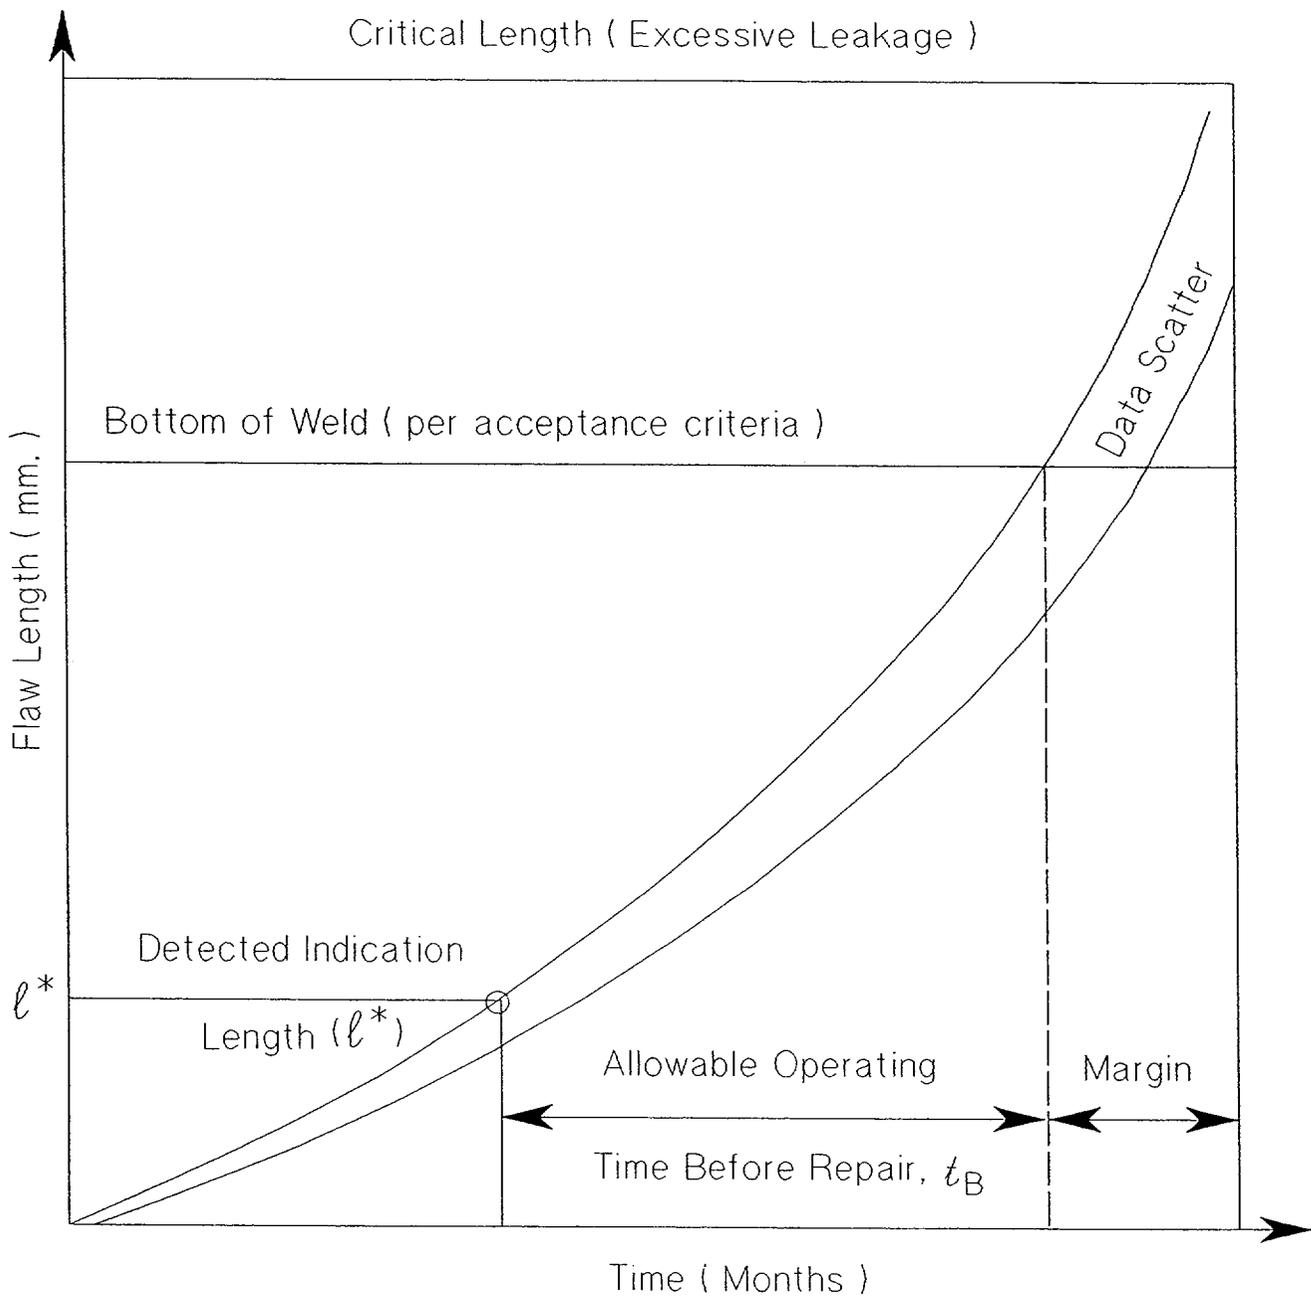
FIGURE 3-2
 SCHEMATIC OF A HEAD PENETRATION FLAW TOLERANCE CHART
 FOR THROUGH-WALL FLAWS

Another way to determine the allowable time of operation with a part-through flaw would be to use Figure 3-2 directly, in effect assuming the part-through flaw is a through-wall flaw. This approach would be more conservative than that above, and the time remaining would then be:

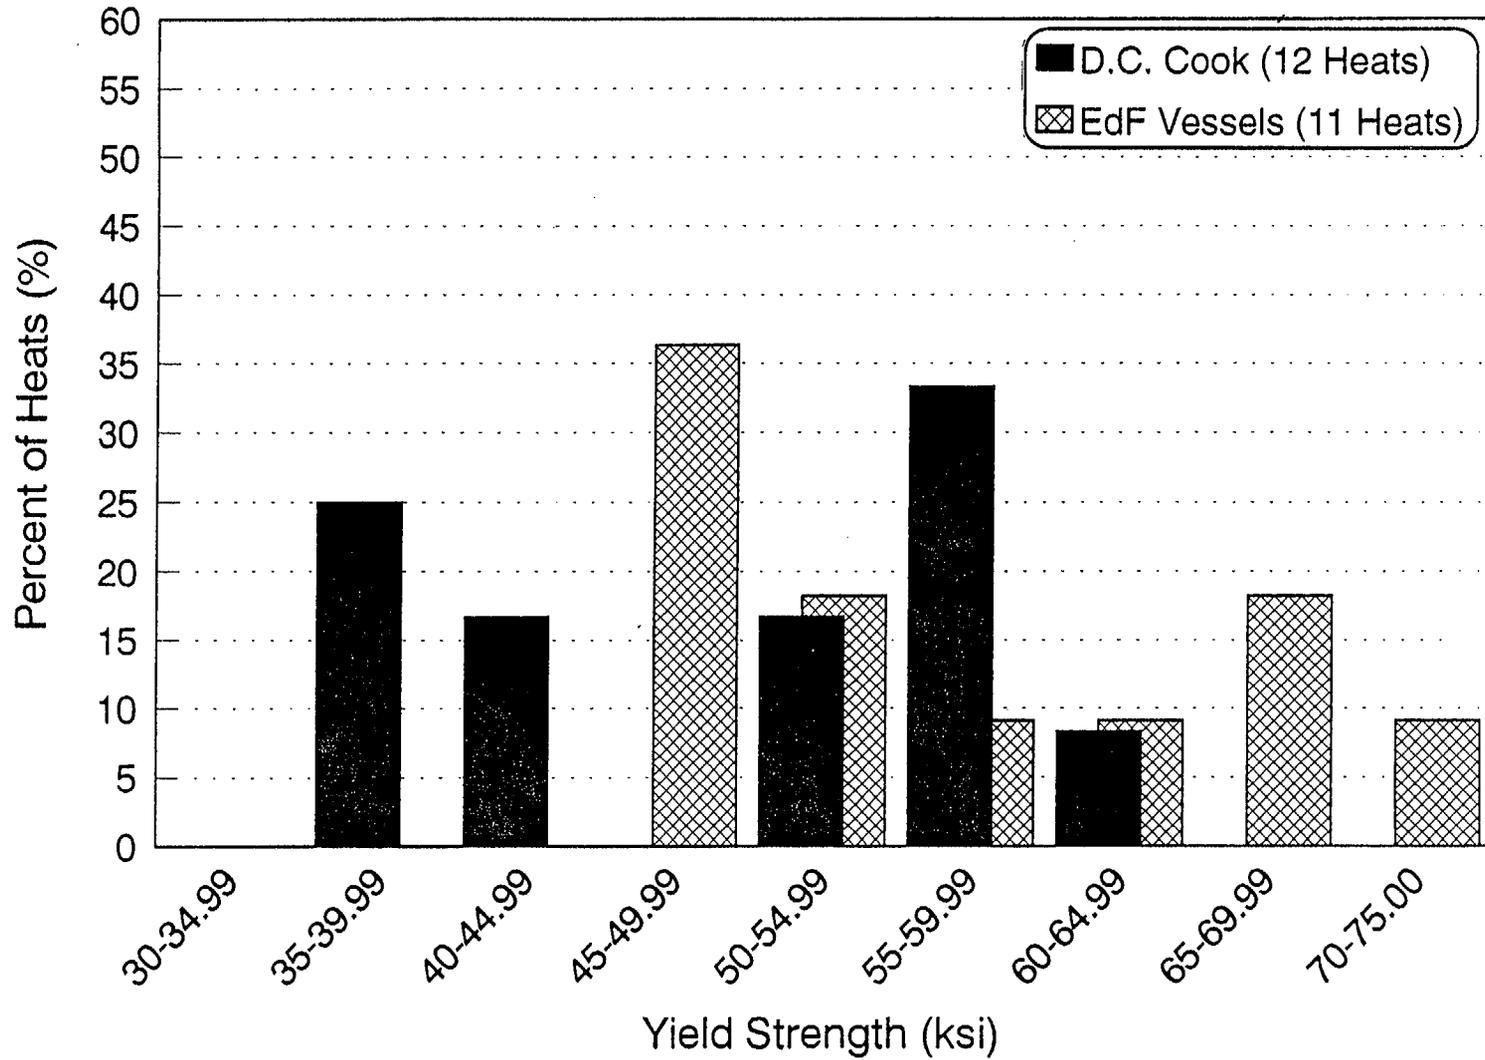
FIGURE 4-1
YIELD STRENGTH OF THE VARIOUS HEATS OF ALLOY 600 USED IN
FABRICATING THE D. C. COOK UNITS 1 AND 2 AND FRENCH HEAD ADAPTOR PENETRATIONS

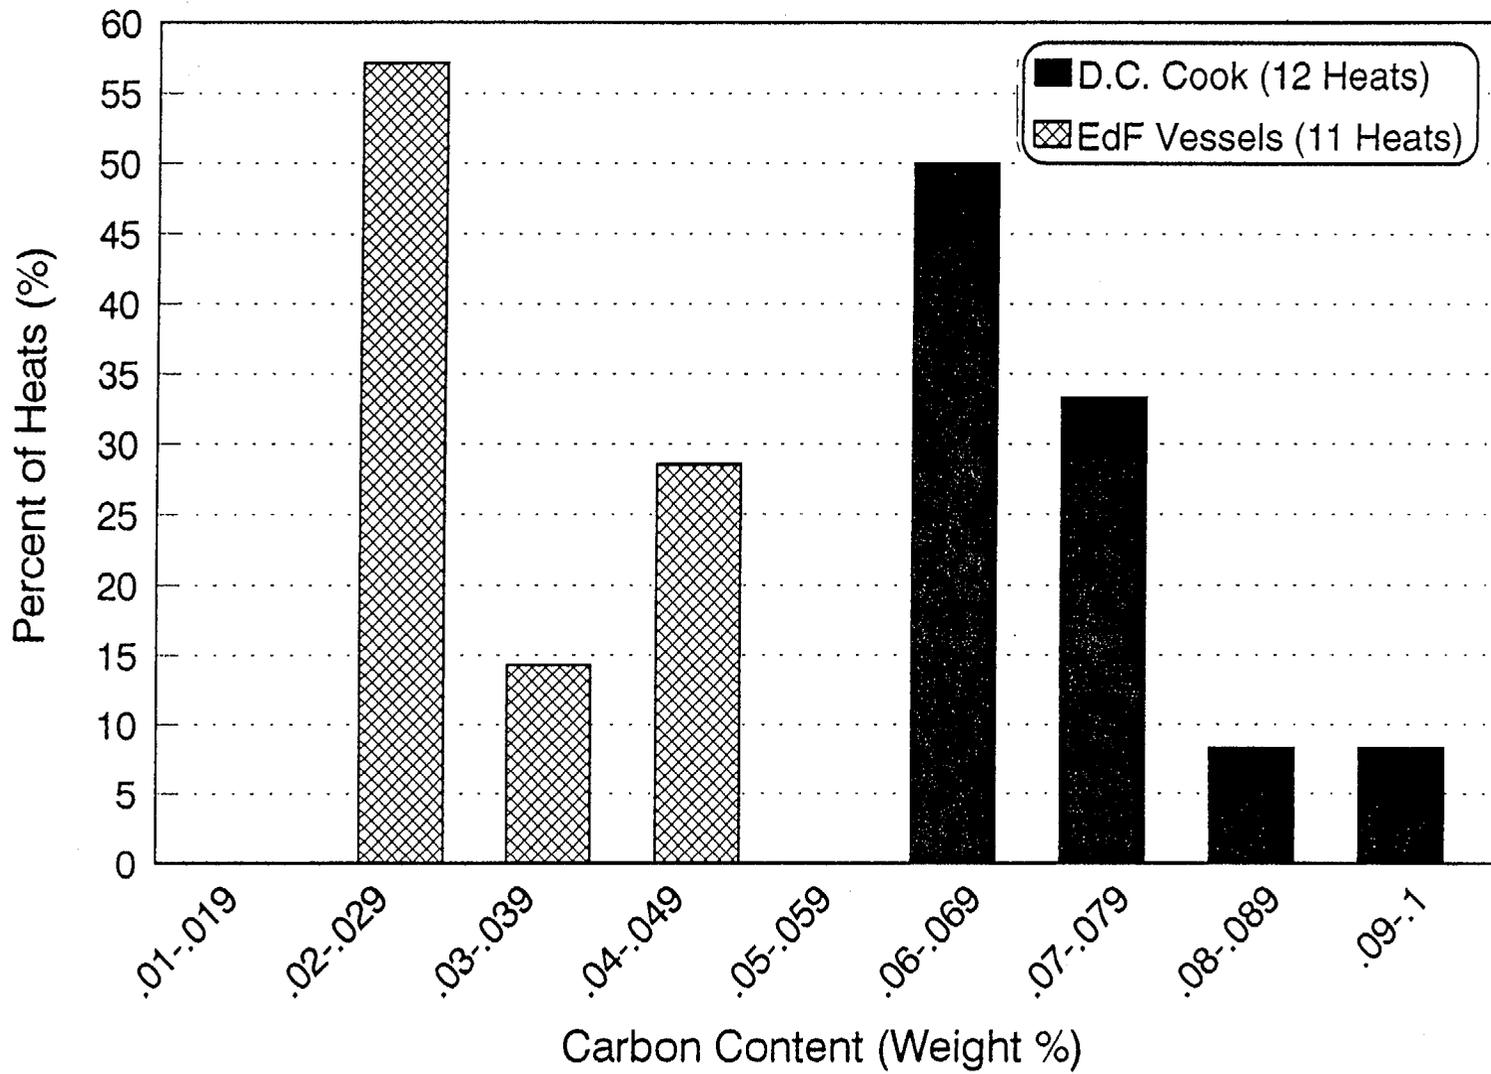
FIGURE 4-2
CARBON CONTENT OF THE VARIOUS HEATS OF ALLOY 600 USED IN
FABRICATING THE D. C. COOK UNITS 1 AND 2 AND FRENCH HEAD ADAPTOR PENETRATIONS

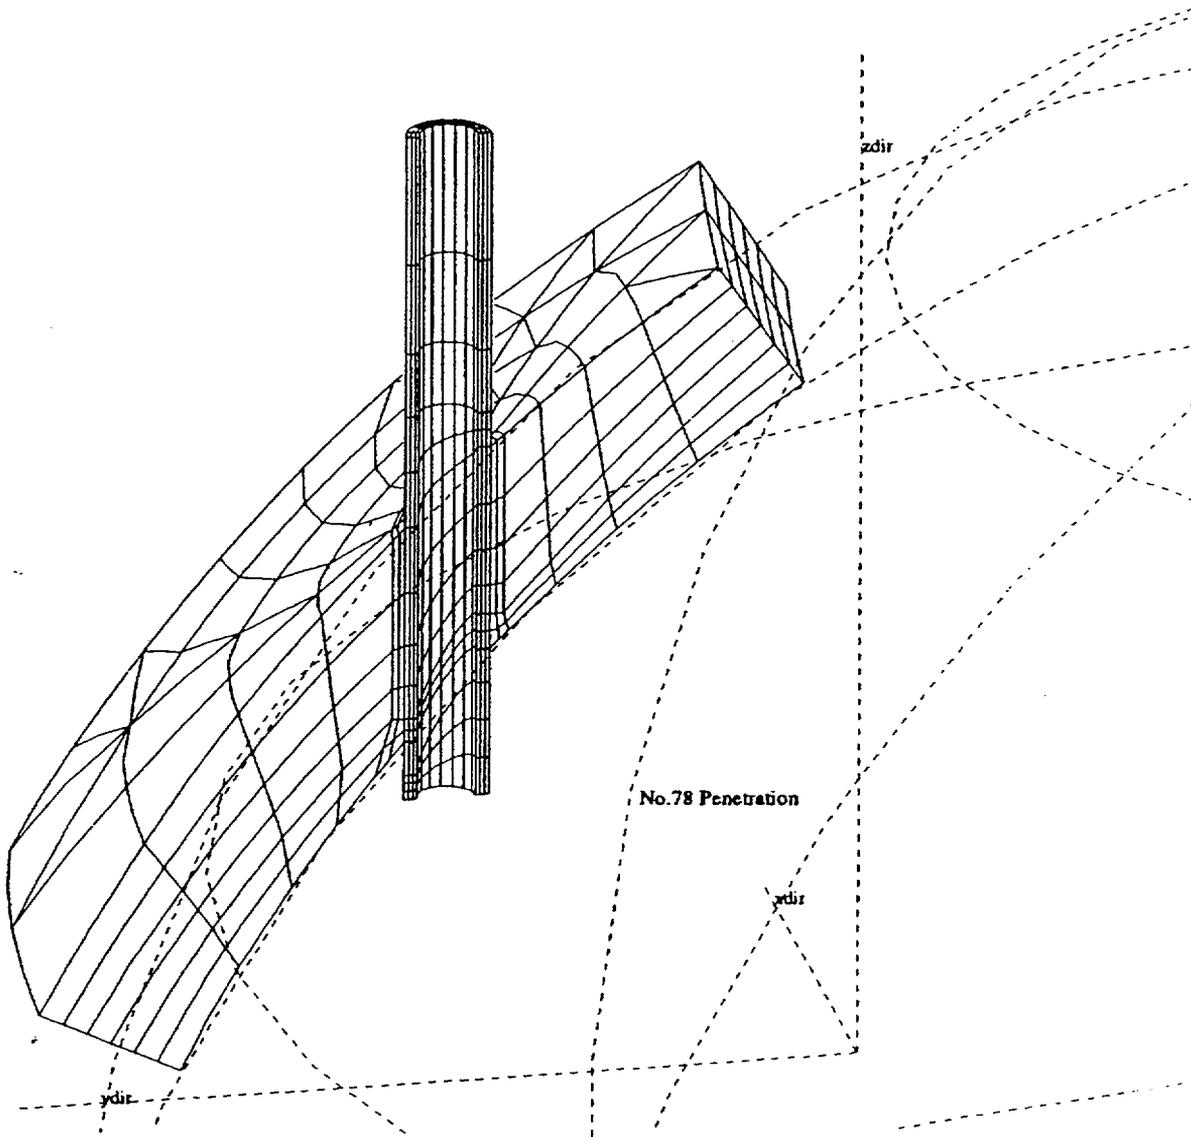
FIGURE 5-1
THREE-DIMENSIONAL MODEL OF THE OUTERMOST PENETRATION

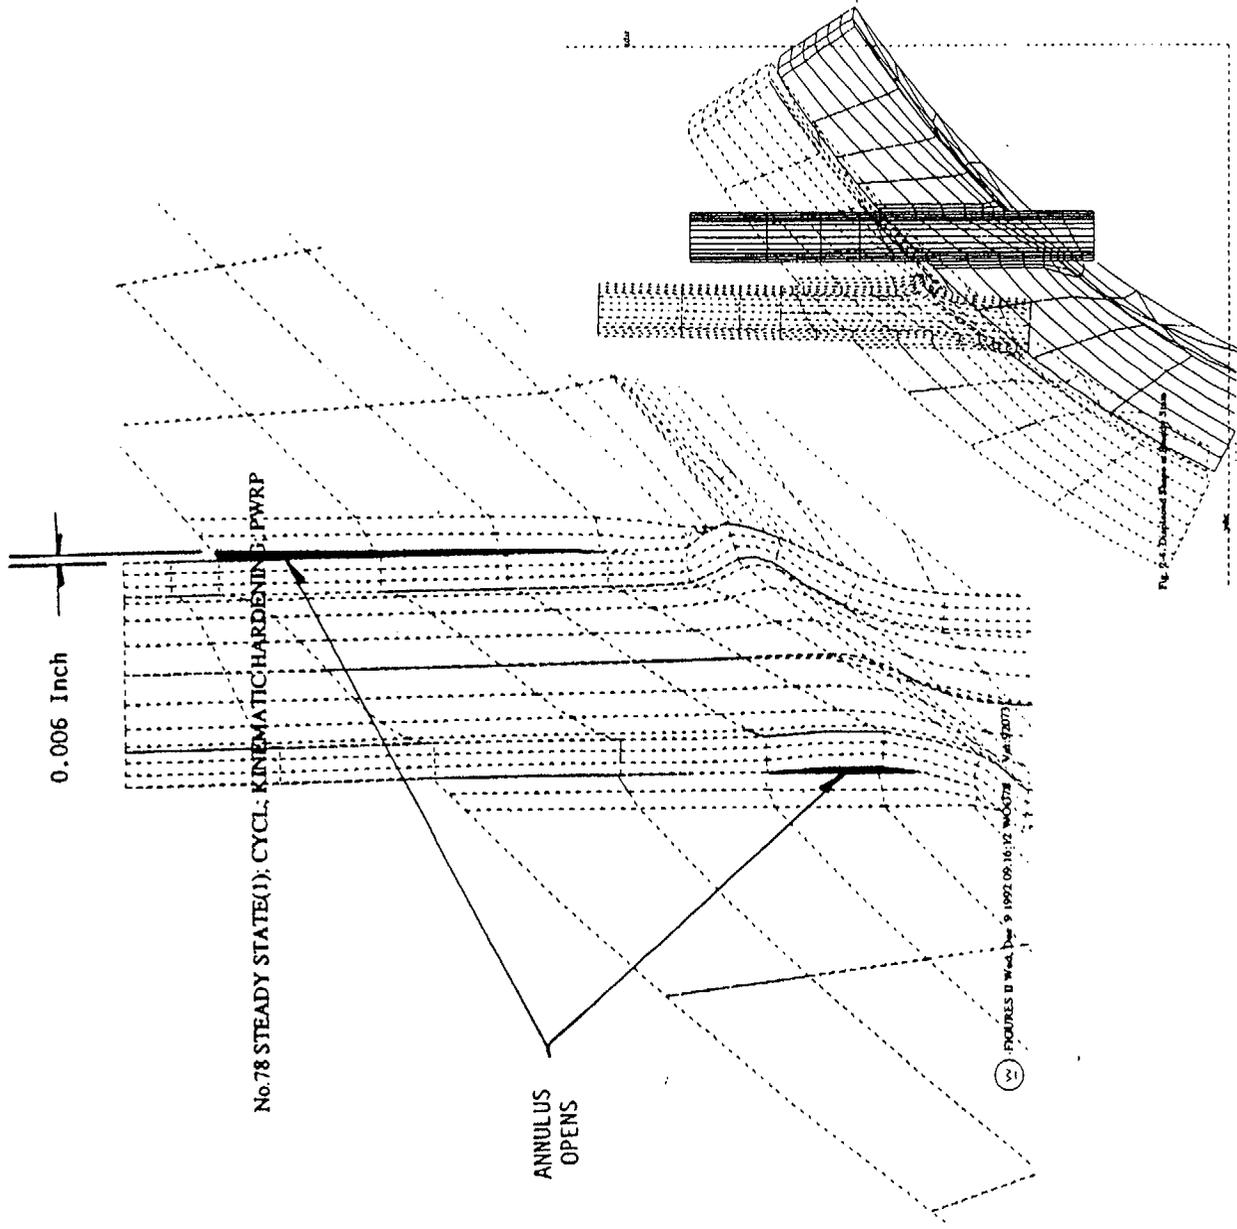
FIGURE 5-2
 STEADY STATE DISPLACEMENT OF RV CLOSURE HEAD AND OUTERMOST PENETRATION

Figure 5-2 shows the outward displacement of the entire model for the steady state condition. For the steady state, the tube OD is pressing on the vessel (i.e. couple each tube node, except for the vertical direction, to its neighbor in the vessel). Figure 5-3 presents the hoop stresses for the steady state condition.

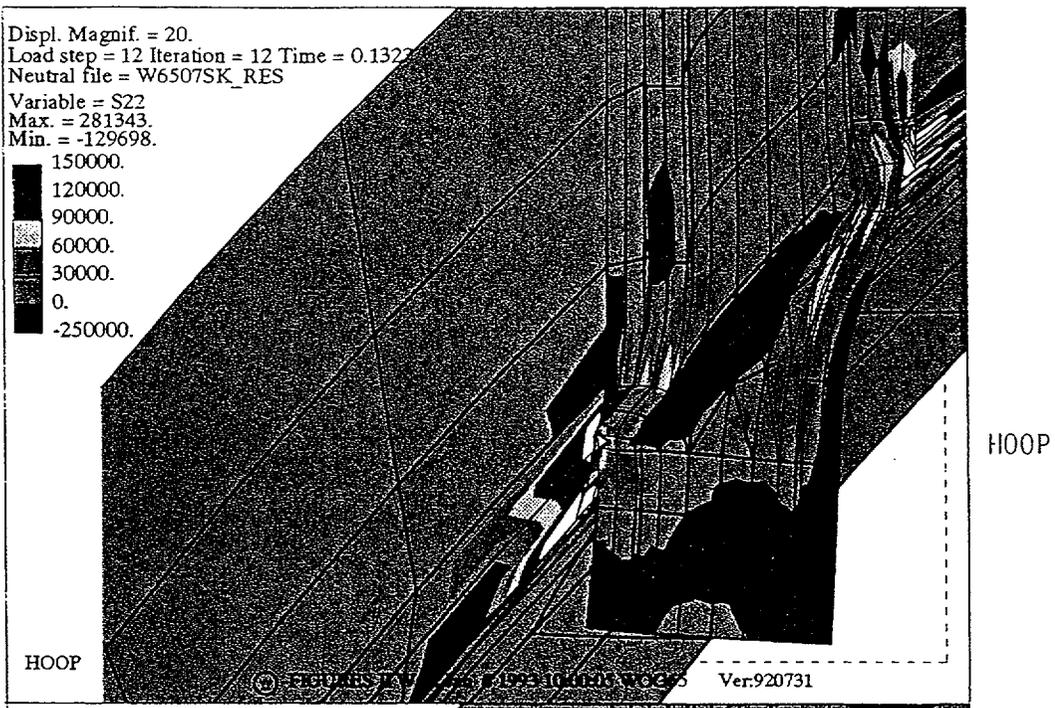
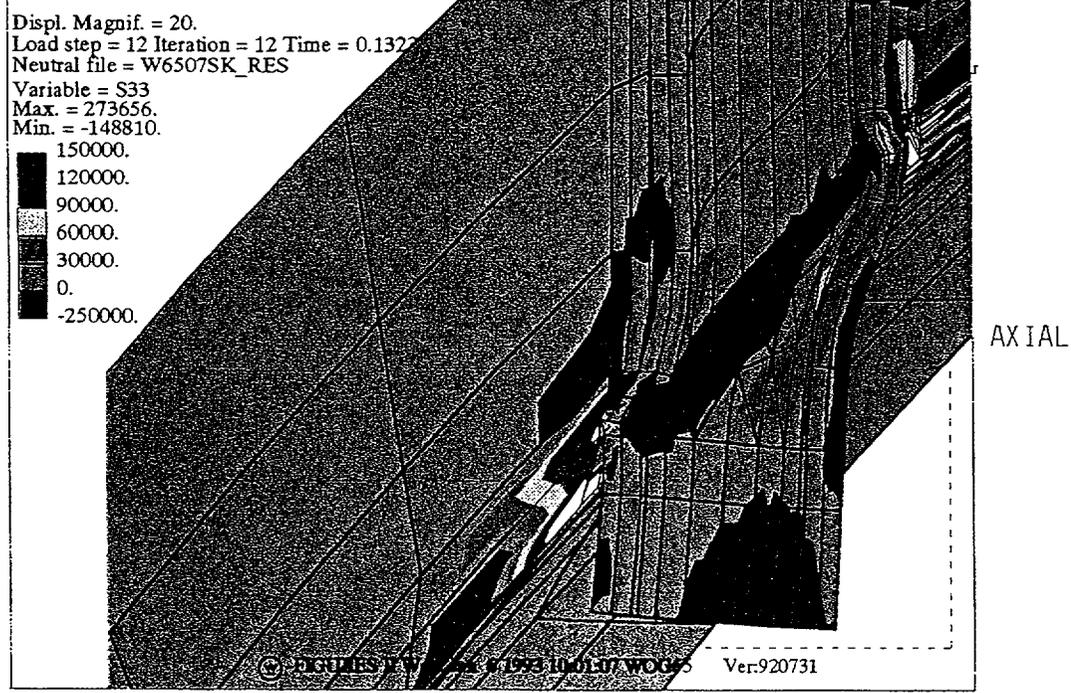
FIGURE 5-5
 STRESS DISTRIBUTION AT STEADY STATE CONDITION
 FOR THE NEXT OUTERMOST PENETRATION

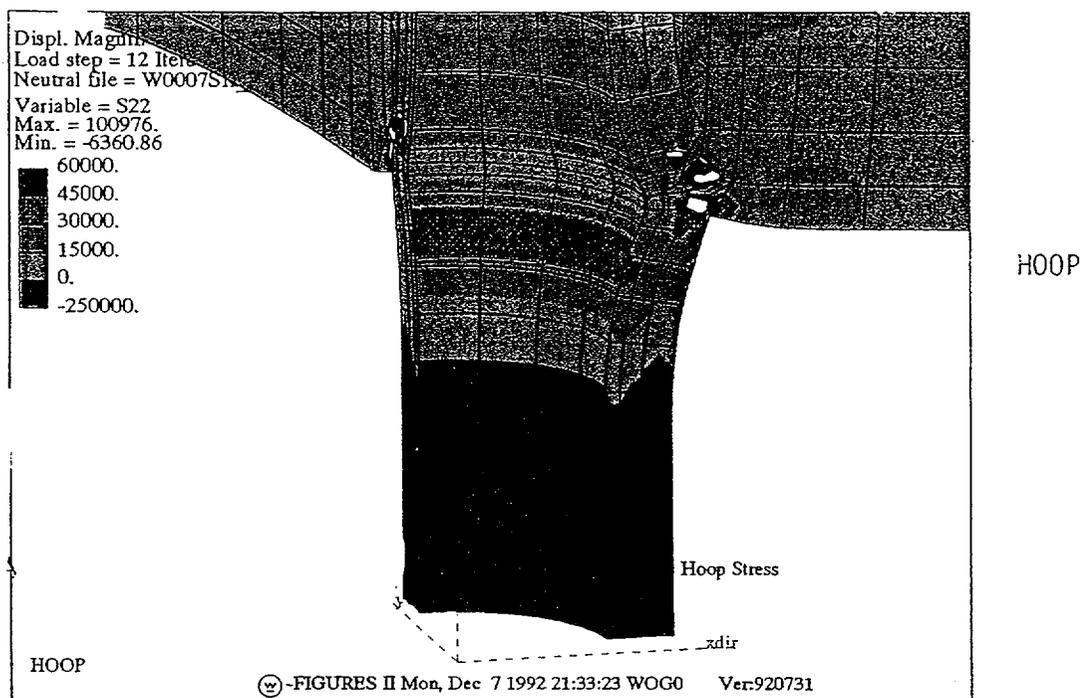
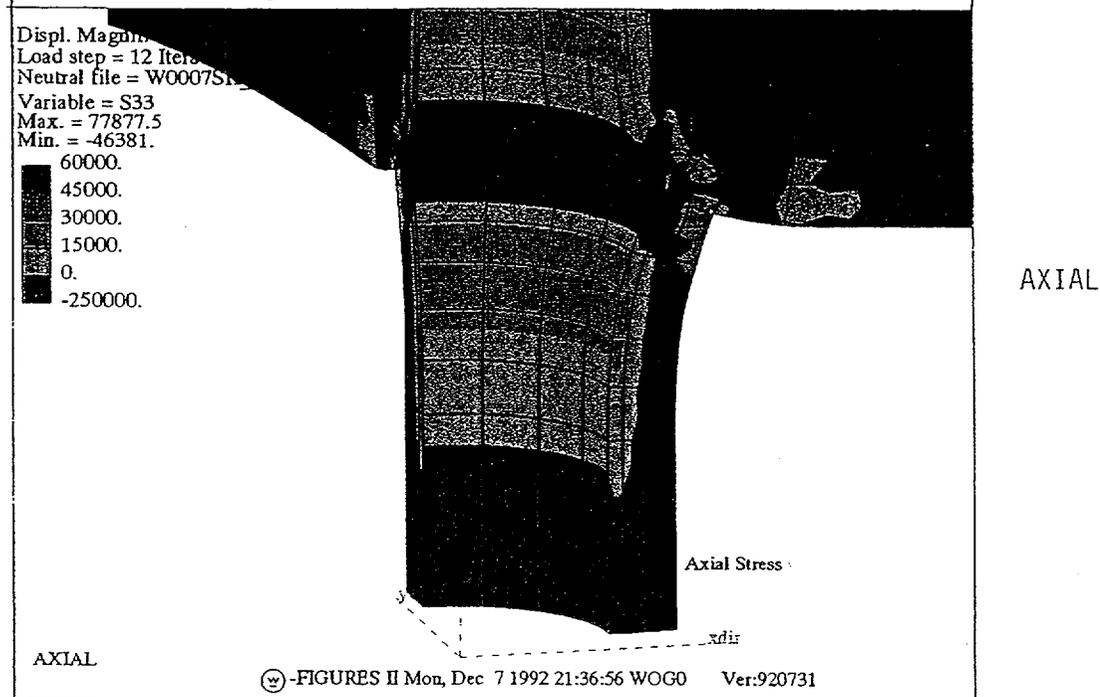
FIGURE 5-6

STRESS DISTRIBUTION AT STEADY STATE CONDITION FOR THE CENTER PENETRATION

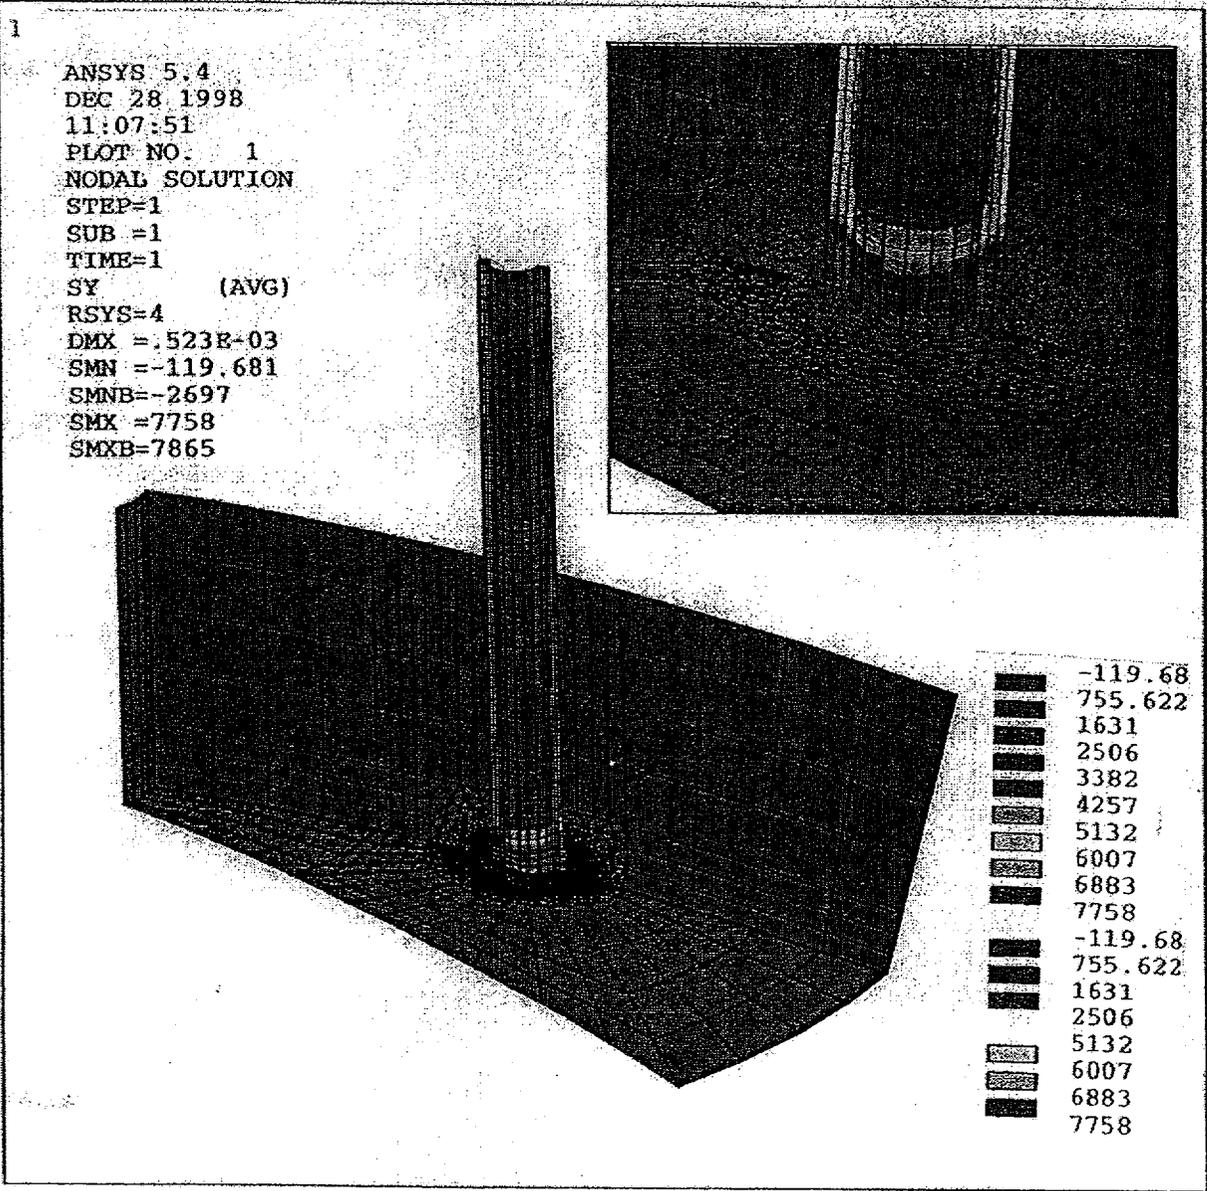
FIGURE 5-9

HOOP STRESS IN THE HEAD VENT AS A RESULT OF DESIGN PRESSURE OF 2500 PSI

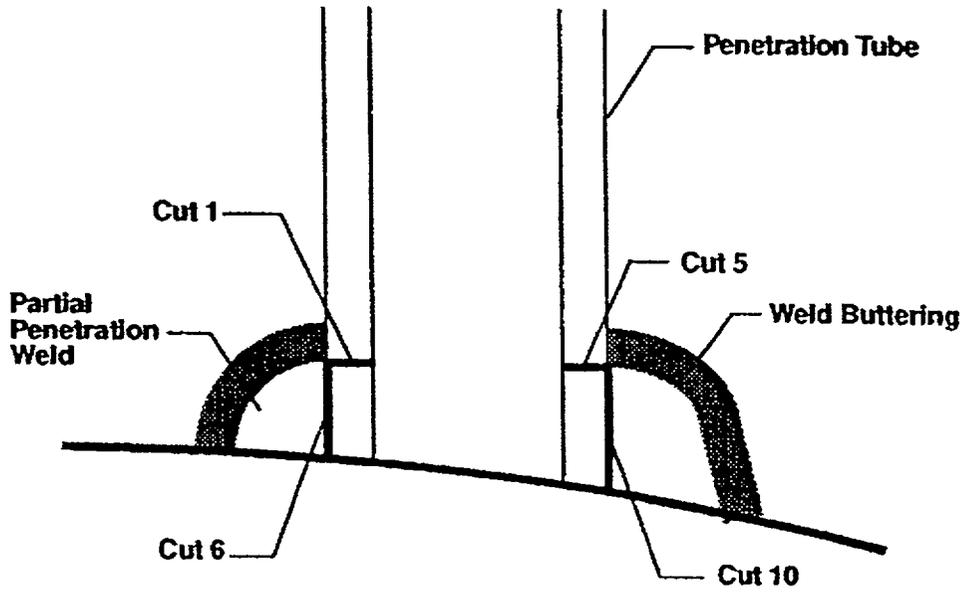
FIGURE 5-11

VARIOUS CUTS TAKEN FOR ANALYSIS OF THE HEAD VENT

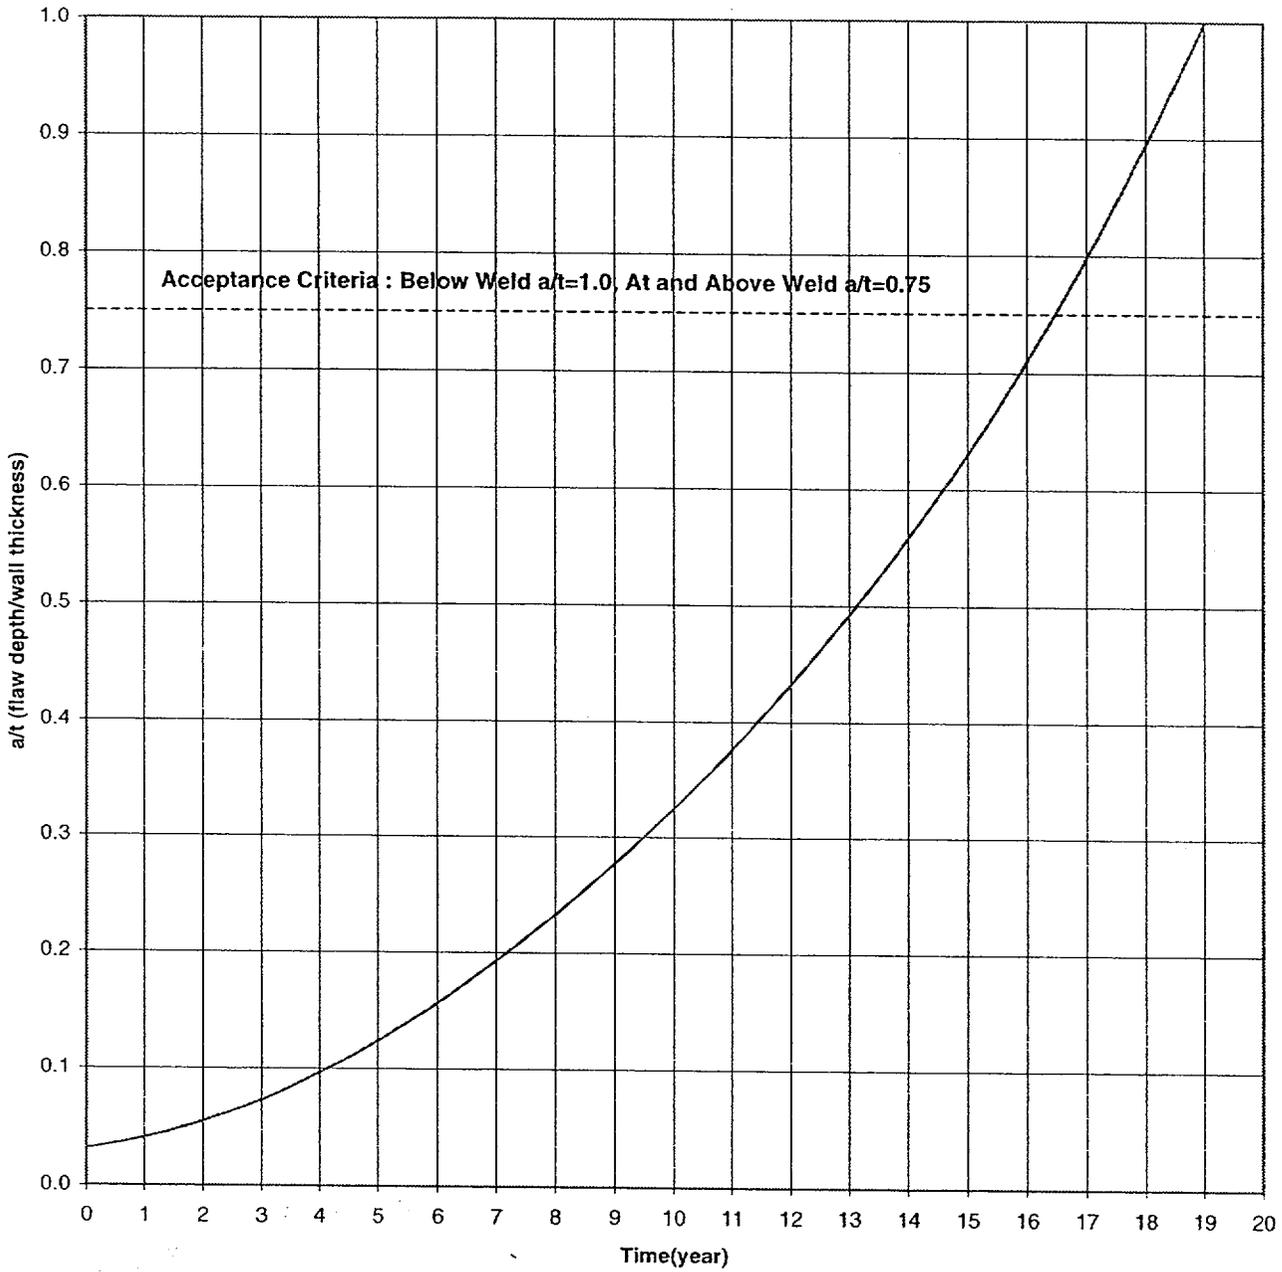
FIGURE 6-1a

CRACK GROWTH PREDICTIONS FOR LONGITUDINAL INSIDE SURFACE FLAWS IN THE
HEAD PENETRATIONS IN THE D. C. COOK UNIT 1 AT AND BELOW THE
ATTACHMENT WELD

The results of the calculated growth through the wall for inside surface axial flaws postulated in the penetrations are summarized in Figures 6-1a and 6-1b for Unit 1, and Figures 6-2a and 6-2b for Unit 2. Figures 6-1 and 6-2 apply to surface crack locations anywhere in the weld region of any of the penetrations, since the stress results were taken at the highest stressed location, which is in the outermost penetration. The "a" figure in each case is a prediction of crack growth at and below the attachment weld region, while the "b" figure covers crack growth above the weld. Figures 6-1c and 6-2c apply to crack growth for outside surface axial flaws, regardless of location, for the two units. Note that the predicted extension through the penetration thickness requires many years at the operating temperature for either D. C. Cook Unit 1 or 2, regardless of the location.

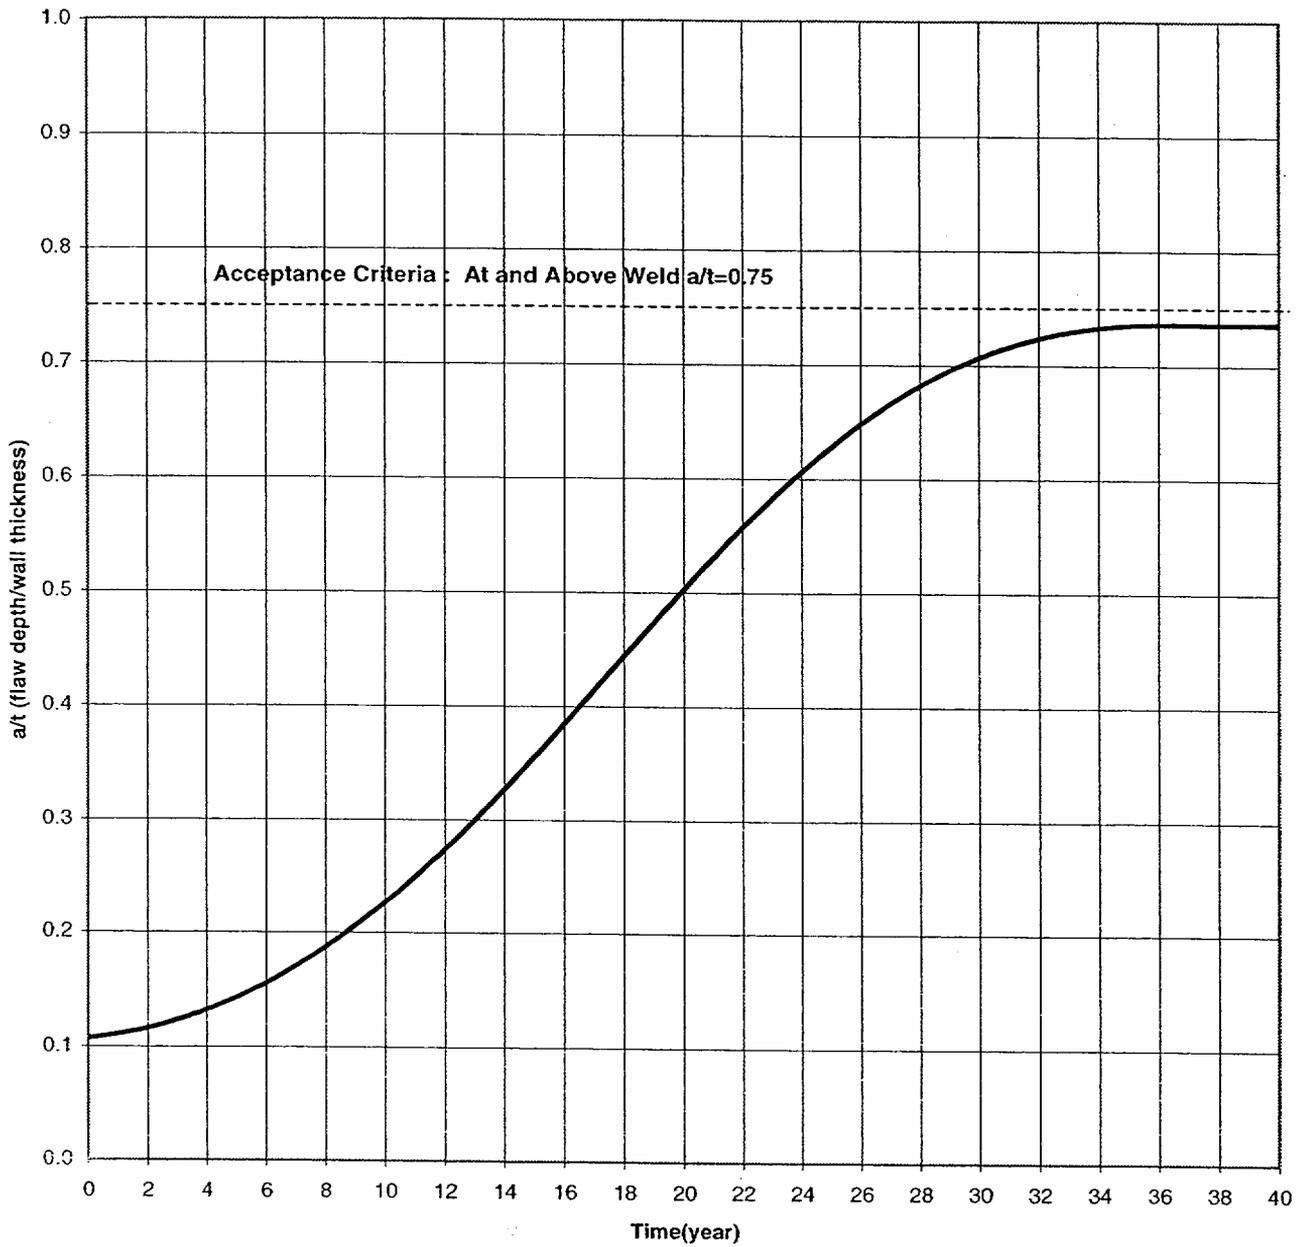
FIGURE 6-1b

CRACK GROWTH PREDICTIONS FOR LONGITUDINAL INSIDE SURFACE FLAWS IN THE
HEAD PENETRATIONS AT THE D. C. COOK UNIT 1 ABOVE THE
ATTACHMENT WELD
