WCAP-15753 NON-PROPRIETARY VERSION OF WCAP-14118,
“STRUCTURAL INTEGRITY EVALUATION OF REACTOR VESSEL UPPER HEAD
PENETRATIONS TO SUPPORT CONTINUED OPERATION:
D. C. COOK UNITS 1 AND 2”

INDIANA MICHIGAN POWER COMPANY (I&M) SUMMARY OF
WESTINGHOUSE ELECTRIC CORPORATION
WCAP-14118, REVISION 4

October 2001

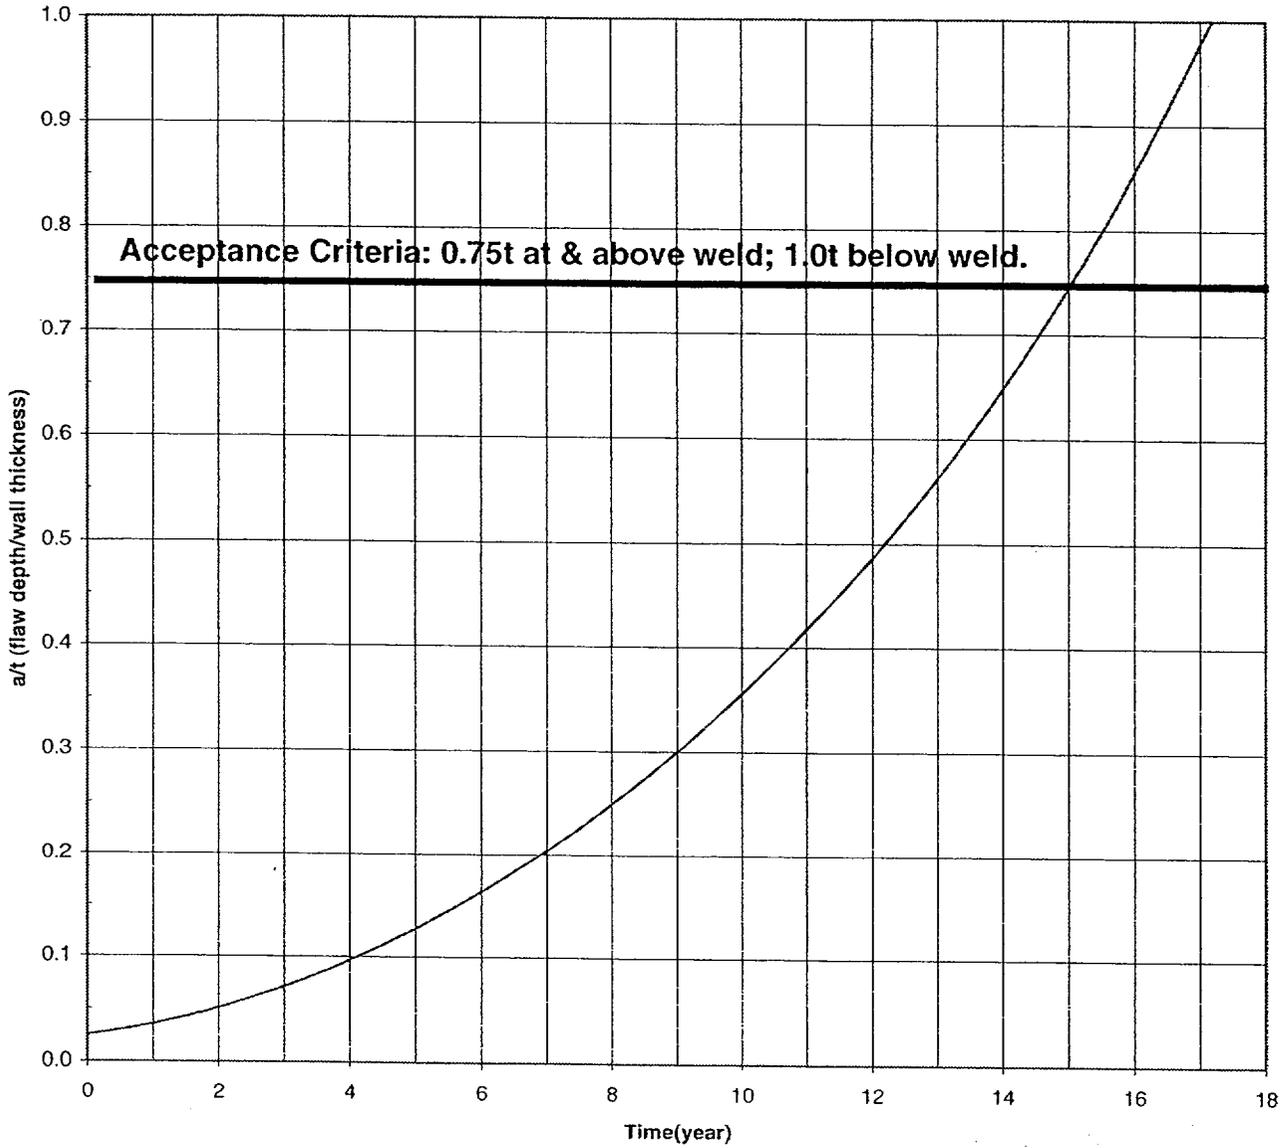
FIGURE 6-1c

CRACK GROWTH PREDICTIONS FOR LONGITUDINAL OUTSIDE SURFACE FLAWS IN THE
HEAD PENETRATIONS AT THE D. C. COOK UNIT 1

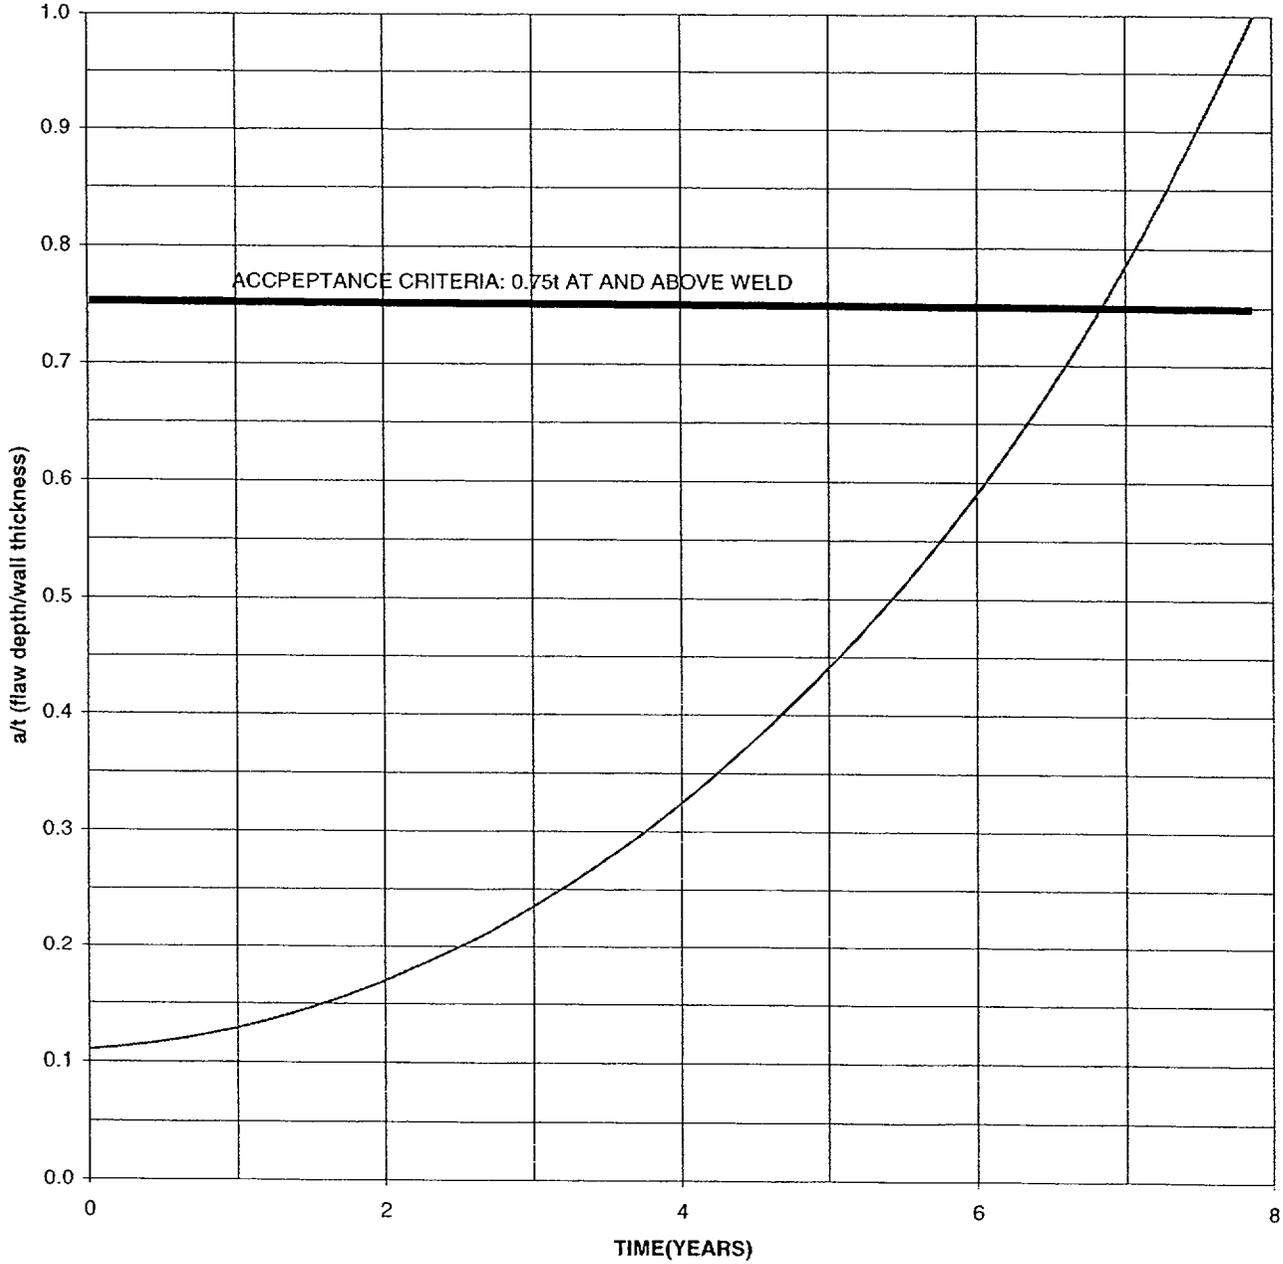
FIGURE 6-1d
CRACK GROWTH PREDICTION FOR LONGITUDINAL SURFACE FLAWS IN THE
HEAD VENT NEAR THE ATTACHMENT WELD

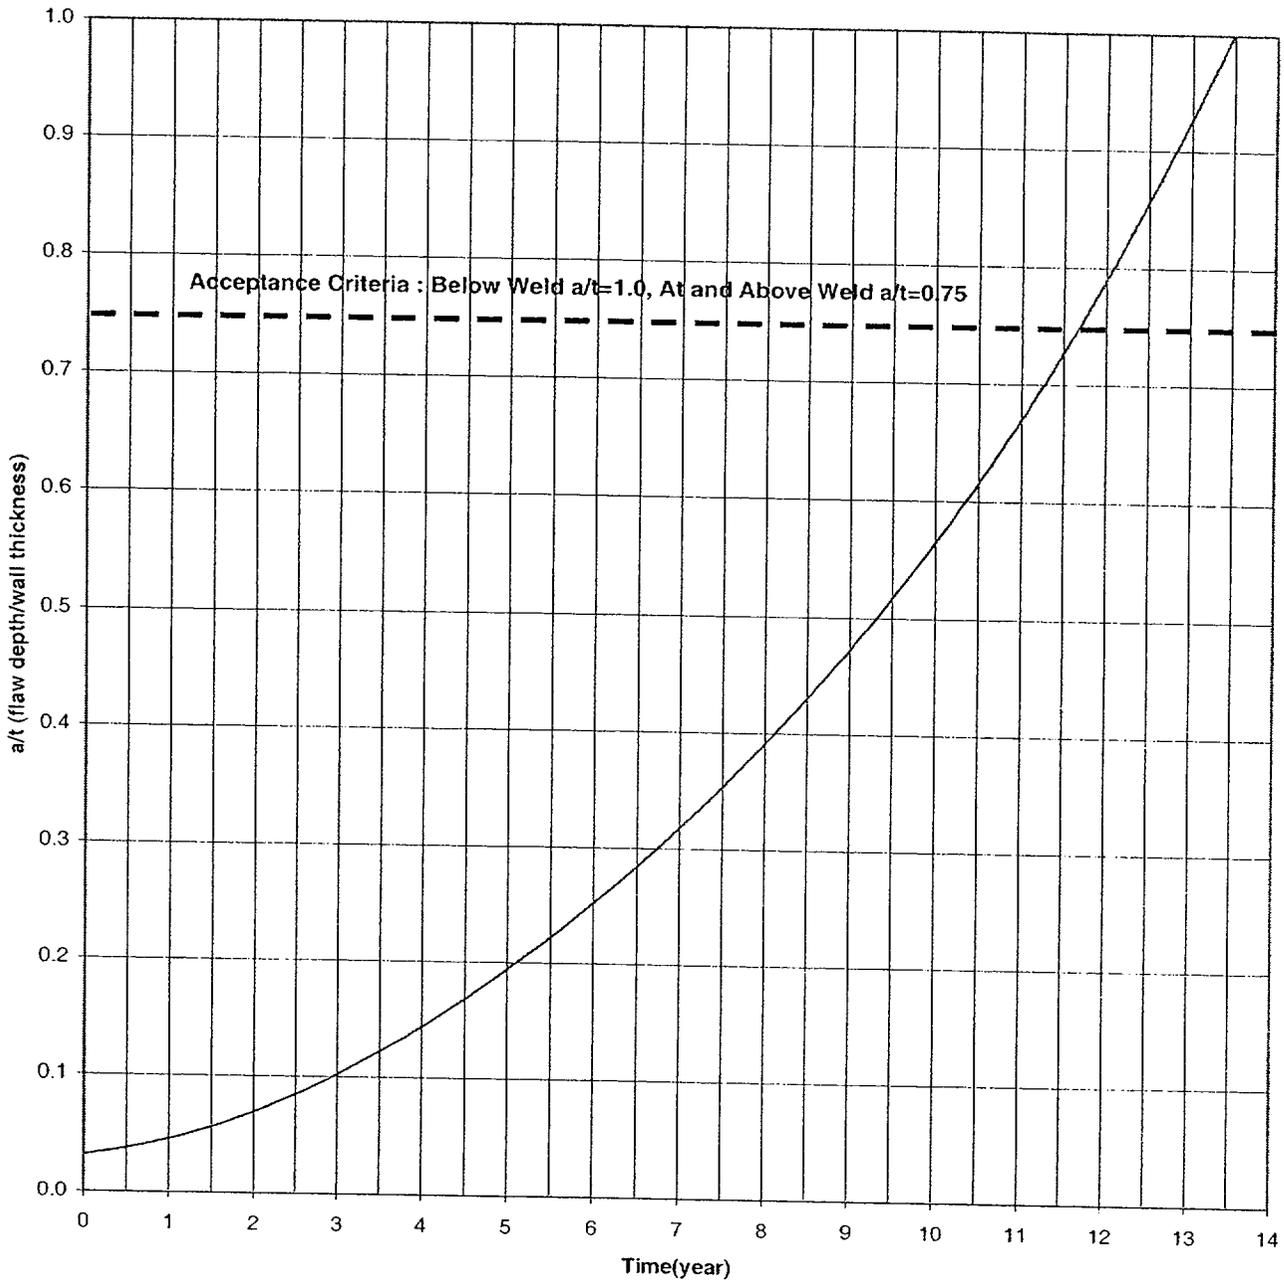
FIGURE 6-2a

CRACK GROWTH PREDICTIONS FOR LONGITUDINAL INSIDE SURFACE FLAWS IN THE
 HEAD PENETRATIONS AT THE D. C. COOK UNIT 2 AT AND BELOW THE
 ATTACHMENT WELD

The results of the calculated growth through the wall for inside surface axial flaws postulated in the penetrations are summarized in Figures 6-1a and 6-1b for Unit 1, and Figures 6-2a and 6-2b for Unit 2. Figures 6-1 and 6-2 apply to surface crack locations anywhere in the weld region of any of the penetrations, since the stress results were taken at the highest stressed location, which is in the outermost penetration. The "a" figure in each case is a prediction of crack growth at and below the attachment weld region, while the "b" figure covers crack growth above the weld. Figures 6-1c and 6-2c apply to crack growth for outside surface axial flaws, regardless of location, for the two units. Note that the predicted extension through the penetration thickness requires many years at the operating temperature for either D. C. Cook Unit 1 or 2, regardless of the location.

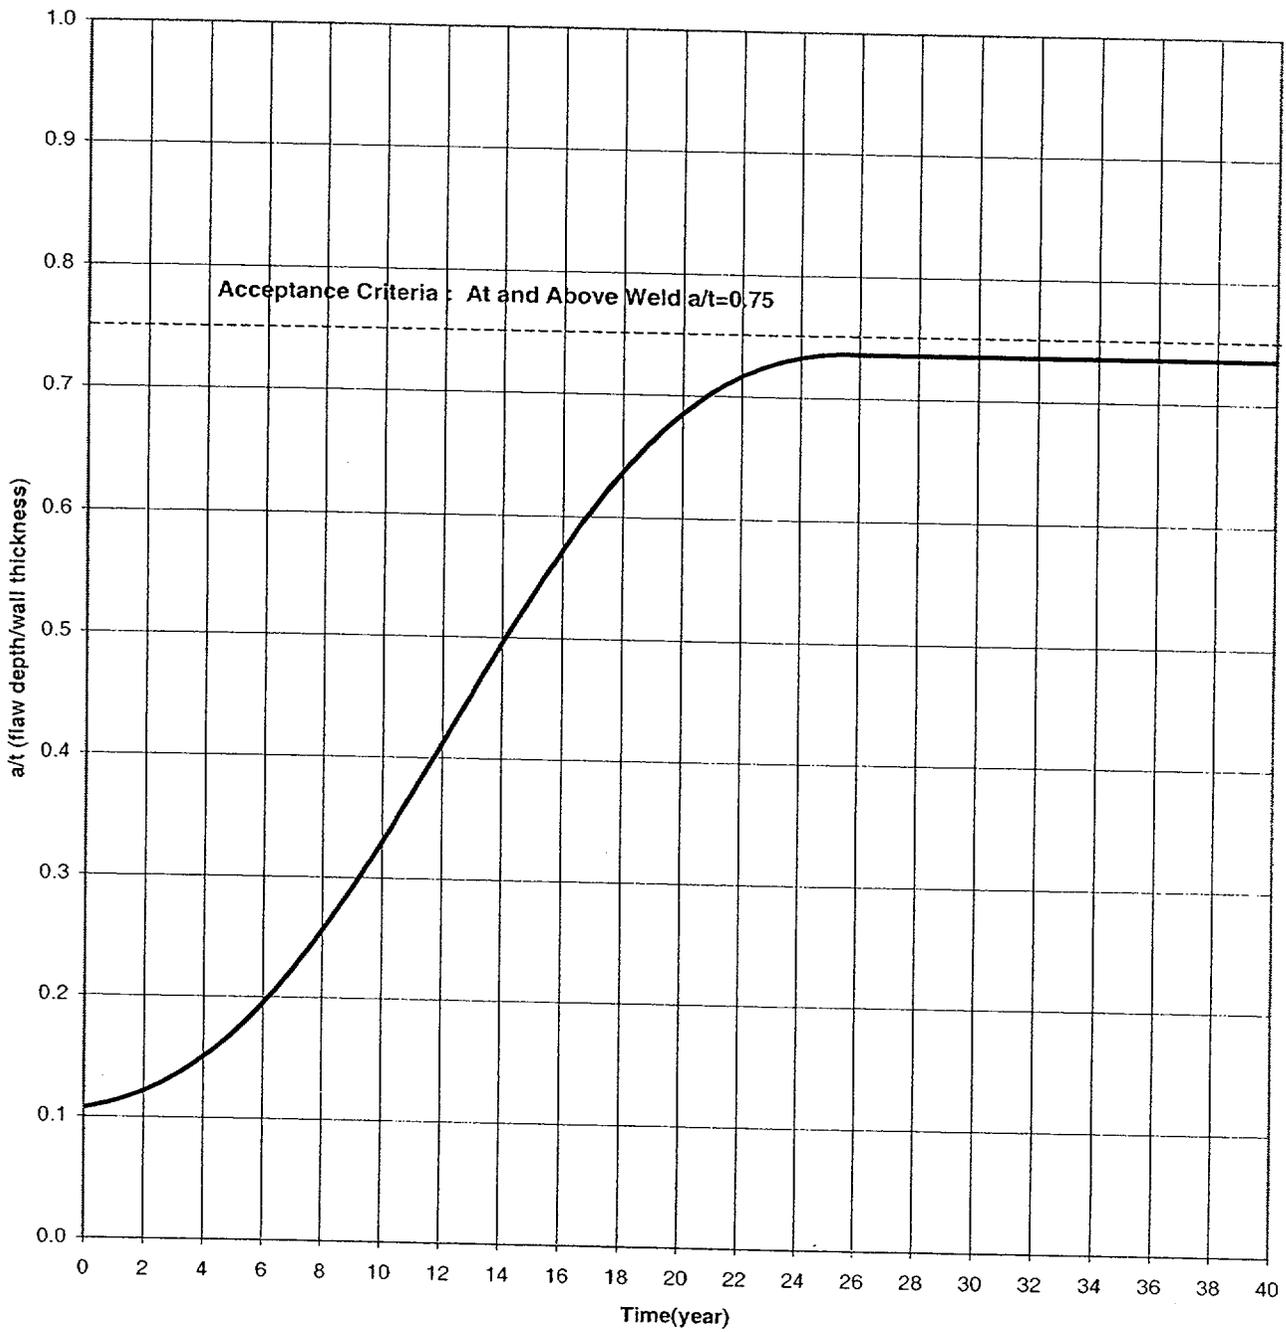
FIGURE 6-2b

CRACK GROWTH PREDICTIONS FOR LONGITUDINAL INSIDE SURFACE FLAWS IN THE
 HEAD PENETRATIONS AT THE D. C. COOK UNIT 2 ABOVE THE
 ATTACHMENT WELD

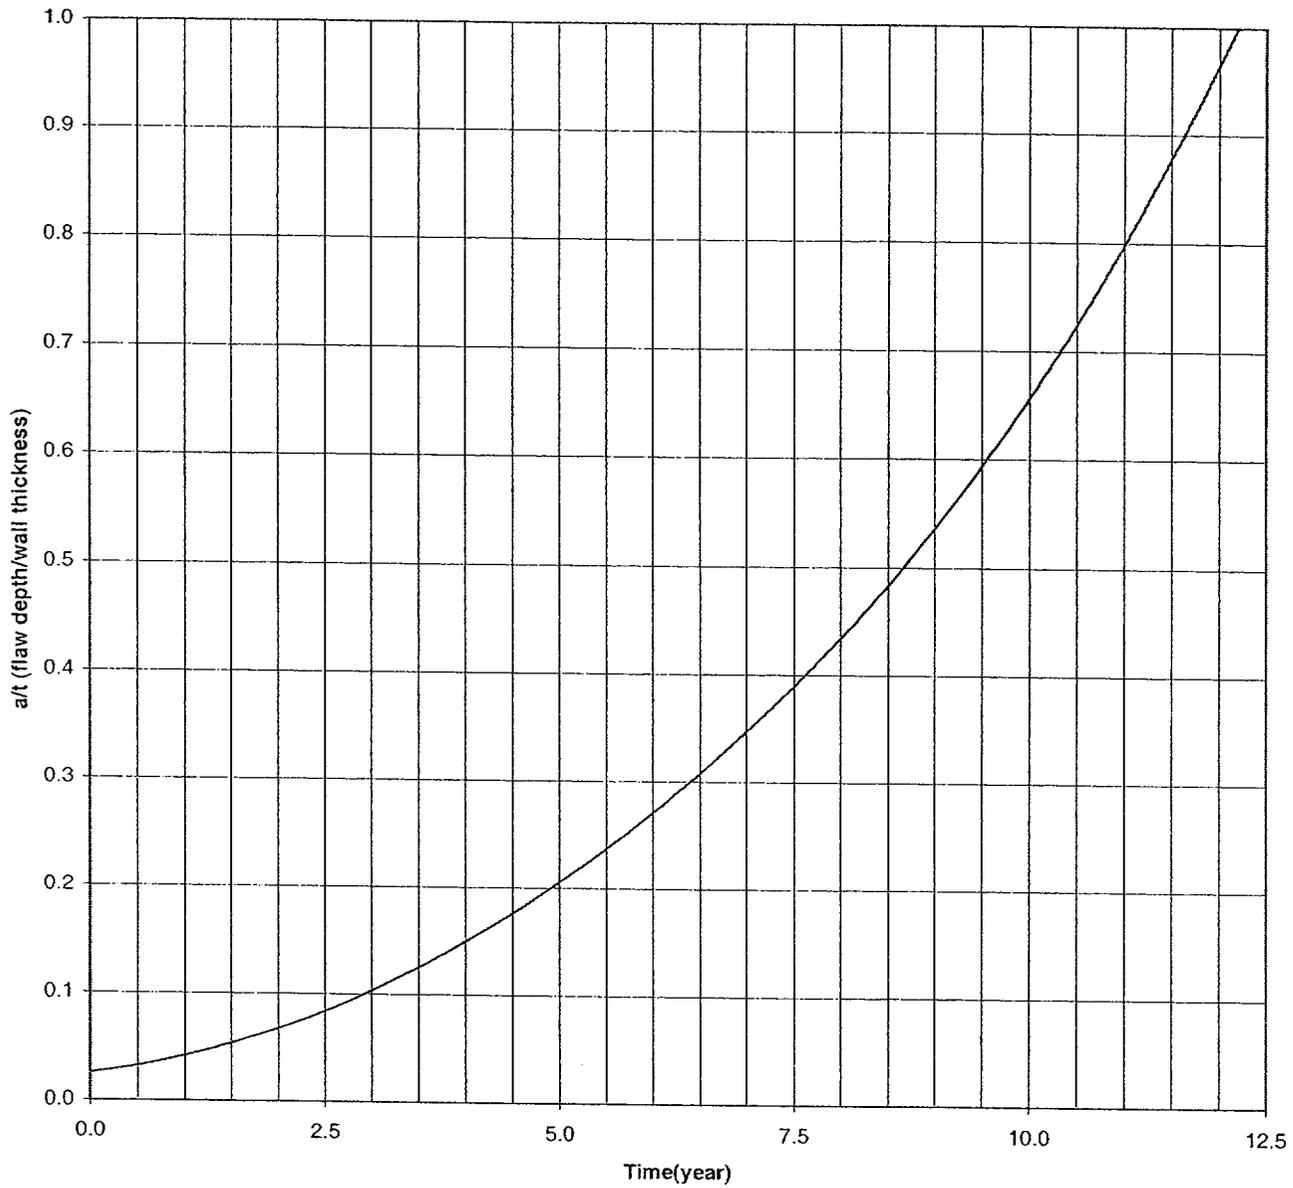
FIGURE 6-2c

CRACK GROWTH PREDICTIONS FOR LONGITUDINAL OUTSIDE SURFACE FLAWS IN THE
HEAD PENETRATIONS AT THE D. C. COOK UNIT 2

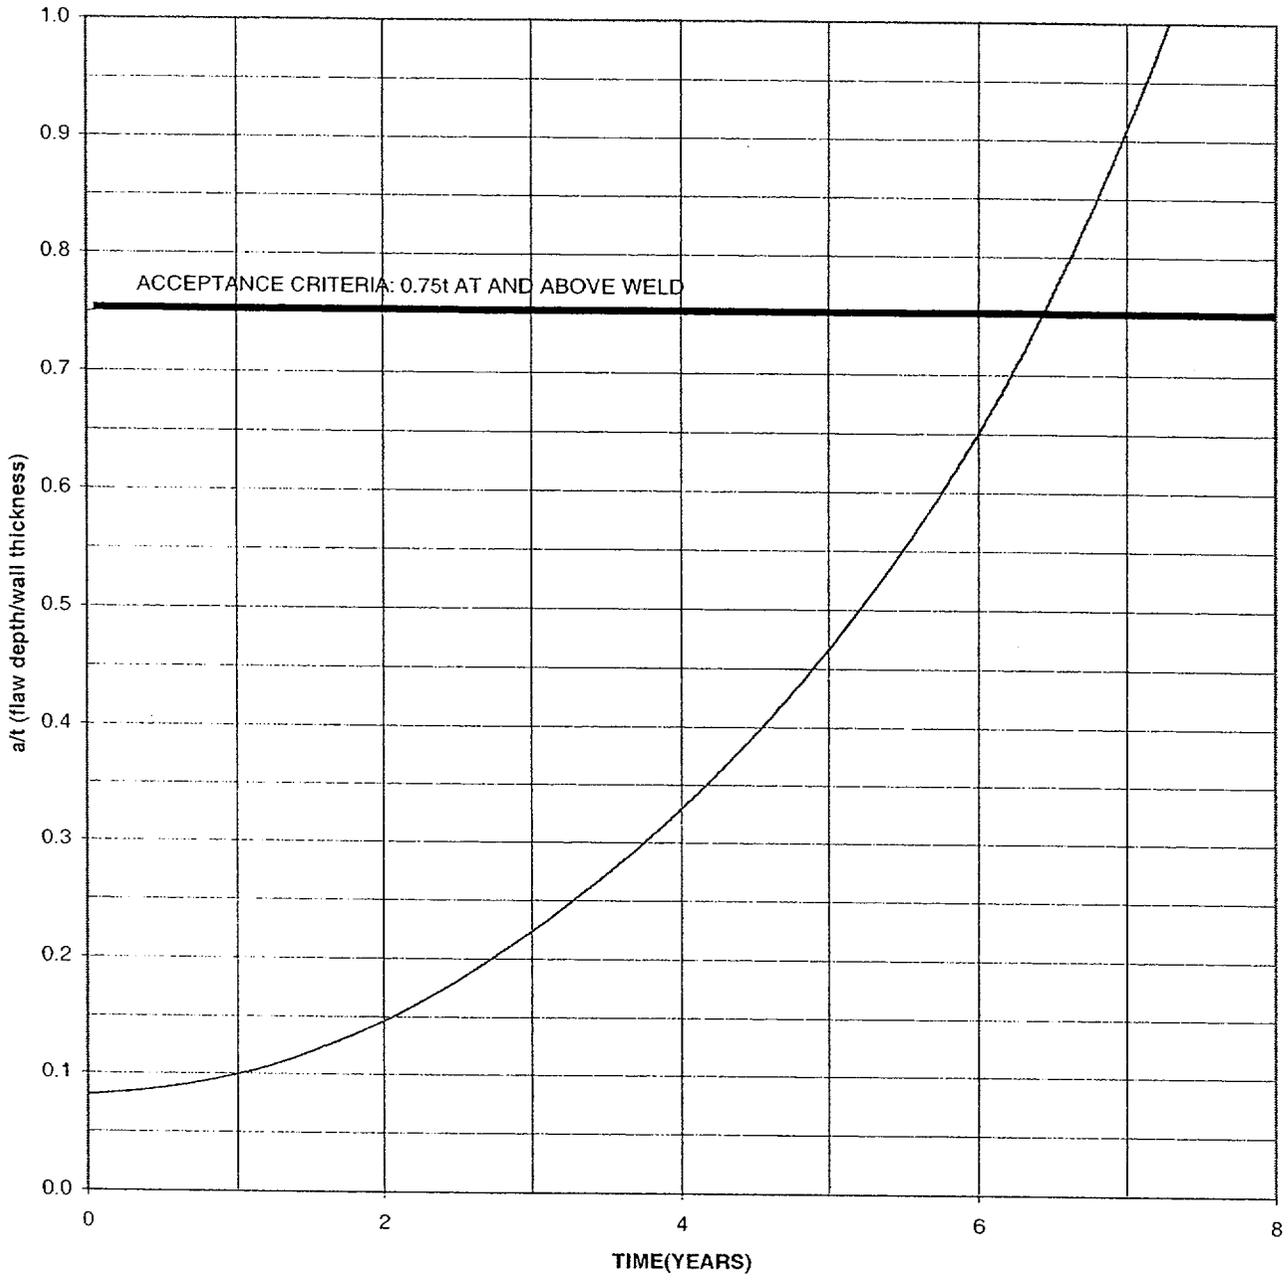
FIGURE 6-2d
 CRACK GROWTH PREDICTION FOR LONGITUDINAL SURFACE FLAWS IN THE
 HEAD VENT NEAR THE ATTACHMENT WELD

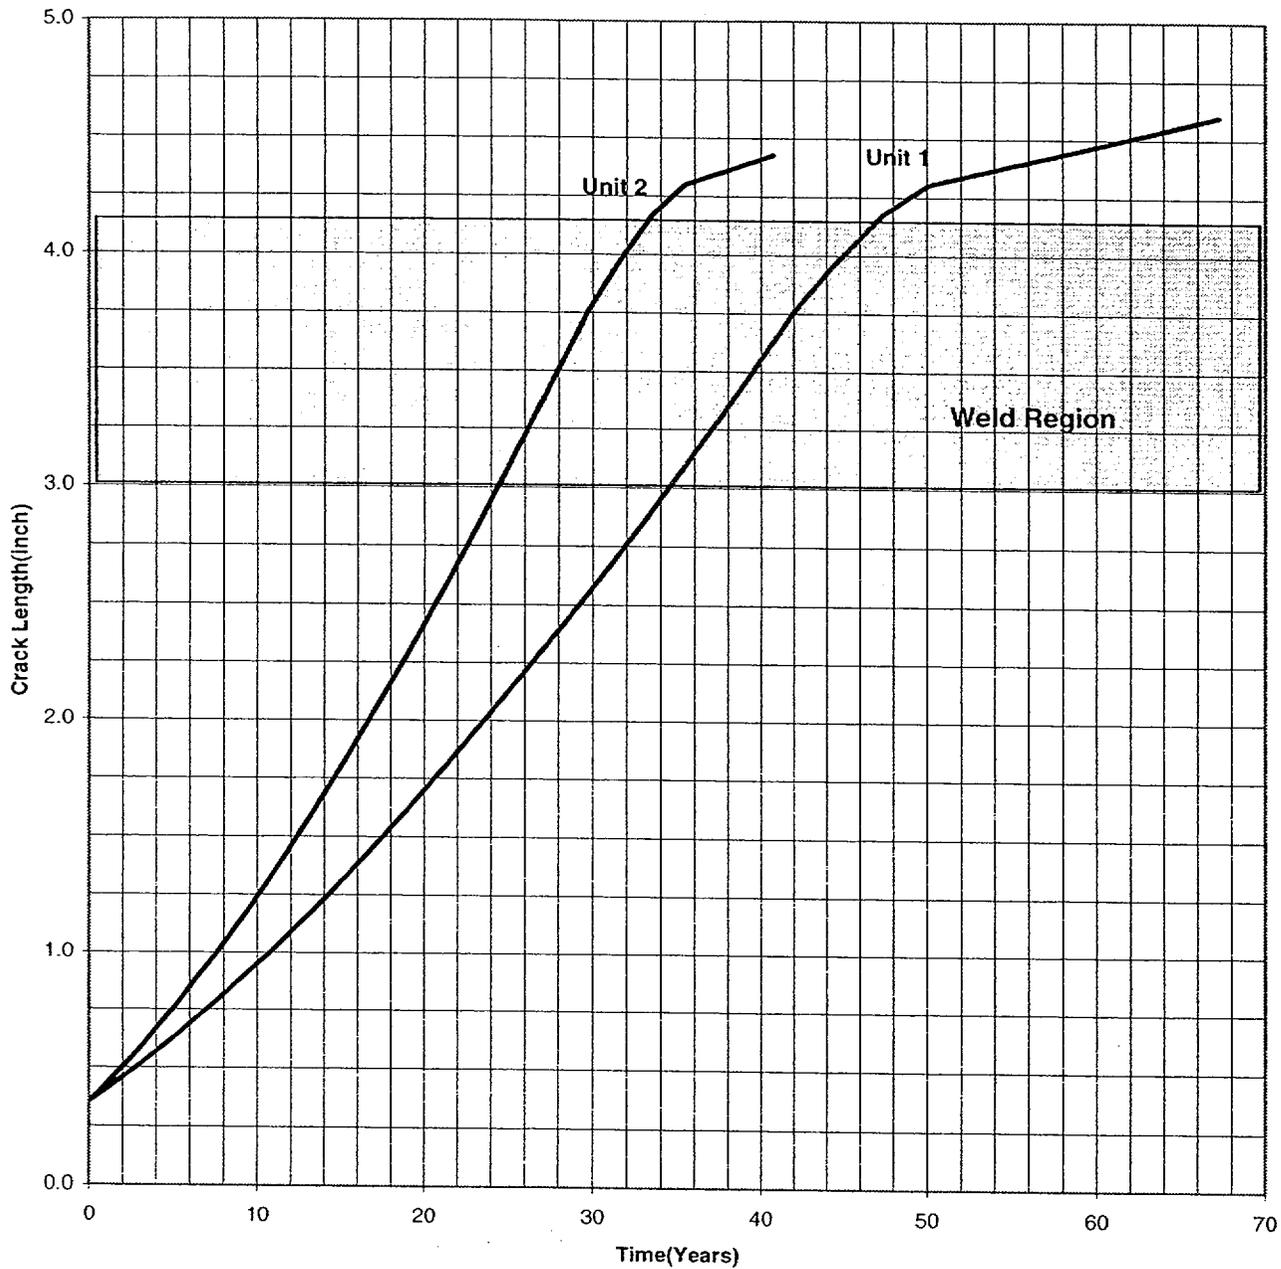
FIGURE 6-3
CRACK GROWTH PREDICTIONS FOR THROUGH-WALL FLAWS LOCATED AT THE
LOWER HILLSIDE IN THE OUTERMOST HEAD PENETRATIONS
OF D. C. COOK UNITS 1 AND 2

Figures 6-3 and 6-4 present the predicted crack growth for a through-wall flaw postulated to exist below the weld region in the outermost row of penetrations. These results are for the lower hillside and centerside locations respectively. Note that on each of these figures there are two curves of crack growth vs time. The two curves are generally parallel, show the projected growth for the two different Units. The growth for Unit 1 is slower, because it operates at a lower temperature. Although there are different levels of ovality (and therefore residual stress) in the different penetrations, it is clear that in the vicinity of the weld and below it, the total stresses approach the yield stress of the material, which was set at 378.6 MPa (55 ksi) for this calculation. Figures 6-5 and 6-6 provide similar results for the next outermost row of penetrations.

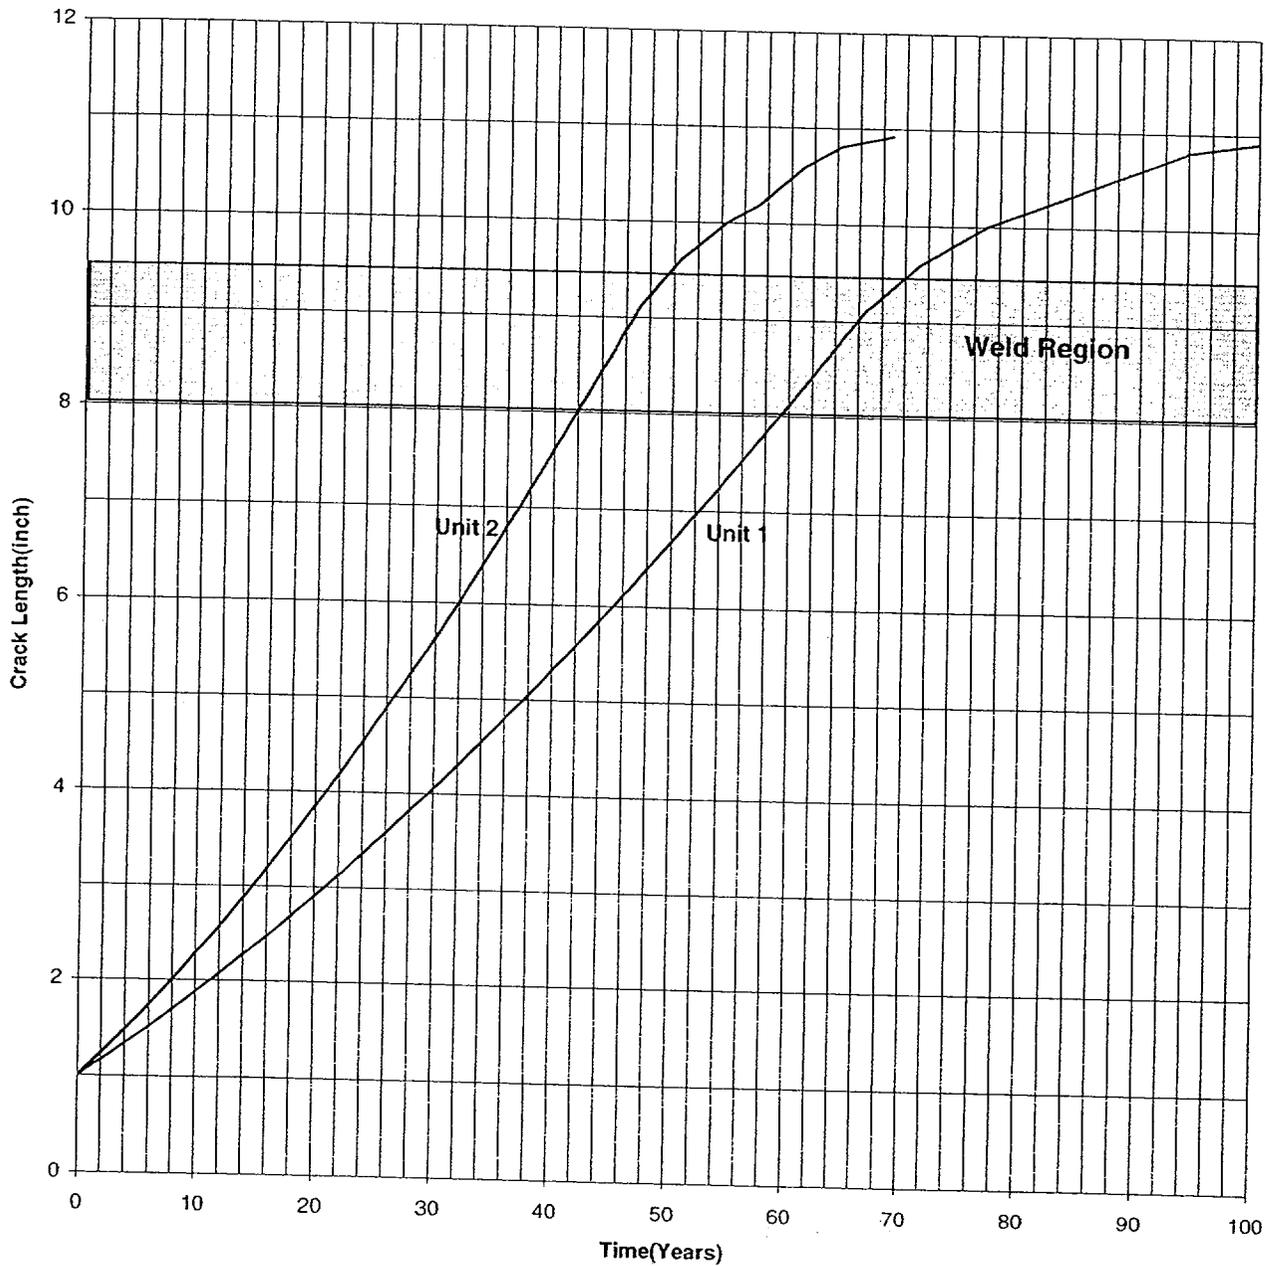
FIGURE 6-4

CRACK GROWTH PREDICTIONS FOR THROUGH-WALL FLAWS LOCATED AT THE
CENTER SIDE OF THE OUTERMOST HEAD PENETRATIONS OF D. C. COOK UNITS 1 AND 2

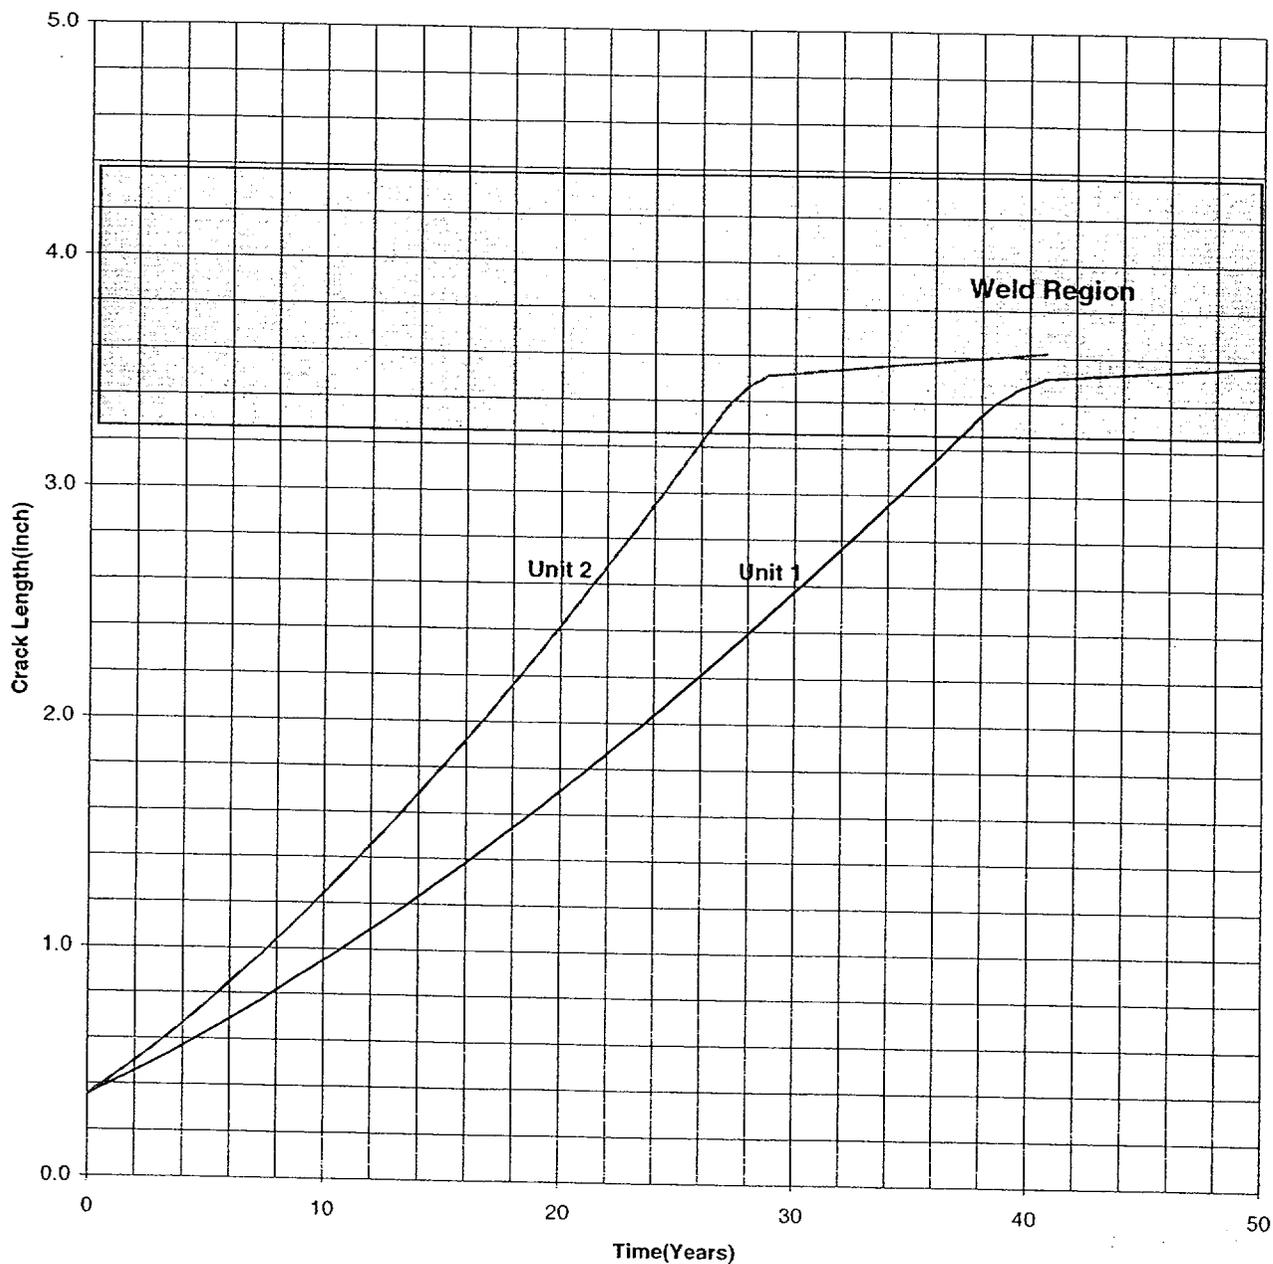
FIGURE 6-5

CRACK GROWTH PREDICTIONS FOR THROUGH-WALL FLAWS LOCATED AT THE LOWER HILLSIDE IN THE NEXT OUTERMOST HEAD PENETRATIONS OF D. C. COOK UNITS 1 AND 2

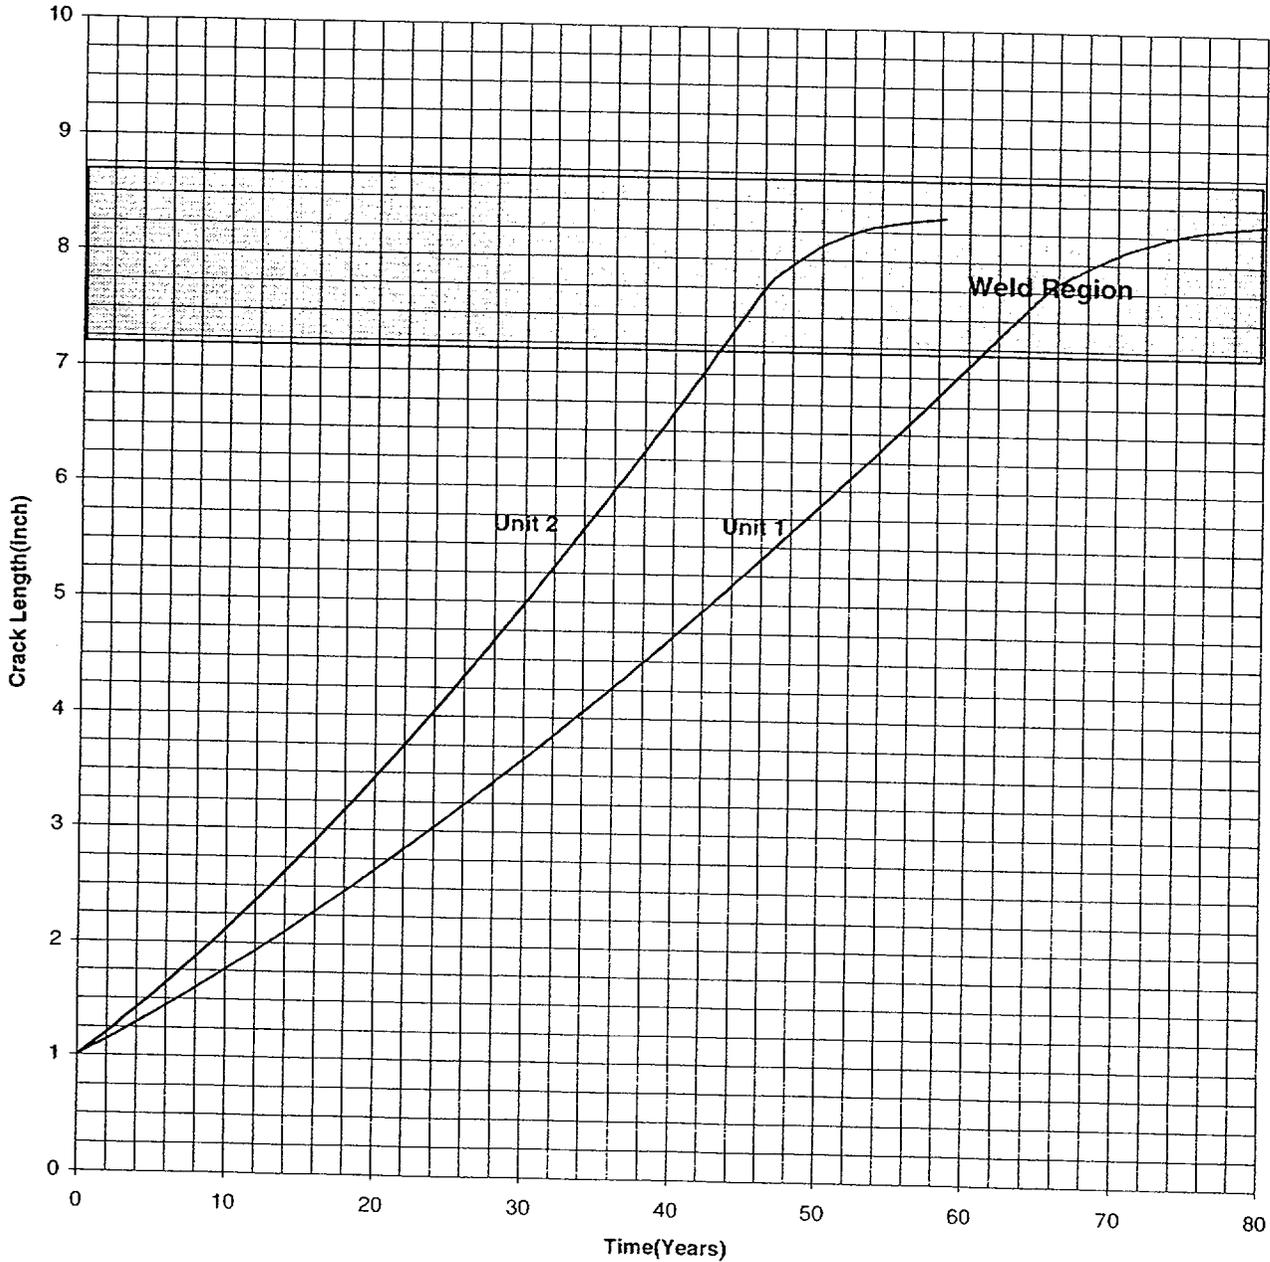
FIGURE 6-6

CRACK GROWTH PREDICTIONS FOR THROUGH-WALL FLAWS LOCATED AT THE CENTER
 SIDE OF THE NEXT OUTERMOST HEAD PENETRATIONS OF D. C. COOK UNITS 1 AND 2

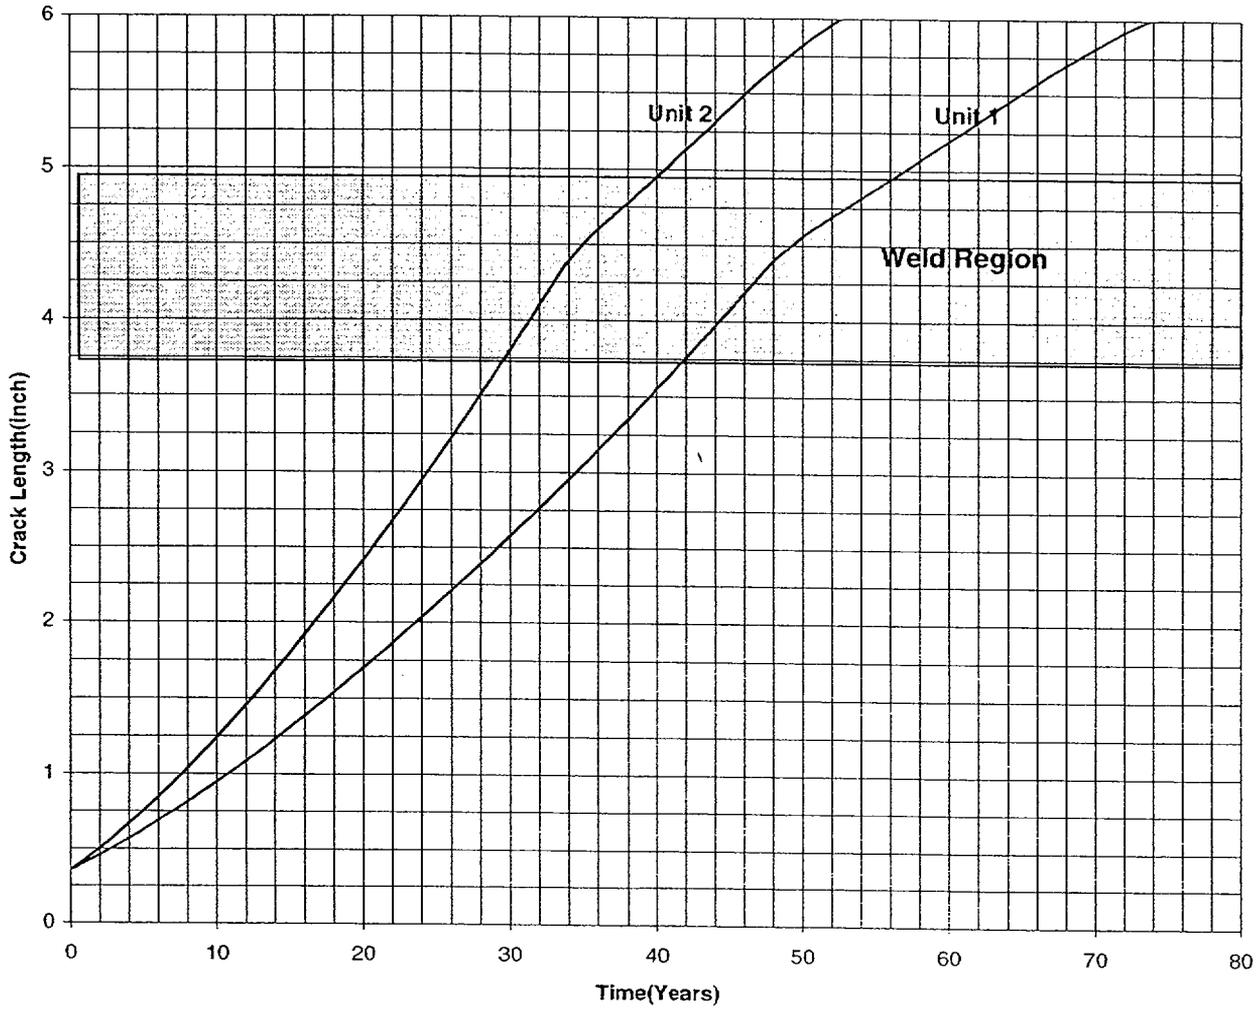
FIGURE 6-7
CRACK GROWTH PREDICTIONS FOR GROWTH OF THROUGH-WALL FLAWS
IN THE CENTER PENETRATION AT D. C. COOK UNITS 1 AND 2

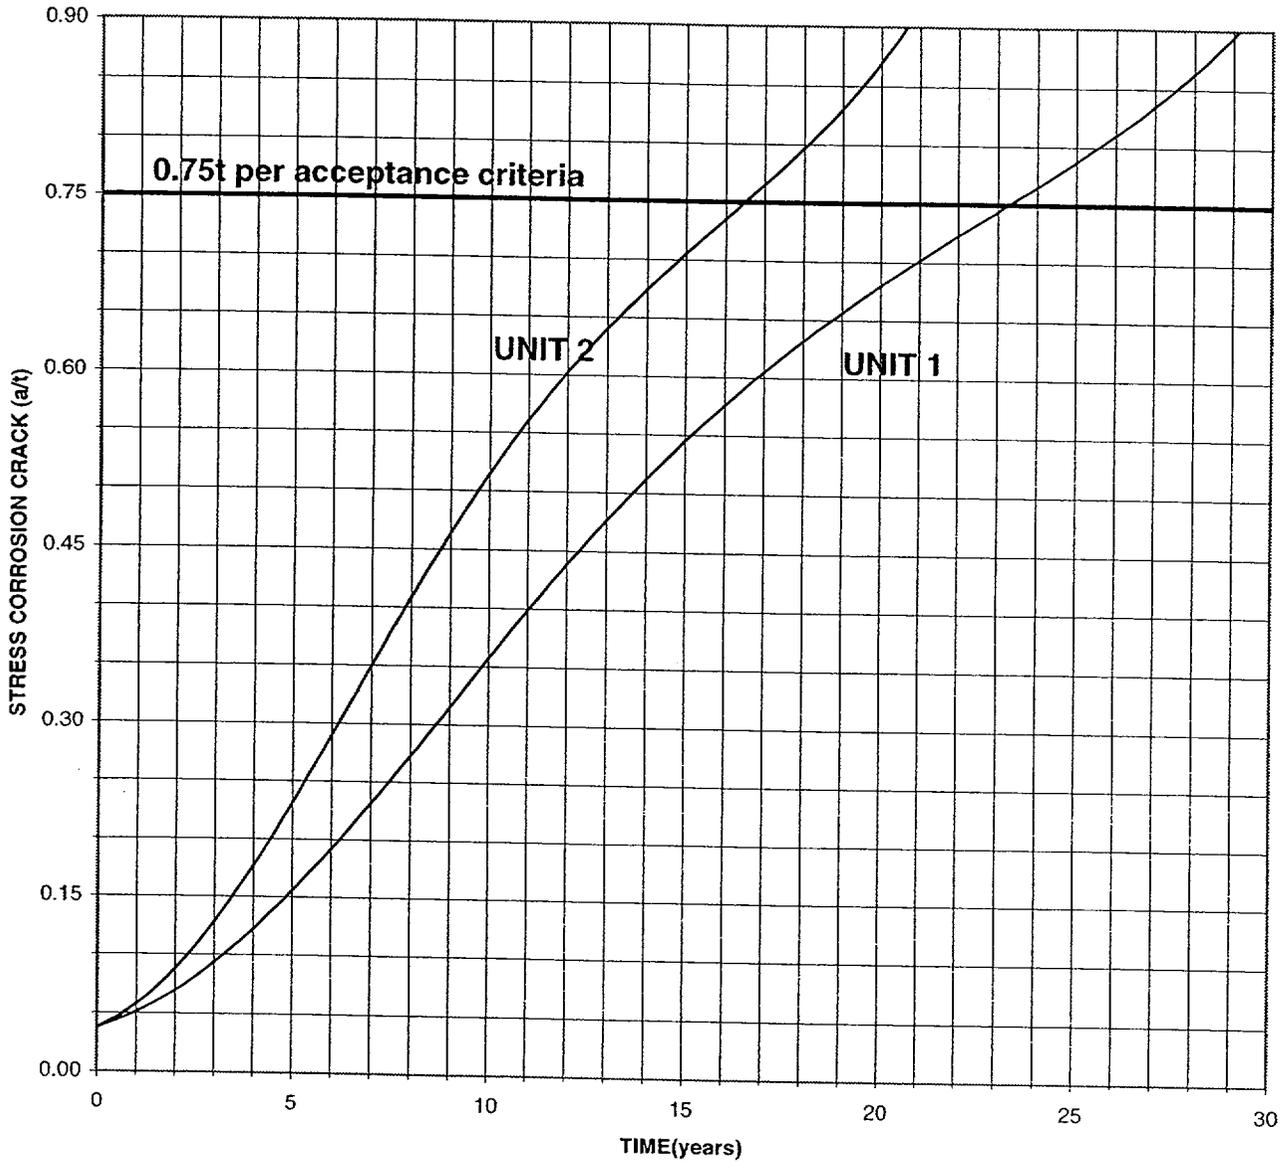
FIGURE 6-8
CRACK GROWTH PREDICTIONS FOR CIRCUMFERENTIAL SURFACE FLAWS
NEAR THE TOP OF THE ATTACHMENT WELD

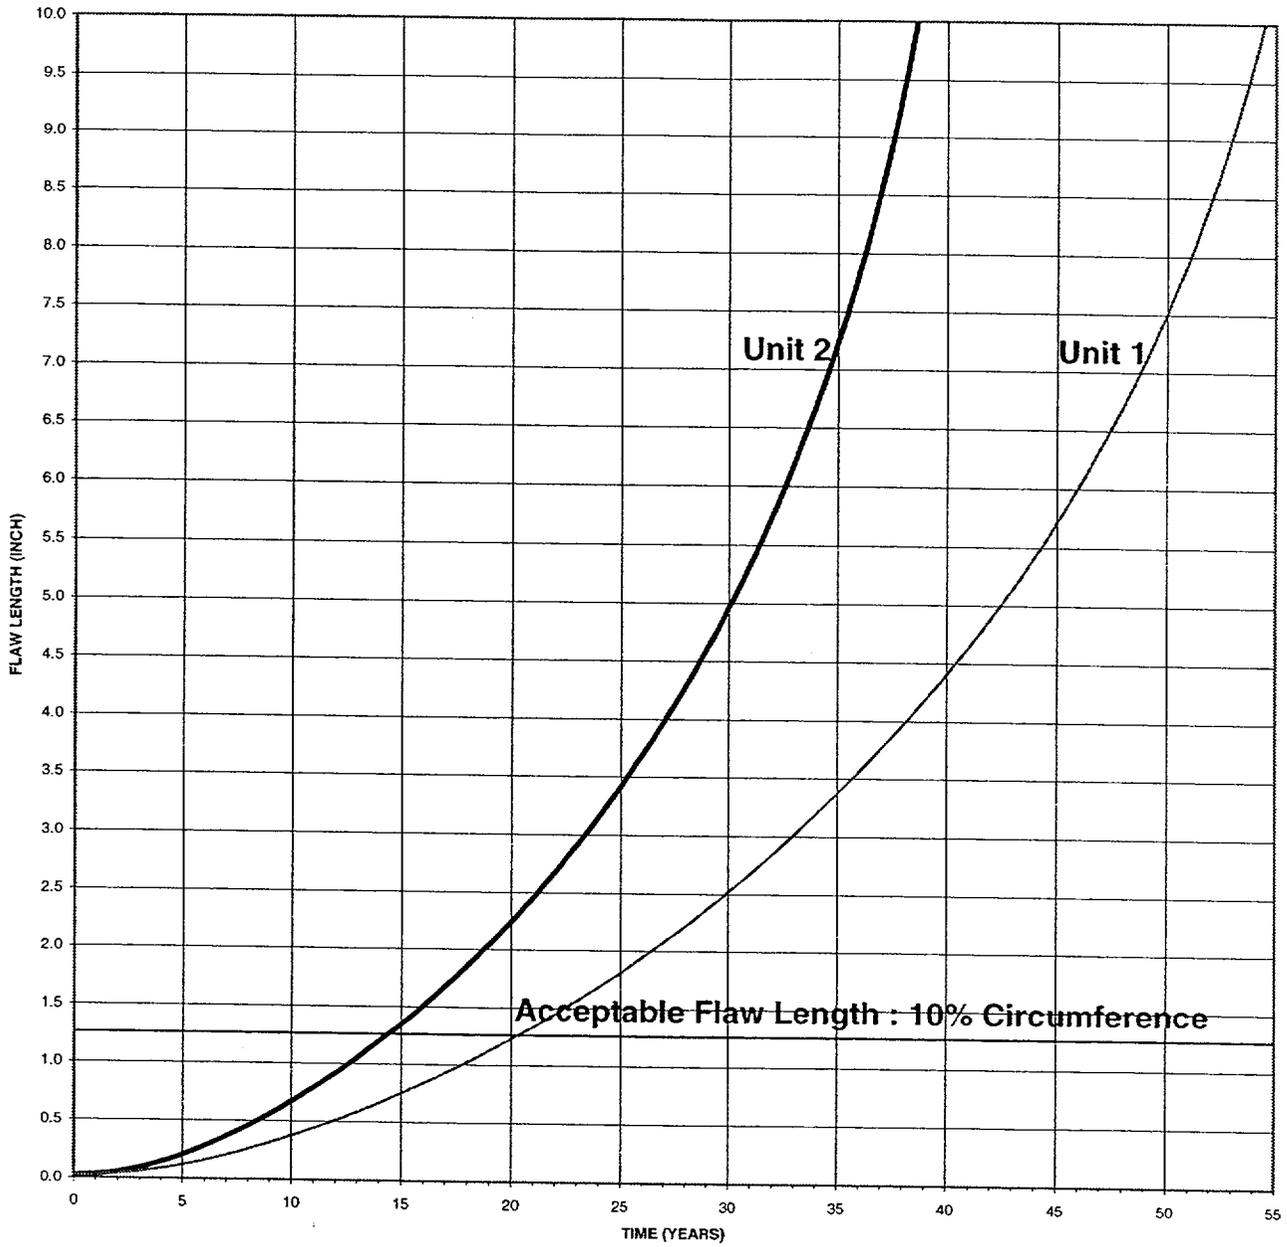
FIGURE 6-9
 CRACK GROWTH PREDICTIONS FOR CIRCUMFERENTIAL THROUGH-WALL CRACKS
 NEAR THE TOP OF THE ATTACHMENT WELD

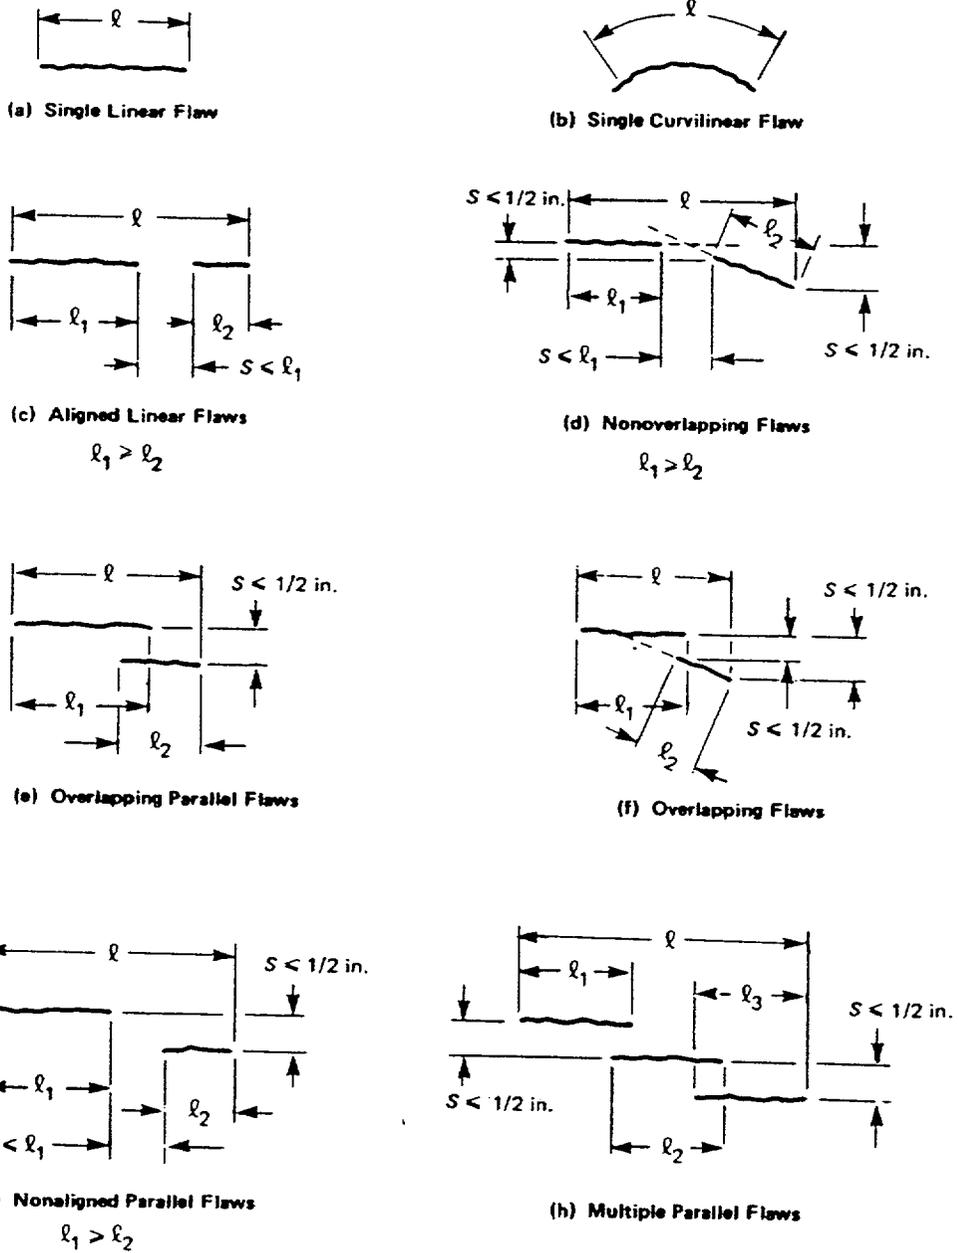
FIGURE 6-10

SECTION XI FLAW PROXIMITY RULES (FIGURE IWA-3400-1)
