WCAP-15753 NON-PROPRIETARY VERSION OF WCAP-14118,
“STRUCTURAL INTEGRITY EVALUATION OF REACTOR VESSEL UPPER HEAD
PENETRATIONS TO SUPPORT CONTINUED OPERATION:
D. C. COOK UNITS 1 AND 2”

INDIANA MICHIGAN POWER COMPANY (I&M) SUMMARY OF
WESTINGHOUSE ELECTRIC CORPORATION
WCAP-14118, REVISION 4

October 2001

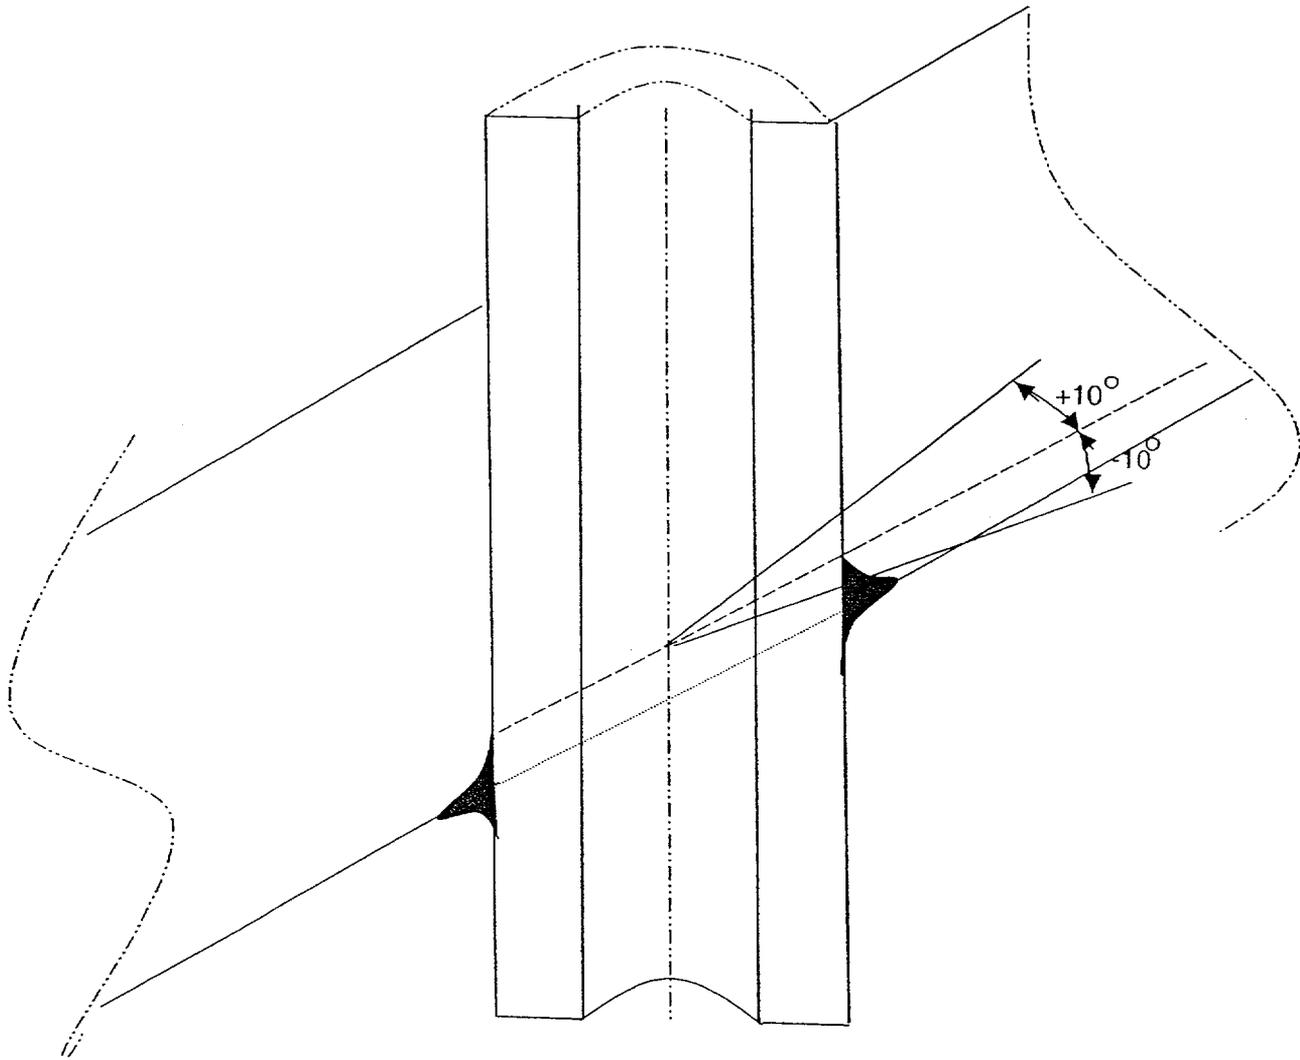
FIGURE 6-11
DEFINITION OF "CIRCUMFERENTIAL"

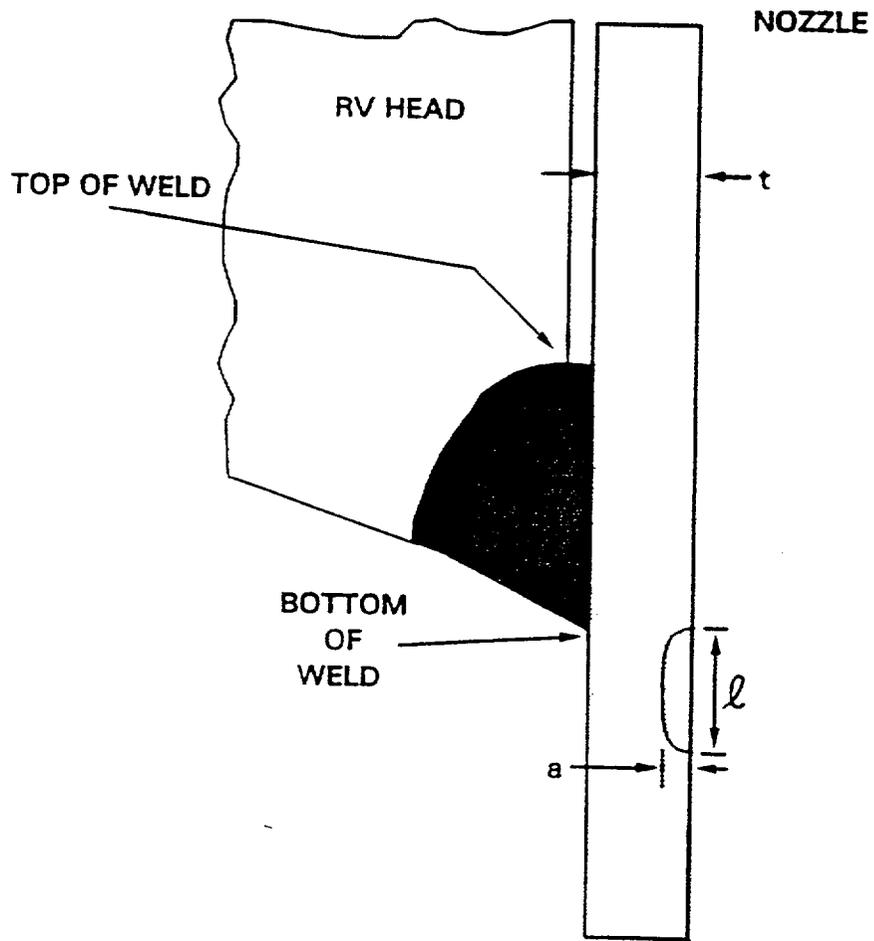
FIGURE 6-12
SCHEMATIC OF HEAD PENETRATION GEOMETRY

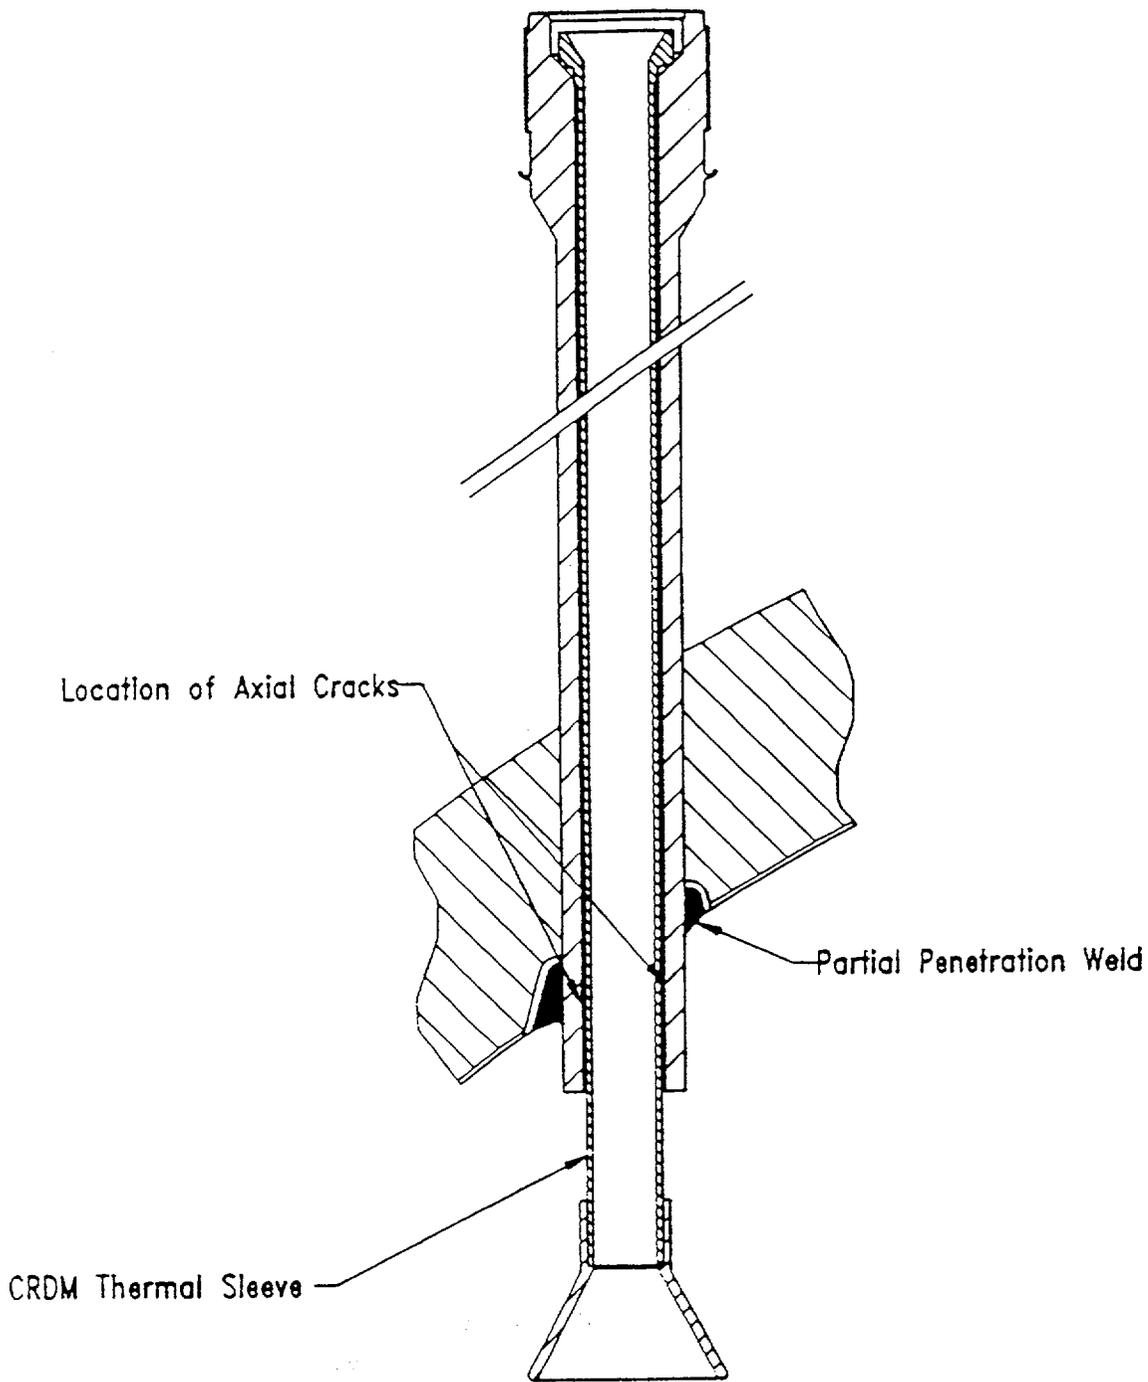
Figure A-1 Typical Head Penetration

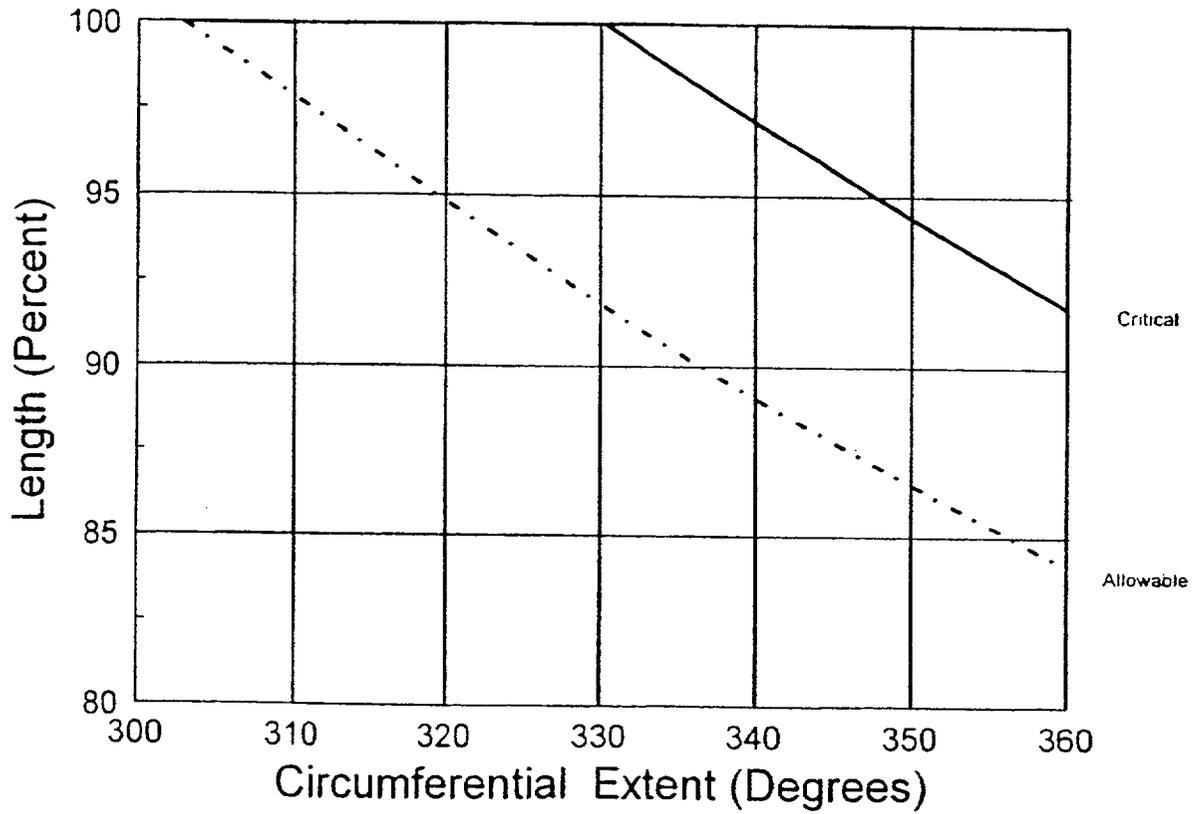
Figure A-2 Allowable Regions of Lack of Fusion for the Outermost Penetration Tube to Weld Fusion Zone: Detailed View.

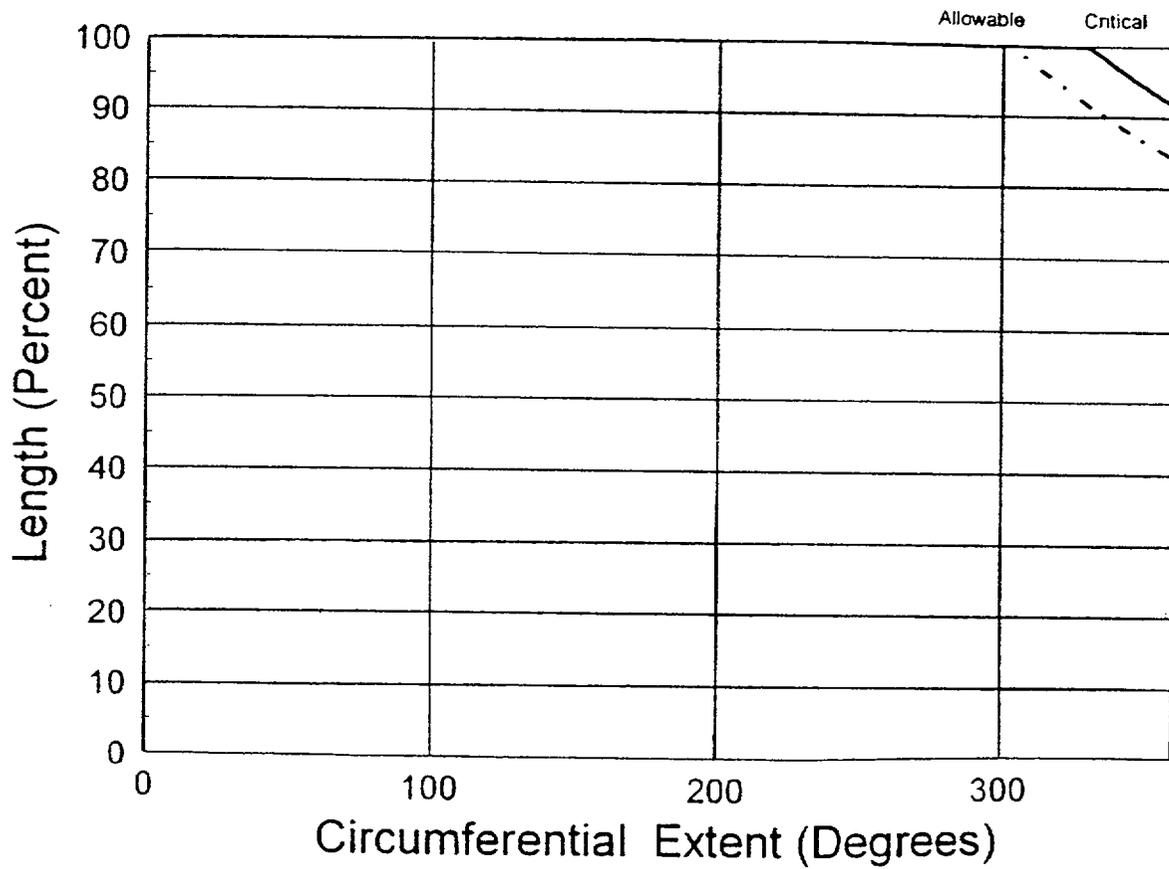
Figure A-3 Allowable Regions of Lack of Fusion for the Outermost Penetration Tube to Weld Fusion Zone.

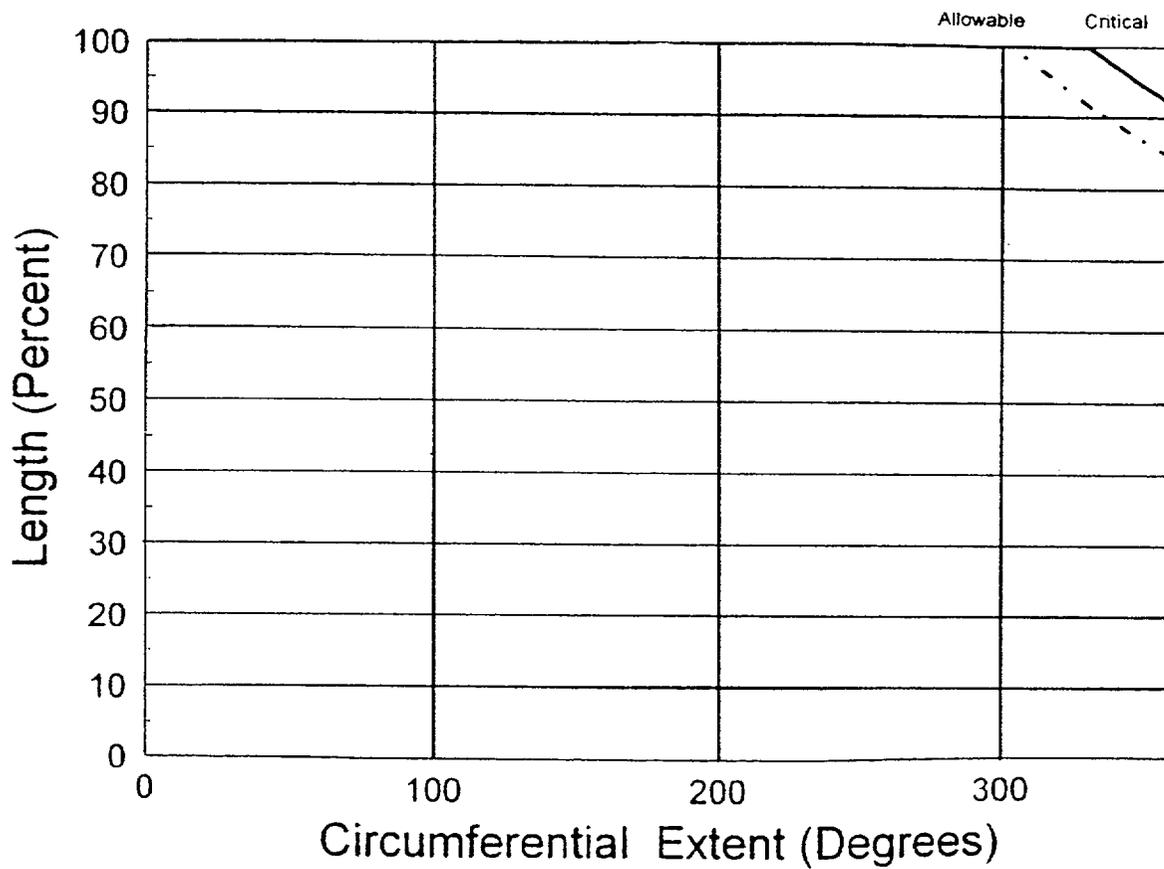
Figure A-4 Allowable Regions of Lack of Fusion for All Penetrations:
Weld to Vessel Fusion Zone.

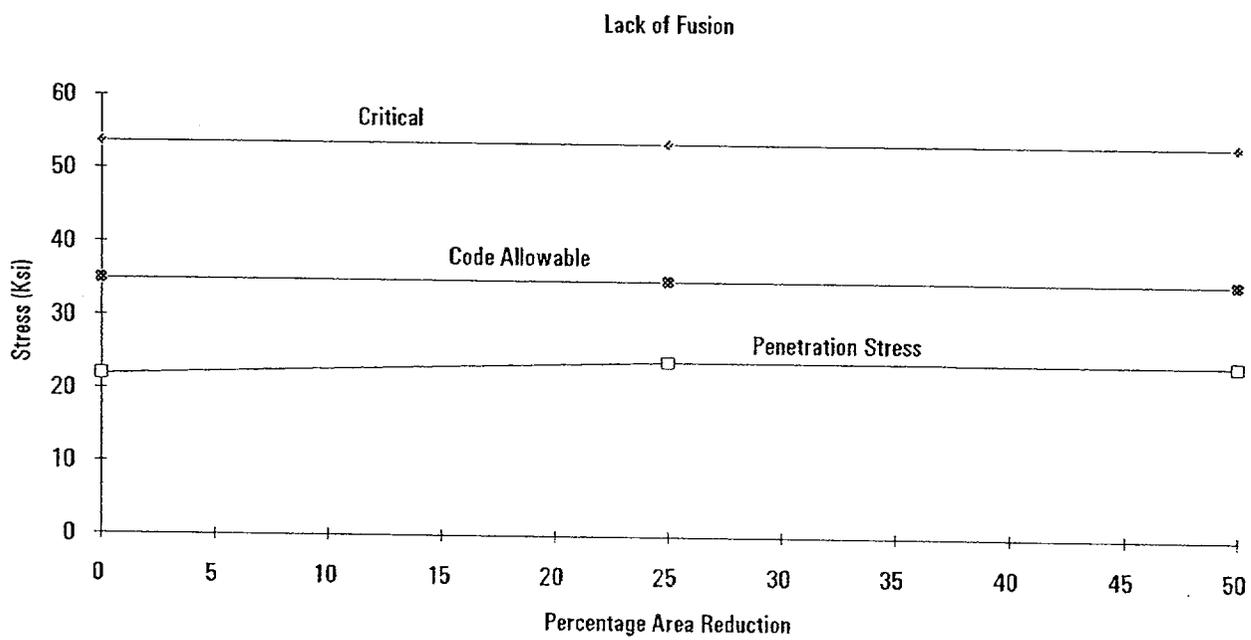
Figure A-5. Allowable Regions of Lack of Fusion for the Weld to Vessel Fusion Zone.

The results of this series of analyses are shown in Figure A-5, where it is clear that large areas of lack of fusion are allowable. As the area of lack of fusion increases, the stresses redistribute themselves, and the stress intensity does not increase in proportion to the area lost. These results seem to confirm that the shear stress is the only important stress governing the critical flaw size for the head fusion zone as well.
