Aging Assessment of Safety-Related Fuses Used in Low- and Medium-Voltage Applications in Nuclear Power Plants

Brookhaven National Laboratory

**U.S. Nuclear Regulatory Commission
Office of Nuclear Reactor Regulation
Washington, DC 20555-0001**

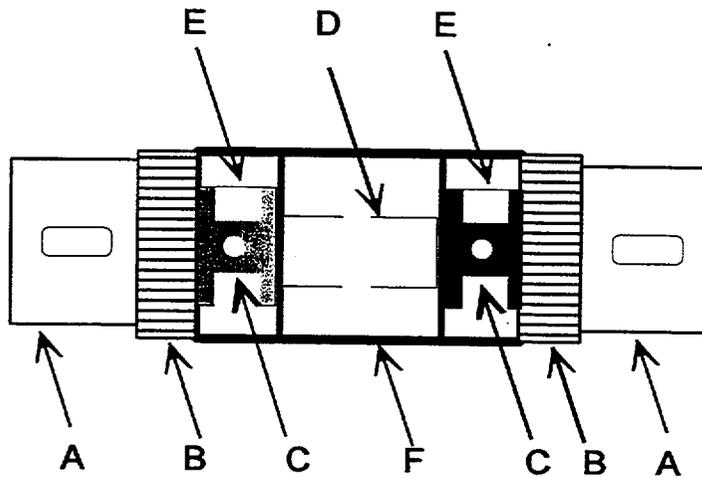
Figure 1 Sample low-voltage fuse construction

The fusible element is constructed of zinc, copper, or silver alloys, and may contain one or more narrow sections. These narrow sections are weak-links that are designed to melt under prescribed conditions. The number of fusible elements and their design are dictated by the specifications of the fuse. Non-current limiting fuses may use one large element, which is suitable for heavy overloads and short circuit currents. This can be combined with a time-delay element to form a "dual-element" fuse (see Figure 1). Current-limiting fuses use multiple elements with several weak-links in each instead of one large element. This use of multiple, smaller elements helps to quickly (within one-half cycle of the event) extinguish the arcs caused by high fault currents, and limit the current passed during a fault.

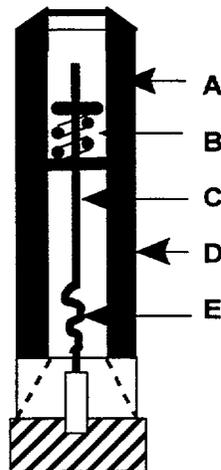
Figure 2 Schematic of expulsion type medium-voltage fuse

Another type of medium-voltage fuse is the expulsion fuse, which is also known as the solid-material fuse or boric-acid fuse. This type of fuse generates a gas to help extinguish the arc generated by interruption of a fault current. As the gas is generated it quenches the arc and is expelled from the fuse. The design of this fuse includes an arcing rod that is attached to the fusible element. The arcing rod is spring loaded so that when the fusible element melts, it releases the rod. Spring tension then pushes the rod up through the top of the fuse cartridge and away from the broken end of the fusible element, thus increasing the arc gap. The internal surface of the fuse cartridge is lined with a solid material that generates a deionizing gas when heated by the arc. This gas helps to extinguish the arc, thus breaking the circuit. Figure 2 shows this type of fuse schematically.

- A = Solid gas generating material
- B = Spring
- C = Arcing rod
- D = Fuse Cartridge
- E = Fusible element

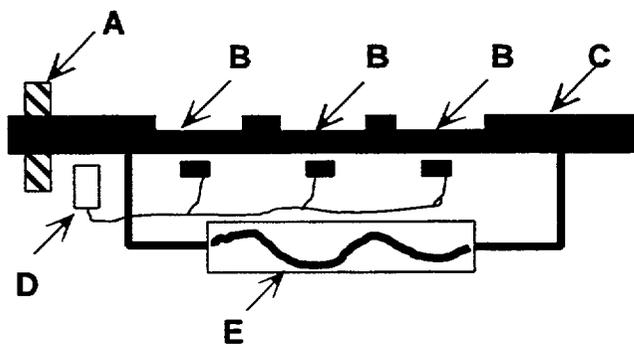
Figure 3 Schematic of one electronic medium-voltage fuse design

Upon an overcurrent condition, a current transformer and electronic sensing circuits sense the overcurrent and initiate a trip signal to activate a device that will disrupt the primary current path. Depending on the fuse design, the primary current path can be disrupted by activating a power cartridge, which generates a gas to drive a piston away from its contact surface, or by detonating explosive charges to force one or more selectively weakened sections of the primary conductor out of place. Once the primary path is broken, all current flows through the fusible element causing it to melt and break the circuit. One electronic fuse design is shown schematically in Figure 3.

- A = Current sensing transformer
- B = Selectively weakened breakpoints with pyrotechnic cutting charge below each
- C = Bus bar (primary fuse conducting path)
- D = Electronic sensing circuitry
- E = Fusible element embedded in sand

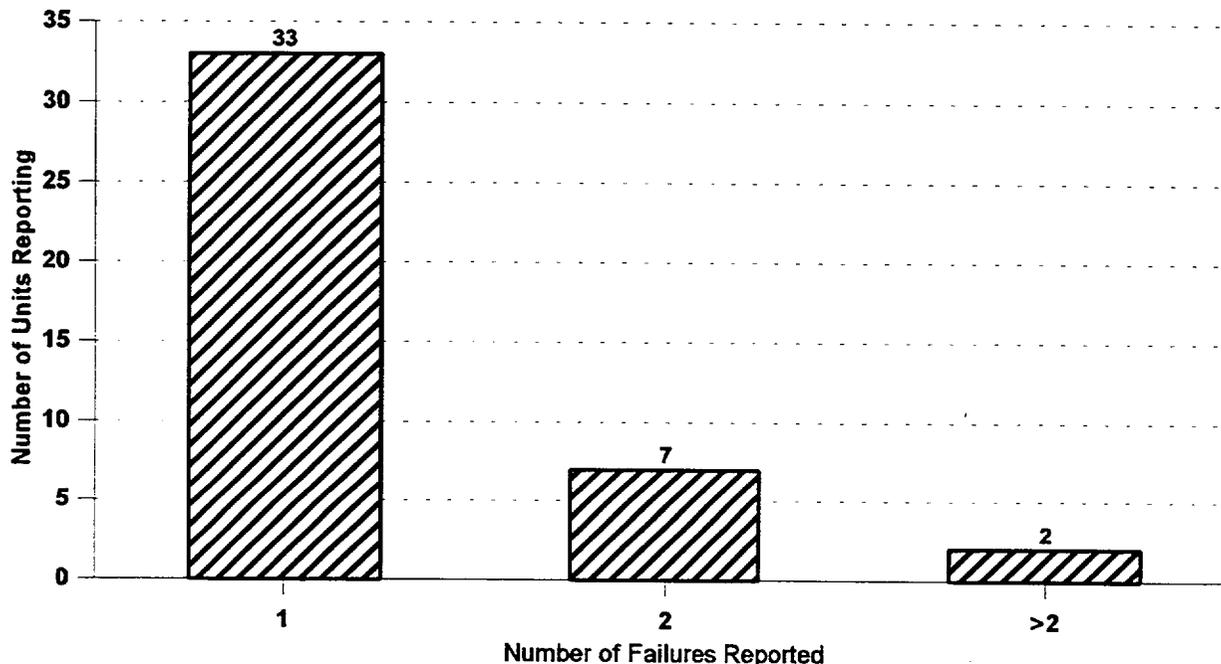
Figure 4 Distribution of age-related fuse failures per unit from LERs

are relatively infrequent. The distribution of age-related failures reported per unit is shown in Figure 4. For the units reporting, the fuse failures were relatively evenly distributed among the units, with no one unit having a majority of the failures. This indicates there is no specific age-related fuse problem at any one plant. In most cases, only one fuse failure per unit was reported.

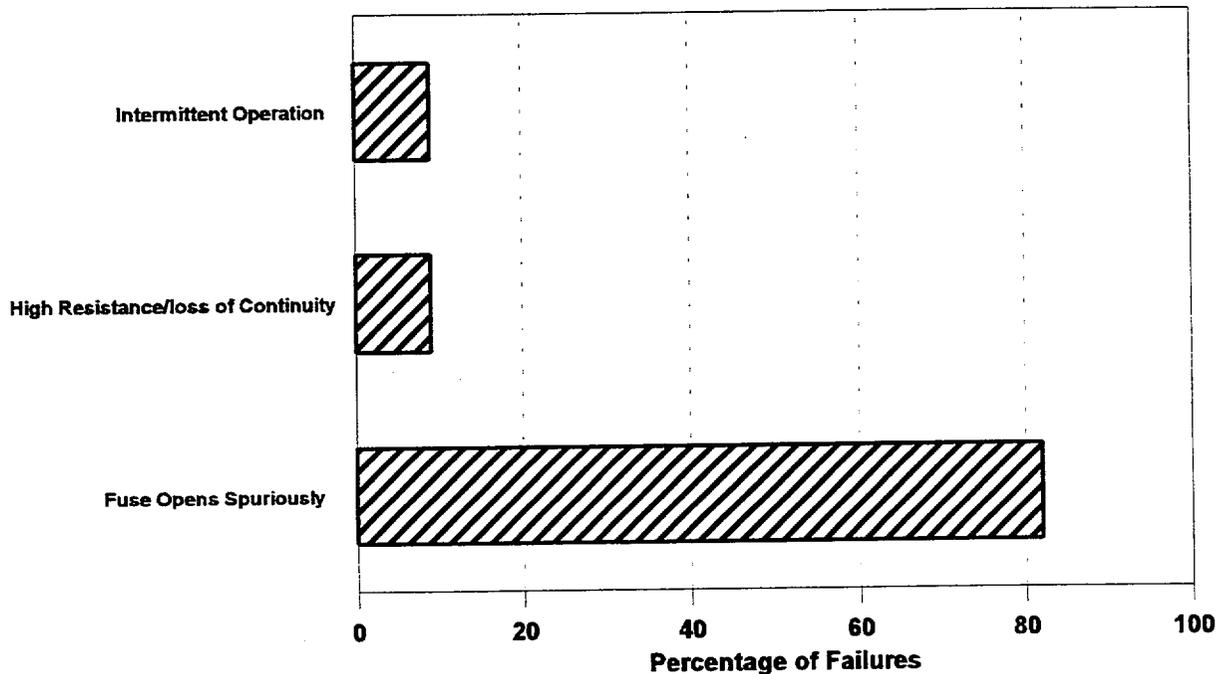
Figure 5 Distribution of fuse failure modes from LERs

The age-related fuse failures were analyzed to identify the predominant aging characteristics of the failures experienced. Figure 5 shows the distribution of failure modes identified. As shown, the predominant failure mode experienced (82%) was "FUSE OPENS SPURIOUSLY," which indicates that the fusible element opened and caused an open circuit when it should not have. The failure mode "HIGH RESISTANCE/LOSS OF CONTINUITY" represented 9% of the failures. These failures typically involved problems with the fuse being loose in the fuse holder due to weakened clips and failing to complete the circuit, and/or degradation of the electrical contact surfaces. The remaining events (9%) involved the failure mode "INTERMITTENT OPERATION" of the fuse, which were typically due to loose fuse holder clips or a broken solder joint between the fuse element and end cap. No events were identified involving any of the other potential fuse failure modes identified previously.

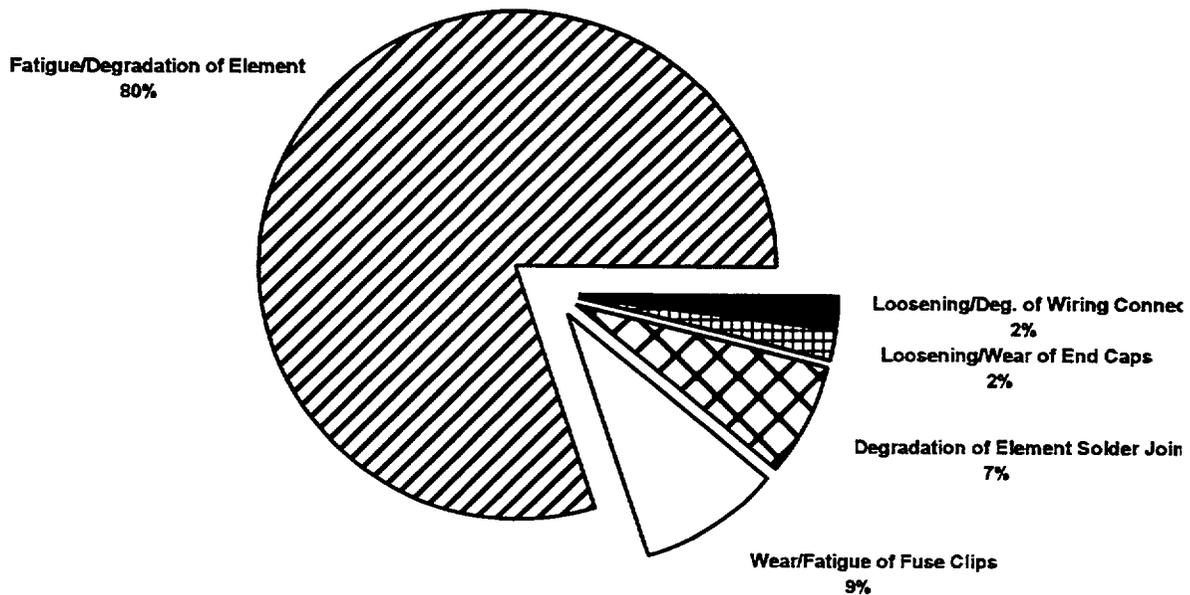
Figure 6 Fuse failure mechanisms from LERs

The predominant failure mechanism (80%) was found to be "FATIGUE/ DEGRADATION" of the fusible link, which led to failure of the fuse. Fatigue is typically due to degradation over a period of time from exposure to elevated temperature, voltage transients, or short duration over-current conditions. It can lead to weakening of the fuse element, or a reduction in cross section, which reduces its current carrying capacity. Other less frequent failure mechanisms found were "WEAR/FATIGUE" of the fuse holder clips (9%) or "DEGRADATION" of the end

cap to fuse element solder joint (7%). Fatigue of the fuse holder clips can typically occur due to repeated insertion and removal of the fuses, such as during maintenance or surveillance testing. Degradation of the solder joint was found to occur in several cases due to cold solder joints that degraded during subsequent operation. The remaining failures were due to loosening/degradation of the wiring connections to the fuse holder, and loosening/ wear of the end caps on the fuse itself. The percentage of failures related to each of the failure mechanisms is shown in Figure 6.

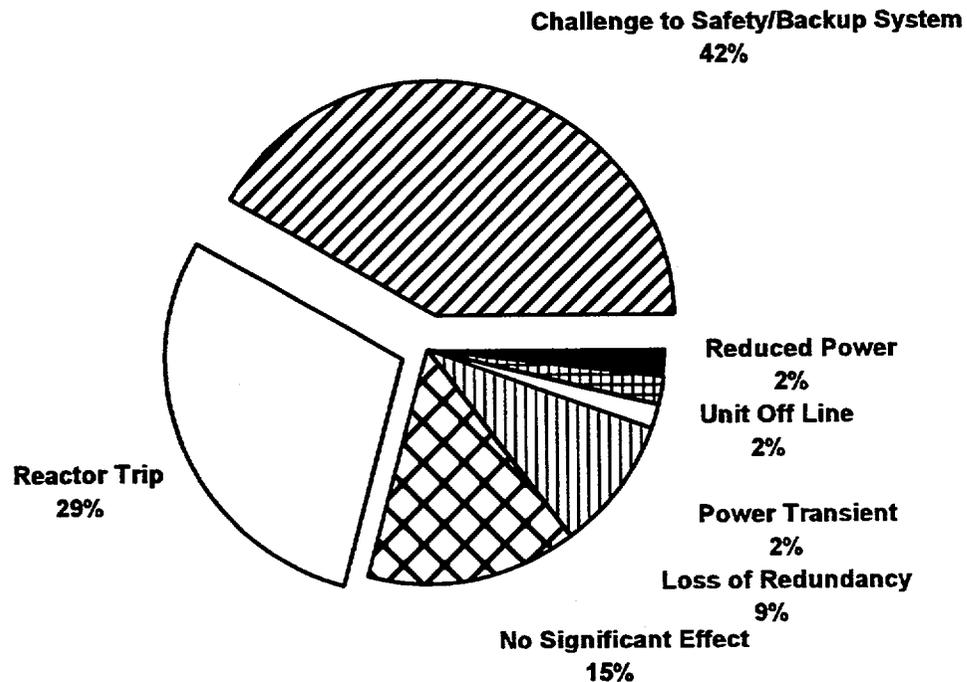
Figure 7 Effect of fuse failures on plant performance from LERs

The various effects of the fuse failures on plant performance are shown in Figure 7. The predominant effect (42%) was found to be a challenge to a safety or backup system. This is expected from this database since any actuation of an engineered safety feature is reportable as an LER. Typical examples of these events are the following:

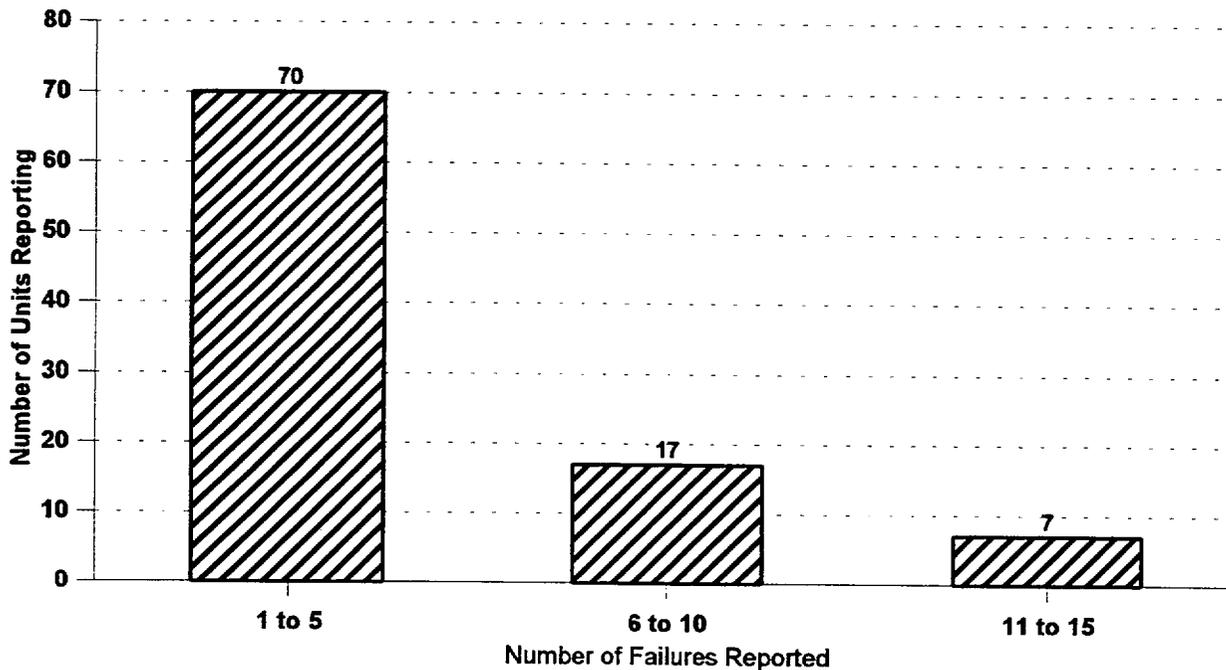
Figure 10 Distribution of age-related fuse failures per unit from NPRDS

among the failures reported to the NPRDS was relatively low. The failure reports reviewed for this program represented 94 nuclear units. The distribution of age-related failures reported per nuclear unit is shown in Figure 10.

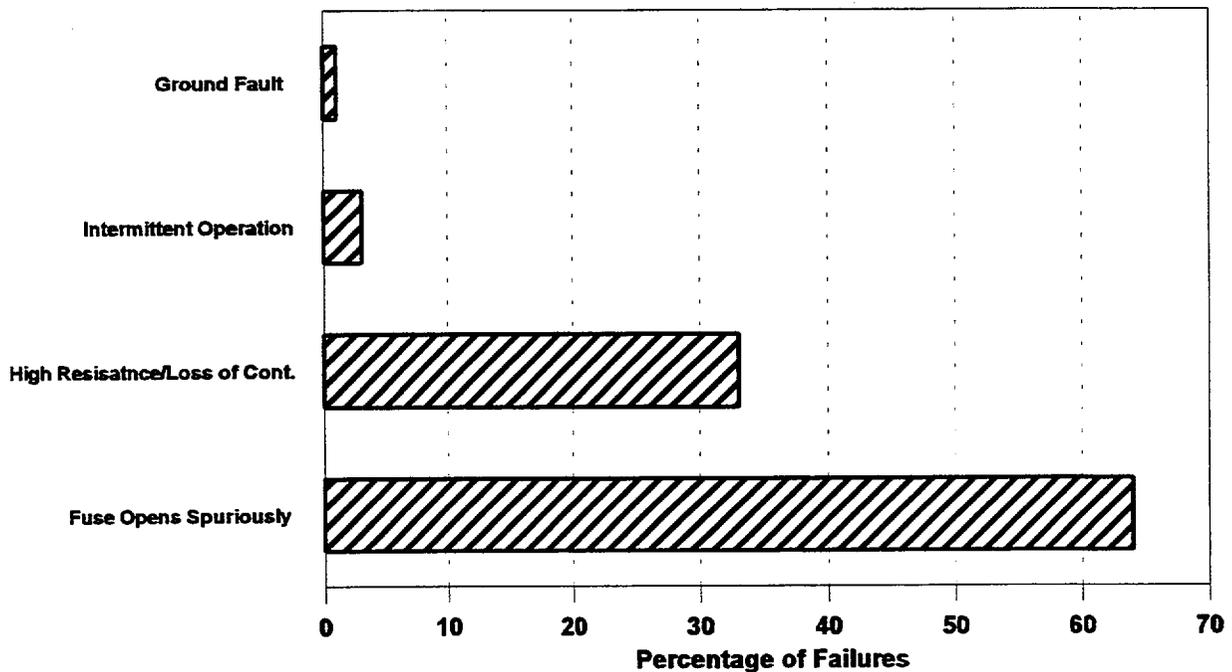
Figure 11 Distribution of fuse failure modes from NPRDS

The fuse failures identified as age-related were analyzed to determine the predominant aging characteristics of the failures experienced. Figure 11 shows the distribution of failure modes encountered during the review. As shown, the predominant failure mode experienced (64%) was “FUSE OPENS SPURIOUSLY,” which indicates that the fusible element opened and caused an open circuit when it should not have. The failure mode “HIGH RESISTANCE/LOSS OF CONTINUITY,” which represented 33% of the age-related failures reported, was significant in that it was a failure mode of the fuse holder. These failures typically involved: problems with the fuse being loose in the fuse holder due to weakened, broken, or misaligned clips; degraded or open electrical connection between fuse and holder; degraded or open electrical connection between the fuse holder and its wiring terminations; broken fuse holder parts; and failing to complete the circuit.

A small number of events (2.5%) involved the failure mode “INTERMITTENT OPERATION” of the fuse, which were typically caused by loose fuse holder clips or faulty fuse holder wiring terminations. Finally, less than 1% of the events involved the “GROUND FAULT” failure mode, which was usually caused by dirt or contamination on a high voltage fuse/fuse holder assembly faulting to ground. It should be noted that latter three failure modes, representing more than 35% of the age-related events reviewed, involved failures of the fuse holder assembly and its terminal connections. No events were reviewed involving any of the other potential fuse failure modes identified previously.

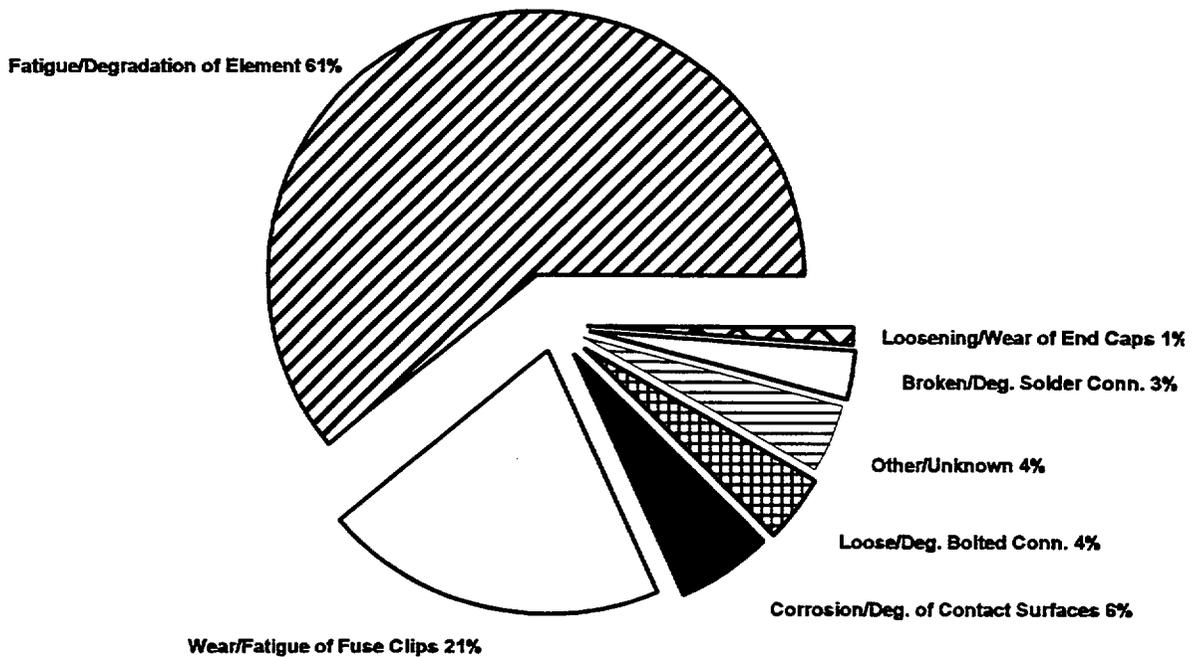
Figure 12 Fuse failure mechanisms from NPRDS

The predominant failure mechanism (61%) was found to be “FATIGUE/DEGRADATION OF ELEMENT,” i.e., of the fusible element or link, which led to unexpected failure of the fuse. This is to be distinguished from the normal opening of the fusible link when the fuse is exposed to overcurrent conditions for a prescribed time. Fatigue is typically due to the degradation of the metallic fuse element over time as a result of exposure to elevated temperature, voltage transients, or short duration overcurrent conditions. It can lead to weakening of the fuse element, or a reduction in cross section, which reduces its current carrying capacity.

A second important failure mechanism was “WEAR/FATIGUE OF FUSE CLIPS” (21%). Fatigue of the fuse holder clips can typically occur due to high temperature, mechanical stress, and repeated insertion and removal of the fuses, such as during maintenance or surveillance testing. Other less frequently cited failure mechanisms found were “CORROSION/DEGRADATION OF CONTACT SURFACES” (6%), loose, broken, or degraded soldered (3%) or bolted/screwed (4%) wiring connections, and “LOOSENING/WEAR OF END CAPS” (1%). The remainder of the failure mechanisms (approximately 4%) included a variety of mechanisms, such as, contamination, moisture intrusion, fatigue or breakage of fuse holder base, or unknown. The percentage of failures related to each of the failure mechanisms is shown in Figure 12.

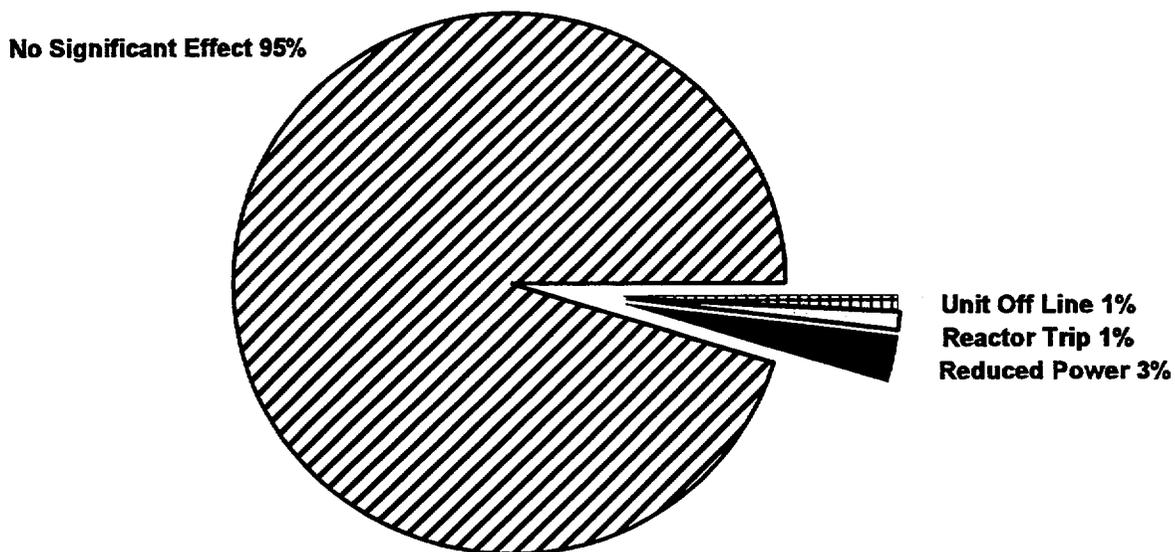
Figure 13 Effect of fuse failures on plant performance from NPRDS

The effects of fuse failures on plant performance are shown on Figure 13. In contrast to the LER data base, which by its nature involves events that have the most serious effects on nuclear plant operation, the NPRDS is a general equipment and component failure data base. Hence, most of the fuse failures reported to NPRDS resulted in "NO SIGNIFICANT EFFECT" (95%) on plant operation. Among the fuse failures reviewed, 3% resulted in "REDUCED POWER" operations, 1% resulted in a "REACTOR TRIP", and 1% resulted in the taking the "UNIT OFF LINE."

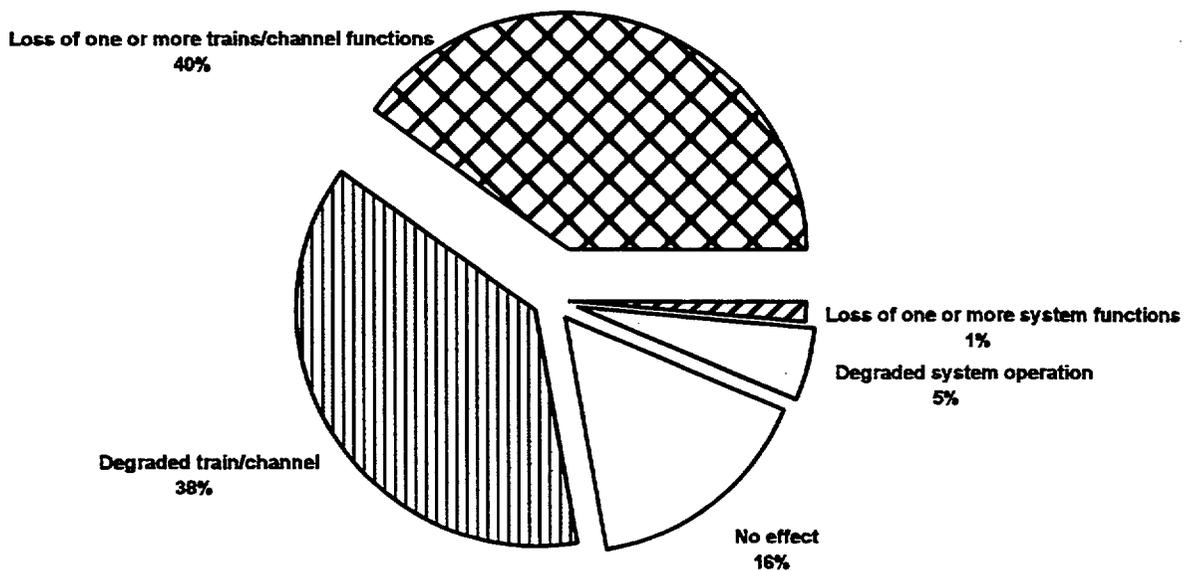
Figure 14 Effect of fuse failures on system performance from NPRDS

Another measure of the significance of fuse failures can be found by looking at the effect of a fuse failure upon the system in which it is located. This information is included as part of the NPRDS failure report and is shown on Figure 14 for fuse failures. More than three-fourths of the failures result in either "DEGRADED TRAIN/CHANNEL" (38%) or the "LOSS OF ONE OR MORE TRAINS/CHANNEL FUNCTIONS" (40%). Another 5% of the fuse failures caused "DEGRADED SYSTEM OPERATION," and the "LOSS OF ONE OR MORE SYSTEM FUNCTIONS" was reported in 1% of the failures. Finally, in 16% of the fuse failures reported to NPRDS, the plants indicated that there was "NO EFFECT" at all on the system in which the problem was found.

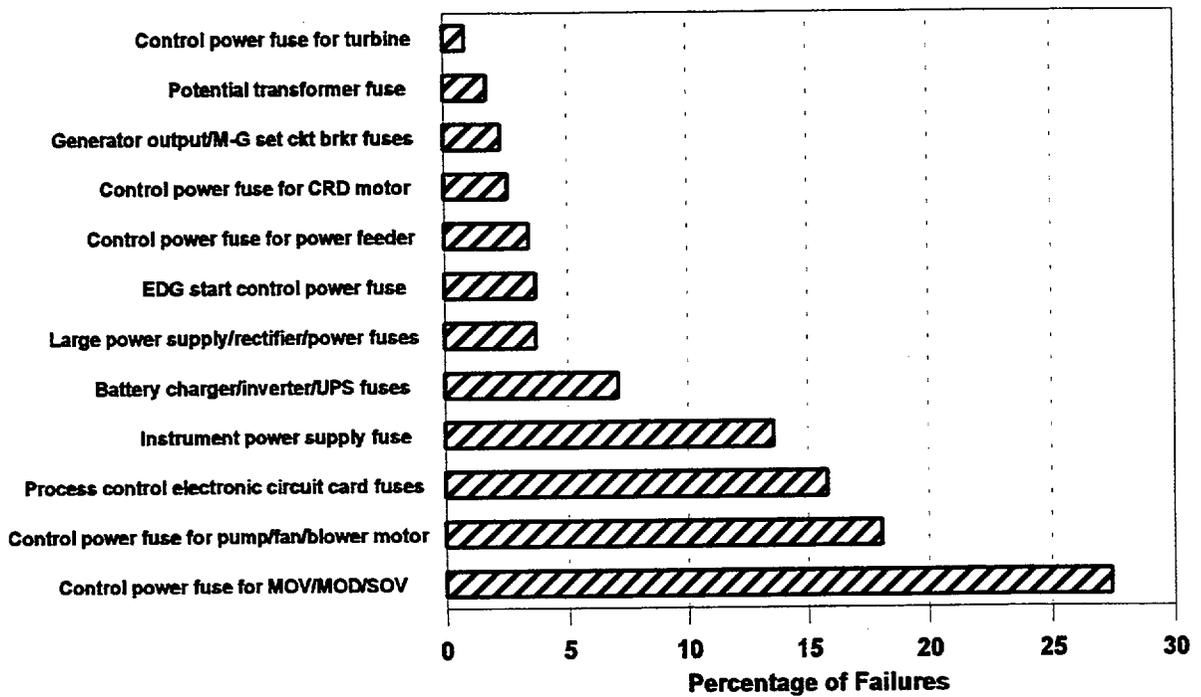
Figure 15 Distribution of applications for failed fuses reported to NPRDS

Another important piece of information found in the NPRDS data is the application in which the failed fuse assembly was being used. These data can provide insight into how fuse failures may affect plant operation and safety, and suggest approaches that may be taken to mitigate the effects of fuse failures. The fuse application data are presented in Figure 15. The most common application involved control power fuses for motor operated valves and dampers (23%) or solenoid operated valves (5%). Control power fuses for electric drive motors for pumps, fans, and blowers were involved in 18% of the failure reports. Also significant were

electronic circuit card fuses for process control circuits and systems (16%) and closely related were instrument power supply fuses (14%). Finally, a fairly large number of fuse failures occurred in large power supply/rectifier applications (4%) and in battery chargers/inverters/uninterruptible power supplies (7%). The latter application was the subject of an earlier BNL study on the operating experience and aging-seismic assessment of battery chargers and inverters (reported in NUREG/CR-4564 and NUREG/CR-5051), which included an examination of the fuse failures experienced in this equipment that were potentially the result of elevated operating temperatures.

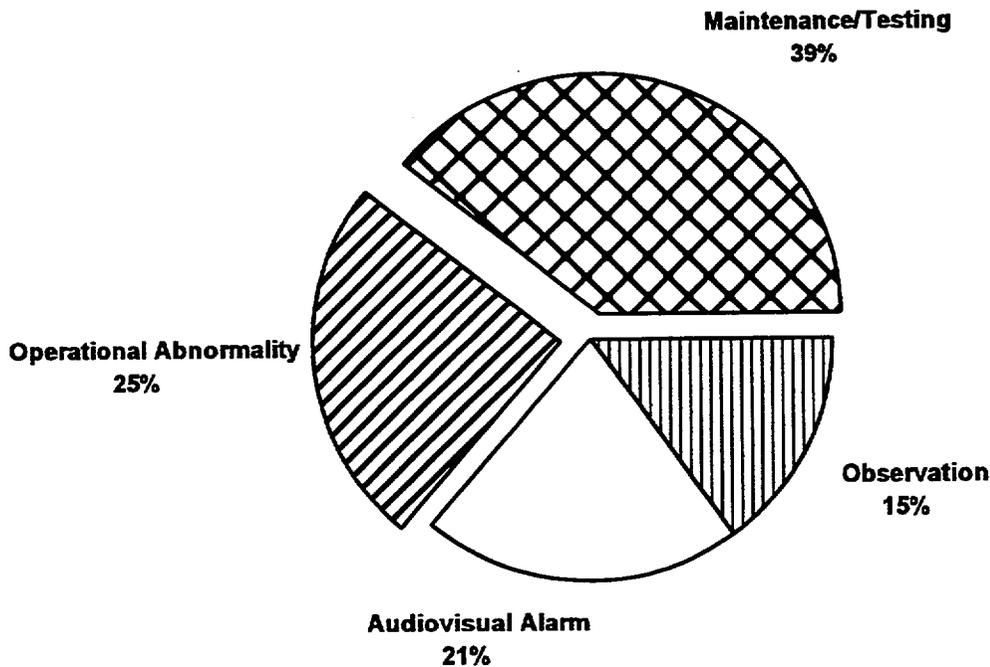
Figure 16 Fuse failure detection methods from NPRDS

The NPRDS data were also sorted to identify the predominant methods for detection of fuse failures. This information can sometimes show whether the methods and techniques being used to discover degraded or failed fuses are well-matched with the predominant failure mechanisms encountered for this component. The NPRDS failure detection data are shown on Figure 16. The greatest number of fuse failures were detected during "MAINTENANCE" and "TESTING" activities (39%) and by "OBSERVATION" (15%) by plant operating and maintenance personnel. This is significant because it reflects proactive efforts on the part of licensees to find these failures before they can cause more serious problems. Another 25% of the NPRDS failures were detected by "OPERATIONAL ABNORMALITIES." This category would include failures to operate when required, off-normal performance, loss of position

indication, or loss of control power indication. Finally, "AUDIOVISUAL ALARMS" accounted for the detection of 21% of the fuse failures. It should be noted that several NPRDS reports

mentioned that imaging infrared thermography surveys were used to identify incipient fuse and fuse holder failures. Licensees are taking advantage of this technology to detect hot spots that could indicate potential fuse assembly failures.

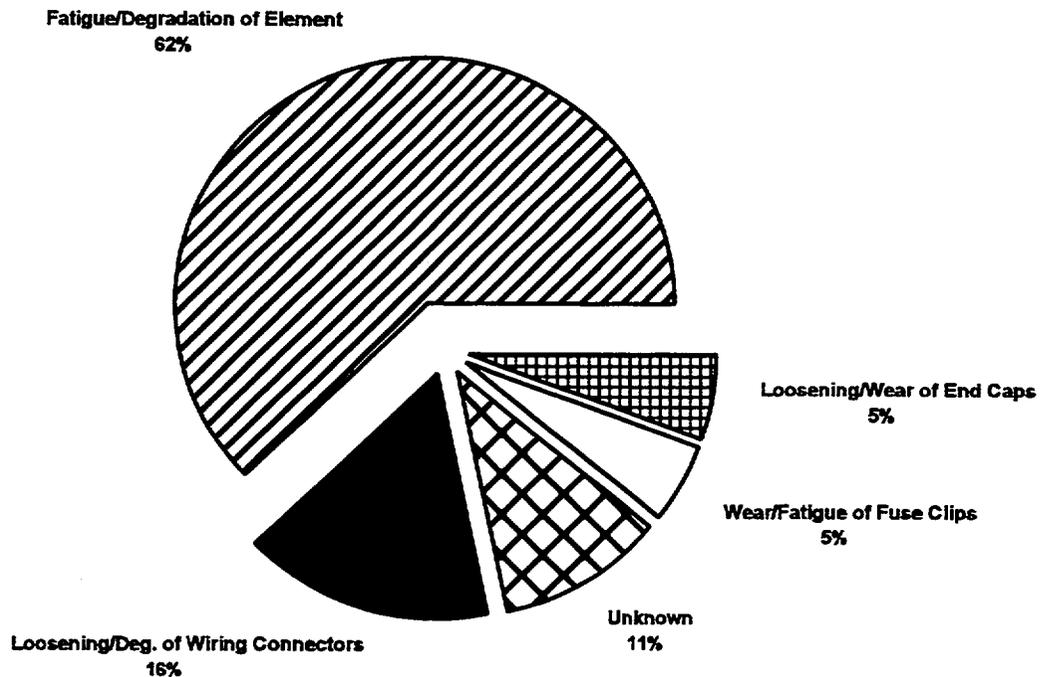
Figure 19 Fuse failure mechanisms from EPIX

The predominant fuse failure mechanism was "FATIGUE/DEGRADATION OF THE FUSIBLE ELEMENT," which accounted for 62% of the failures. This is consistent with the predominant failure mechanism found in the NPRDS data. Again, for failures attributed to aging in which no information on the failure mechanism was presented in the report, and the fuse is described as "blown," it was assumed for purposes of this evaluation that the mechanism was fatigue of the fusible element. Other less frequently found mechanisms were "LOOSENING/DEGRADATION OF THE WIRING CONNECTIONS" (16%), "MECHANICAL WEAR/FATIGUE OF FUSE HOLDER CLIPS" which caused loosening of the fuse in the fuse holder (5%), and "LOOSENING/ DEGRADATION OF THE FUSE END CAPS" (5%). These results are summarized in Figure 19.

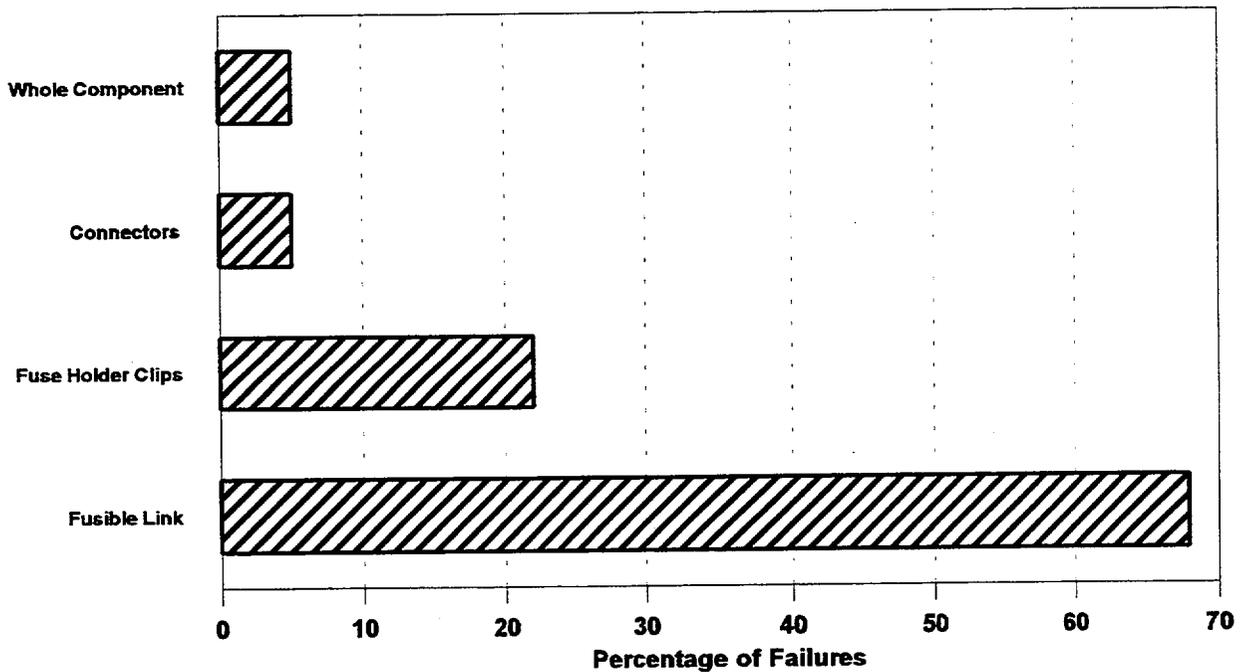
Figure 20 Distribution of fuse subcomponents failed from EPIX

In analyzing the subcomponent that failed in the fuse assembly, the “FUSIBLE LINK” is the major contributor (68% of the total failures). This is followed by the “FUSE HOLDER CLIPS” (22%), which failed as a result of fatigue, wear, and embrittlement. “CONNECTORS” failed 5% of the time and involved disconnection of the connector to the fuse holder and, in one case, fusion of the connector itself. Another 5% of the failures were attributed to the whole fuse assembly, which was deemed to be a generally faulty component. These results are summarized in Figure 20.

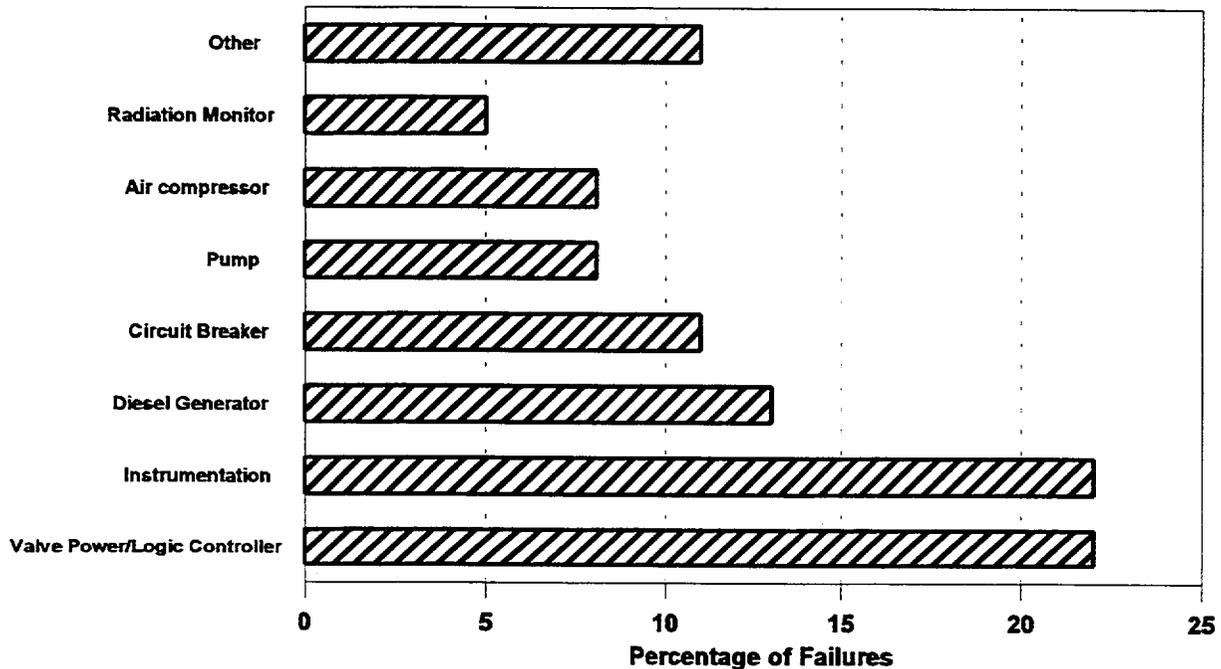
Figure 21 Distribution of applications for failed fuses from EPIX

The applications for which fuses failed by age-related mechanisms were analyzed in detail. In 22% of the EPIX listings, fuse failure resulted in the non-operability of valves. These fuses

were either in a logic controller or in a power circuit for the valve. Another 22% of the fuse failures caused failure of instrumentation circuits. The applications for the fuse failures are summarized in Figure 21.

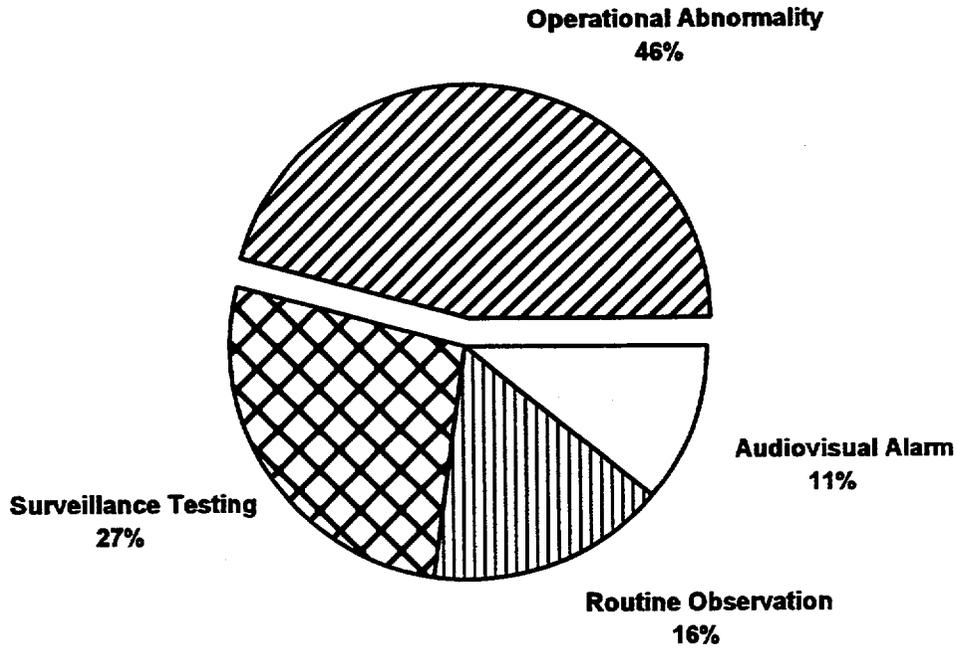
Figure 22 Fuse failure detection methods from EPIX

Figure 22 shows the fuse failure detection methods that were identified from the EPIX system data. "OPERATIONAL ABNORMALITIES" detected 46% of the fuse failures, and a large fraction of failures were detected by "SURVEILLANCE TESTING" (27%). "ROUTINE OBSERVATION" (16%) and "AUDIOVISUAL ALARMS" (11%) were the remaining detection methods.

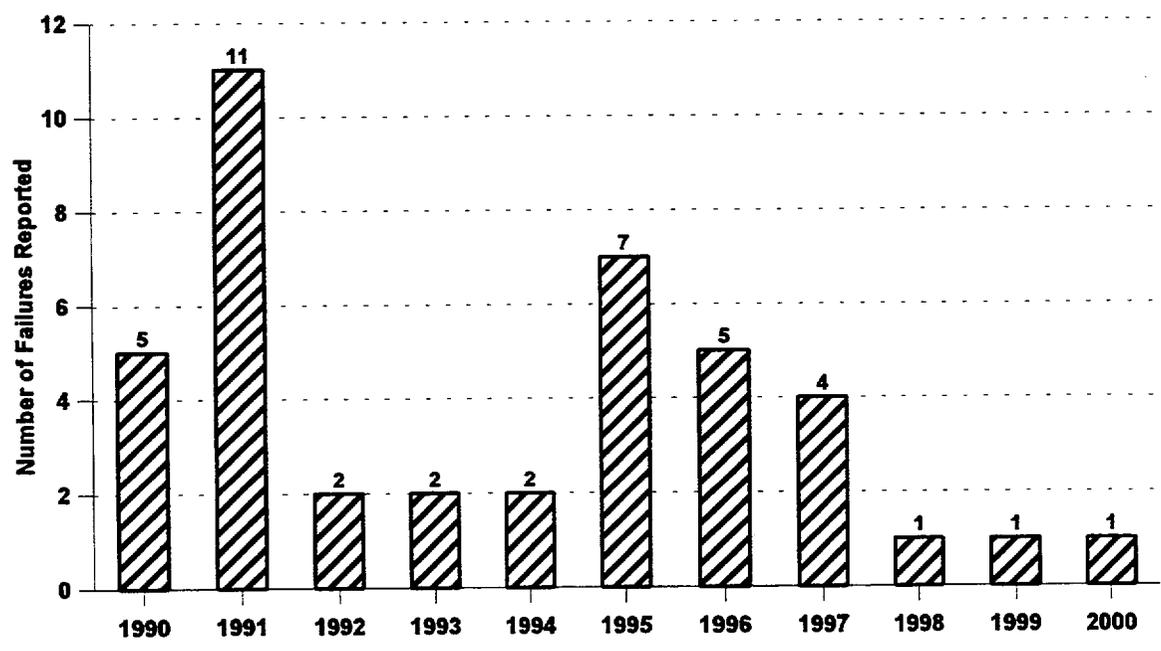
Figure 23 Number of age-related fuse failures reported per year as LERs

The LER data were sorted to obtain fuse failures per year over the past ten years. If the number of fuse failures per year was increasing, this could indicate a potential problem with management of fuse aging. However, the results presented in Figure 23 show no discernible trend in the number of reported fuse failures. The relatively large number of fuse failures reported in 1991 is followed by a decline in 1992. This could reflect the increased attention to fuse control programs suggested in NRC Information Notice 91-51. At that time, a number of

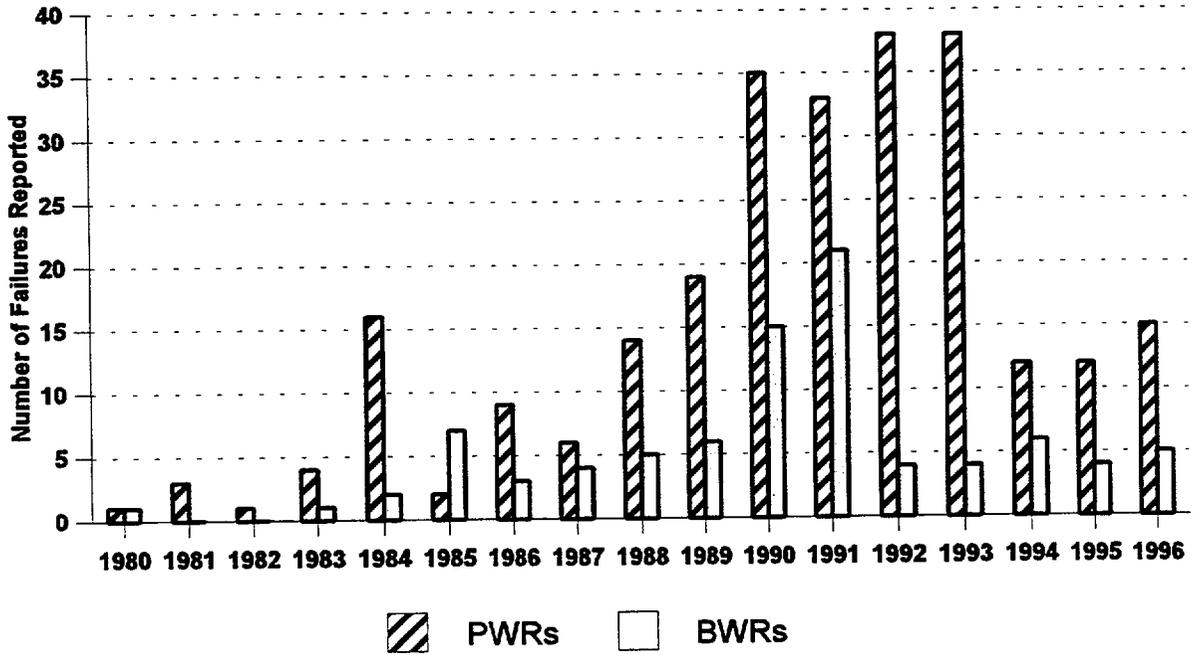
Figure 24 Number of age-related fuse failures reported per year to NPRDS

Figure 24 also shows a large number of fuse failures reported at PWRs in 1992 and 1993, and generally, after that time, a greater number of fuse failures than for BWRs. Since the total quantity of fuse failures reported in any given year would depend on the number of nuclear units that were operating during that year, the data were normalized by dividing the annual failure totals by the number of operating nuclear units in each year. The resulting plot of fuse failures per unit year showed that the rate of age-related fuse failures was nearly the same for BWRs and PWRs throughout the period except for the years 1991 and 1992, where the rate was more than double for PWRs. To examine this more closely, the data for PWRs was sorted by nuclear steam supply system (NSSS) vendor, and normalized by dividing the annual totals by the number of operating nuclear units in each year. The results of this analysis are presented in Figure 25.

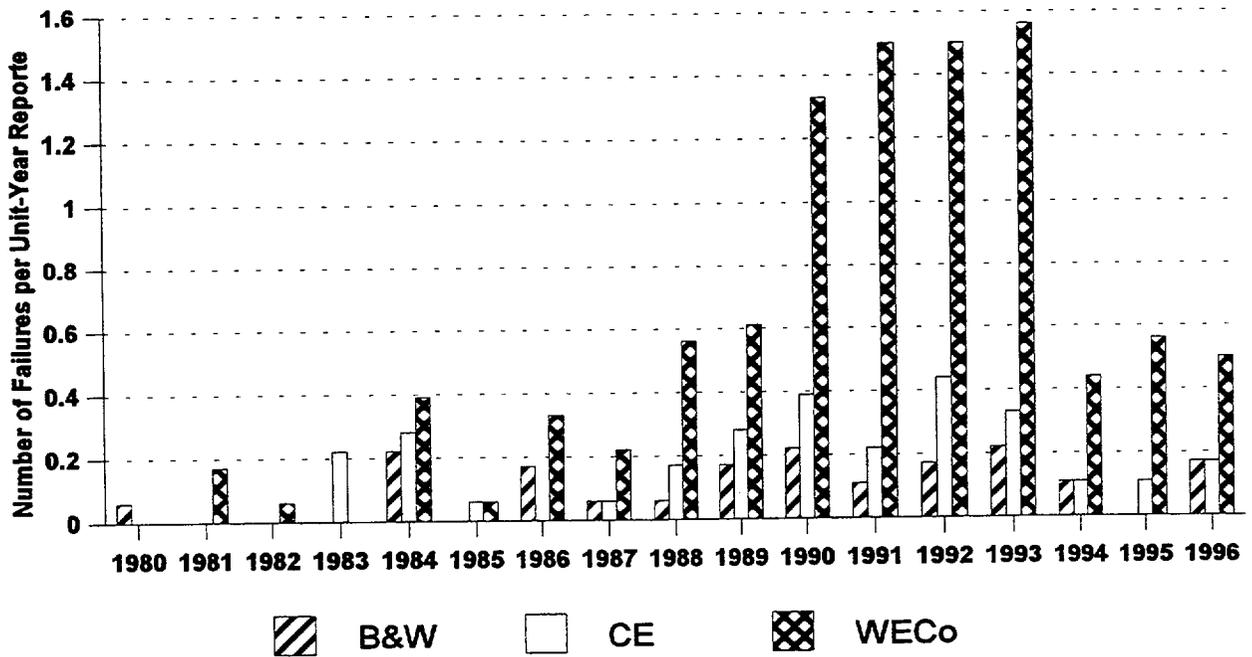
Figure 25 Number of age-related fuse failures per unit-year for PWRs reported to NPRDS

Figure 25 indicates that Westinghouse (WEC) PWRs had a higher rate of age-related fuse failures per unit year than the Combustion Engineering (CE) and Babcock & Wilcox (B&W) reactors throughout the period shown. During the years 1990 through 1993, the rate for Westinghouse reactors was more than four times that reported at the CE and B&W PWRs. Some of this difference may be attributed to the heightened awareness for fuse maintenance and inspection following IN 91-51 on fuse control programs. More likely, problems with incorrectly sized fuses in Westinghouse System 7300 printed circuit cards, as reported in NRC IN 93-87, contributed to the higher rate of age-related fuse failures per unit year. This is supported by the data which show that more than one third of the fuse failures reported in the years 1991-93 were in applications involving the process control system circuit cards or their power supply cards. From 1994 on, the number of failures per unit year for the Westinghouse plants dropped dramatically, however it still remained higher than for the CE and B&W units.

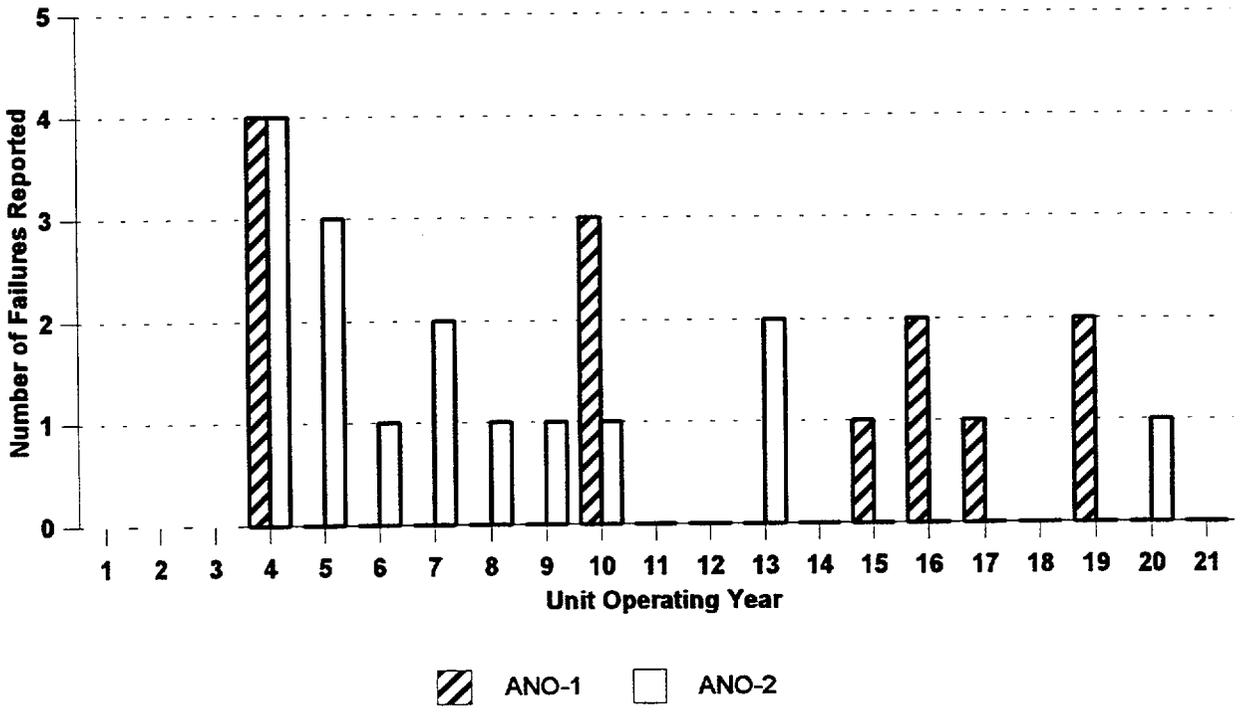
Figure 27 Age-related fuse failures at ANO 1 & 2 grouped by unit year - NPRDS & EPIX

Another approach to searching for trends in the fuse failures data base was to look at all of the failures for a particular plant over an extended period of time. This was done for the Arkansas Nuclear One (ANO) plant for the period from 1980 through 1996 using the NPRDS database, and from 1997 to 2000 using the EPIX database. Since there are two nuclear units at this plant, a greater population of fuses could be examined in which the policies and procedures with regard to fuses would be similar. This review included nine age-related failures from ANO Unit 1 (out of 29 NPRDS reports reviewed), 15 age-related failures from ANO Unit 2 (out of 23 NPRDS reports reviewed), and one age-related failure from each unit from the EPIX data base. The age-related failures from the NPRDS and EPIX reviews were then grouped by the unit year of commercial operation (rather than by calendar year) in order to place the data from the two nuclear units on a comparable time scale. These resulting groupings are plotted on Figure 27.

From Figure 27 it can be seen that most of the failures for ANO Unit 2 occurred during the early years of the plant operation, during the fourth through the tenth years of operation. There were four age-related fuse failures at ANO Unit 2, occurring in four different systems, in the fourth year of operation. As seen in the figure, the number of failures at Unit 2 per unit year decreased over the next few years to the point where only sporadic fuse problems were reported after the tenth year of operation. One fuse failure in the fifth year of operation at Unit 2 occurred in a control power fuse to a control element assembly (reactor control rod drive) and resulted in a reactor trip.

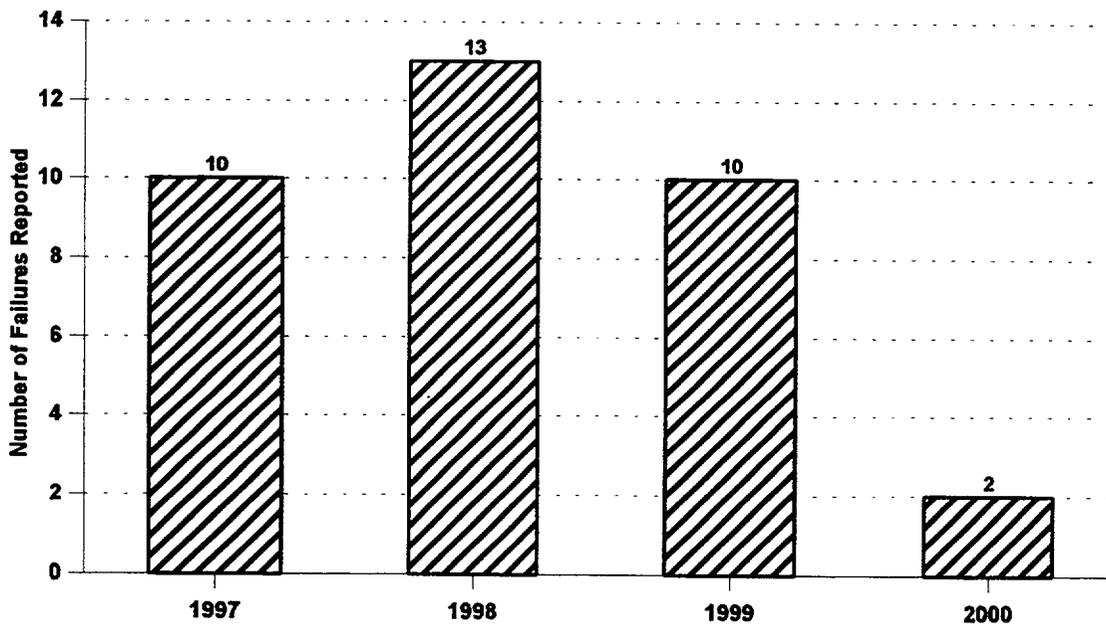
Figure 28 Number of age-related fuse failures reported per year to EPIX

Fuse failures by year, as reported to the EPIX system are given in Figure 28. Since the EPIX system was initiated in 1997 to replace the NPRDS database, it contained only four years of operating experience. Therefore, extracting insights by trending this data is somewhat uncertain at the time this analysis was performed. Nevertheless, the data were evaluated for completeness. As shown, in the years 1997, 1998, and 1999, the number of age-related fuse failures was relatively constant, and no discernable trends are evident. In the year 2000, only two fuse failures occurred, which may be due to incomplete data entry into the database at the time of this study. The current year 2001 is not included in this evaluation since it is a partial year.

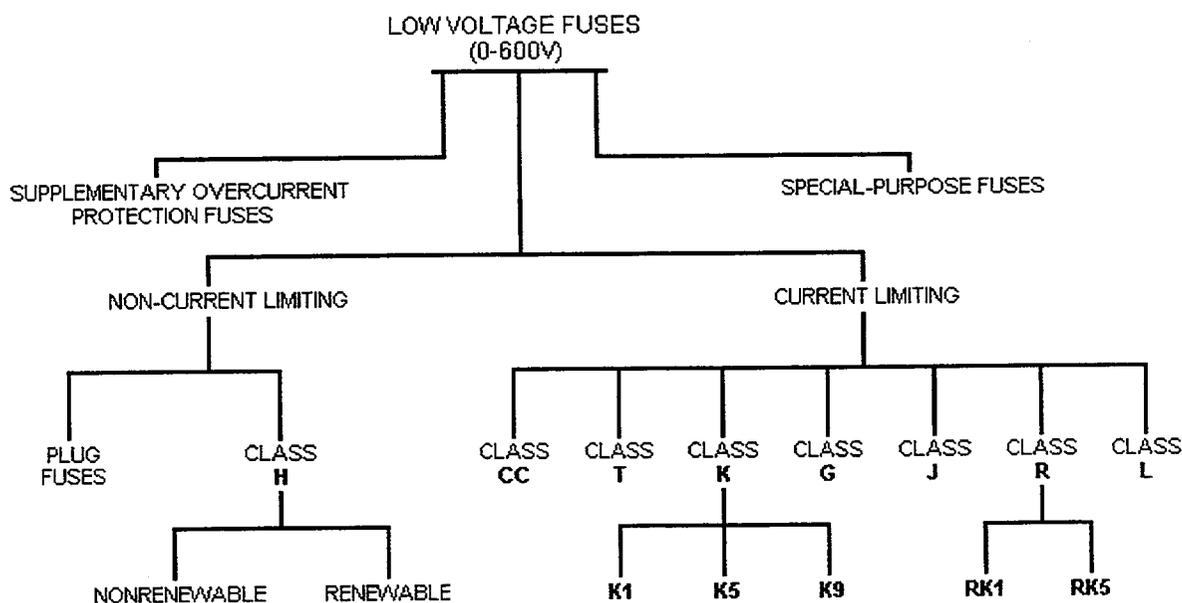
Figure A-1 Underwriters Laboratories, Inc. fuse classifications

The National Electrical Manufacturers Association (NEMA) and the Underwriters Laboratories (UL) have set standards that govern the manufacture, performance, size, and testing of fuses. Most fuse types are labeled and identified by their UL classification which are summarized in Figure A-1. The most common classes of fuses for nuclear power plant applications are discussed in the following paragraphs.
