Aging Assessment of Safety-Related Fuses Used in Low- and Medium-Voltage Applications in Nuclear Power Plants

**U.S. Nuclear Regulatory Commission
Office of Nuclear Reactor Regulation
Washington, DC 20555-0001**

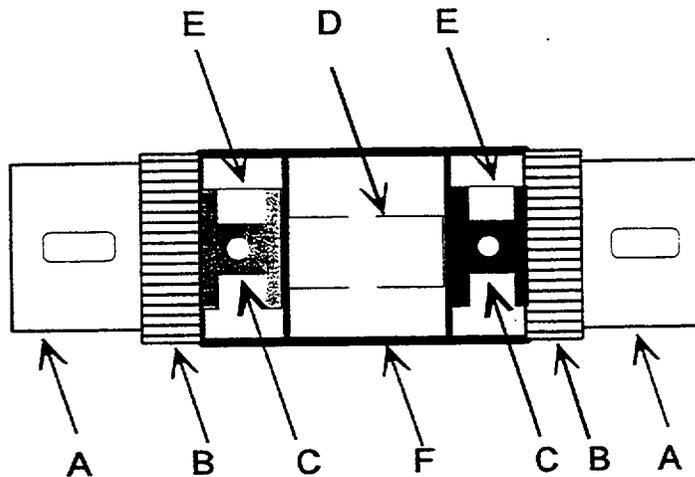
The fusible element is constructed of zinc, copper, or silver alloys, and may contain one or more narrow sections. These narrow sections are weak-links that are designed to melt under prescribed conditions. The number of fusible elements and their design are dictated by the specifications of the fuse. Non-current limiting fuses may use one large element, which is suitable for heavy overloads and short circuit currents. This can be combined with a time-delay element to form a "dual-element" fuse (see Figure 1). Current-limiting fuses use multiple elements with several weak-links in each instead of one large element. This use of multiple, smaller elements helps to quickly (within one-half cycle of the event) extinguish the arcs caused by high fault currents, and limit the current passed during a fault.

Figure 1 Sample low-voltage fuse construction

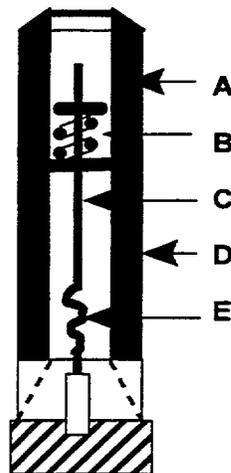
Another type of medium-voltage fuse is the expulsion fuse, which is also known as the solid-material fuse or boric-acid fuse. This type of fuse generates a gas to help extinguish the arc generated by interruption of a fault current. As the gas is generated it quenches the arc and is expelled from the fuse. The design of this fuse includes an arcing rod that is attached to the fusible element. The arcing rod is spring loaded so that when the fusible element melts, it releases the rod. Spring tension then pushes the rod up through the top of the fuse cartridge and away from the broken end of the fusible element, thus increasing the arc gap. The internal surface of the fuse cartridge is lined with a solid material that generates a deionizing gas when heated by the arc. This gas helps to extinguish the arc, thus breaking the circuit. Figure 2 shows this type of fuse schematically.

Figure 2 Schematic of expulsion type medium-voltage fuse

- A = Solid gas generating material
- B = Spring
- C = Arcing rod
- D = Fuse Cartridge
- E = Fusible element

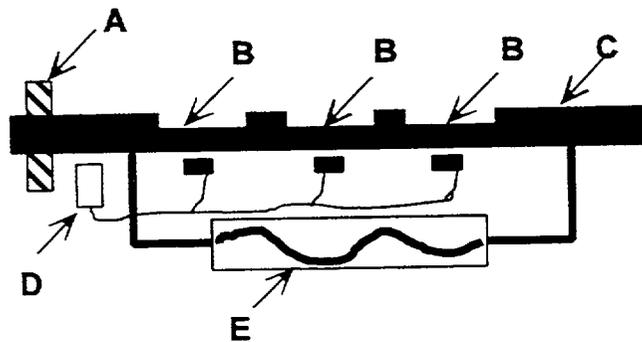
Upon an overcurrent condition, a current transformer and electronic sensing circuits sense the overcurrent and initiate a trip signal to activate a device that will disrupt the primary current path. Depending on the fuse design, the primary current path can be disrupted by activating a power cartridge, which generates a gas to drive a piston away from its contact surface, or by detonating explosive charges to force one or more selectively weakened sections of the primary conductor out of place. Once the primary path is broken, all current flows through the fusible element causing it to melt and break the circuit. One electronic fuse design is shown schematically in Figure 3.

Figure 3 Schematic of one electronic medium-voltage fuse design

- A = Current sensing transformer
- B = Selectively weakened breakpoints with pyrotechnic cutting charge below each
- C = Bus bar (primary fuse conducting path)
- D = Electronic sensing circuitry
- E = Fusible element embedded in sand

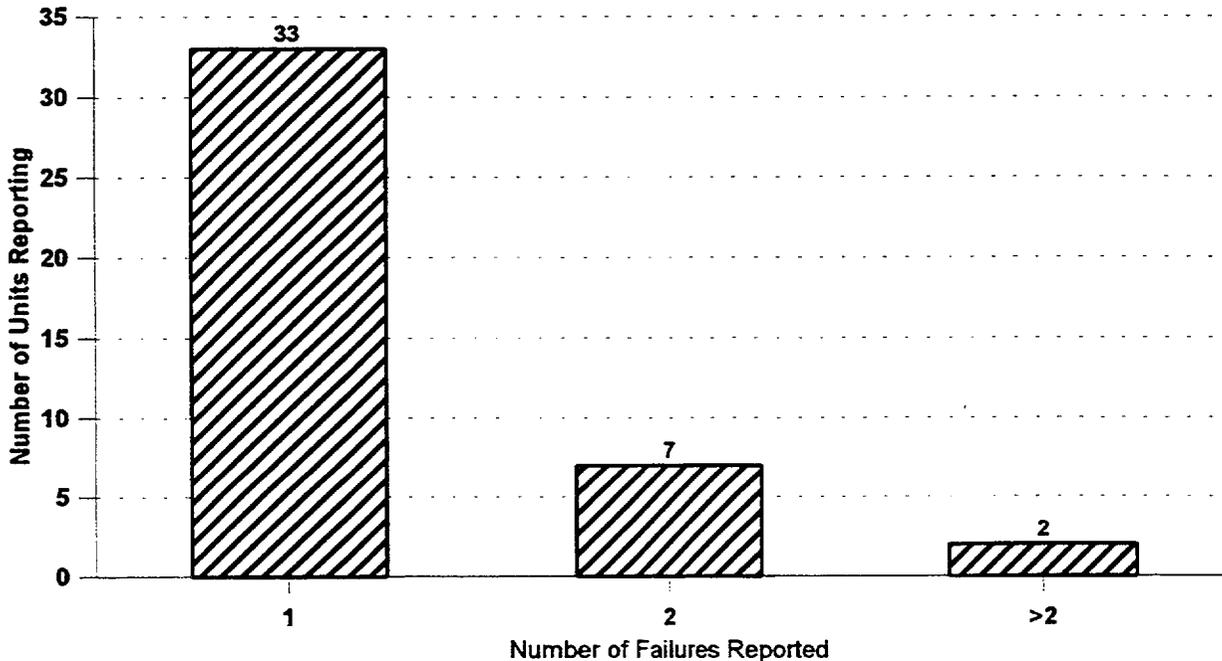
are relatively infrequent. The distribution of age-related failures reported per unit is shown in Figure 4. For the units reporting, the fuse failures were relatively evenly distributed among the units, with no one unit having a majority of the failures. This indicates there is no specific age-related fuse problem at any one plant. In most cases, only one fuse failure per unit was reported.

Figure 4 Distribution of age-related fuse failures per unit from LERs

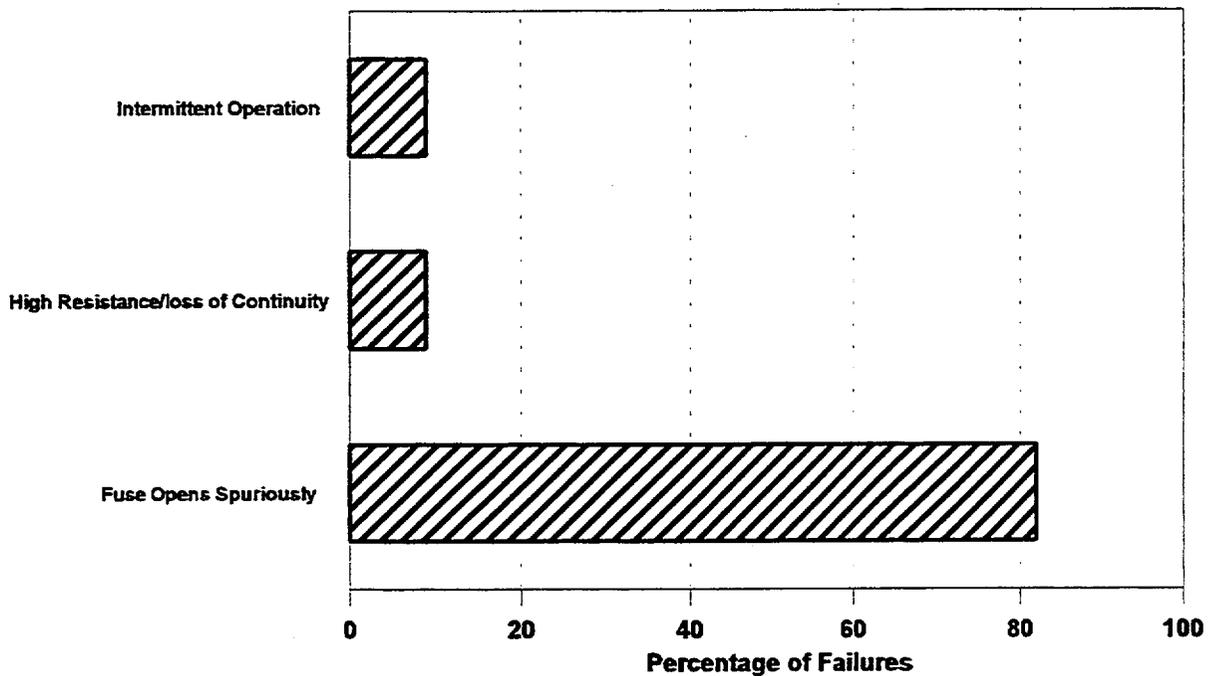
The age-related fuse failures were analyzed to identify the predominant aging characteristics of the failures experienced. Figure 5 shows the distribution of failure modes identified. As shown, the predominant failure mode experienced (82%) was “FUSE OPENS SPURIOUSLY,” which indicates that the fusible element opened and caused an open circuit when it should not have. The failure mode “HIGH RESISTANCE/LOSS OF CONTINUITY” represented 9% of the failures. These failures typically involved problems with the fuse being loose in the fuse holder due to weakened clips and failing to complete the circuit, and/or degradation of the electrical contact surfaces. The remaining events (9%) involved the failure mode “INTERMITTENT OPERATION” of the fuse, which were typically due to loose fuse holder clips or a broken solder joint between the fuse element and end cap. No events were identified involving any of the other potential fuse failure modes identified previously.

Figure 5 Distribution of fuse failure modes from LERs

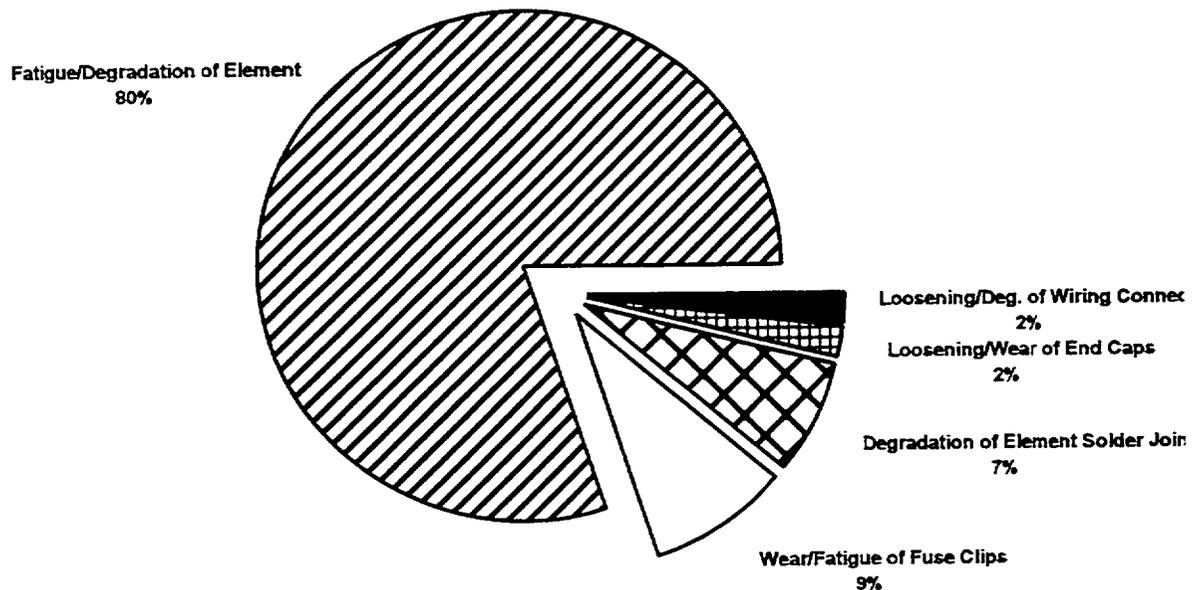
The predominant failure mechanism (80%) was found to be “FATIGUE/ DEGRADATION” of the fusible link, which led to failure of the fuse. Fatigue is typically due to degradation over a period of time from exposure to elevated temperature, voltage transients, or short duration over-current conditions. It can lead to weakening of the fuse element, or a reduction in cross section, which reduces its current carrying capacity. Other less frequent failure mechanisms found were “WEAR/FATIGUE” of the fuse holder clips (9%) or “DEGRADATION” of the end

cap to fuse element solder joint (7%). Fatigue of the fuse holder clips can typically occur due to repeated insertion and removal of the fuses, such as during maintenance or surveillance testing. Degradation of the solder joint was found to occur in several cases due to cold solder joints that degraded during subsequent operation. The remaining failures were due to loosening/degradation of the wiring connections to the fuse holder, and loosening/ wear of the end caps on the fuse itself. The percentage of failures related to each of the failure mechanisms is shown in Figure 6.

Figure 6 Fuse failure mechanisms from LERs

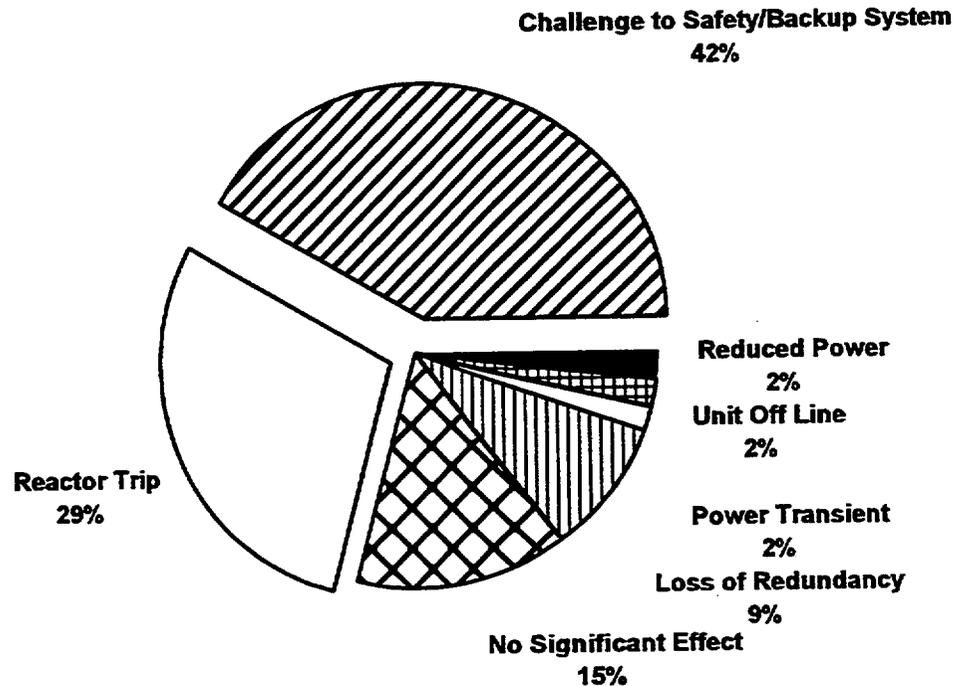
The various effects of the fuse failures on plant performance are shown in Figure 7. The predominant effect (42%) was found to be a challenge to a safety or backup system. This is expected from this database since any actuation of an engineered safety feature is reportable as an LER. Typical examples of these events are the following:

Figure 7 Effect of fuse failures on plant performance from LERs

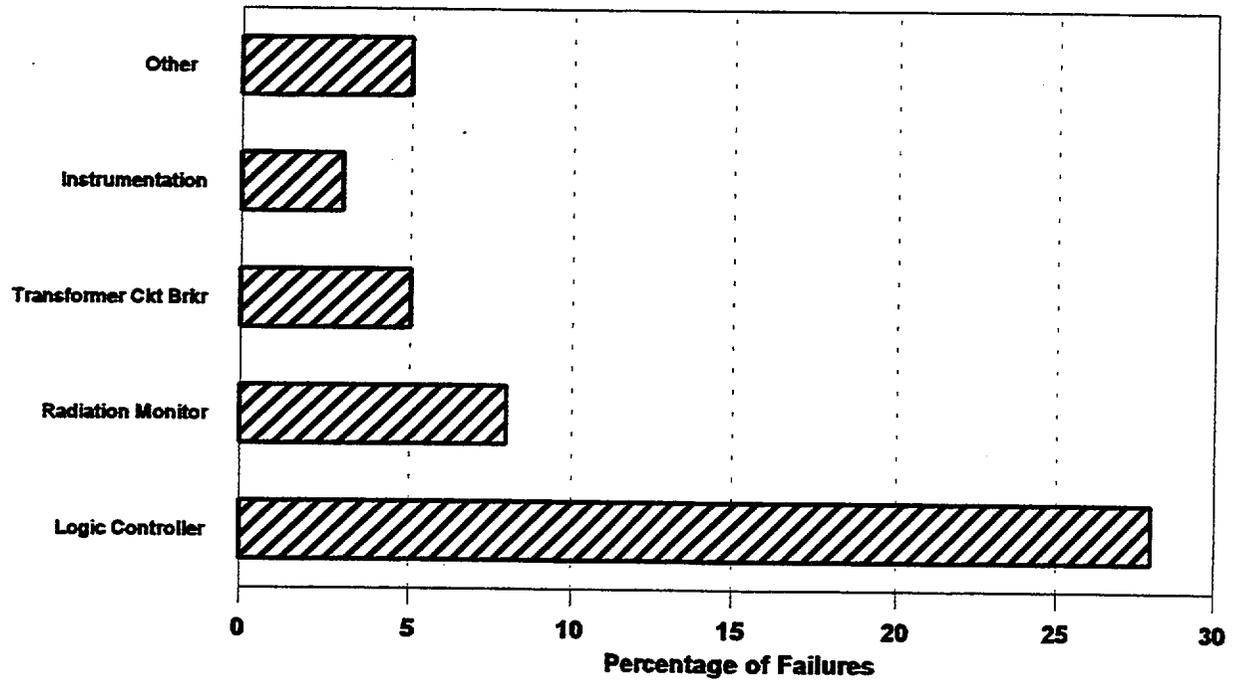
Figure 8 Distribution of applications for failed fuses from LERs

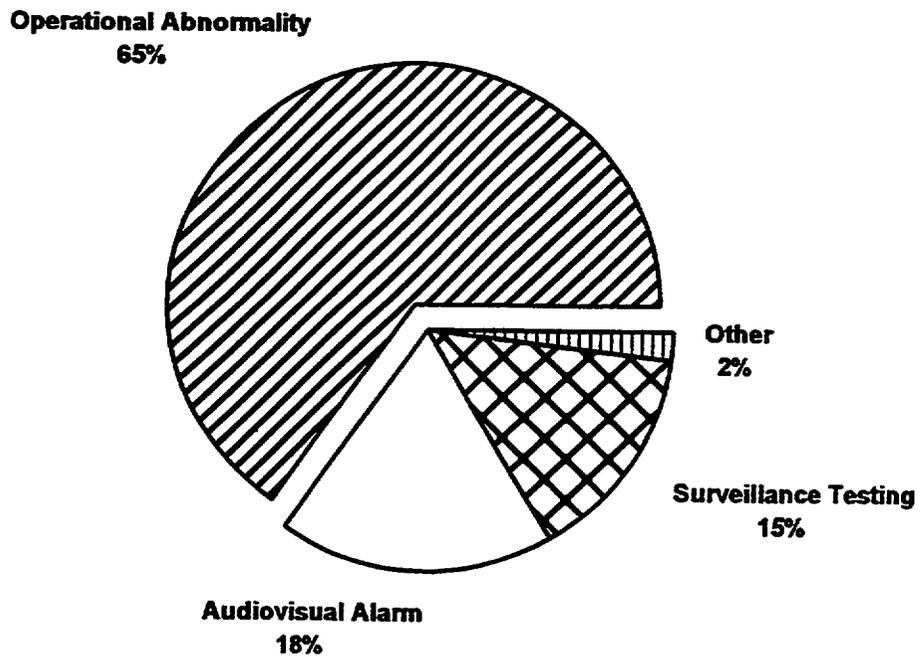
Figure 9 Fuse failure detection methods from LERs

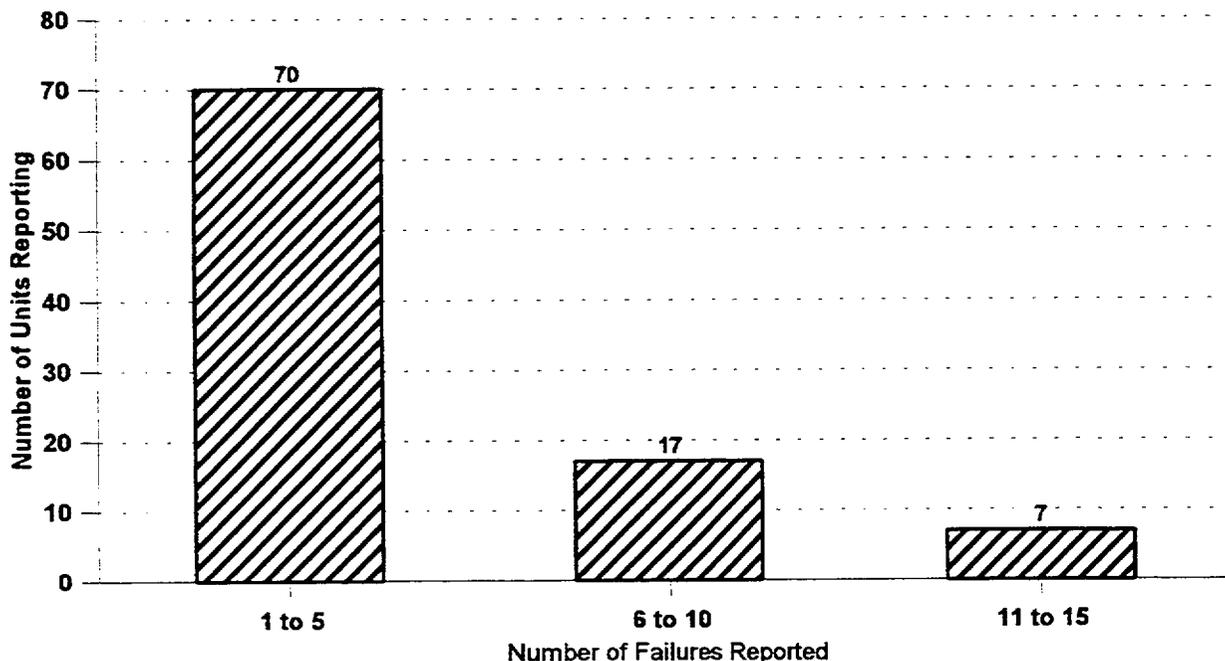
among the failures reported to the NPRDS was relatively low. The failure reports reviewed for this program represented 94 nuclear units. The distribution of age-related failures reported per nuclear unit is shown in Figure 10.

Figure 10 Distribution of age-related fuse failures per unit from NPRDS

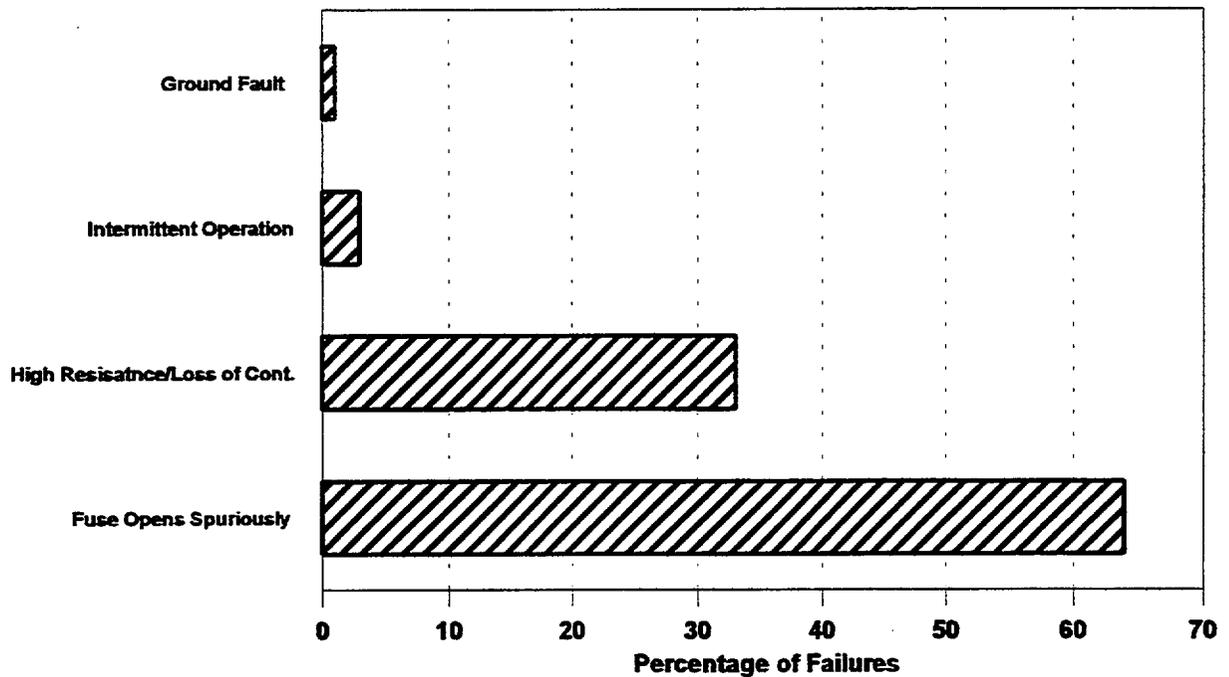
The fuse failures identified as age-related were analyzed to determine the predominant aging characteristics of the failures experienced. Figure 11 shows the distribution of failure modes encountered during the review. As shown, the predominant failure mode experienced (64%) was “FUSE OPENS SPURIOUSLY,” which indicates that the fusible element opened and caused an open circuit when it should not have. The failure mode “HIGH RESISTANCE/LOSS OF CONTINUITY,” which represented 33% of the age-related failures reported, was significant in that it was a failure mode of the fuse holder. These failures typically involved: problems with the fuse being loose in the fuse holder due to weakened, broken, or misaligned clips; degraded or open electrical connection between fuse and holder; degraded or open electrical connection between the fuse holder and its wiring terminations; broken fuse holder parts; and failing to complete the circuit.

A small number of events (2.5%) involved the failure mode “INTERMITTENT OPERATION” of the fuse, which were typically caused by loose fuse holder clips or faulty fuse holder wiring terminations. Finally, less than 1% of the events involved the “GROUND FAULT” failure mode, which was usually caused by dirt or contamination on a high voltage fuse/fuse holder assembly faulting to ground. It should be noted that latter three failure modes, representing more than 35% of the age-related events reviewed, involved failures of the fuse holder assembly and its terminal connections. No events were reviewed involving any of the other potential fuse failure modes identified previously.

Figure 11 Distribution of fuse failure modes from NPRDS

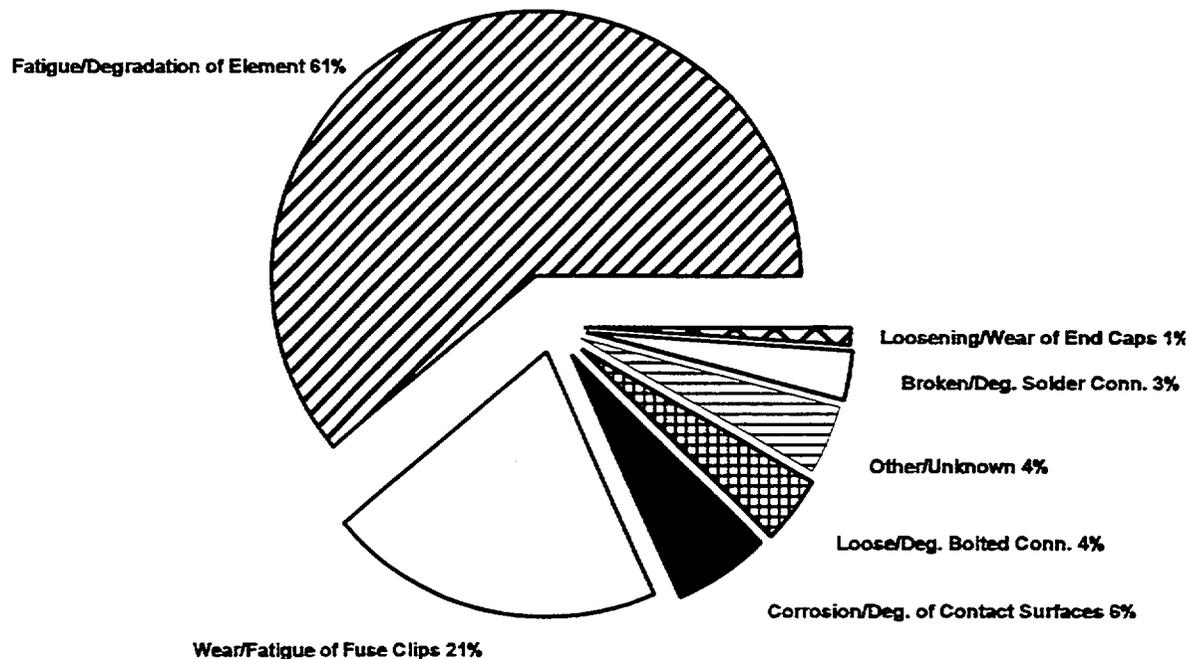
The predominant failure mechanism (61%) was found to be “FATIGUE/DEGRADATION OF ELEMENT,” i.e., of the fusible element or link, which led to unexpected failure of the fuse. This is to be distinguished from the normal opening of the fusible link when the fuse is exposed to overcurrent conditions for a prescribed time. Fatigue is typically due to the degradation of the metallic fuse element over time as a result of exposure to elevated temperature, voltage transients, or short duration overcurrent conditions. It can lead to weakening of the fuse element, or a reduction in cross section, which reduces its current carrying capacity.

A second important failure mechanism was “WEAR/FATIGUE OF FUSE CLIPS” (21%). Fatigue of the fuse holder clips can typically occur due to high temperature, mechanical stress, and repeated insertion and removal of the fuses, such as during maintenance or surveillance testing. Other less frequently cited failure mechanisms found were “CORROSION/DEGRADATION OF CONTACT SURFACES” (6%), loose, broken, or degraded soldered (3%) or bolted/screwed (4%) wiring connections, and “LOOSENING/WEAR OF END CAPS” (1%). The remainder of the failure mechanisms (approximately 4%) included a variety of mechanisms, such as, contamination, moisture intrusion, fatigue or breakage of fuse holder base, or unknown. The percentage of failures related to each of the failure mechanisms is shown in Figure 12.

Figure 12 Fuse failure mechanisms from NPRDS

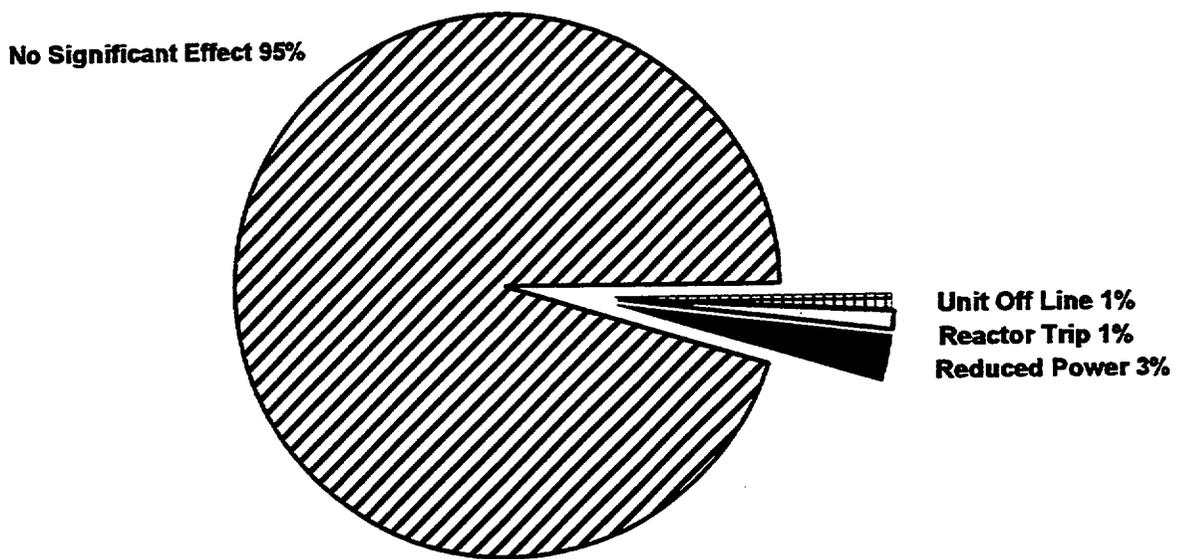
The effects of fuse failures on plant performance are shown on Figure 13. In contrast to the LER data base, which by its nature involves events that have the most serious effects on nuclear plant operation, the NPRDS is a general equipment and component failure data base. Hence, most of the fuse failures reported to NPRDS resulted in "NO SIGNIFICANT EFFECT" (95%) on plant operation. Among the fuse failures reviewed, 3% resulted in "REDUCED POWER" operations, 1% resulted in a "REACTOR TRIP", and 1% resulted in the taking the "UNIT OFF LINE."

Figure 13 Effect of fuse failures on plant performance from NPRDS

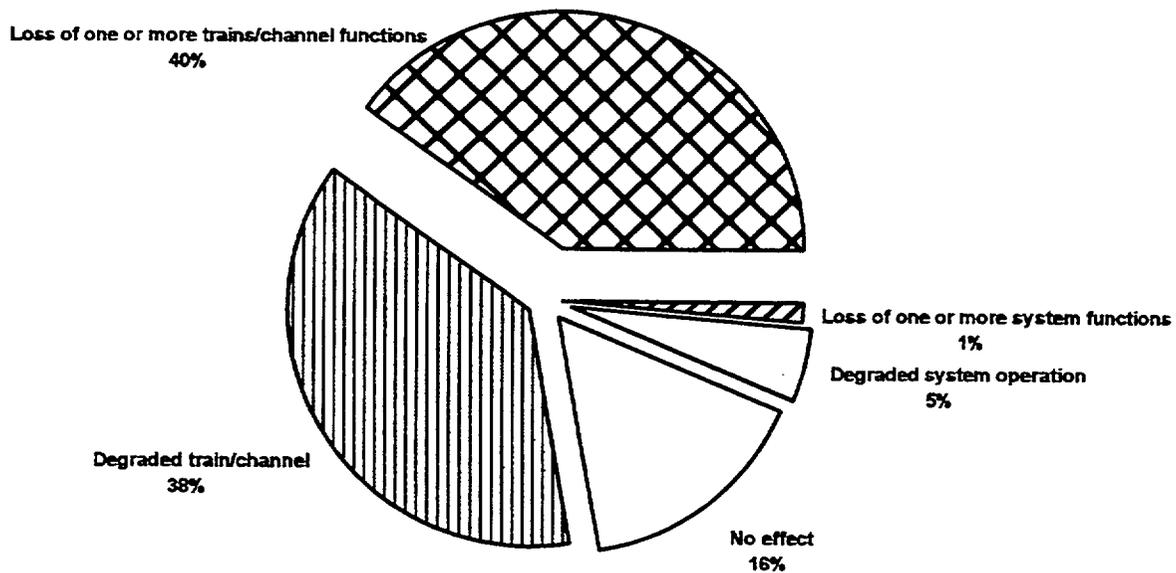
Another measure of the significance of fuse failures can be found by looking at the effect of a fuse failure upon the system in which it is located. This information is included as part of the NPRDS failure report and is shown on Figure 14 for fuse failures. More than three-fourths of the failures result in either "DEGRADED TRAIN/CHANNEL" (38%) or the "LOSS OF ONE OR MORE TRAINS/CHANNEL FUNCTIONS" (40%). Another 5% of the fuse failures caused "DEGRADED SYSTEM OPERATION," and the "LOSS OF ONE OR MORE SYSTEM FUNCTIONS" was reported in 1% of the failures. Finally, in 16% of the fuse failures reported to NPRDS, the plants indicated that there was "NO EFFECT" at all on the system in which the problem was found.

Figure 14 Effect of fuse failures on system performance from NPRDS

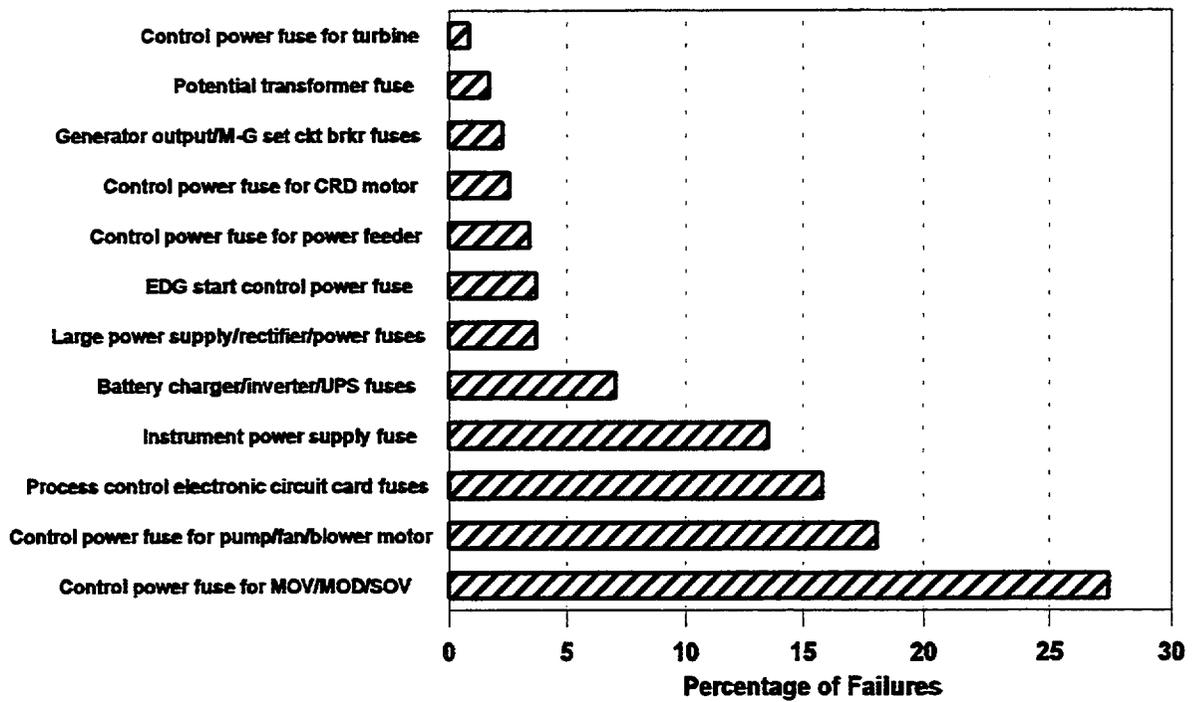
Another important piece of information found in the NPRDS data is the application in which the failed fuse assembly was being used. These data can provide insight into how fuse failures may affect plant operation and safety, and suggest approaches that may be taken to mitigate the effects of fuse failures. The fuse application data are presented in Figure 15. The most common application involved control power fuses for motor operated valves and dampers (23%) or solenoid operated valves (5%). Control power fuses for electric drive motors for pumps, fans, and blowers were involved in 18% of the failure reports. Also significant were

electronic circuit card fuses for process control circuits and systems (16%) and closely related were instrument power supply fuses (14%). Finally, a fairly large number of fuse failures occurred in large power supply/rectifier applications (4%) and in battery chargers/inverters/uninterruptible power supplies (7%). The latter application was the subject of an earlier BNL study on the operating experience and aging-seismic assessment of battery chargers and inverters (reported in NUREG/CR-4564 and NUREG/CR-5051), which included an examination of the fuse failures experienced in this equipment that were potentially the result of elevated operating temperatures.

Figure 15 Distribution of applications for failed fuses reported to NPRDS

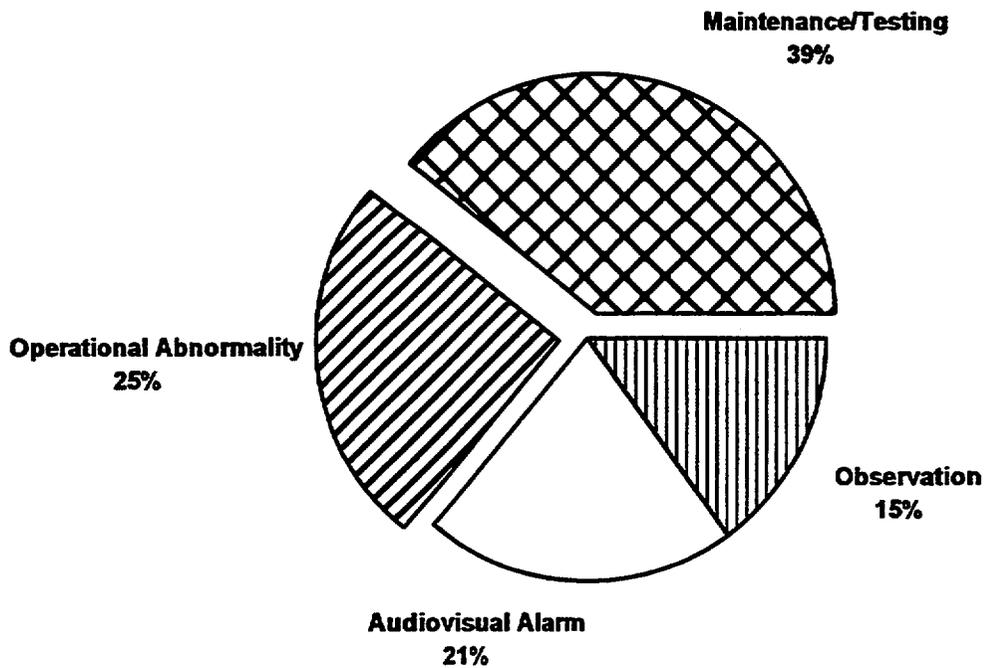
The NPRDS data were also sorted to identify the predominant methods for detection of fuse failures. This information can sometimes show whether the methods and techniques being used to discover degraded or failed fuses are well-matched with the predominant failure mechanisms encountered for this component. The NPRDS failure detection data are shown on Figure 16. The greatest number of fuse failures were detected during "MAINTENANCE" and "TESTING" activities (39%) and by "OBSERVATION" (15%) by plant operating and maintenance personnel. This is significant because it reflects proactive efforts on the part of licensees to find these failures before they can cause more serious problems. Another 25% of the NPRDS failures were detected by "OPERATIONAL ABNORMALITIES." This category would include failures to operate when required, off-normal performance, loss of position

indication, or loss of control power indication. Finally, "AUDIOVISUAL ALARMS" accounted for the detection of 21% of the fuse failures. It should be noted that several NPRDS reports

Figure 16 Fuse failure detection methods from NPRDS

mentioned that imaging infrared thermography surveys were used to identify incipient fuse and fuse holder failures. Licensees are taking advantage of this technology to detect hot spots that could indicate potential fuse assembly failures.

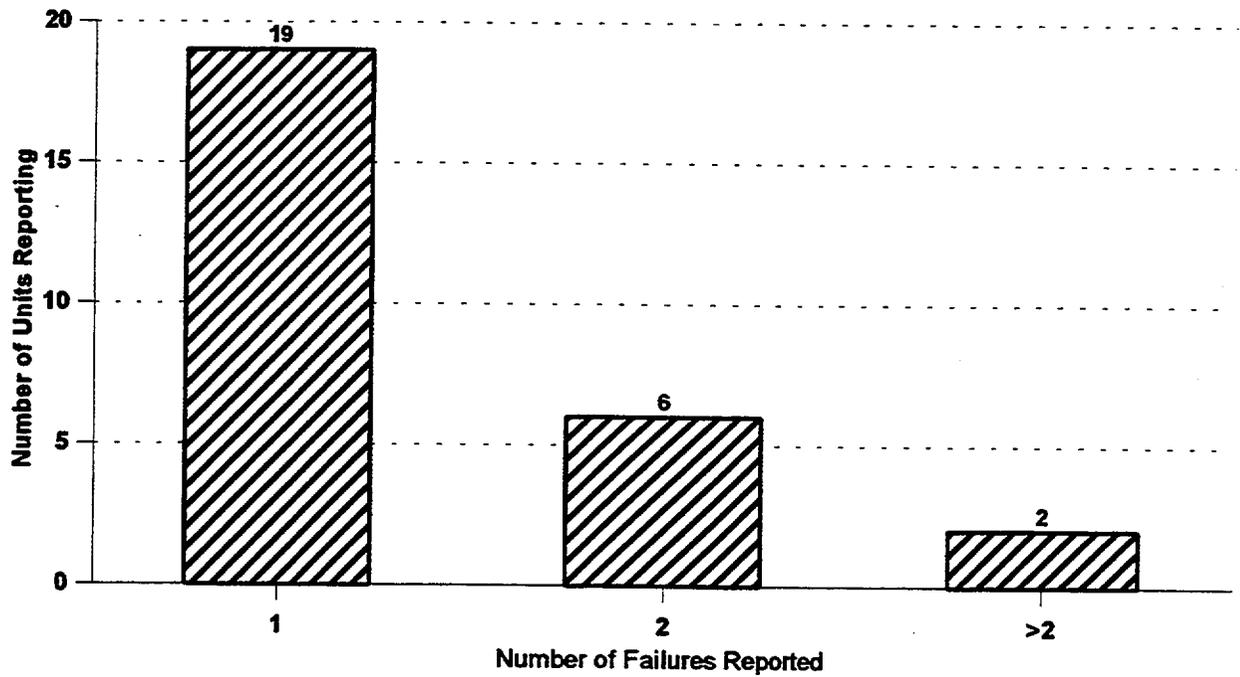
Figure 17 Distribution of age-related fuse failures per unit from EPIX

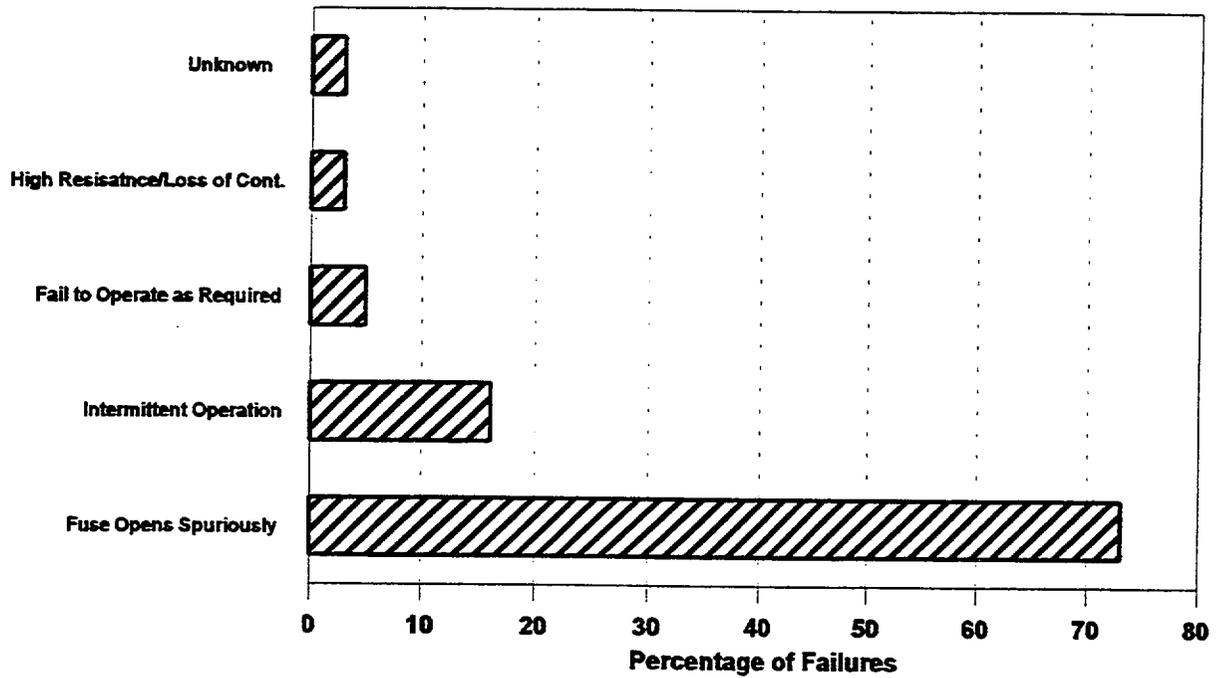
Figure 18 Distribution of fuse failure modes from EPIX

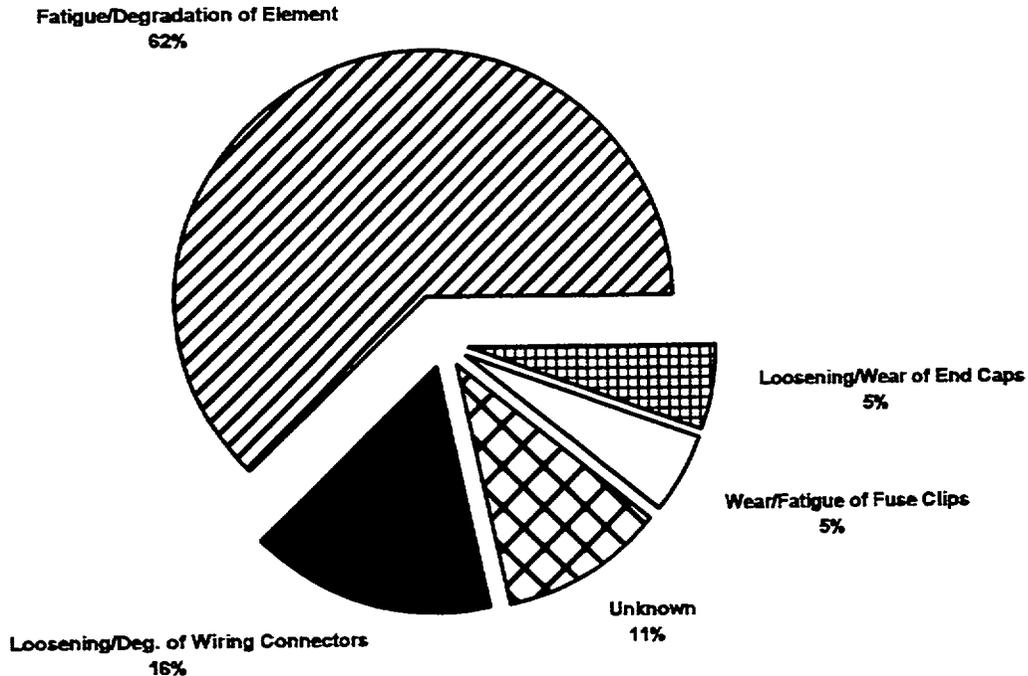
The predominant fuse failure mechanism was "FATIGUE/DEGRADATION OF THE FUSIBLE ELEMENT," which accounted for 62% of the failures. This is consistent with the predominant failure mechanism found in the NPRDS data. Again, for failures attributed to aging in which no information on the failure mechanism was presented in the report, and the fuse is described as "blown," it was assumed for purposes of this evaluation that the mechanism was fatigue of the fusible element. Other less frequently found mechanisms were "LOOSENING/DEGRADATION OF THE WIRING CONNECTIONS" (16%), "MECHANICAL WEAR/FATIGUE OF FUSE HOLDER CLIPS" which caused loosening of the fuse in the fuse holder (5%), and "LOOSENING/ DEGRADATION OF THE FUSE END CAPS" (5%). These results are summarized in Figure 19.

Figure 19 Fuse failure mechanisms from EPIX

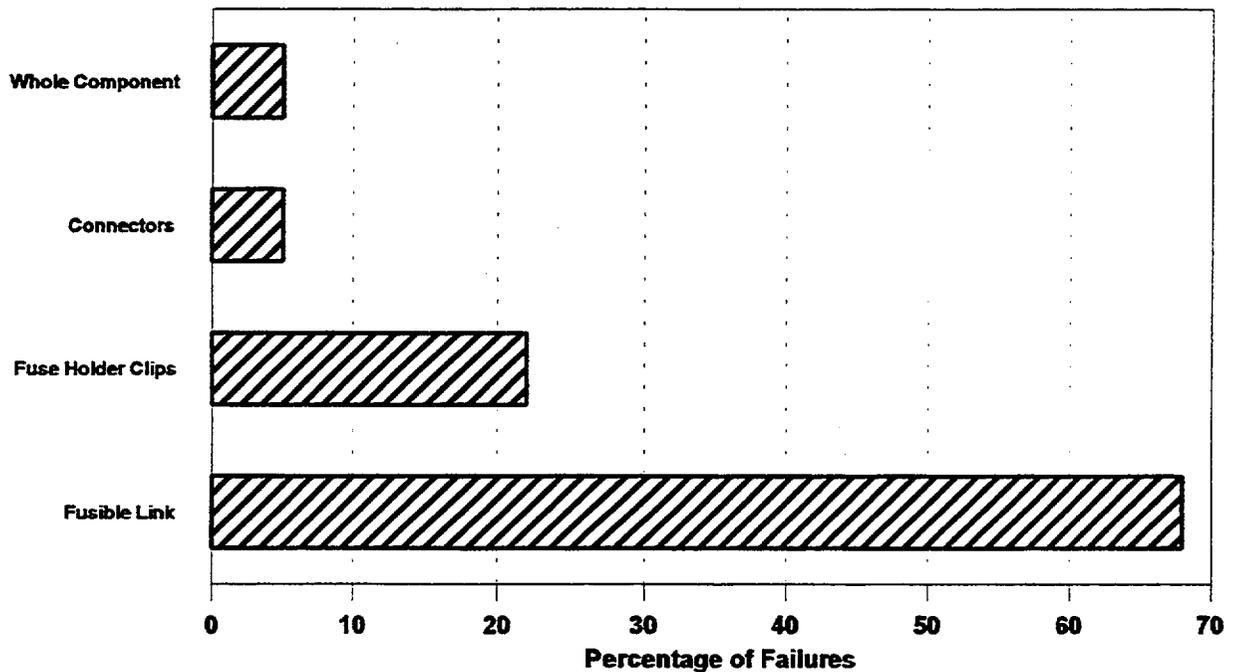
In analyzing the subcomponent that failed in the fuse assembly, the “FUSIBLE LINK” is the major contributor (68% of the total failures). This is followed by the “FUSE HOLDER CLIPS” (22%), which failed as a result of fatigue, wear, and embrittlement. “CONNECTORS” failed 5% of the time and involved disconnection of the connector to the fuse holder and, in one case, fusion of the connector itself. Another 5% of the failures were attributed to the whole fuse assembly, which was deemed to be a generally faulty component. These results are summarized in Figure 20.

Figure 20 Distribution of fuse subcomponents failed from EPIX

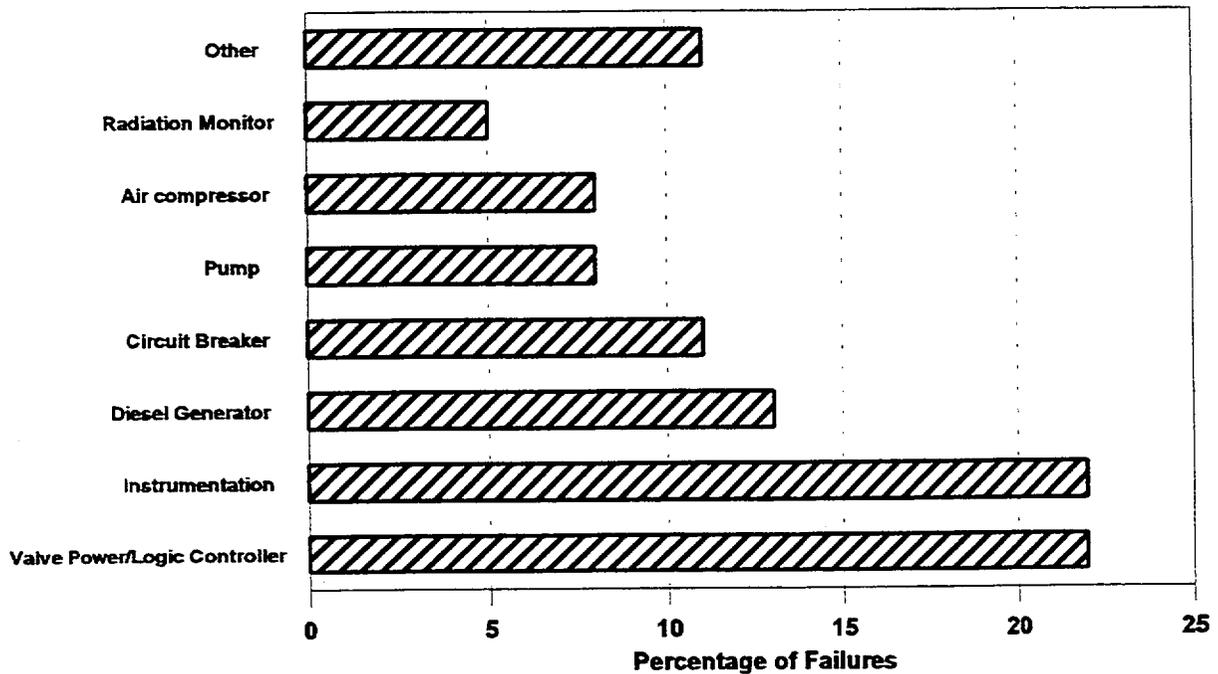
The applications for which fuses failed by age-related mechanisms were analyzed in detail. In 22% of the EPIX listings, fuse failure resulted in the non-operability of valves. These fuses

were either in a logic controller or in a power circuit for the valve. Another 22% of the fuse failures caused failure of instrumentation circuits. The applications for the fuse failures are summarized in Figure 21.

Figure 21 Distribution of applications for failed fuses from EPIX

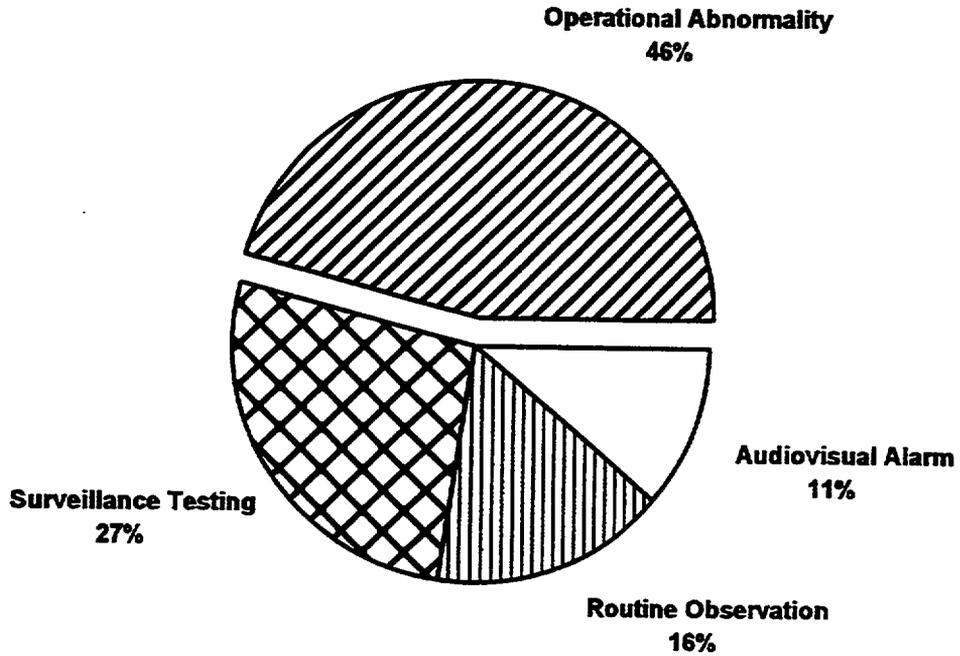
Figure 22 shows the fuse failure detection methods that were identified from the EPIX system data. “OPERATIONAL ABNORMALITIES” detected 46% of the fuse failures, and a large fraction of failures were detected by “SURVEILLANCE TESTING” (27%). “ROUTINE OBSERVATION” (16%) and “AUDIOVISUAL ALARMS” (11%) were the remaining detection methods.

Figure 22 Fuse failure detection methods from EPIX

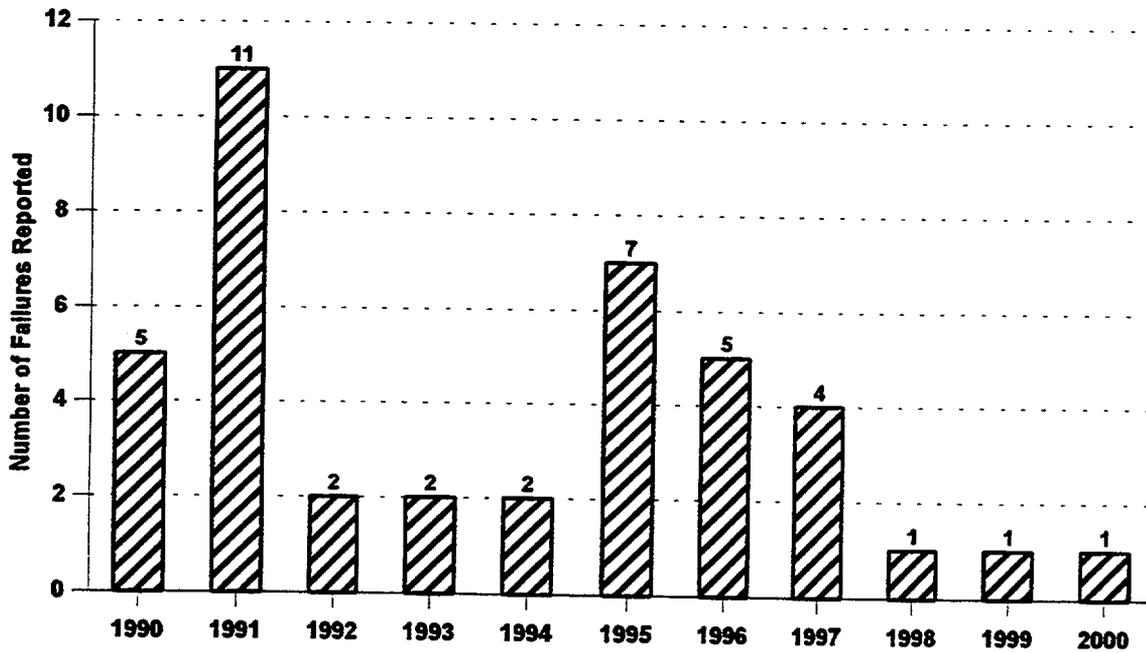
The LER data were sorted to obtain fuse failures per year over the past ten years. If the number of fuse failures per year was increasing, this could indicate a potential problem with management of fuse aging. However, the results presented in Figure 23 show no discernible trend in the number of reported fuse failures. The relatively large number of fuse failures reported in 1991 is followed by a decline in 1992. This could reflect the increased attention to fuse control programs suggested in NRC Information Notice 91-51. At that time, a number of

Figure 23 Number of age-related fuse failures reported per year as LERs

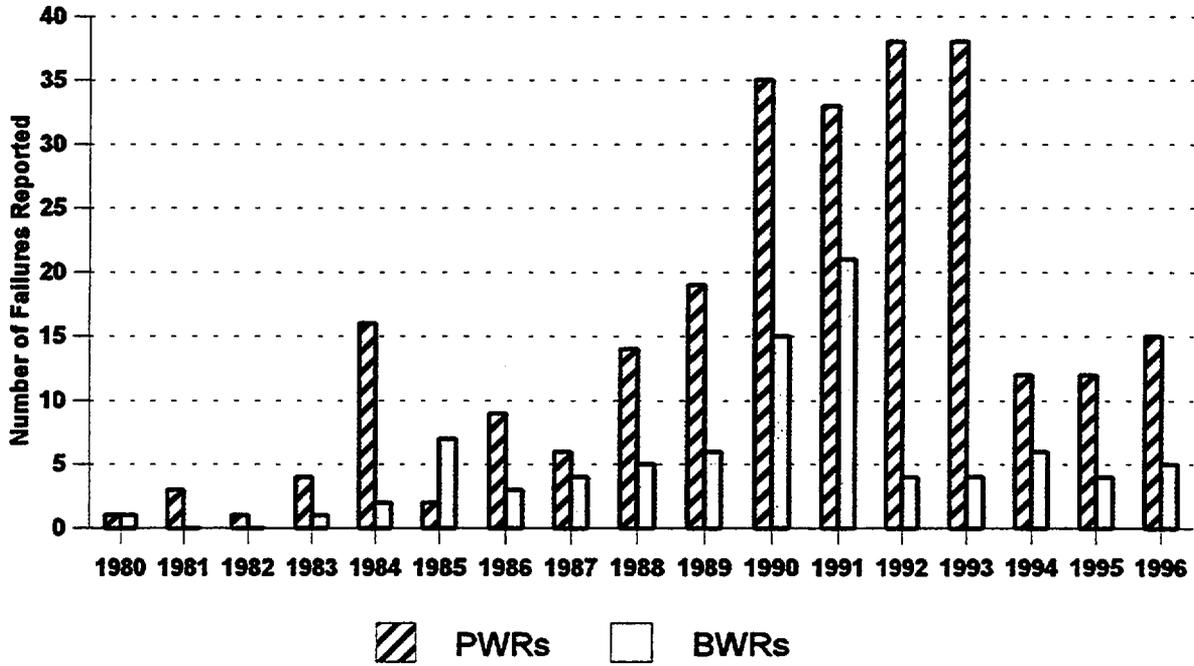
Figure 24 also shows a large number of fuse failures reported at PWRs in 1992 and 1993, and generally, after that time, a greater number of fuse failures than for BWRs. Since the total quantity of fuse failures reported in any given year would depend on the number of nuclear units that were operating during that year, the data were normalized by dividing the annual failure totals by the number of operating nuclear units in each year. The resulting plot of fuse failures per unit year showed that the rate of age-related fuse failures was nearly the same for BWRs and PWRs throughout the period except for the years 1991 and 1992, where the rate was more than double for PWRs. To examine this more closely, the data for PWRs was sorted by nuclear steam supply system (NSSS) vendor, and normalized by dividing the annual totals by the number of operating nuclear units in each year. The results of this analysis are presented in Figure 25.

Figure 24 Number of age-related fuse failures reported per year to NPRDS

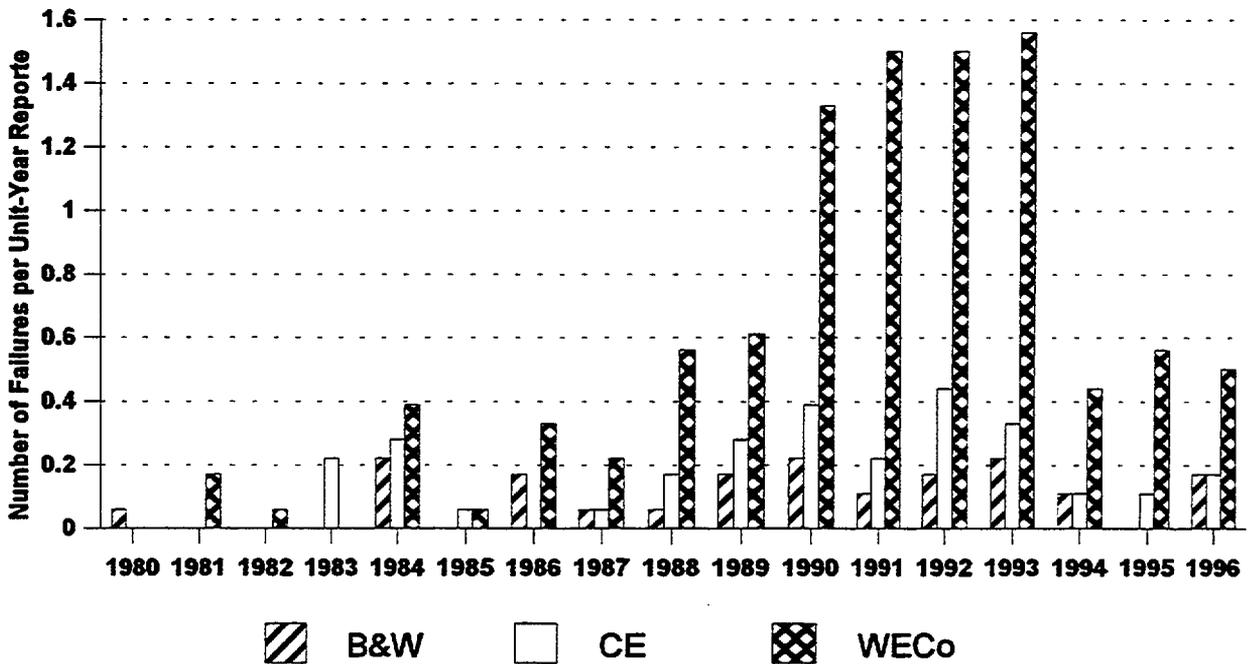
Figure 25 Number of age-related fuse failures per unit-year for PWRs reported to NPRDS

Figure 25 indicates that Westinghouse (WEC) PWRs had a higher rate of age-related fuse failures per unit year than the Combustion Engineering (CE) and Babcock & Wilcox (B&W) reactors throughout the period shown. During the years 1990 through 1993, the rate for Westinghouse reactors was more than four times that reported at the CE and B&W PWRs. Some of this difference may be attributed to the heightened awareness for fuse maintenance and inspection following IN 91-51 on fuse control programs. More likely, problems with incorrectly sized fuses in Westinghouse System 7300 printed circuit cards, as reported in NRC IN 93-87, contributed to the higher rate of age-related fuse failures per unit year. This is supported by the data which show that more than one third of the fuse failures reported in the years 1991-93 were in applications involving the process control system circuit cards or their power supply cards. From 1994 on, the number of failures per unit year for the Westinghouse plants dropped dramatically, however it still remained higher than for the CE and B&W units.
