Aging Assessment of Safety-Related Fuses Used in Low- and Medium-Voltage Applications in Nuclear Power Plants

**U.S. Nuclear Regulatory Commission
Office of Nuclear Reactor Regulation
Washington, DC 20555-0001**

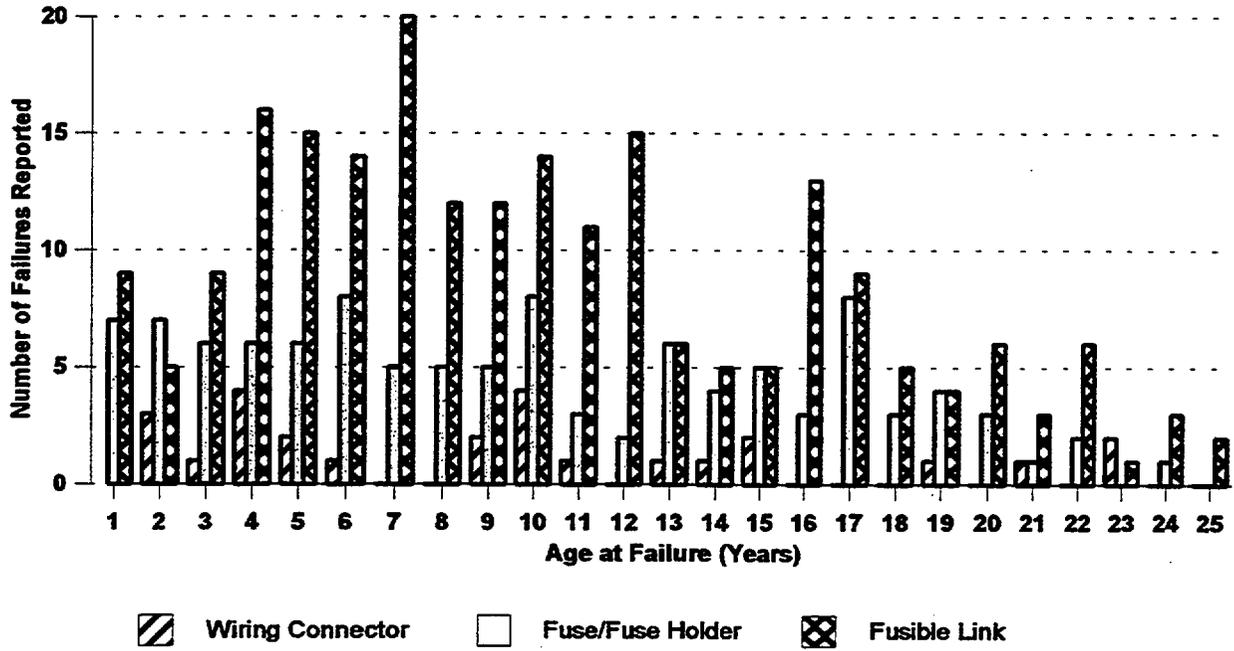
Figure 26 Number of age-related fuse failures grouped by major subcomponent reported to NPRDS

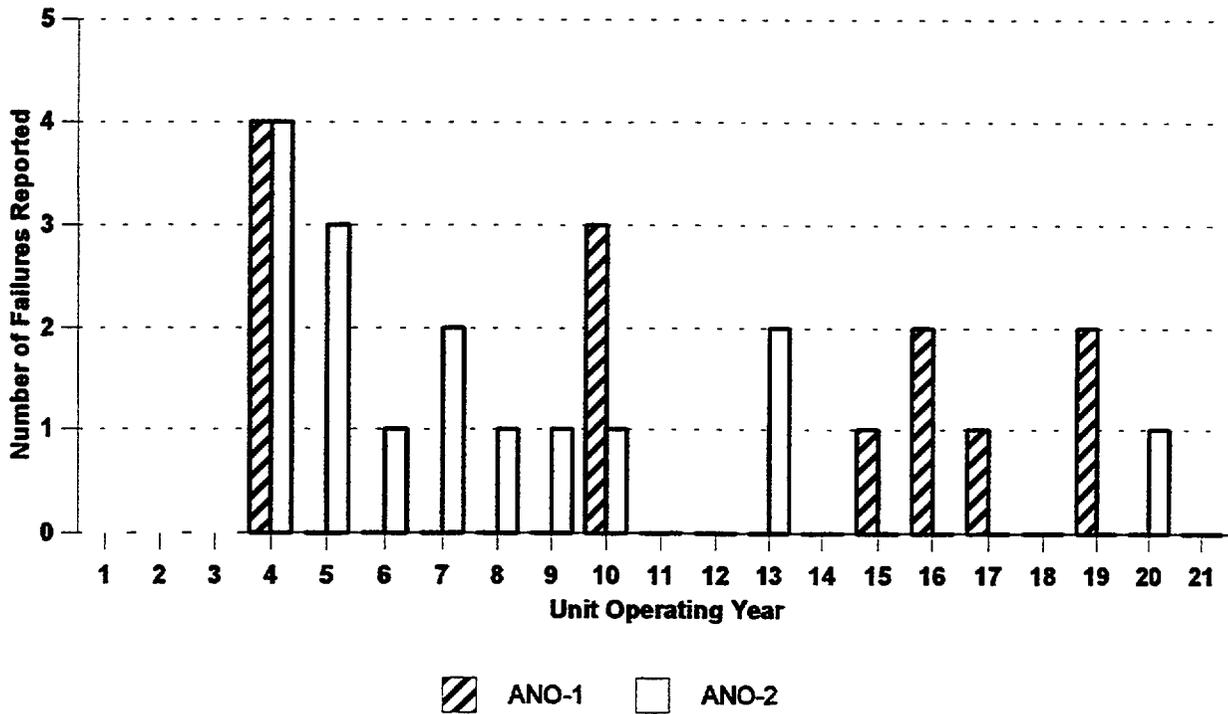
Another approach to searching for trends in the fuse failures data base was to look at all of the failures for a particular plant over an extended period of time. This was done for the Arkansas Nuclear One (ANO) plant for the period from 1980 through 1996 using the NPRDS database, and from 1997 to 2000 using the EPIX database. Since there are two nuclear units at this plant, a greater population of fuses could be examined in which the policies and procedures with regard to fuses would be similar. This review included nine age-related failures from ANO Unit 1 (out of 29 NPRDS reports reviewed), 15 age-related failures from ANO Unit 2 (out of 23 NPRDS reports reviewed), and one age-related failure from each unit from the EPIX data base. The age-related failures from the NPRDS and EPIX reviews were then grouped by the unit year of commercial operation (rather than by calendar year) in order to place the data from the two nuclear units on a comparable time scale. These resulting groupings are plotted on Figure 27.

Figure 27 Age-related fuse failures at ANO 1 & 2 grouped by unit year - NPRDS & EPIX

From Figure 27 it can be seen that most of the failures for ANO Unit 2 occurred during the early years of the plant operation, during the fourth through the tenth years of operation. There were four age-related fuse failures at ANO Unit 2, occurring in four different systems, in the fourth year of operation. As seen in the figure, the number of failures at Unit 2 per unit year decreased over the next few years to the point where only sporadic fuse problems were reported after the tenth year of operation. One fuse failure in the fifth year of operation at Unit 2 occurred in a control power fuse to a control element assembly (reactor control rod drive) and resulted in a reactor trip.

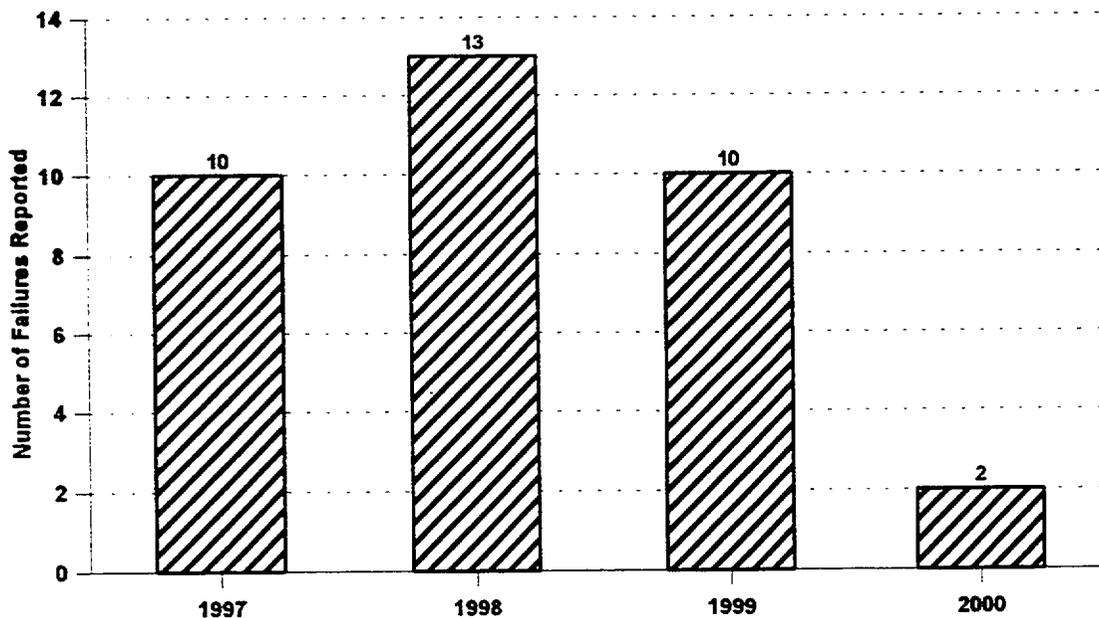
Fuse failures by year, as reported to the EPIX system are given in Figure 28. Since the EPIX system was initiated in 1997 to replace the NPRDS database, it contained only four years of operating experience. Therefore, extracting insights by trending this data is somewhat uncertain at the time this analysis was performed. Nevertheless, the data were evaluated for completeness. As shown, in the years 1997, 1998, and 1999, the number of age-related fuse failures was relatively constant, and no discernable trends are evident. In the year 2000, only two fuse failures occurred, which may be due to incomplete data entry into the database at the time of this study. The current year 2001 is not included in this evaluation since it is a partial year.

Figure 28 Number of age-related fuse failures reported per year to EPIX

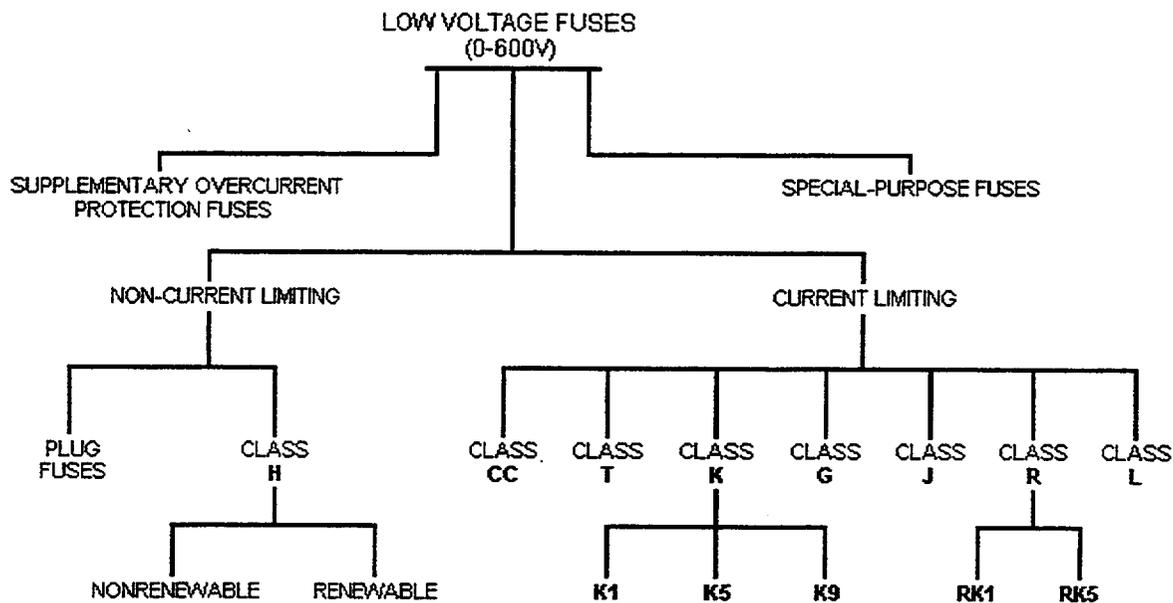
The National Electrical Manufacturers Association (NEMA) and the Underwriters Laboratories (UL) have set standards that govern the manufacture, performance, size, and testing of fuses. Most fuse types are labeled and identified by their UL classification which are summarized in Figure A-1. The most common classes of fuses for nuclear power plant applications are discussed in the following paragraphs.

Figure A-1 Underwriters Laboratories, Inc. fuse classifications
