H. B. ROBINSON STEAM ELECTRIC PLANT, UNIT NO. 2  
 DOCKET NO. 50-261/LICENSE NO. DPR-23

REVISED RELIEF REQUEST NO. 18 REGARDING EXAMINATION OF  
 THE REACTOR PRESSURE VESSEL HEAD PENETRATION CANOPY SEAL  
 WELD REPAIRS FOR THE FOURTH TEN-YEAR INSERVICE INSPECTION INTERVAL

## H. B. ROBINSON STEAM ELECTRIC PLANT, UNIT NO. 2

### 10 CFR 50.55a RELIEF REQUEST NO. 18

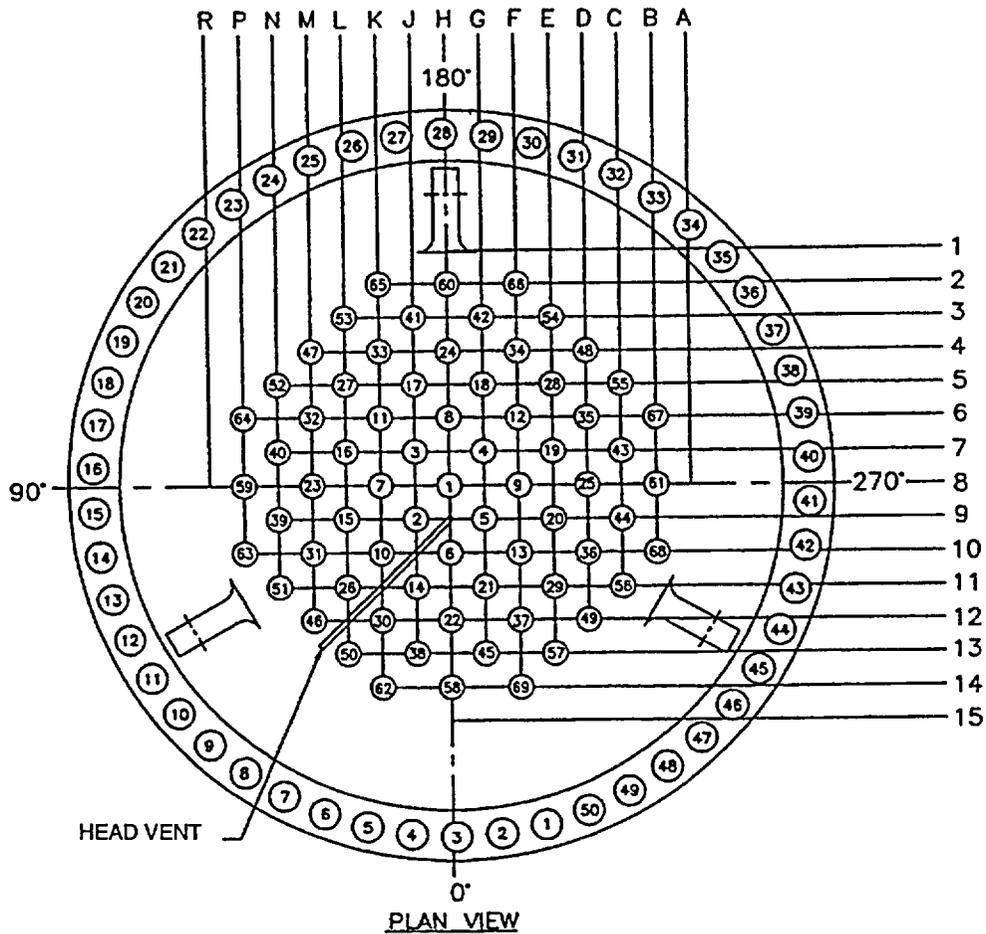
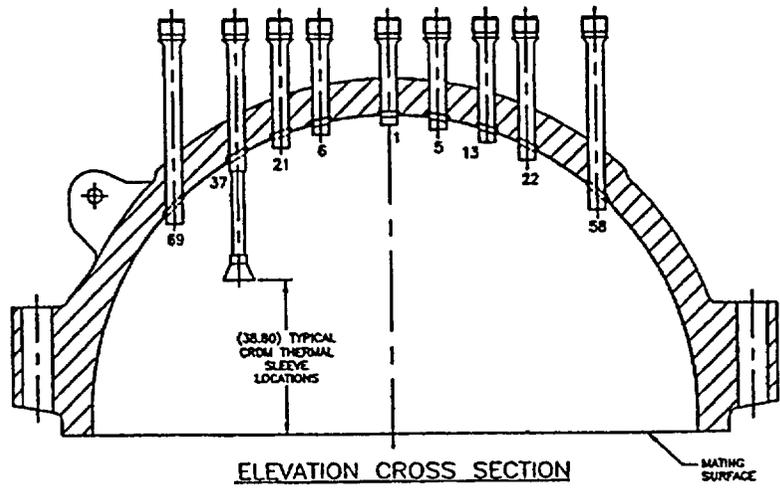
**FIGURE 1. HBRSEP, UNIT NO. 2, REACTOR PRESSURE VESSEL HEAD PENETRATIONS**

NOTE. PENETRATIONS DEPICTED IN CROSS SECTION ARE REPRESENTATIVE OF DIFFERENT RADIAL LOCATIONS

The components applicable to this relief request are the H. B. Robinson Steam Electric Plant (HBRSEP), Unit No. 2, reactor pressure vessel head penetration canopy seal welds for penetration numbers 10, 14, and 30 (see Figure 1). The reactor pressure vessel head penetrations are American Society of Mechanical Engineers (ASME) Code Class 1 attachments to the HBRSEP, Unit No. 2, reactor pressure vessel. The reactor pressure vessel head penetration tube and associated attachment are the pressure-retaining components. The threaded connection between these two components carries the structural loads and establishes the pressure boundary. Any leakage through the threaded connection is normally contained by the canopy seal weld (see Figure 2). The canopy seal welds are nonstructural.
