**SUBJECT: Fort Calhoun Station (FCS) Steam Generator Eddy Current Test Report - 2002 Refueling Outage**

## **FORT CALHOUN STATION STEAM GENERATOR EDDY CURRENT TEST REPORT**

**2002 REFUELING OUTAGE**

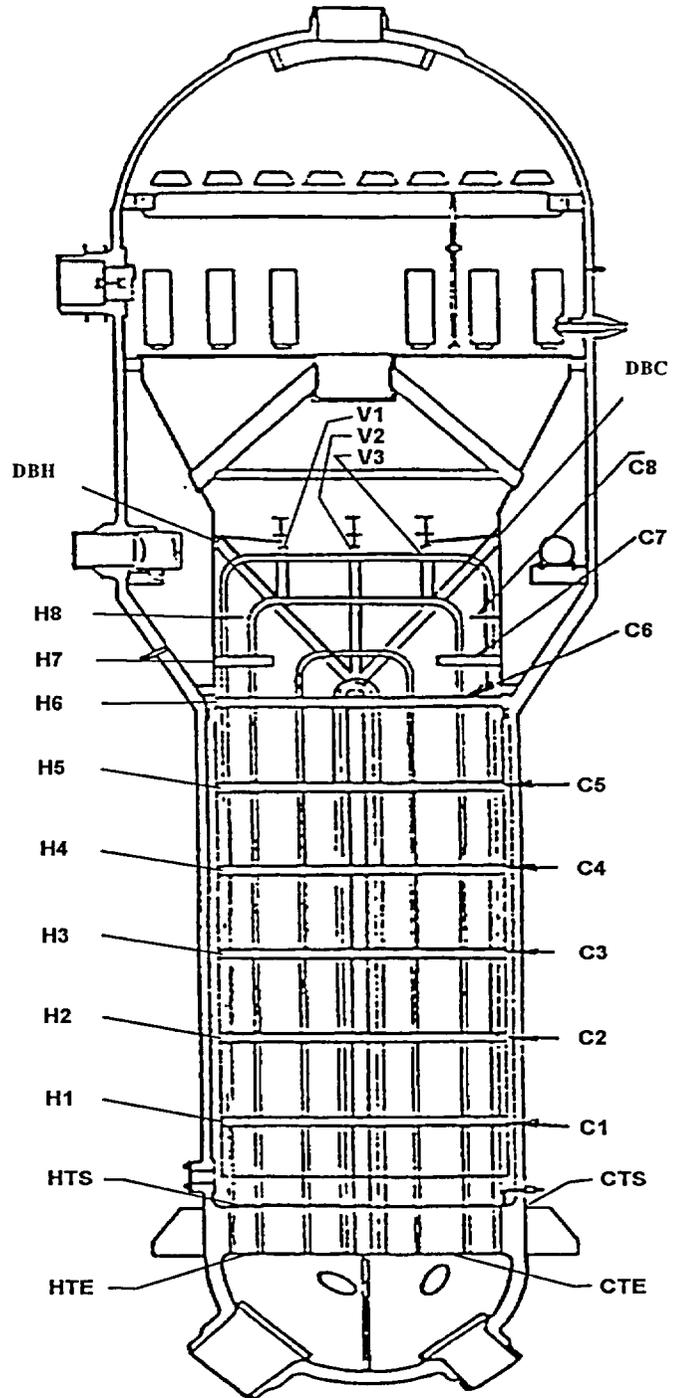
**FIGURE 1**  
**FCS STEAM GENERATOR ELEVATION DRAWING**

All tube supports in the FCS steam generators are carbon steel. The vertical supports at the top of the tube bundle are of the vertical strap/scallop bar design typical of early CE steam generators. Support is provided in the U-bend region by diagonal bars, or "batwings", also a common CE design. The uppermost horizontal support is a partial drilled plate which supports all tubes in rows 74 and above. The remaining horizontal supports are of the egg crate lattice type which have drilled tube support plates integrated into the egg crates on both the hot and the cold leg sides at each elevation. Approximately 975 tubes pass through at least one drilled plate, and several hundred tubes pass through all of the drilled plates. The solid drilled plates also have  $\frac{1}{4}$  inch diameter flow holes nominally in the center of each triangular array of three tubes.

FCS steam generator support notations referenced throughout this report can be found on Figure 1.

- HTE Hot Leg Tube End
- HTS Hot Leg Tubesheet
- H1-H6 Hot Leg Full Supports
- H7 Hot Leg Partial Egg Crate
- H8 Hot Leg Partial Drilled Support
- DBH Diagonal Bar Hot Leg
- V1-V3 Vertical Supports
- DBC Diagonal Bar Cold Leg
- C8 Cold Leg Partial Drilled Support
- C7 Cold Leg Partial Egg Crate
- C1-C6 Cold Leg Full Supports
- CTS Cold Leg Tubesheet
- CTE Cold Leg Tube End

The numbers and locations of each type of indication found are summarized in Tables 1 and 2. Support notations are shown on Figure 1 and definitions of indication acronyms can be found in the Appendix.

All pluggable indications are reported in Tables 3 and 4. Support notation for each steam generator is shown in Figure 1. Depth estimates were made only on pluggable indications for the purpose of providing input to assessments of overall steam generator condition. No tubes were left in service on the basis of sizing.
