WCAP-15987-NP
Revision 2

May 2003

Technical Basis for the Embedded Flaw Process for Repair of Reactor Vessel Head Penetrations

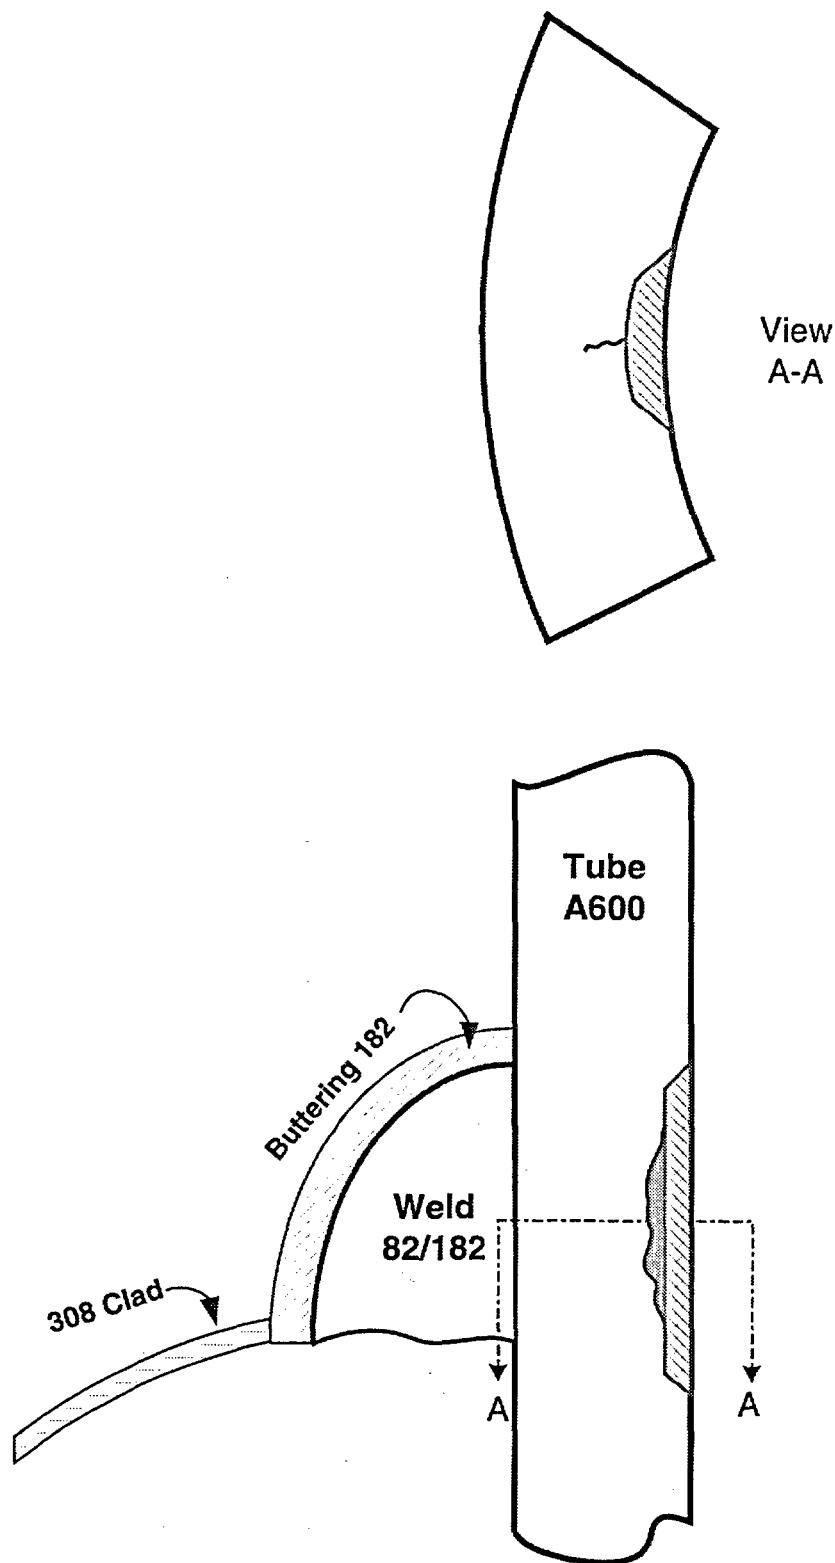
Figure 1-1 Application of the Embedded Flaw Repair to a Flaw in the Head Penetration Tube Inside Surface

The embedded flaw repair for a head penetration is shown schematically in Figure 1-1. Notice that the inside diameter must be maintained after repair to allow for travel of the CRDMs or CEDMs.

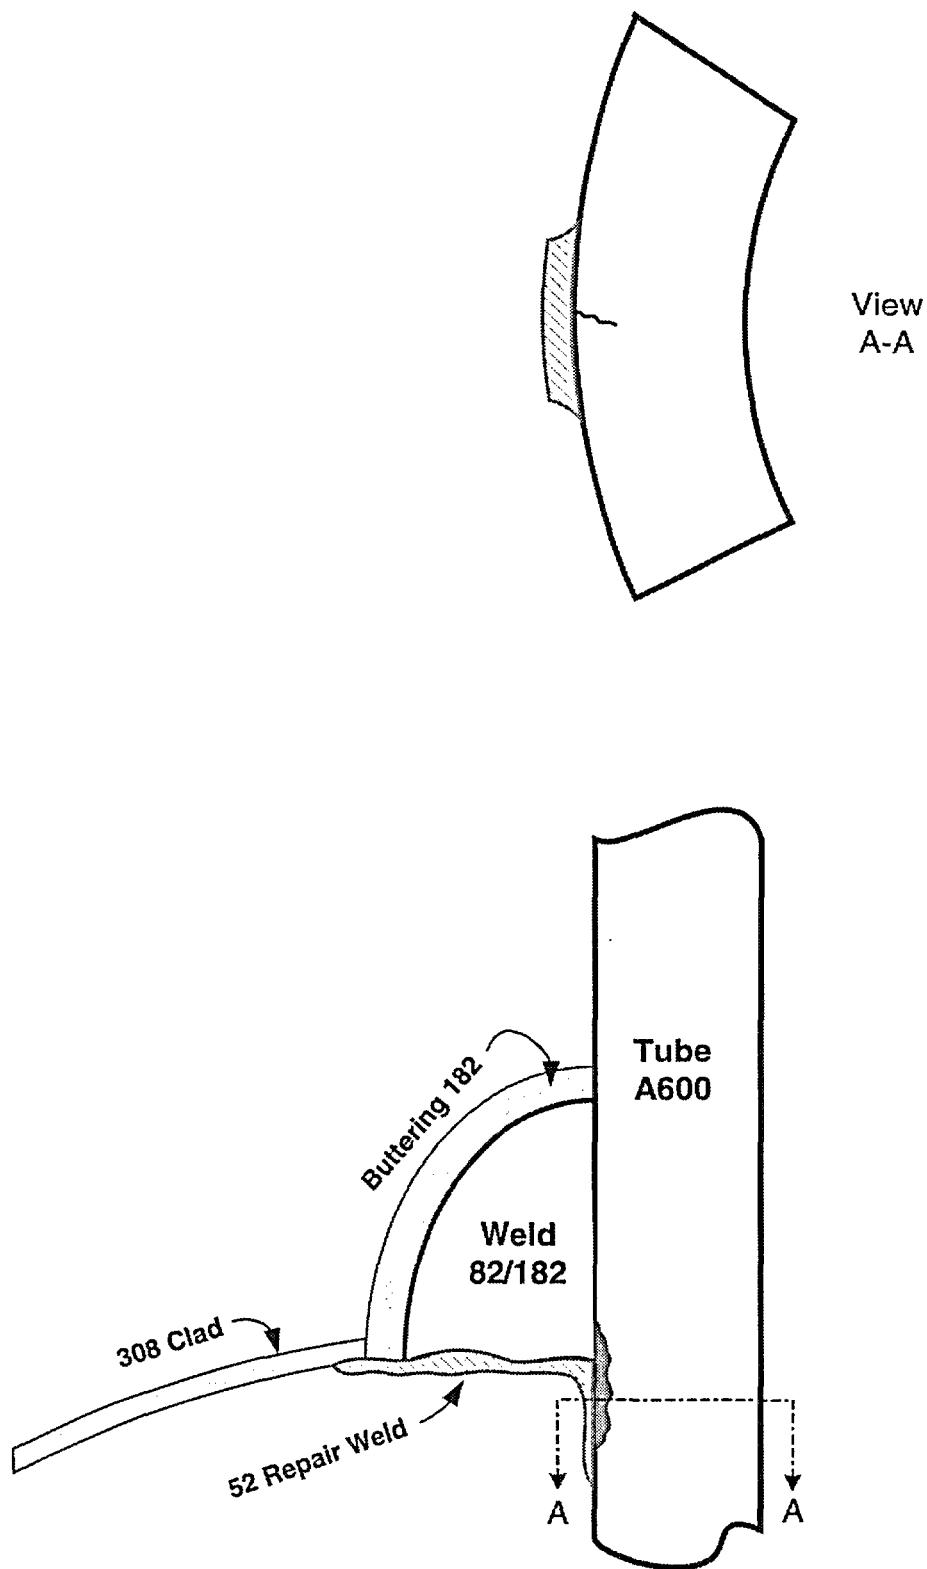
Figure 1-2 Application of the Embedded Flaw Repair to a Flaw in the Head Penetration Tube Outside Surface, or to a Flaw in the Attachment Weld (J-Weld)

The repair for a J-weld is shown schematically in Figure 1-2, where it can be seen that no excavation is required in this case. The extent of the repair weld is such that the entire Alloy 182/82 weld is covered, as will be discussed in Section 2 of the report.

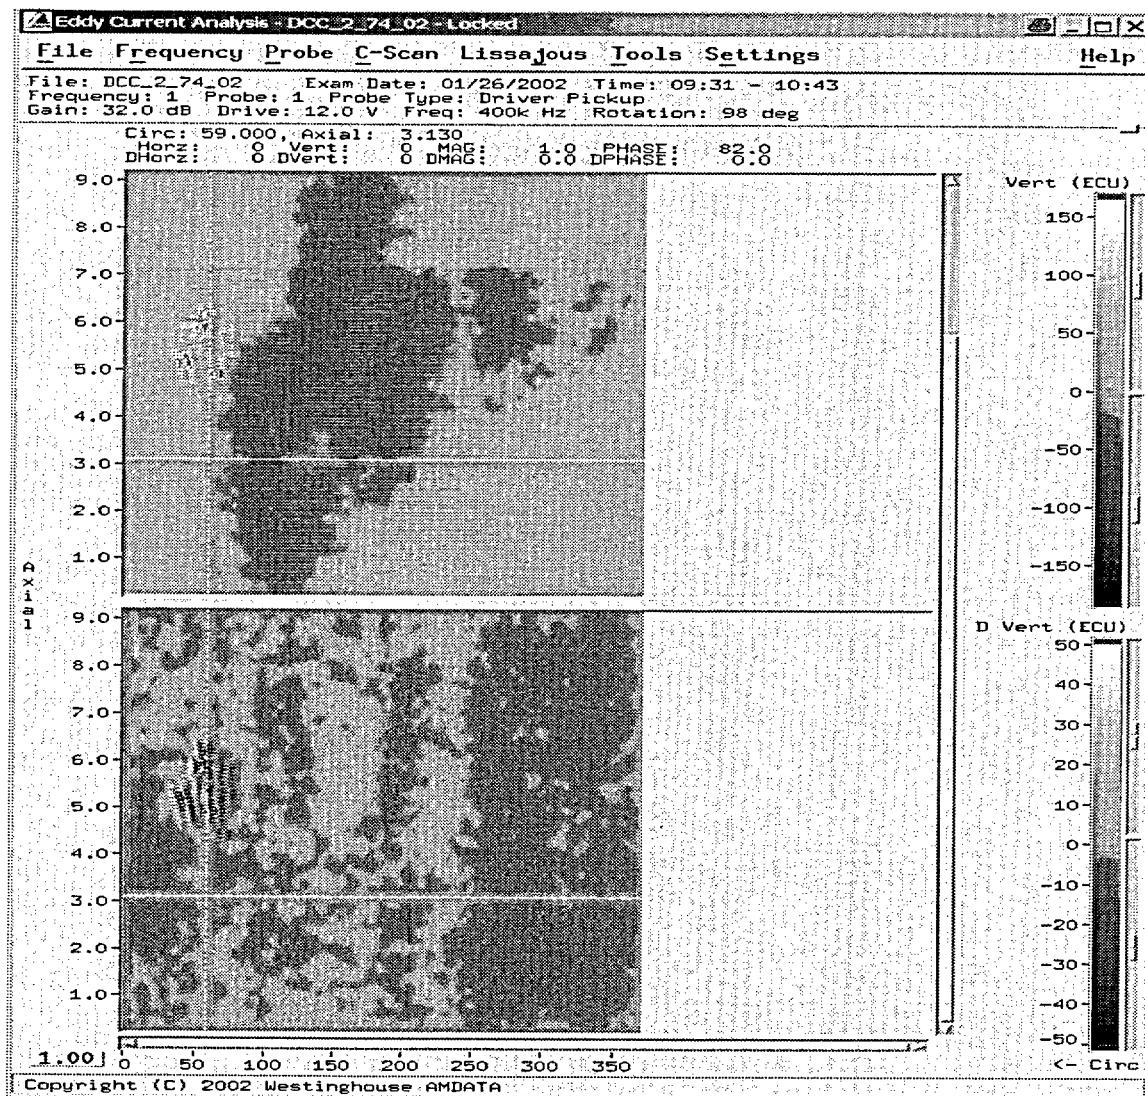
Figure 4-1 ECT View of Craze Cracking

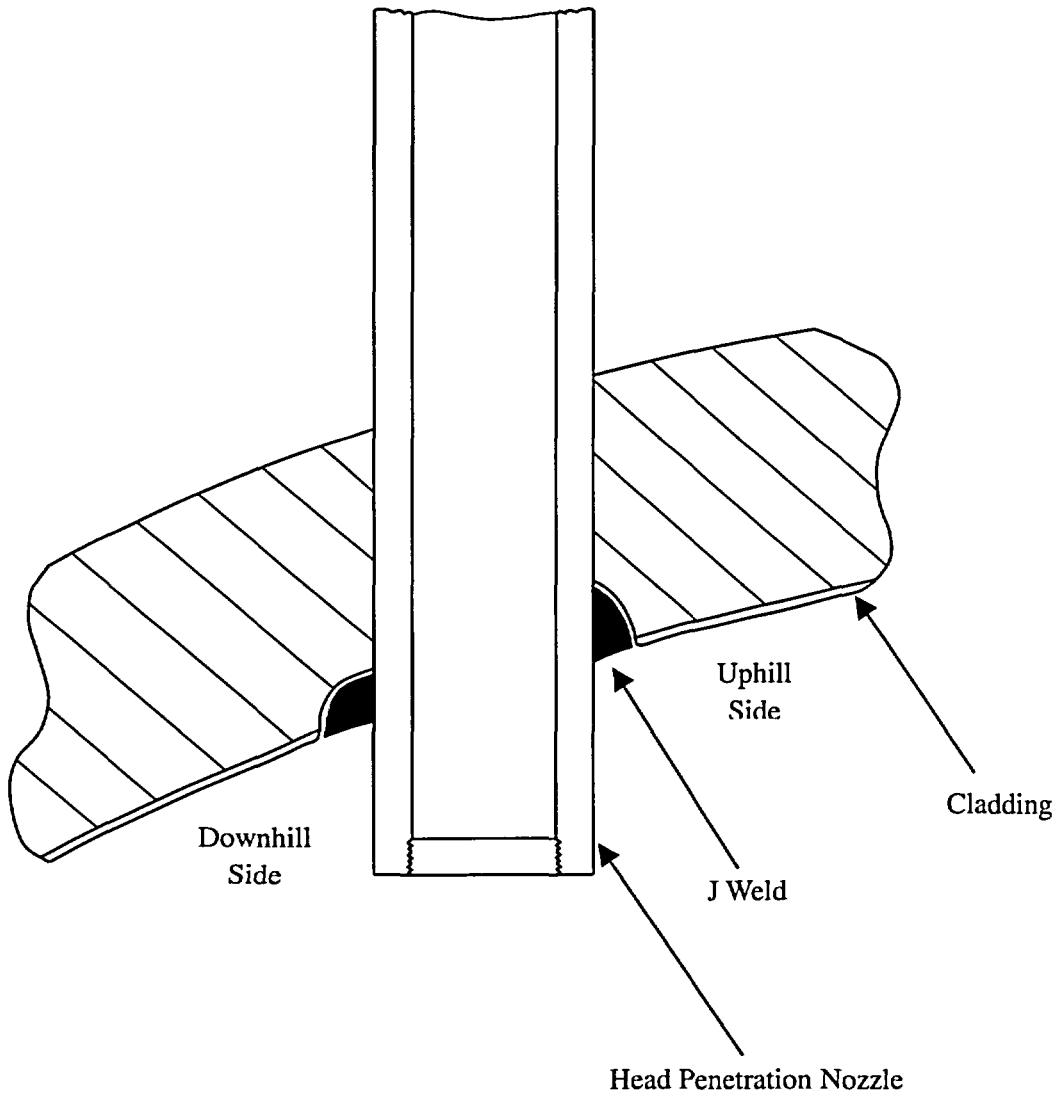
Figure C.1-1 Typical Configuration of a Vessel Head Penetration Nozzle

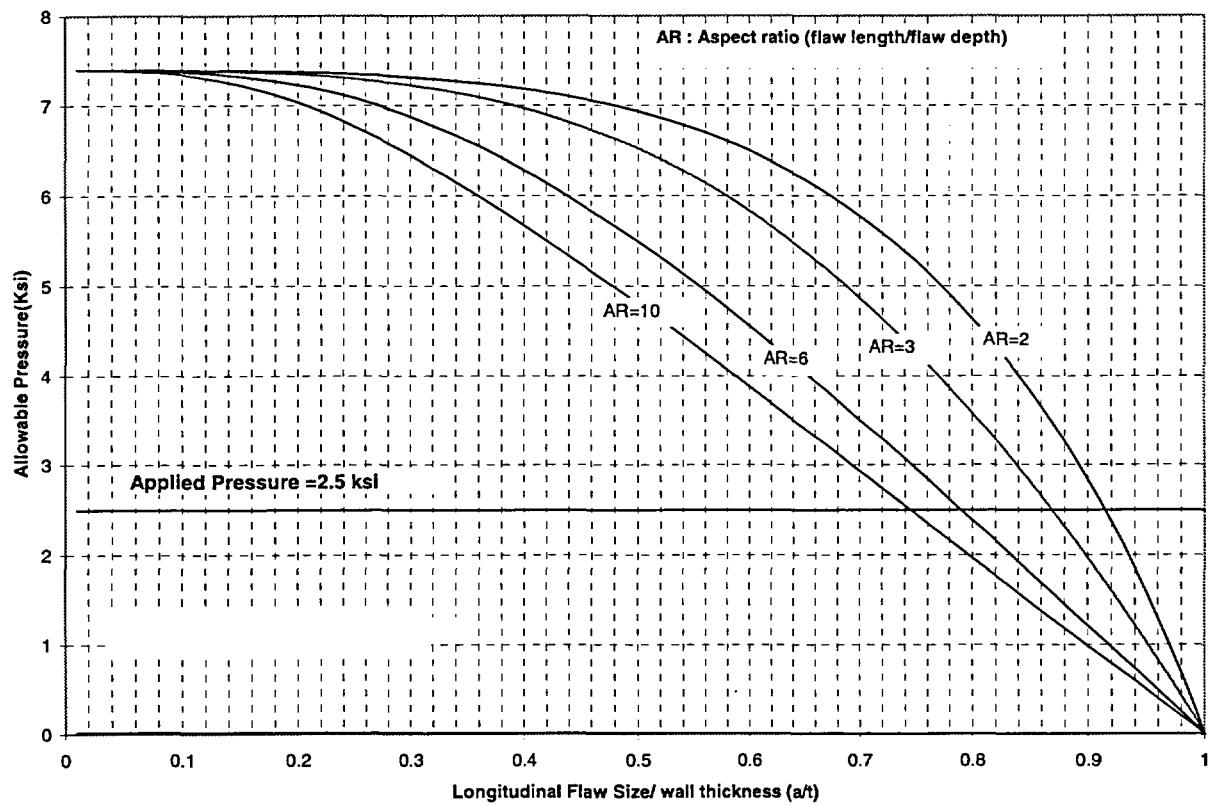
Figure C.2-2 Determination of Allowable Axial Flaw Sizes

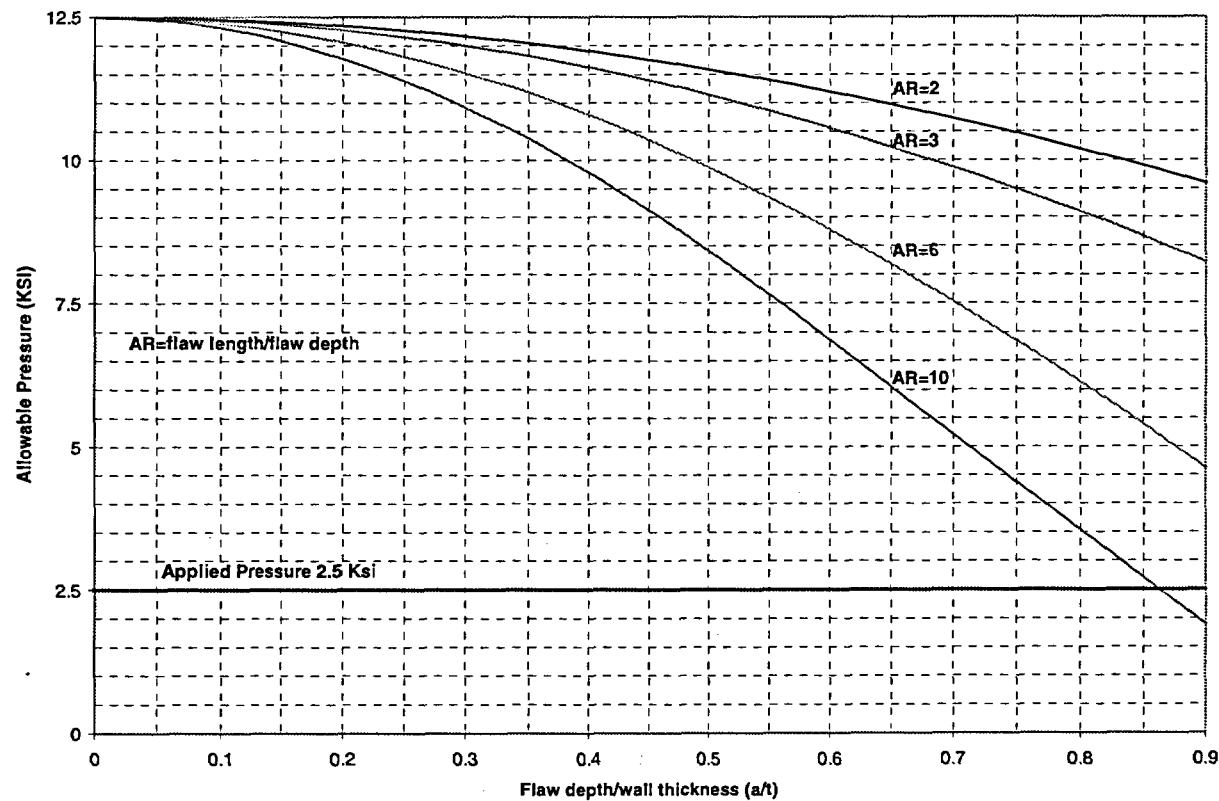
Figure C.2-3 Determination of Allowable Circumferential Flaw Sizes

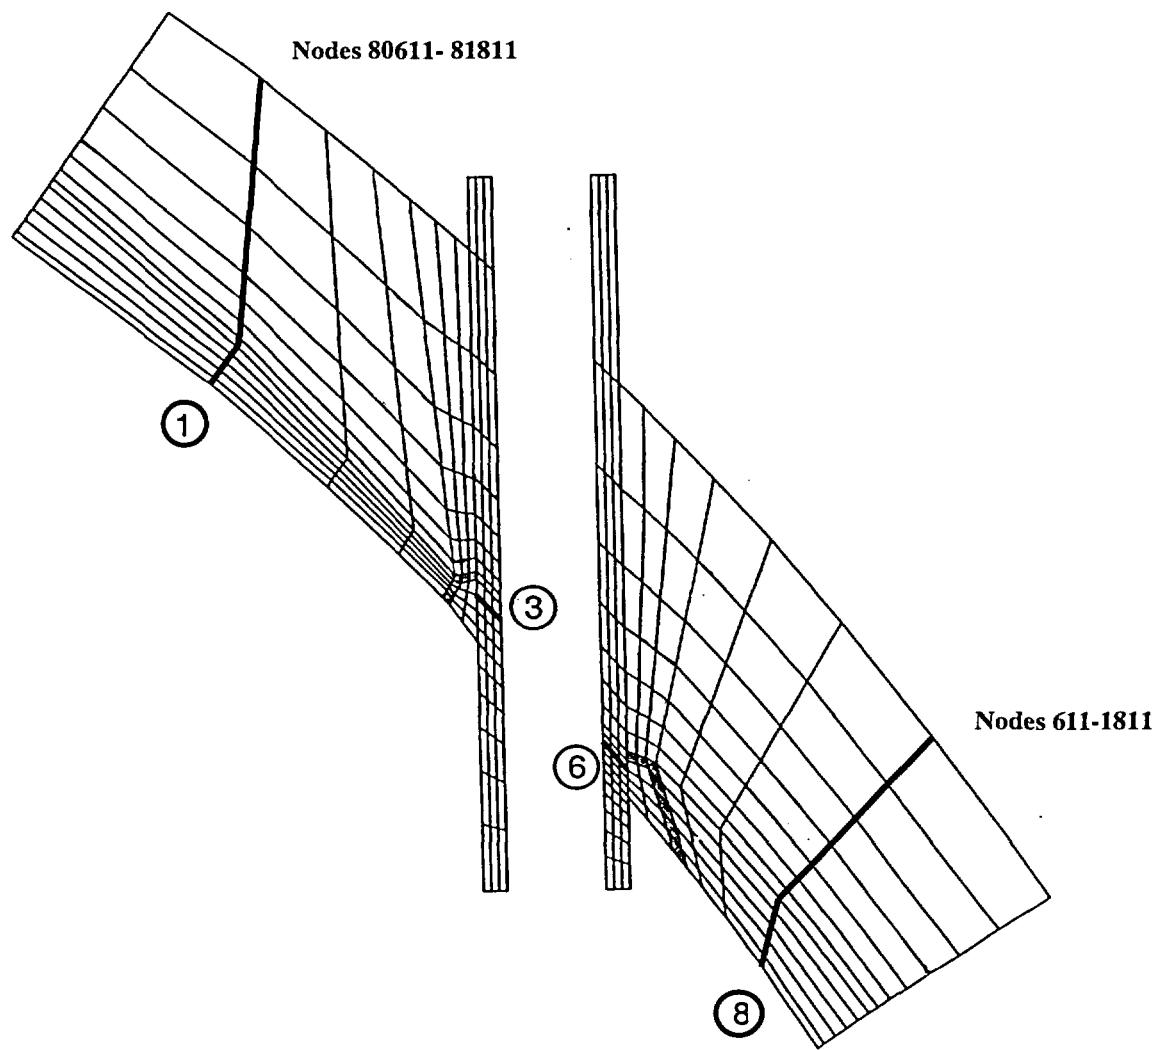
Figure C.2-4 Finite Element Model with Selected Stress Cuts

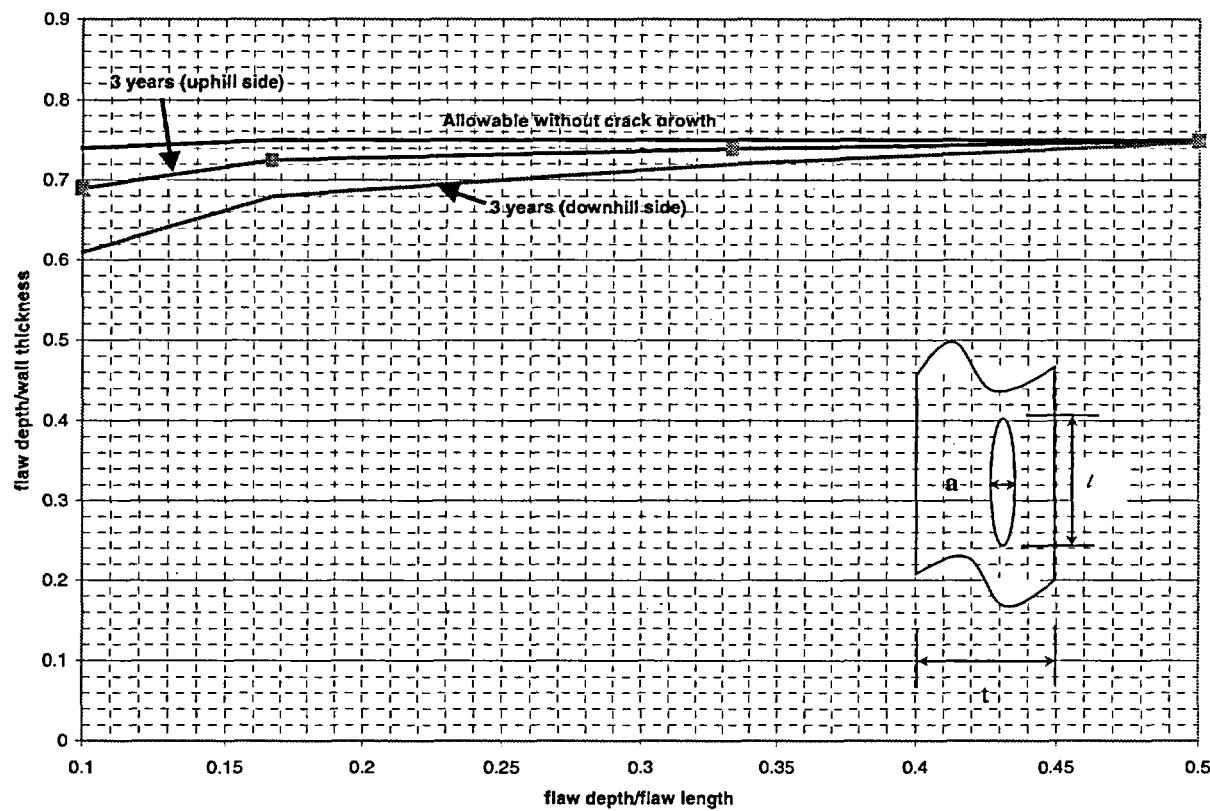
Figure C.2-5 Maximum Allowable Embedded Axial Flaw Sizes

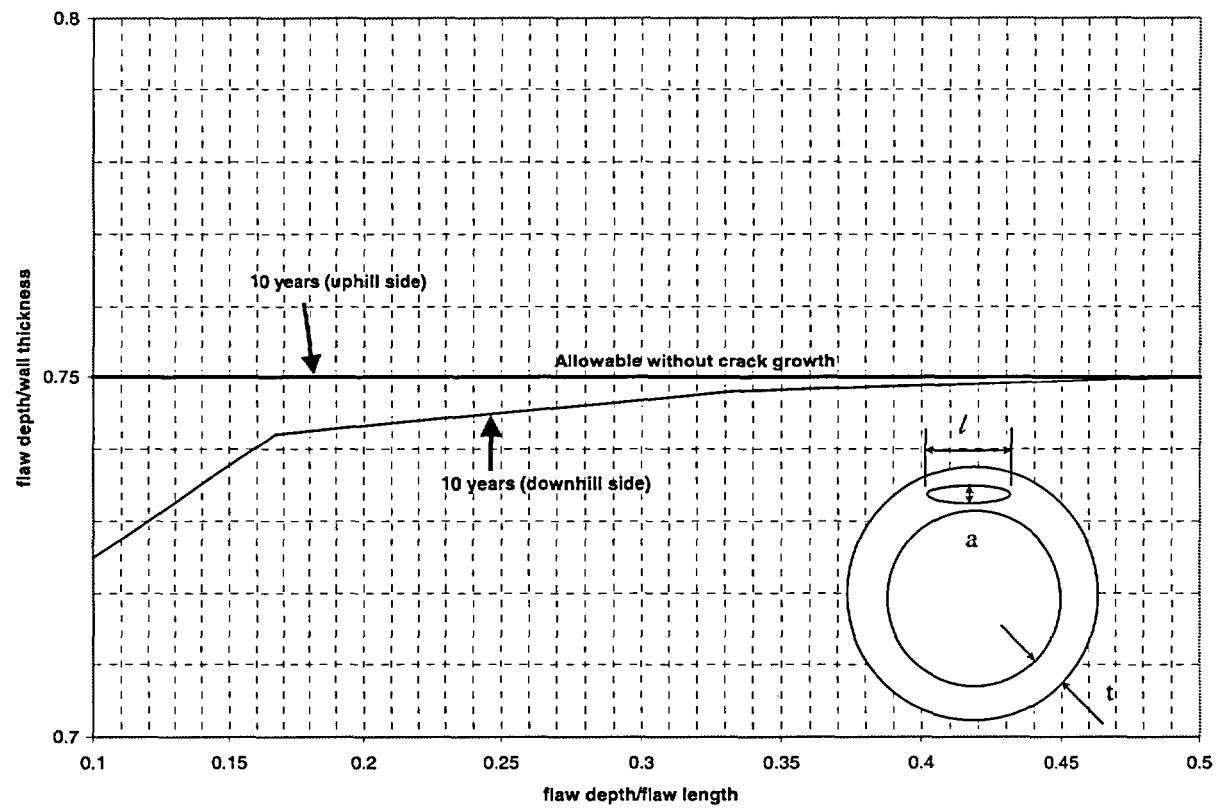
Figure C.2-6 Maximum Allowable Embedded Circumferential Flaw sizes

For illustration purposes, Figure C.2-6 presents the maximum allowable flaw sizes for the embedded circumferential flaws in the head penetration nozzles along with the ASME Code based allowable flaw depths and shapes discussed in Section C.2.1. The results have incorporated the effects of fatigue crack growth.

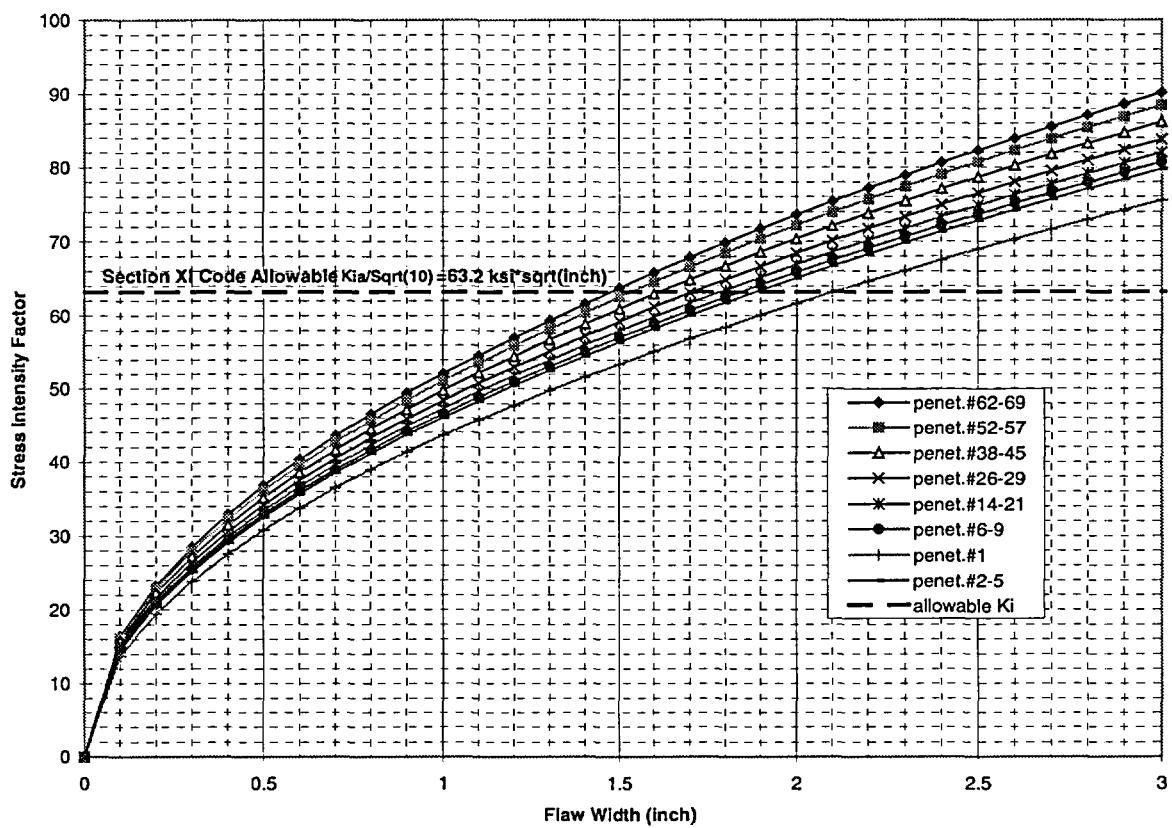
Figure C.3-2 Determination of Allowable Flaw Size (for Illustration Purposes Only)

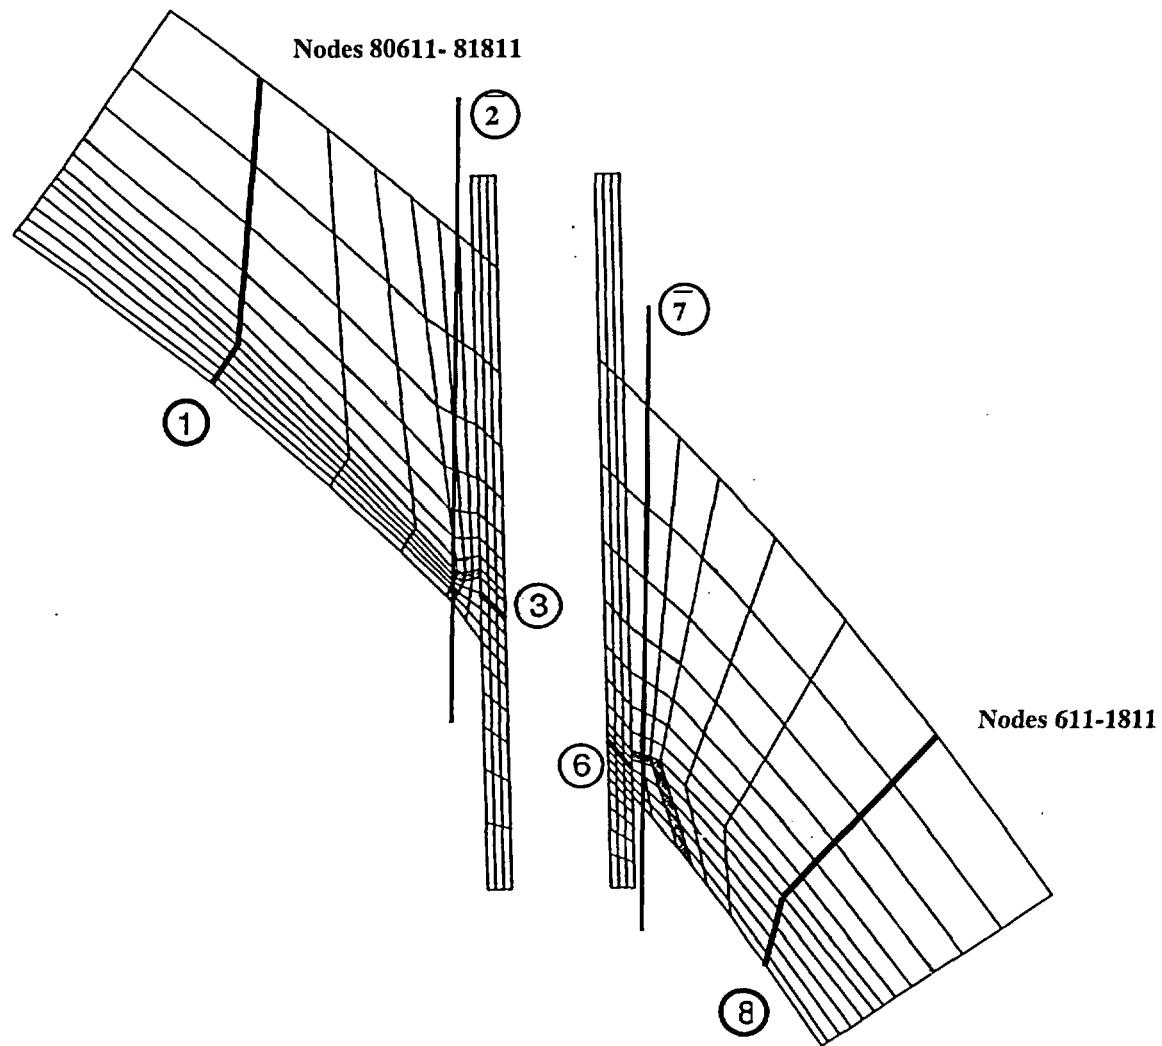
Figure C.3-4 Finite Element Model with Selected Stress Cuts

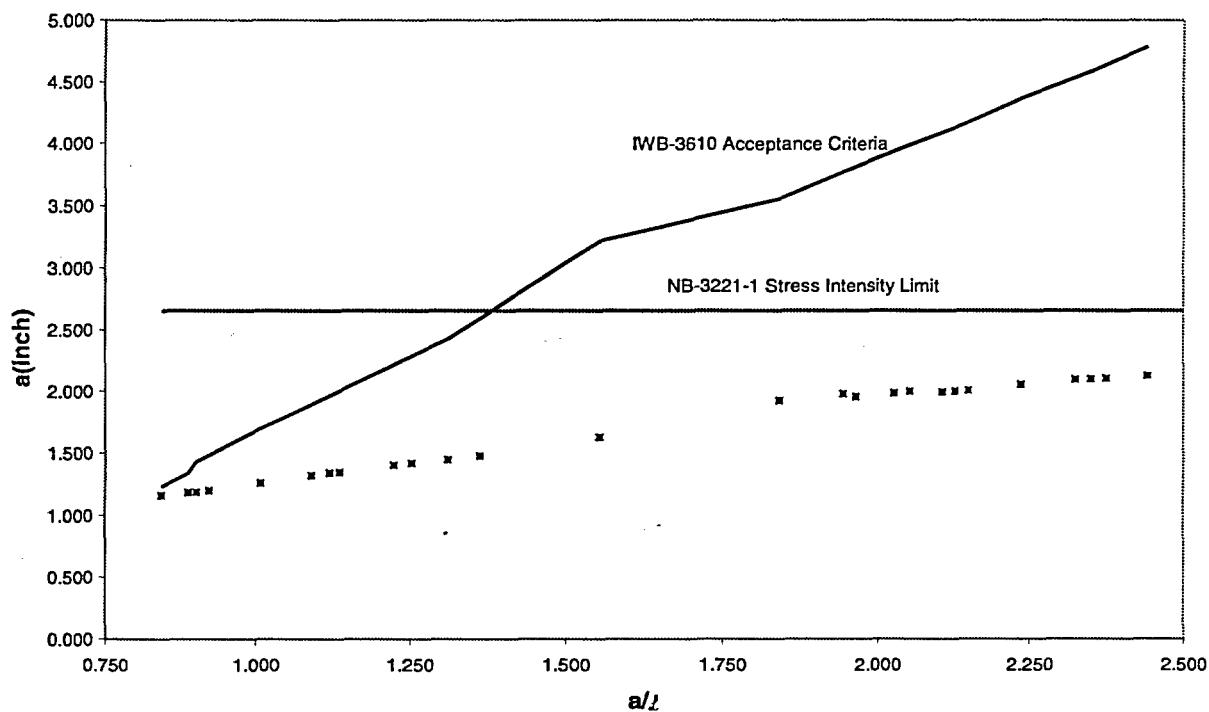
Figure C.3-5 Fatigue Crack Growth Adjusted Allowable Flaw Sizes for Head Penetration Attachment Welds (for Illustration Purposes Only)

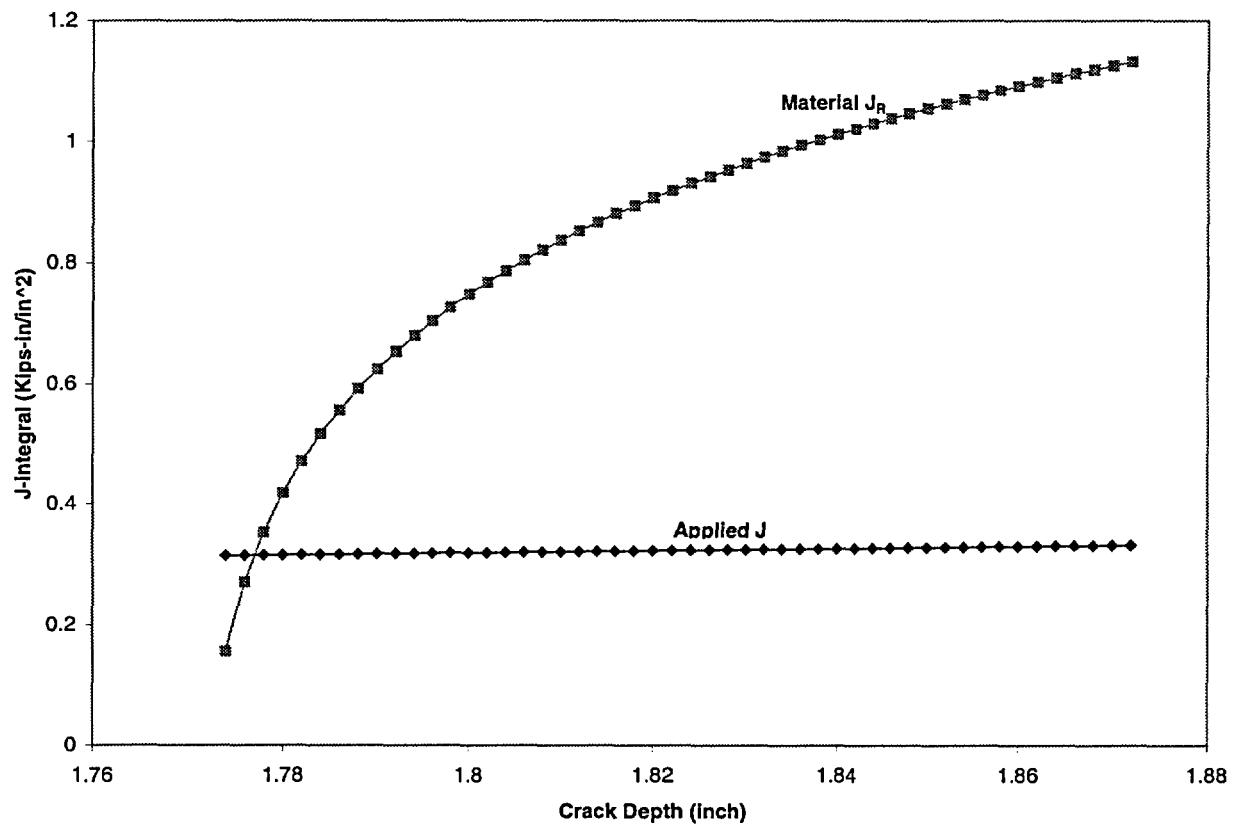
**Figure C.3-6 Comparison of the Slope of the Applied J-Integral and J-R Curve
(for Illustration Purposes Only)**

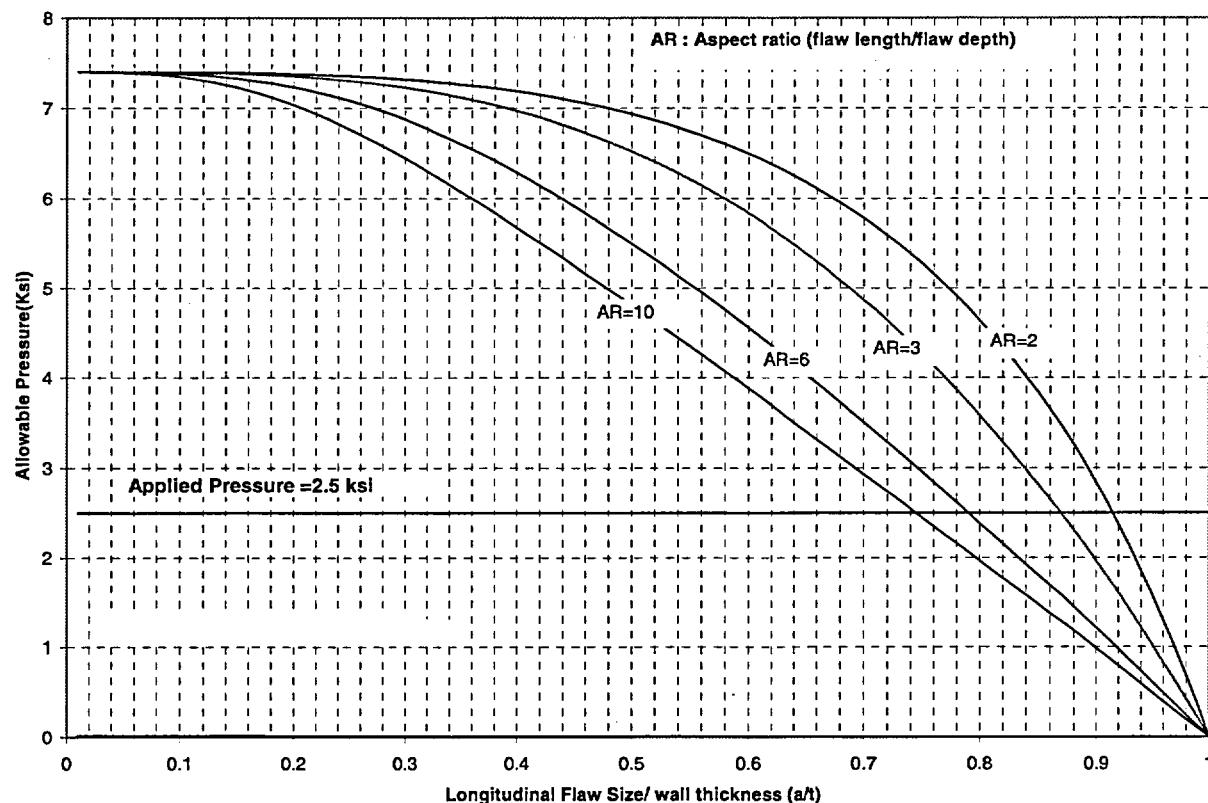
**Figure C.4-2 Determination of Allowable Axial Outside Surface Flaw Sizes
(For Illustration Purposes Only)**

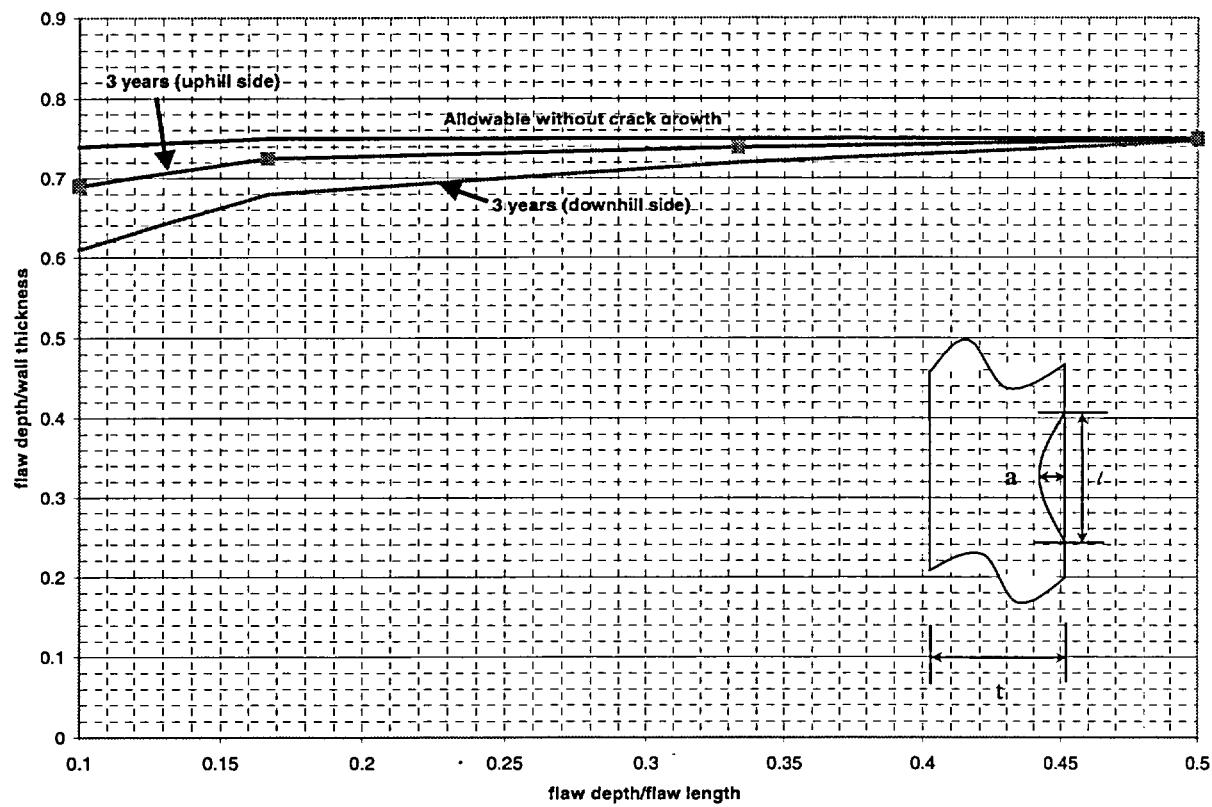
**Figure C.4-3 Maximum Allowable Embedded Axial Outside Surface Flaw sizes
(for Illustration Purposes Only)**

Figure C.4-3 illustrates the maximum allowable flaw sizes for the embedded axial outside surface flaws in the head penetration nozzles along with the ASME Code based allowable flaw depths and shapes discussed in Section C.4.2. The results have incorporated the effects of fatigue crack growth.
