UCRL-ID-127355

Electrochemical and Metallographic Evaluation of Alloys C-22 and 625

May 1997

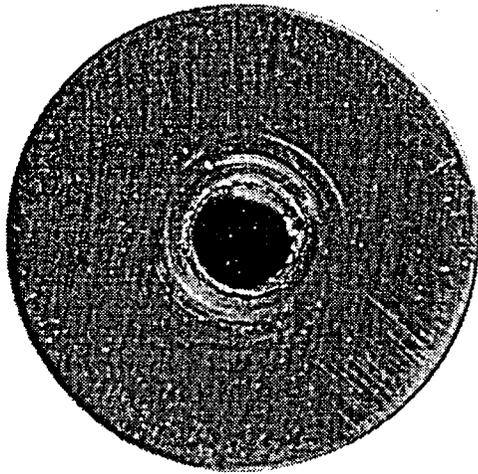
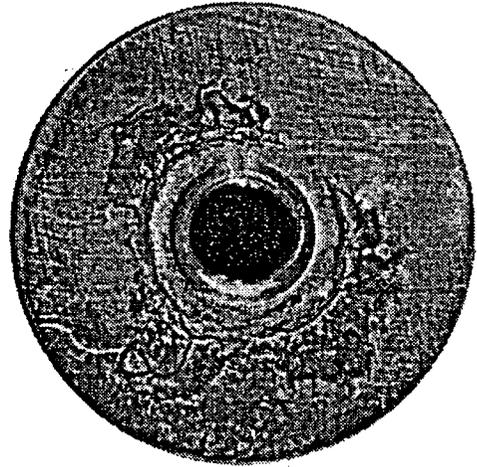
Alloy C-22

Alloy 625

Figure 1. Surface Appearance (Vertical Mode) of Alloys C-22 and 625 in Acidic Brines Containing 10 wt% NaCl at 90°C

Results indicate that Alloy C-22 was immune to pitting corrosion in all salt solutions tested. Furthermore, this alloy showed very little or no crevice corrosion tendency. In general, the specimen surface was unattacked. Contrary to this observation, Alloy 625 exhibited a tendency to surface degradation including crevice corrosion, pitting corrosion, and cracking. A comparison of specimen surface appearance of both alloys tested in acidified brine containing 10 wt% NaCl is illustrated in Figure 1.

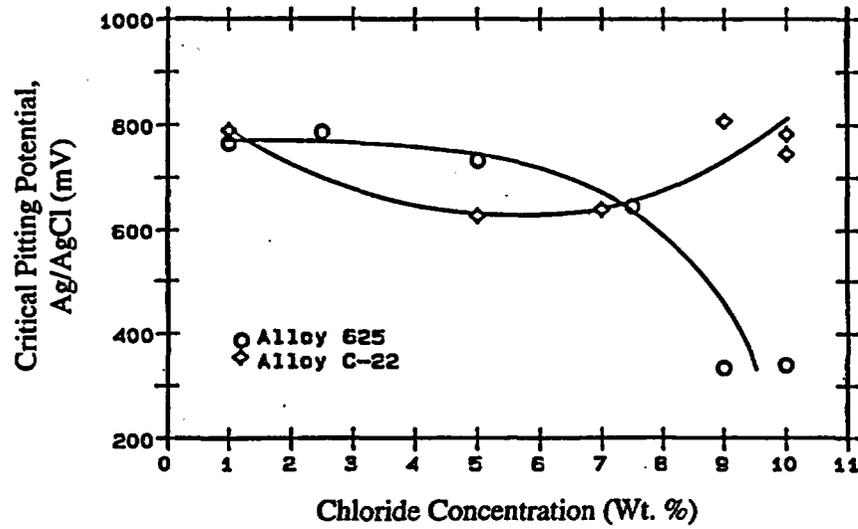
Figure 2. Critical Pitting Potential vs Chloride Concentration in Acidic Brines at 90°C

The relationship between E_{pit} and Cl^- concentration for Alloys C-22 and 625 in acidic brines is illustrated in Figure 2. It appears that for Alloy 625, E_{pit} was gradually shifted to more active values with increasing Cl^- concentration. A similar effect of Cl^- concentration on E_{pit} has been reported elsewhere⁽⁴⁻⁷⁾ for alloys susceptible to pitting corrosion. For Alloy C-22, even though E_{pit} was shifted to a more active value due to an increase in NaCl concentration from 1 to 5 wt%, above 5 to 7 wt% NaCl E_{pit} was shifted to more noble values.

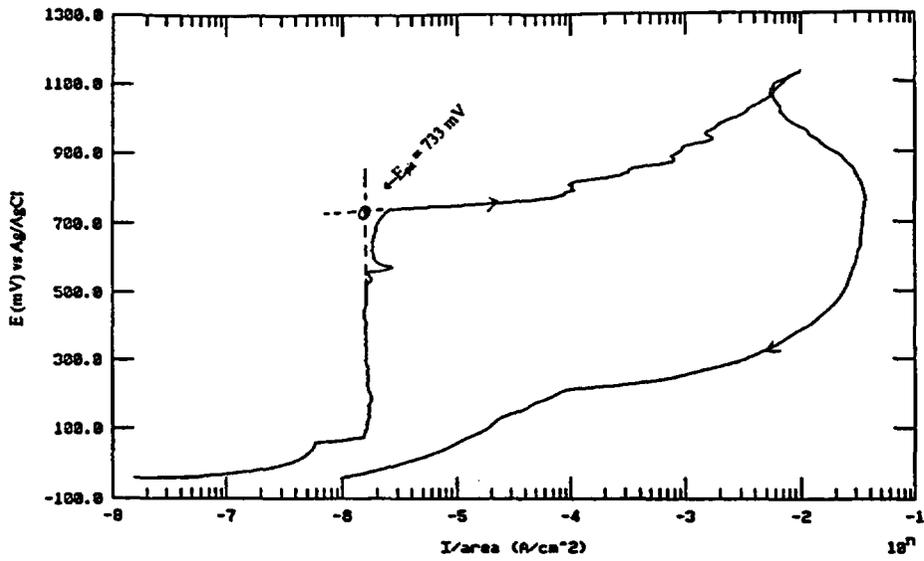
Figure 3. CPP Diagram of Alloy 625 in Acidic Brine Containing 5 wt% NaCl at 90°C

Except in 1 wt% NaCl solution, a clockwise hysteresis loop was traced for Alloy 625 during reverse potential scan in all environments tested, identifying E_{pit} . But E_{prot} could not be determined from these CPP diagrams

since the return polarization curve did not intersect the forward polarization curve at the passive current density (Figure 3), thus, showing no repassivation phenomenon in these tests.

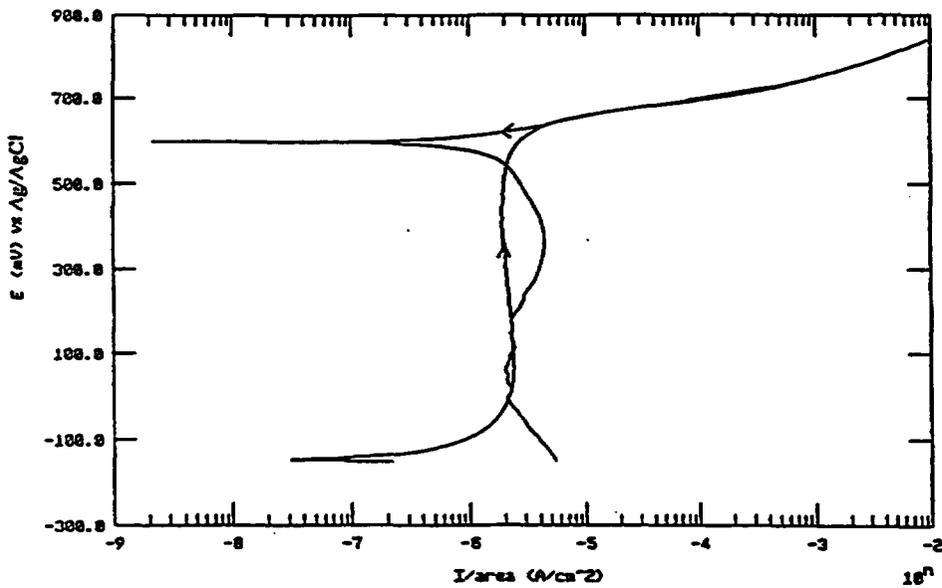
Figure 4. CPP Diagram of Alloy C-22 in Acidic Brine Containing 5 wt% NaCl at 90°C

For Alloy C-22, which did not exhibit any pitting susceptibility, the return polarization curve followed a counter-clockwise path upon reversal of the potential scan. The critical potential became sufficiently noble to overlap the transpassive region, as shown in Figure 4. It has been suggested^(8,9) that when the electrochemical potential of a passivated alloy is raised sufficiently, the potential drop across the double layer may often become high enough for the oxidation of entities in the solution - often that of water, but especially in concentrated solutions. This may result in the formation of oxides on the alloy surface as anodic products, and uniform corrosion of the alloy may then occur with little or no localized attack. Such a phenomenon may possibly account for the absence of pitting in Alloy C-22.
