Status of Reactor Vessel Head Penetration Inspection Activities

**Tom Alley, Duke Energy
Chair, Alloy 600 Inspection WG**

**NRC-MRP Meeting
June 12, 2003**

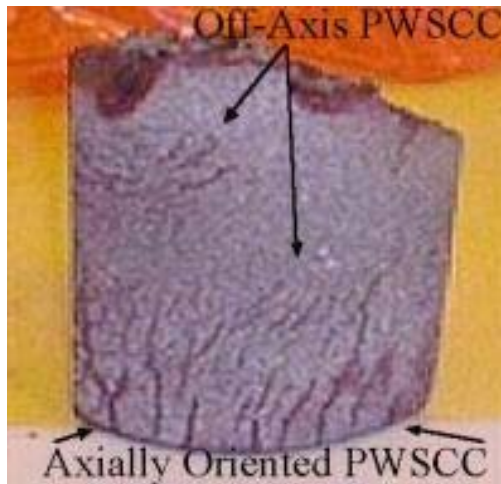
▲ Specimen #56

- OD-initiated PWSCC
 - Range of sizes & locations
- Off-axis flaws (~45 degrees) are representative of circumferential flaw in outermost penetration

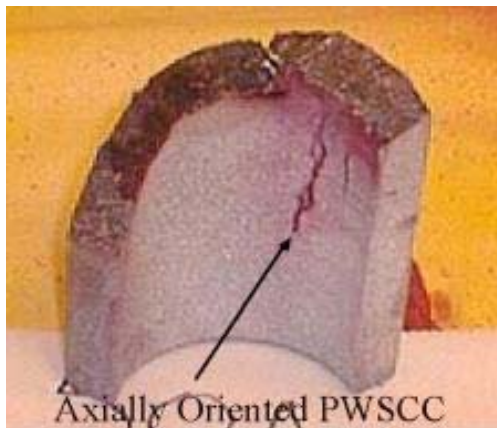
▲ Specimen #50

- ID-initiated PWSCC

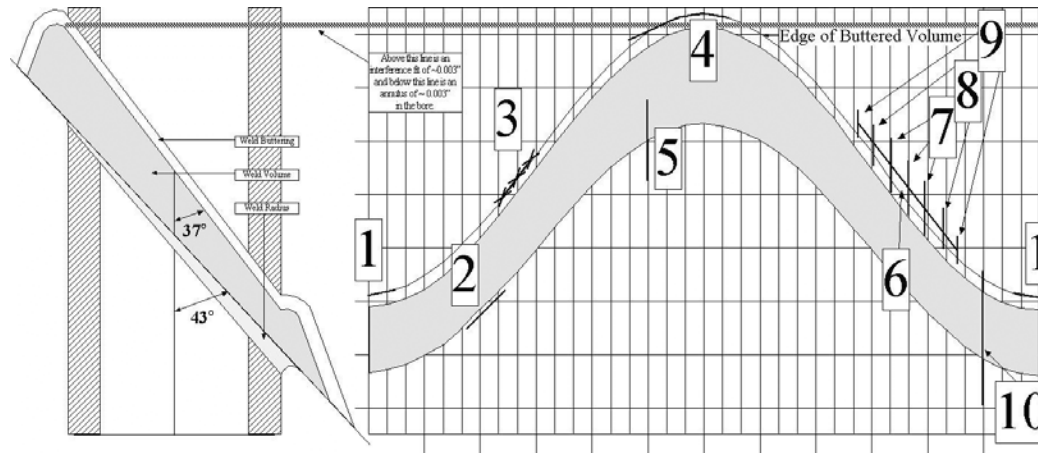
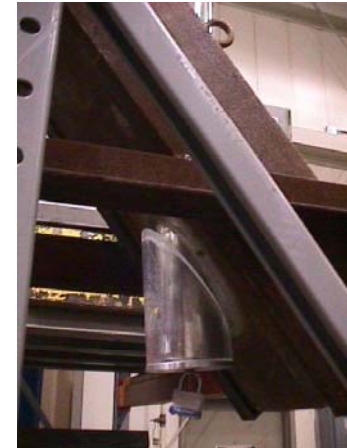
2001 Demo Mock-ups – Full Scale

- ▲ #1 & 4 – Circ. above weld. Corner trap one direction only. Min. skew angle. This circ position exhibits maximum distortion during fabrication, affecting UT contact.
- ▲ #2 – Circ. Below weld. No corner trap when UT oriented down. Near max skew angle.
- ▲ #3 – Circ. flaw at max skew. Cross-hatch simulates PWSCC affecting corner-trap
- ▲ #5 & 10– Axial flaw. Corner-trap lost over weld. Maximum distortion.
- ▲ #6,7, 8, 9 – Circ. & axial combination.

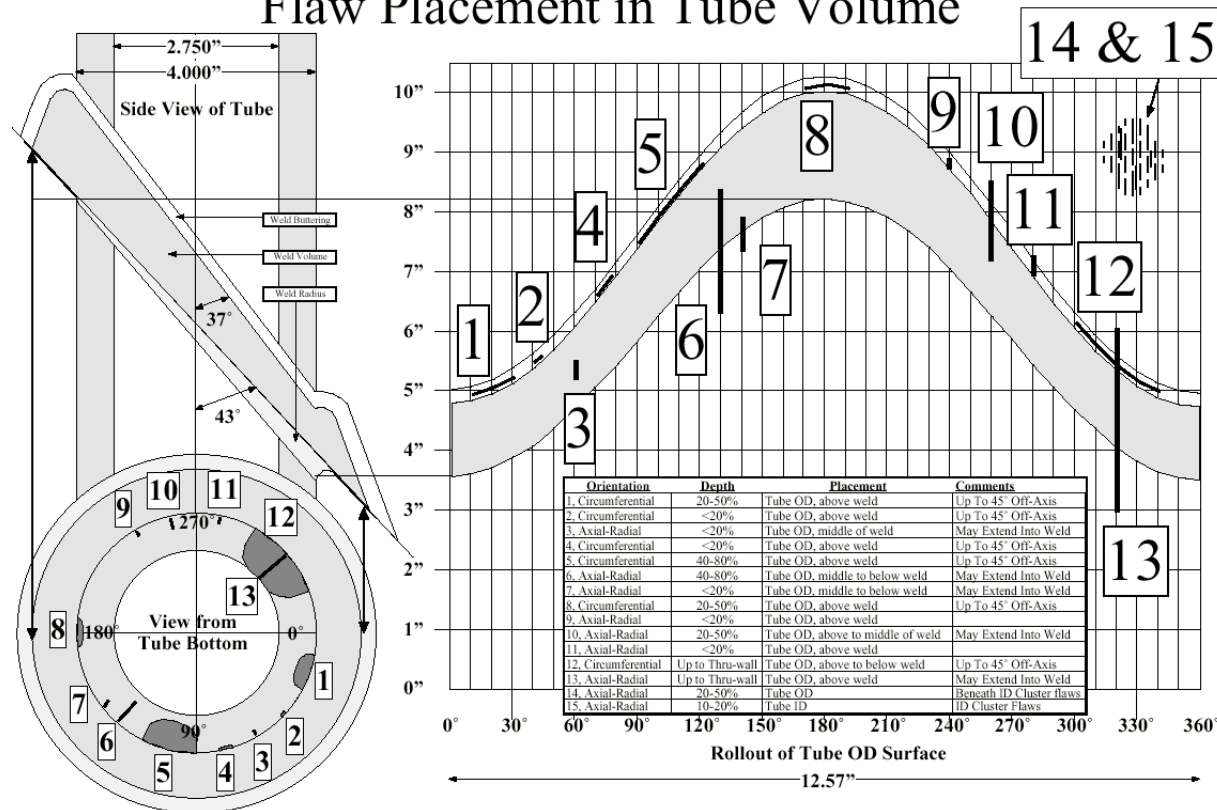
MRP CRDM Generic Mockup Layout for
Flaw Placement in Tube Volume

- Axial, circ, & off-axis tube flaws
 - ~20 flaws, up to 100% deep, 0.1 to 3.0" in length
- Cluster flaws in tube
 - ~25 flaws up to 20% deep, 0.1 to .25" in length
- Axial & circ. attachment weld flaws
 - ~15 flaws, up to 100% deep, 0.1 to 1.0" in length
 - Located at weld/head & weld/tube interface
 - *Most challenging geometry*
 - Flaws approaching & thru triple-point
 - *Allowing leak point to annulus*

NOTE: Flaw locations and sizes are shown only to describe typical types of flaws to be included in blind mockups. Actual flaw sizes and locations are confidential. Drawing is not to scale.

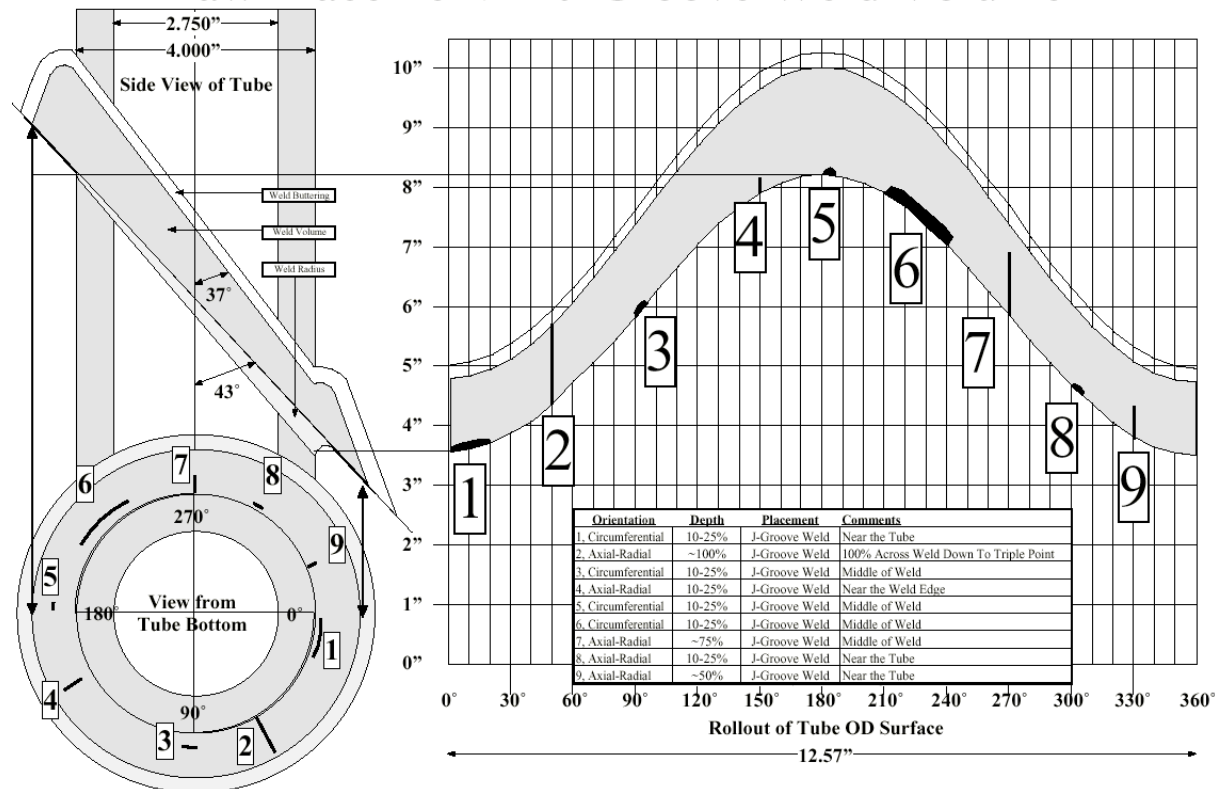
MRP CRDM Generic Mockup Layout for Flaw Placement in J-Groove Weld Volume

NOTE: Flaw locations and sizes are shown only to describe typical types of flaws to be included in blind mockups. Actual flaw sizes and locations are confidential. Drawing is not to scale.

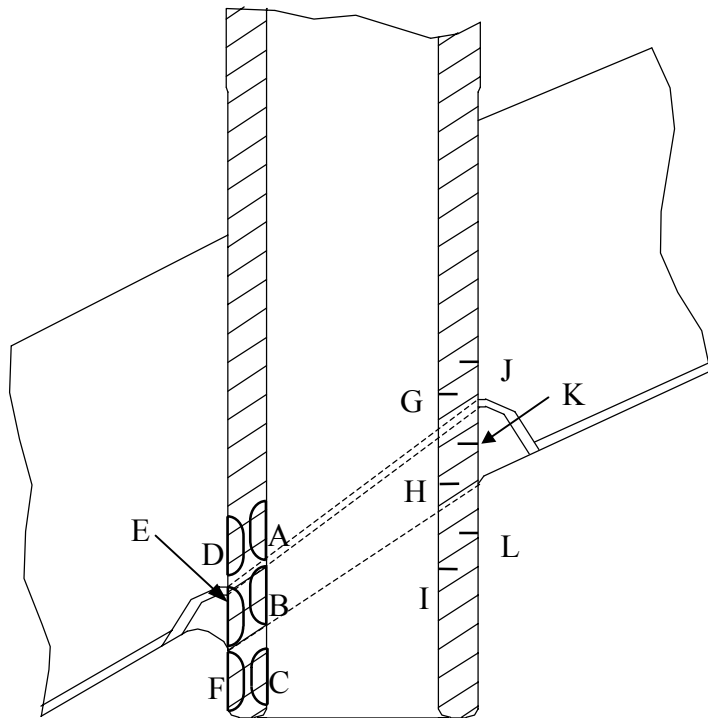
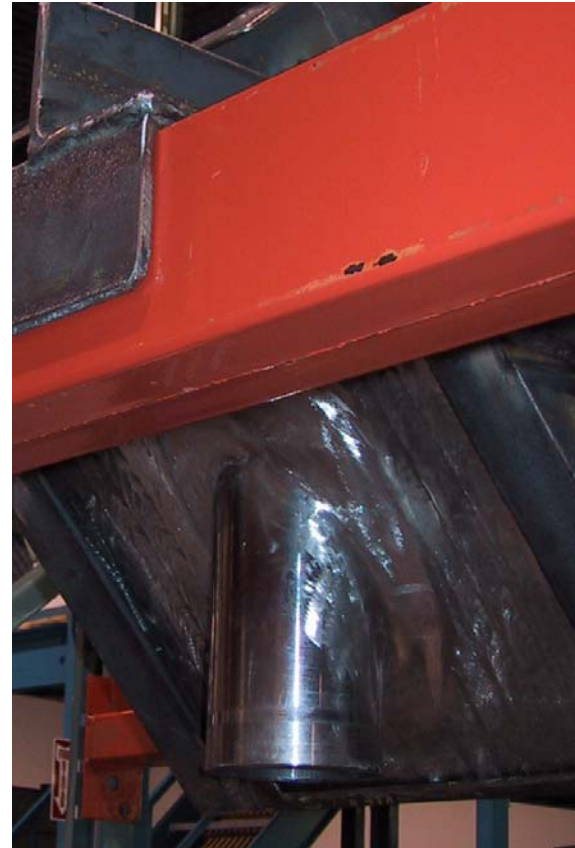
2002 Demo Tube Flaw mock-up “J”

- Full-scale mock-up with CIP flaws in tube

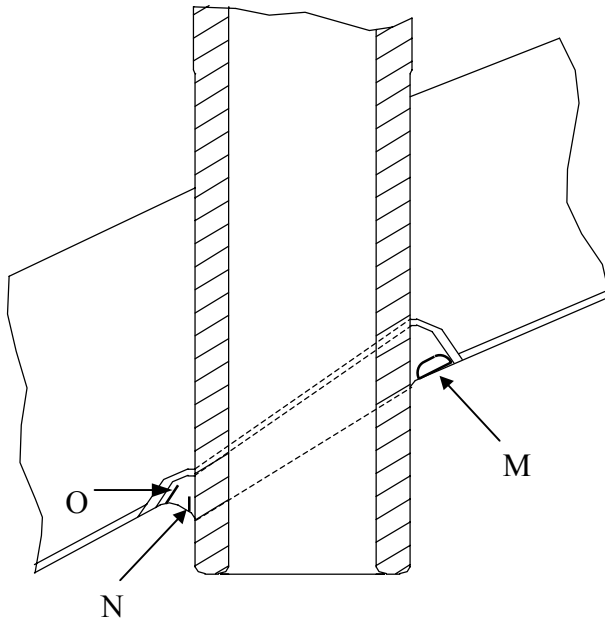
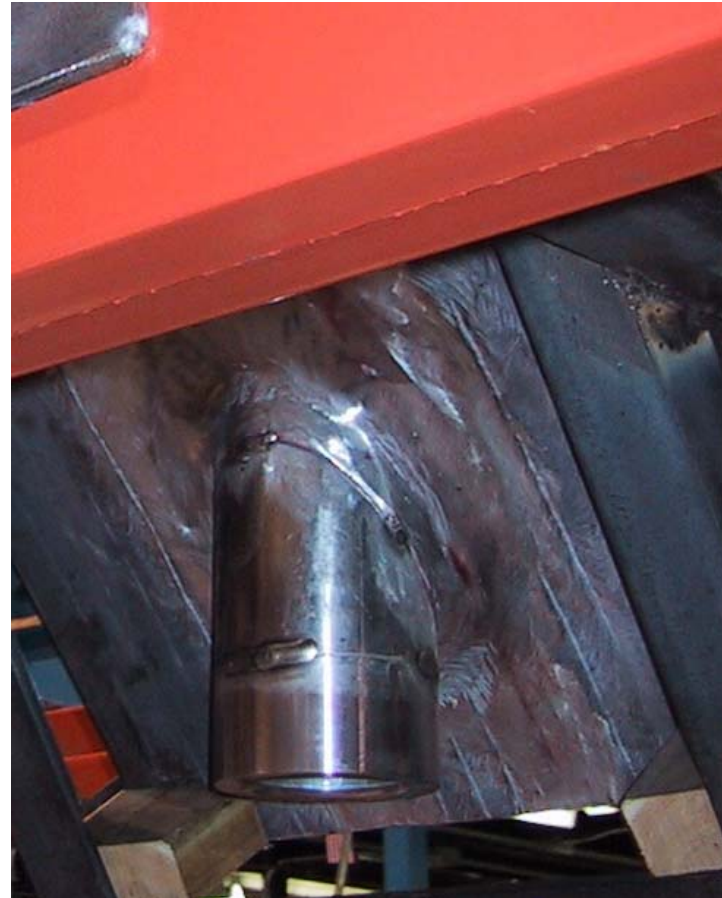
2002 Demo Weld Flaw Mock-up “K”

▲ CIP flaws for

- UT from inside surface of tube
- And ET from the wetted surface

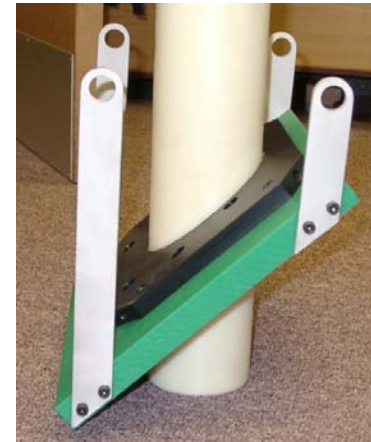
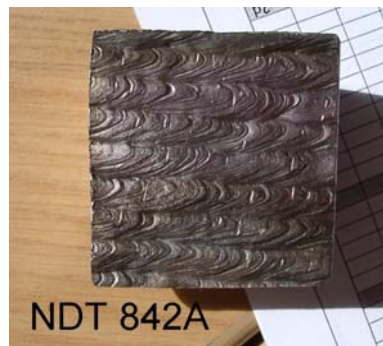
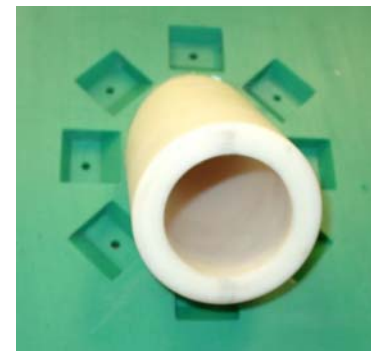
2002 Demo Weld Flaw Mock-up “L”

- ▲ **SCC flaw coupons for demo of ET on wetted surface**
- ▲ **Coupons contain cracks of varying**
 - width
 - length
 - Orientation

- Ground Surface Condition
 - Detected 0.16" long, 0.00031" wide
- Un-ground (as-welded) Surface Condition
 - Detected 0.55" long, 0.00197" wide
 - Missed; 1.42" long, 0.00591" wide
- Continue to pursue additional/alternate techniques to improve the detection capabilities

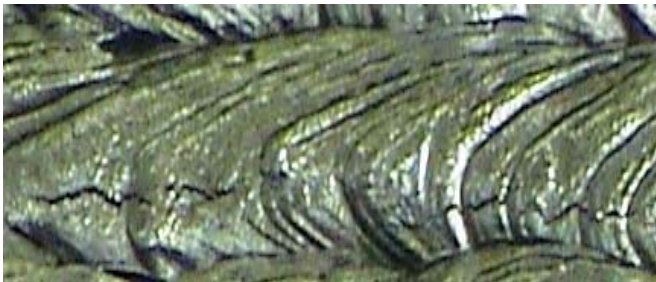
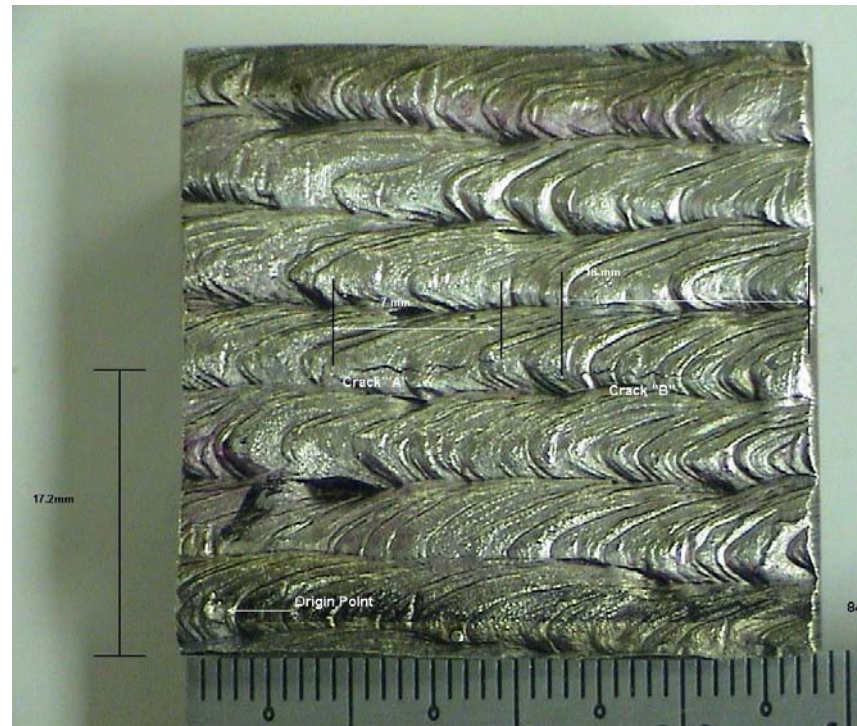
2002 Demo – Mock-up “L” Crack Specimens

- ▲ Laboratory-grown SCC
- ▲ As-welded and ground surfaces
- ▲ Flaws vary in:
 - Length, width, orientation with respect to weld direction

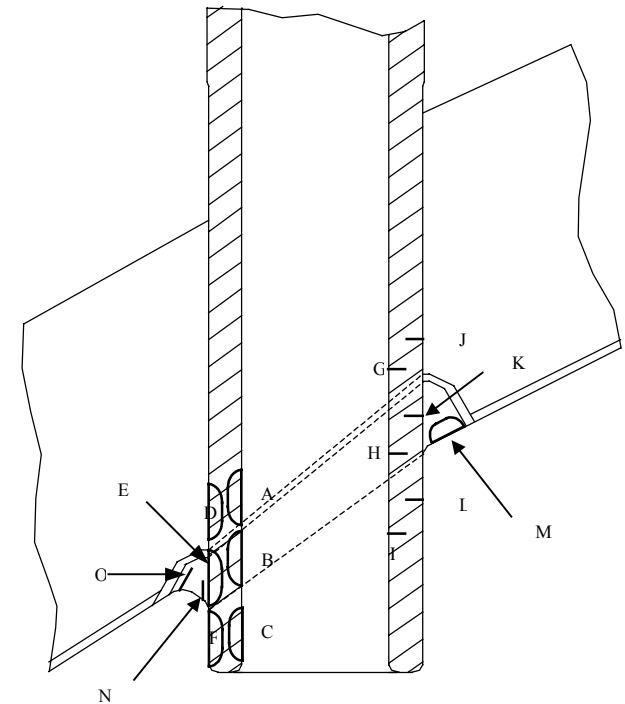
Flaw Designations Nomenclature

Flaw Designation	Flaw Description	Contained in Mockups
A	ID Axial Above the Weld	Yes
B	ID Axial Over the Weld	Yes
C	ID Axial Below the Weld	Yes
D	OD Axial Above the Weld	Yes
E	OD Axial Over the Weld	Yes
F	OD Axial Below the Weld	Yes
G	ID Circumferential Above the Weld	N/A (Note 1)
H	ID Circumferential Over the Weld	N/A (Note 1)
I	ID Circumferential Below the Weld	Yes
J	OD Circumferential Above the Weld	Yes
K	OD Circumferential Over the Weld	Yes
L	OD Circumferential Below the Weld	Yes
M	Axial/Radial @ Wetted Surface of the J-Groove Weld	Yes
N	Circumferential/Axial (reference to tube) on Wetted Surface near interface of tube to J-Groove Weld	Yes
O	Circumferential/Axial (referenced to tube) on Wetted Surface near Head (clad) to J-Groove Weld	Yes
Notes:	(1) Presence of back-wall does not influence detection and analysis of ID surface initiated flaws to the degree that it affects OD surface initiated flaws

Vendor A – UT Blade & Open Tube Probe Detection Results						
See Flaw Table 4 and drawing for description of flaw types “A” through “O”						
Field Used UT Techniques	A, B, & C ID Axial Flaws	G, H, & I ID Circumferential Flaws	D, E, & F OD Axial Flaws	J, K, & L OD Circumferential Flaws	M, N, & O Weld Flaws	Cluster Flaws OD Flaws under shallow (< 3 mm deep) ID Cluster Flaws
“Axial Blade” (TOFD UT COAF) (Note 1) 3 degree scan increment	5%-86% TWE detected (Note 4) Orientation of flaws < 12 % TWE was inconsistent (Note 5)	11%-49% TWE detected Orientation of flaws < 12 % TWE was inconsistent	28%-100% TWE detected 4 flaws < 24% TWE missed: 1-D type flaw, 1-E type flaw, 2-EF type flaws	15%-100% TWE detected 1 K-type false call @ 7% TWE (Note 6)	(Note 7)	100% detection of ID & OD
“Circ Blade” (TOFD UT AOCF) (Note 2) 3 degree scan increment	11%-86% TWE detected 1 B type flaw < 5% TWE missed Orientation of flaws < 12 % TWE was inconsistent (Note 5)	11%-49% TWE detected Orientation of flaws < 12 % TWE was inconsistent	15%-100% TWE detected 4 flaws < 13% TWE missed: 2-D type flaws, 1-E type flaw, 1-EF type flaw	15%-100% TWE detected 1 K-type false call @ 15% TWE (Note 6)	(Note 7)	100% detection of ID & OD
