ATTACHMENT 3b
ULNRC 04861
CALLAWAY PLANT

WCAP-15932-NP
Revision 1

Improved Justification of Partial-Length
RPC Inspection of Tube Joints of Model F
Steam Generators of Ameren-UE
Callaway Plant

**Westinghouse Electric Company LLC
P.O. Box 355
Pittsburgh, PA 15230-0355**

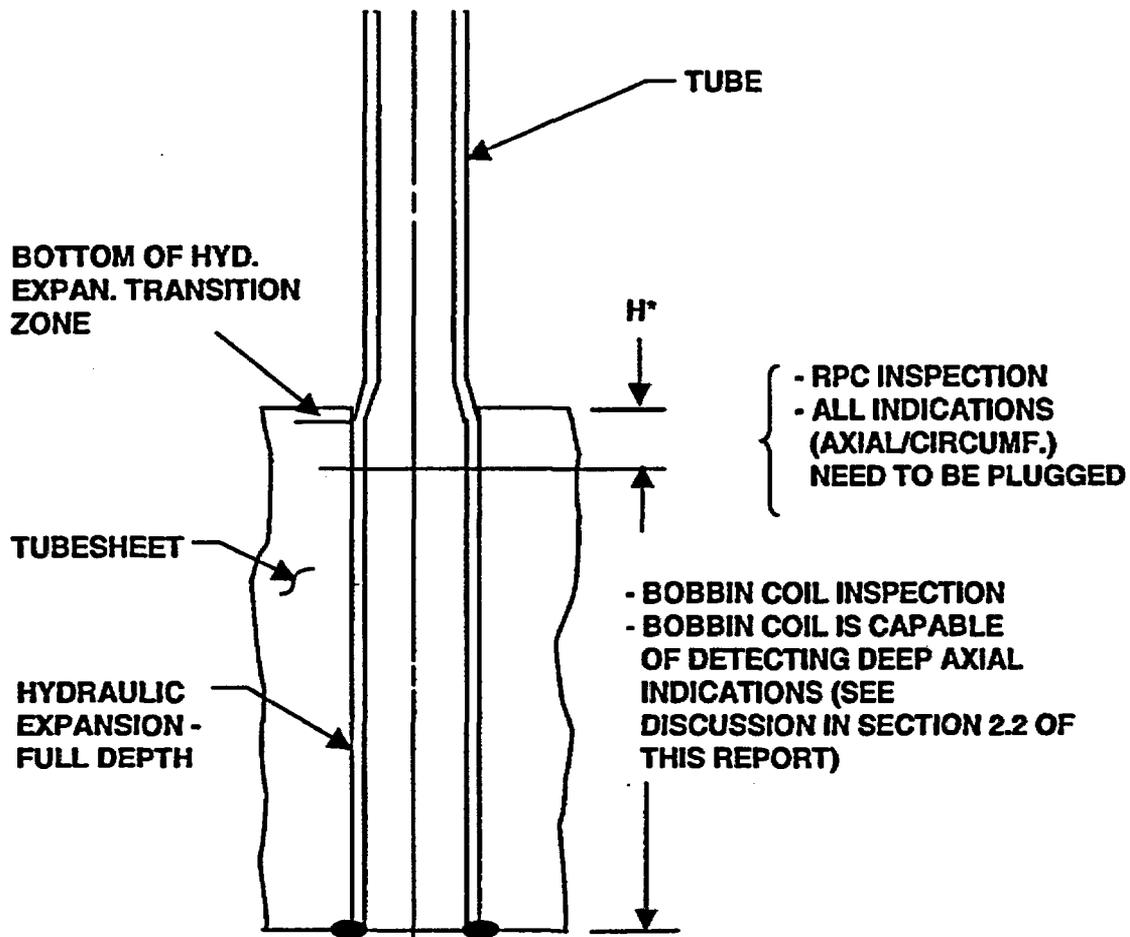
Figure 2-1
H* Tubesheet Region Partial-RPC Justification
for Steam Generators

Because PWSCC has been indicated within the three-inch RPC inspection depth of the Callaway SGs, it is recommended to implement inspection to the H* depths. (Refer to Figures 2-1 and 3-1 and Table 3-1 determined in this evaluation.)

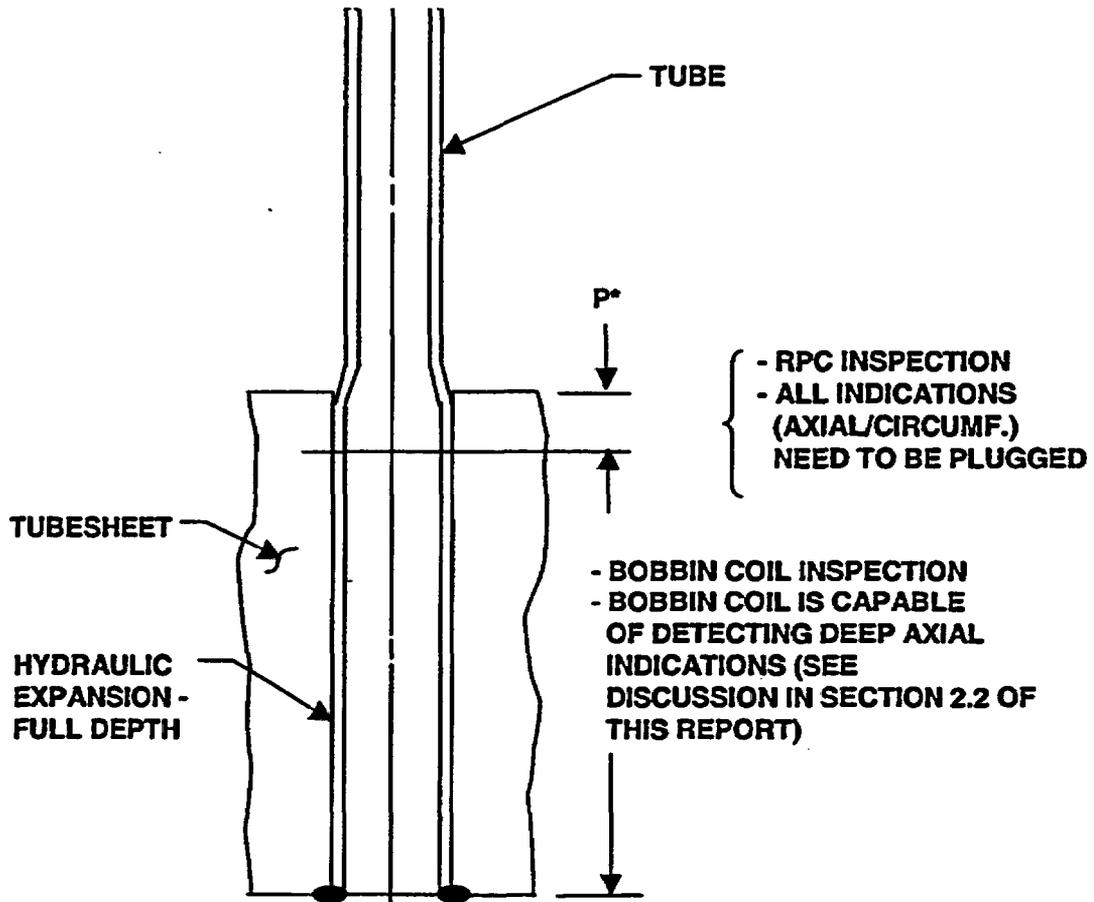
Figure 2-2
P* Tubesheet Region PLRPC Justification
for Steam Generators

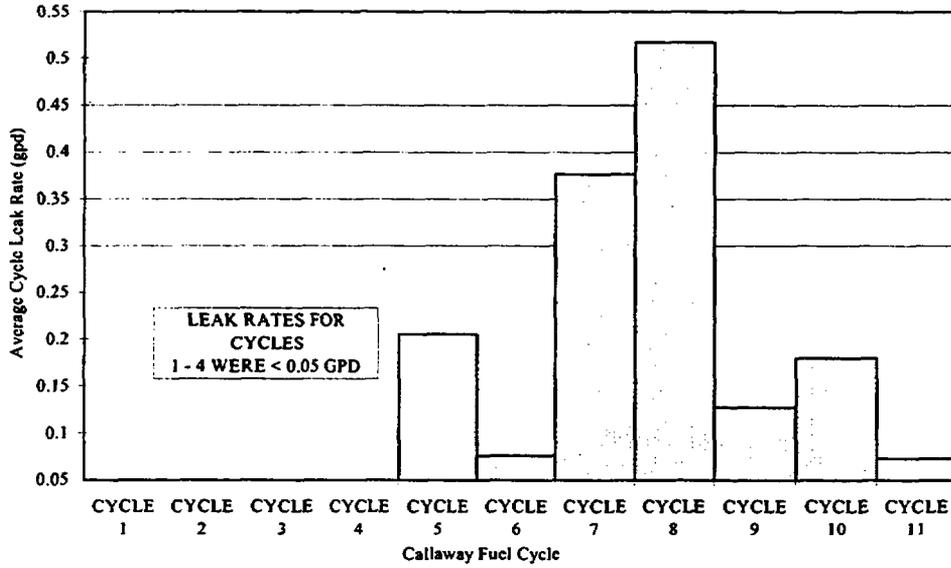
CALLAWAY PRIMARY-TO-SECONDARY LEAKAGE HISTORY
(Combined leakage from all tube defects)

Figure 6.1
Callaway Leak Rate During Operation
The Leak Rate for Cycle 12 was 0.31 gpd.

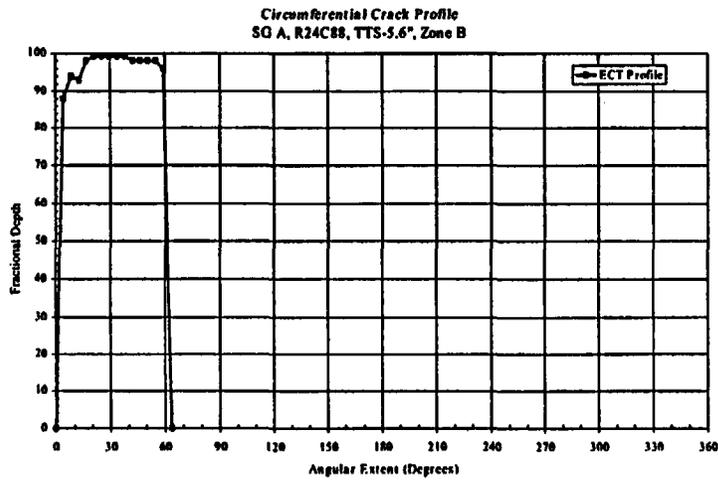
Figure 6.2
Short 60° by 100% TW Crack

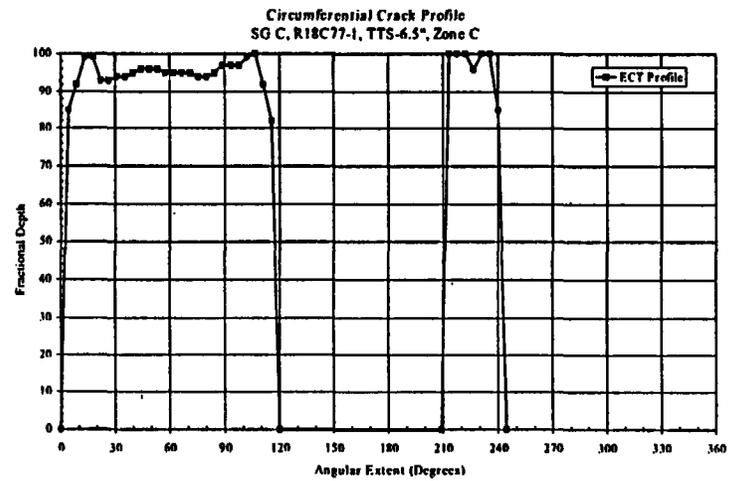
Figure 6.4
Multiple 100% TW Cracks, 150° Total

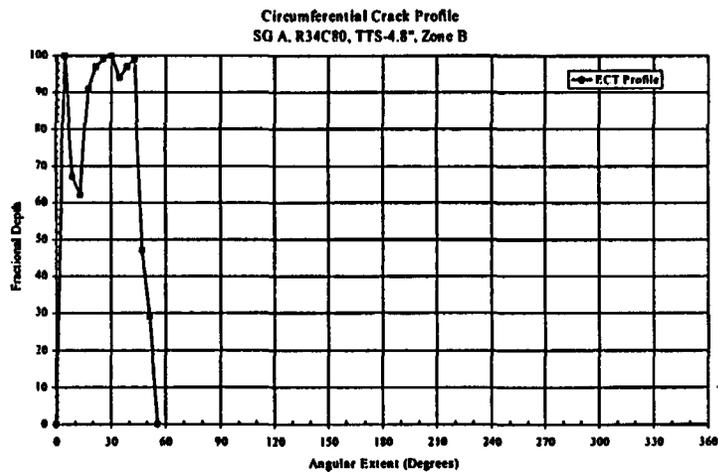
Figure 6.3
Short 50° Crack with Some 100% Depth

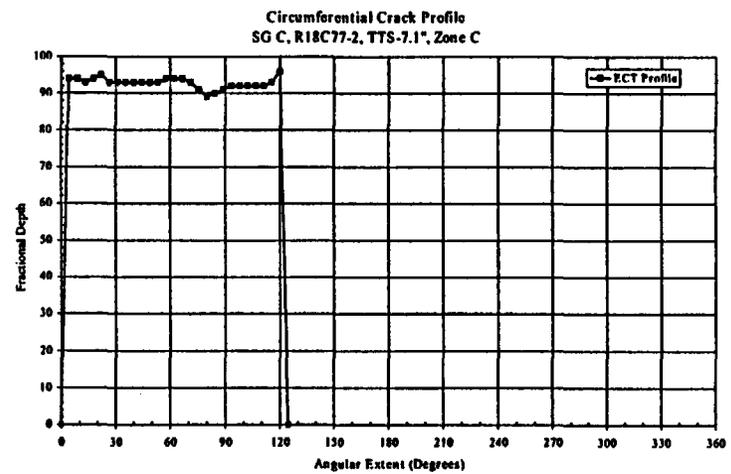
Figure 6.5
Single 120° by 95% TW Crack

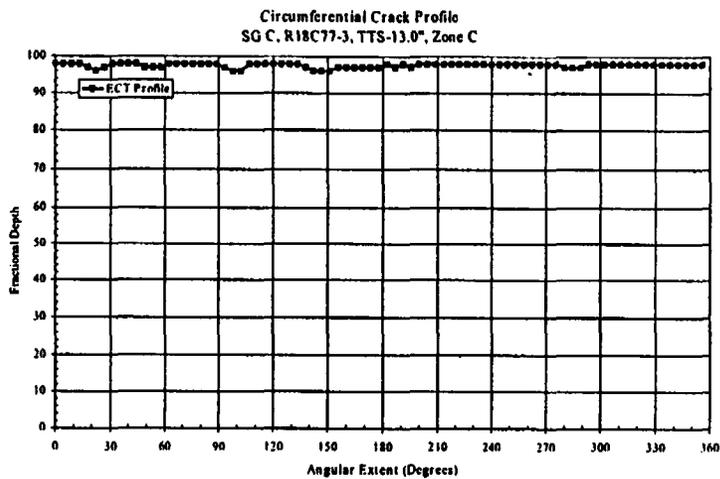
Figure 6.6
Large 360° by 100% TW Crack

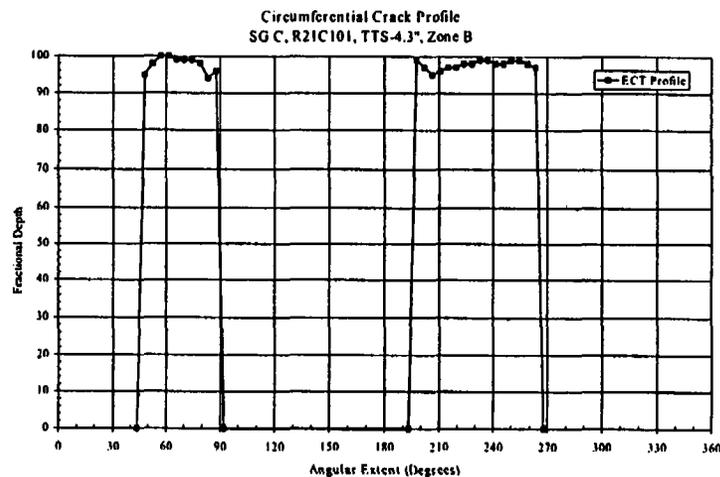
Figure 6.8
Multiple 100% TW Cracks, 120° Total

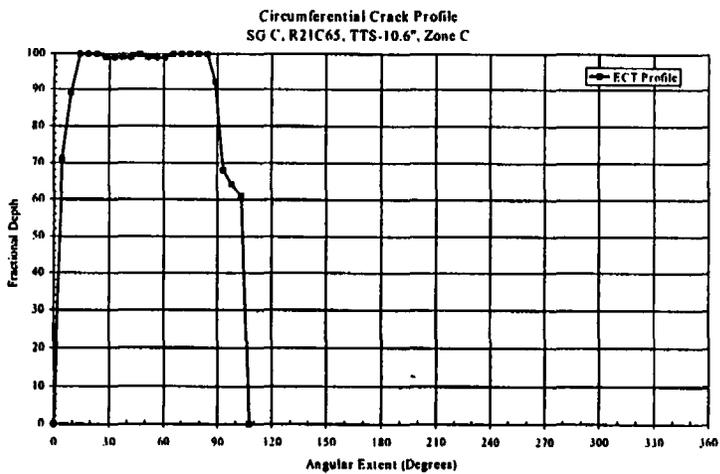
Figure 6.7
Single 90° by 100% TW Crack

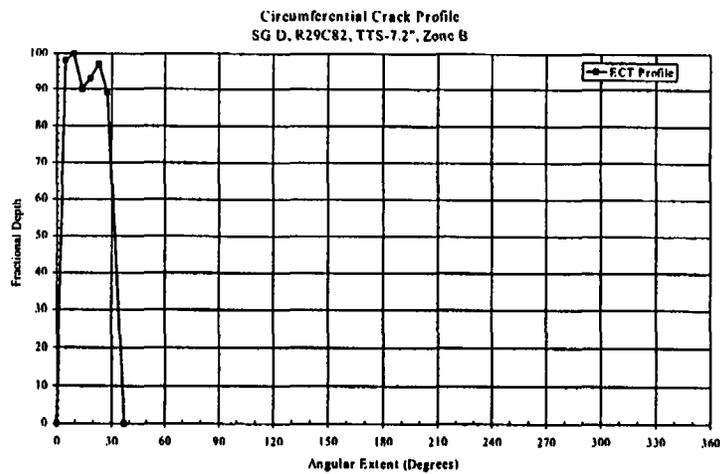
Figure 6.9
Short 30° by 95% TW Crack

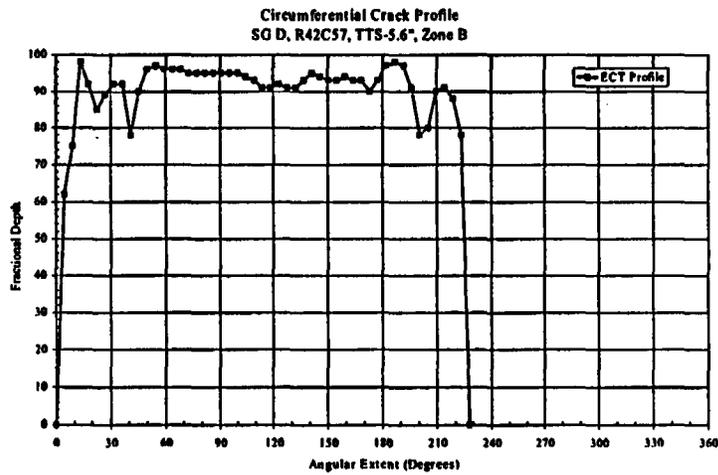
Figure 6.10
 Long 100% Throughwall

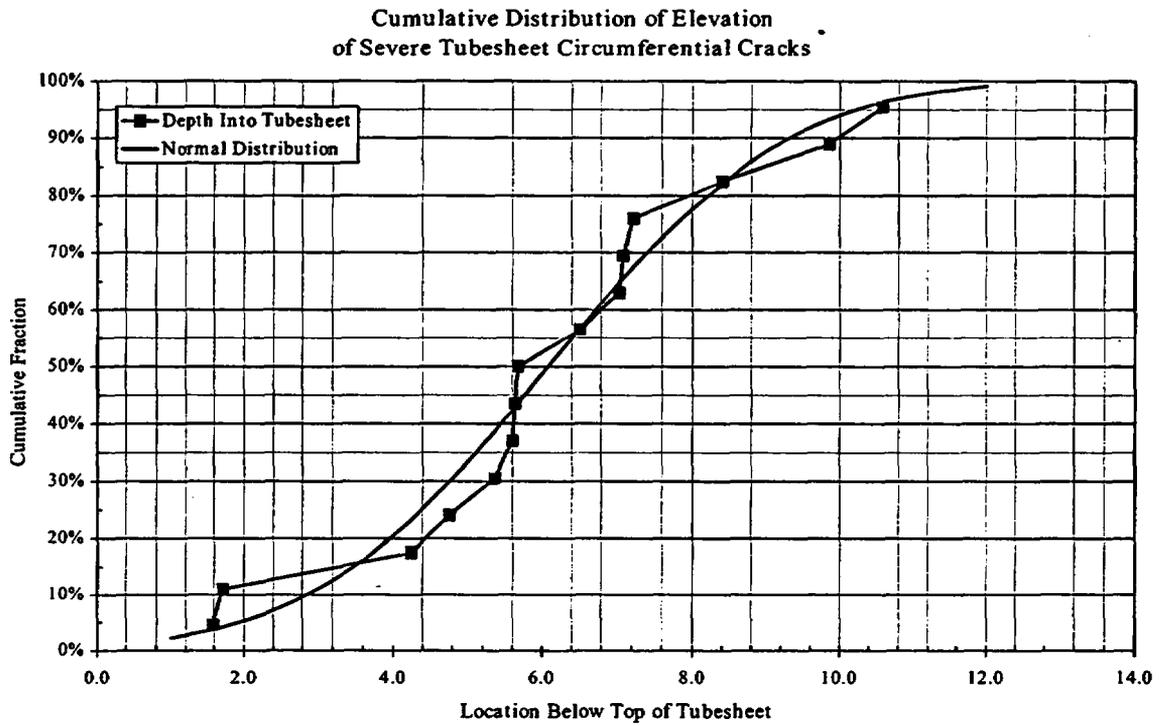
Figure 6.14. Distribution of Severe Indications Locations

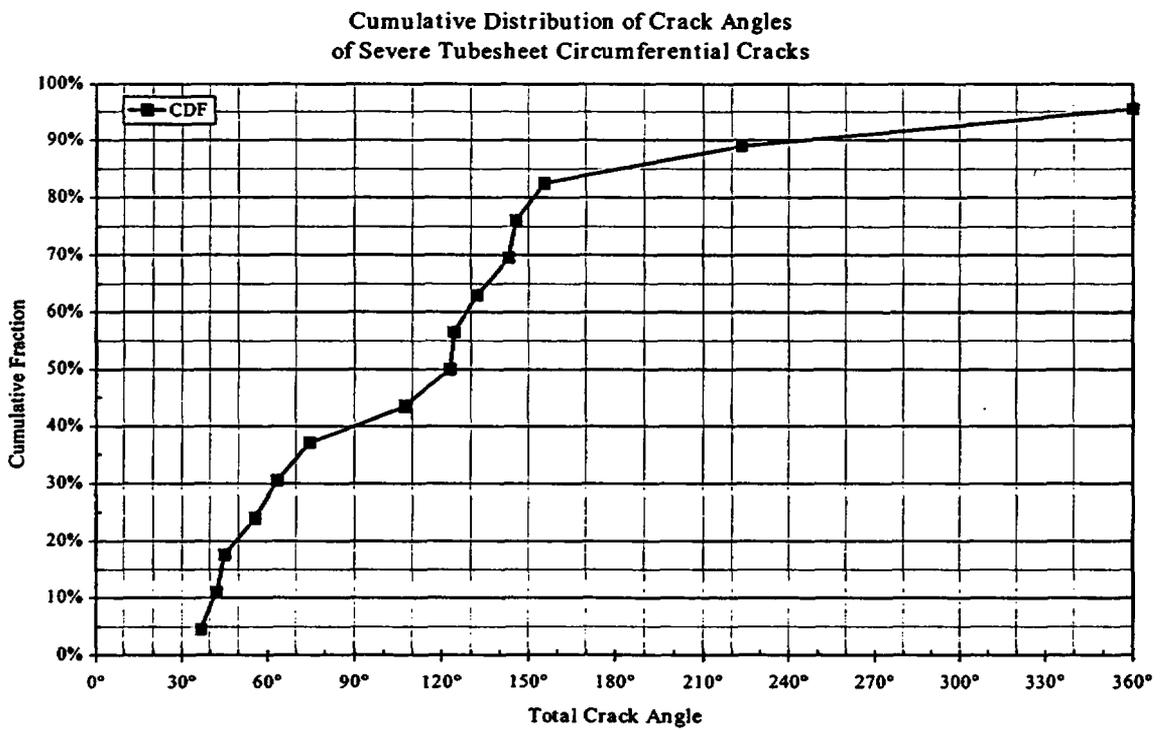
Figure 6.15: Distribution of Severe Indication Total Angles

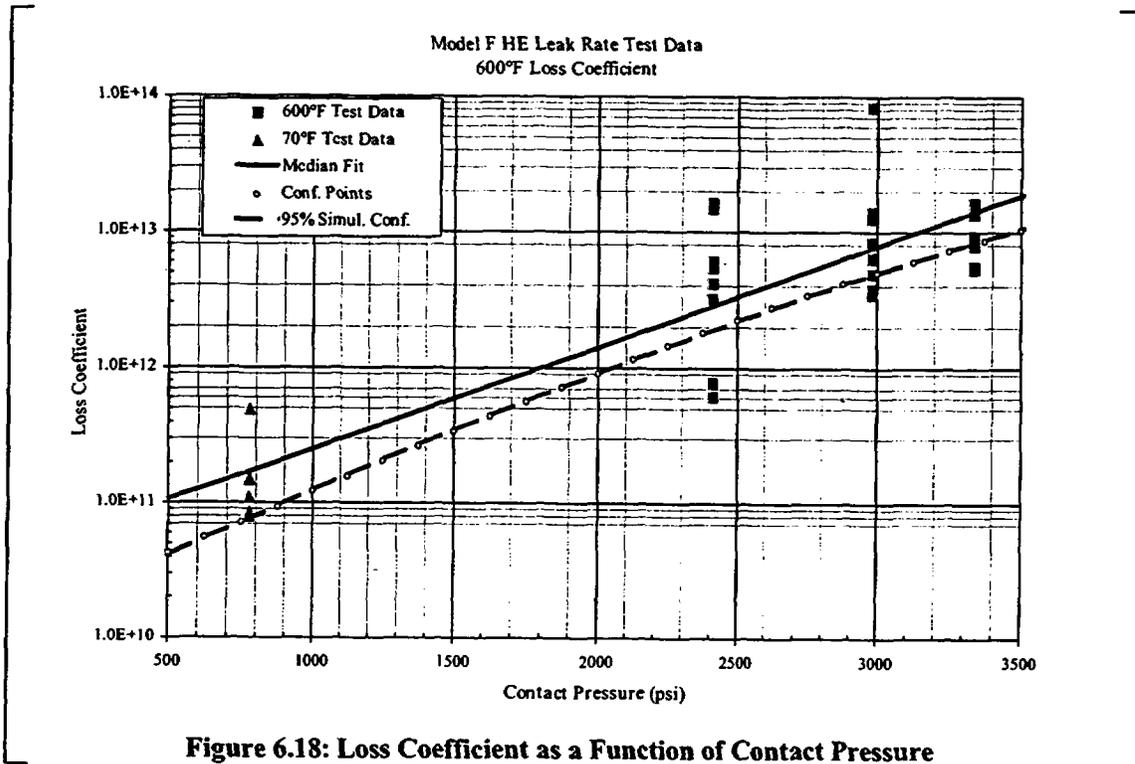
Figure 6.18: Loss Coefficient as a Function of Contact Pressure

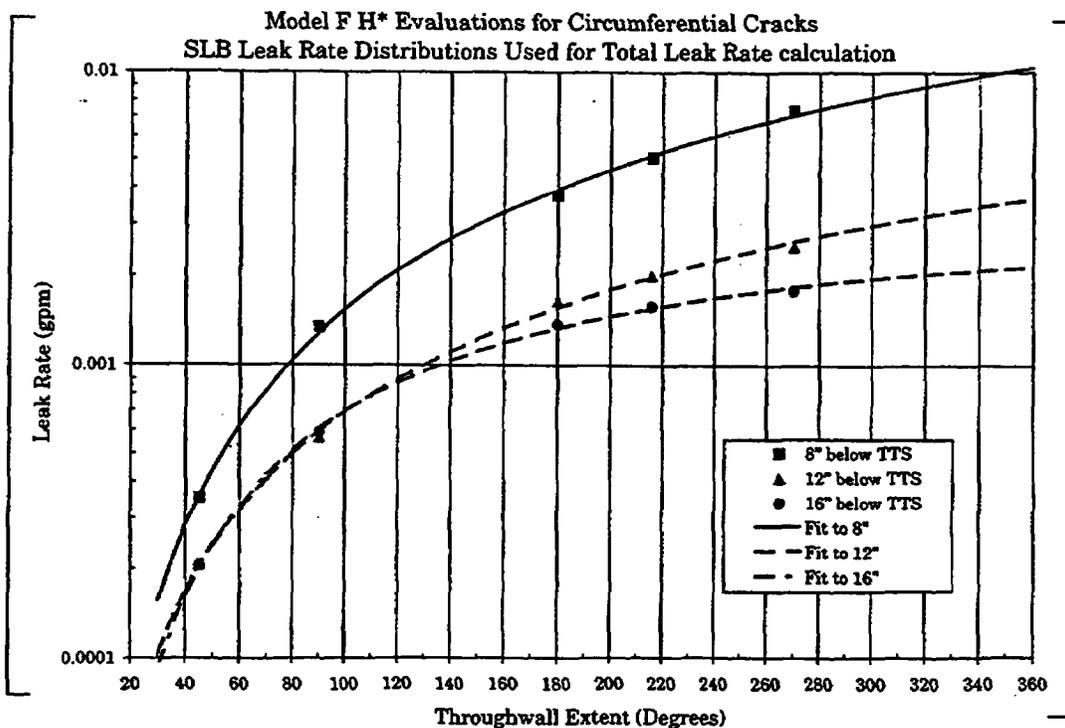
Figure 6.19: Predicted Leak Rates in GPM vs. Through-Wall Extent

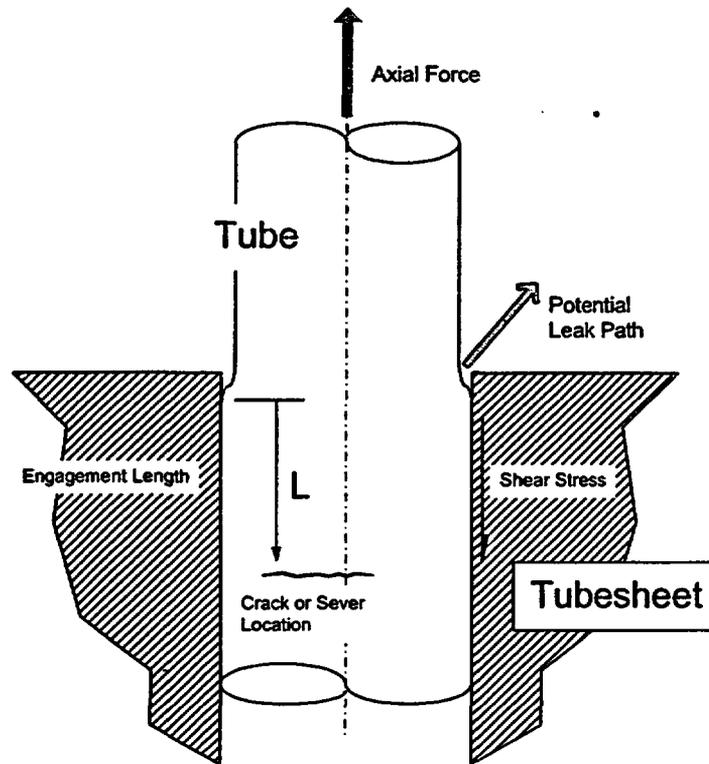
Figure B.1: Tube with Circumferential Crack or Sever Within the Tubesheet.

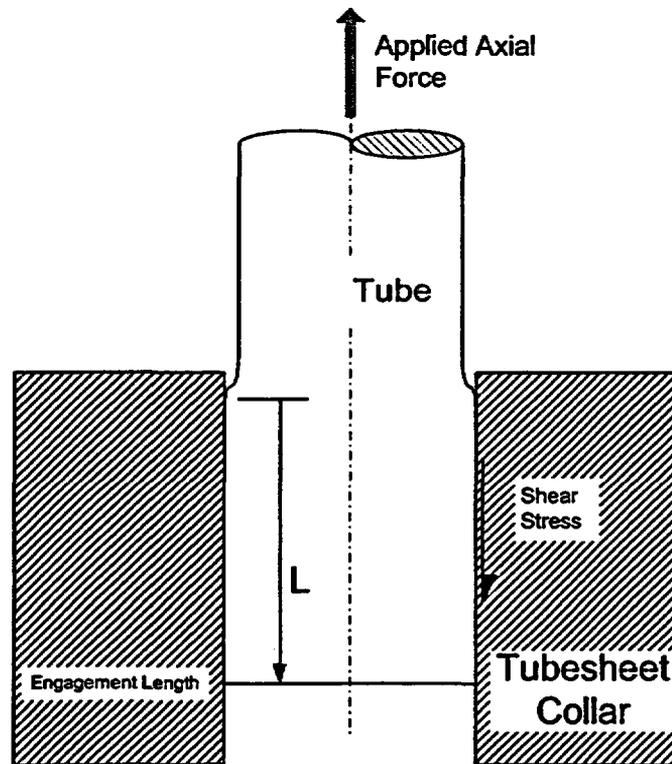
Figure B.2: Tube-to-Tubesheet Pullout Testing

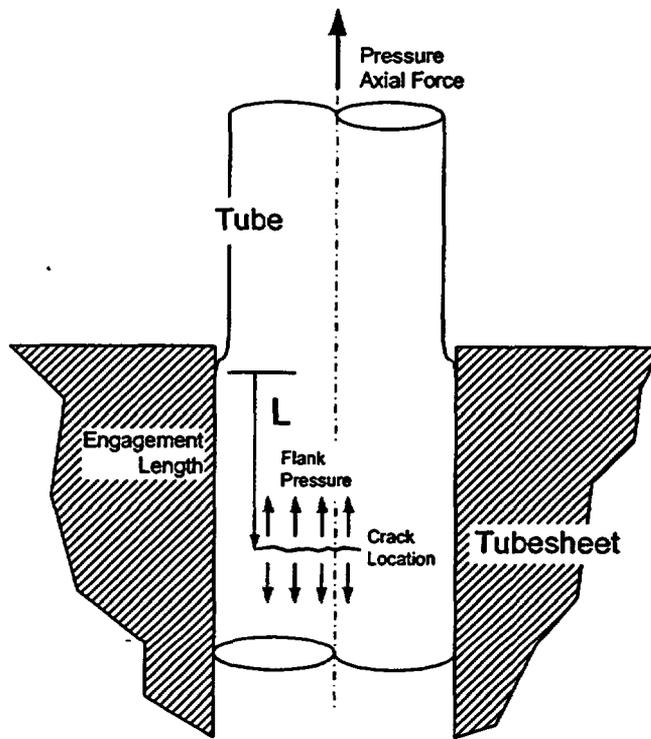
Figure C.1: Tube with circumferential crack within the tubesheet.

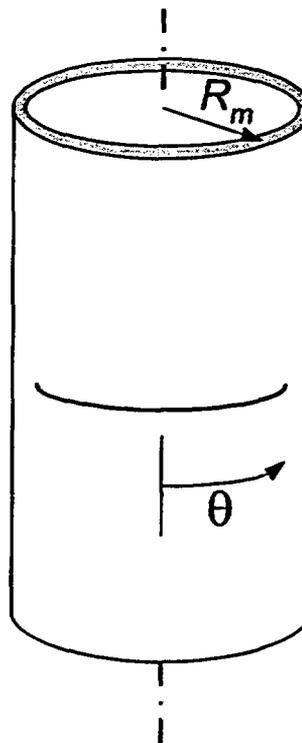
Figure C.2: Circumferential crack in a tube

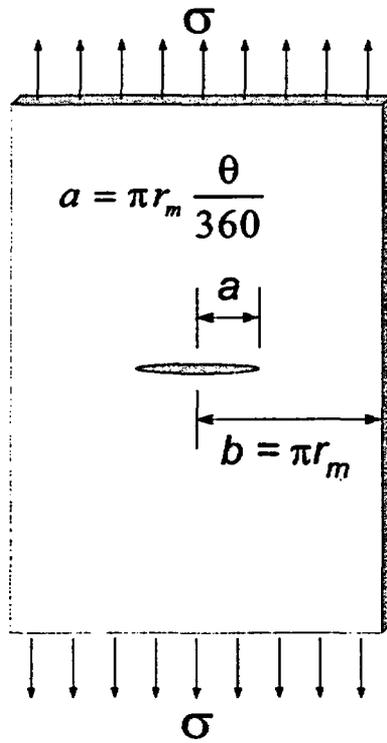
Figure C.3: Flat plate equivalent to a guided tube.

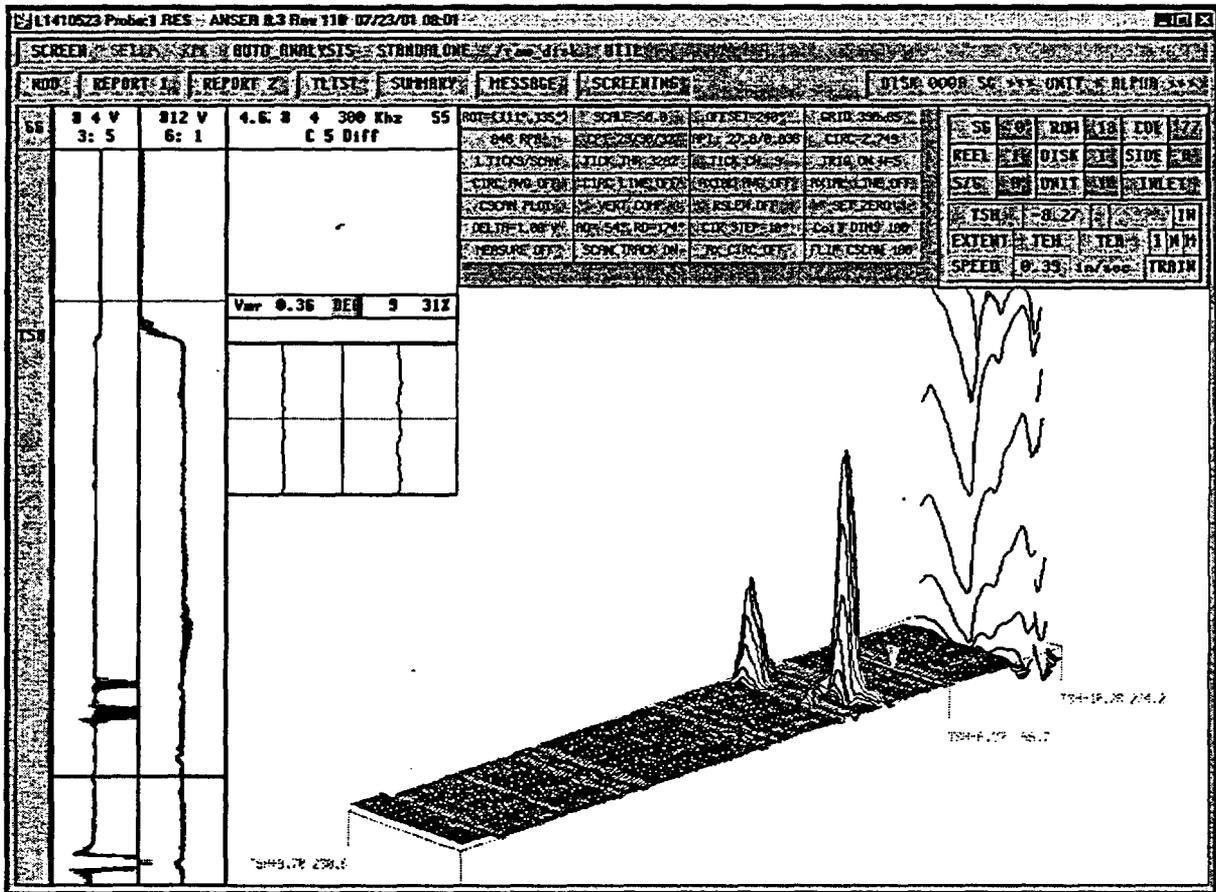
Figure D.4: Severed Tube Eddy Current Image (at 10.26")

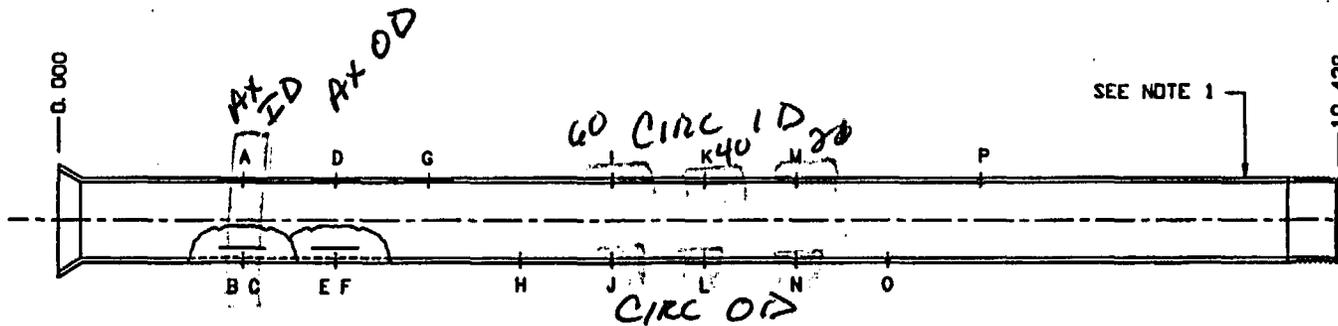
1. THE MATERIAL HEAT NUMBER, HT NX0888, AND THE AS BUILT NUMBER, 1280791B, ARE ETCHED AT THE RIGHT TUBE END.
2. THIS STANDARD WAS MADE VIA PA 83-799886-02, FTI WD 11482 AND FROM DESIGN DRAWING 1280475D-01, FOR FTI.
3. THE AS BUILT DIMENSIONS WERE OBTAINED FROM FTI SHOP DATA SHEETS, QCIR 99-00999 AND QCIR 99-01288.
4. EACH FLAW IS CENTERED ABOUT THE SPECIFIED AXIAL AND AZIMUTHAL LOCATIONS.
5. THE DEPTHS IN PERCENT THROUGH WALL (%TW) ARE BASED UPON THE ACTUAL MEAN WALL THICKNESS (MWT) OF THE TUBING, .042".

① **RPC GT CALIBRATION STANDARD**
MAT'L: ALLOY 600, .683" O.D., .042" MEAN WALL

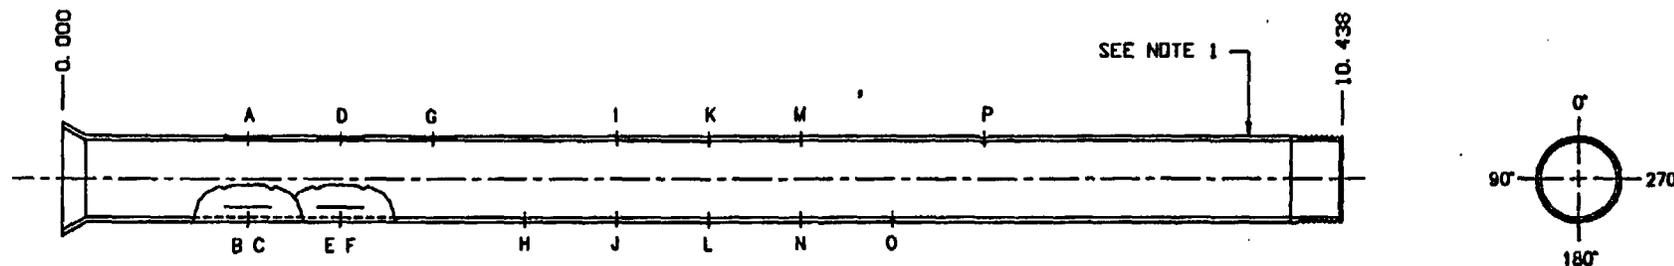
1. THE MATERIAL HEAT NUMBER, HT NX0888, AND THE AS BUILT NUMBER, 1280792B, ARE ETCHED AT THE RIGHT TUBE END.
2. THIS STANDARD WAS MADE VIA PA 83-799886-02, FTI WD 11482 AND FROM DESIGN DRAWING 1280475D-01, FOR FTI.
3. THE AS BUILT DIMENSIONS WERE OBTAINED FROM FTI SHOP DATA SHEETS, QCIR 99-00999 AND QCIR 99-01289.
4. EACH FLAW IS CENTERED ABOUT THE SPECIFIED AXIAL AND AZIMUTHAL LOCATIONS.
5. THE DEPTHS IN PERCENT THROUGH WALL (%TW) ARE BASED UPON THE ACTUAL MEAN WALL THICKNESS (MWT) OF THE TUBING, .041".

① RPC GT CALIBRATION STANDARD
 MAT'L: ALLOY 600, .682" O.D., .041" MEAN WALL

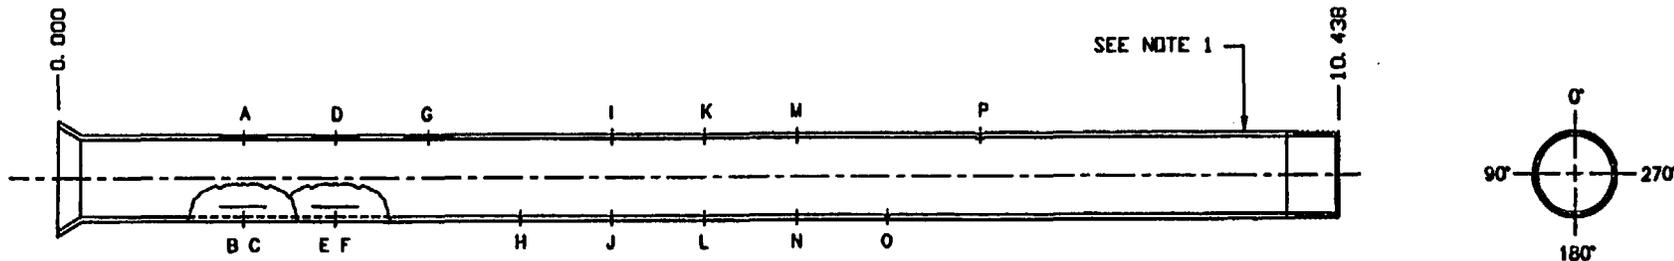
1. THE MATERIAL HEAT NUMBER, HT NX0888, AND THE AS BUILT NUMBER, 1280794B, ARE ETCHED AT THE RIGHT TUBE END.
2. THIS STANDARD WAS MADE VIA PA 83-799886-01, FTI WD 11482 AND SI 39-5005364-00, FROM DESIGN DRAWING 1280475D-00, FOR FTI.
3. THE AS BUILT DIMENSIONS WERE OBTAINED FROM FTI SHDP DATA SHEETS, QCIR 99-00734 AND QCIR 99-01091.
4. EACH FLAW IS CENTERED ABOUT THE SPECIFIED AXIAL AND AZIMUTHAL LOCATIONS.
5. THE DEPTHS IN PERCENT THROUGH WALL (%TW) ARE BASED UPON THE ACTUAL MEAN WALL THICKNESS (MWT) OF THE TUBING, .042".

① RPC GT CALIBRATION STANDARD
 MAT'L: ALLOY 600, .684" O.D., .042" MEAN WALL

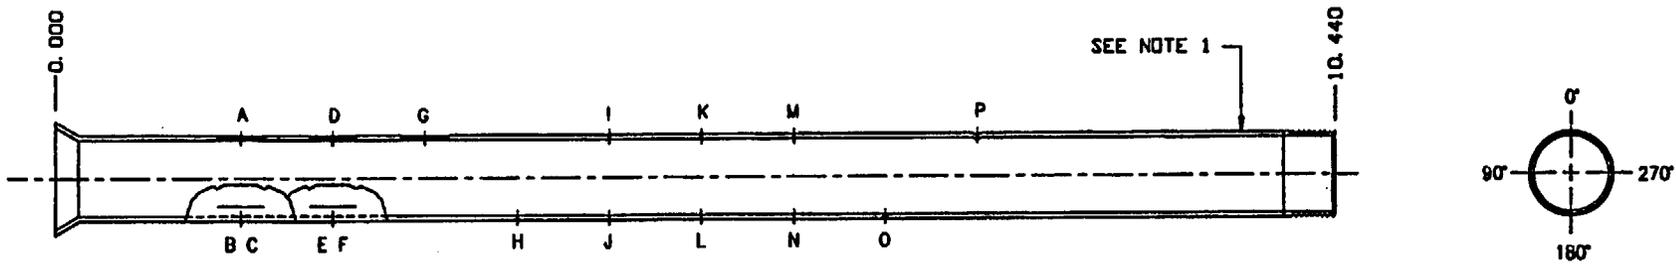
1. THE MATERIAL HEAT NUMBER, HT NX0888, AND THE AS BUILT NUMBER, 1280796B, ARE ETCHED AT THE RIGHT TUBE END.
2. THIS STANDARD WAS MADE VIA PA 83-799886-01, FTI WD 11482 AND SI 39-5005364-00, FROM DESIGN DRAWING 1280475D-00, FOR FTI.
3. THE AS BUILT DIMENSIONS WERE OBTAINED FROM FTI SHOP DATA SHEETS, QCIR 99-00999 AND QCIR 99-01087.
4. EACH FLAW IS CENTERED ABOUT THE SPECIFIED AXIAL AND AZIMUTHAL LOCATIONS.
5. THE DEPTHS IN PERCENT THROUGH WALL (%TW) ARE BASED UPON THE ACTUAL MEAN WALL THICKNESS (MWT) OF THE TUBING, .042".

① **RPC GT CALIBRATION STANDARD**
MAT'L: ALLOY 600, .684" O.D., .042" MEAN WALL

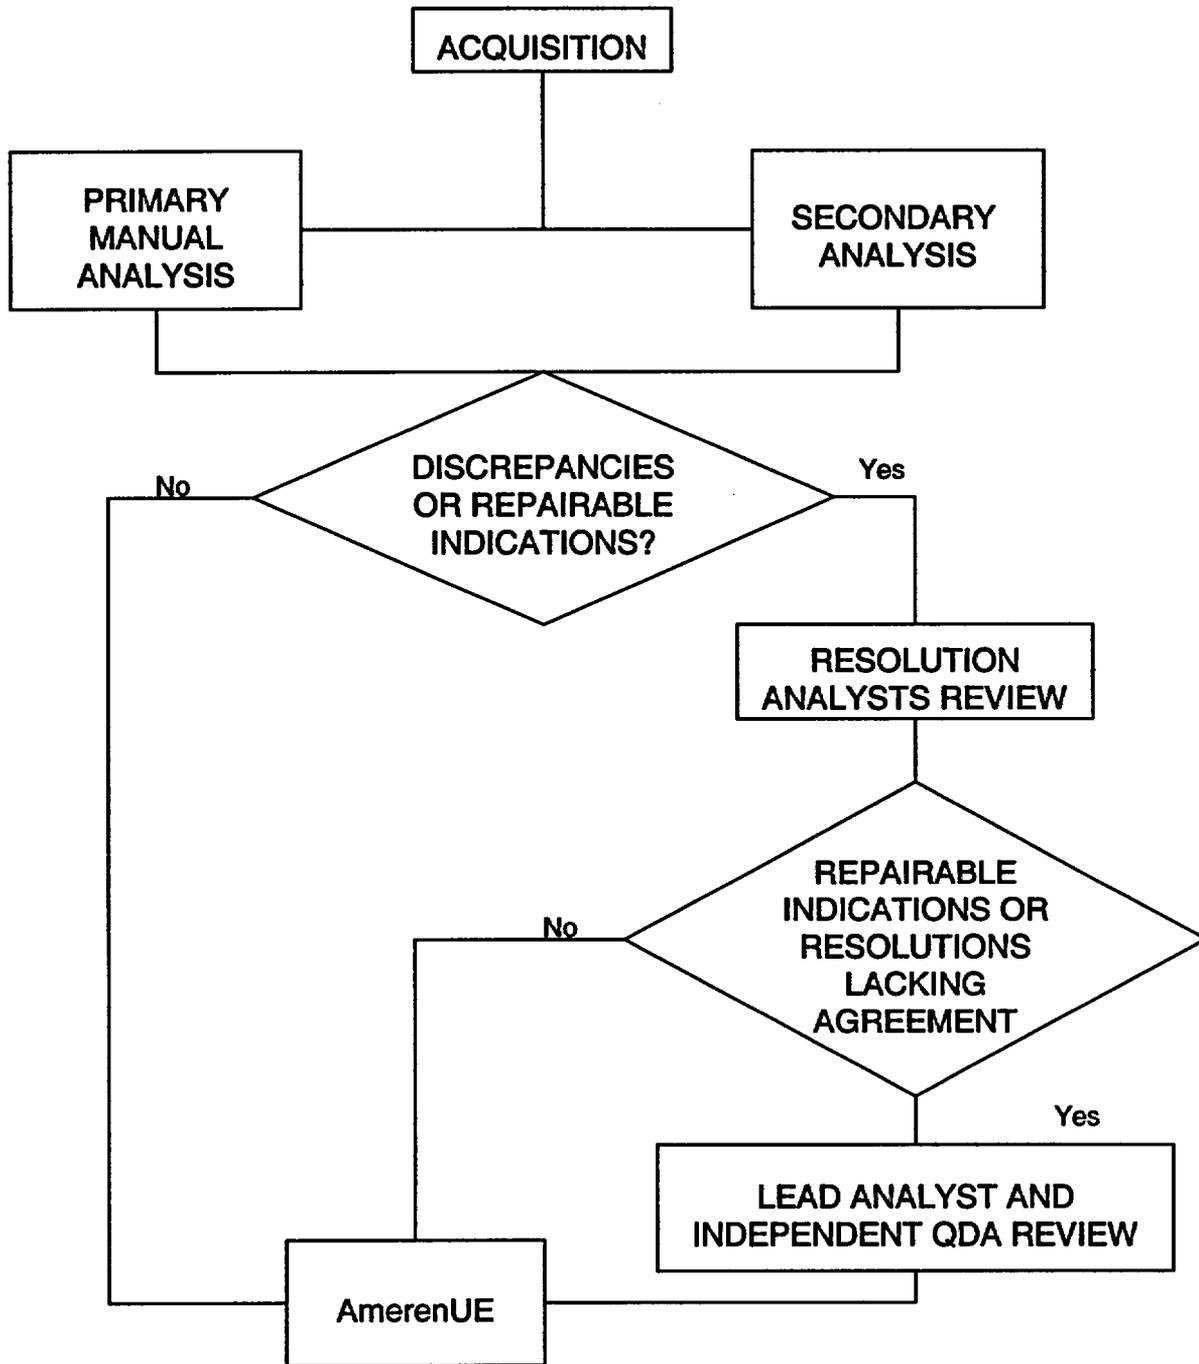
STEAM GENERATOR EDDY CURRENT TESTING DATA FLOW

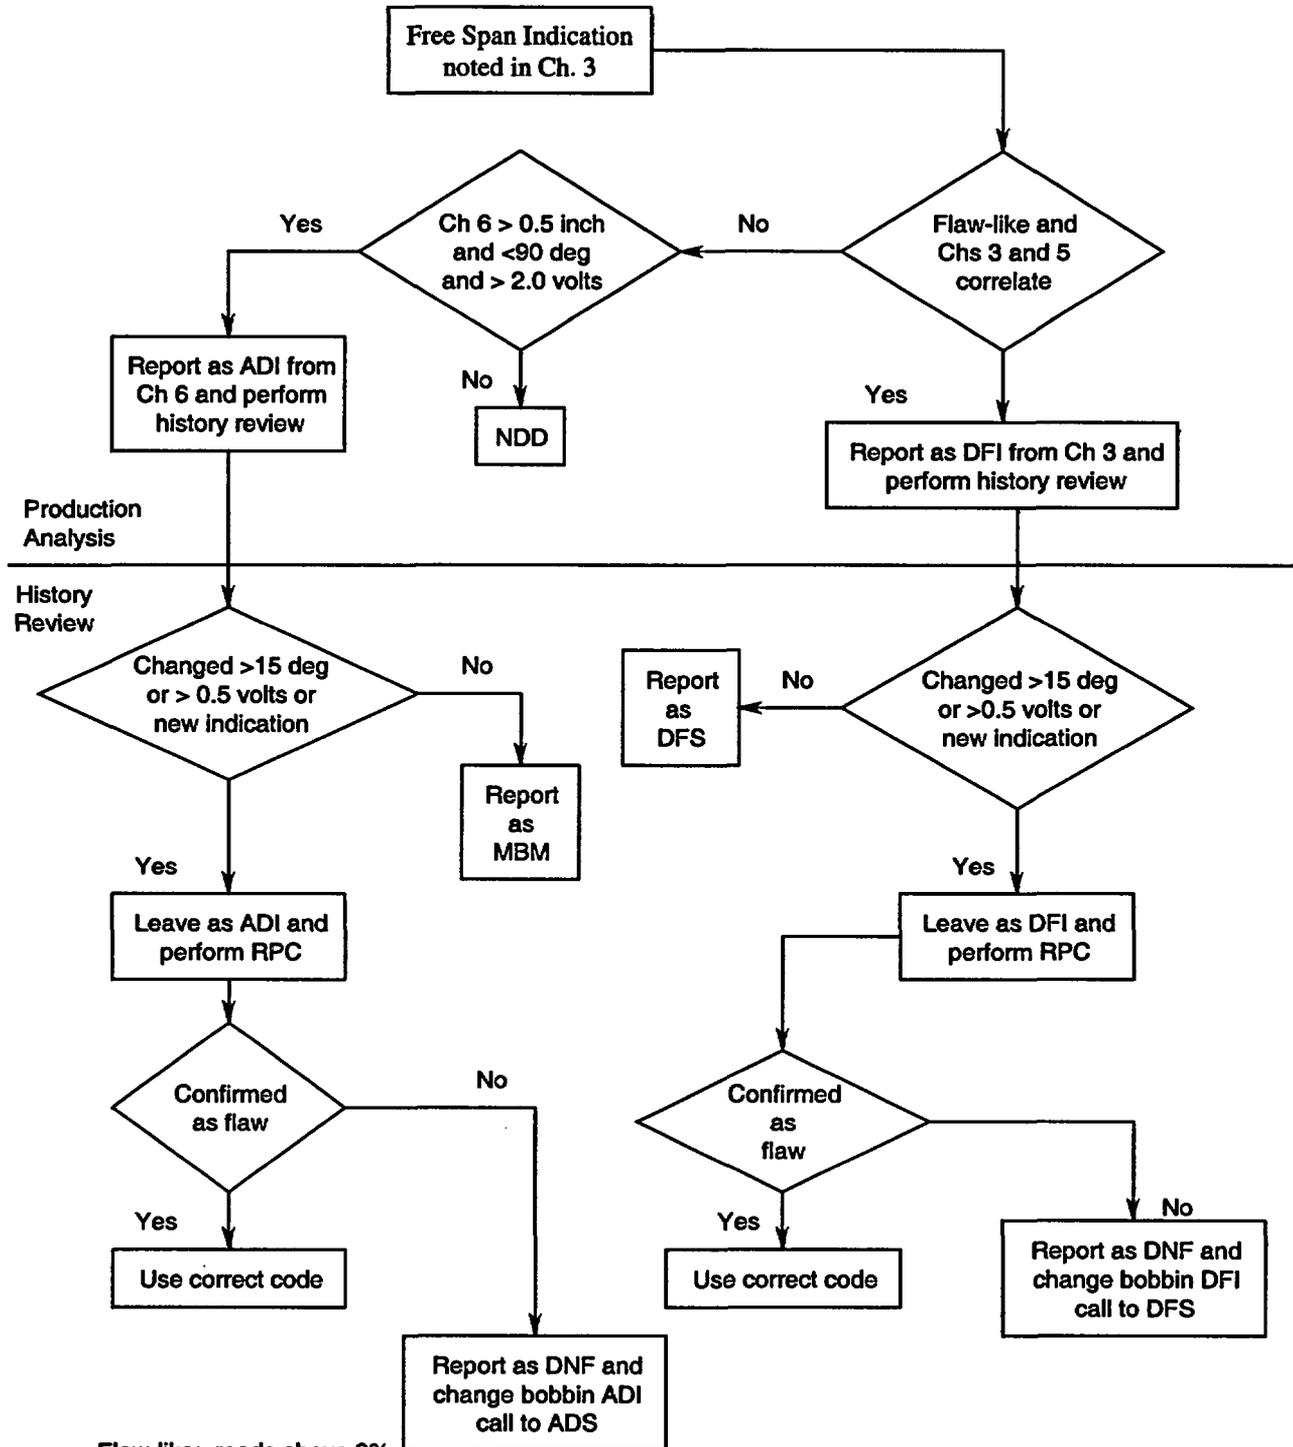
FREE SPAN BOBBIN COIL INDICATION FLOW CHART

Flaw-like: reads above 0%

Correlate: both chs 3 and 5 read above 0%

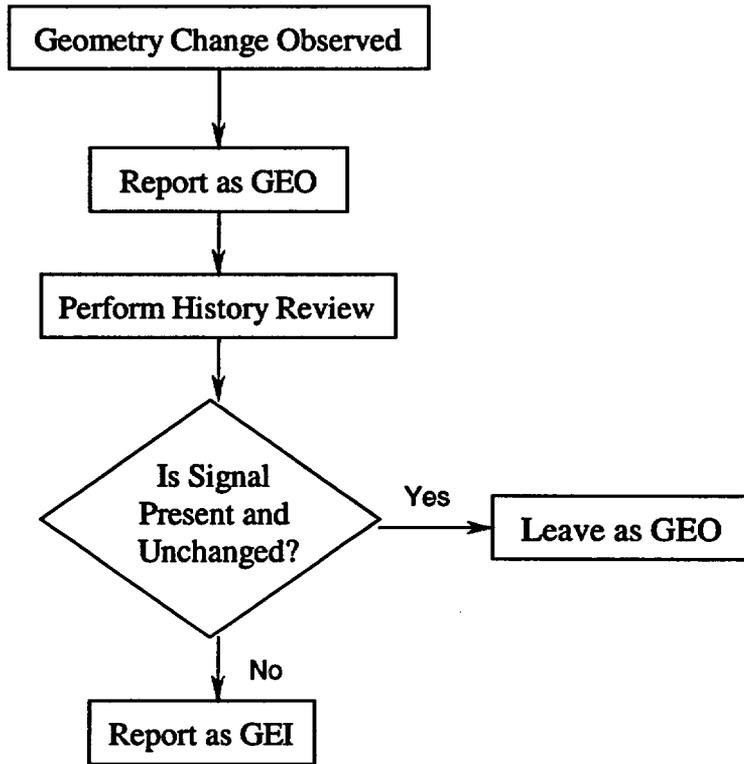
GEOMETRY CHANGE DISPOSITION FLOW CHART

History Review will be performed using RF10 data for all four SG's. If RF10 data is not available RF9 or RF8 data can also be used.

Note: When reviewing signals for change allow for some differences in phase and amplitude on the +Point channels. Due to the differential nature of the +Point coils, variations in the rotational and push speeds can result in changes in the phase and amplitude of signals produced by localized geometry changes.

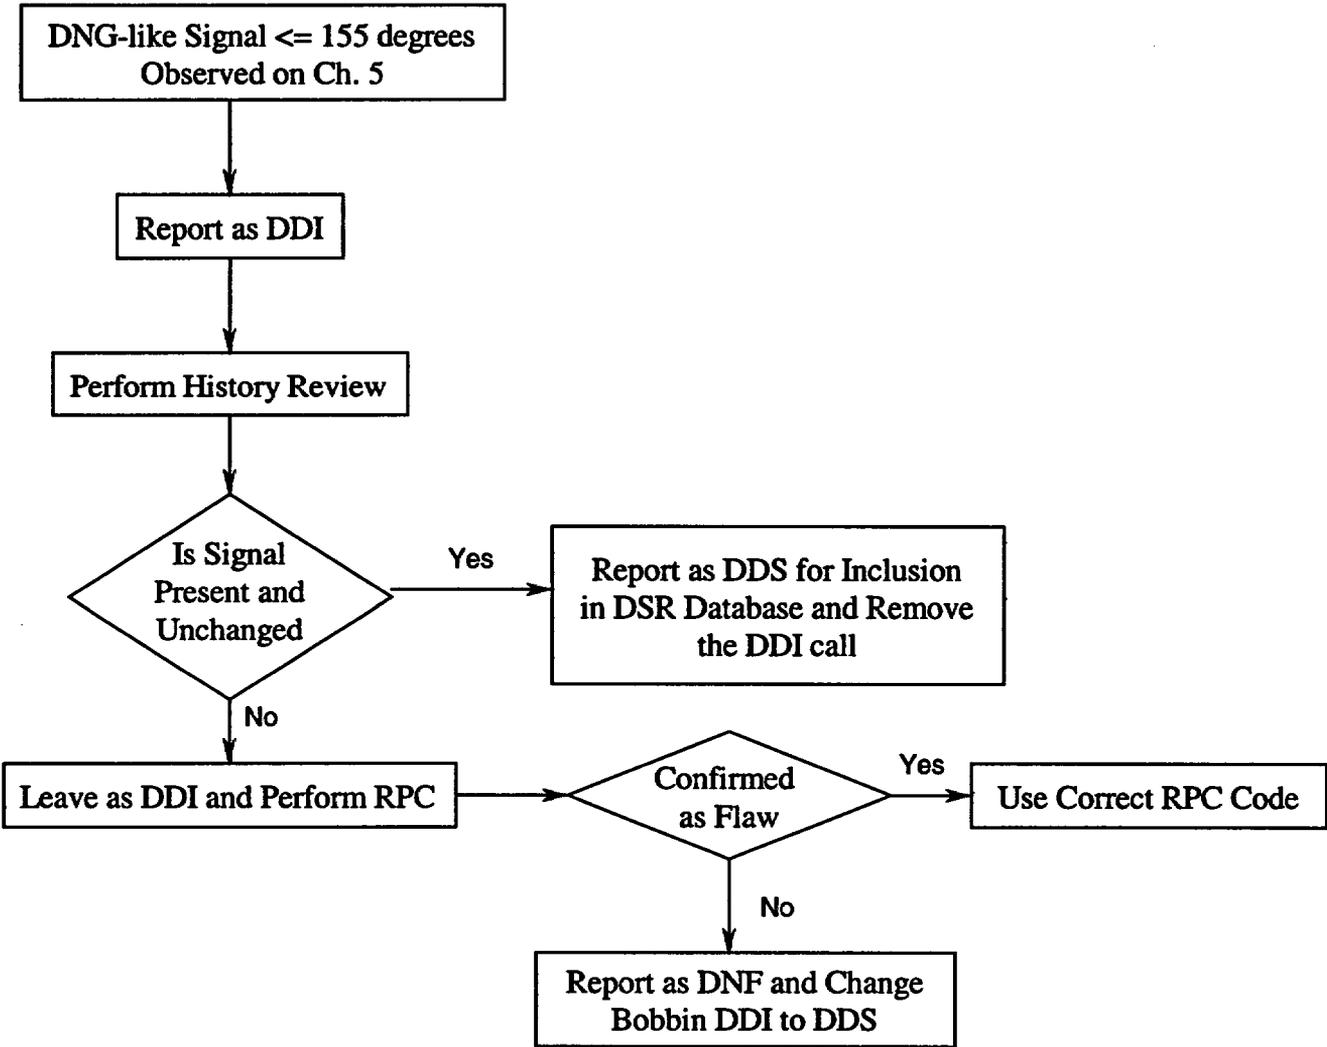
DING SIGNAL DISPOSITION FLOW CHART

If there's a previous DDS call at the current location, the history review will be performed using RF9 for SG's B and C, and RF10 for SG's A and D. New calls will be reviewed using RF5 data for SG's B and C, and RF6 data for SG's A and D.
