Spent Fuel Cladding
Containment Credit Tests

C. N. Wilson
V. M. Oversby

Waste Management 84 Conference
Tucson, Arizona
March 11-15, 1984

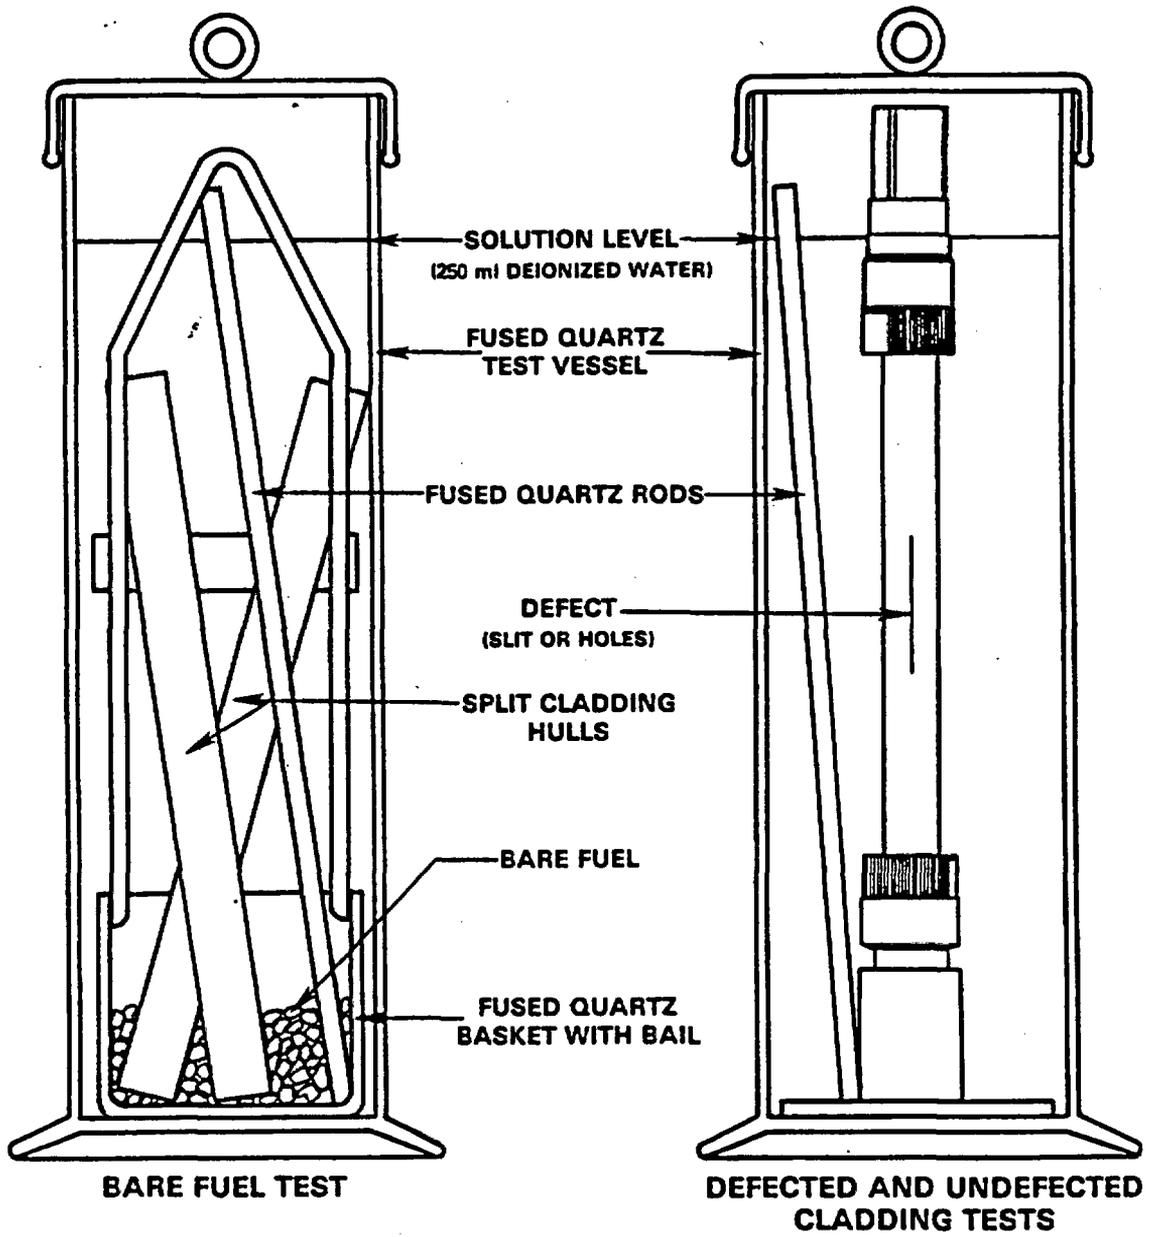
FIGURE 2. Test Apparatus.

The test apparatus is shown in Figure 2. The bare fuel and cladding hulls are placed in a fused quartz basket. As a result of thermal cracking of the UO_2 pellets during irradiation, the bare fuel material is present as pellet pieces with mean particle size in the 2 to 3 mm range. The undefected, laser drilled and slit cladding specimens are fitted with end caps which provide a water tight seal by compression of ethylene propylene O-rings against the cladding exterior. The upper end cap is vented to allow water entering the defect to fill the specimen internal free volume and completely water log the fuel. Several fused quartz rods are contained in each test vessel which can be periodically removed to monitor radionuclide plateout during the tests.

Each test vessel is initially filled with 250 ml of deionized water giving the approximate solution level shown in Figure 2. Solution samples (10 ml) are removed at day 1, 5, 15, 30 and every 30 days thereafter. Ten ml of fresh deionized water is added for each solution sample taken to maintain a constant solution level. Fused quartz rods are periodically removed, rinsed with fresh deionized water, stripped with HNO_3 and the strip solution

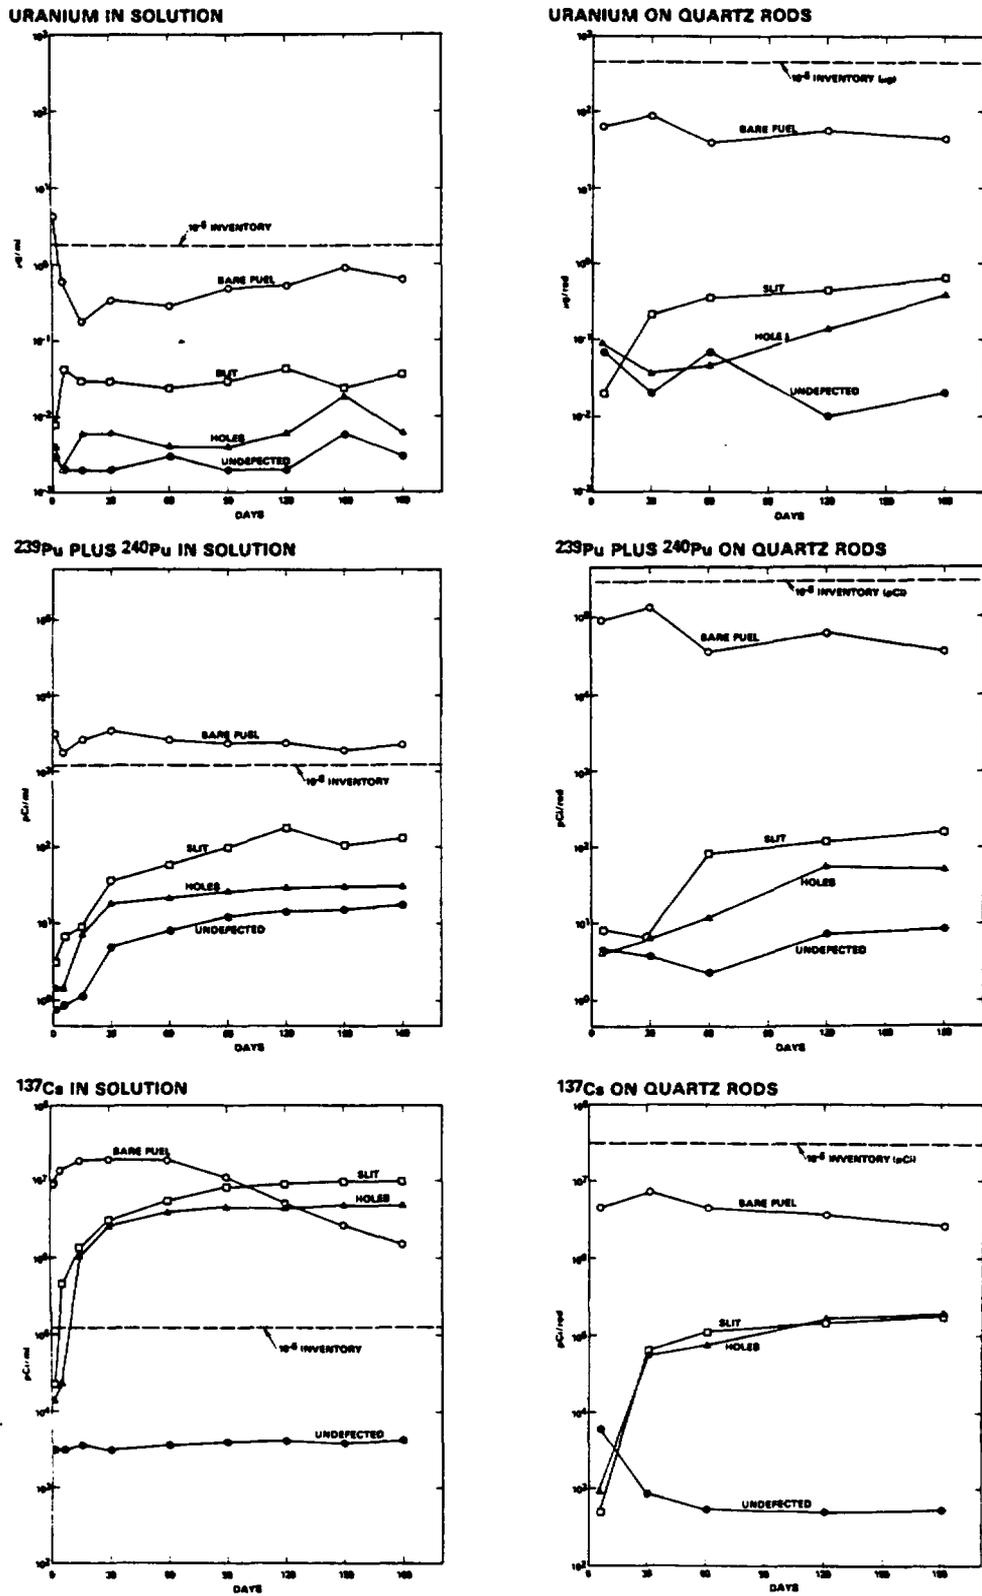
FIGURE 3. Uranium, ^{239}Pu plus ^{240}Pu and ^{137}Cs measured in solution and on fused quartz rod specimens during the first 180 days testing.

Uranium, ^{239}Pu plus ^{240}Pu and ^{137}Cs results for solution and fused quartz rod samples through 180 days are given in Figure 3. The solution concentration for each species that would result if 10^{-5} of the test specimen inventory were dissolved in the 250 ml of test solution is indicated on each of the solution data plots. The quantity of each species corresponding to 10^{-5} of the test specimen inventory is indicated on each of the fused quartz rod data plots. The 10^{-5} inventory values are given to relate the data to geologic repository release rate limits given in 10 CFR 60,⁽⁴⁾ and are established using ORIGEN code calculated inventory data for PWR fuel 10 years after discharge.⁽⁵⁾ The 10CFR60 limits are based on 1000 year inventories. For uranium and plutonium the 10 and 1000 year inventories are similar; ^{137}Cs has decayed to negligible levels by 1000 years after disposal. Data given in each plot for the "undefected" specimen indicates released levels for each species from cladding exterior surface contamination. The primary source of the cladding exterior contamination is sectioning and handling of the fuel specimens in contaminated hot cells. The cladding exterior surfaces were decontaminated to approximately 50 dpm smearable alpha prior to final specimen preparation in a clean hot cell. However, the remaining exterior contamination levels are most likely greater than those to be expected on whole fuel rods received at a repository.

It is interesting to note from the Figure 3 data that most of the release in both the bare fuel and defected cladding tests appears to have occurred during the first 30 days. Substantially reduced releases of uranium and plutonium were observed in the defected cladding tests in comparison to the bare fuel test. Reduced uranium release with the defected cladding specimens is particularly noteworthy since, after an initial preferential release of highly soluble fission products such as cesium, it is expected that UO_2 matrix dissolution will control radionuclide release. Localized solution oxygen depletion and saturation effects within the defected cladding may account for the observed lower actinide release from these specimens.
