PRELIMINARY FISSION-PRODUCT AND POST-IRRADIATION EXAMINATION  
RESULTS FROM THE BTF-105B LOCA/LOECC TEST

J.D. IRISH, S.T. CRAIG AND P.J. VALLIANT

Fuel Safety Branch  
Reactor Safety Division  
AECL, Chalk River Laboratories  
Chalk River, Ontario, Canada K0J 1J0

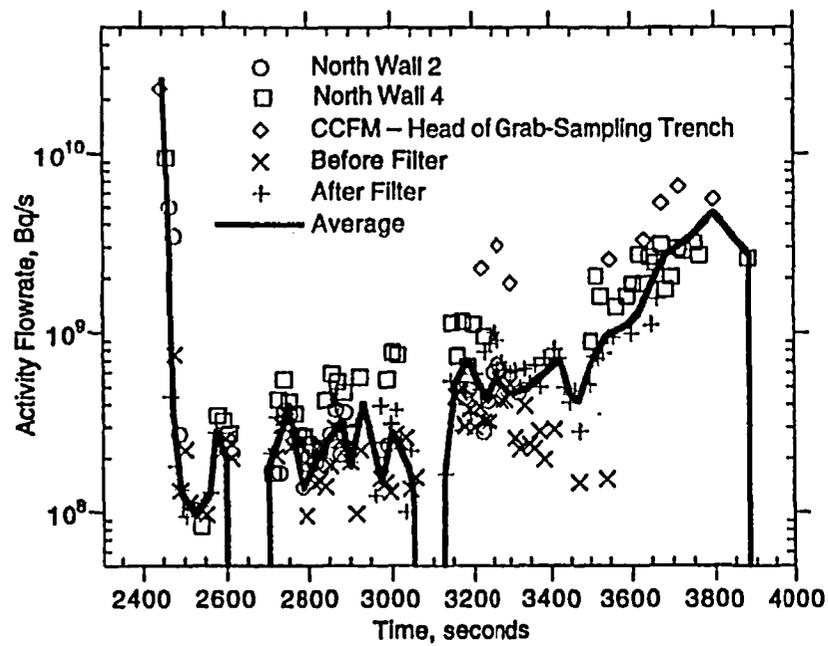
$^{135}\text{Xe}$  flowrates during the transient are plotted in Figure 1 along with the average flowrate used for integrating the total release. Initially five spectrometers detected  $^{135}\text{Xe}$  and were in good agreement. As iodine deposits increased, the measurements diverged and  $^{135}\text{Xe}$  detection ceased. Consequently, total release as measured at the blowdown tank and by samples taken from the tank are considered more reliable. Integrated activity flowrate values for  $^{85\text{m}}\text{Kr}$ ,  $^{88}\text{Kr}$ , and  $^{135}\text{Xe}$  are included in Table 1.

FIGURE 1:  $^{135}\text{Xe}$  ACTIVITY FLOWRATE

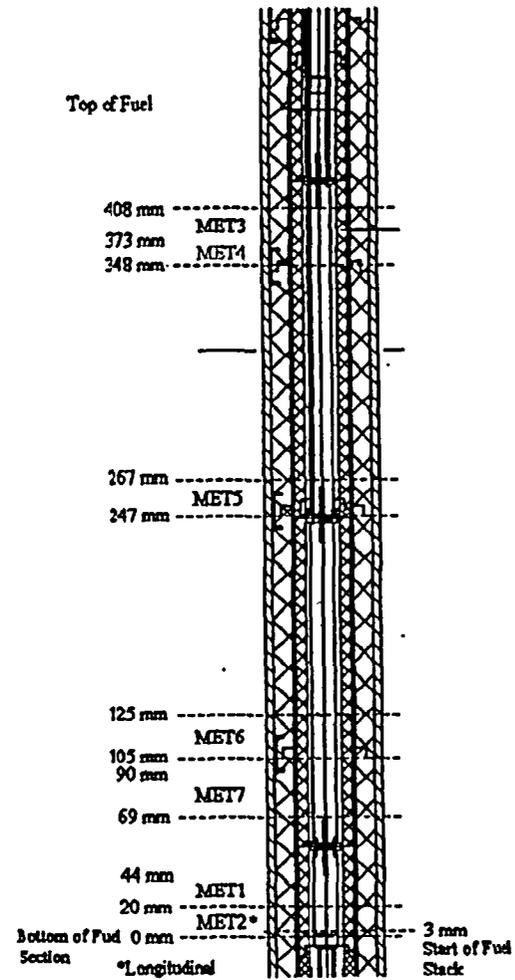
After the transient, the fuel element was destructively examined in hot cells. Transverse sections were taken at five axial locations as indicated in Figure 2 for metallographic examinations. Coolant flow was downward over the fuel element; therefore, temperatures would have been higher towards the bottom end of the fuel element.

FIGURE 2: CUTTING DIAGRAM

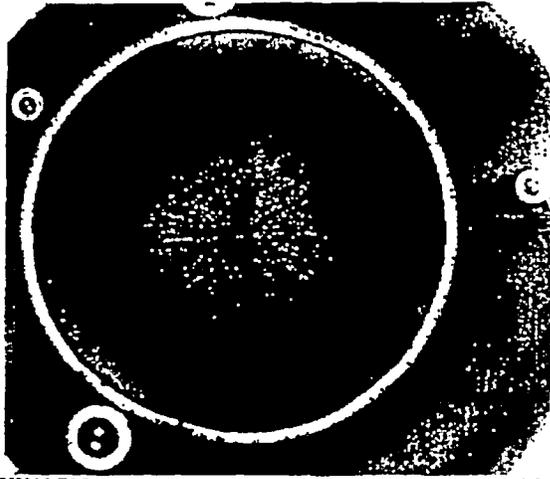
KK19C15 4.8x

Figure 3 shows the fuel cross-section at 373 mm from the bottom of the element. This figure shows the fuel element, most of the coolant channel and, in the corners, part of the  $\text{ZrO}_2$  shroud which surrounded the coolant channel. This area was remote from the area of maximum damage near the bottom of the element. Aside from a crack through the sheath wall, a fairly uniform oxide layer thickness of 80 to 125  $\mu\text{m}$  and a slight ellipticity, the sheath was not severely damaged. The fuel was cracked but none appears to be missing and there was extensive columnar grain growth. This grain growth was observed in a sister element following the initial irradiation and is not a product of the BTF-105B irradiations. All of the thermocouples in the coolant channel at this elevation appear to be in good mechanical condition and show minimal sheath oxidation. For example, see the cross-section through a Ti/Zr/Ta-sheathed thermocouple, shown in Figure 4.

FIGURE 3: CROSS-SECTION AT 373 mm

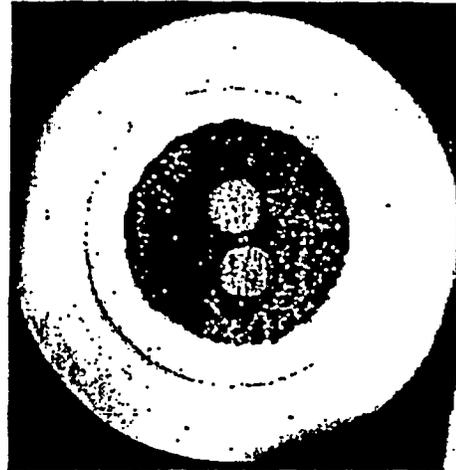
KK19C25 33x

FIGURE 4: THERMOCOUPLE AT 373 mm

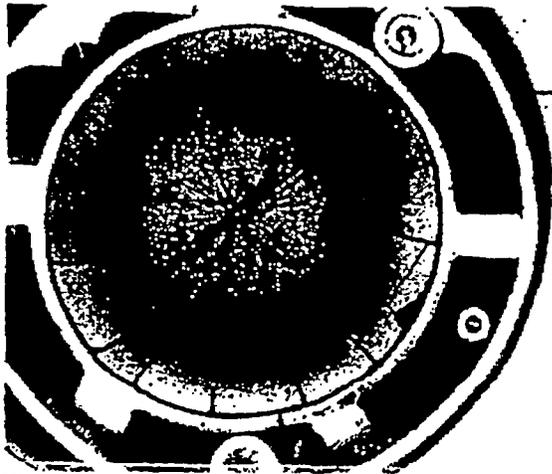
KK19E21 4.8x

Figure 5 shows the fuel cross-section at 247 mm. The fuel element, coolant channel, and a Zircaloy strap surrounding the element to hold a thermocouple against the fuel sheath are shown. The strap was intact and hadn't shifted from its original position, indicating that it performed its function. The sheath was in reasonably good condition with one through-wall crack. There were columnar grains in the centre. In the equiaxed region close to the boundary with the columnar grains, there is a dark ring in the fuel. This was seen at other elevations but was most pronounced at this elevation. The dark band is an indication that there was steam ingress, causing the  $\text{UO}_2$  to become oxidized.

FIGURE 5: CROSS-SECTION AT 247 mm

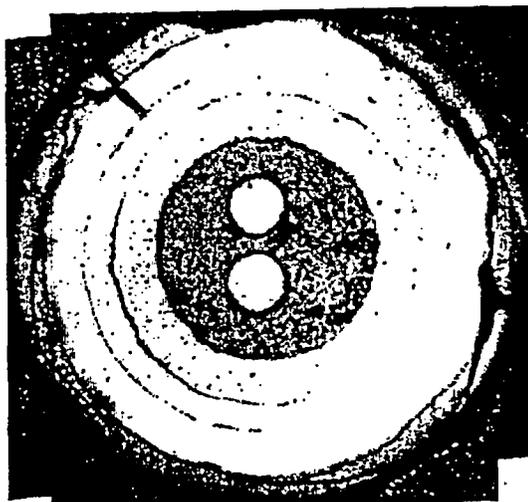
KK19A12

Gamma radiography identified the region below 20 mm as likely to be the most damaged. Figure 7 shows the fuel cross-section at 20 mm. At this elevation only one quarter of the sheath remained. Again, the oxide layer was much thicker at one end of the sheath fragment than at the other end, approximately the thickness of the wall at one end. There was little or no oxide on the inside of this sheath fragment, indicating that this region of the inside of the sheath was not exposed to steam while the element was at high temperature. Large chunks of fuel were missing. A cross-section through a Ti/Zr/Ta-sheathed thermocouple, shown in Figure 8, indicates that although the Ti was oxidized and cracked, thermocouple integrity was not compromised.

FIGURE 8: THERMOCOUPLE AT 20 mm
