Brookhaven National Laboratory Report

BNL-NUREG-34790 (1984)

IMMERSION TEST AND SURFACE STUDIES FOR CREVICE CORROSION OF
GRADE-12 TITANIUM IN A BRINE SOLUTION AT 150°C

AN ELECTROCHEMICAL STUDY OF CREVICE CORROSION OF
GRADE-12 TITANIUM IN A BRINE SOLUTION AT 150°C

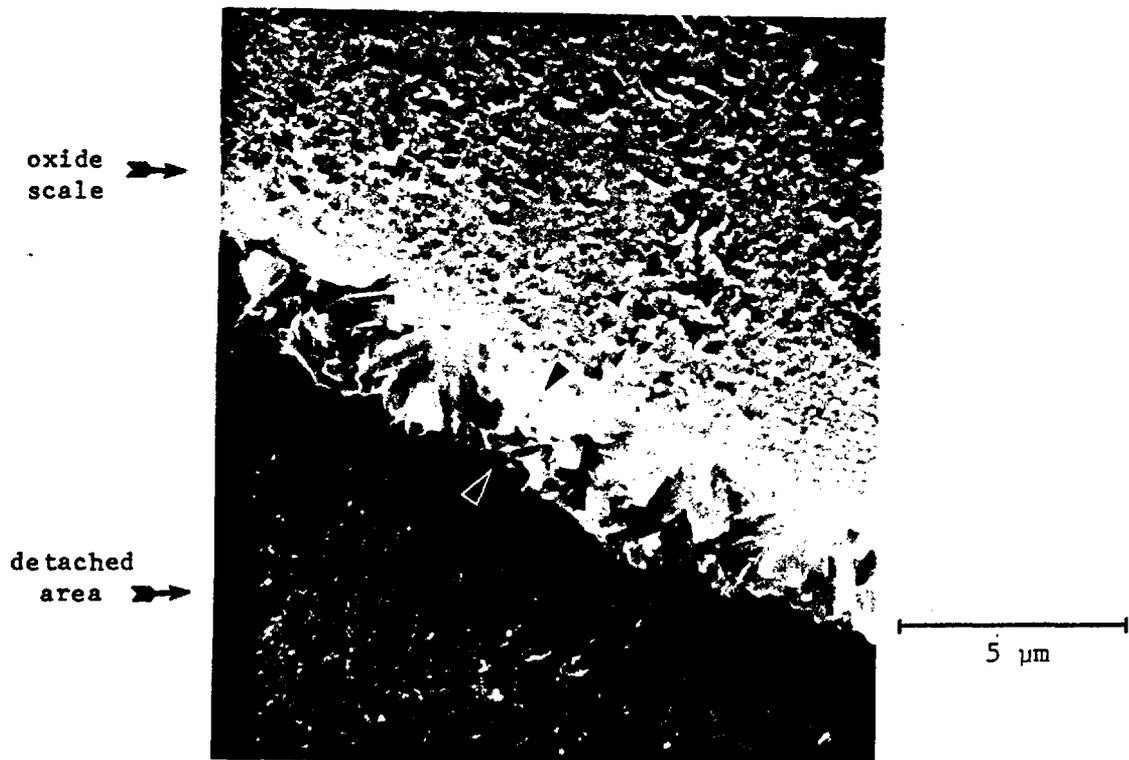
Figure 2. Detached oxide inside a Grade-12 titanium crevice after six weeks' exposure in aerated Brine A at 150°C. Arrow indicates the thickness of oxide.

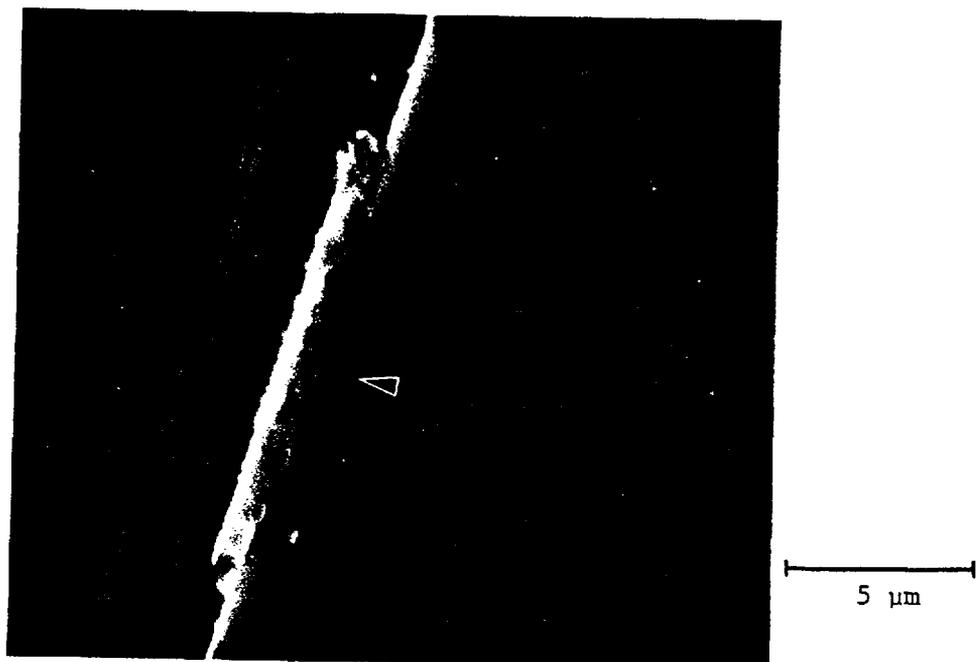
probe. Prior to the EDAX probe measurements, the sample was mounted in epoxy to reveal the cross section of the sample preserving the oxide adhered (Figure 3). The EDAX results were confirmed by Rutherford Backscattering and Auger Spectroscopic Analysis of which procedures are described elsewhere (see Acknowledgment).

Figure 3. Intact oxide used for chemical analysis by EDAX (arrow mark). The oxide was obtained from a Grade-12 titanium crevice after six weeks' exposure in aerated Brine A at 150°C.

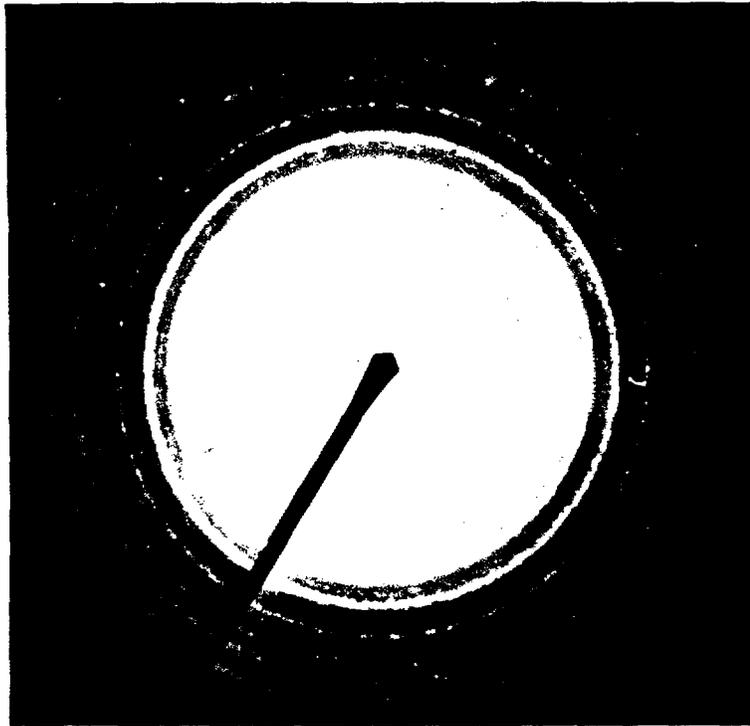
were selected for electron diffraction. Regardless of the color, the diffraction patterns showed strong anatase TiO_2 peaks with traces of Ti_3O_5 also present. A typical diffraction pattern is shown in Figure 4. The anatase form of TiO_2 was mostly present as block-shaped crystals as shown in Figures 5 and 6. For exposures of over two weeks, the largest samples (2 x 4 cm) with the smaller crevice gaps (metal/Teflon) showed a major black corrosion product. This was composed of the rutile form of TiO_2 as identified from the diffraction pattern in Figure 7. The rutile was in the form of needle-shaped crystals as shown in Figures 8 and 9.

Figure 4. Typical diffraction pattern of anatase in an ASTM Grade-12 titanium crevice. A lower oxide peak is also noticeable. The film was selected from a sample which was immersed in Brine A at 150°C for four weeks.

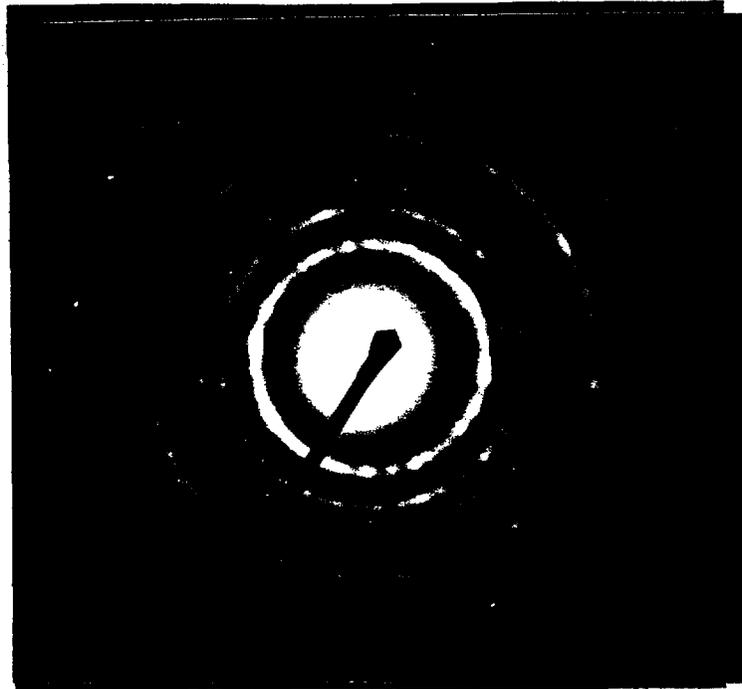
Figure 7. Typical diffraction pattern of rutile in an ASTM Grade-12 titanium crevice. The film was selected from a black oxide area in a sample which was immersed in Brine A at 150°C for two weeks.

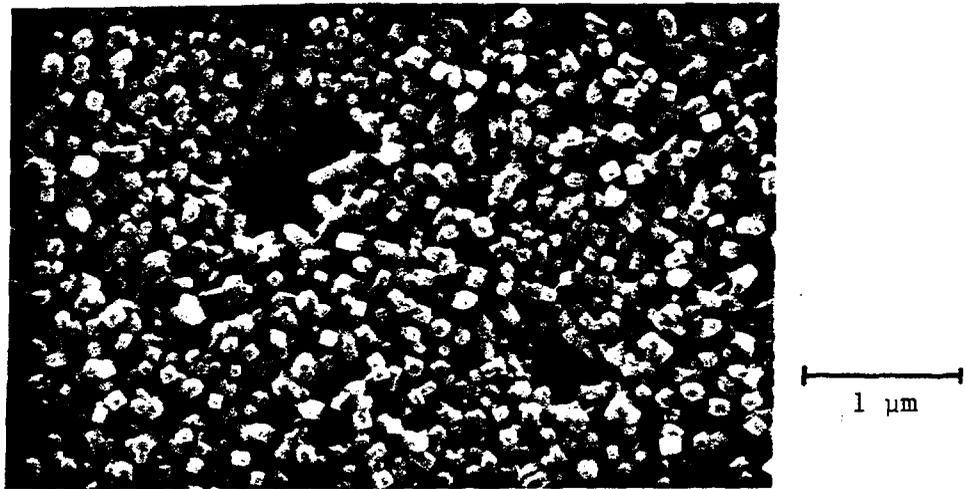
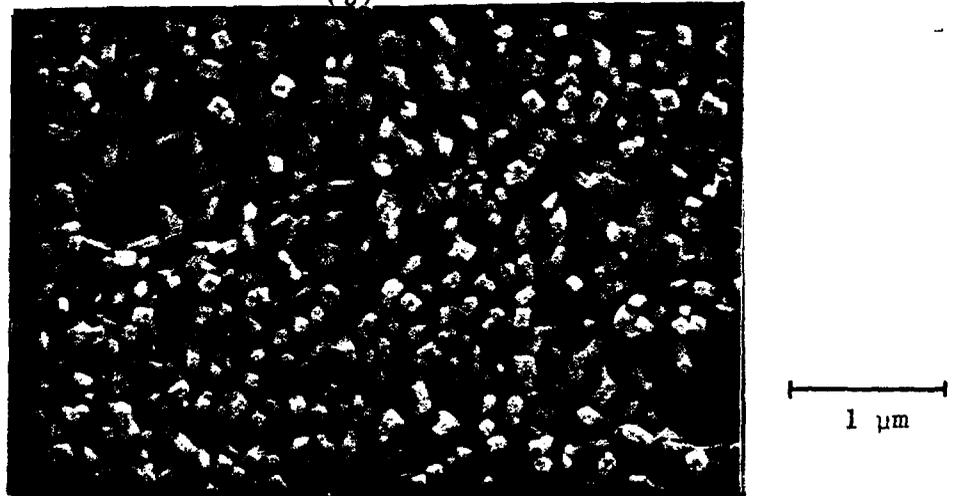
Figure 11. Pit-type morphology in rutile crystals from an ASTM Grade-12 crevice sample exposed for six weeks in oxygenated Brine A at 150°C.

A typical example of severe attack is shown in Figure 10. The degree of attack is determined using the SEM as shown in Figure 1. A type of pitting is often observed in such severely attacked specimens as shown in Figure 11.

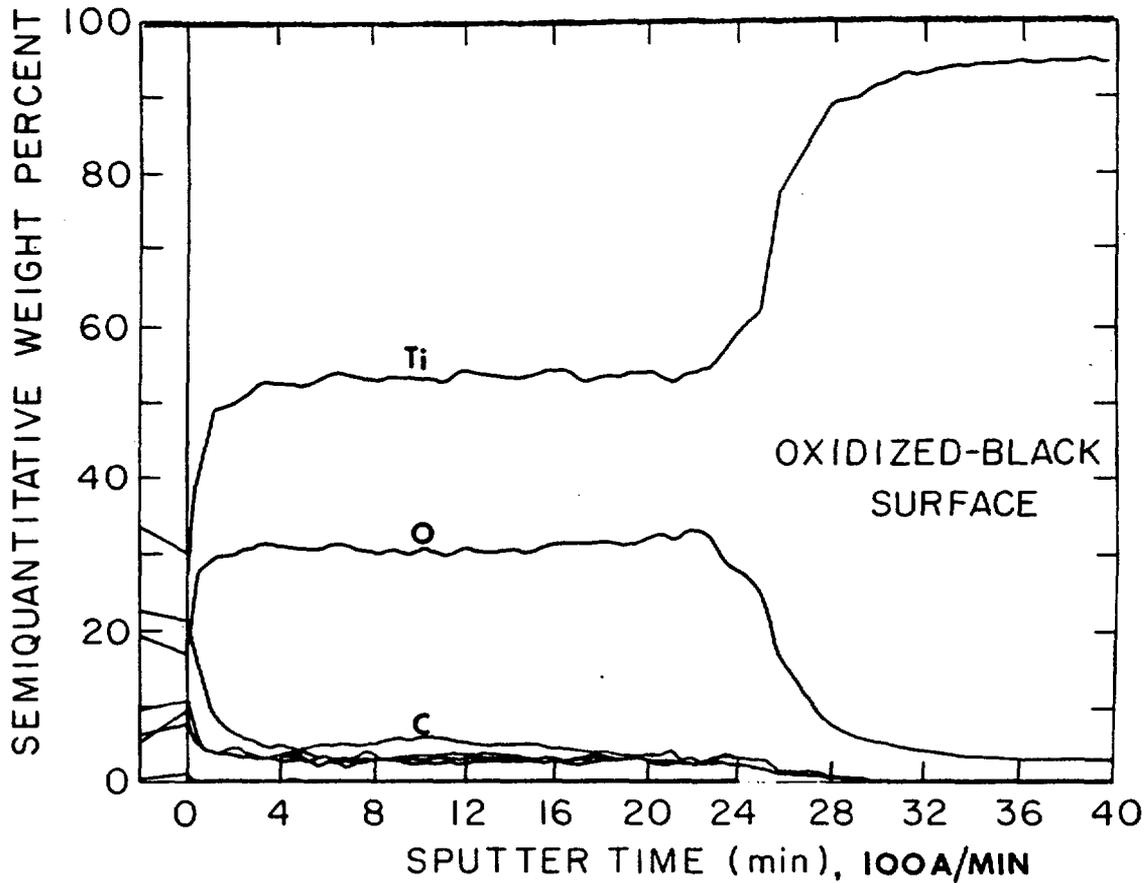
Figure 12. Auger spectrum of the crevice corrosion product and base metal of the sample used for EDAX analysis.

Table 3 shows the EDAX analysis of the crevice corrosion products. They are shown to be enriched in Mo and depleted in Ni, compared to the starting material. However, the Auger spectrum and the Rutherford Backscattering spectrum did not detect these two elements (Figures 12 and 13).

The penetration depth for EDAX analysis is about 4 μm while those for Auger spectroscopy and Rutherford Backscattering are 10 nm and 200 nm respectively. Therefore, Mo is depleted in top 200 nm of the corrosion products near to the solution while the interior of the oxide are enriched with Mo. This may be attributed to the redissolution of Mo by local pH variation although detailed mechanisms are left for future studies.

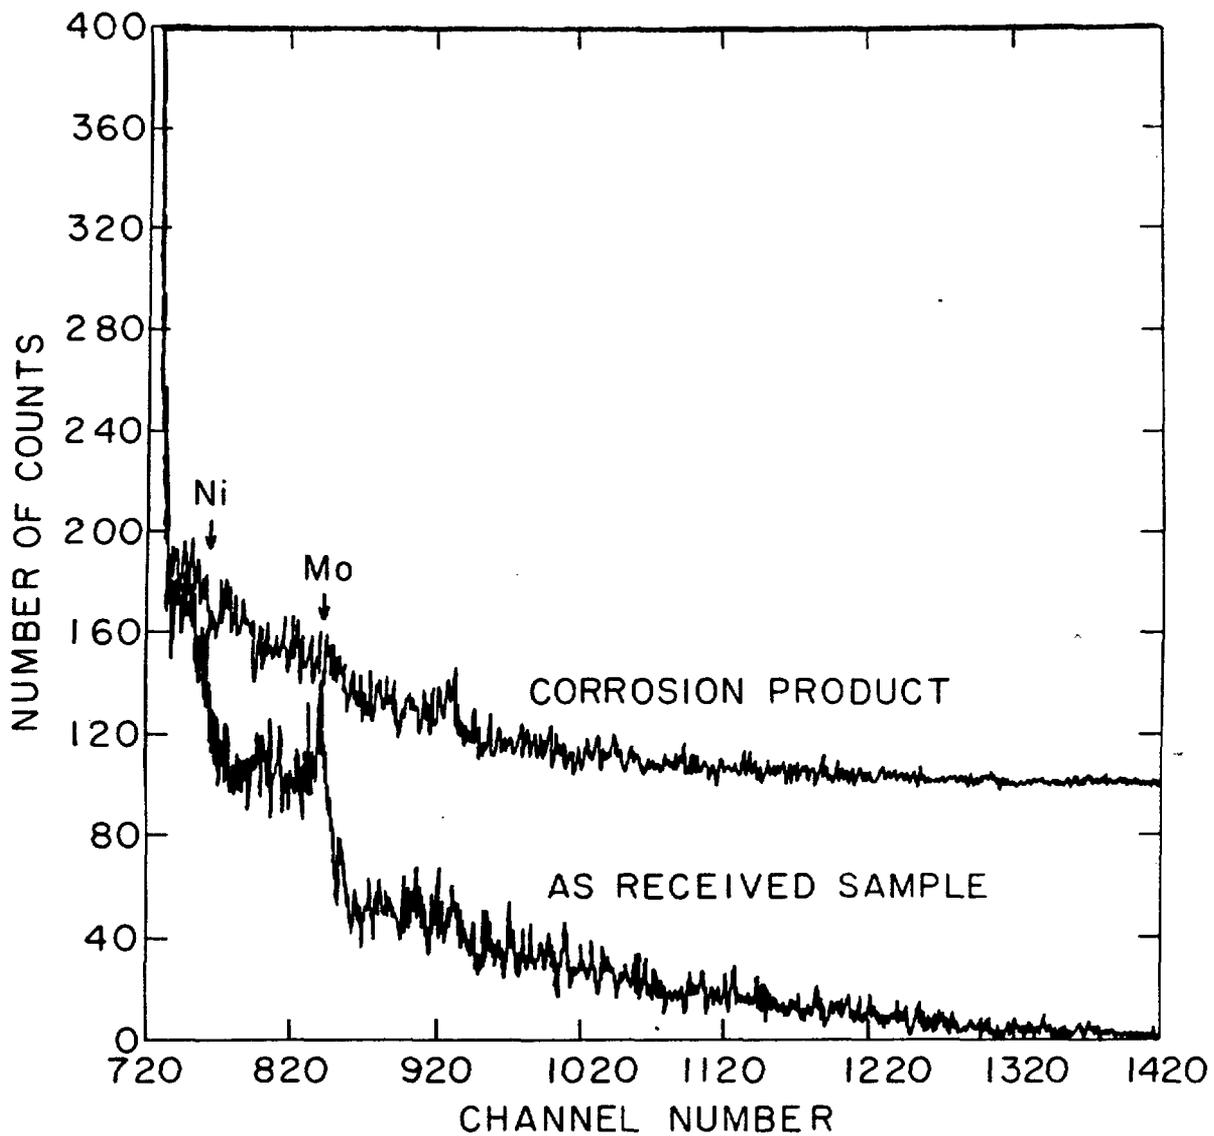
Figure 13. Rutherford backscattering spectrum of the crevice corrosion product of the sample used for EDAX analysis.

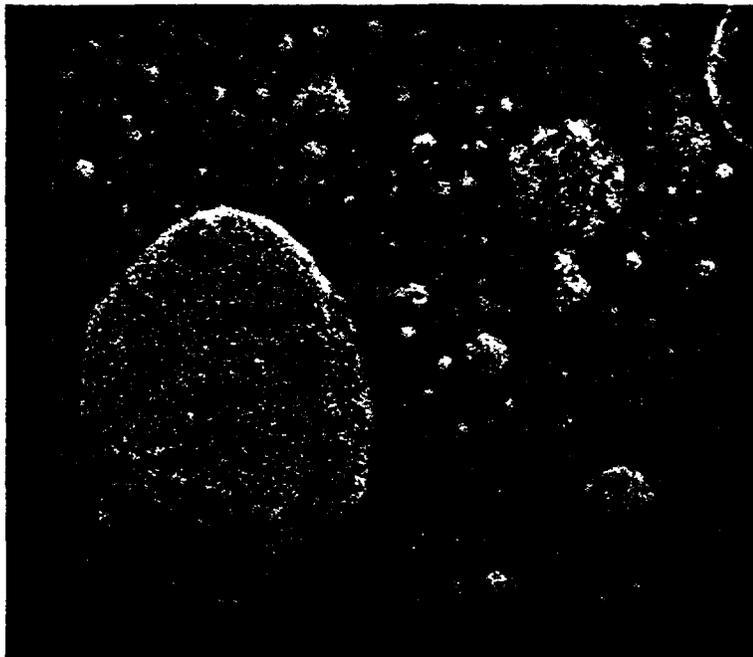
Figure 15. Growing rutile domains in a crevice of ASTM Grade-12 titanium exposed to Brine A at 150°C.

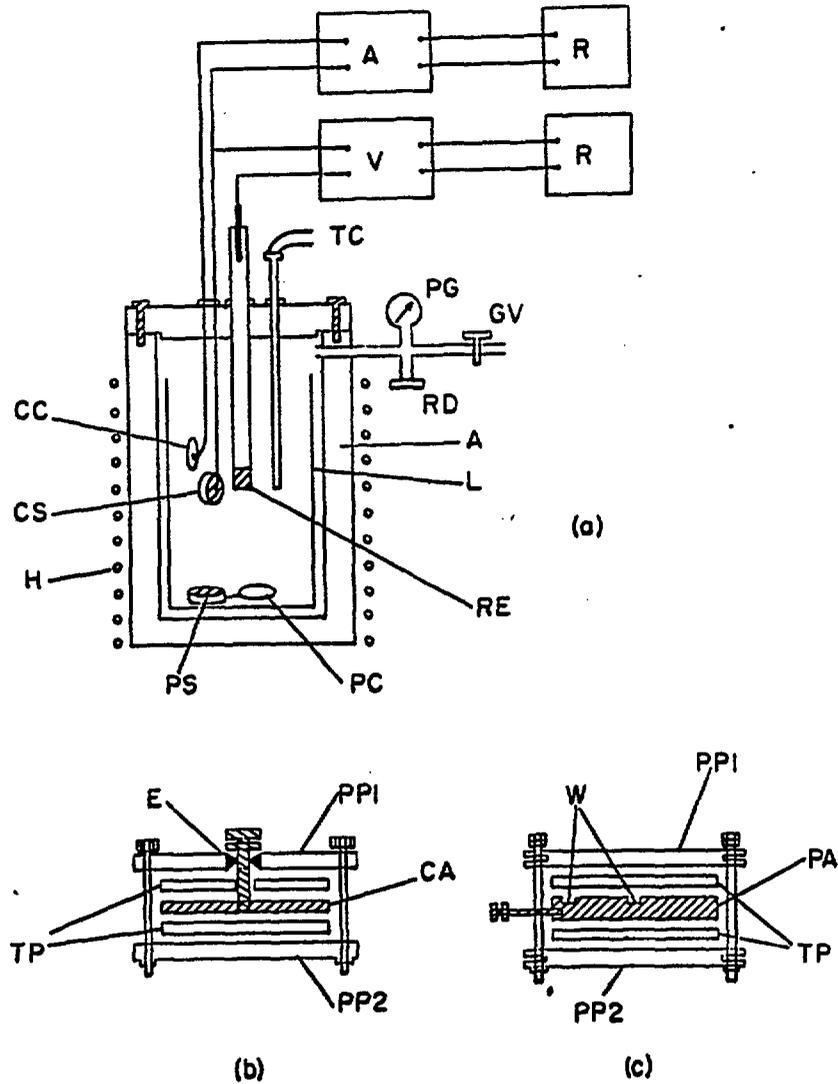
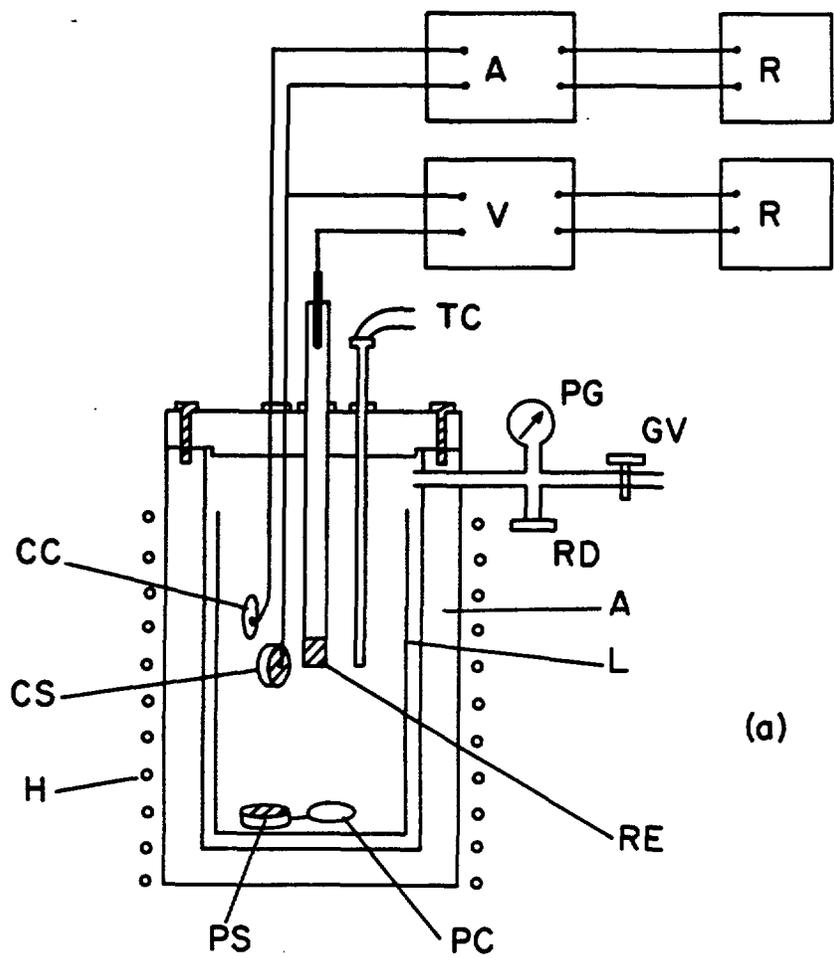
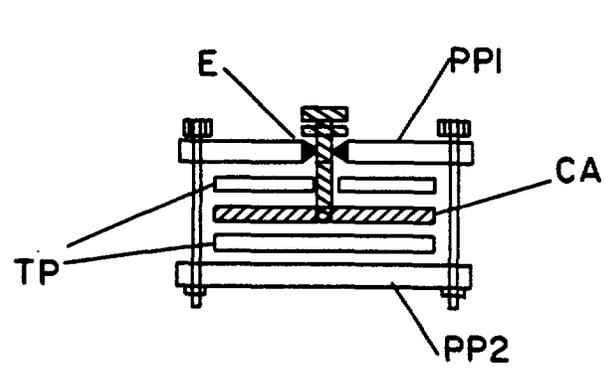
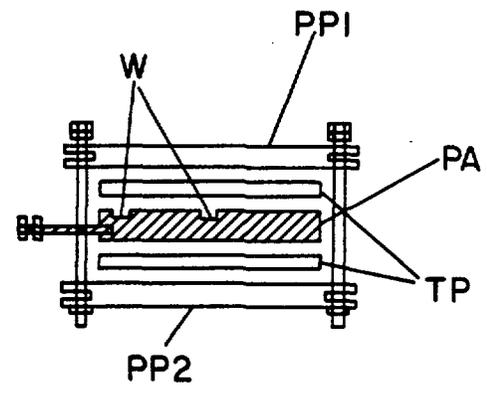
physically separated but connected externally through a current measuring device; a potentiometer monitors the potential with respect to a reference electrode. The current gives an indication of the corrosion rate, whereas the potential can give useful information on crevice conditions. In the present study, the test temperature of 150°C requires the use of an autoclave system. Since Grade-12 titanium is known to be highly corrosion resistant, a very tight crevice is needed to cause attack. This, however, prohibits in situ monitoring of the crevice pH. Consequently, a separate thick crevice specimen with small wells of diameter 0.14 cm was included in the tests to collect a sample of crevice solution, which is used after test completion to measure the pH at room temperature. The test cell and the configuration of the current and pH specimen assemblies are shown schematically in Figure 1; the details are described elsewhere.⁽²⁾ All of the cathode and anode specimens are 5-cm diameter discs. The anode specimen is mirror polished to facilitate the formation of a tight crevice when it is sandwiched and pressed between two Teflon discs of the same size. The connecting lead wires made by

Figure 1. Schematic diagram of the testing equipment for monitoring crevice corrosion under hydrothermal conditions (a) autoclave and accompanying current/potential measuring assembly. AC: stainless steel autoclave, L: Teflon liner, PLG: pressure gage, RD: rupture disc, GV: gas control valve, TC: chromal-alumel thermocouple encased in titanium sheath, R: Ag/AgCl (saturated KCl) reference electrode, CC and CS: Cathode and anode assembly used in measuring current, PC and PS: cathode and anode assembly used in measuring pH, V: potentiometer, A: Current meter, R: recorder. (b) anode assembly used in current/potential measurements. BA: anode, TP: telfon discs, PP1 and PP2: titanium pressing plates, E: enamel used for electrical insulation. (c) anode assembly used in pH measurements. PA: anode disc, W: wells for collection crevice solution.

drawing the alloy sheet, are insulated from the test solution. In this configuration both sides of an anode disc form crevices and, therefore, neglecting the edge area the total anode and cathode areas are equal. The corrosiveness of the brine solution required the use of a Teflon liner and the chromel-alumel thermocouple was encased in a titanium tube.

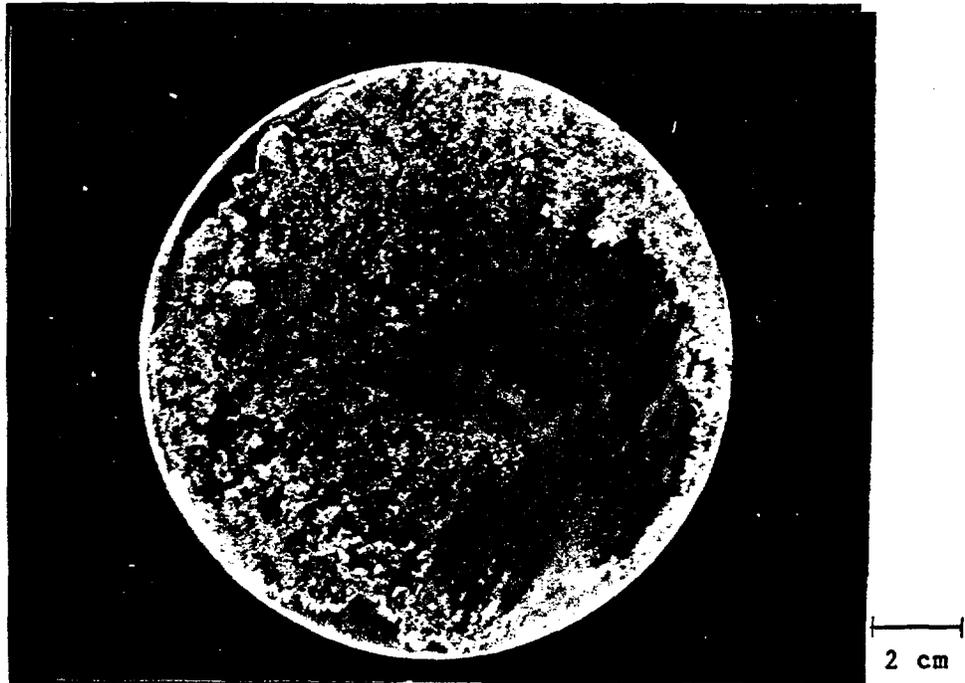
A visual examination of Grade-12 titanium anode specimens showed that crevice corrosion occurs in a non-uniform manner. As shown in Figure 2, a white corrosion product, identified later as the rutile form of TiO_2 , was usually present in larger amounts near the edge of the specimen where pressure from the screws is higher. In pH specimens the area near the wells, which has a relatively large volume of the crevice solution, showed the least amount of corrosion. Therefore, it is clear that the crevice gap is very important in determining the extent of corrosion.

Figure 2. A Grade-12 titanium anode specimen after the test in dilute (by a factor of 100) Brine A. The white areas represent deposits of TiO_2 .

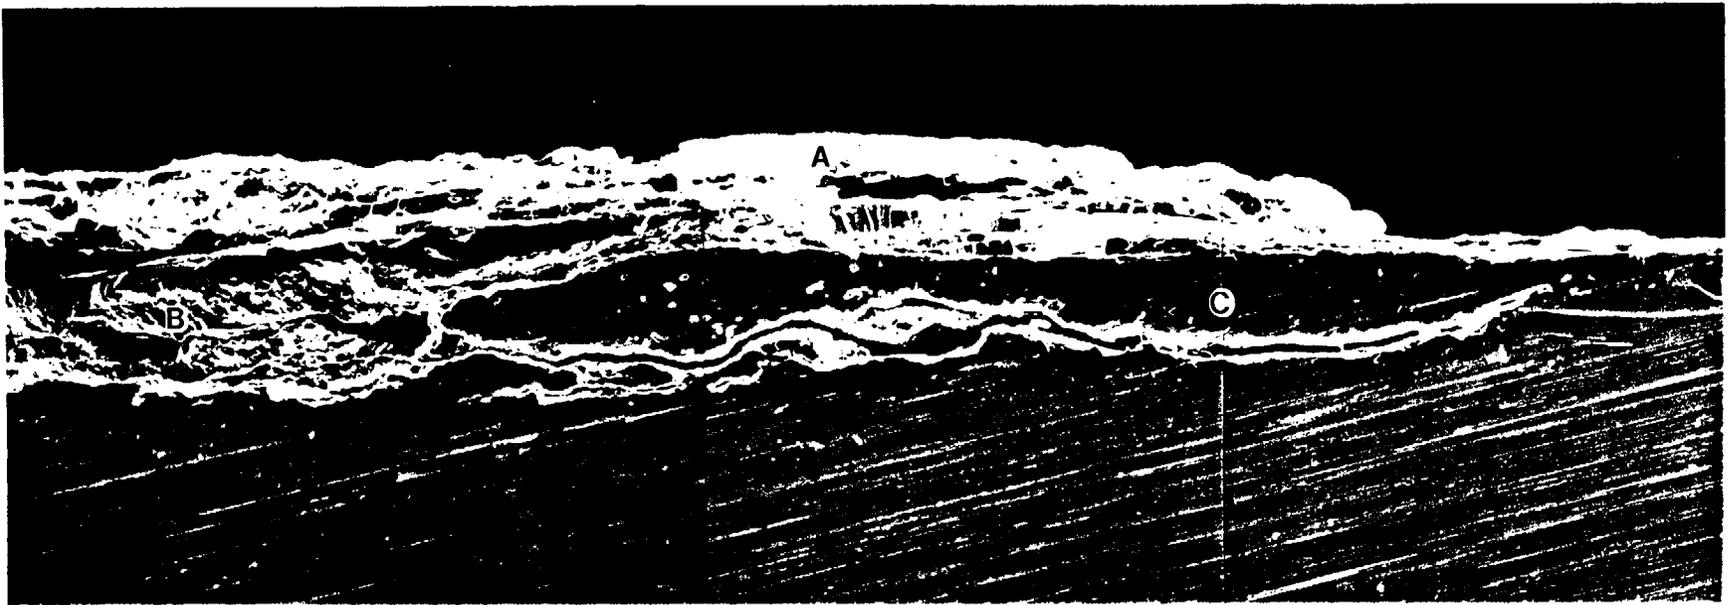
Figure 4. A SEM view of the vertical cross section of a corroded area on a Grade-12 titanium anode specimen.

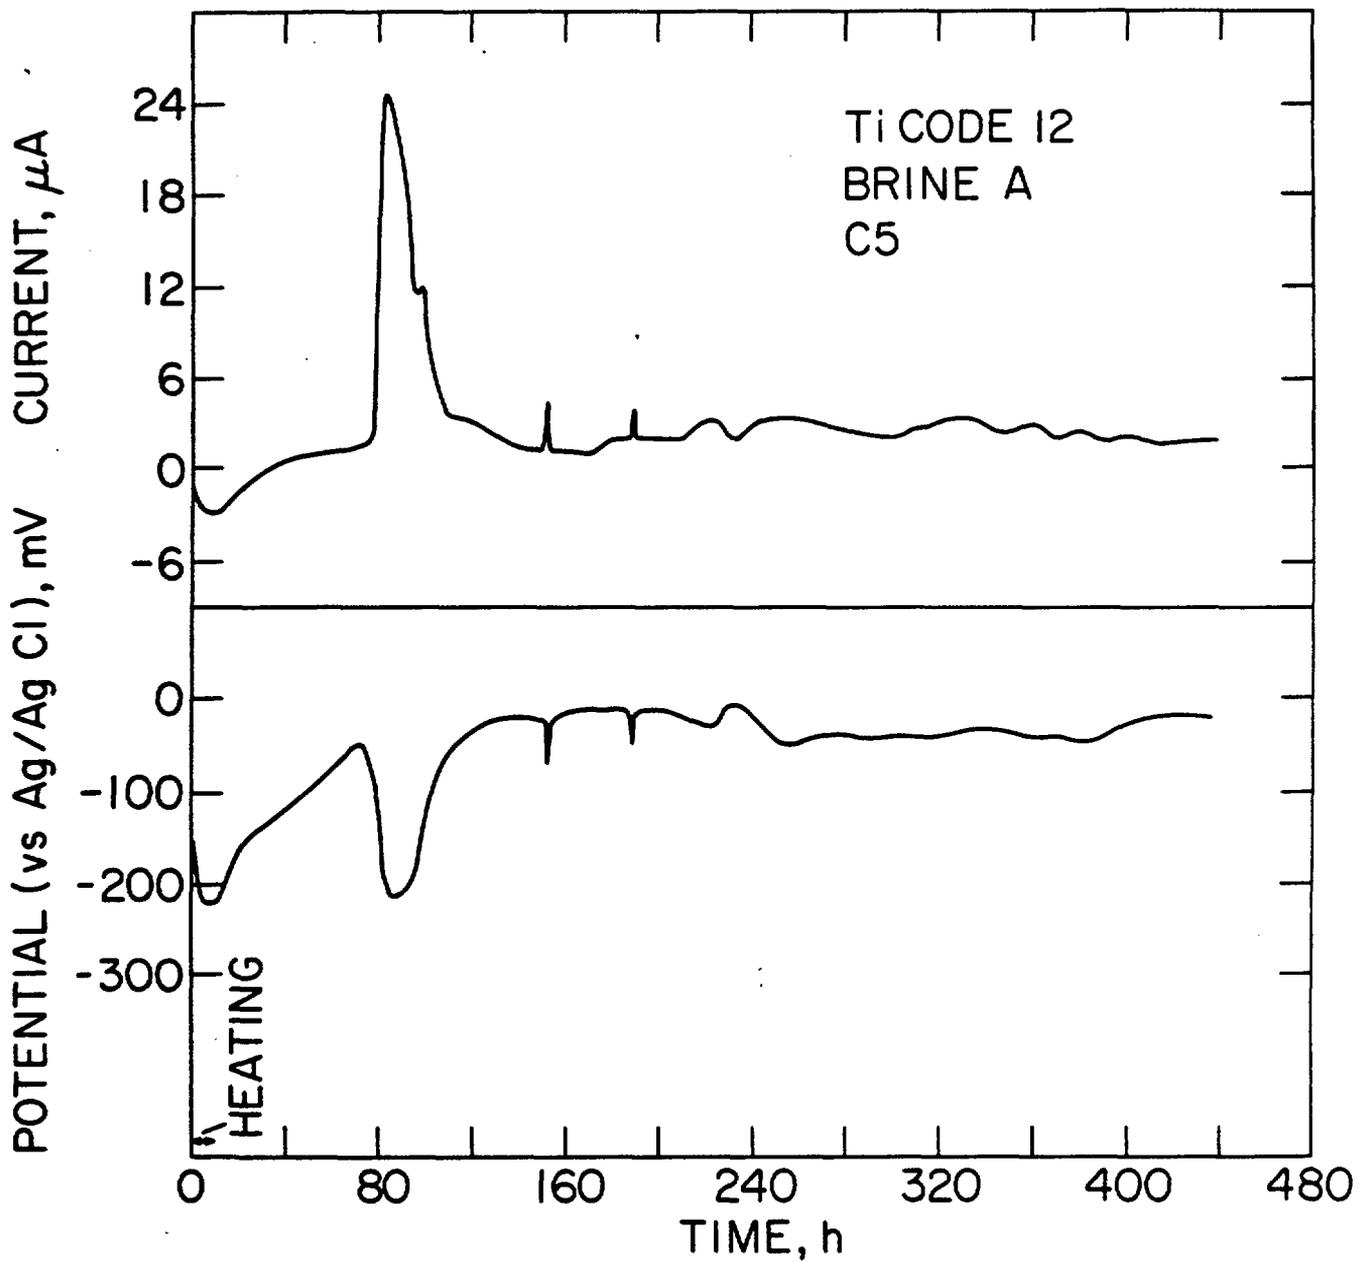
The variation with time of the potential of the cathode/anode coupled assembly, and the current from the cathode to the anode specimen for Grade-12 titanium crevice in neutral Brine A is shown in Figure 7. The behavior of similar crevices in the ten times and the one-hundred times diluted Brine A are shown in Figures 8 and 9. It also shows the uncoupled potentials of the cathode and anode specimens, which were recorded after decoupling the two for

Figure 7. Time dependence of current and potential for Grade-12 titanium in neutral Brine A. The steady state temperature is $\sim 150^{\circ}\text{C}$.

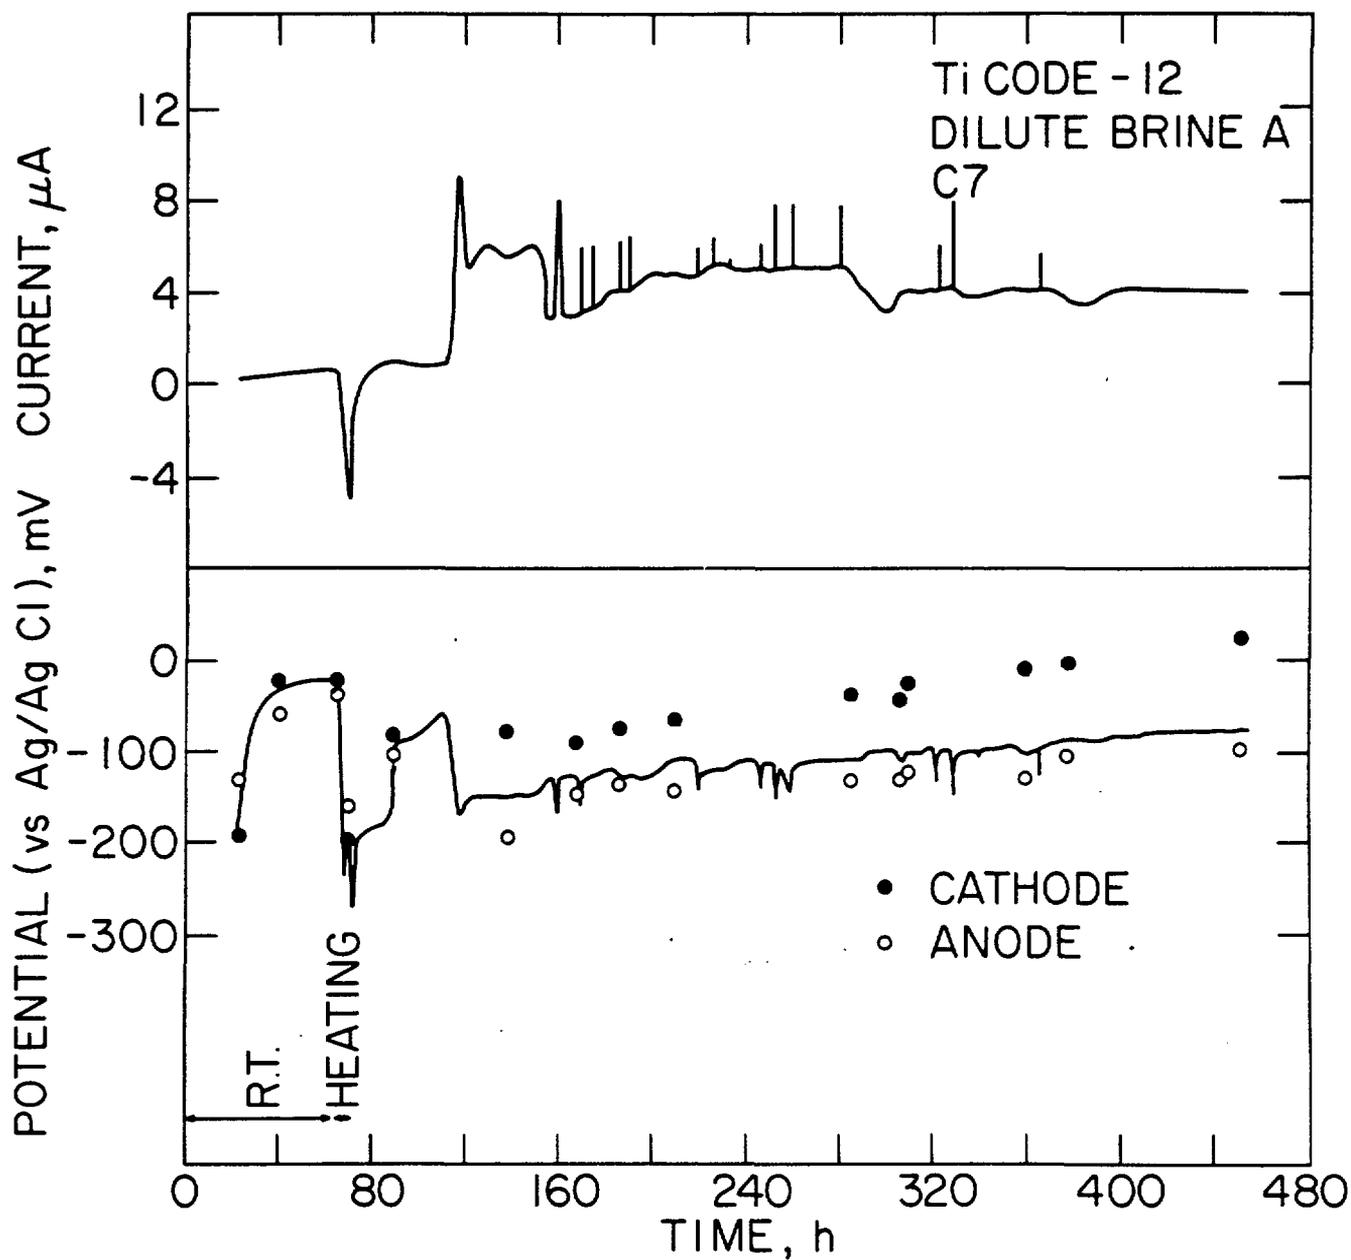
Figure 8. Time dependence of current and potential for Grade-12 titanium crevice in diluted (by a factor of two) Brine A. The closed and open circles represent uncoupled potentials of the freely exposed cathode disk and the anode assembly, respectively. The steady state test temperature is $\sim 150^{\circ}\text{C}$.

- (d) Later, the current shows an abrupt increase which is accompanied by a decrease in crevice potential.
- (e) In the following period which covers most of the test time, the current and potential do not show any reproducible behavior. However, an increase in current is always accompanied by a decrease in coupled potential. For the case of neutral Brine A (Figure 7), the current slowly decreased to a very small value. For ten-times diluted Brine A and acidic Brine A, this attenuation of current was intermediate between the patterns shown in Figures 8 and 10.

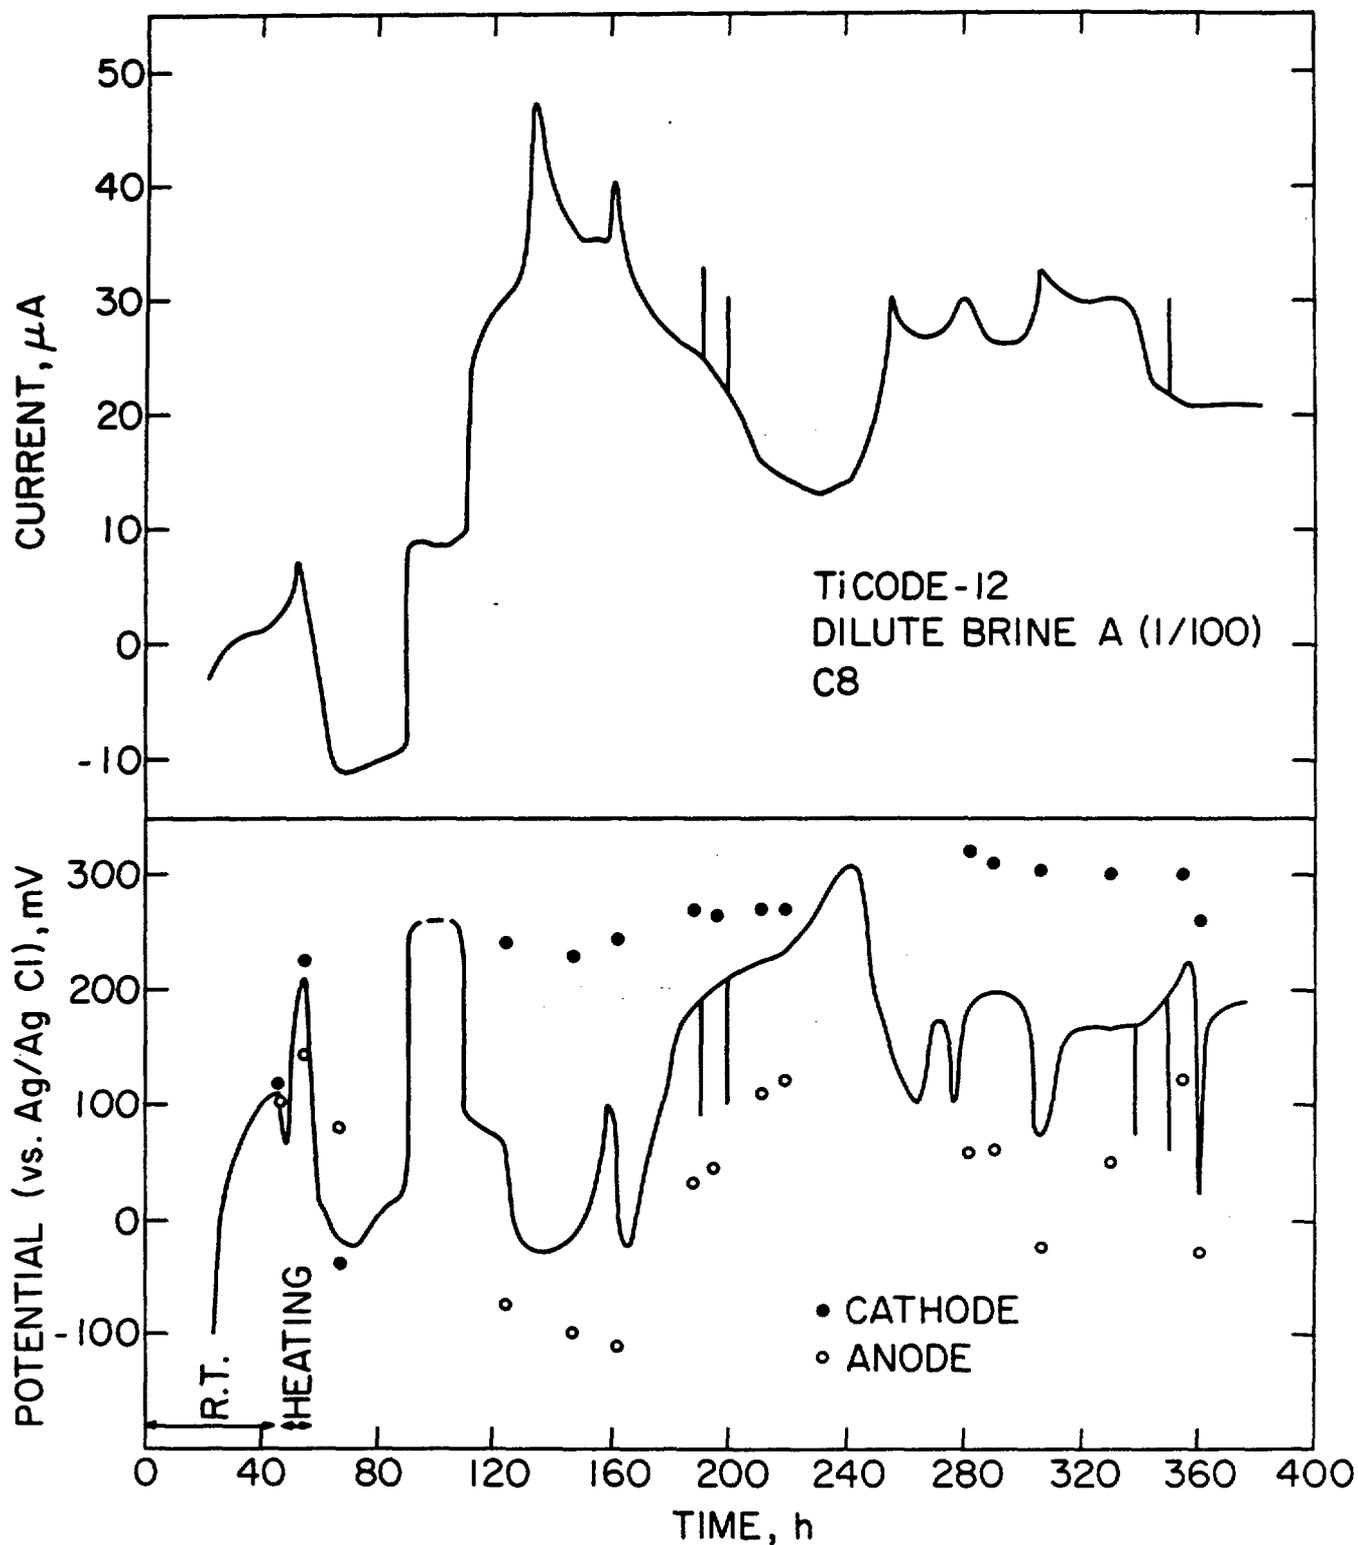
Figure 9. Time dependence of current and potential for Grade-12 titanium in one hundred times diluted Brine A. The closed and open circles represent uncoupled potentials of the freely exposed cathode disk and the anode assembly, respectively. The steady state temperature is $\sim 150^\circ\text{C}$. The broken line between 90 and 110 hours on the potential curve represents the period during which the potential overshoot the recorder scale.

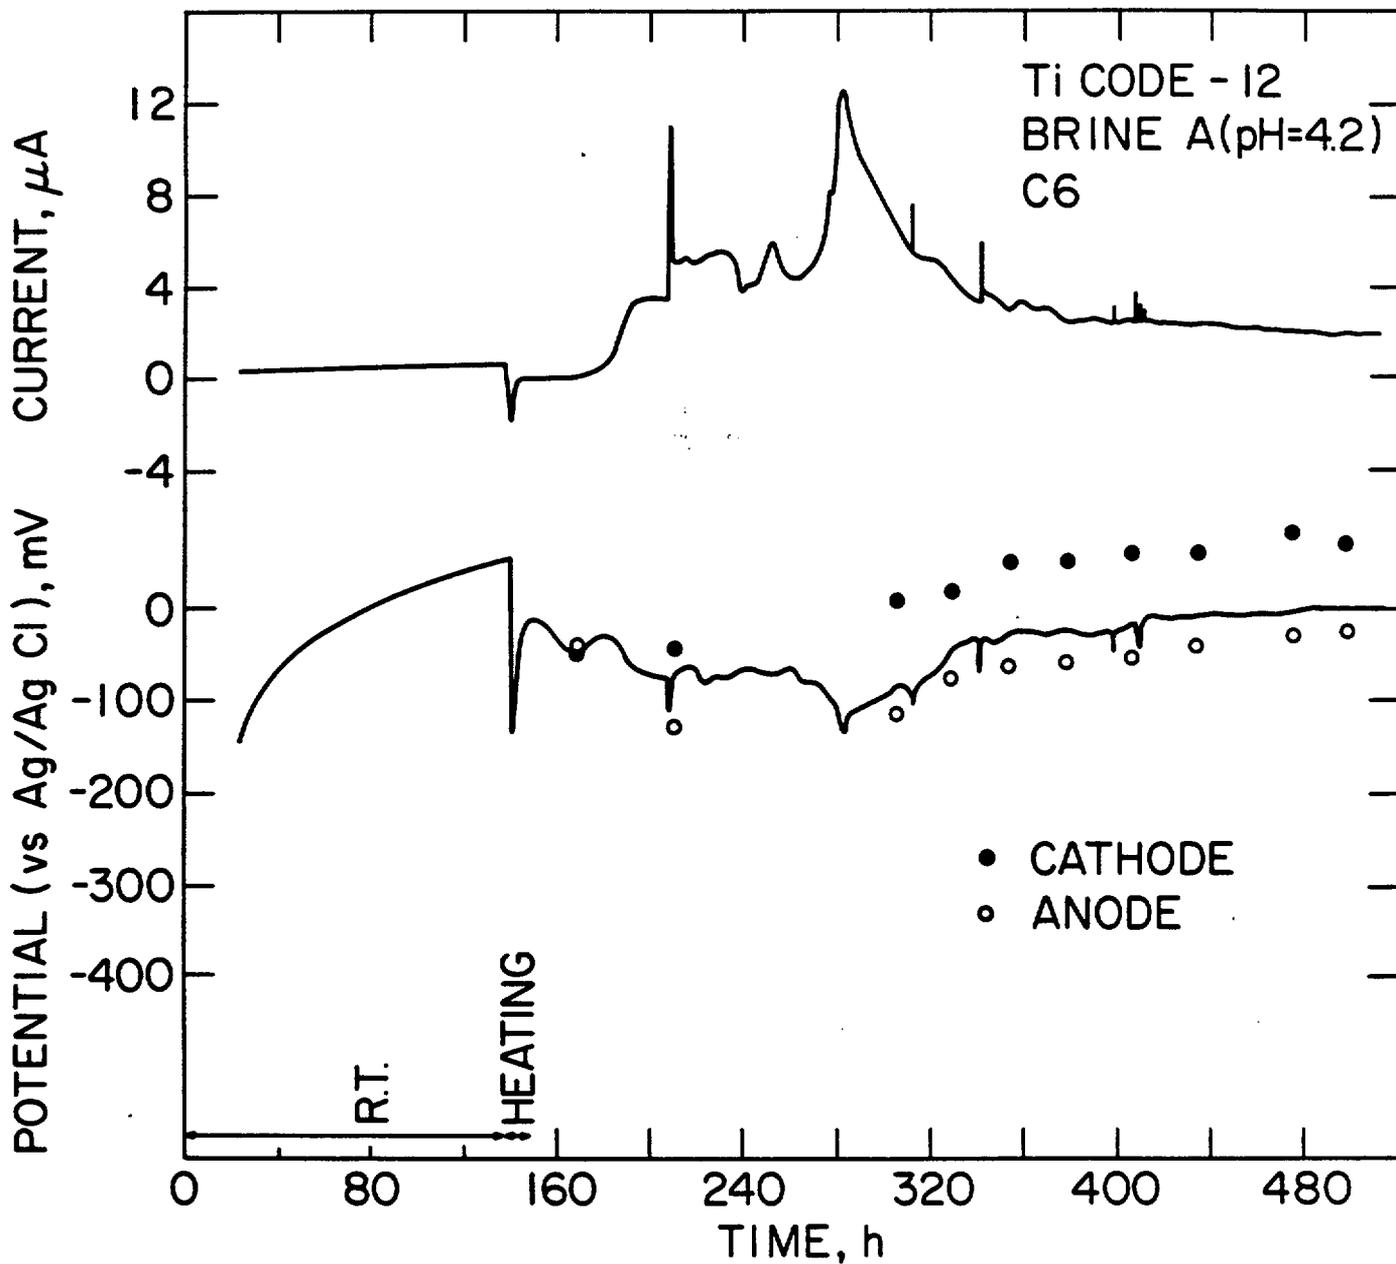
Figure 10. Time dependence of corrosion current and potential of Grade-12 titanium in acidified Brine A at 150°C. Circles represent the decoupled potentials.

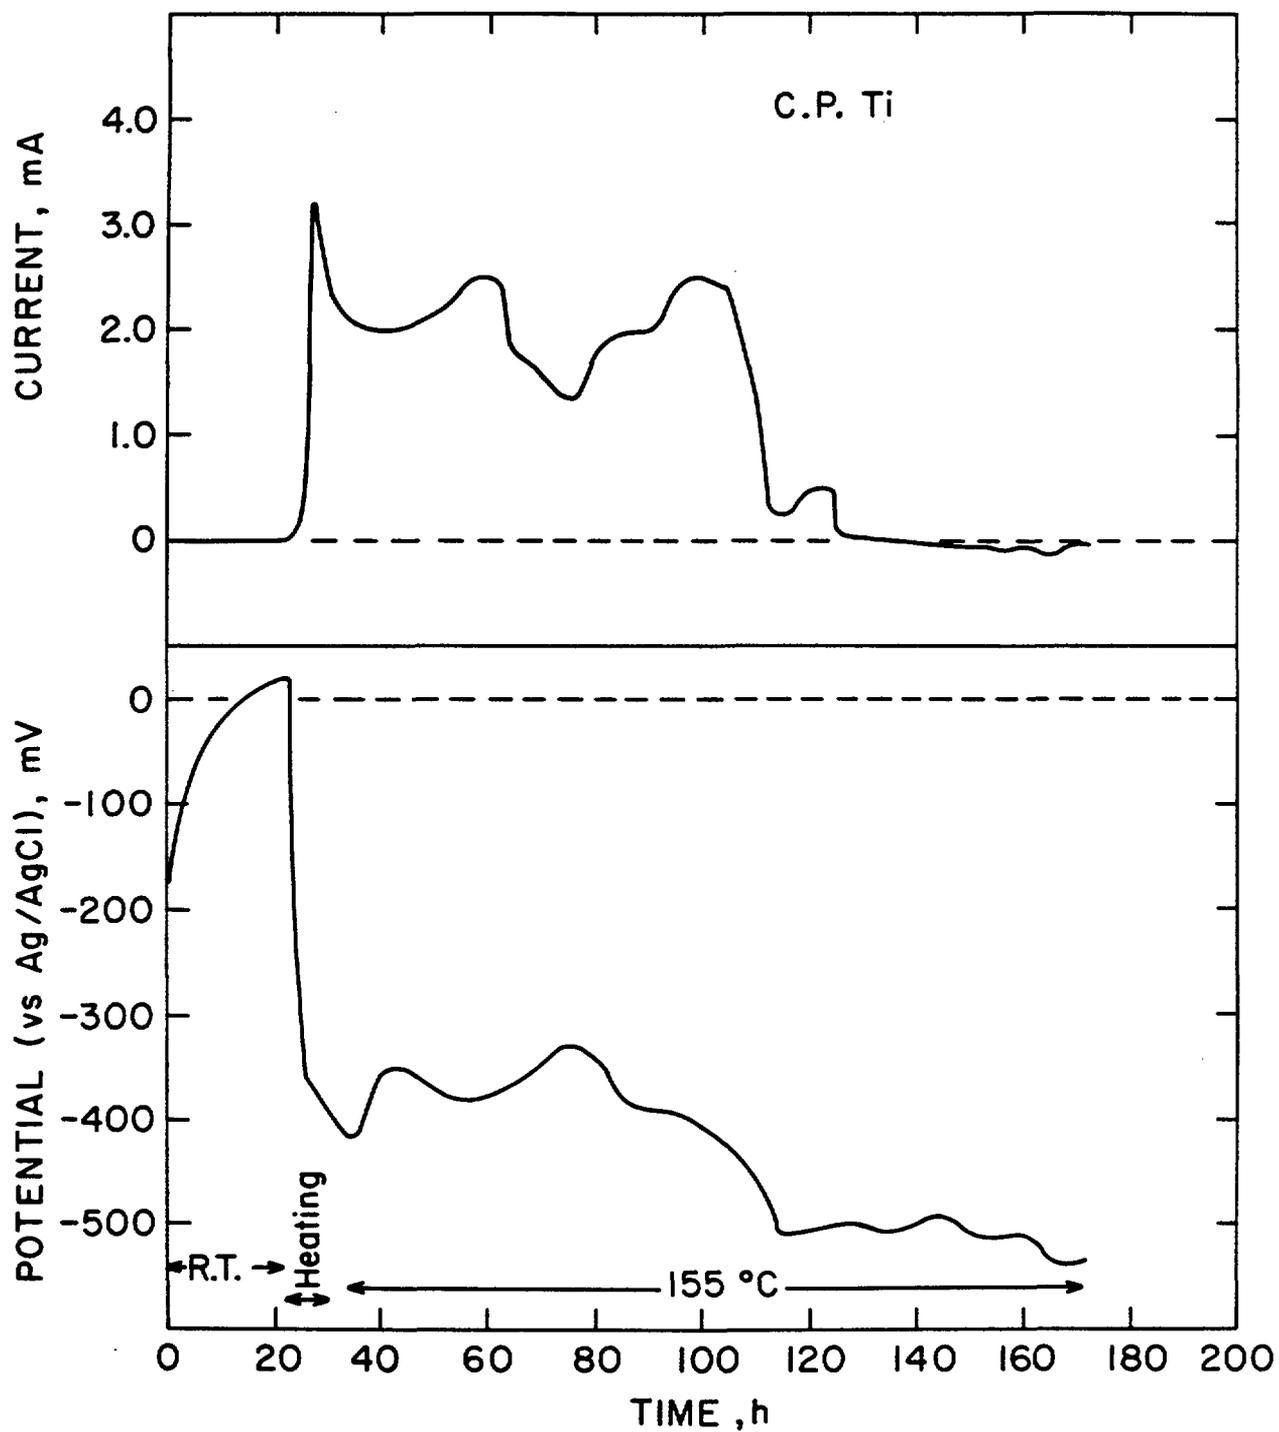
The time dependence of current and potential for Grade-2 titanium crevice in neutral Brine A is shown in Figure 11. In this case the decoupled potentials were not recorded. The figures show several important differences compared to Grade-12 titanium crevices. Firstly, the crevice current is approximately three orders of magnitude higher. Secondly, the above described steps (b) and (c) were not detected; instead step (d) is observed during the heating period. Thirdly, after about 110 hours, the crevice current decreases but it is not accompanied by any potential increase. Finally, after approximately 125 hours the current not only approaches "zero", but changes polarity.

Figure 11. Time dependence of current and potential for Grade-2 titanium in Brine A at steady state temperature 150°C.
