Brookhaven National Laboratory Report

BNL-NUREG-34790 (1984)

IMMERSION TEST AND SURFACE STUDIES FOR CREVICE CORROSION OF
GRADE-12 TITANIUM IN A BRINE SOLUTION AT 150°C

AN ELECTROCHEMICAL STUDY OF CREVICE CORROSION OF
GRADE-12 TITANIUM IN A BRINE SOLUTION AT 150°C

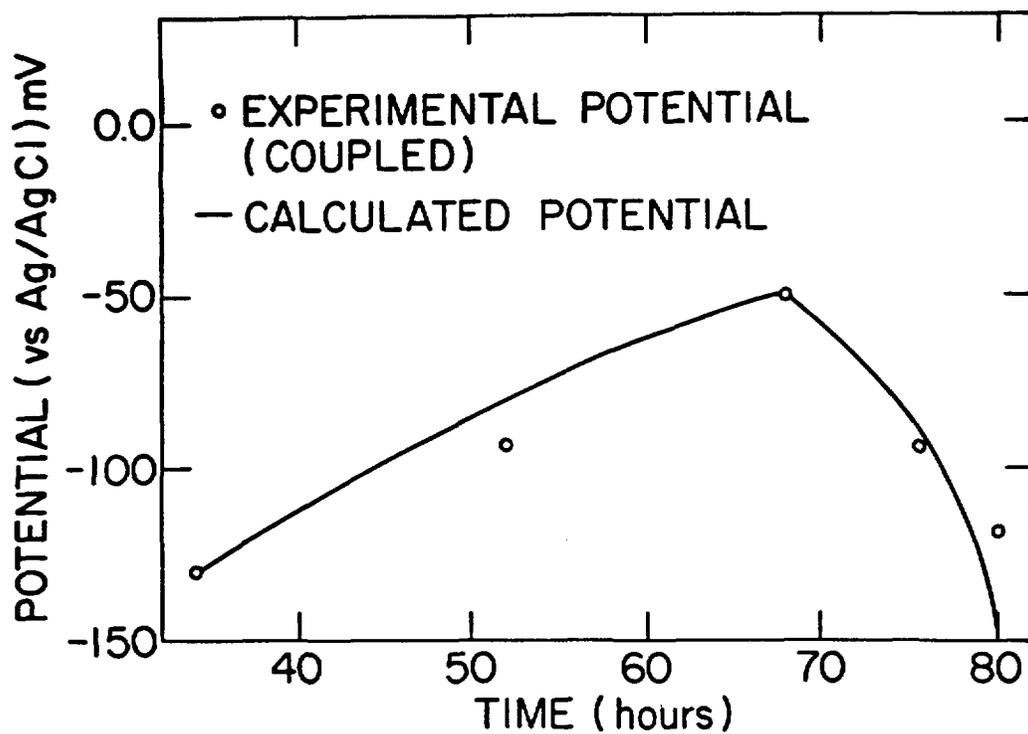
The best fit to our experimental data (neutral Brine A) is shown in Figure 1 for $\delta = 0.3$ cm (effective distance of concentration gradient), $I_p = 7.6 \times 10^{-10}$ amp/cm² (passive current with oxygen reduction), $c = 2.5 \times 10^{-7}$ cm/volt^{9,10} (a proportionality constant between oxide thickness and electrode potential), crevice depth = 2.54 cm, crevice gap = 2 μ m, an oxygen diffusivity (cm²/sec) of $0.0821 \exp(-2440/T)$,¹⁶ a proton diffusivity (cm²/sec) of $0.02838 \exp(-1700/T)$,¹⁶ chloride diffusivity (cm²/sec) of $0.0508 \exp(-2327/T)$,¹⁶ and an anatase density of 3.84 gm/cc.¹⁷ Very little change occurs in Figure 1 with a current variation from 0.24 to 10 μ A/cm², because the main potential drop arises from oxygen effects. Figure 2 shows the concentration profiles in the crevice at various testing times for a current density of 10 μ A/cm². Because the brine solution has a near saturated Cl⁻ ion concentration, the calculated large value indicates some types of precipitates which may form. Also, the low pH level indicates that the actual pH at higher temperatures is much lower than that measured at room temperature (experimental values vary from 2.8 to 4.5). Two curves for oxygen concentrations are shown for different crevice heights. As expected, an increased crevice gap size delays the oxygen depletion time significantly. This is also true for increasing crevice area.

Figure 1. Experimental potential (open circles) and "fitted" potential (solid line) of coupled Grade-12 titanium crevices in aerated neutral brine at 150°C.

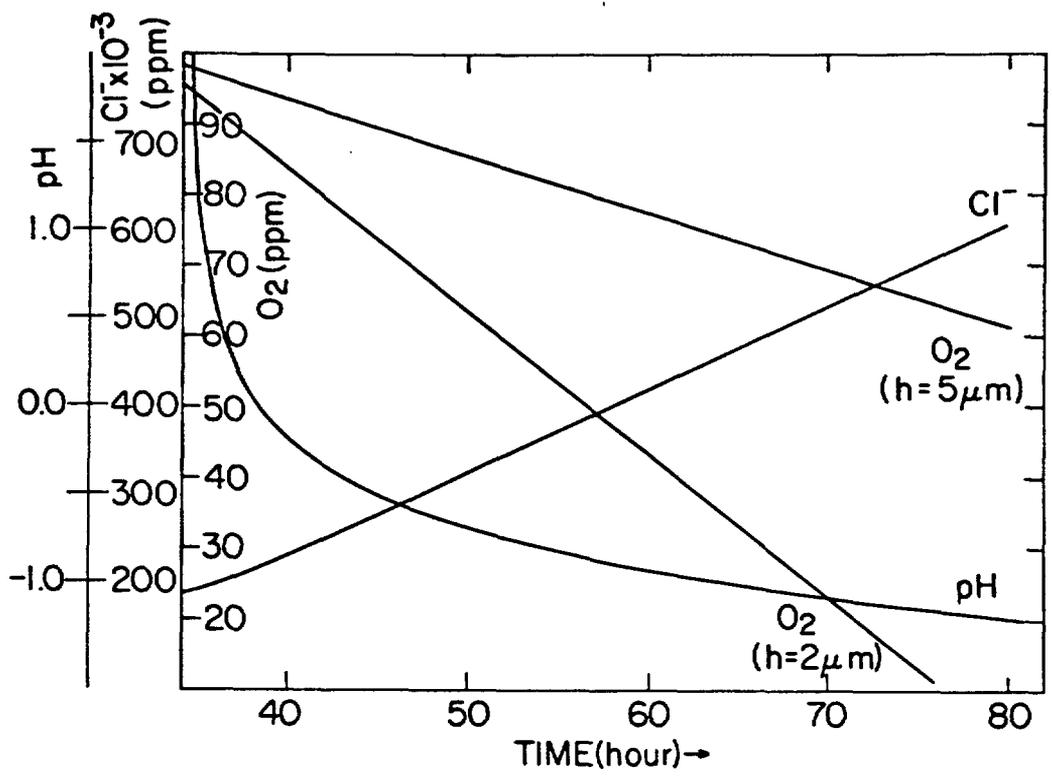
Figure 2. The calculated concentration profiles in the crevice at various testing times for a current density of $10 \mu\text{A}/\text{cm}^2$.

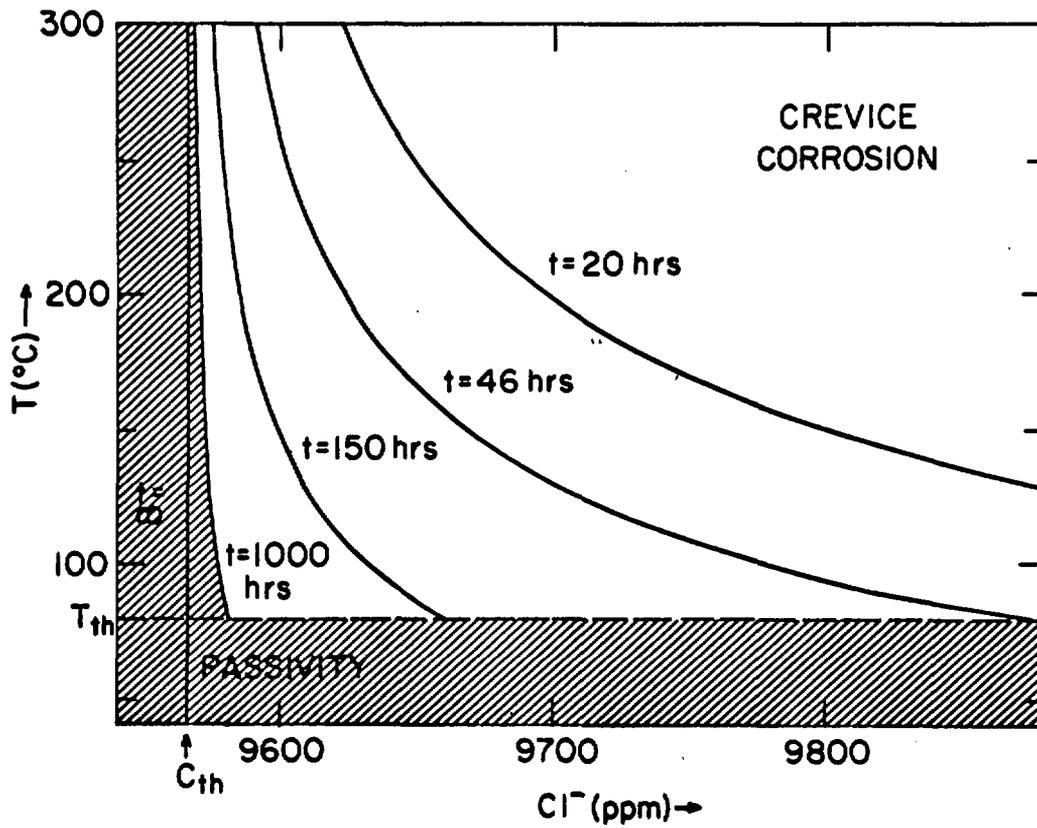
Note that the curves in Figure 3 have been calculated on the basis of a corrosion current which is independent of test temperature. When the temperature dependence of the current is considered, the curves in this figure depend more strongly on the chloride concentration. Also, the model developed shows that there will be a temperature limit, T_{th} , below which mass flow in the corrosion system ceases. Since the calculated T_{th} is lower than the

Figure 3. Immunity domains for crevice corrosion at various service times for Grade-12 titanium in a simulated rock salt brine. The critical anion concentration assumed for passivity breakdown is 190,000 ppm.

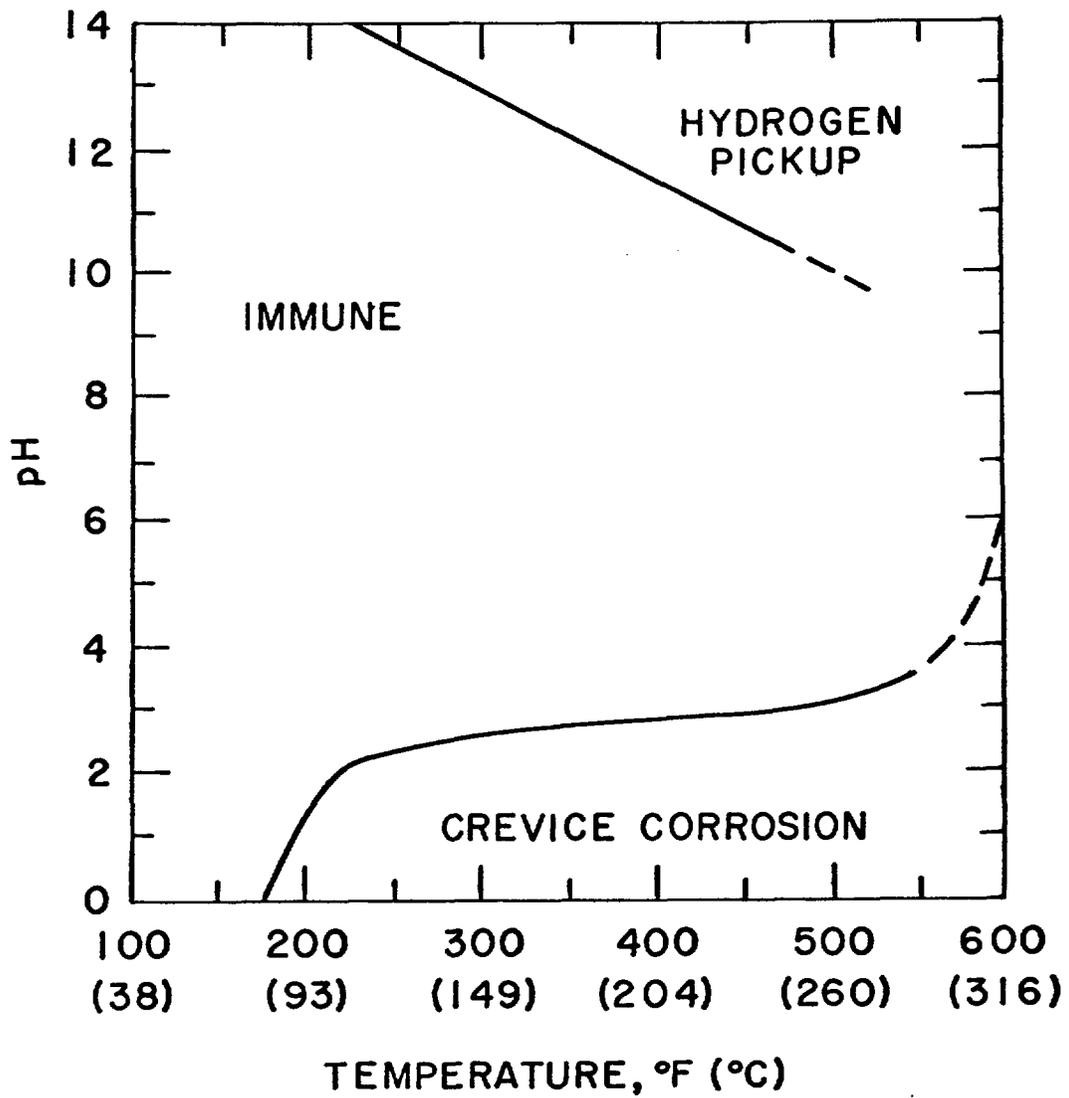
Figure 4. Immunity domains in temperature and pH necessary for passivity breakdown for CP titanium.¹⁸
