**SUBJECT: Fort Calhoun Station (FCS) Steam Generator Eddy Current Test Report -  
2003 Refueling Outage**

## **FORT CALHOUN STATION STEAM GENERATOR EDDY CURRENT TEST REPORT**

**2003 REFUELING OUTAGE**

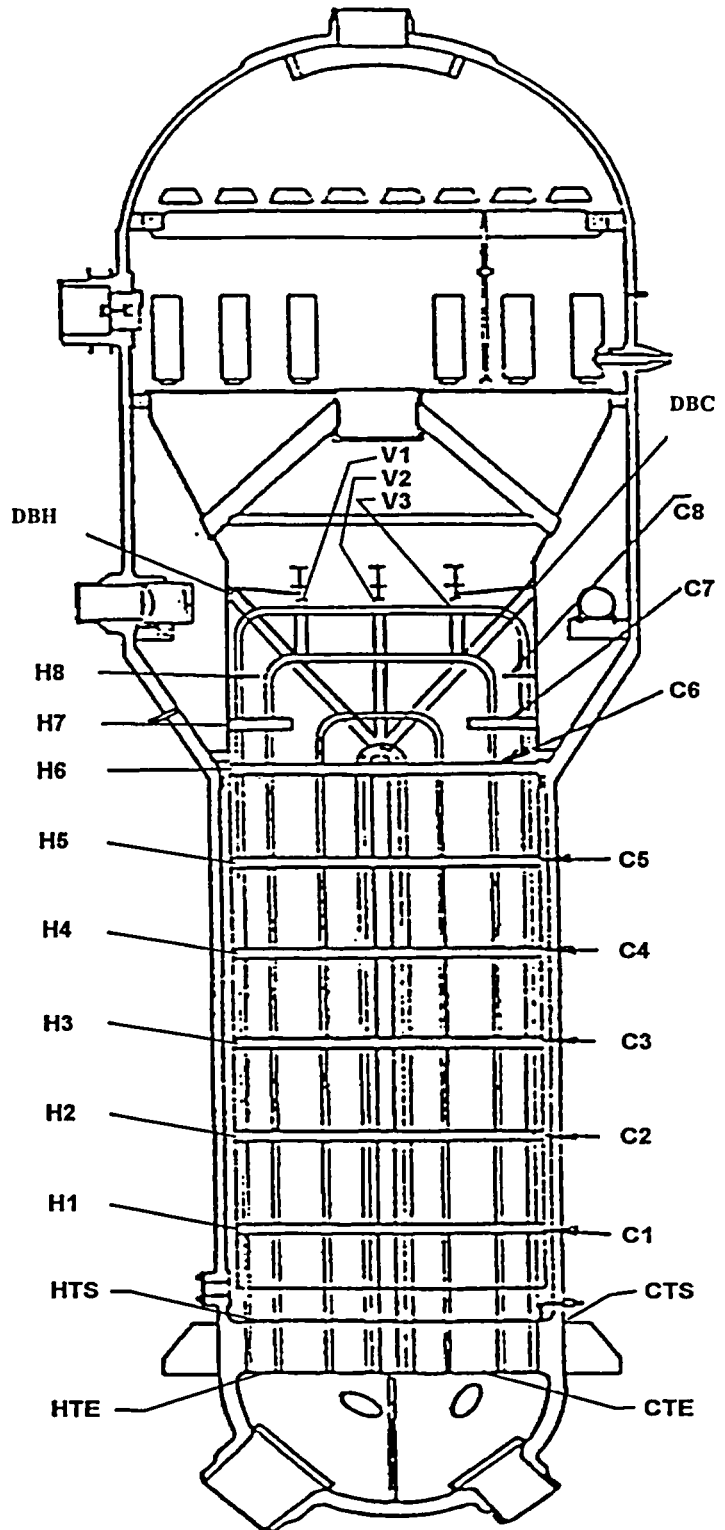
**Figure 1**  
**FORT CALHOUN**  
**STEAM GENERATOR ELEVATION DRAWING**

FCS steam generator support notations referenced throughout this report can be found on Figure-1.

HTE Hot leg Tube End  
HTS Hot Leg Tubesheet  
H1-H6 Hot Leg Full Supports  
H7 Hot Leg Partial Egg Crate  
H8 Hot Leg Partial Drilled Support  
DBH Diagonal Bar Hot Leg

V1-V3 Vertical Supports

DBC Diagonal Bar Cold Leg  
C8 Cold Leg Partial Drilled Support  
C7 Cold Leg Partial Egg Crate  
C6-C1 Cold Leg Full Supports  
CTS Cold Leg Tubesheet  
CTE Cold leg Tube End
