# NATIONAL ENRICHMENT FACILITY

## ENVIRONMENTAL REPORT

#### 3.4.1.1.1 Site Groundwater Investigations

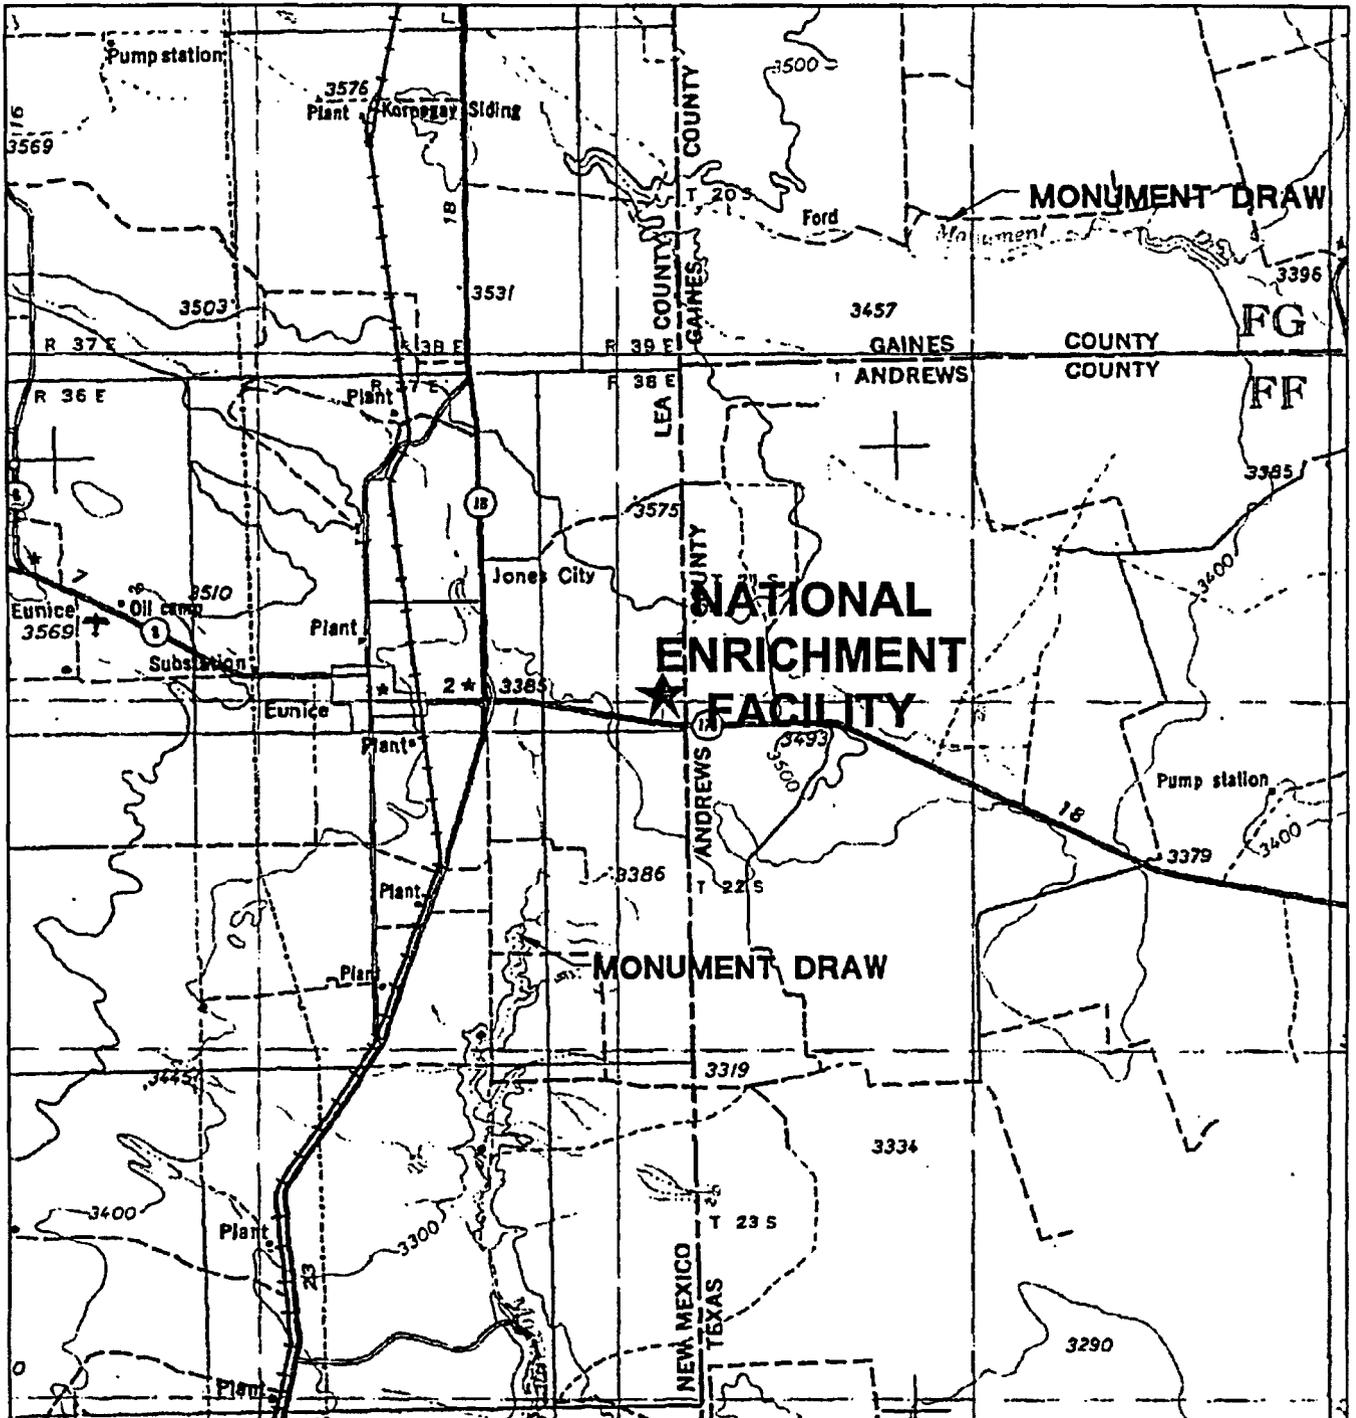
**FIGURE 3.4-2**  
 REGIONAL HYDROLOGIC FEATURES

MAP SOURCE:  
 USGS 1:100,000 30 MIN. X 60 MIN. MAPS  
 HOBBS, NEW MEXICO - TEXAS  
 AND EUNICE NE, TEX. - N. MEX.

CONTOUR INTERVAL: 100 FT
