**MAINE YANKEE
FINAL STATUS SURVEY RELEASE RECORD
FR-0200 YARD EAST
SURVEY UNIT 3**

Final Status Survey FR0200: RCA Yard East Soils Survey Units 3-9 Reference Map

FR0200 SU3: RCA Yard East Soils

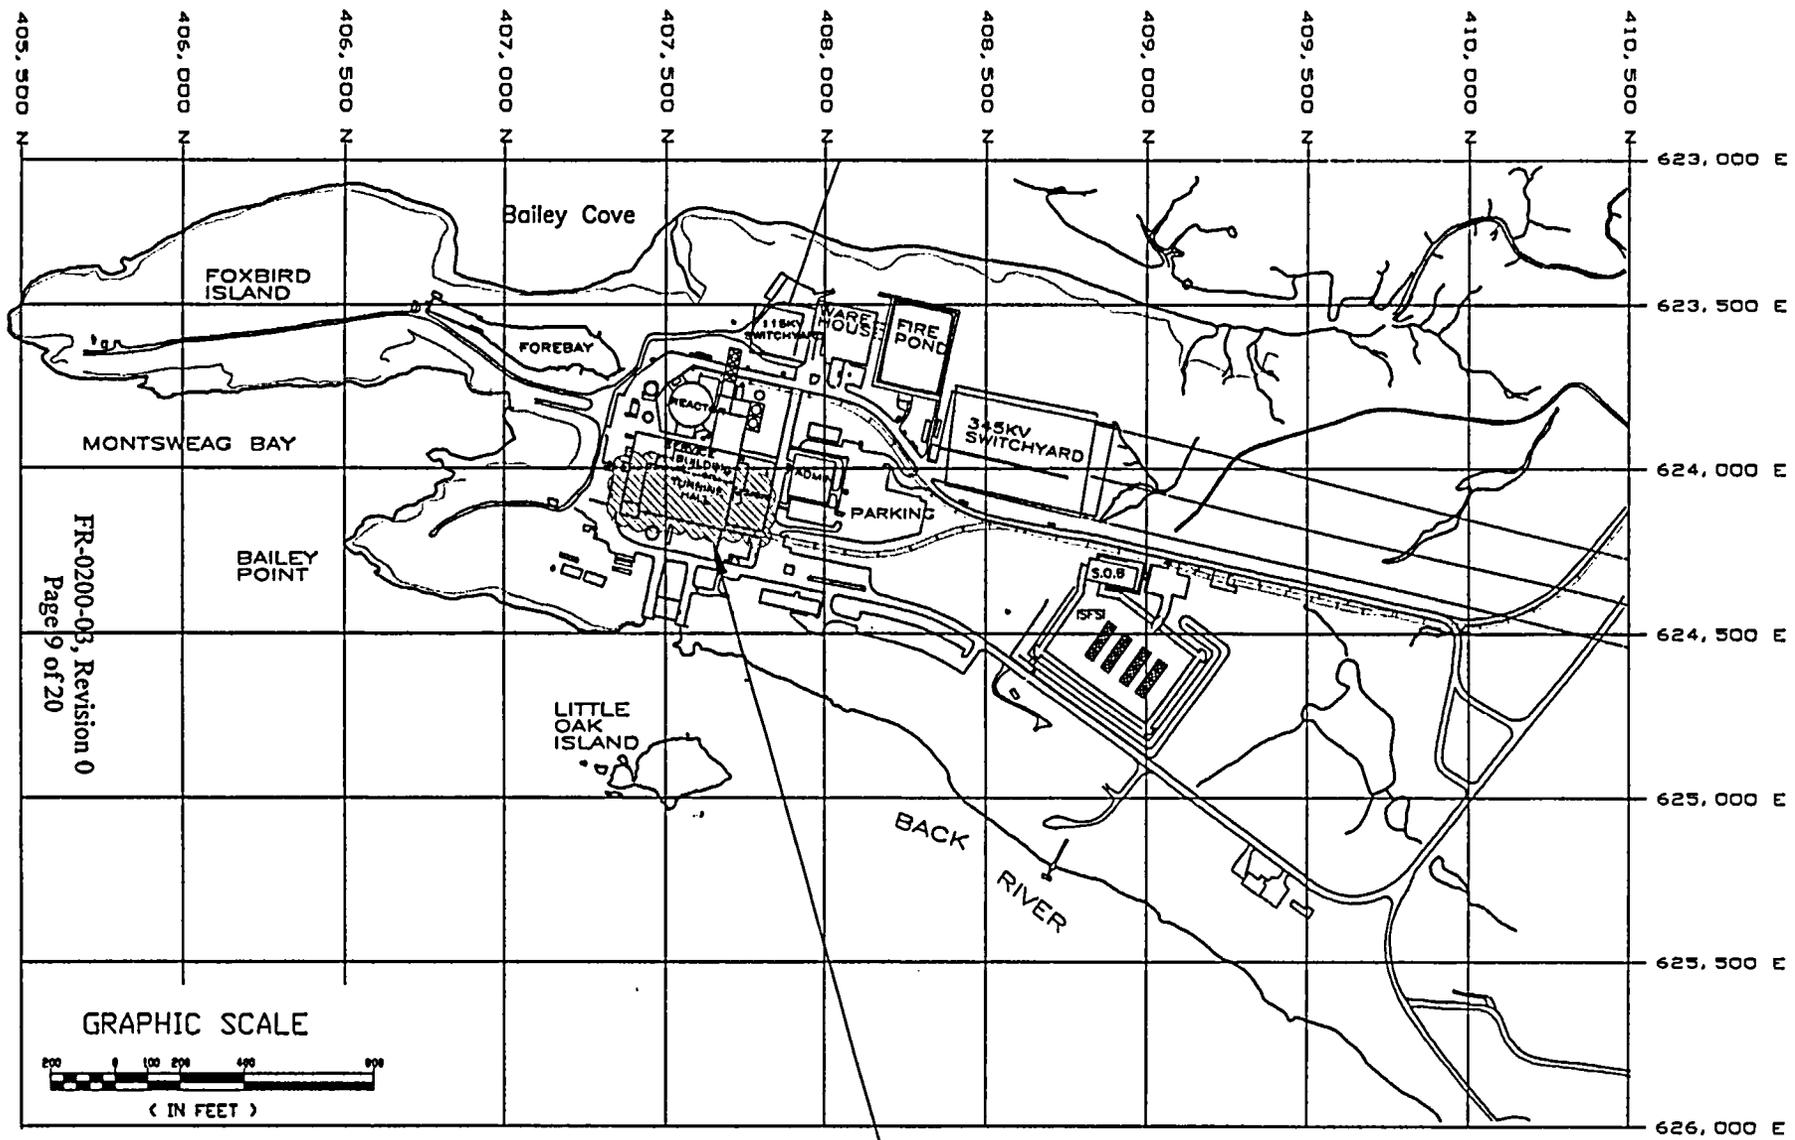
SURVEY AREA, FR0200 SU's 3-9
Yard East Soils

FR-0200 Yard East Survey Unit 3 was located in the SE corner of the site, residing in the former "Industrial Area" yard. The 1687 m² area was bordered on the north by FR-0200 Survey Units 9 and 4 and on the west by FR-0111 Survey Unit 17. Survey Unit 3 is bounded by FR-0200 Survey Unit 1 to the South and East. The survey unit is located within the current Restricted Area (RA) and includes a 4 meter wide buffer zone outside the RA. This survey unit is contained within the triangular coordinates 623965E, 407343N; 623992E, 407469N; and 624228E, 407418N using the Maine State Coordinate System (West Zone) NAD 1927. The location of the survey unit in relation to the Turbine Building and the proximate FR-0200 survey units is shown on map FR0200 REF (Attachment 1).

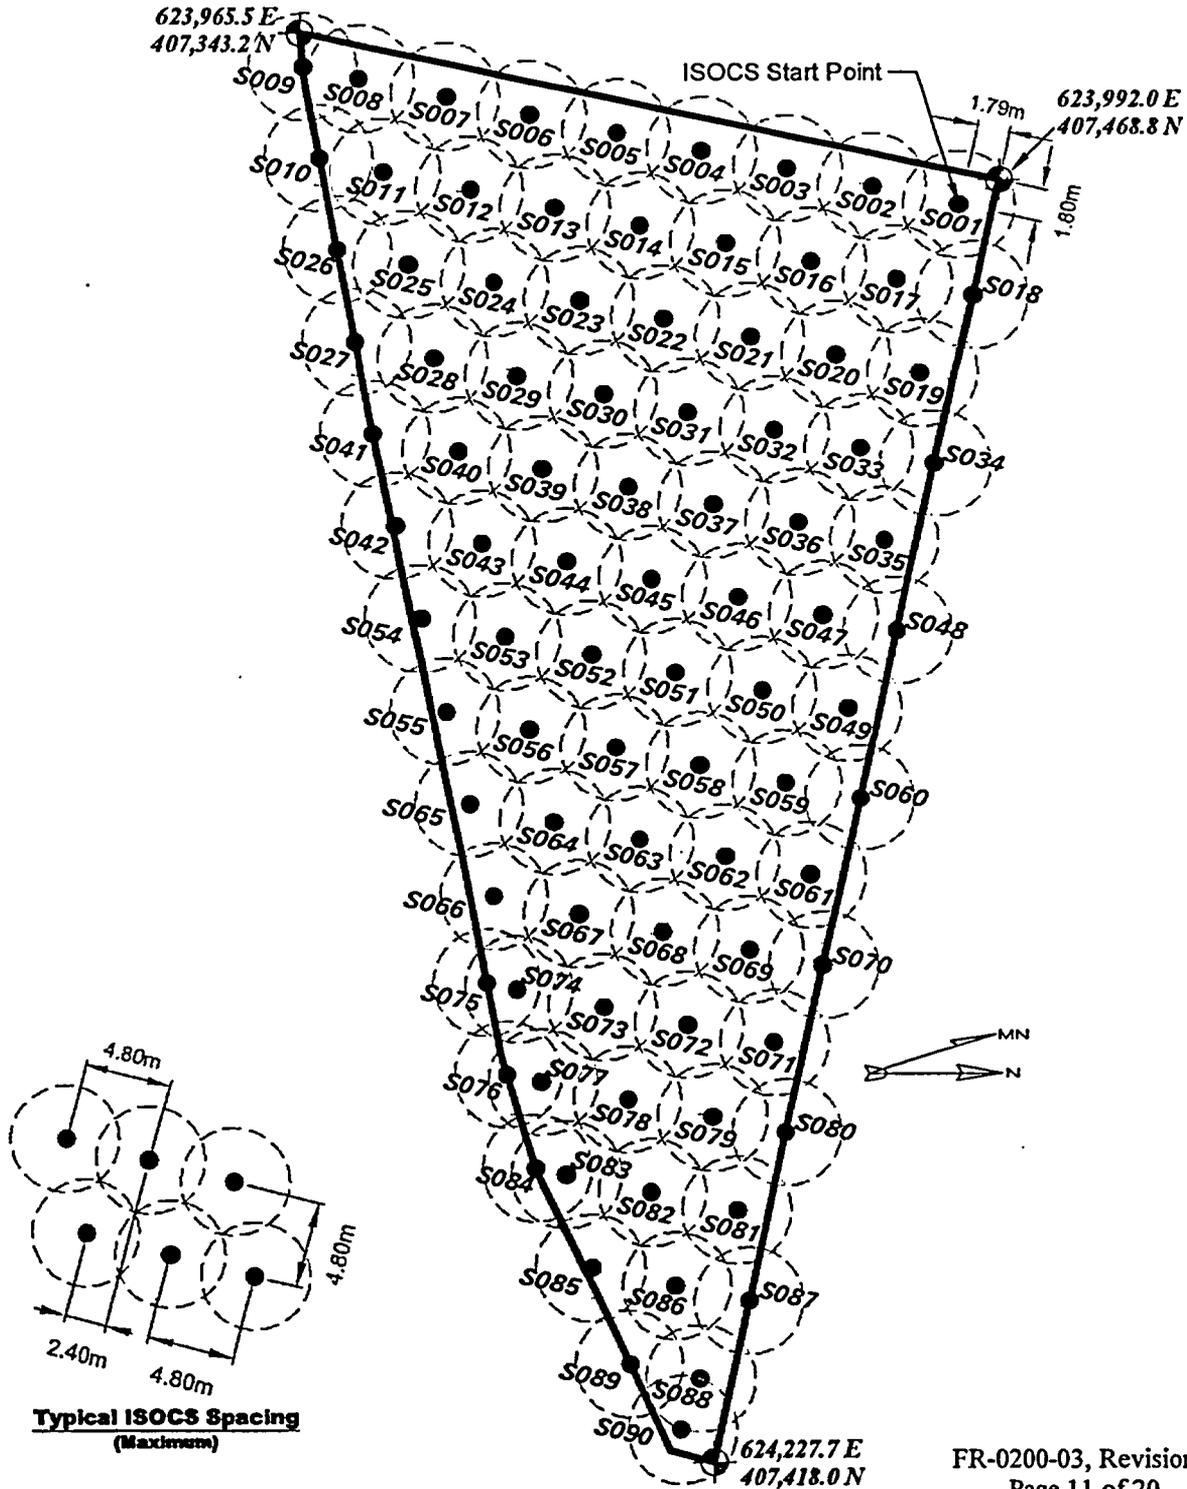
Survey Scans S001 - S090

In accordance with the LTP, scans covering 100% of the 1687 m² area were required for the Class 1 survey unit. This was accomplished by use of an *in situ* gamma spectroscopy detector (ISOCS) configured at a 3-meter distance from the surface to obtain overlapping 28-m² fields of view. The ISOCS detector was positioned perpendicular to the surface. Locations of the 90 survey scans are shown on map FR0200-3a (Attachment 1).

ISOCS gamma scans were performed at 90 locations using an investigation level of 1.0 pCi/g Cs-137 and 0.36 pCi/g Co-60. The gamma scans were performed for a sufficient count time to achieve a Minimum Detectable Activity (MDA) of approximately 25% of the DCGL. All identified scan activity levels and MDAs were below the investigation levels. Therefore, no investigation surveys were performed as a result of the scan surveys.

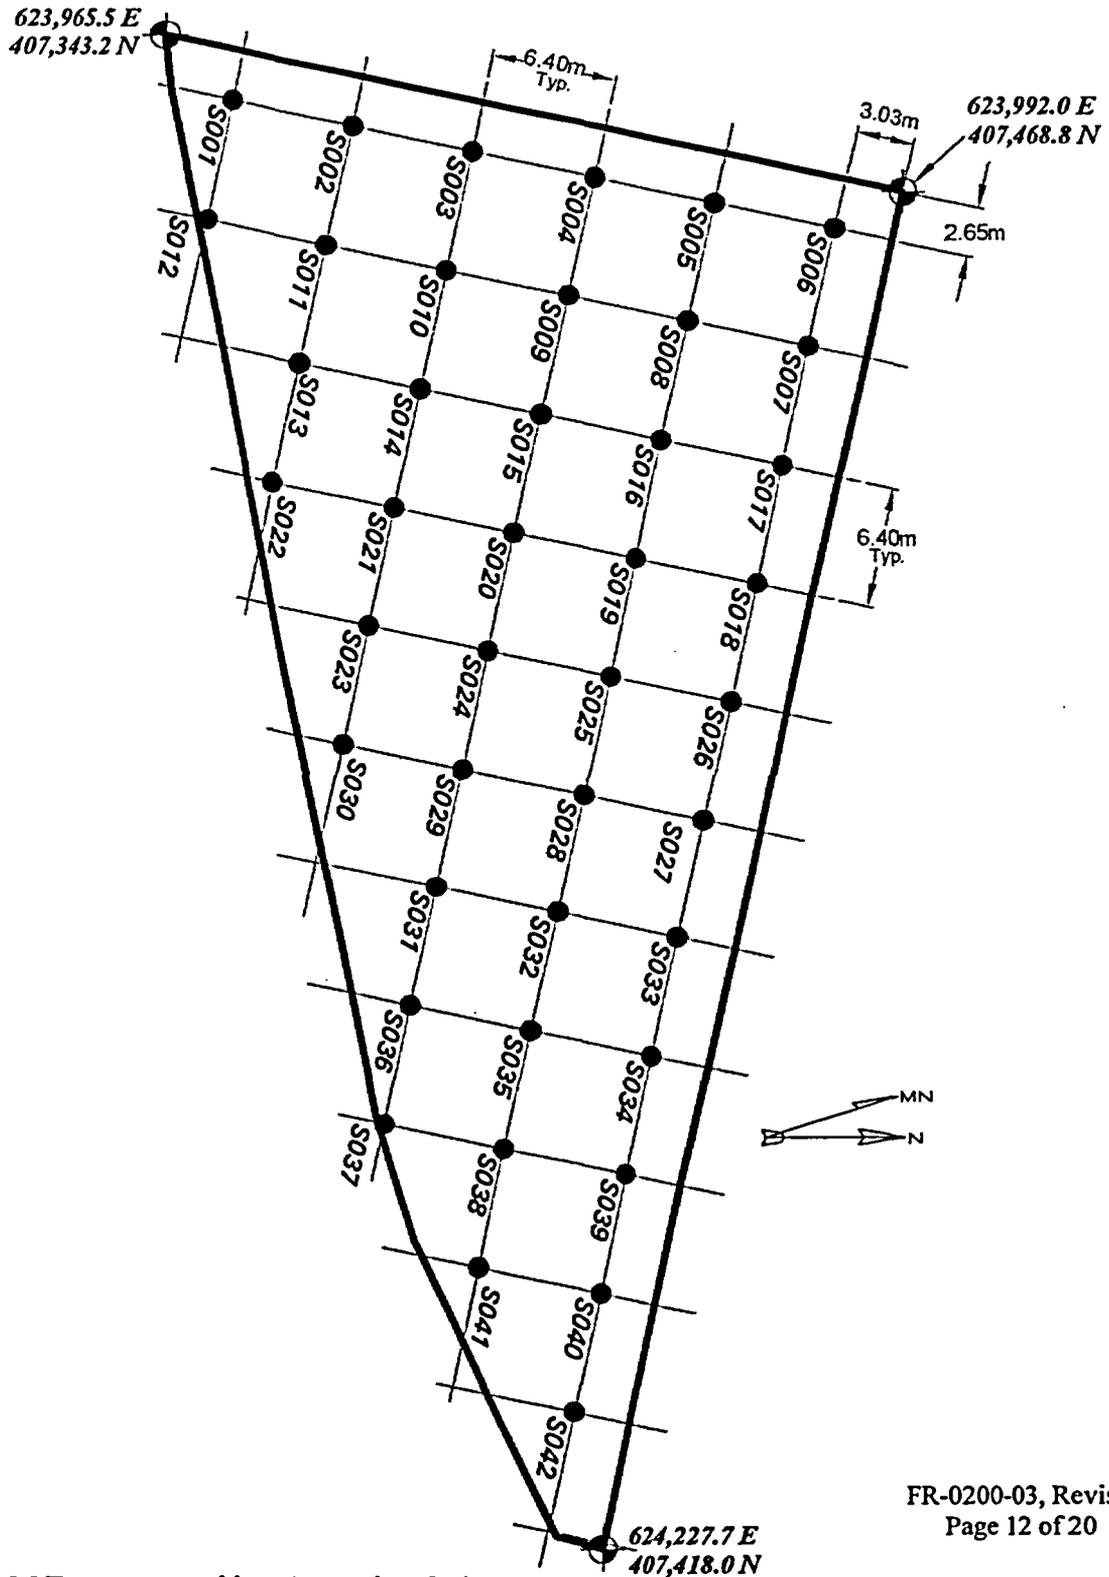
Final Status Survey FR0200 SU3: RCA Yard East Soils Direct Points S001 - S042

A total of 42 direct measurements were performed in Survey Unit 3. One sample contained Cs-137 with levels of residual activity greater than the MDA but below the DCGL. No samples contained detectable Co-60 activity. All other measurements were below the MDA. The results are presented in Table 2. No investigations were necessary or performed based on the direct measurement results.

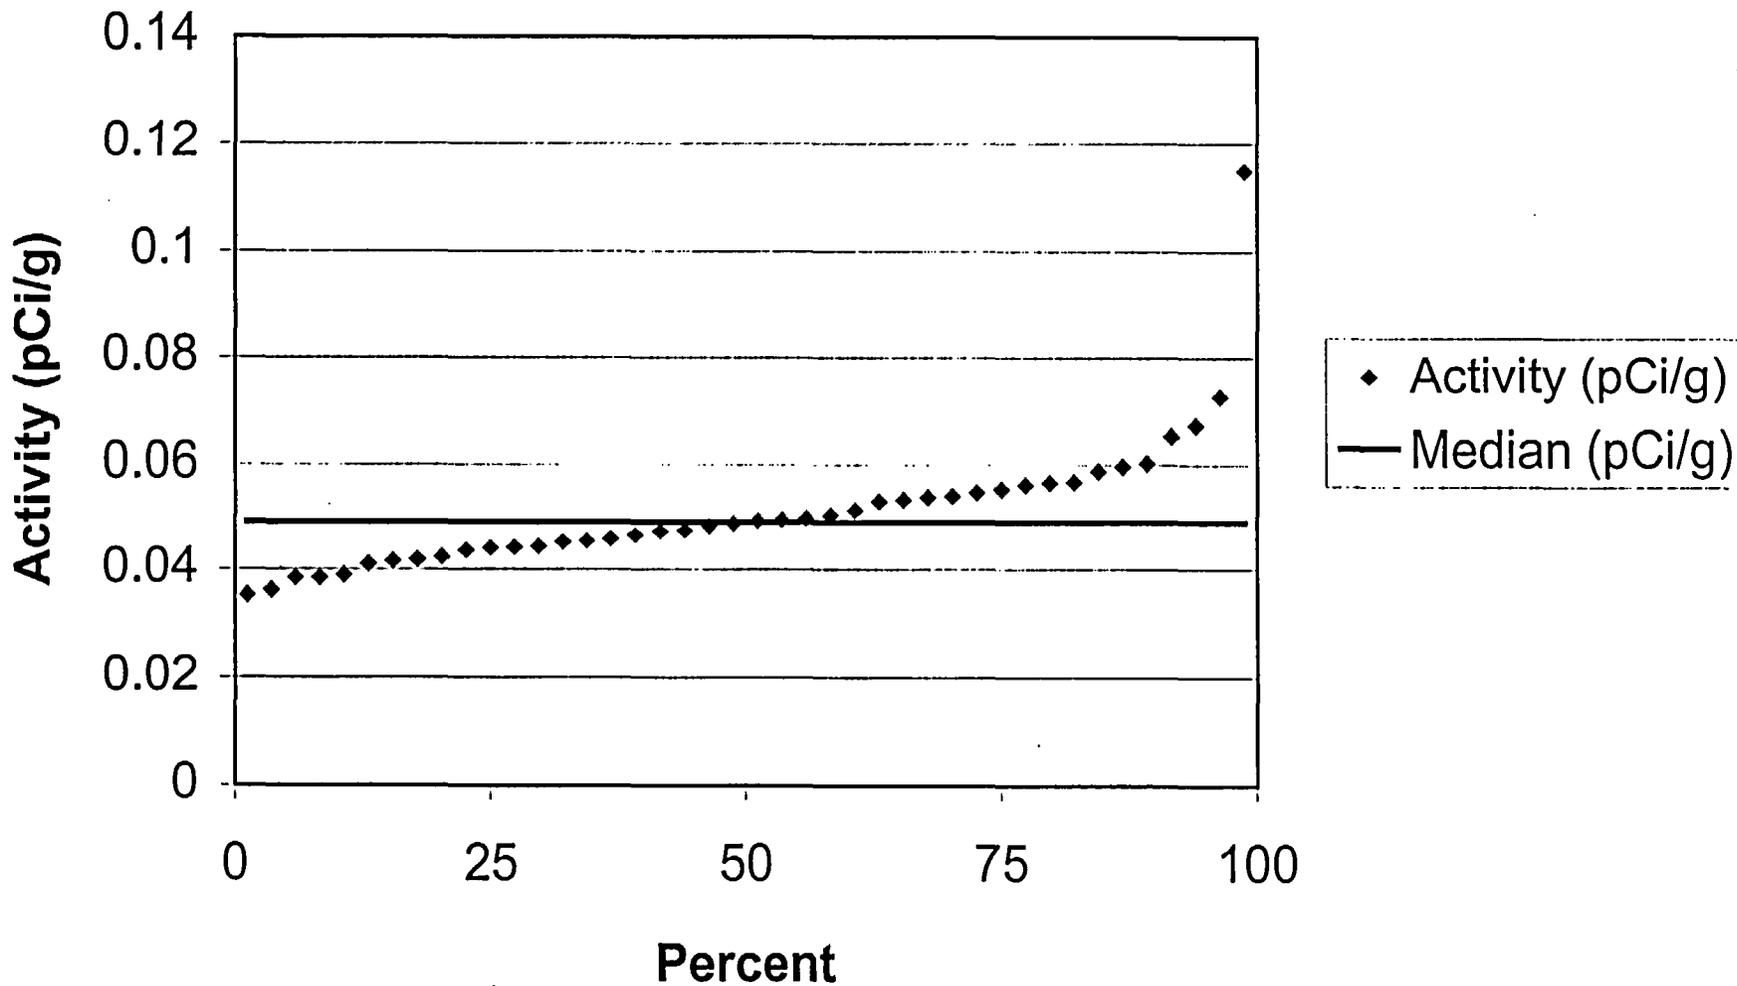
FR0200 SU-3 Quantile Plot

2. The Quantile Plot was generated from the unity data listed in Table 2. The data set and plot are consistent with expectations for a Class 1 survey unit. All of the measurements are below the DCGL of 2.39 pCi/g for Cs-137.

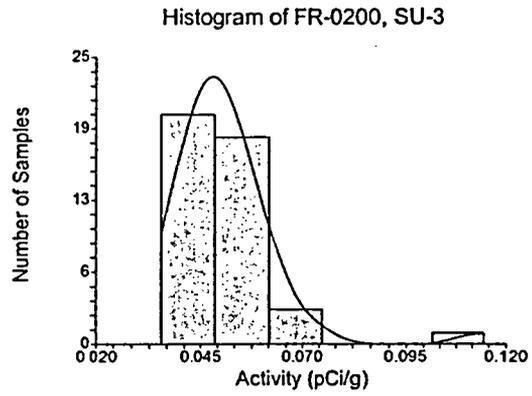
Plots Section

3. A Histogram Plot was also developed. This plot shows a log-normal distribution with one outlier.
4. A Retrospective Power Curve was constructed, based on FSS results. The curve shows that this survey unit having a mean residual activity at a small fraction of the DCGL has a high probability ("power") of meeting the release criteria. Thus, it can be concluded that the direct measurement data support rejection of the null hypothesis, providing high confidence that the survey unit satisfied the release criteria and that the data quality objectives were met.

The Retrospective Power Curve shown in Attachment 4 confirmed that sufficient samples were taken to support rejection of the null hypothesis, providing high confidence that the survey unit satisfied the release criteria and the data quality objectives were met. Attachment 4 also revealed that direct measurement data represented essentially a log-normal distribution with one outlier.
