**MAINE YANKEE  
FINAL STATUS SURVEY RELEASE RECORD  
FR-0200 YARD EAST  
SURVEY UNIT 9**

**A. SURVEY UNIT DESCRIPTION**

FR-0200 Yard East Survey Unit 9 was located in the southeast corner of the site, mostly residing in the former "Industrial Area" yard. The 1413 m<sup>2</sup> area was bordered on the north by FR-0200 Survey Unit 5, on the west by FR-0200 Survey Unit 4, on the south by FR-0200 Survey Unit 3, and on the east by FR-0200 Survey Unit 1. As shown on map FR0200-9 SITE, this survey unit is approximately centered by the coordinates 624183E and 407489N using the Maine State Coordinate System (West Zone) NAD 1927. The location of the survey unit in relation to the Service Building and the surrounding FR-0200 and FR-0111 survey units is shown on map FR0200-9 REF (Attachment 1). The survey unit is located within the expanded Restricted Area boundary.

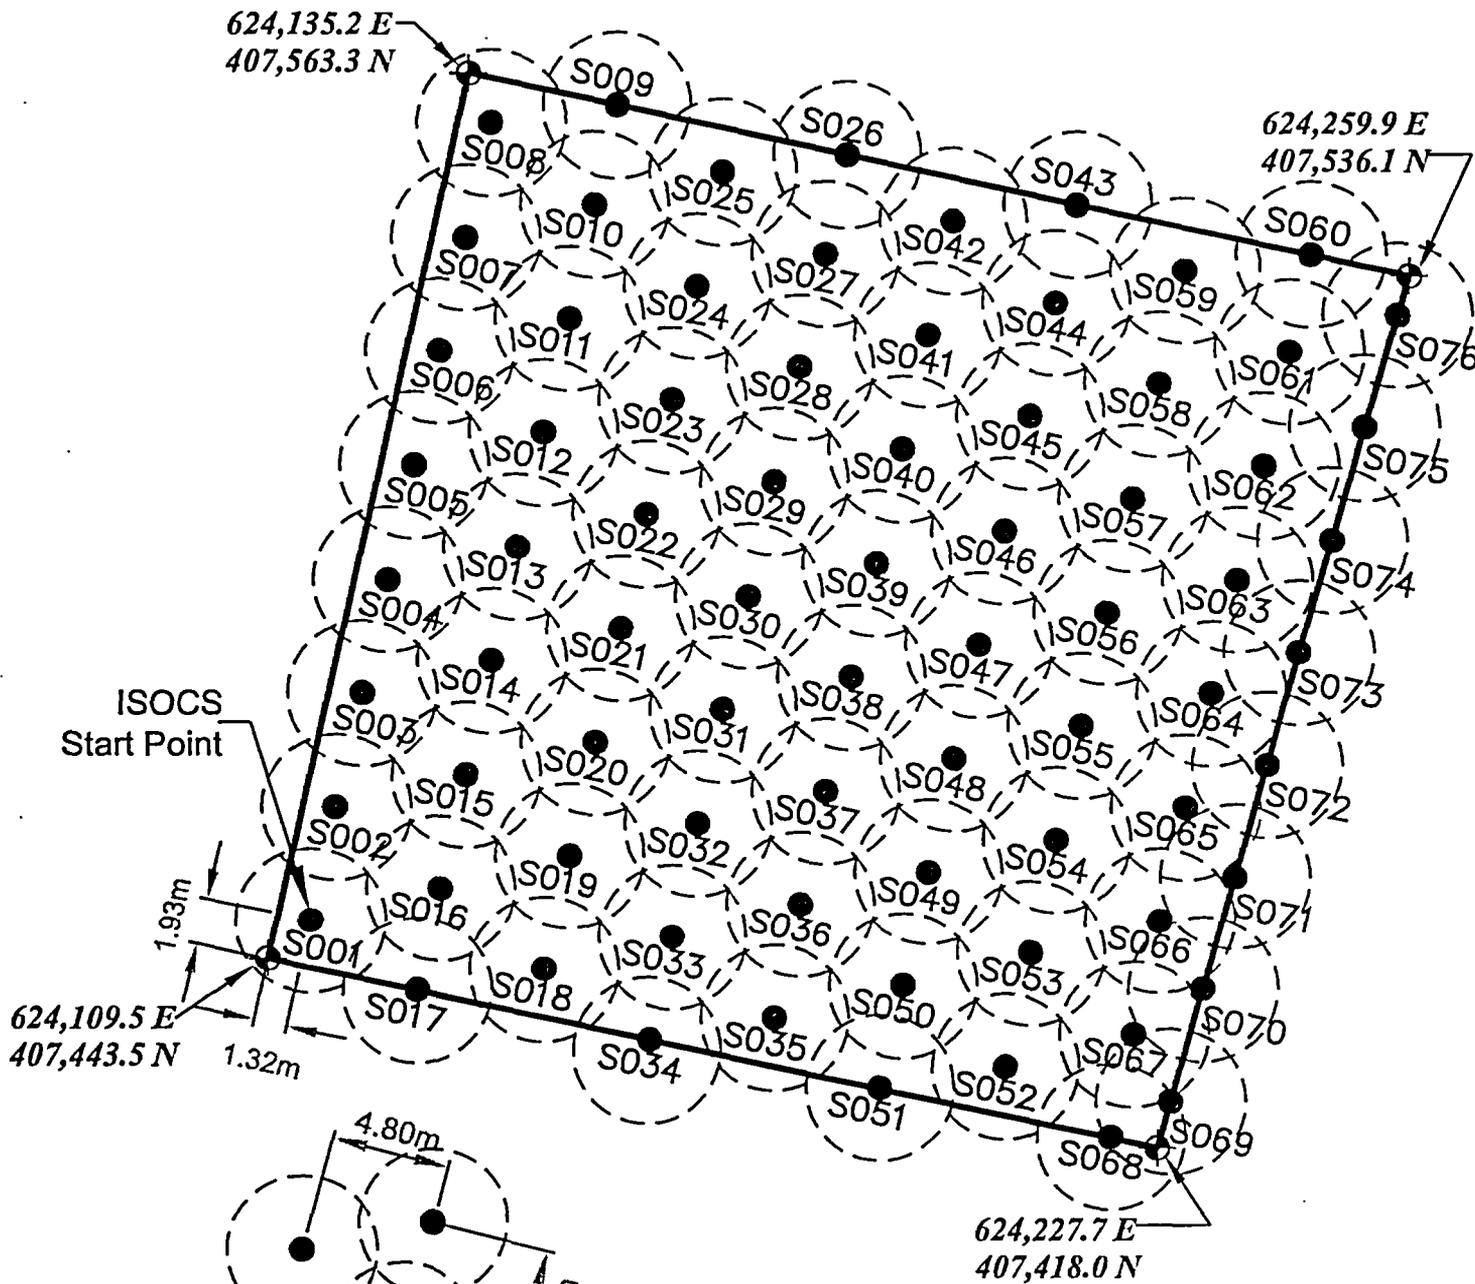
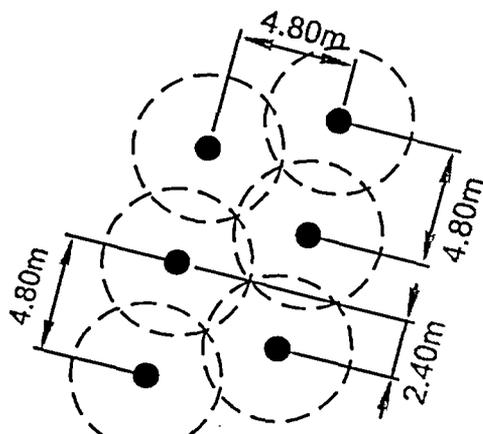
### Final Status Survey FR0200 SU9: Yard East ISOCS Scans S001 - S076

In accordance with the LTP, scans covering 100% of the 1413 m<sup>2</sup> area were required for the Class 1 survey unit. This was accomplished by use of an *in situ* gamma spectroscopy detector (ISOCS) configured at a 3-meter distance from the surface to obtain overlapping 28-m<sup>2</sup> fields of view. The ISOCS detector was positioned perpendicular to the surface. Locations of the 100 survey scans are shown on map FR0200-9a and 9c (Attachment 1).

**Typical ISOCS Spacing**  
(Maximum)

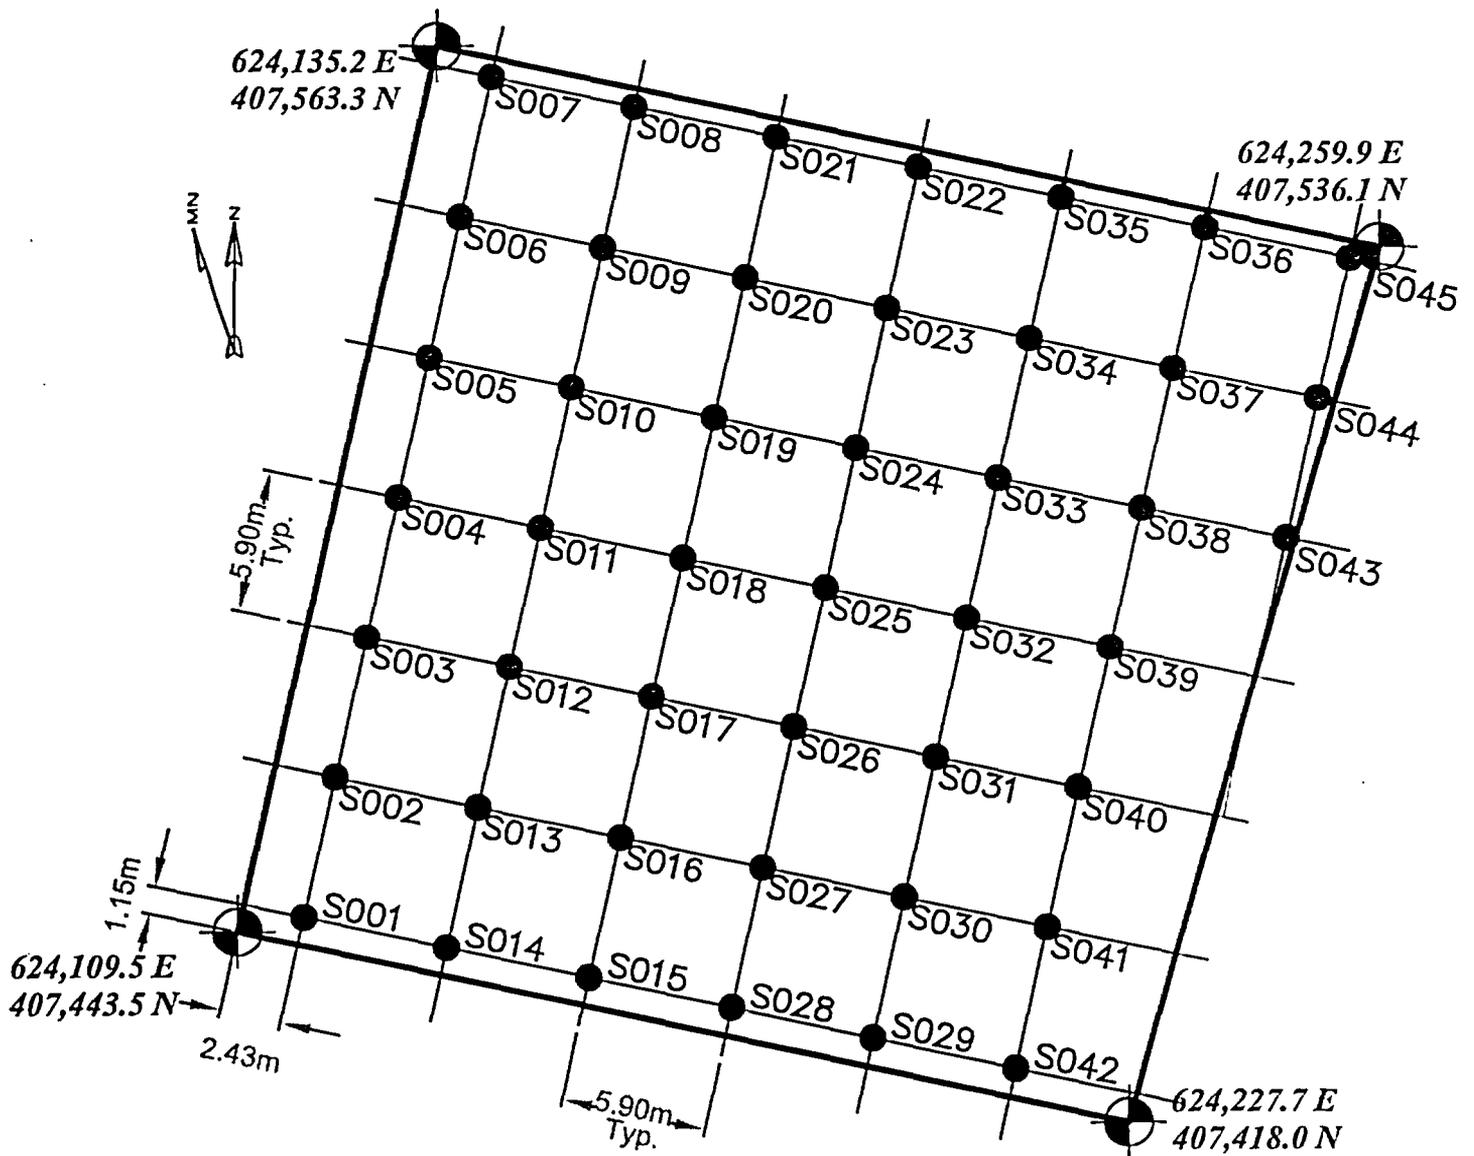
### Final Status Survey FR0200 SU9: Yard East Direct Points S001 - S045

A total of 45 direct measurements were performed in Survey Unit 9. Five samples contained detectable Cs-137 with levels of activity greater than the MDA but below the DCGL. Four samples contained detectable Co-60 activity above the MDA but below the DCGL. All other measurements were below the MDA. The results are presented in Table 2. No investigations were necessary as a result of the direct measurements.

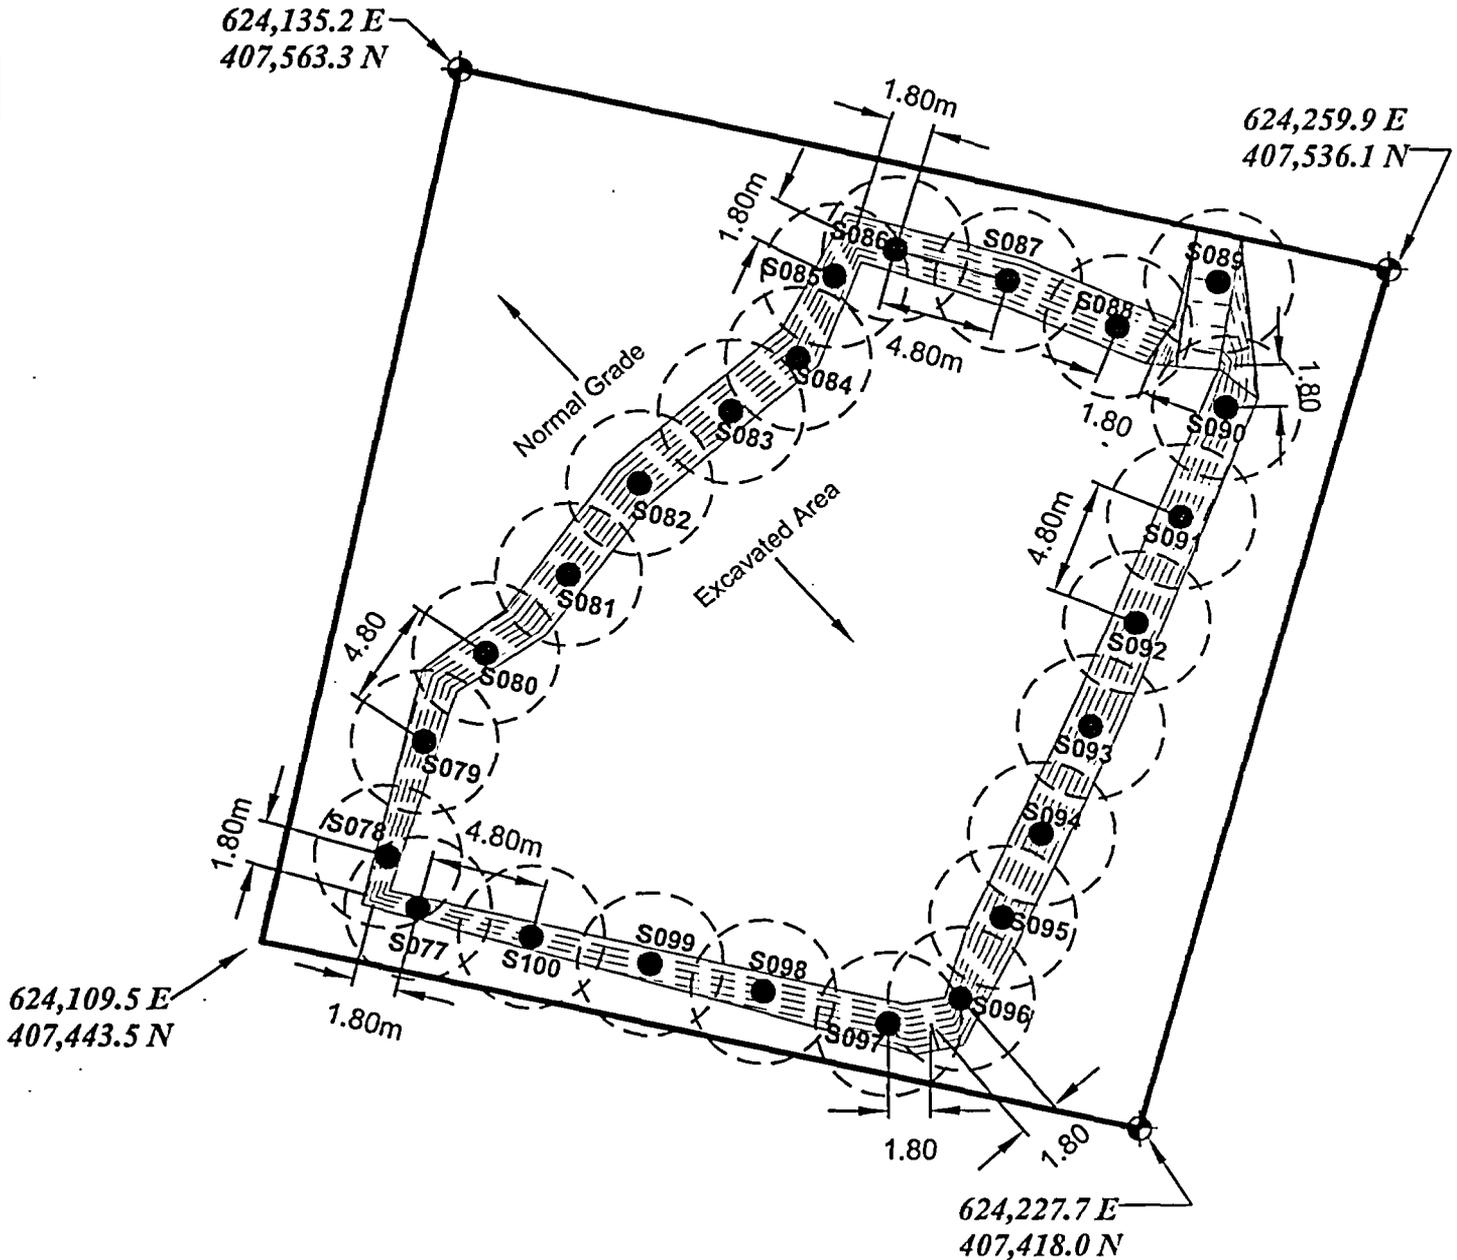
### Final Status Survey FR0200 SU9: Yard East ISOCS Scans S077 - S100 Excavation Walls

ISOCS gamma scans were performed at 100 locations using an investigation level of 1.0 pCi/g Cs-137 and 0.36 pCi/g Co-60. The gamma scans were performed for a sufficient count time to achieve a Minimum Detectable Activity (MDA) of approximately 16% of the DCGL. All identified scan activity levels and MDAs were below the investigation levels. Therefore, no investigation surveys were performed as a result of the scan surveys.

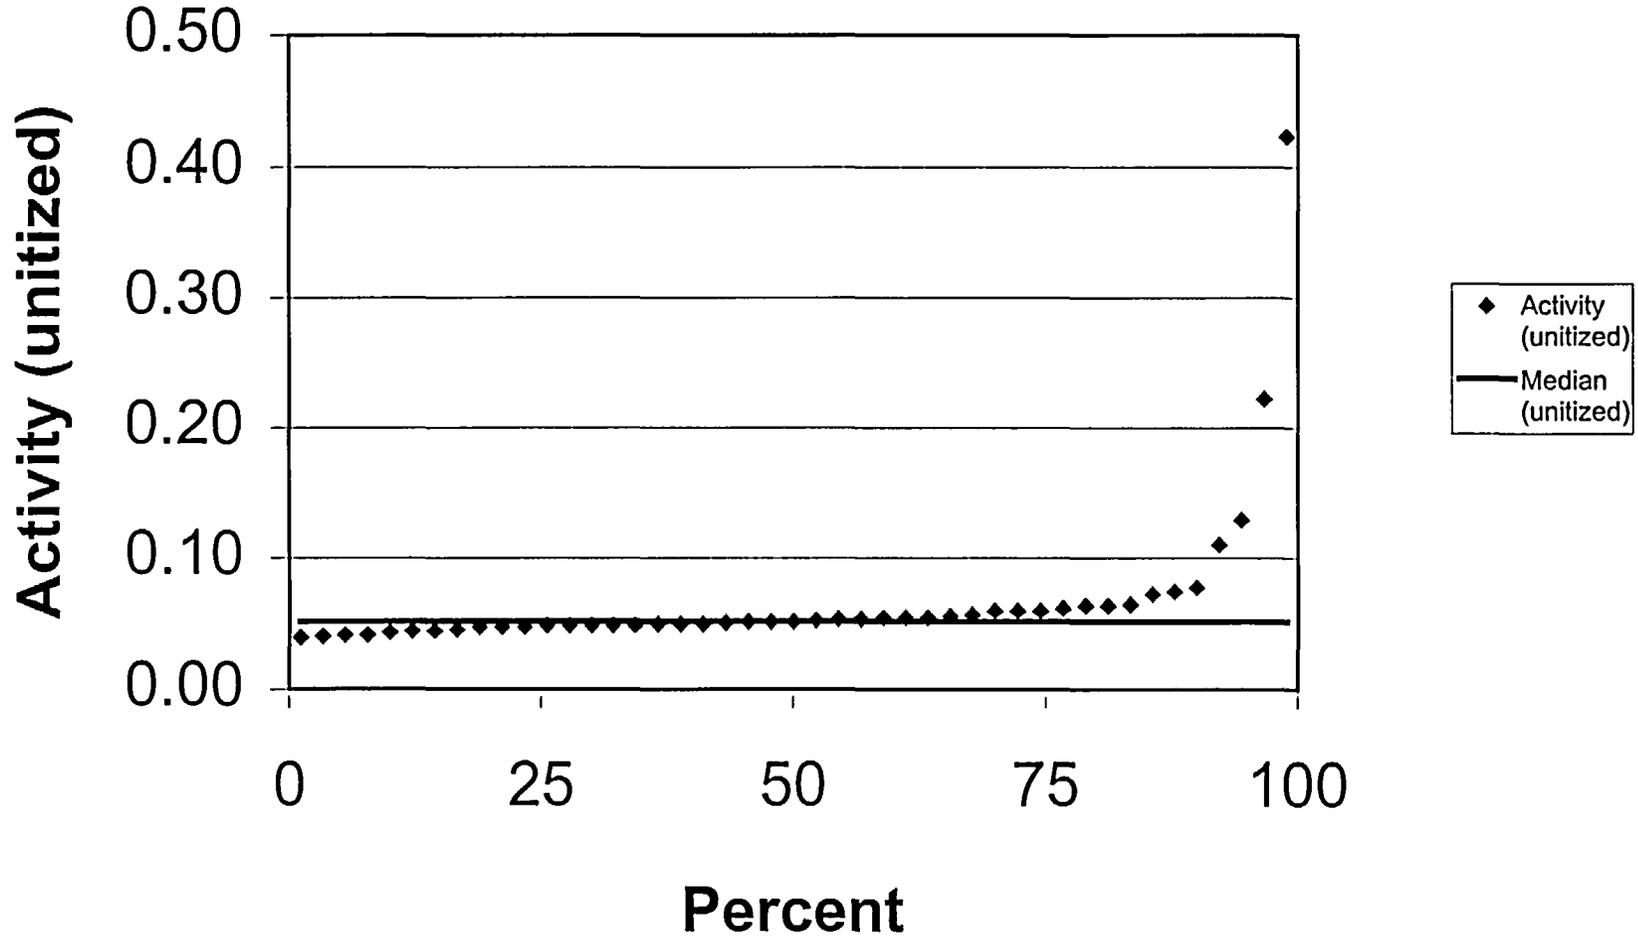
# FR0200 SU-9 Quantile Plot

2. The Quantile Plot was generated from the unity data listed in Table 2. The data set and plot are consistent with expectations for a Class 1 survey unit. All of the measurements are below the DCGLs of 4.2 pCi/g (Cs-137) and 1.5 pCi/g (Co-60) for land outside the restricted area.
3. A Histogram Plot was also developed. This plot shows a log-normal distribution with two outliers.
4. A Retrospective Power Curve was constructed, based on FSS results. The curve shows that this survey unit having a mean residual activity at a small fraction of the DCGL has a high probability (“power”) of meeting the release criteria. Thus, it can be concluded that the direct measurement data support rejection of the null hypothesis, providing high confidence that the survey unit satisfied the release criteria and that the data quality objectives were met.

The Retrospective Power Curve shown in Attachment 4 confirmed that sufficient samples were taken to support rejection of the null hypothesis, providing high confidence that the survey unit satisfied the release criteria and the data quality objectives were met. Attachment 4 also revealed that direct measurement data represented essentially a log-normal distribution with two outliers.
