# **BUILDING 150/UNDERGROUND STORAGE TANK DECOMMISSIONING PROJECT**

## **BETHESDA NATIONAL NAVAL MEDICAL CENTER**

**Project No. USN 2000-035**

**Revision 3  
January 6, 2004**

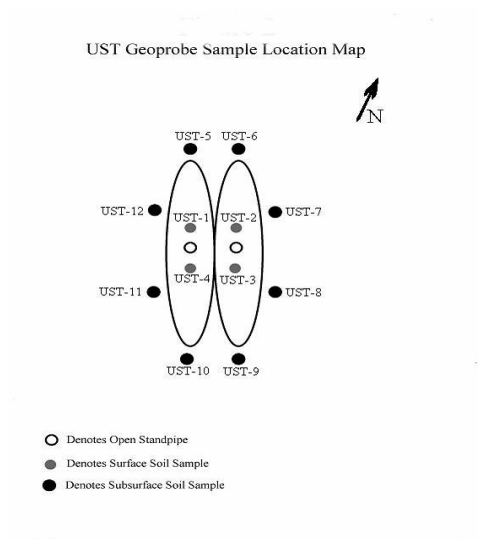
**Figure 2. UST Geoprobe Sample Location Diagram**

Figure 2 present a diagram of the pre excavation geoprobe sampling locations.

Pre excavation geoprobe soil sampling of the soils around and above the two UST's was performed during NWT's previous site visit in March of 2002. The purpose of the soil sampling prior to removal of the two UST's was to provide data as to the physical condition of the two UST's and whether or not material inside of the UST's had leaked into the surrounding soils. Based upon the results of the soil sampling, the two UST's were intact and the contents of the

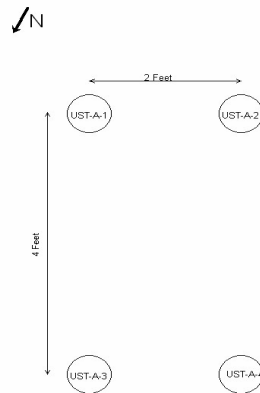
**Figure 3. UST-A**

UST Tank Sampling Pattern Diagram

- f. Table 5 presents a summary of the UST footprint soil sample analysis.
- g. Sample USTA-1 results (15.9 pCi/g) were above natural background levels but well below the DCGL. This sample was taken from an area where a small amount (~ 1 pint) of water leaked from the tank during removal.

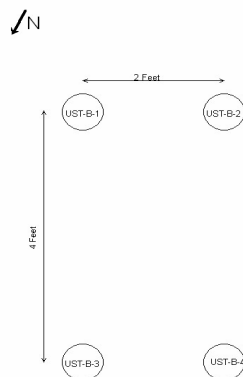
**Figure 4. UST-B Footprint Sample Location Diagram**

UST Tank Sampling Pattern Diagram

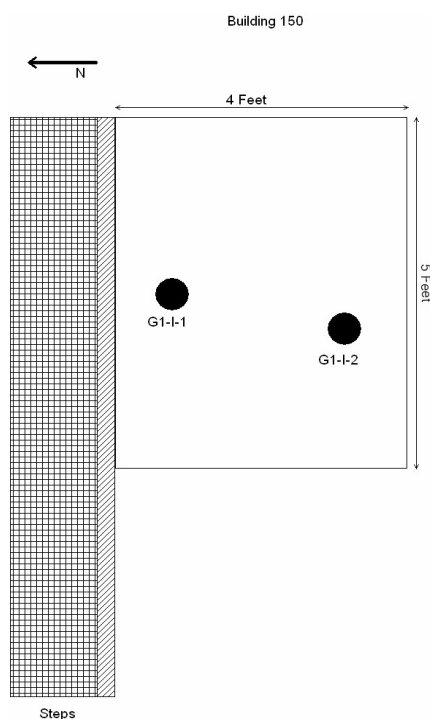
**Figure 5. Post Remediation Soil Sample Location Diagram**

- b. The laboratory data for the soil samples is presented in this report in Appendix K.
- c. Figure 5 presents a diagram showing the soil sample locations for the remediated area.
- d. Table 6 presents a summary of the post remediation soil samples.

- a. Two soil samples were collected from the area following the gamma scan survey. The samples were sent to NWT's laboratory in Livermore, CA for gamma spectroscopy analysis to quantify Co-60 concentrations. The results of the samples were below the DCGL.

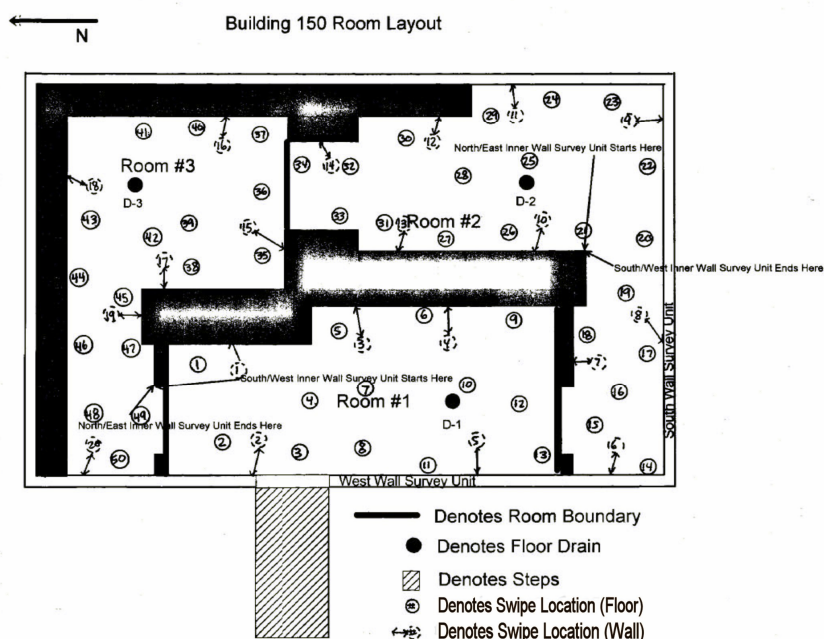
**Figure 6. Building 150 Swipe Location Map**

- A detailed loose surface contamination survey was performed on the surfaces and debris located inside of the building prior to work starting inside of the building.
- Swipe samples were collected for analysis of removable alpha and beta contamination activity. The swipes were collected over an area of 100 cm<sup>2</sup>. Dry cloth swipes were used for the swipe samples. Samples were analyzed using a Ludlum Model 2929 Dual Channel Scaler. The Ludlum Model 2929 Dual Channel Scaler is ZnS(Ag) phoswich scintillation alpha/beta radiation counter. This unit provides a full range of simultaneous alpha and beta counting at the levels required for environmental release surveys. Data is reported in units of dpm per 100 cm<sup>2</sup>.
- The locations of the swipe samples are presented in Figure 6 below.

- Appendix L provides the swipe results. None of the swipe samples exceeded the MDA of 12 dpm/100cm<sup>2</sup> α and 228 dpm/100cm<sup>2</sup> βγ. None of the swipe measurements exceeded 10% of the DCGL.

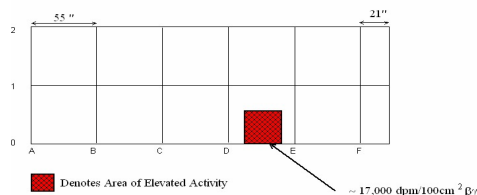
**Figure 7. Building 150 Wall Areas Requiring Remediation**

North Outer Wall Grid Layout Map

- Any areas identified during the scan survey performed as outlined in Section 9.3 of this report that were above the DCGL, required remediation.
- It was anticipated that the contamination was in the uppermost 1/2 inch (approximate) of the concrete. The areas identified during the scan survey as requiring remediation were remediated using a concrete scabbler. Removal of 1/2 inch of the concrete surface in the identified areas was sufficient.

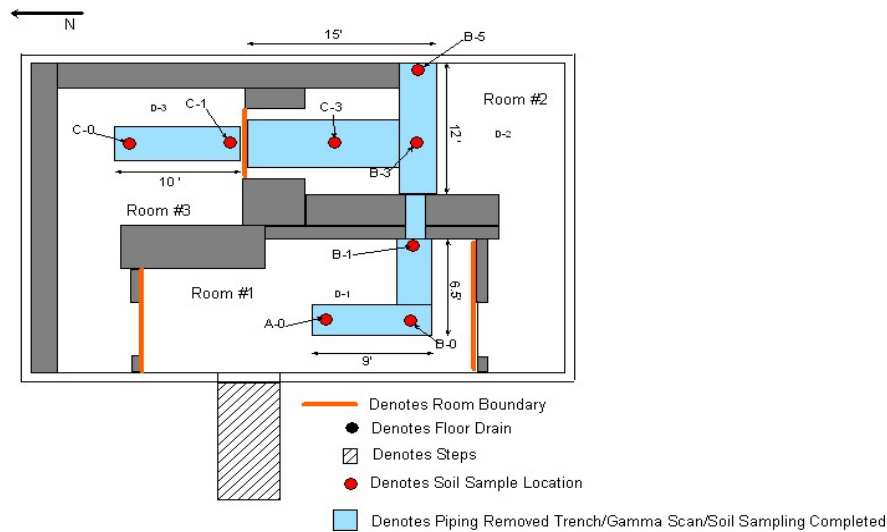
**Figure 9. Building 150 Interior Trench/Sample Location Map**

- a. The drain lines were removed from the trenches using hand tools and chain-falls.
- b. A 100 % gamma scan survey was performed inside of the trenches. The survey was conducted with 2" by 2" NaI detectors coupled to data loggers operating in the single channel analyzer mode.
- c. No detectable activity above background radiation levels was detected during these surveys.
- d. Soil samples were collected at a maximum of every 10 linear feet of the trenches. The samples were sent to an offsite laboratory for gamma spectroscopy analysis to quantify Co-60 concentrations. None of the soil sample results exceeded the DCGL. The laboratory data for the soil samples is presented in Appendix Q.
- e. Table 8 presents a summary of the soil sample results.
- f. Figure 9 presents a map of the interior trenches and soil sample locations inside of Building 150.

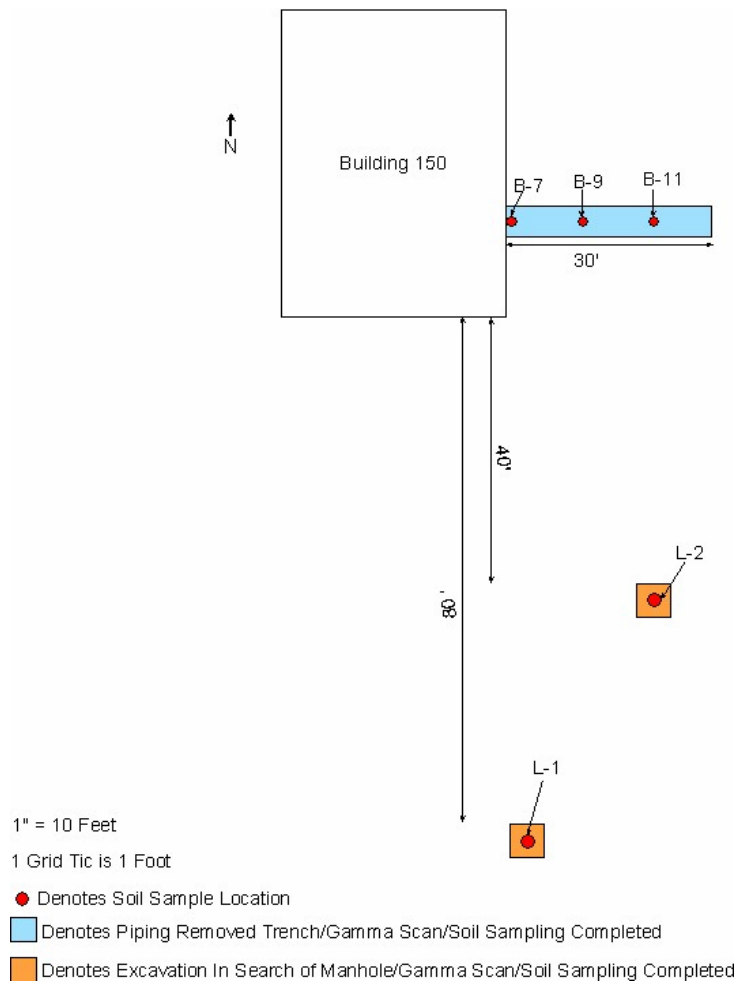
**Figure 10. Building 150 Exterior Trench/Sample Location Map**

- a. A 100 % gamma scan survey was performed inside of the trenches. The survey was conducted with 2" by 2" Nal detectors coupled to data loggers operating in the single channel analyzer mode.
- b. No detectable activity above background radiation levels was detected during these surveys.
- c. Soil samples were collected at a maximum of every 10 linear feet of the trenches. The samples were sent to an offsite laboratory for gamma spectroscopy analysis to quantify Co-60 concentrations. None of the soil sample results exceeded the DCGL. The laboratory data for the soil samples is presented in Appendix R.
- d. Table 8 presents a summary of the soil sample results.
- e. Figure 10 presents a map of the exterior trenches and soil sample locations outside of Building 150.

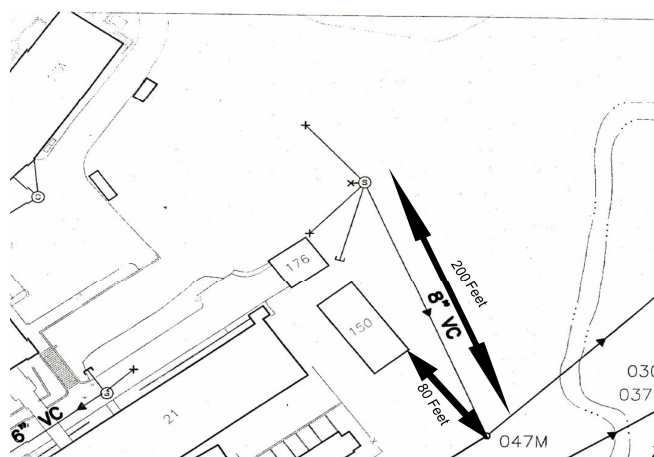
**Figure 11. Manhole 047M Location Map**

- An attempt to locate manhole 047M was made by excavating test holes in the locations where site engineering drawings indicated the manhole was located.
- Figure 11 presents a map of the possible location of manhole 047M.
- The test holes were approximately 5 feet in diameter and 8 foot in depth. No indication of the manhole was identified inside of the test holes.

- d. A 100 % gamma scan survey was performed inside of the test holes. The survey was conducted with 2" by 2" NaI detectors coupled to data loggers operating in the single channel analyzer mode.
- e. No detectable activity above background radiation levels was detected during these surveys.
- f. Soil samples were collected in the bottom of each of the test holes. The samples were sent to an offsite laboratory for gamma spectroscopy analysis to quantify Co-60 concentrations. None of the soil sample results exceeded the DCGL. The laboratory data for the soil samples is presented in Appendix S.
- g. Table 8 presents a summary of the soil sample results.
- h. Figure 10 presents a map of the manhole investigation trenches and soil sample locations outside of Building 150.

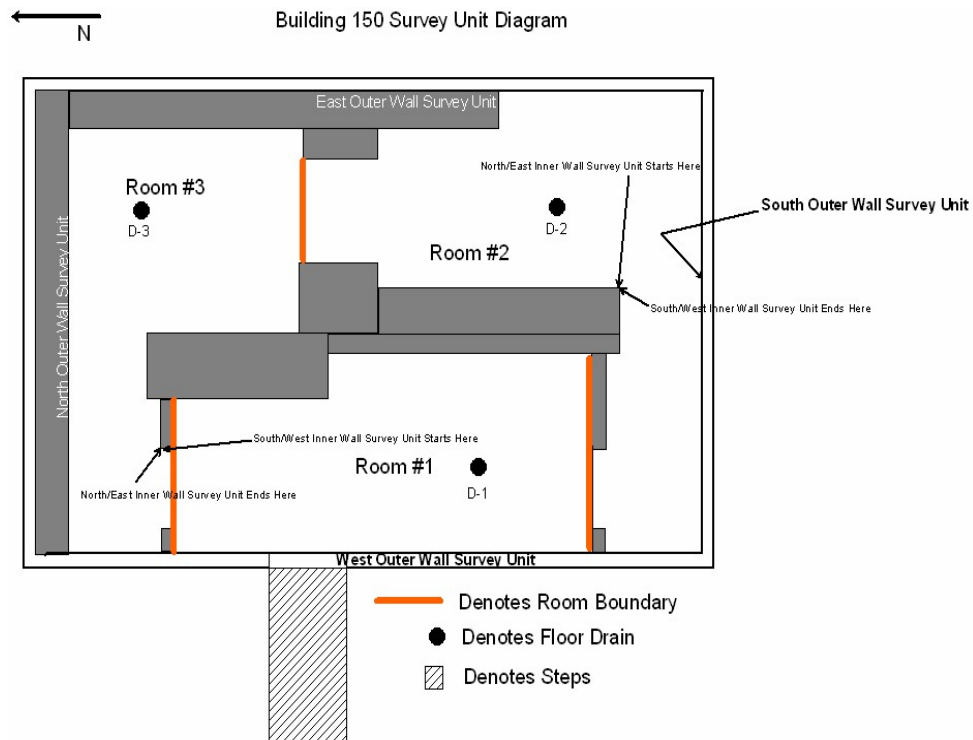
**Figure 13. Survey Units-Building 150**

Figure 13 is a diagram of the Building 150 interior areas, presenting a layout of the different survey units.

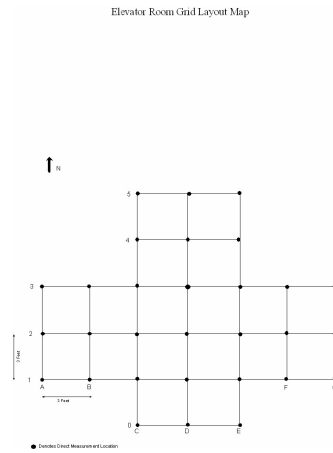
**Figure 14. Elevator Shaft Room Survey Unit Diagram**

Figure 14 is a diagram of the elevator shaft room survey unit.

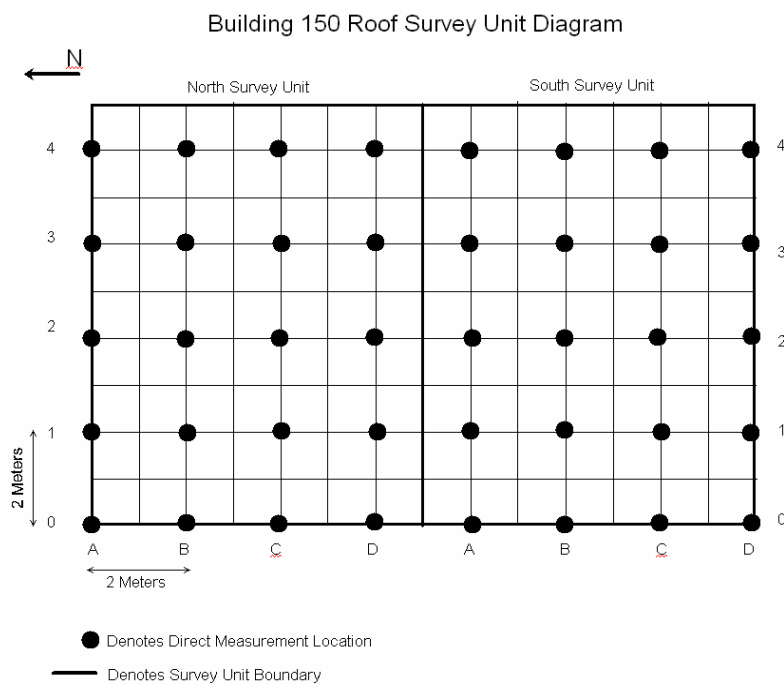
**Figure 15. Building 150 Roof Survey Unit Diagram**

Figure 15 is a diagram of the Building 150 roof area, presenting a layout of the different survey units.

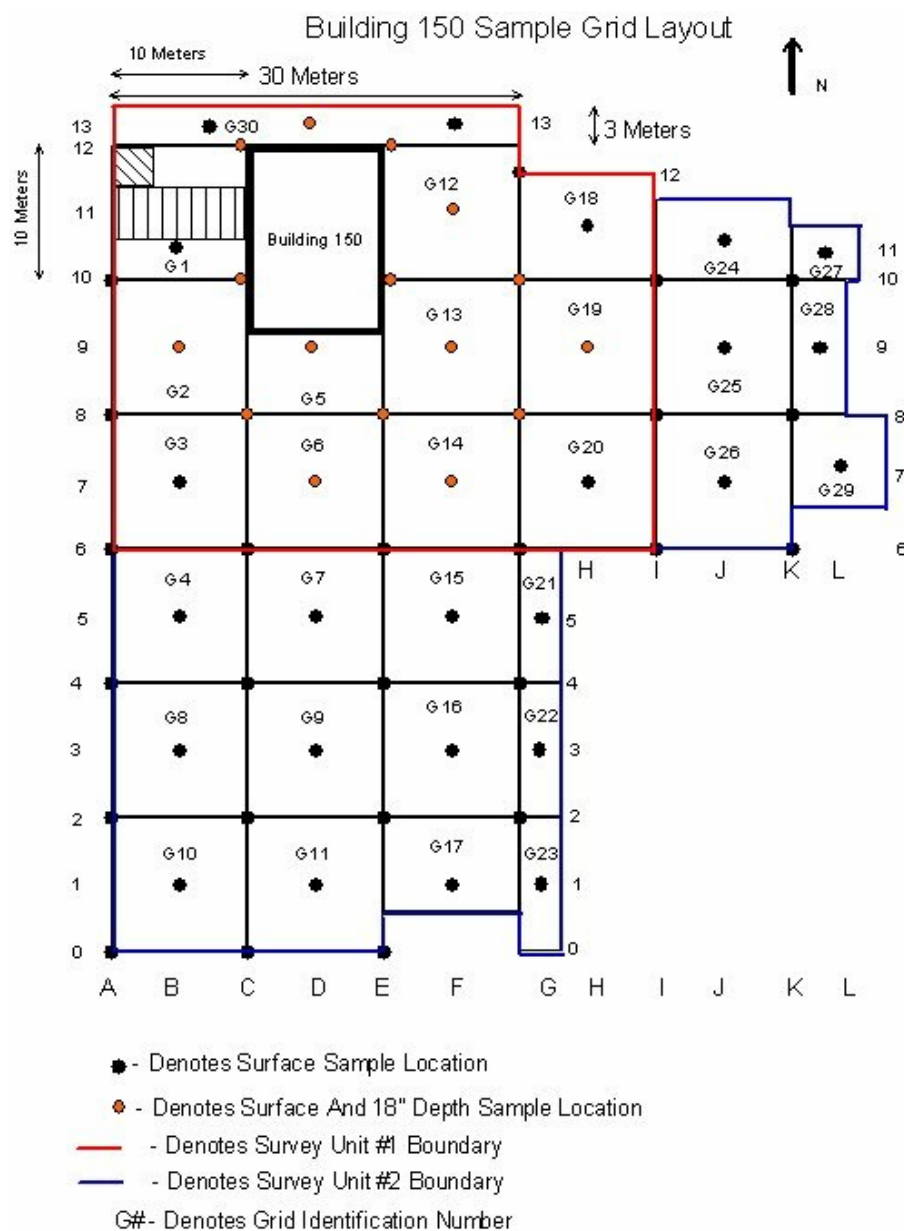
**Figure 16. Building 150 Outside Open Land Area Survey Unit Layout Diagram**

The open land area outside of Building 150 was divided into two survey units based upon contamination potential. Whenever possible, ten meter by ten meter grids were setup in each of the survey units.

Figure 16 presents a diagram showing the survey units outside of Building 150.

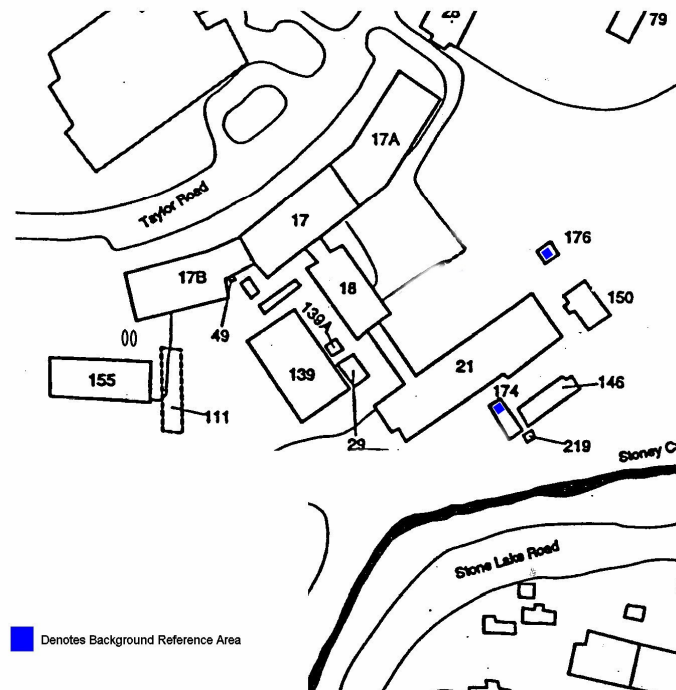
**Figure 17. Background Reference Areas-Building Surfaces**

The results of the building surface background reference area surveys are presented in Appendix V.

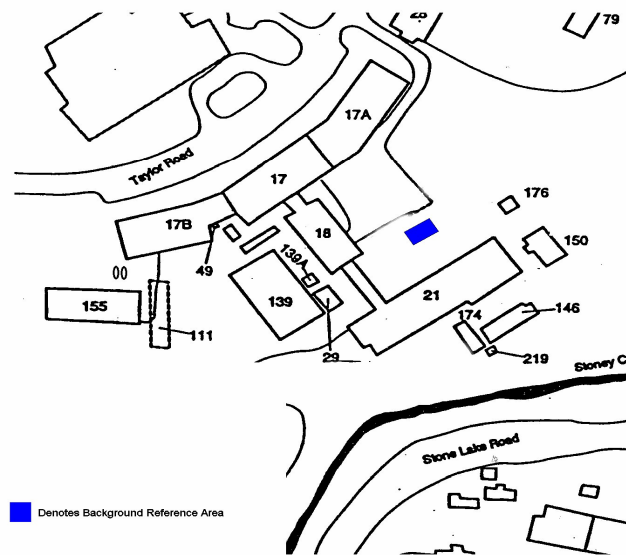
**Figure 18. Background Reference Area-Outside Land Areas**

An open land area north east of Building 21 was selected as the reference (background) areas for the open land areas outside of Building 150. This area was selected because it was non-impacted from Building 150 operations and has the same chemical, physical, biological, and geological characteristics as the exterior open land areas outside of Building 150. Figure 18 provides a diagram of the reference area showing the location where radiation measurements were taken.

The results of the outside land area background reference area surveys are presented in Appendix W.

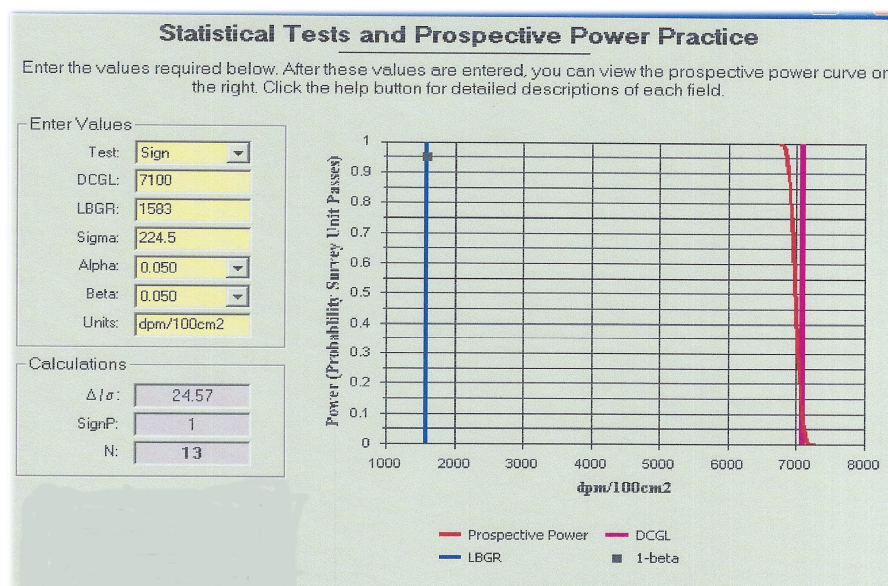
**Figure 19. Statistical Test and Power Curve**

As a conservative measure, 16 data points were selected as the required number of data points. Figure 19 presents a graphical illustration of the prospective power curve, calculated relative shift and Sign p values that were generated when calculating the required number of data points.

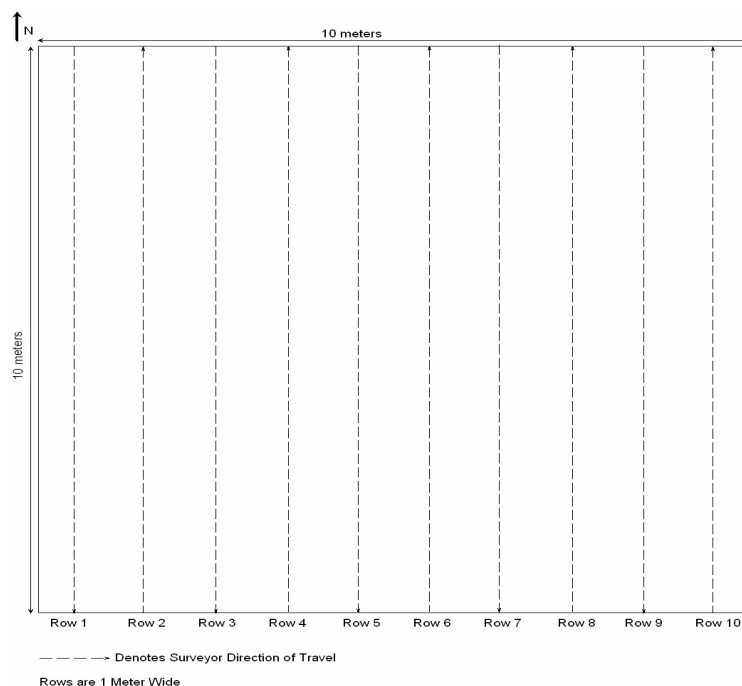
**Figure 20. Surveyor Direction of Travel Diagram**

NOTE: All the grids were surveyed with the same starting point and direction of travel with the exception of Grid #30.

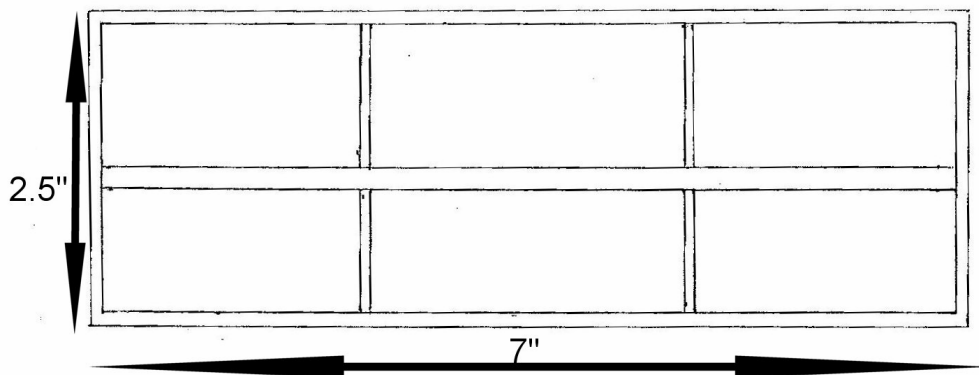
*Diagram 1. Model 43-37 Detector Dimension Diagram*

Drawing is 50% of Full Scale With Exception of Center Bar Which is Full Scale
