Section 4:
Session 4: Crack Growth Rate Studies for
the Disposition of Flaws

US REGULATORY EXPERIENCE AND PROGNOSIS WITH RPV HEAD DEGRADATION AND VHP NOZZLE CRACKING

Allen L. Hiser, Jr.

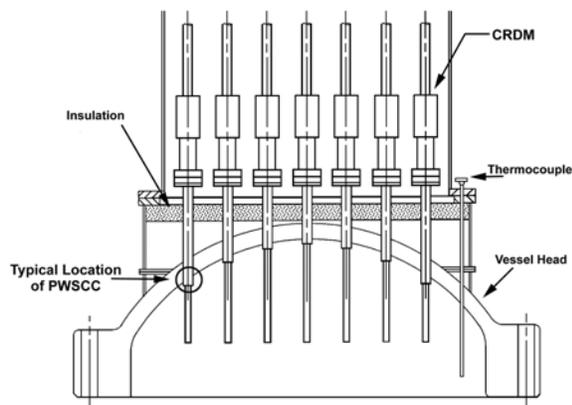
Figure 1 Schematic cross-section of an upper RPV head for a B&W plant.

A schematic cross-section of an upper head is provided in Fig. 1. This schematic is for a head fabricated by Babcock and Wilcox. A schematic cross-section of a CRDM nozzle is provided in Fig. 2., illustrating the J groove weld, the counterbored region just above the J-groove weld (and the annulus between the RPV head and the CRDM nozzle), and the shrink fit region of the head and the CRDM nozzle.

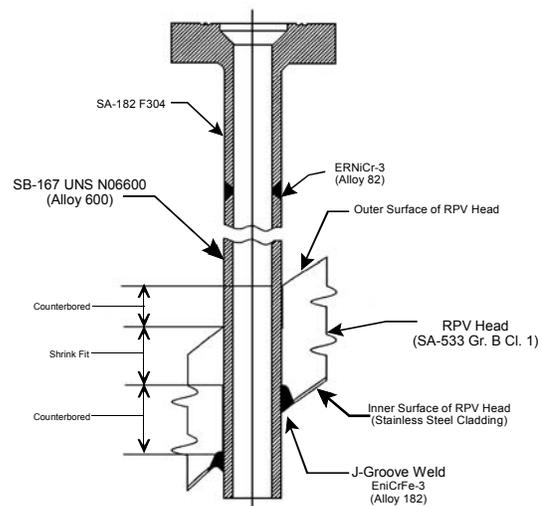
Figure 2 Schematic cross-section of a CRDM nozzle in an upper RPV head.

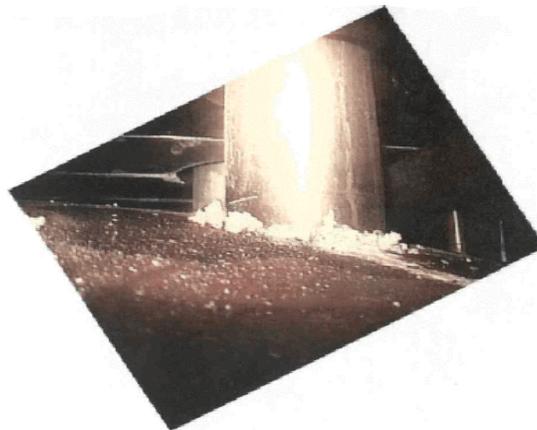
Figure 3 Leakage at Oconee Unit 1 identified fall 2000.

In the fall of 2000, the inspection findings in the U. S. became more significant. At Oconee Unit 1 that fall, boron deposits were identified on the RPV head at one CRDM nozzle and at five (of the eight) thermocouple nozzles (one of only two plants with small diameter thermocouple nozzles). Contrary to expectations, the boron deposits were very small (less than 1 in.³ total volume), as illustrated in Fig. 3. Analysis of the CRDM nozzle identified an axial-radial PWSCC crack that initiated in the J-groove weld and propagated part way into the outer diameter surface of the nozzle. The crack in the J-groove weld was arrested when it encountered the RPV head base material, consistent with expectations.

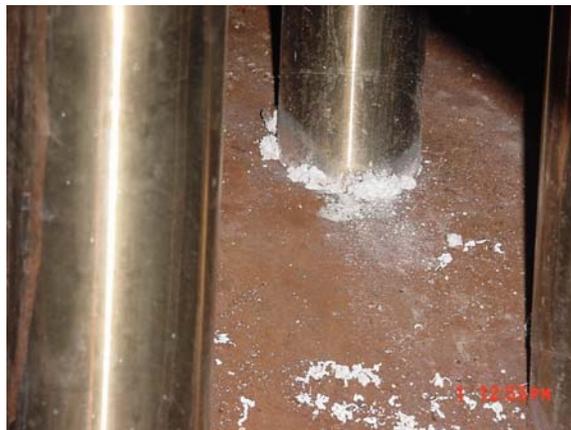
Figure 4 Boric acid deposits identified at Crystal River Unit 3 during its fall 2001 outage.

Of the plants that did inspections in fall 2001, Crystal River Unit 3 identified a nozzle with boron deposits, and ultrasonic examination revealed a through-wall circumferential crack that extended $\sim 90^\circ$ around the nozzle (Fig. 4). This nozzle was repaired.

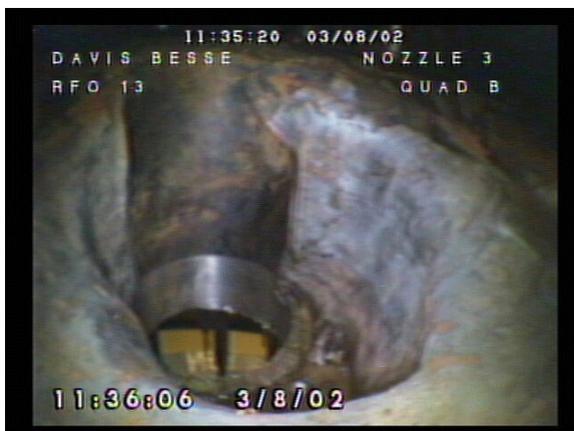
Figure 5 Cavity identified at Davis-Besse during its spring 2002 outage.

The Davis-Besse refueling outage began on February 16, 2002. The licensee planned to perform a visual inspection of the outer surface of the RPV head looking for signs of boron deposits, and ultrasonic inspection of all CRDM nozzles. The inspection identified five nozzles with indications, including three with through-wall cracks, and the licensee decided to repair all five nozzles. During machining to facilitate repair of nozzle #3, the equipment rotated and was removed from the head. Upon removal, the licensee found that the nozzle had tipped, with the CRDM flange (located above the head) contacting the flange of an adjacent CRDM. The licensee cleaned the surface of the RPV head and found a large cavity adjacent to nozzle #3 (Fig. 5), where the RPV head base material had been corroded down to the stainless steel cladding. Subsequent investigation revealed an additional much smaller degraded area near nozzle #2, located within the wall thickness (no cladding was exposed).

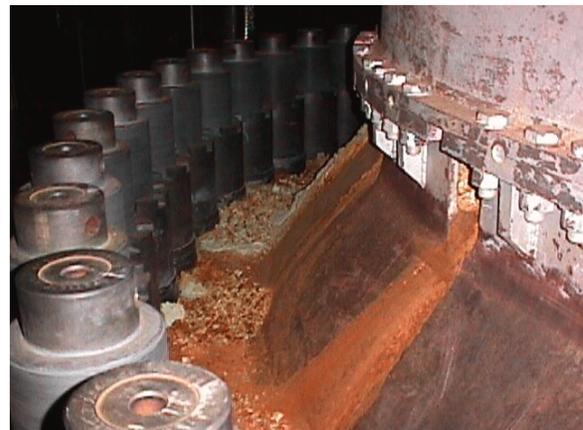
Figure 6 Boric acid and corrosion products identified on the RPV head flange of Davis-Besse during its 2000 outage.

The licensee completed a root cause analysis (Ref. 7). One of the new pieces of information in that report was a photograph of the head from the 2000 refueling outage (Fig. 6). A similar photograph, albeit without the reddish tinting from corrosion product, has subsequently been identified from the 1998 outage.

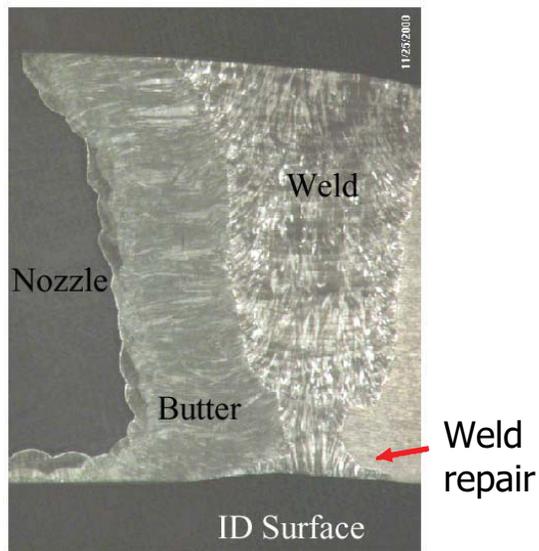
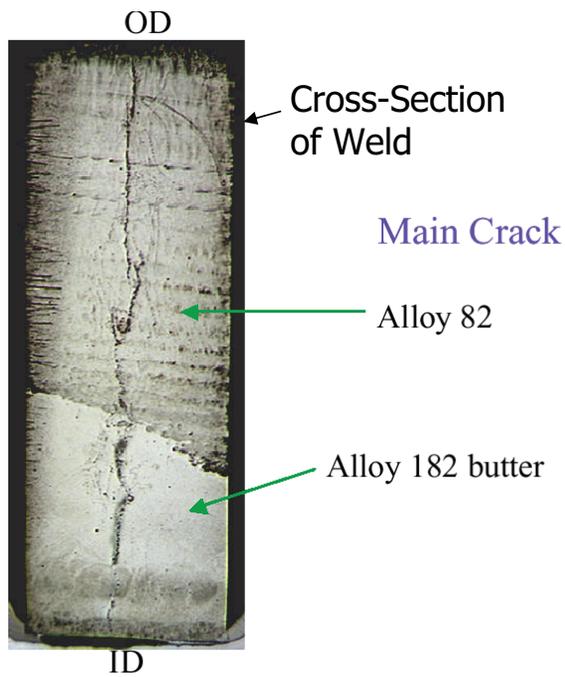
Figure 1. Photographs from the VC Summer hot leg, showing that both Alloys 182 and 82 are susceptible to primary water stress corrosion cracking (source: <http://www.nrc.gov/NRC/REACTOR/SUMMER/index.htm>).

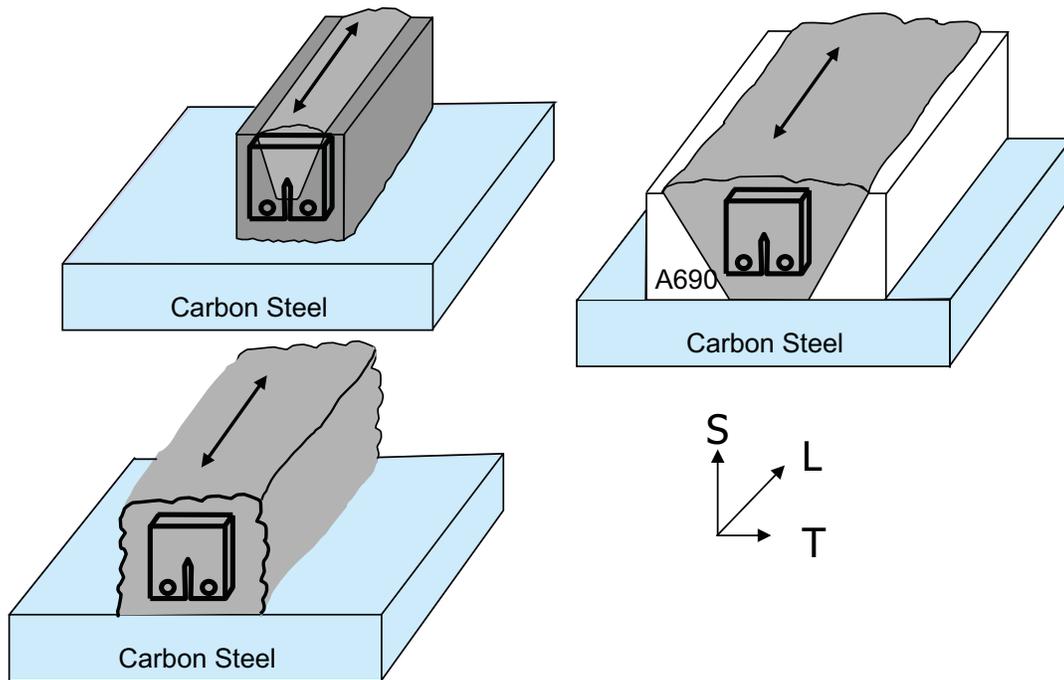
Figure 2. Specimen fabrication methods. Cracks grow from root-to-crown, in the T-S orientation. The arrows denote the welding direction. For the method in the upper left corner, the darker gray weld metal represents Alloy 82 weld buildup, which was subsequently machined to form a groove. Alloy 182 weld metal was then deposited (lighter gray). The end of the notch and the precrack were located in the Alloy 182 material. A similar specimen fabrication method has also been used by Studsvik [7].

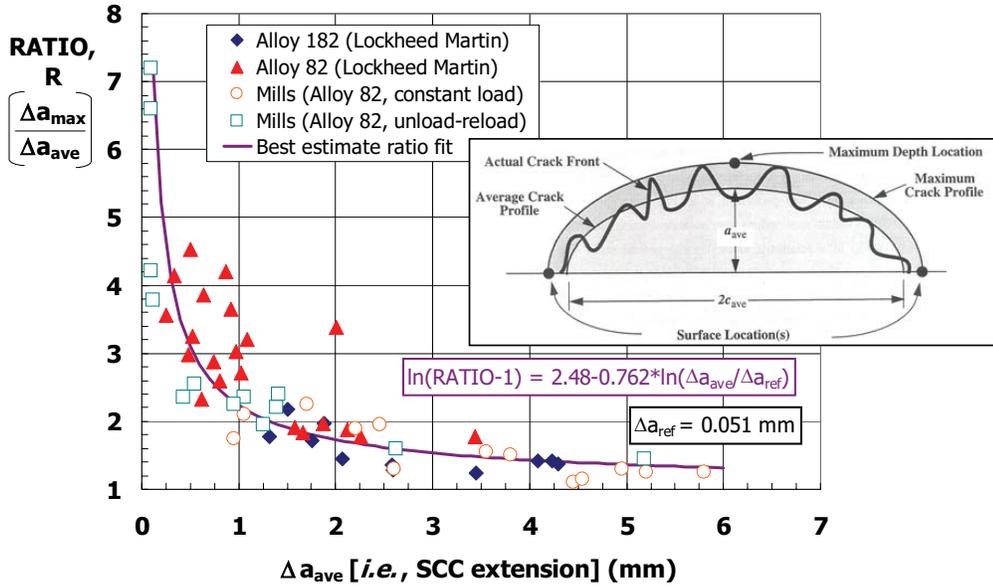
Figure 7. Quantification of the RATIO ($\equiv \Delta a_{\max}/\Delta a_{\text{ave}}$) as a function of crack depth, based on data from [8] and the present work.

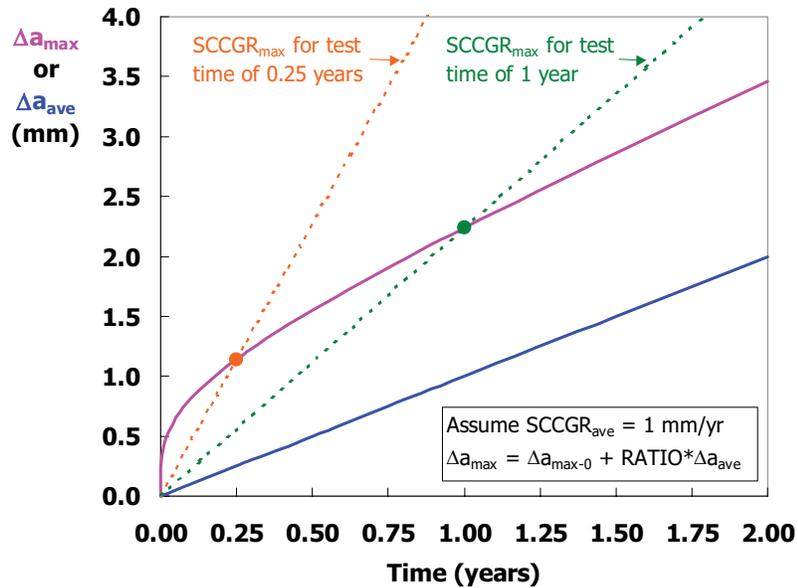
Figure 8. Schematic illustration of the effect of test time on the apparent maximum SCCGR. The Δa_{\max} curve (magenta) was obtained by integrating the RATIO data in Figure 7, and by assuming an $\text{SCCGR}_{\text{ave}}$ of 1 mm/yr.

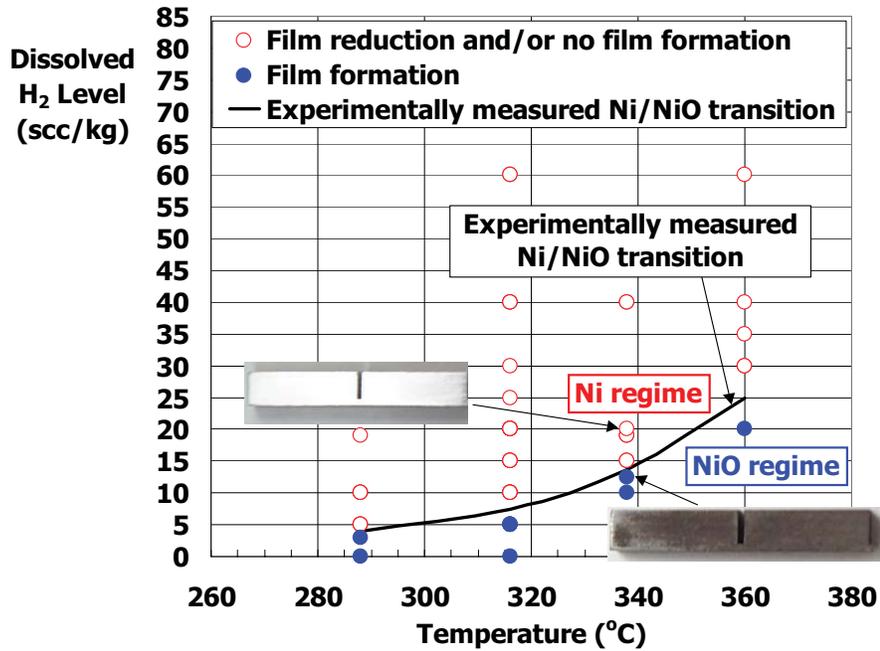
Figure 17. Summary plot of contact electric resistance (CER) and corrosion coupon data [27].

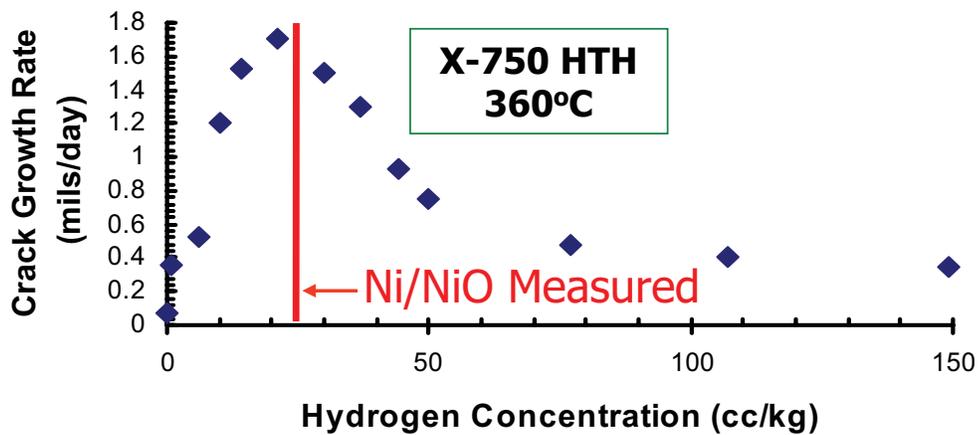
Figure 18. Dissolved hydrogen crack growth rate functionality at 360°C for Alloy X-750 in the HTH heat treatment [18].

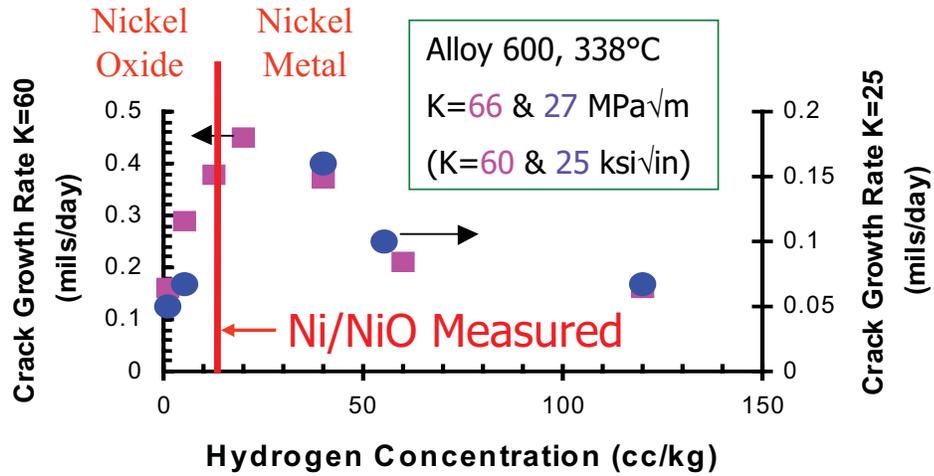
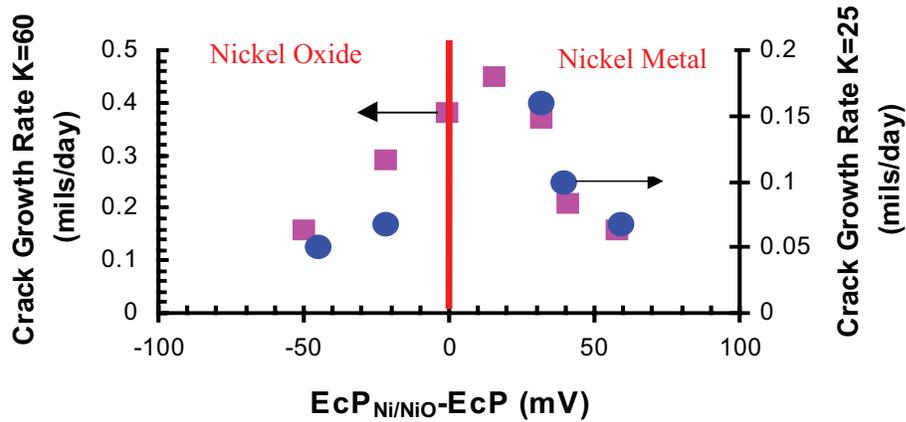
Figure 19. Alloy 600 dissolved hydrogen crack growth rate functionality at 338°C [18]. A value of 13.8 scc/kg H_2 was used as the hydrogen concentration of the Ni/NiO phase transition at 338°C, as shown in Figure 17. Details for calculating the correlating parameter $E_{cP_{Ni/NiO}} - E_{cP}$ are provided in References [17] and [29].

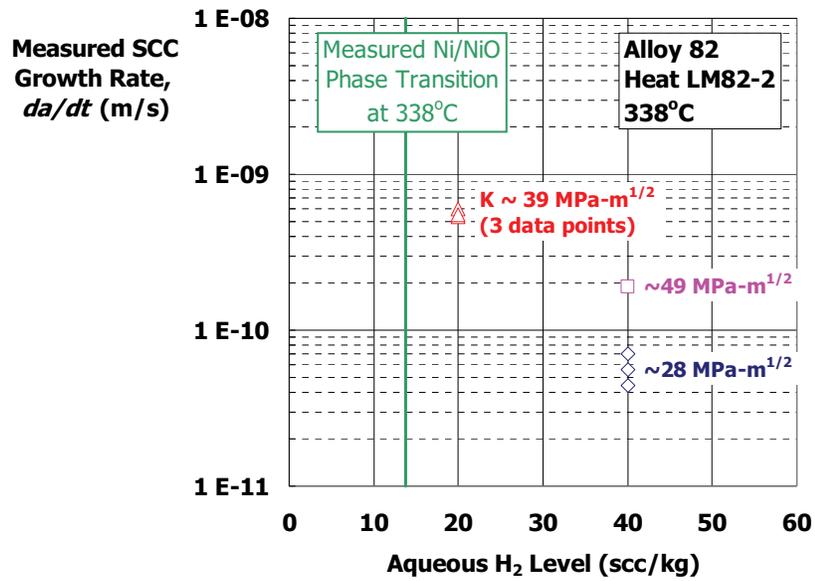
Figure 20. Effect of dissolved hydrogen on SCCGR of Alloy 82 (heat LM82-2) at 338°C. Note that the SCCGRs were not normalized to 325°C.

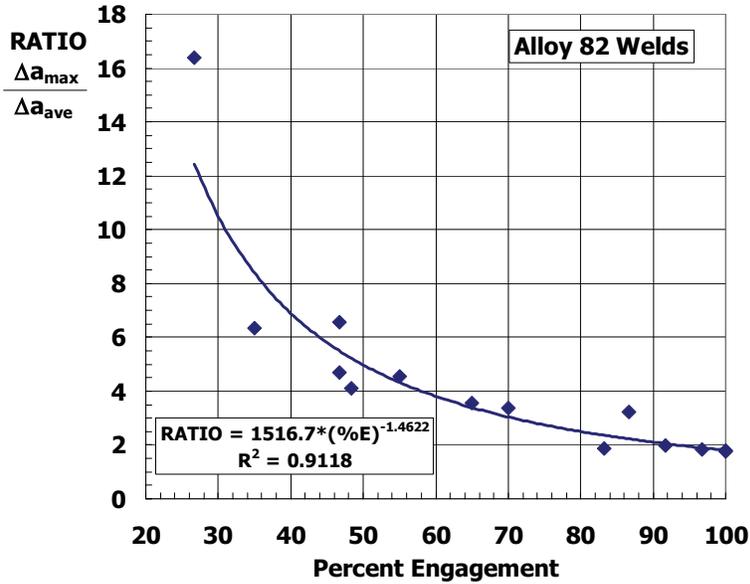
Figure A2. Correlation of maximum-to-average SCC extent ratio with percent engagement (%E). This correlation shows that, consistent with expectations, cracks with high ratios tend to have relatively low engagement. This plot can be used along with Figure 7 to infer the percent engagement for a specimen even if only Δa_{max} is known. This procedure may be of value in screening historical data for which percent engagement is not available.

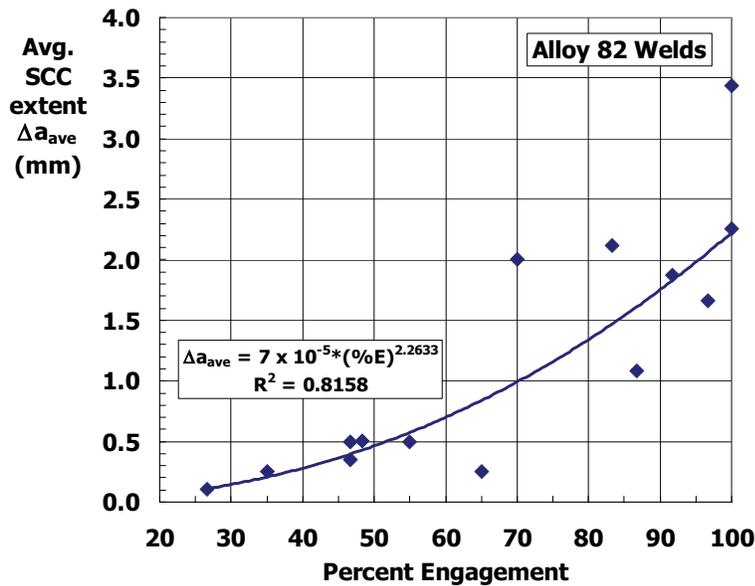
Figure A3. Correlation of average SCC extent (*i.e.*, Δa_{ave}) with percent engagement (%E). This correlation shows that, as expected, cracks with a larger depth of SCC also tend to be closer to full engagement across the precrack. This correlation may also be useful in certain cases for analyzing historical data for which %E is not available.

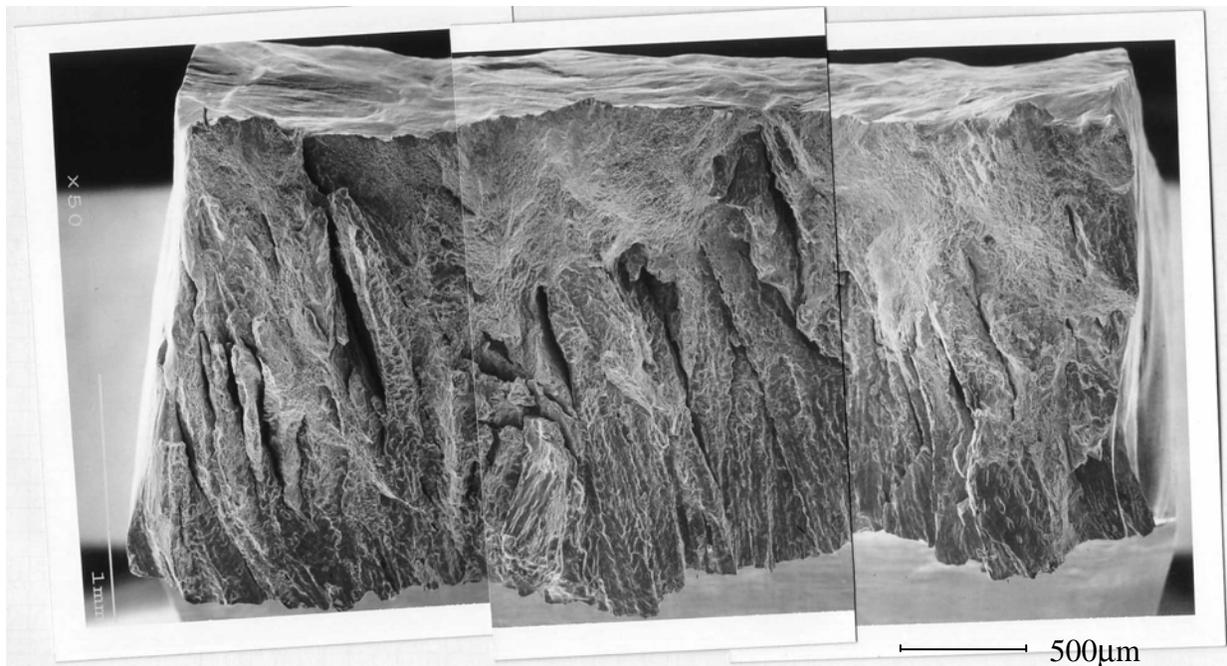
FIGURE 5 - SEM microphotograph of the fractured surface of Alloy 82 weld metal of the SSRT test specimen (Temp.: 360 °C)

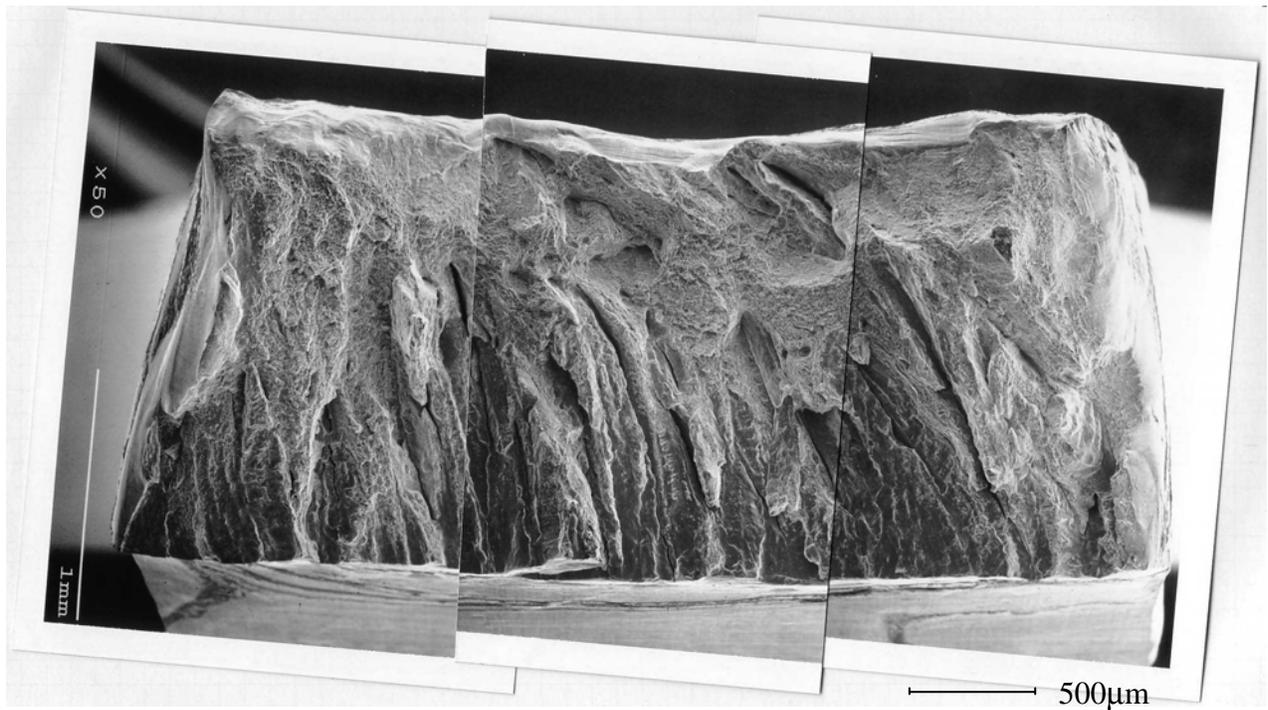
FIGURE 6 - SEM microphotograph of the fractured surface of Alloy 132 weld metal of the SSRT test specimen (Temp.: 360 °C)

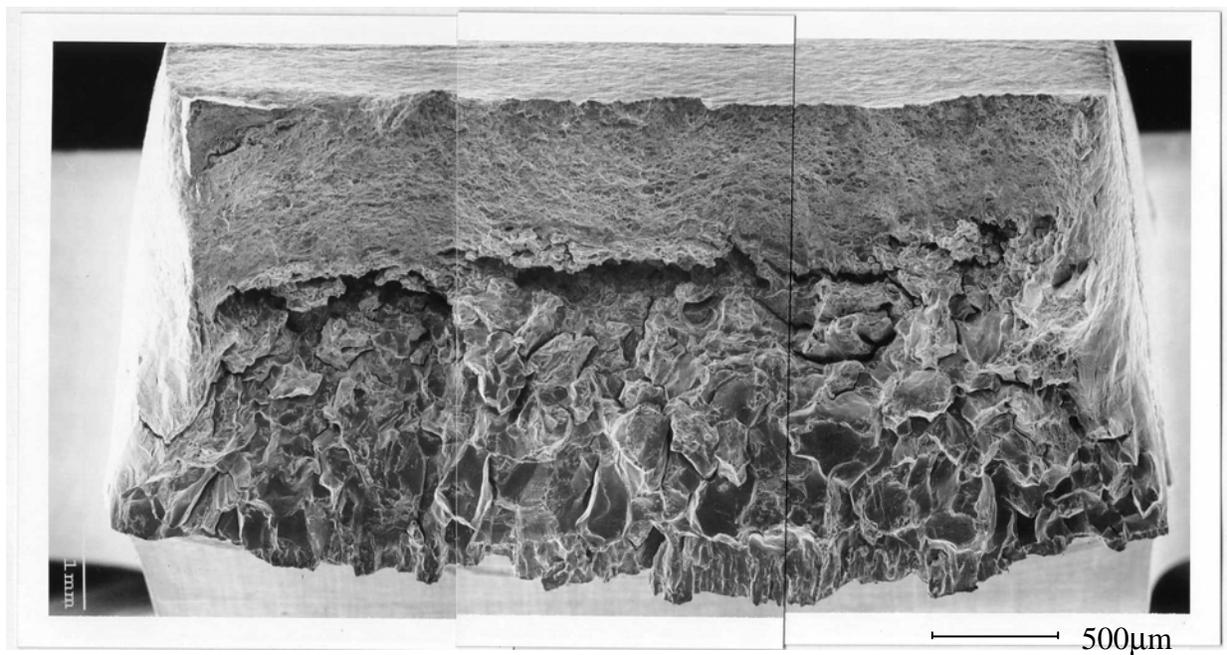
FIGURE 7 - SEM microphotograph of the fractured surface of HAZ welded by Alloy 82 of the SSRT test specimen (Temp.: 360 °C)

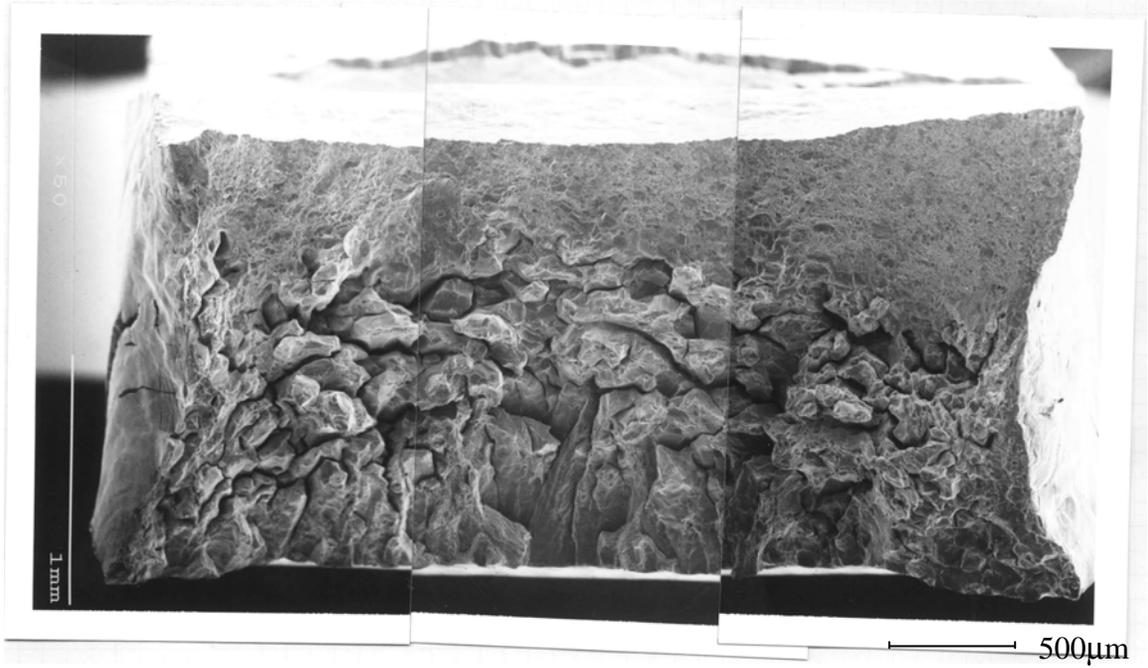
FIGURE 8 - SEM microphotograph of the fractured surface of HAZ welded by Alloy 132 of the SSRT test specimen (Temp.: 360 °C)

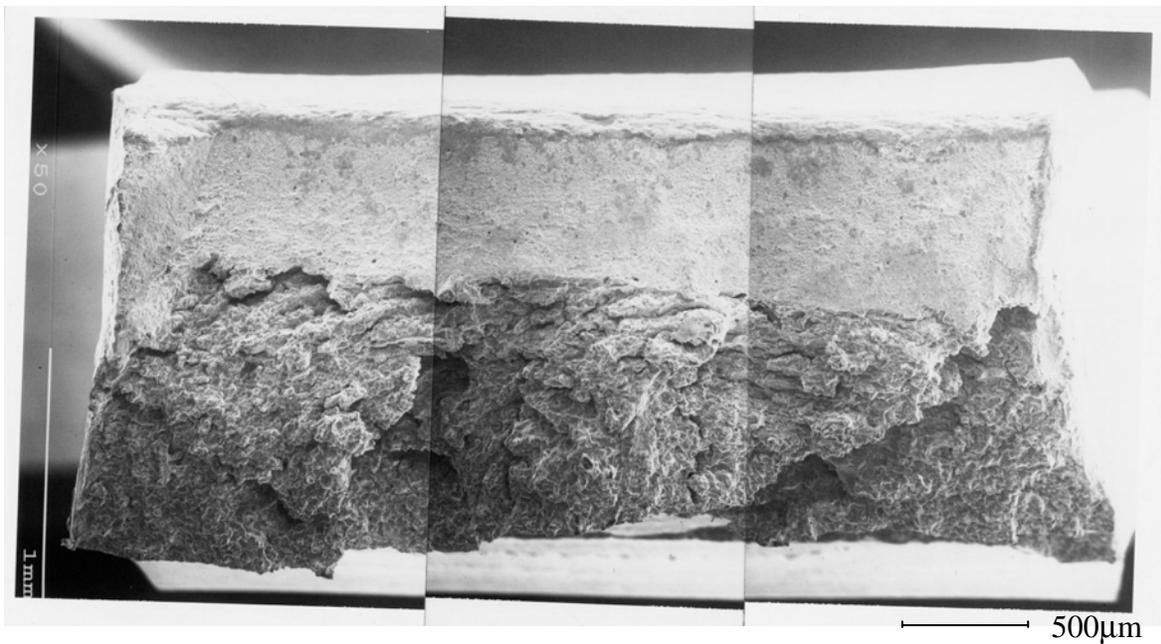
FIGURE 9 - SEM microphotograph of the fractured surface of Alloy 600 base metal of the SSRT test specimen (Temp.: 360 °C)

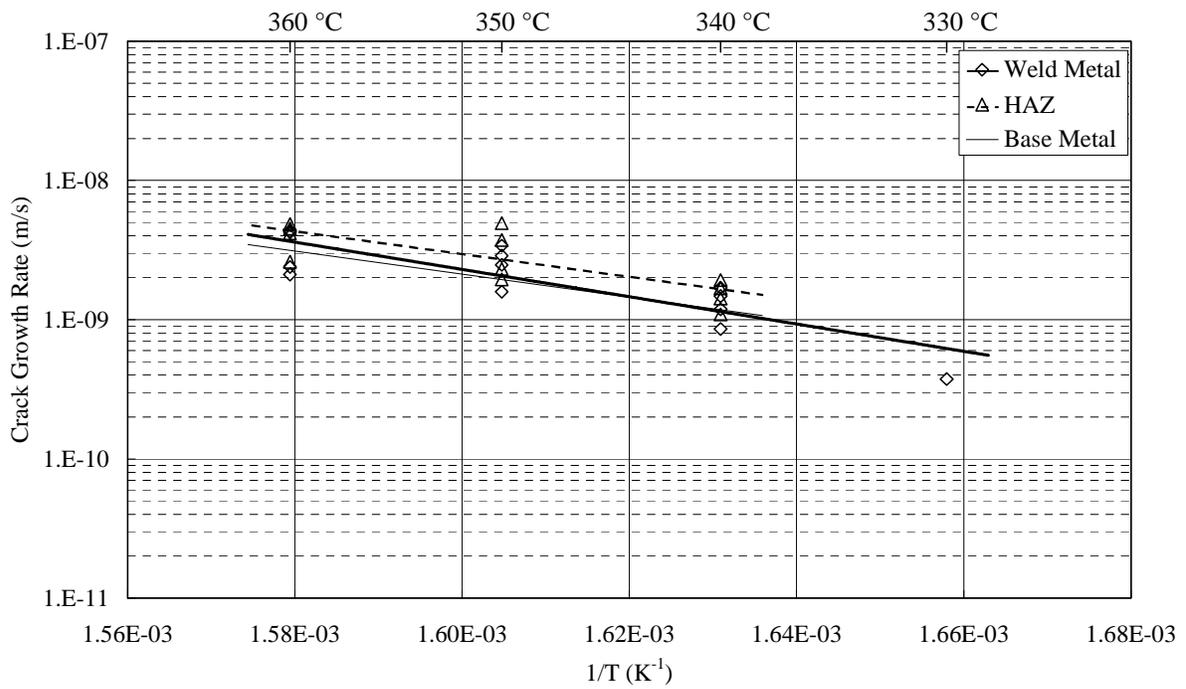
FIGURE 10 - Relationship between Temperature and Crack Growth Rate of Alloy 82 Weld Metal and HAZ in SSRT

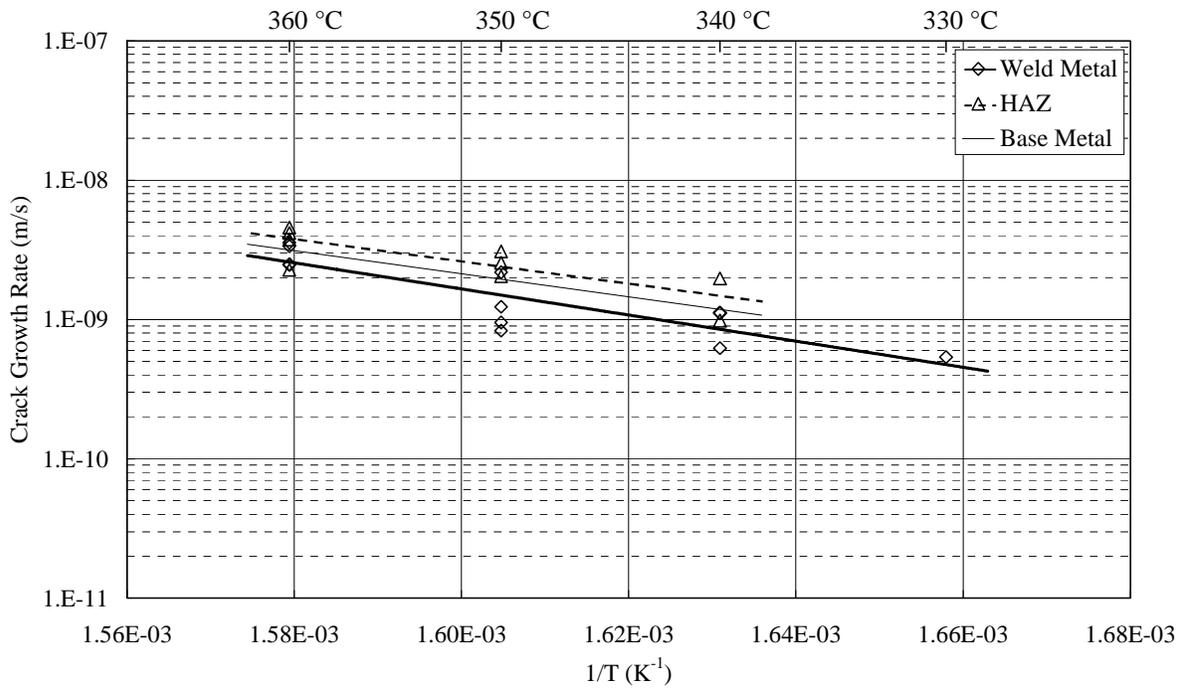
FIGURE 11 - Relationship between Temperature and Crack Growth Rate of Alloy 132 Weld Metal and HAZ in SSRT

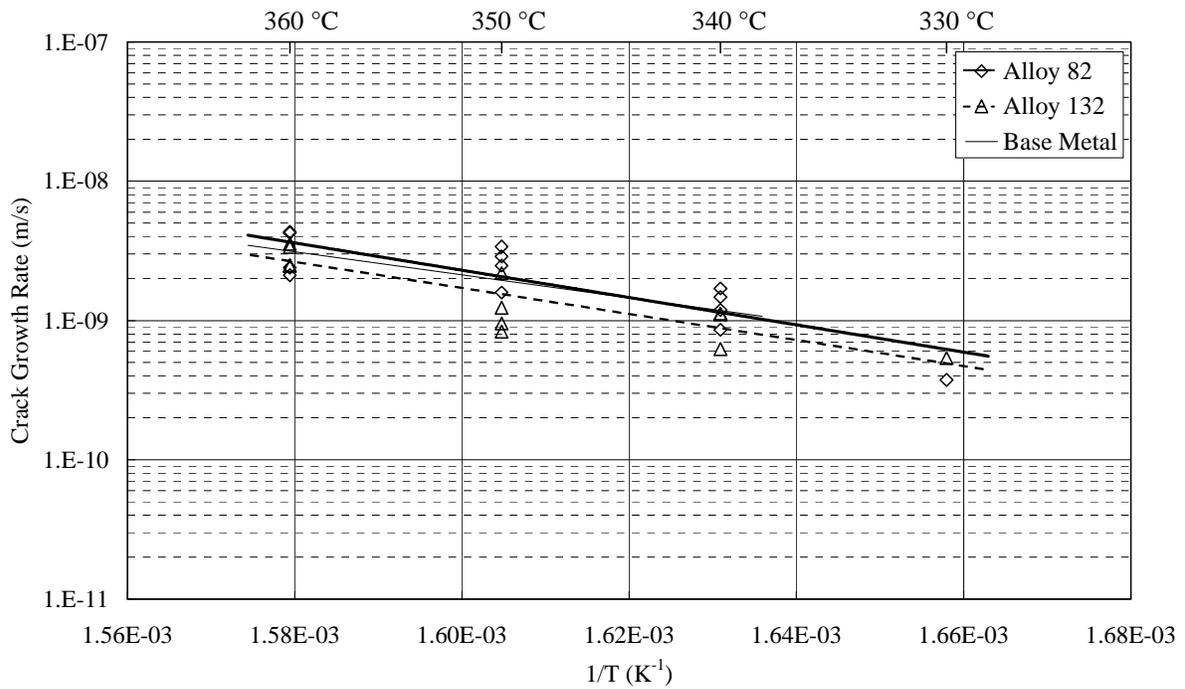
FIGURE 12 - Relationship between Temperature and Crack Growth Rate of Weld Metal in SSRT

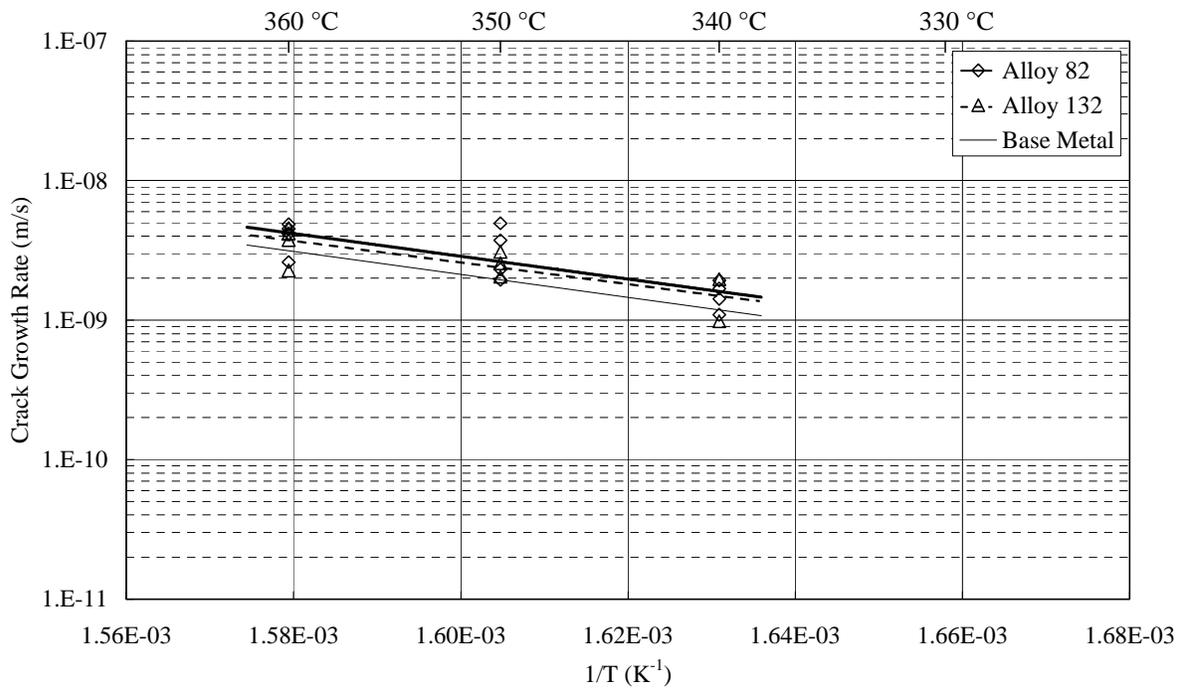
FIGURE 13 - Relationship between Temperature and Crack Growth Rate of HAZ in SSRT

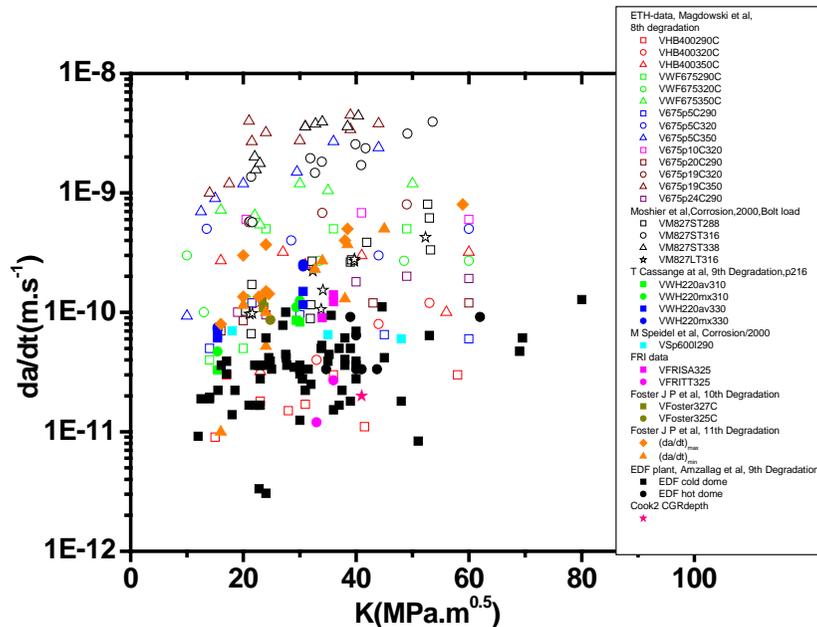
Figure 1 Crack growth rates of alloy 600 thick-plate materials in simulated PWR primary water environments [4-12].

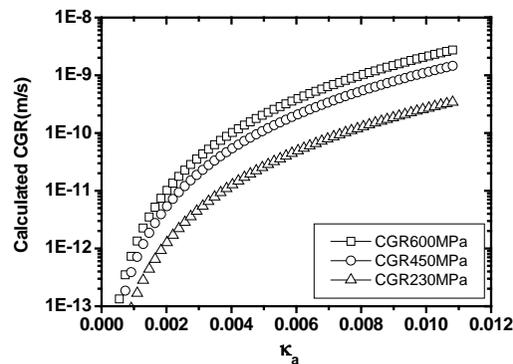
Figure 4 Sensitivity analysis of the effect of YS at different κ_a levels ($m = \text{constant}$) using Equation (17)

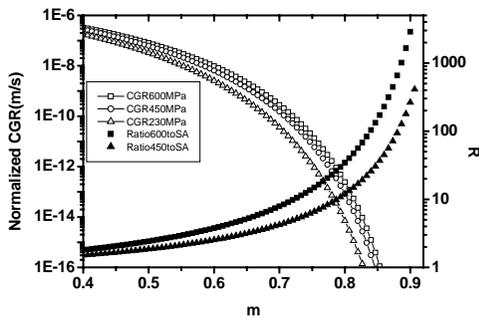
Figure 5. Sensitivity analysis of the effect of YS on CGR for different values of m ($\kappa_a = \text{constant}$) using Equation (17)

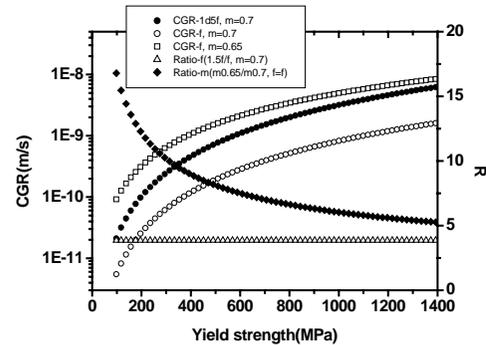
Figure 6. Sensitivity analysis of the effects of κ_a or m on CGR for different values of YS using Equation (17)

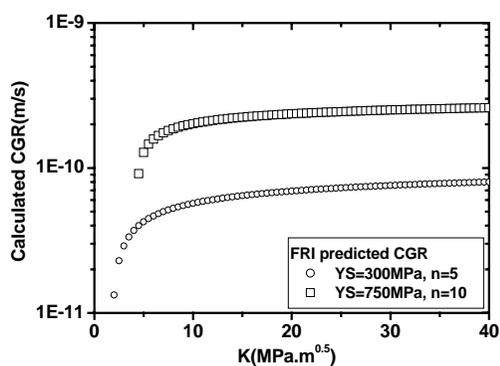
Figure 7. Calculated values of CGR as a function of K for two materials with different values of YS and strain hardening exponent n (Gao’s definition).

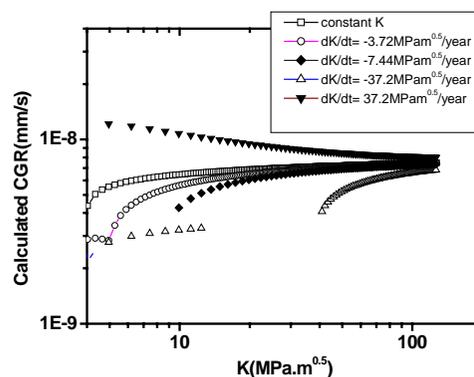
Figure 8. Calculated CGR values with the FRI generalized CGR formulation, under conditions of $dK/dt > 0$, $dK/dt = 0$, and $dK/dt < 0$.

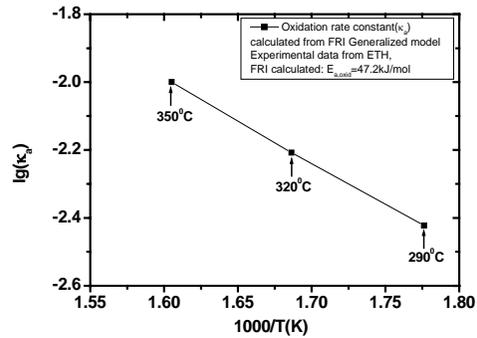
Figure 12 κ_a values at different temperatures calculated with the data from Figures 11 using equation (14).

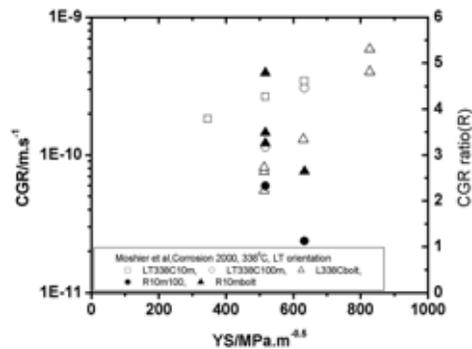
Figure 14. CGR data from Ref. [9] for alloy 600 in simulated PWR primary water under different loading methods. There are two kinds of active loading. Symbol ‘10m’ means active loading with a holding time of 10 min, and symbol ‘100m’ means active loading with a holding time of 100min.

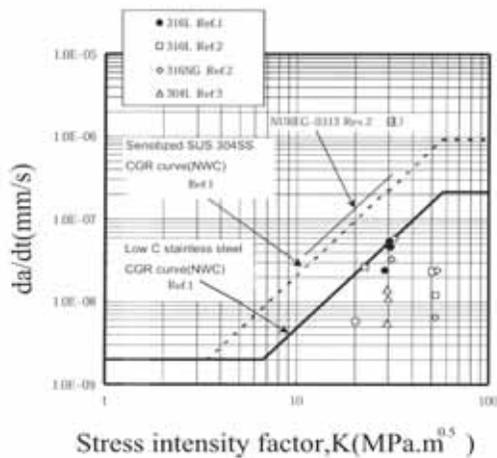
Figure 19 SCC CGR-K diagram for stainless steels in BWR environments [27, 30]

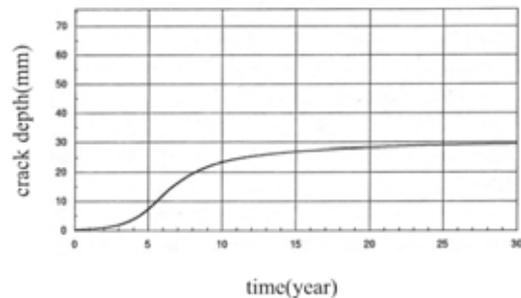
Figure 20 Increase in crack depth over time for an H6a weld in a BWR core shroud [27]

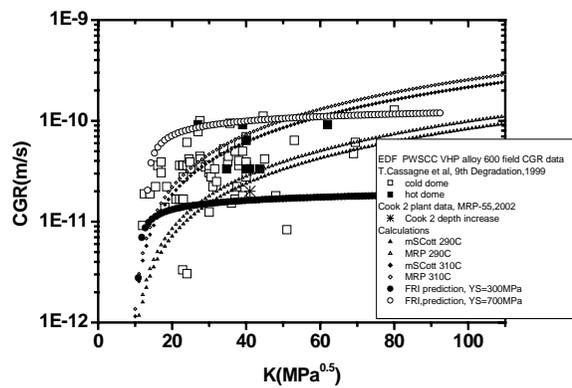
Figure 21 Plant CGR data for vessel head penetrations from EDF and Cook2, along with values predicted by different CGR models

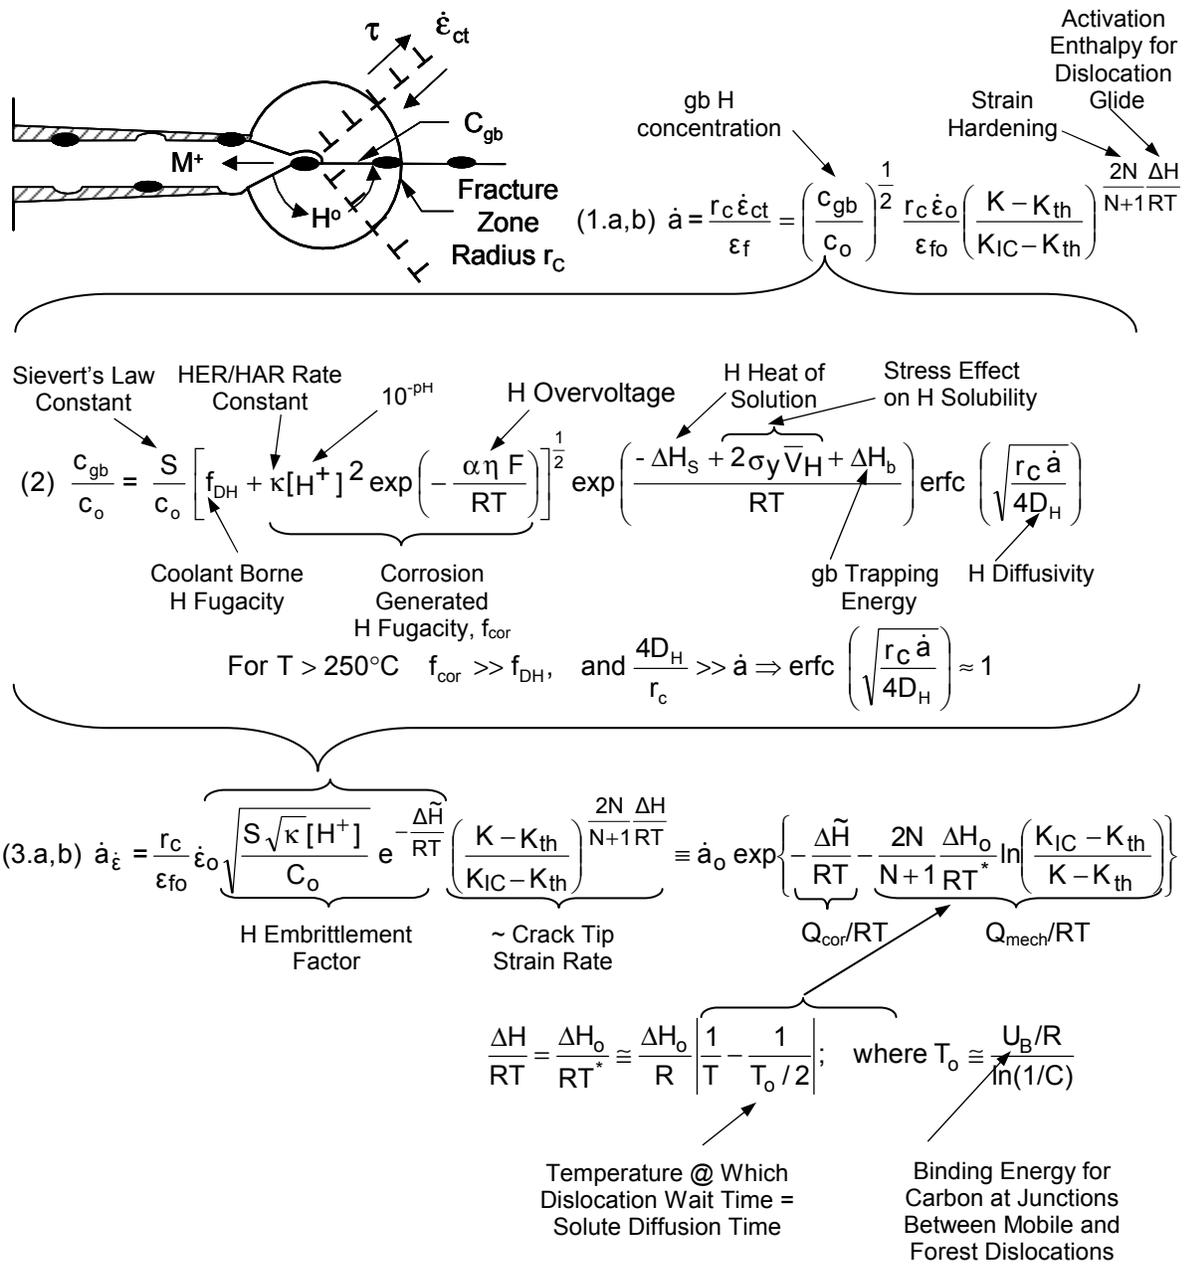
Fig. 1. Essential features of the HACF model with model equations showing corrosion and mechanical contributions to the crack growth rate.

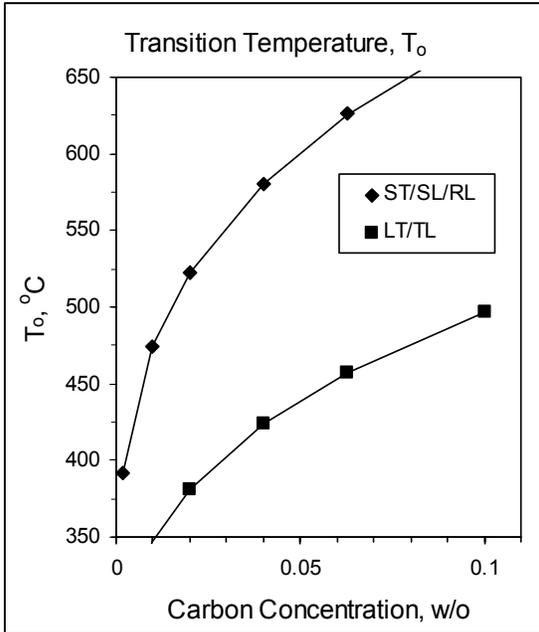
Figure 8. Carbon and Crack Growth Orientation Dependence of the Transition Temperature.

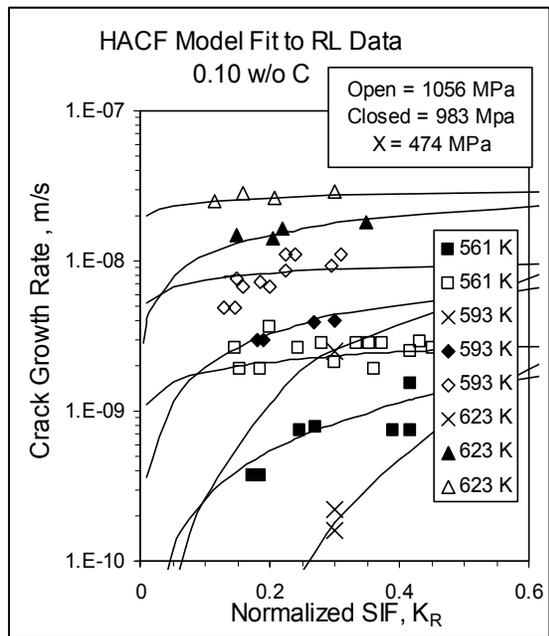
Figure 9. HACF Model Fit to RL CGR Data. Both temperature and yield stress (cold work) effects on CGR are shown.

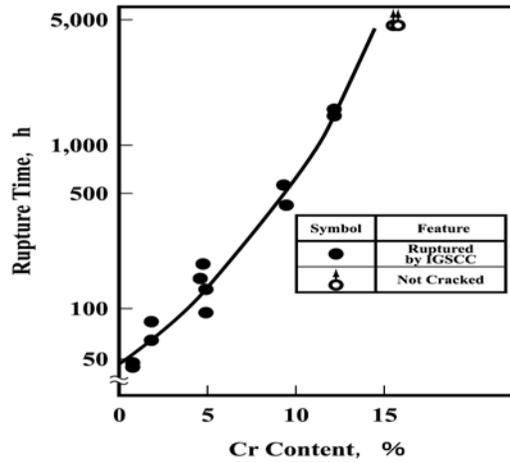
Fig 1 Effect of Cr content on the stress corrosion cracking resistance of solution annealed Ni base-Cr-Fe alloys in 360°C high temperature water using by constant load stress corrosion cracking test (applied stress is $2.4 \times 0.2\%$ Proof stress)

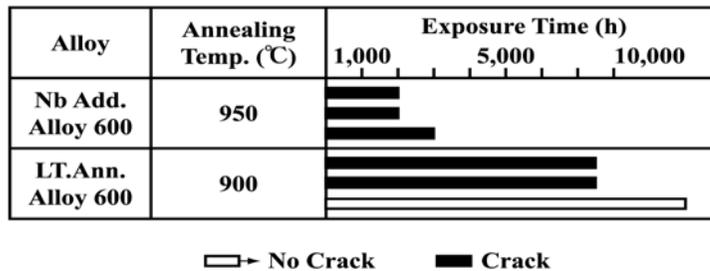
Fig. 2 Effect of Nb addition on the stress corrosion cracking resistance of annealed Alloy 600 in 360°C high temperature water, using by prestrained U bent specimen.

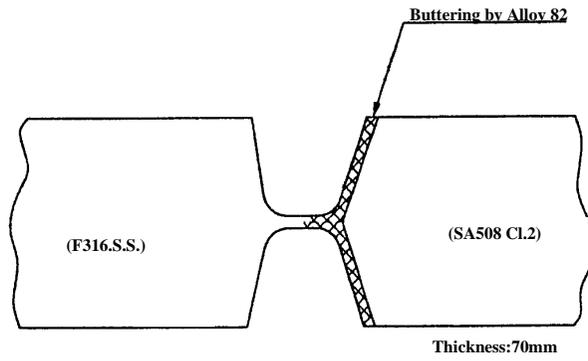
Figure 3 Welding joint configuration of dissimilar metal arc welding model by Alloy 132

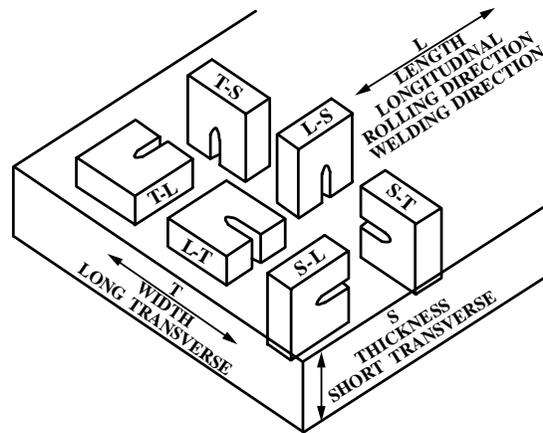
Figure 6 Terminology used for orientation of cracks in the test specimens with respect to the weld

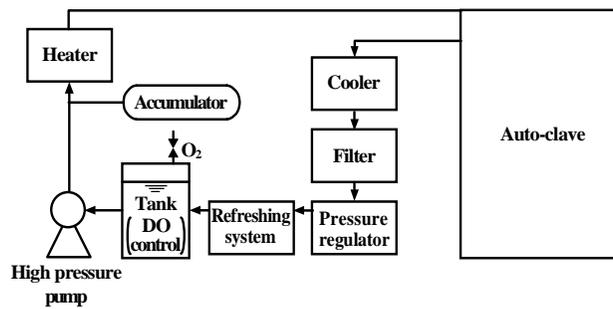
Figure 7 Schematic of the SCC test equipment
