Section 4:
Session 4: Crack Growth Rate Studies for
the Disposition of Flaws

US REGULATORY EXPERIENCE AND PROGNOSIS WITH RPV HEAD DEGRADATION AND VHP NOZZLE CRACKING

Allen L. Hiser, Jr.

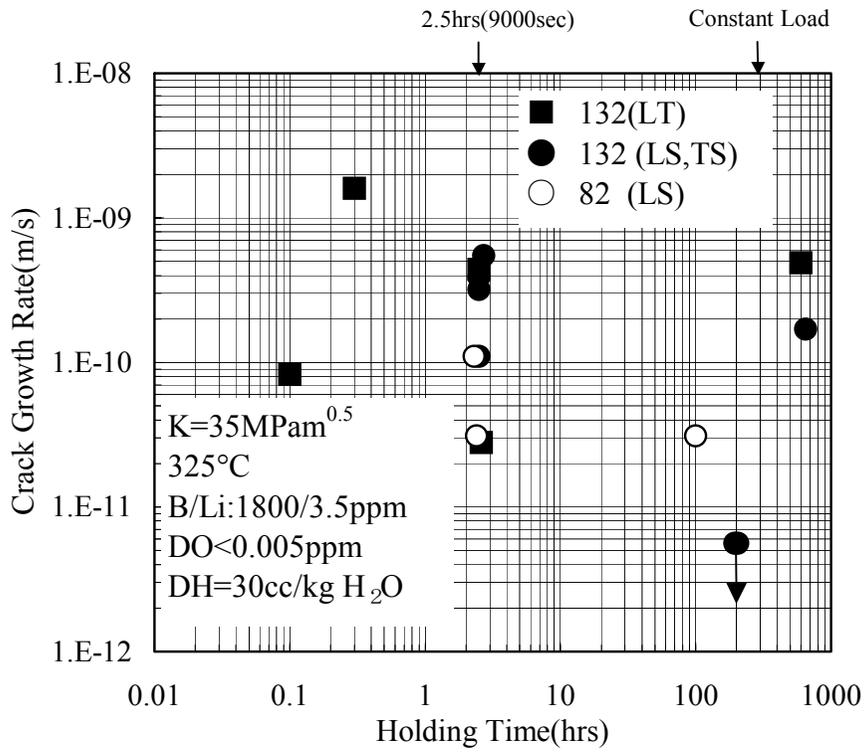
Figure 18 The effect of holding time for cyclic loading on CGRs

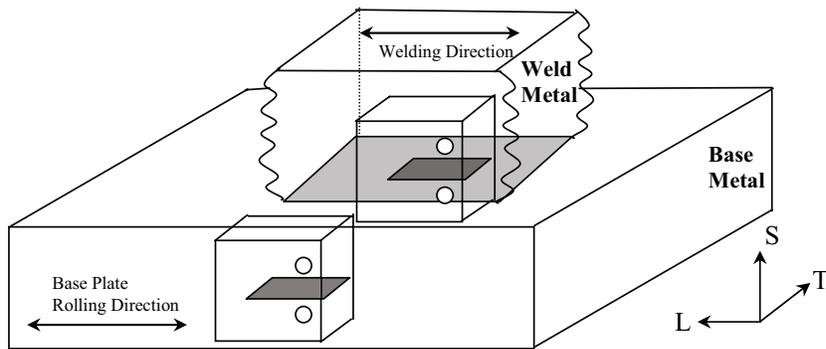
Figure 1. Schematic of the HAZ specimen and base metal specimen orientation relative to the weld deposit. For the HAZ specimens, the notch tip lies in the HAZ. The sketch is not to scale.

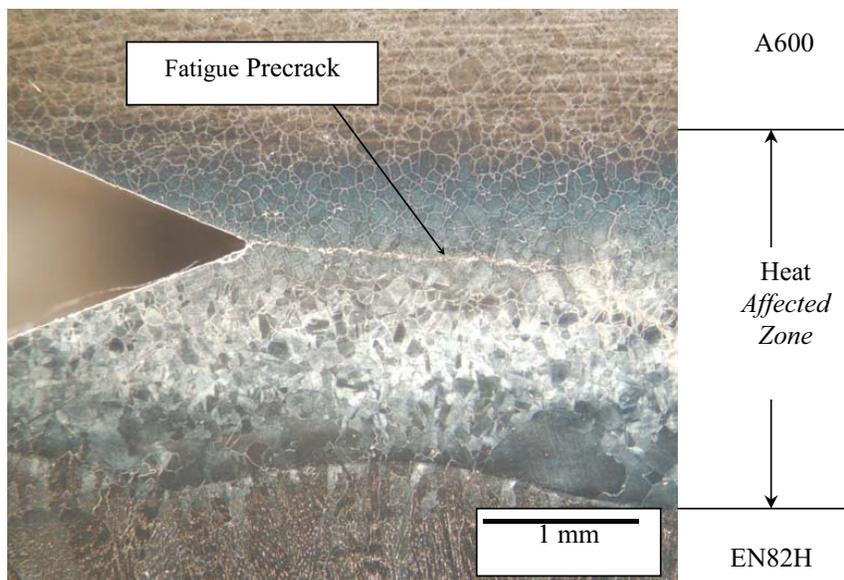
Figure 2. Light macrograph of the CT specimen notch and fatigue precrack. Note that the precrack is entirely within the A600 HAZ. 8:1 Phosphoric Acid, Electrolytic Etch.

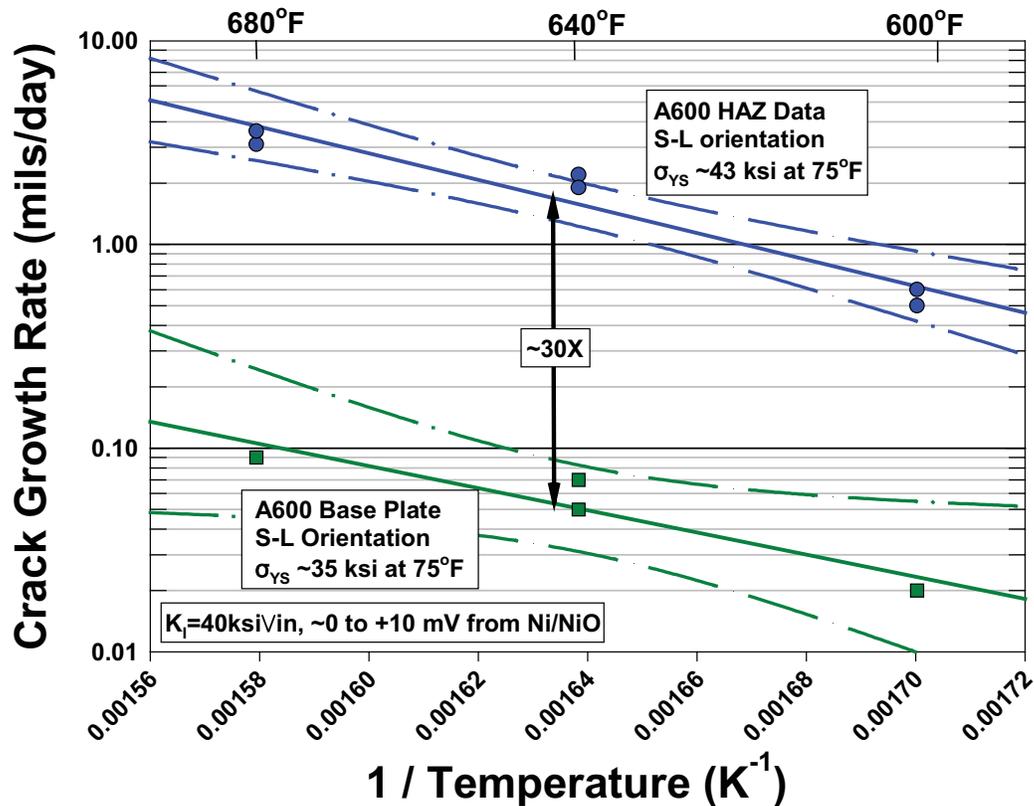
Figure 3. Comparison of the A600 HAZ data (blue points) with a prediction for typical high temperature annealed A600 (i.e. the unaffected base material).

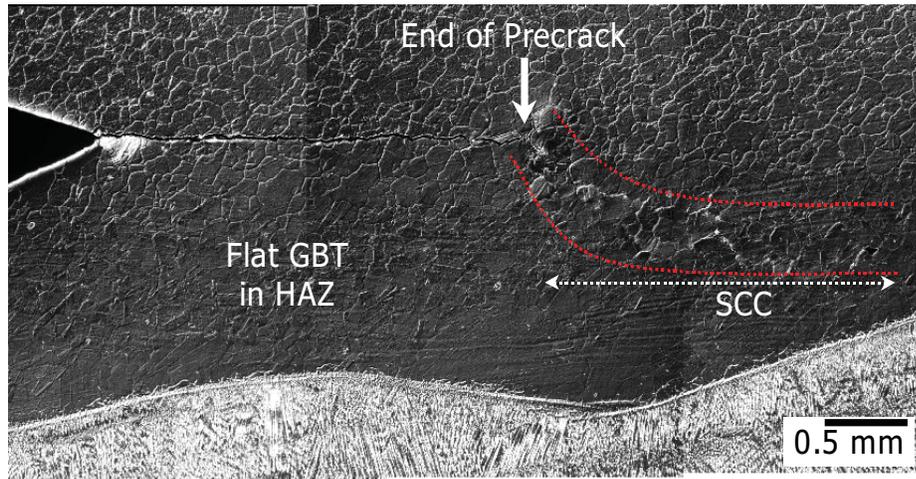
Figure 4. Cross section of the fatigue precrack and SCC crack plane from an A600 HAZ sample at 680°F. GBT refers to the grain boundary topography.

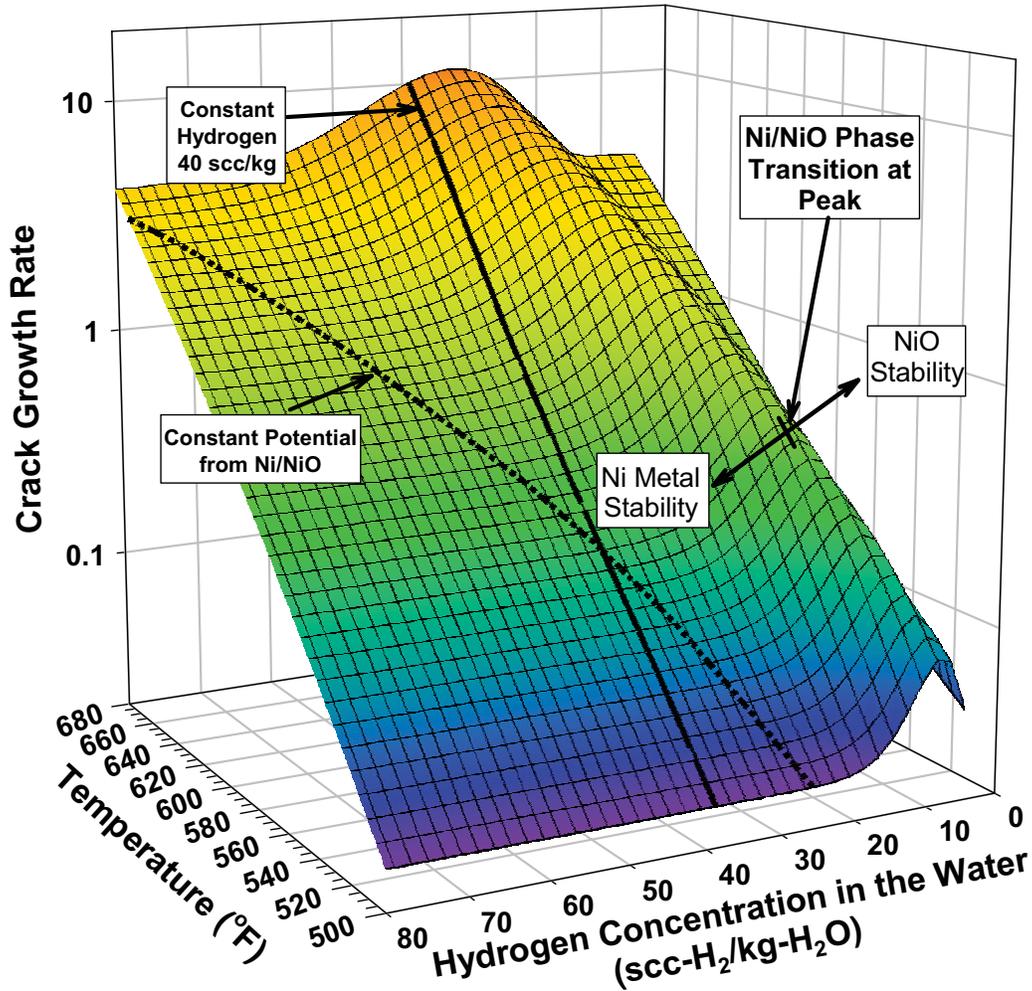
Figure 6. Schematic illustration of the effect of the Ni/NiO phase transition on the stress corrosion crack growth rate of A600-type alloys in high purity water. When determining the activation energy for crack growth, testing should be done at constant potential (dashed line) or far into the Ni metal stability regime to avoid biasing some of the data to faster crack growth rates and larger apparent activation energies.

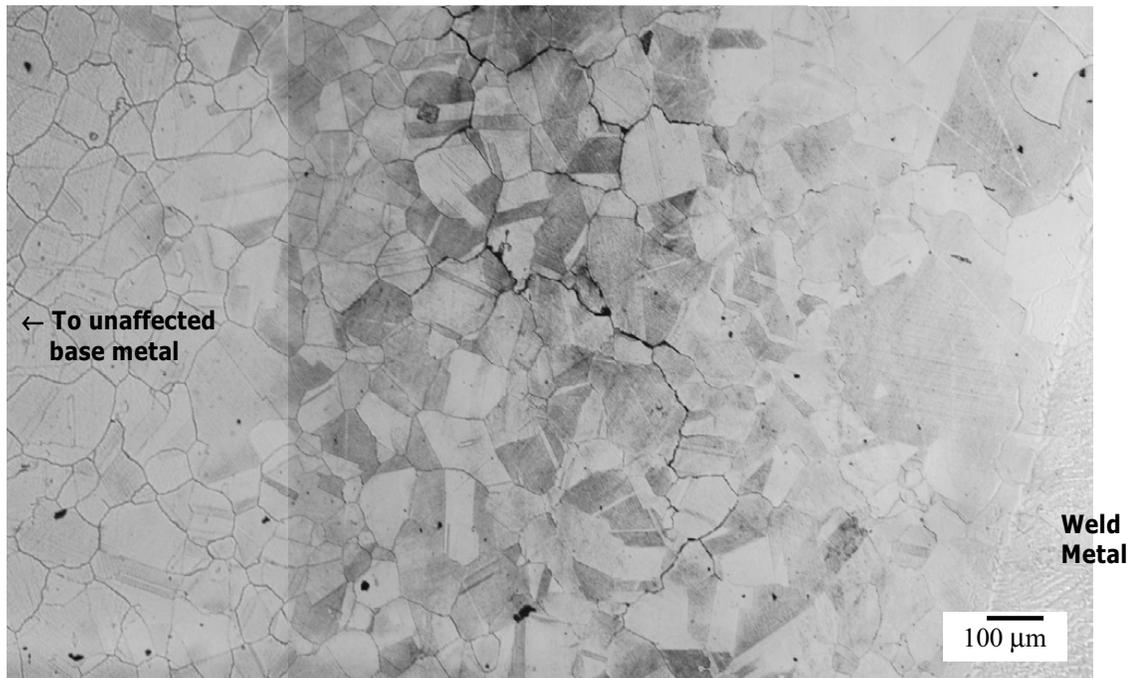
Figure 7. Light micrograph of a HAZ SCC crack. Note the intergranular crack path and crack branching. 8:1 phosphoric acid, Nomarski, DIC.

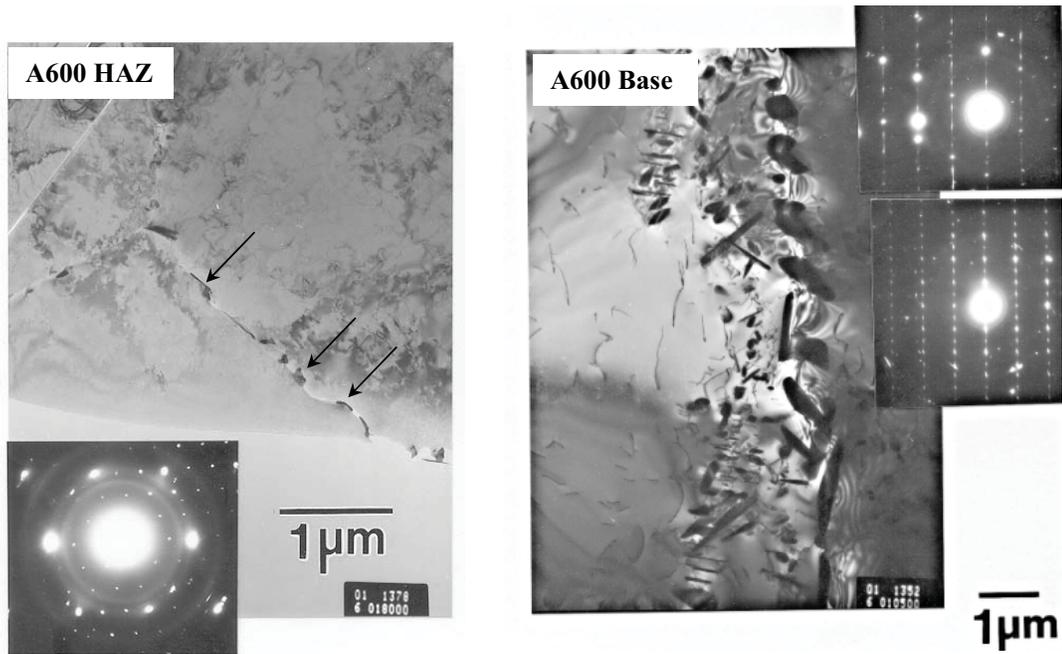
Figure 8. Transmission electron microscopy of the A600 HAZ (left) and the A600 base material (right). Note the few $M_{23}C_6$ -type carbides in the HAZ (arrows) while the unaffected base material displays extensive inter- and intra-granular M_7C_3 -type carbides.

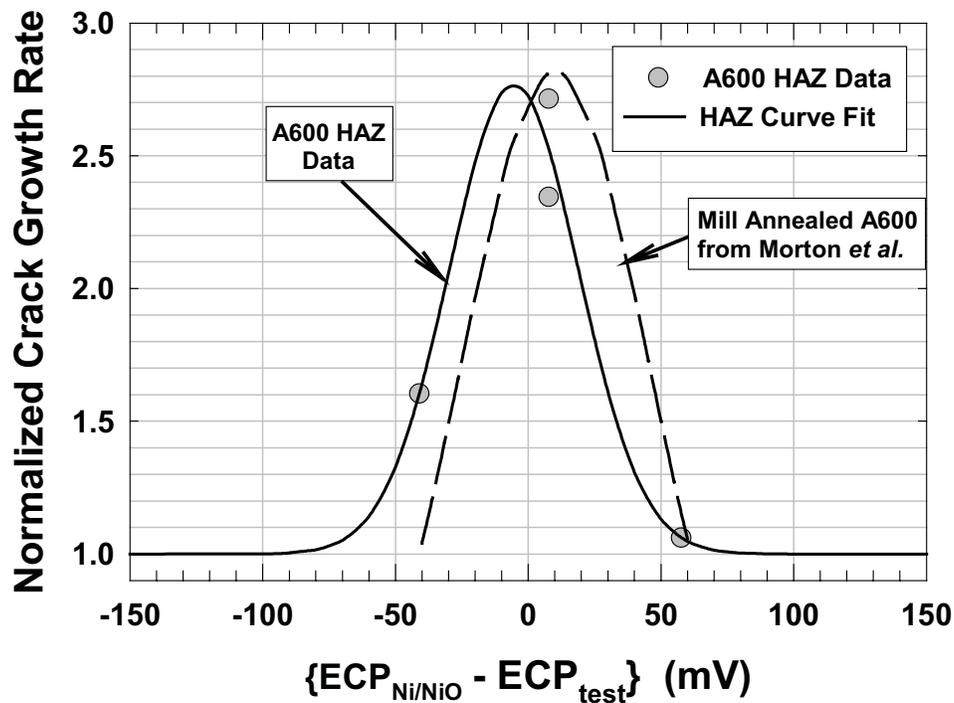
Figure 14. Comparison of the effect of electrochemical potential on the crack growth rate of A600 base material and on the A600 heat affected zone, showing almost identical response. See reference [11] for additional information.

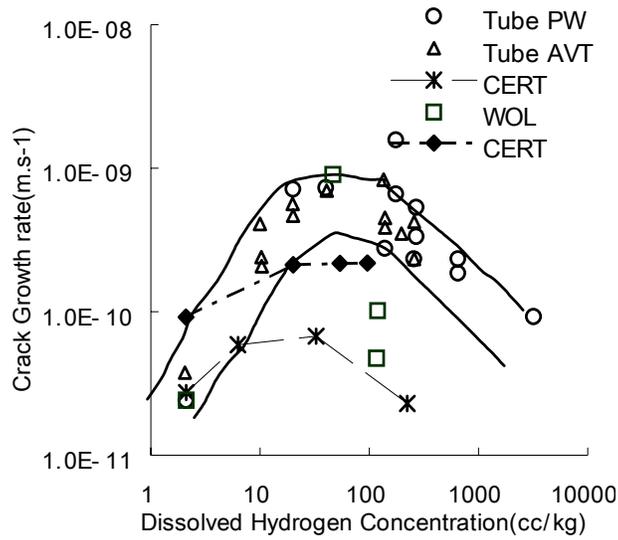
FIGURE 1. Influence of hydrogen concentration on the crack growth rate of PWSCC in Alloy 600 at 360°C.^{10,11}

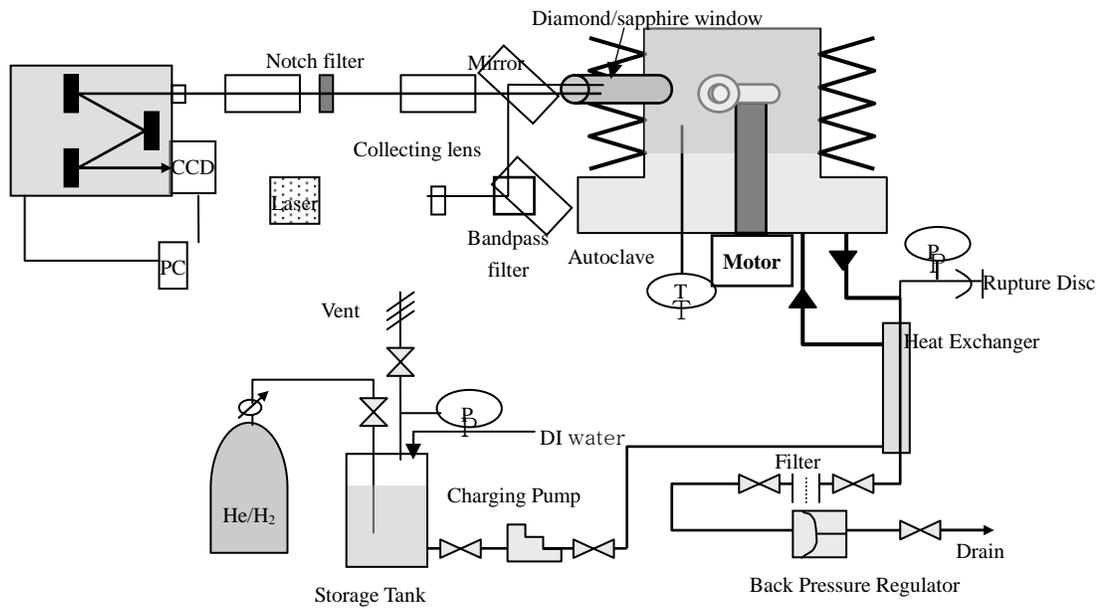
FIGURE 2. Layout of in-situ Raman spectroscopic measurement system in high temperature aqueous environment.

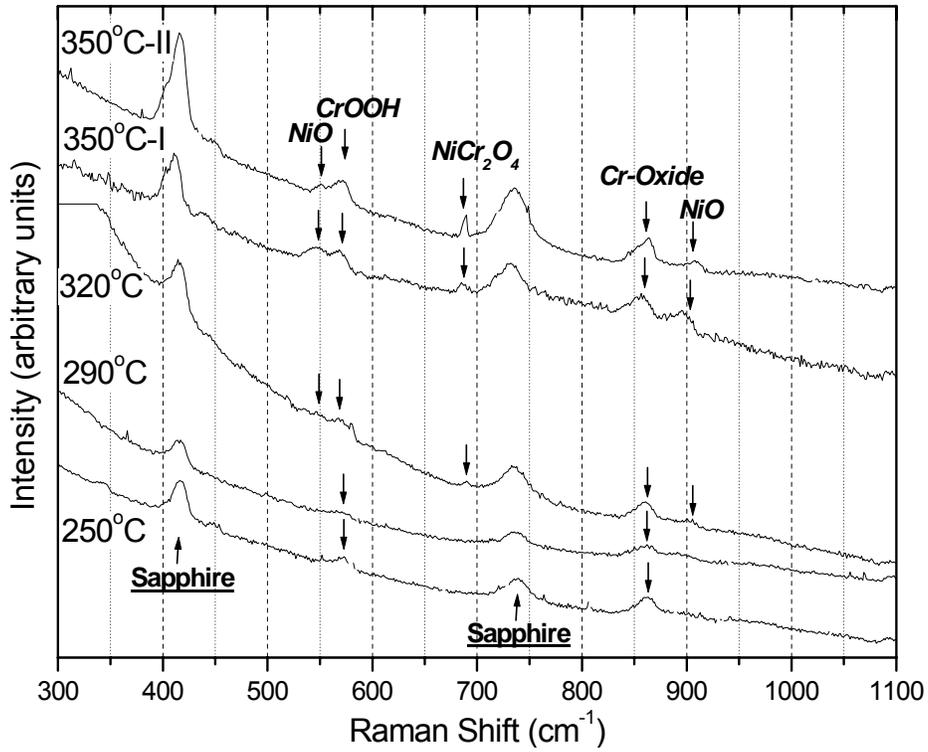
FIGURE 5. In-situ Raman spectra obtained for Alloy 600 by holding at 250, 290, 320 and 350 °C, respectively, during heating up to 350 °C in PWR water condition with $DH_2=30\text{cc(STP)/kg}$.

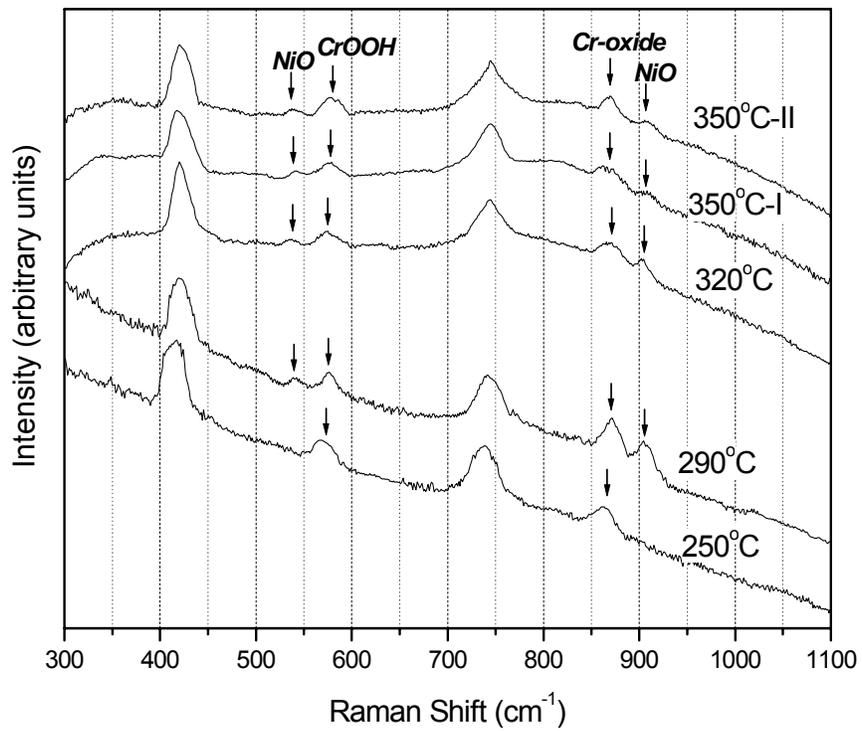
FIGURE 6. In-situ Raman spectra obtained for Alloy 600 by holding at 250, 290, 320 and 350°C, respectively, during heating up to 350°C in PWR water condition with $DH_2=1cc(STP)/kg$.

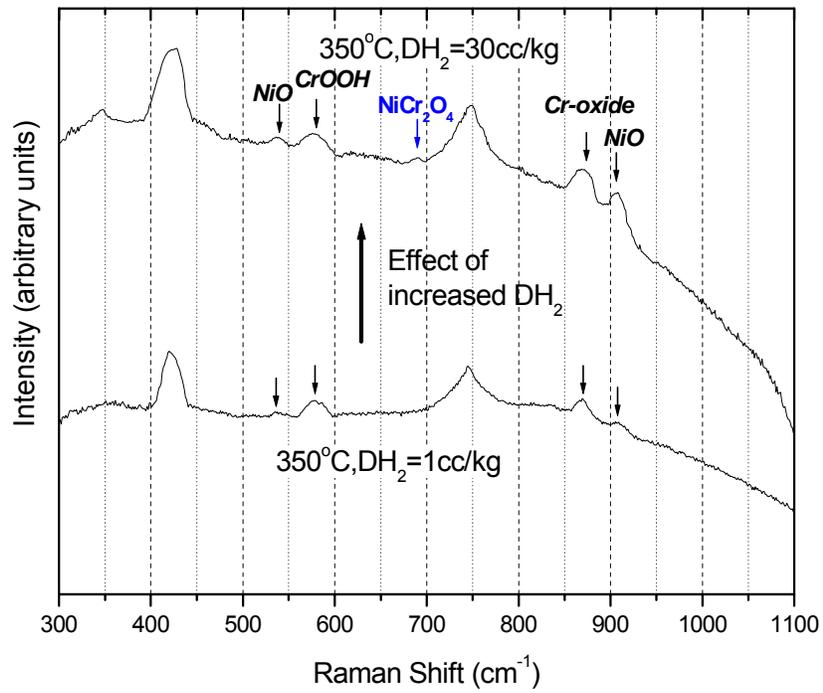
FIGURE 7. In-situ Raman spectra obtained for Alloy 600 at 350°C in PWR water as the DH₂ in water was increased from 1 to 30 cc/kg.

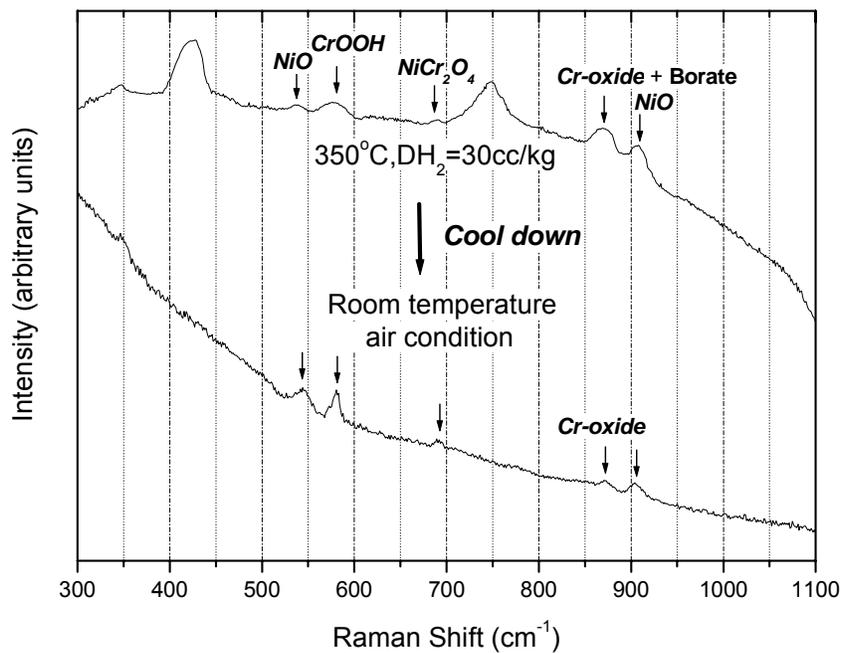
FIGURE 8. Comparison of Raman spectra obtained for Alloy 600 between by in-situ method at 350°C in PWR water with $\text{DH}_2 = 30\text{ cc/kg}$ and by ex-situ method in room temperature and air condition.

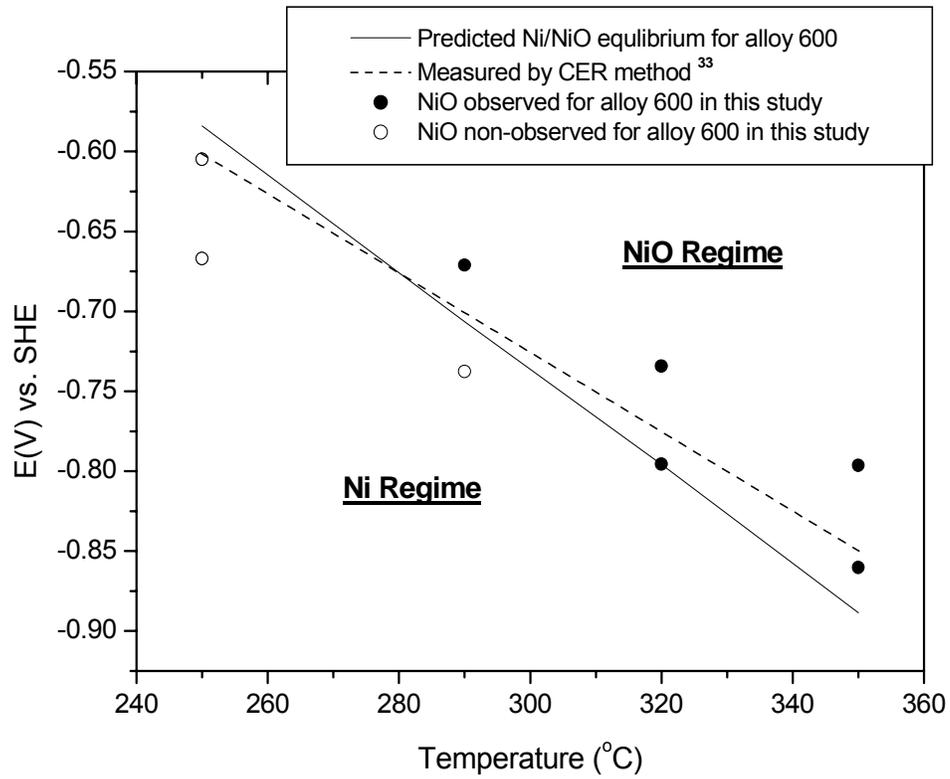
FIGURE 9. Summary plot on electrochemical potential for nickel in the Alloy 600 as a function of temperature.

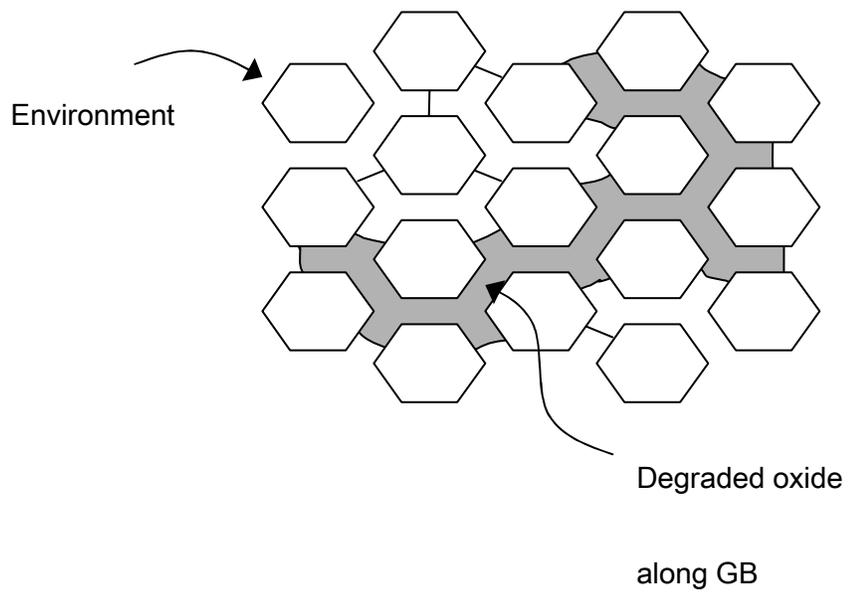
FIGURE 10. Postulated Redox-induced GB Oxide Degradation Mechanism.

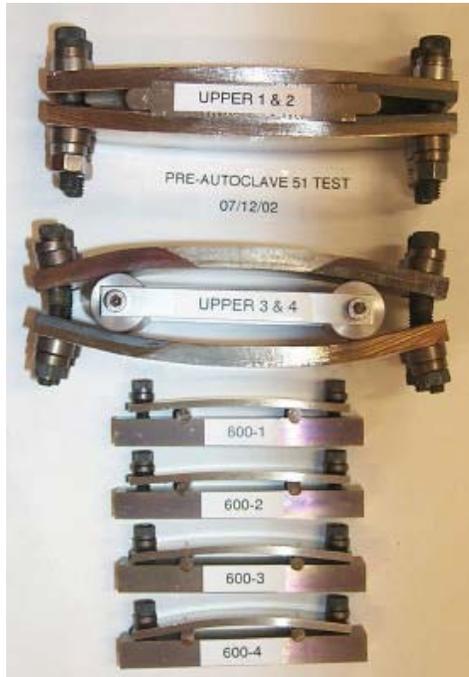
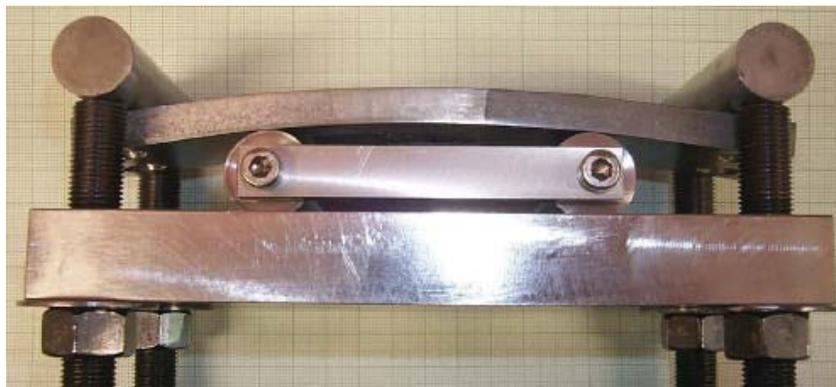
Figure 1 - Photographs of Alloy 52M (Upper 1 thru 4), Alloy 600 (600-1 thru-4), and Alloy 182- 4 (lower photo) bent beam test specimens. [Specimens with suffixes -1 and -2 were strained 0.35%; those with suffixes -3 and -4 wee strained 1.0%]

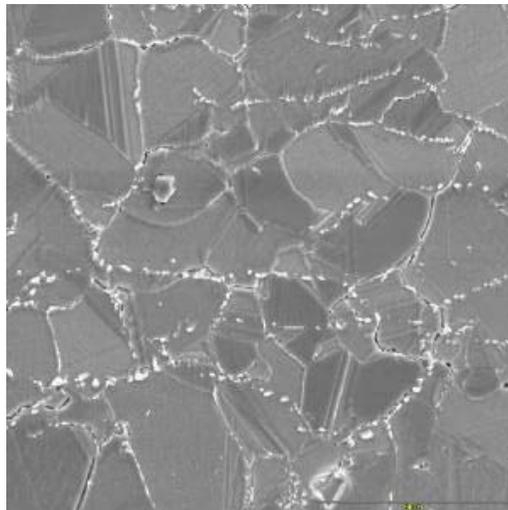
Figure 3 – Microstructure of Alloy 600 Heat WF147

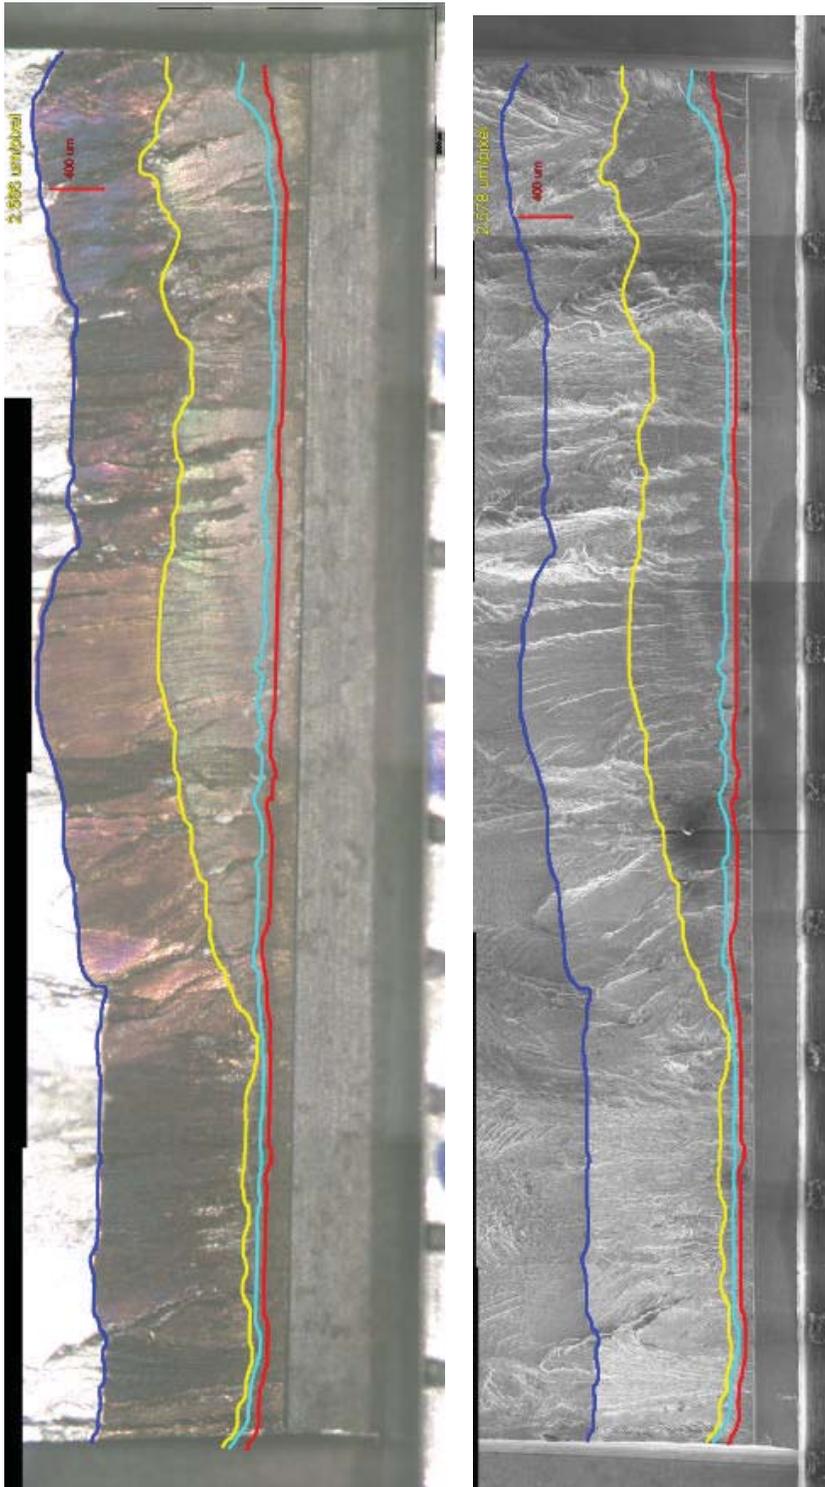
Figure 4 – Optical (top) and SEM (bottom) micrographs of an Alloy 182 crack growth specimen, showing the precrack and environmental crack extension across the face of the specimen.

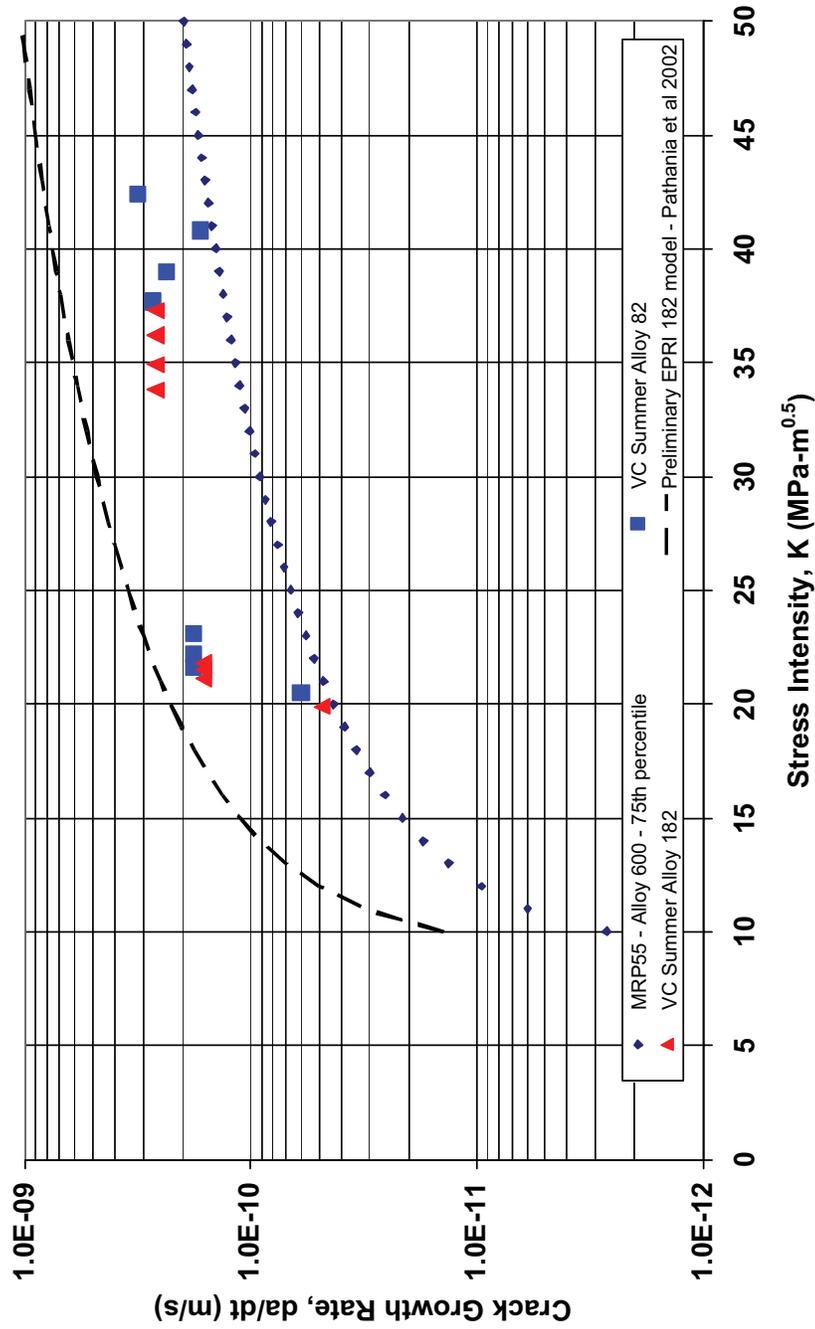
Figure 5 – Crack growth rate results for the Summer Alloy 82 and 182 weld metals compared with published data

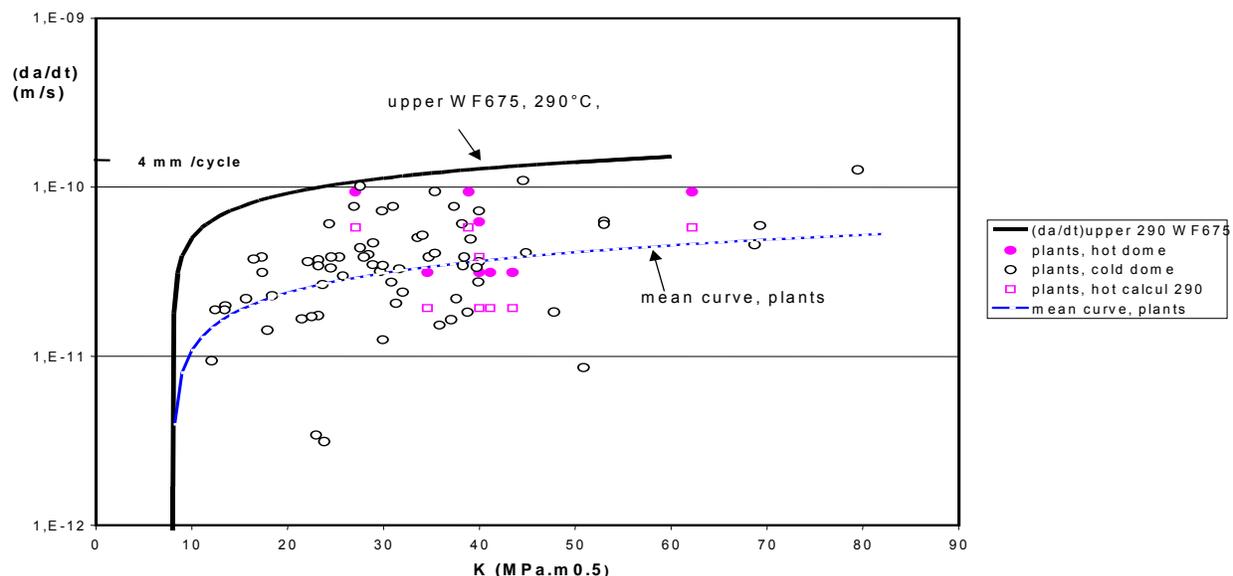
Fig. 2: Comparison between laboratory and field experience (by courtesy of EDF, this conference ref.¹²), Showing the representation of CGR versus the estimated K values for field and laboratory data, expressed either at the assumed temperatures respectively of 300°C and 290°C, some data being converted to 290°C.

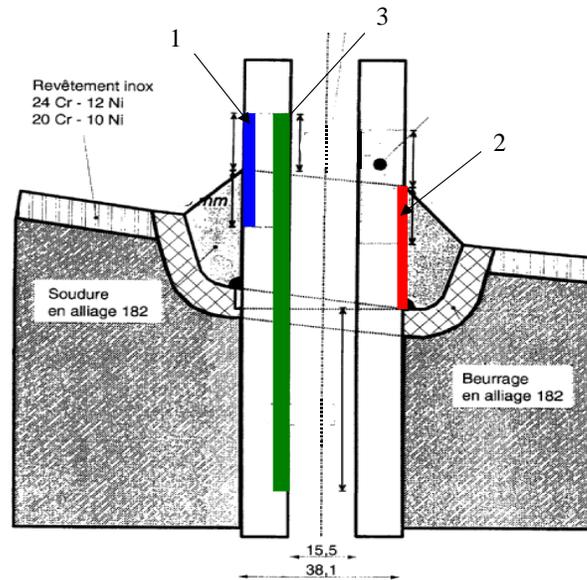
Figure 3, showing schematically the BMI zones covered by NDE examinations
