Chemical Effects/Head-Loss Testing
Quick Look Report, Tests 1 & 2
September 16, 2005

J. Oras, J.H. Park, K. Kasza, K. Natesan, and W. J. Shack
Argonne National Laboratory

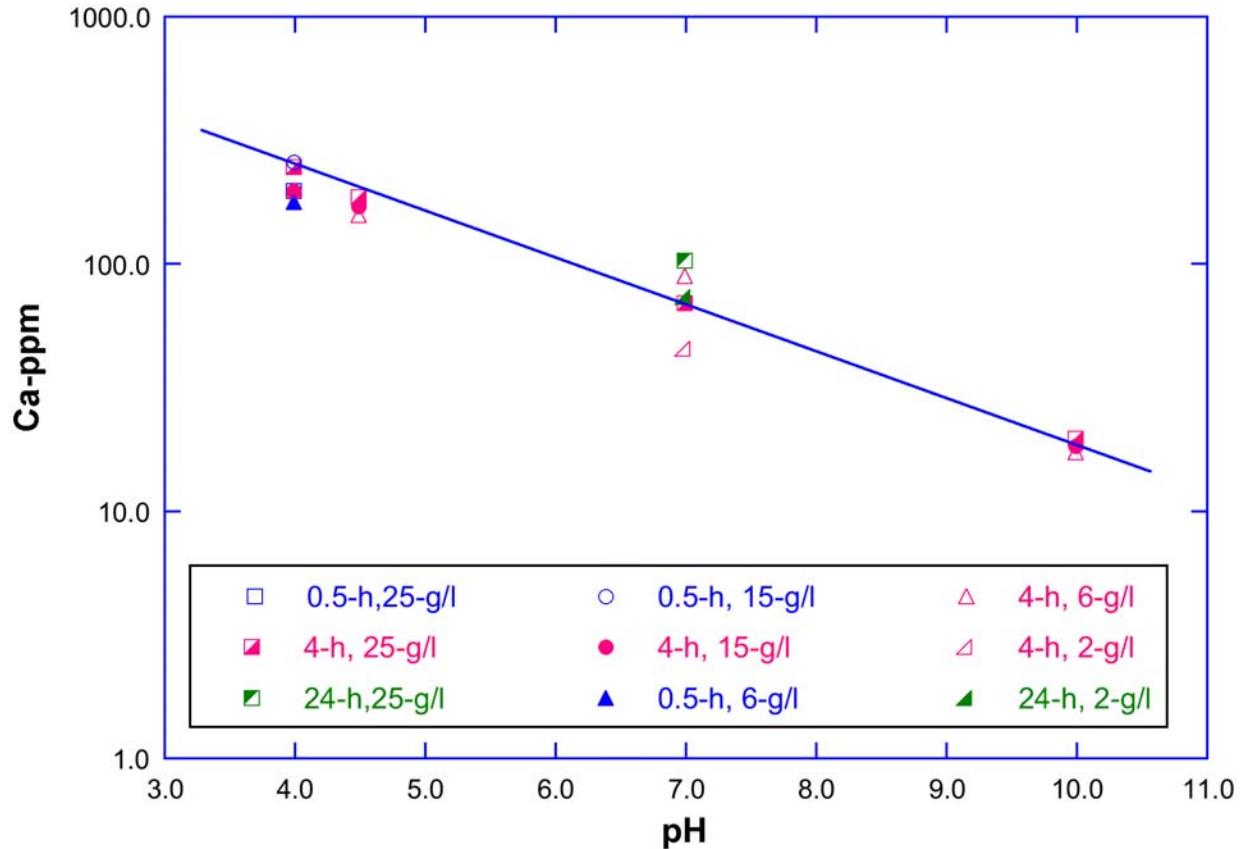
Figure 1. Dependence of dissolved Ca level on initial solution pH

Small scale dissolution tests were performed for a range of CalSil concentrations that encompassed the ICET-3 conditions for durations ranging from 35 minutes to 24 hours. The results of these tests are summarized in Table 1. The Ca concentration values in this table are the dissolved Ca levels at the end of the leaching period. The “initial pH” values given in the table are the initial starting pH of the solution before the CalSil addition while the “final pH” values represent the pH at test termination. The CalSil dissolution raises the pH of initially acidic solutions to near pH 7 due to the hydrolysis of potassium and sodium released from the CalSil. However, the pH of the solutions already buffered with either NaOH or LiOH did not vary much upon CalSil dissolution. The amount of dissolved Ca most strongly depends on the initial pH of the solution as seen in Fig. 1 while the initial CalSil loading has very little effect for the loadings examined in this study.

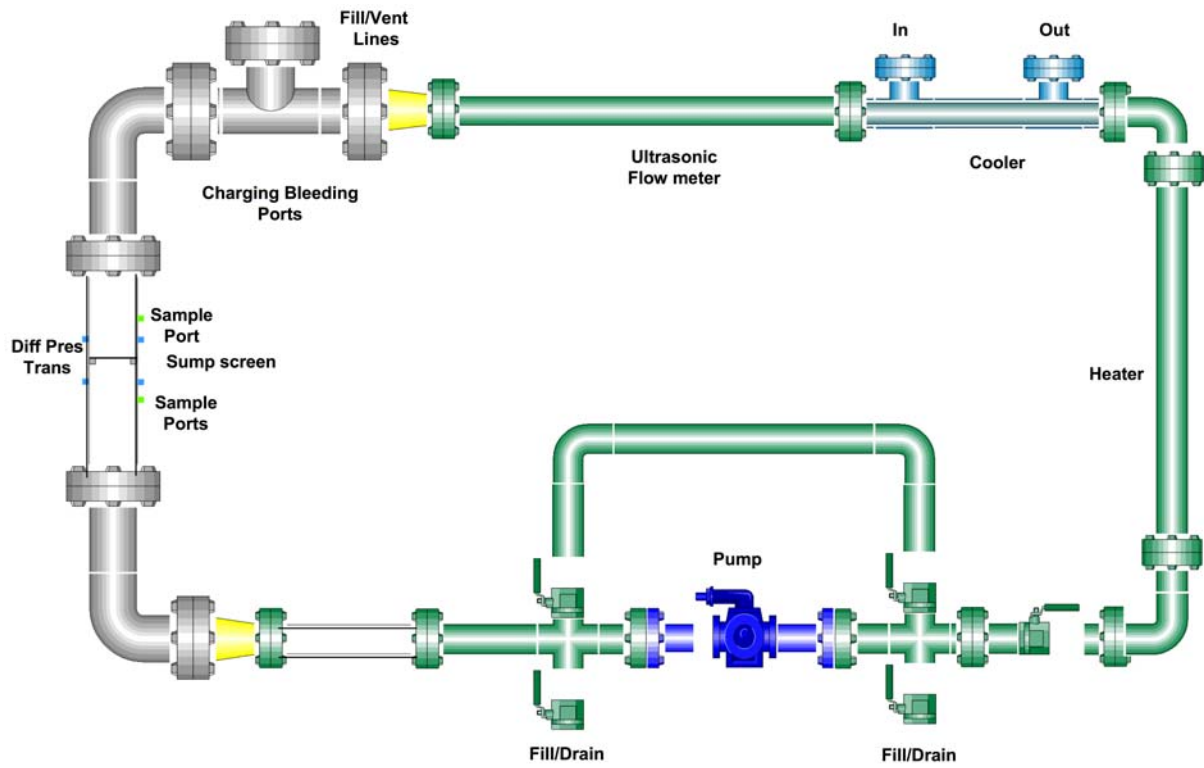
Figure 2. Schematic of the test loop

A schematic of the ANL test loop is shown in Fig. 2. The test screen has an effective diameter of 6 in. The fluid volume in the loop is 4.2 ft³. At 0.1 ft/s, the transit time around the loop is about 4 minutes. For these tests, a perforated plate with a 51% flow area and staggered 3/16 in. holes was installed in the test-section. The test screen is shown in Fig. 3. In scaling results from the ANL test facility, the mass of chemical product per unit area of screen must be considered. The amount of chemical product produced scales with fluid volume while the screen area per fluid volume determines the product mass per unit screen area.

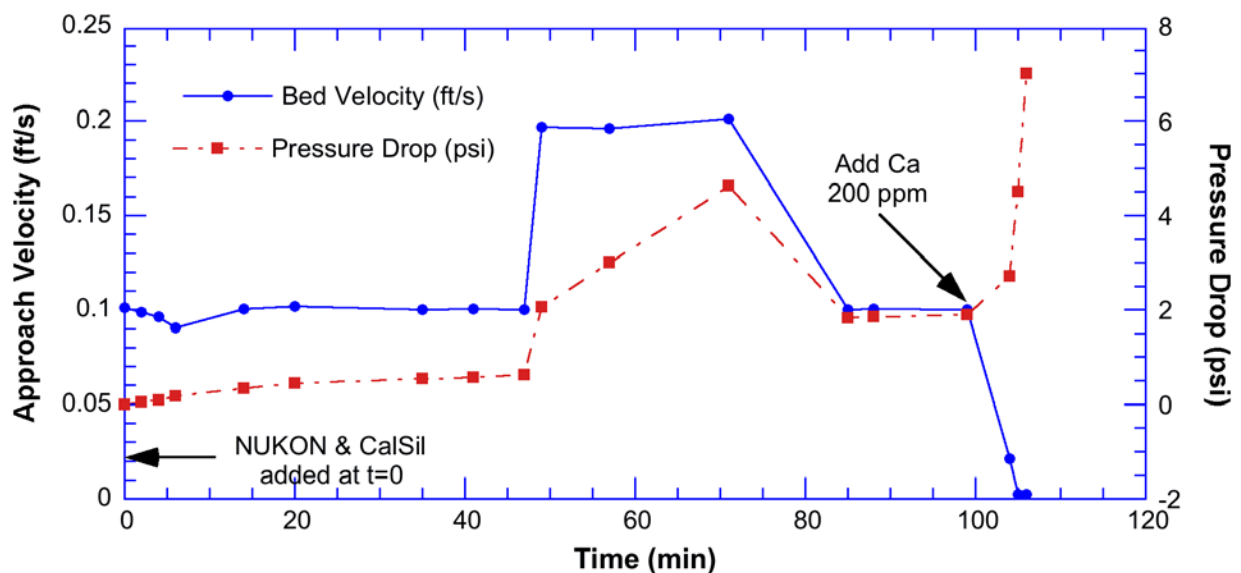
Figure 4. Flow rate and pressure drop as a function of time in Test 1.

After the chemical solution was prepared, the physical debris bed was built by adding a slurry containing 15 g NUKON/15 g CalSil to the loop with the loop flow at 0.1 ft/s. The bed was about 3/4 in thick. The NUKON bed formed essentially in the first pass of the debris past the test screen. The pressure drop across the bed slowly increased as the test loop solution recirculated, presumably due to increasingly effective filtration of fine CalSil particles. After recirculating for about 45 minutes, the flow rate was then increased to 0.2 ft/s. At this flow rate, the bed compressed to about 5/8 in thick. The flow rate was then reduced back to 0.1 ft/s. The pressure drop and flow velocity at each stage of the debris bed formation is shown in Fig. 4. The physical debris bed at this point in the test is shown in Fig. 5.

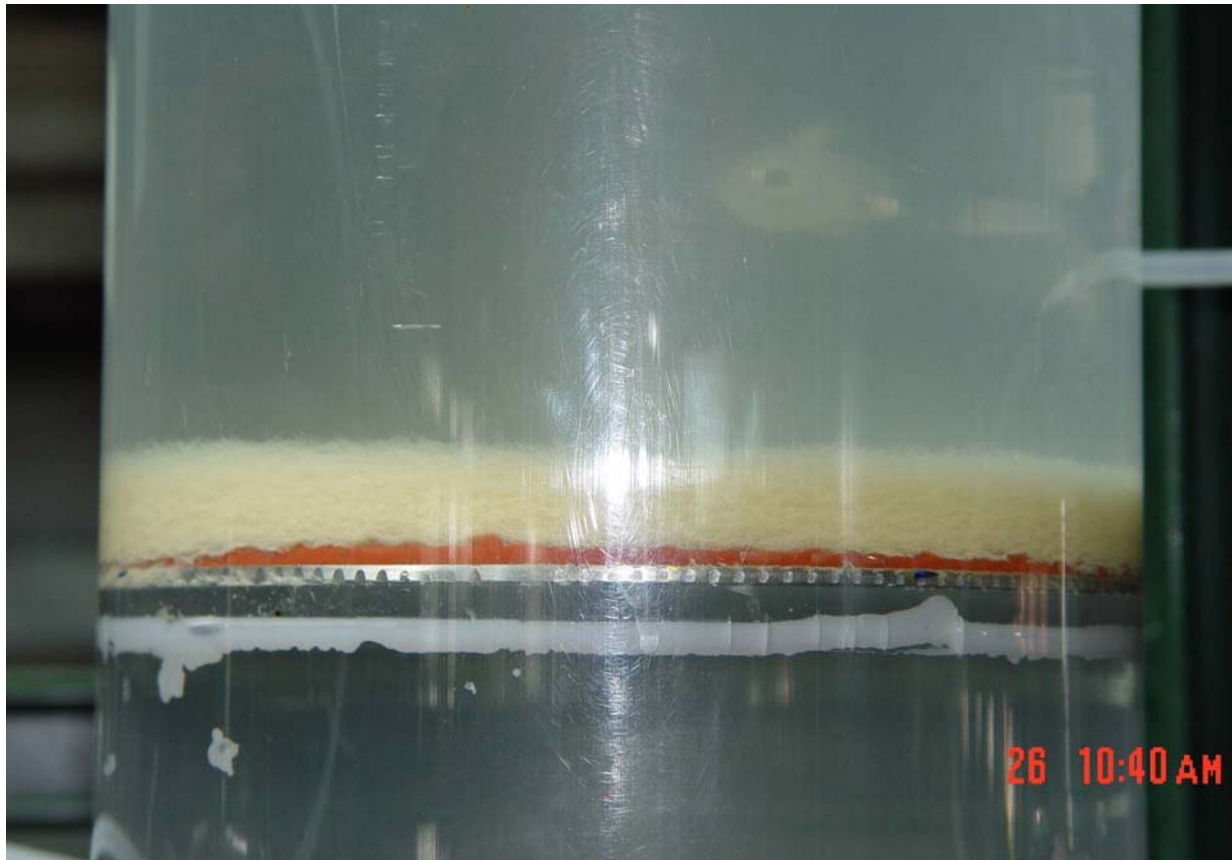
Figure 5. NUKON/CalSil bed before formation of the $\text{Ca}_3(\text{PO}_4)_3$ precipitate

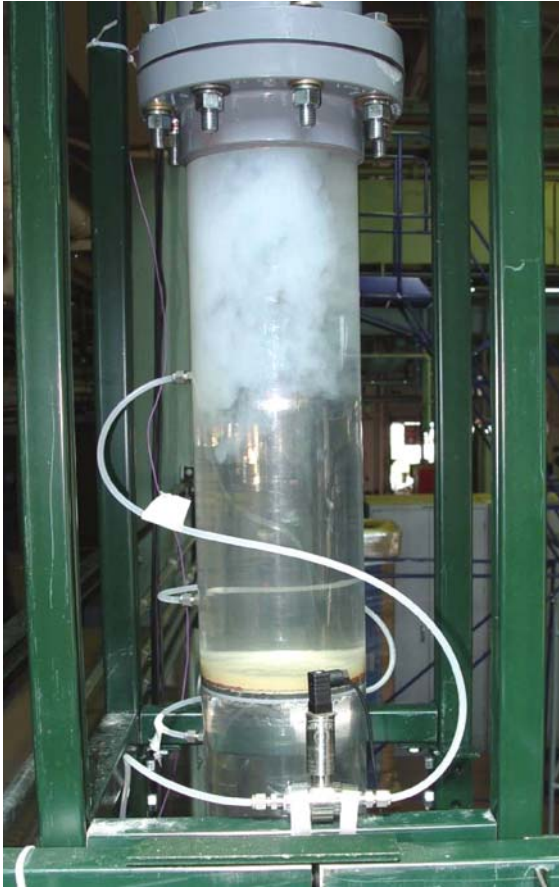
Figure 6.
 $\text{Ca}_3(\text{PO}_4)_2$ forming after addition of CaCl_2 and approaching the debris bed.

The CaCl_2 was then added to the vertical part of the test loop just above the clear test section. A total of 400 ml of CaCl_2 solution was added over a 4 minute period (the transit time around the loop at 0.1 ft/s) to obtain the 200 ppm dissolved Ca inventory. A fine, milky precipitate was observed as shown in Figure 6 just after the introduction of the CaCl_2 . The pressure drop across the bed increased from 1.7 psi to greater than 7.0 psi within 10 minutes of introducing the CaCl_2 . An accurate pressure drop measurement could not be obtained beyond this point, because the loop was running unpressurized, and the pump started to cavitate as the precipitate continued to accumulate on the bed. The flow rate and pressure drop as a function of time after CaCl_2 addition are also shown in Fig. 4. As discussed previously, the 200 ppm Ca inventory is likely not sufficient to produce the full amount of $\text{Ca}_3(\text{PO}_4)_2$ formed during ICET-3. However, no additional Ca was added to simulate the depletion of all the available phosphate as in ICET-3, since the pressure drop across the bed had already caused the pump to cavitate. Figure 7 shows the accumulation of the precipitate on the debris bed just before the pump was shut off.

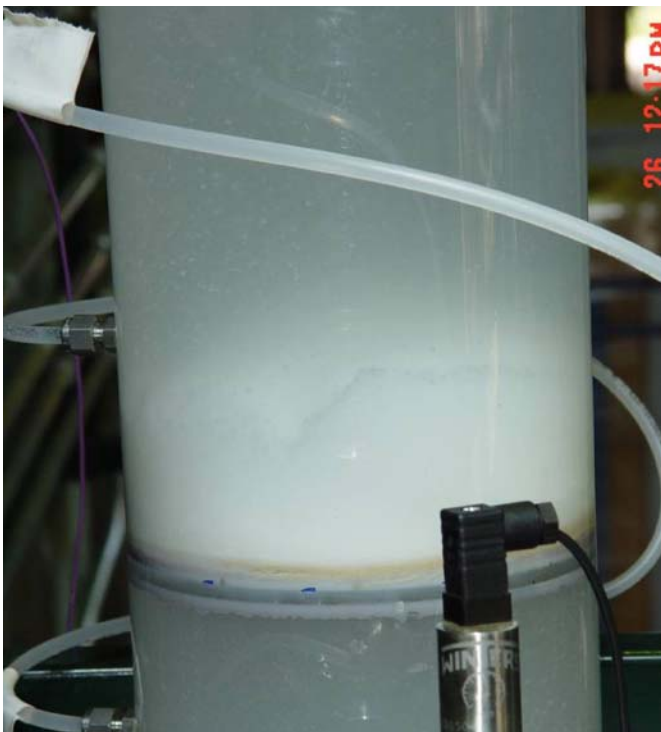
Figure 7.
Precipitate buildup on the fiber debris bed just after the pump was turned off.

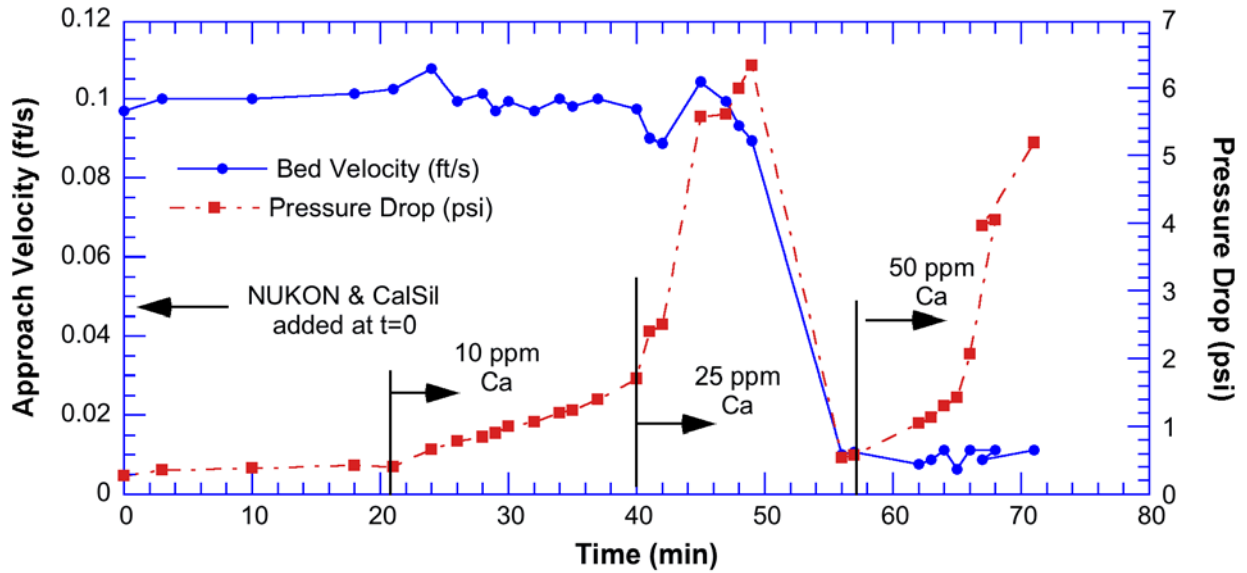
Figure 8. Flow rate and pressure drop as a function of time in Test 2.

When CaCl_2 equivalent to an inventory of 10 ppm dissolved Ca in the loop volume was added, the pressure drop at a flow rate of 0.1 ft/s increased from 0.4 psi to 1.4 psi. The $\text{Ca}_3(\text{PO}_4)_2$ precipitate was again visible, but the cloud was much fainter than the previous test which had a 200 ppm Ca inventory. Additional CaCl_2 was then added to simulate a 25 ppm inventory. The pressure drop increased from 1.4 psi to 6.4 psi and the pump again started to cavitate, since the test loop was unpressurized. The velocity was then decreased to 0.01 ft/s at which point the pressure drop decreased to 0.5 psi. A final increment of CaCl_2 was added to simulate a 50 ppm inventory of total dissolved Ca. At a flow rate of 0.01 ft/s, the pressure drop increased from 0.5 psi to 1.0 psi within 4 minutes. Under continuing operation for another 12 minutes, the pressure drop increased to 5.2 psi, but the velocity could not be maintained as the suction pressure on the pump dropped. The flow rate and pressure drop as a function of time in Test 2 are shown in Fig. 8.
