Re: DURITA SITE - CLOSURE CELL CROSS-SECTIONS AND MATERIAL DATA

Hecla Mining Company - Durita Site
Closure Cell Cover Construction Compliance with Criterion 6
March 26, 1999

DURITA SITE - CLOSURE CELL
 AS-BUILT
 2/5/97 12/15/97 MEI
 CROSS-SECTION @ 47,750 EAST

CROSS-SECTION @ 36,713.5 NORTH

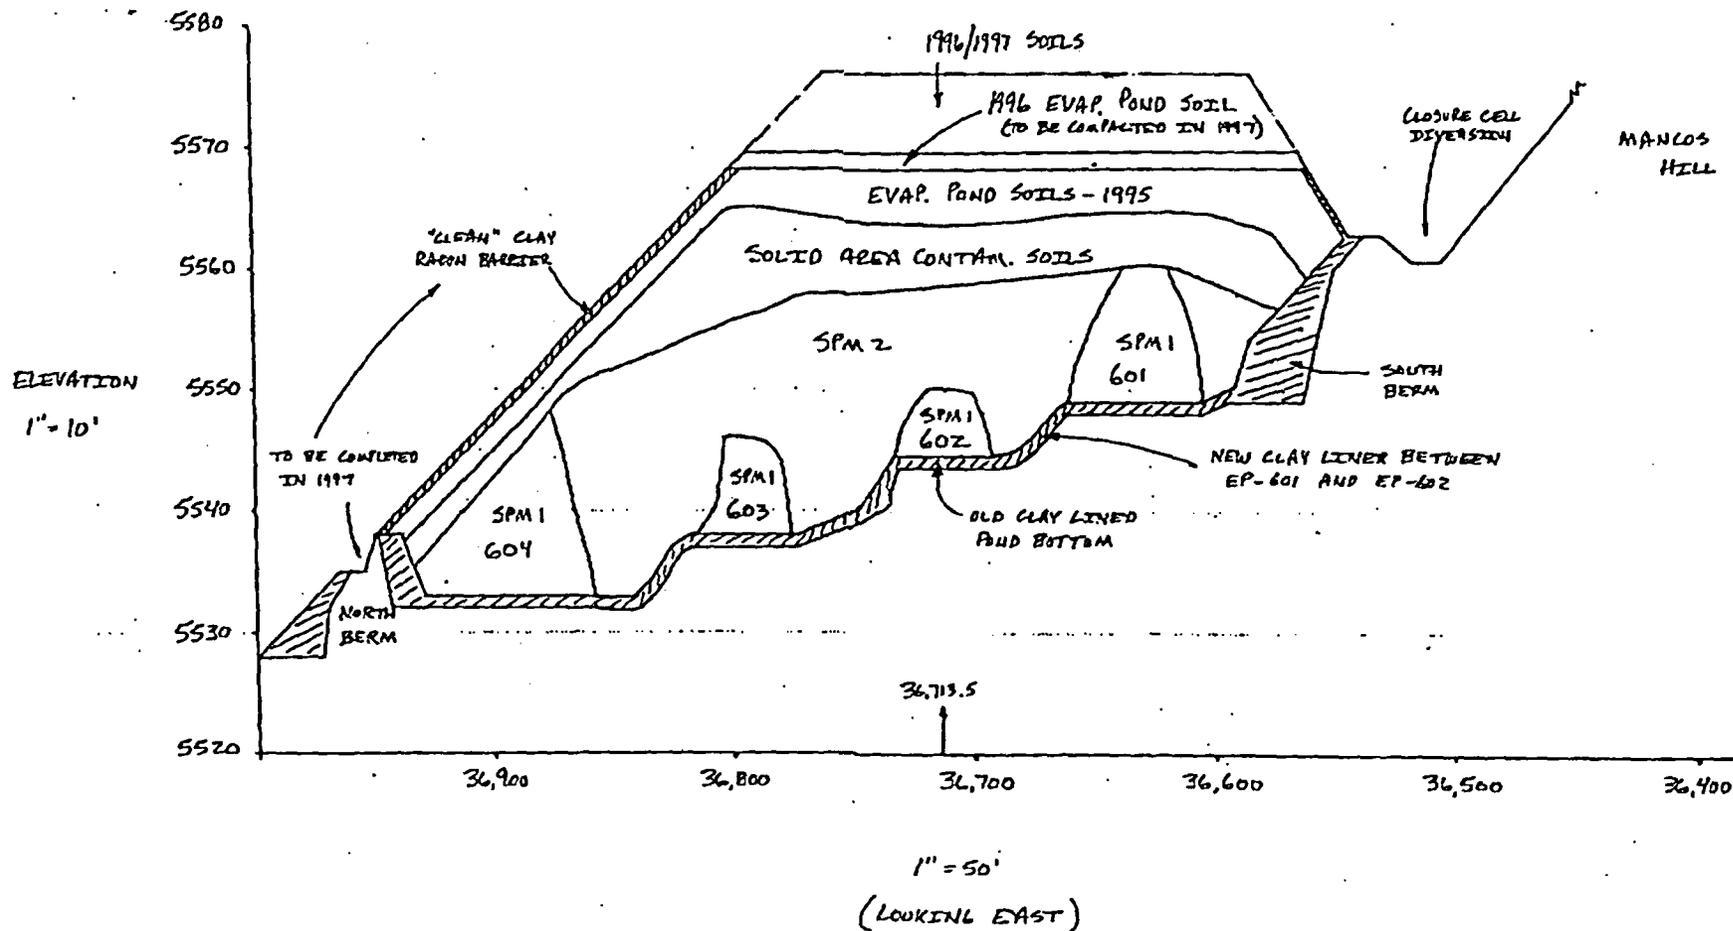
Attached are two as-built cross-sections through the Closure Cell. The sections show what types of materials were placed into the Cell and each layer's thickness. Cross-section layer locations and elevations are based on field data collected by Dan McWilliams (on-site soils testing engineer during 1995), Del-Mont Consultants (project surveyors), and myself (soils testing during the 1997 construction season).

Durita Site 1997 Closure Cell Soil Layer Conditions							
Layer # (from bottom)	Description	Thickness (cm/R)	Density (g/cm ³)	Relative & Specified Compaction (%)	Radium Activity (@ 1,000 yr) (pCi/g)	Moisture Content (%)	Exit Flux (pCi/m ² /s)
1	SPM	300/9.8	1.61	96.2/90	266	15	— ¹
2	Solid Area Contaminated Soils	120/3.9	1.64	95.9/90.0	20	10	— ¹
3	Evaporation Pond Contaminated Soils	107/3.5	1.79	99.0/95.0	35	13	— ¹
4	Clean Clay/ Radon Barrier/ 96/97 Soils	285/8.7	1.86	98.4/95.0	7 ²	13.8	— ¹
