UNC RECOVERY SYTEMS

COMPLIANCE INVESTIGATION REPORT

Subject: UNITED NUCLEAR CORPORATION  
SCRAP RECOVERY FACILITY  
Wood River Junction, Rhode Island  
License No. SNM-777

Type "A" case - Criticality Incident

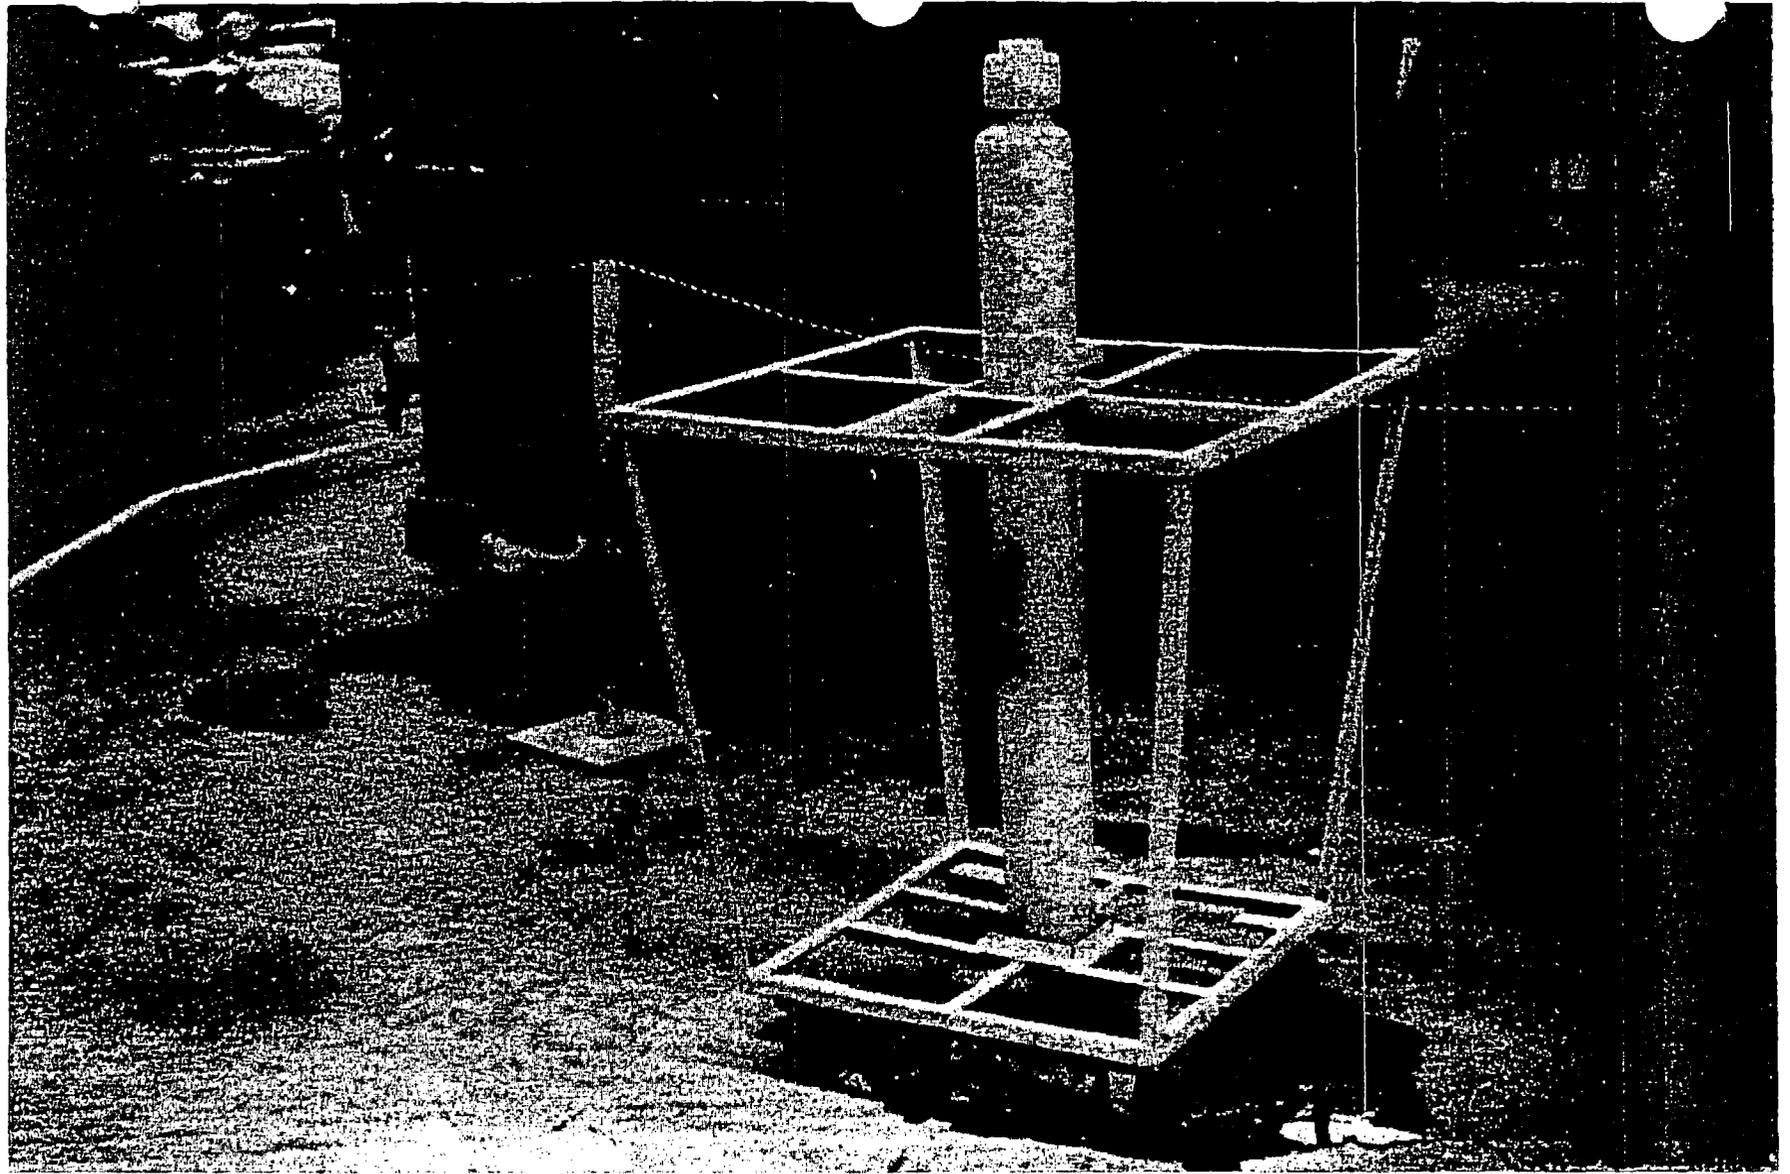
1. Bottle "X" - This first picture shows Bottle "X" in a "safe" cart, just southeast of hood 1-J-5B. A broken seam in the bottle has allowed solution to leak out onto the floor. The bottle still contains crystals of uranium nitrate that occupy about 1/3 of the total volume of the bottle.

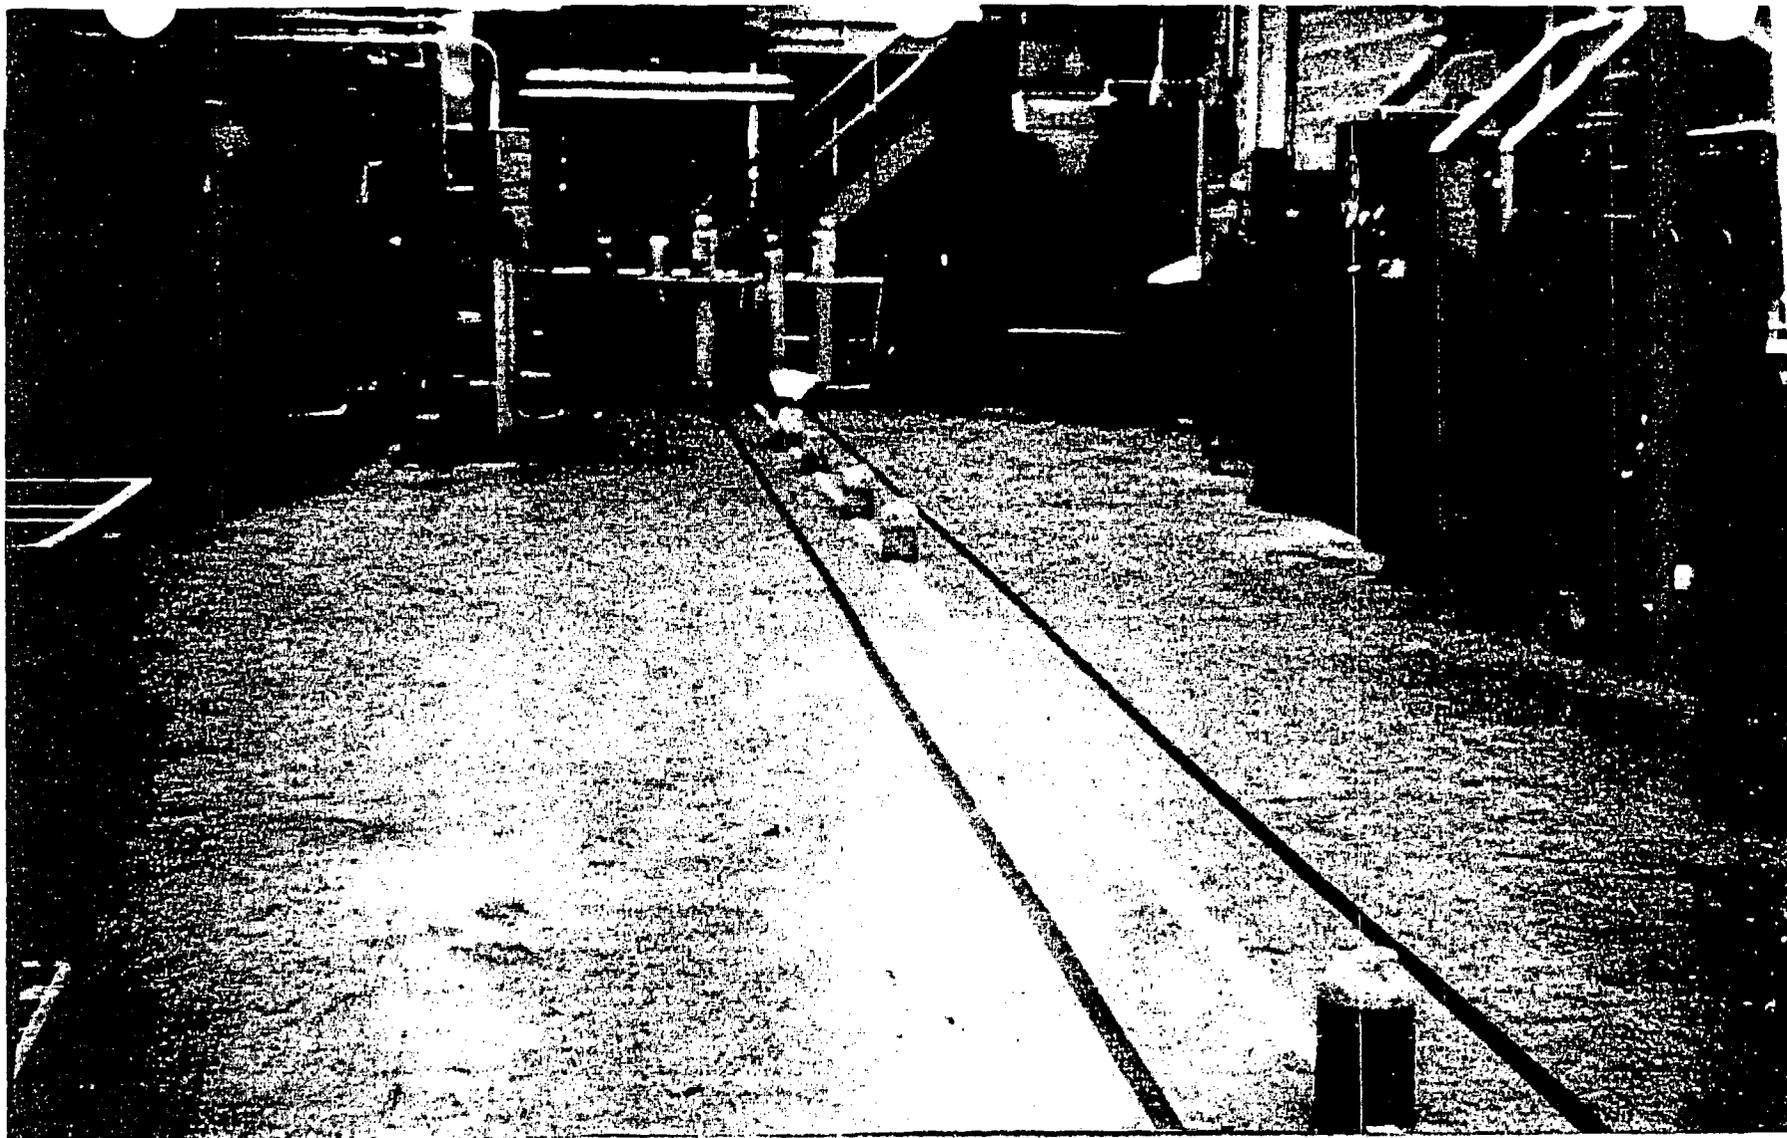
2. South Side of the Process Area - This second picture was taken facing east and shows the south side of the process area, between Bottle "X", which is in the cart shown at the left edge of the picture, and the evaporator-precipitator area. The lines on the floor designate the "safe" way down which "safe" carts containing the 11 liter bottles are to be transported. The first four one-gallon bottles that are spaced along the center line, contain both precipitate and solution from the nuclear incident. This material was drained from the organic wash column 1-C-9.

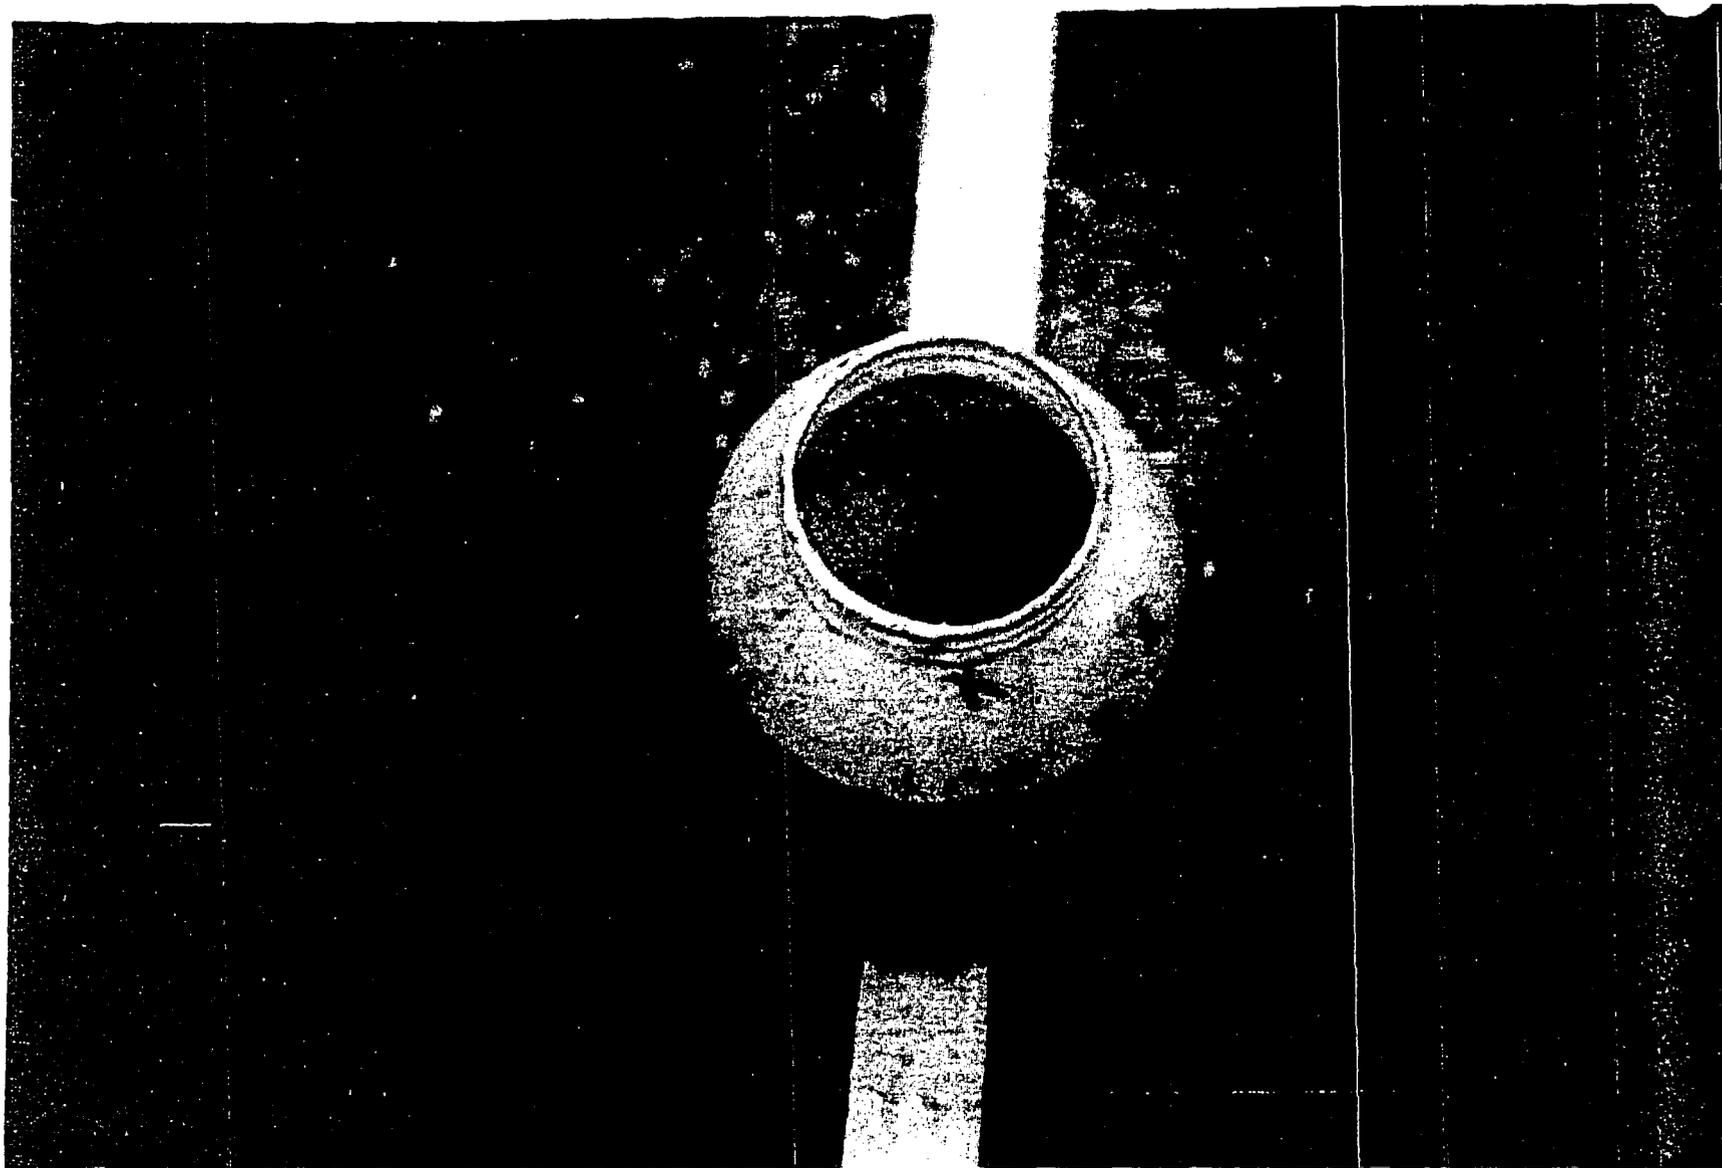
3. Close-Up of a Gallon Jar - This close-up shows one of the one gallon jars of material that was drained from the sodium carbonate make-up tank. This is one of the four bottles shown in picture 2.

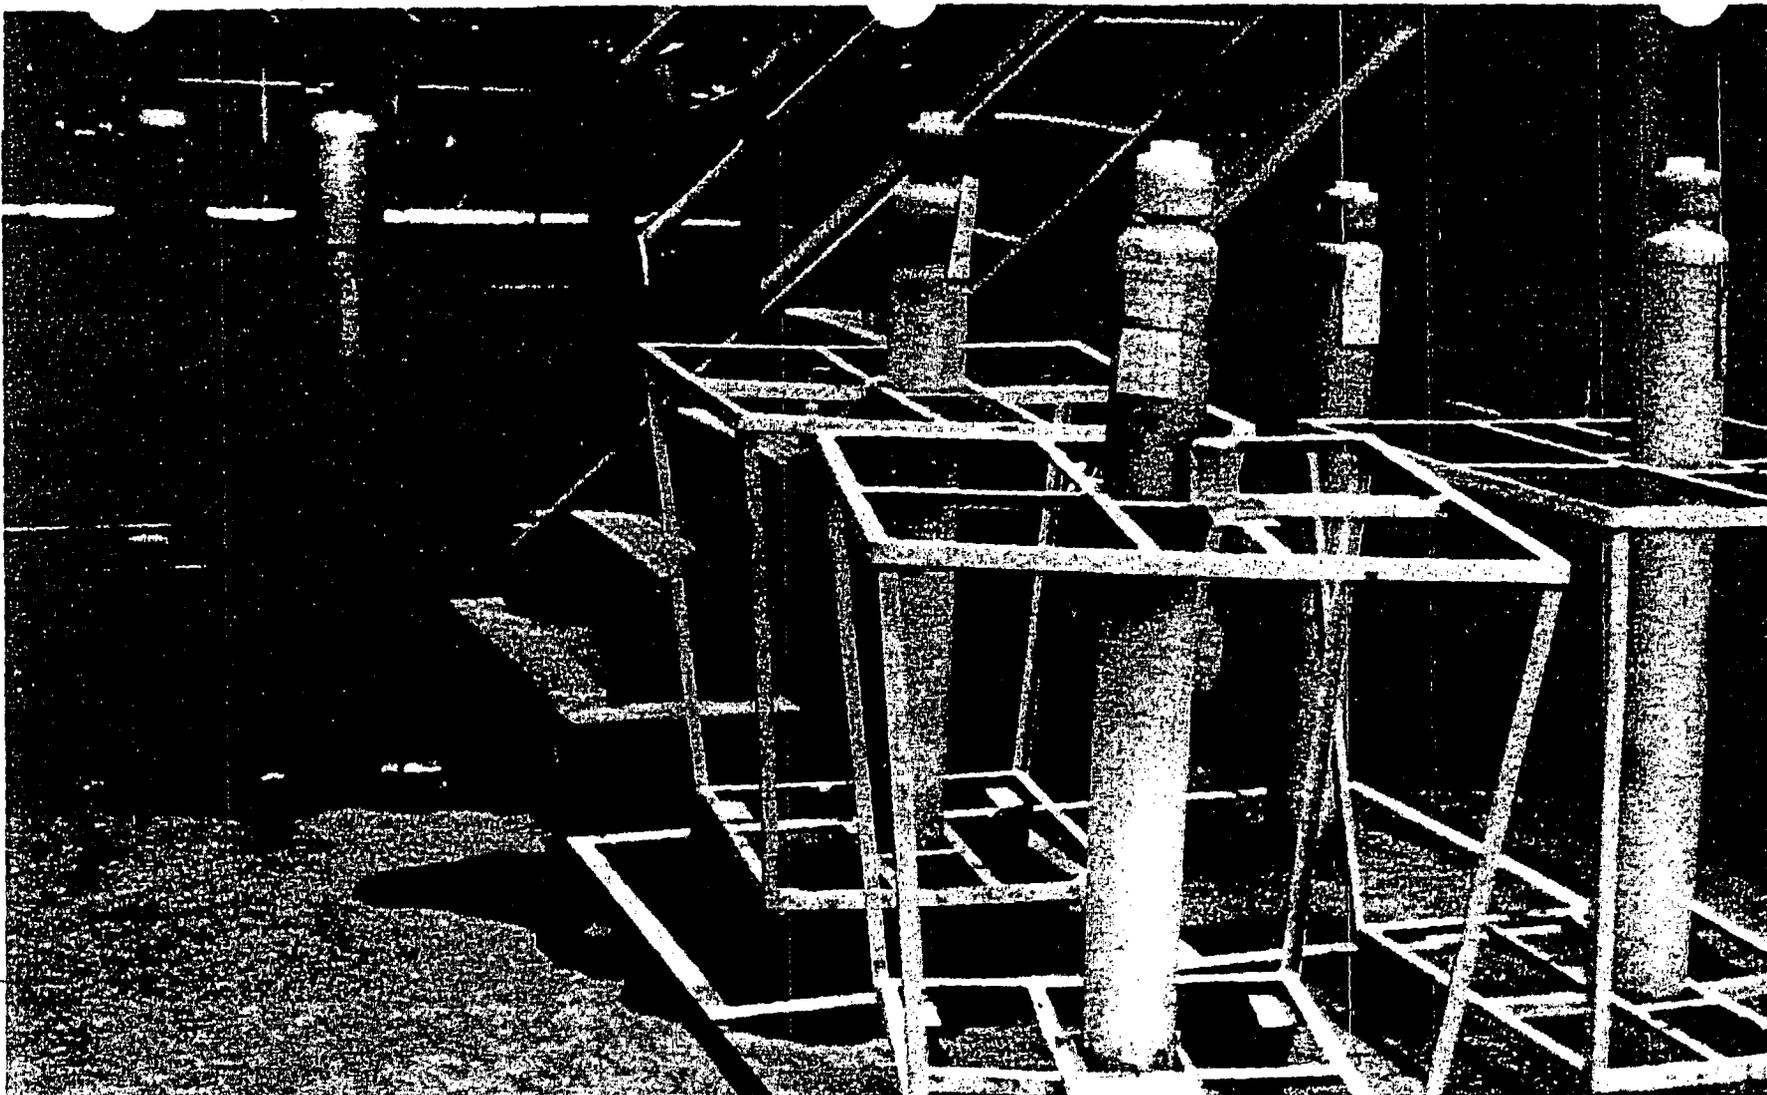
4. The Evaporator-Precipitator Storage Area - This picture shows four of the five 11 liter bottles that were stored in the evaporator-precipitator area. Three of the bottles are stored in safe carts, one is stored in the center of the 28" square area marked off on the floor, and one is stored on the center line of the "safe" way just west of the four 11 liter bottles. (The latter bottle is not shown by this picture.)

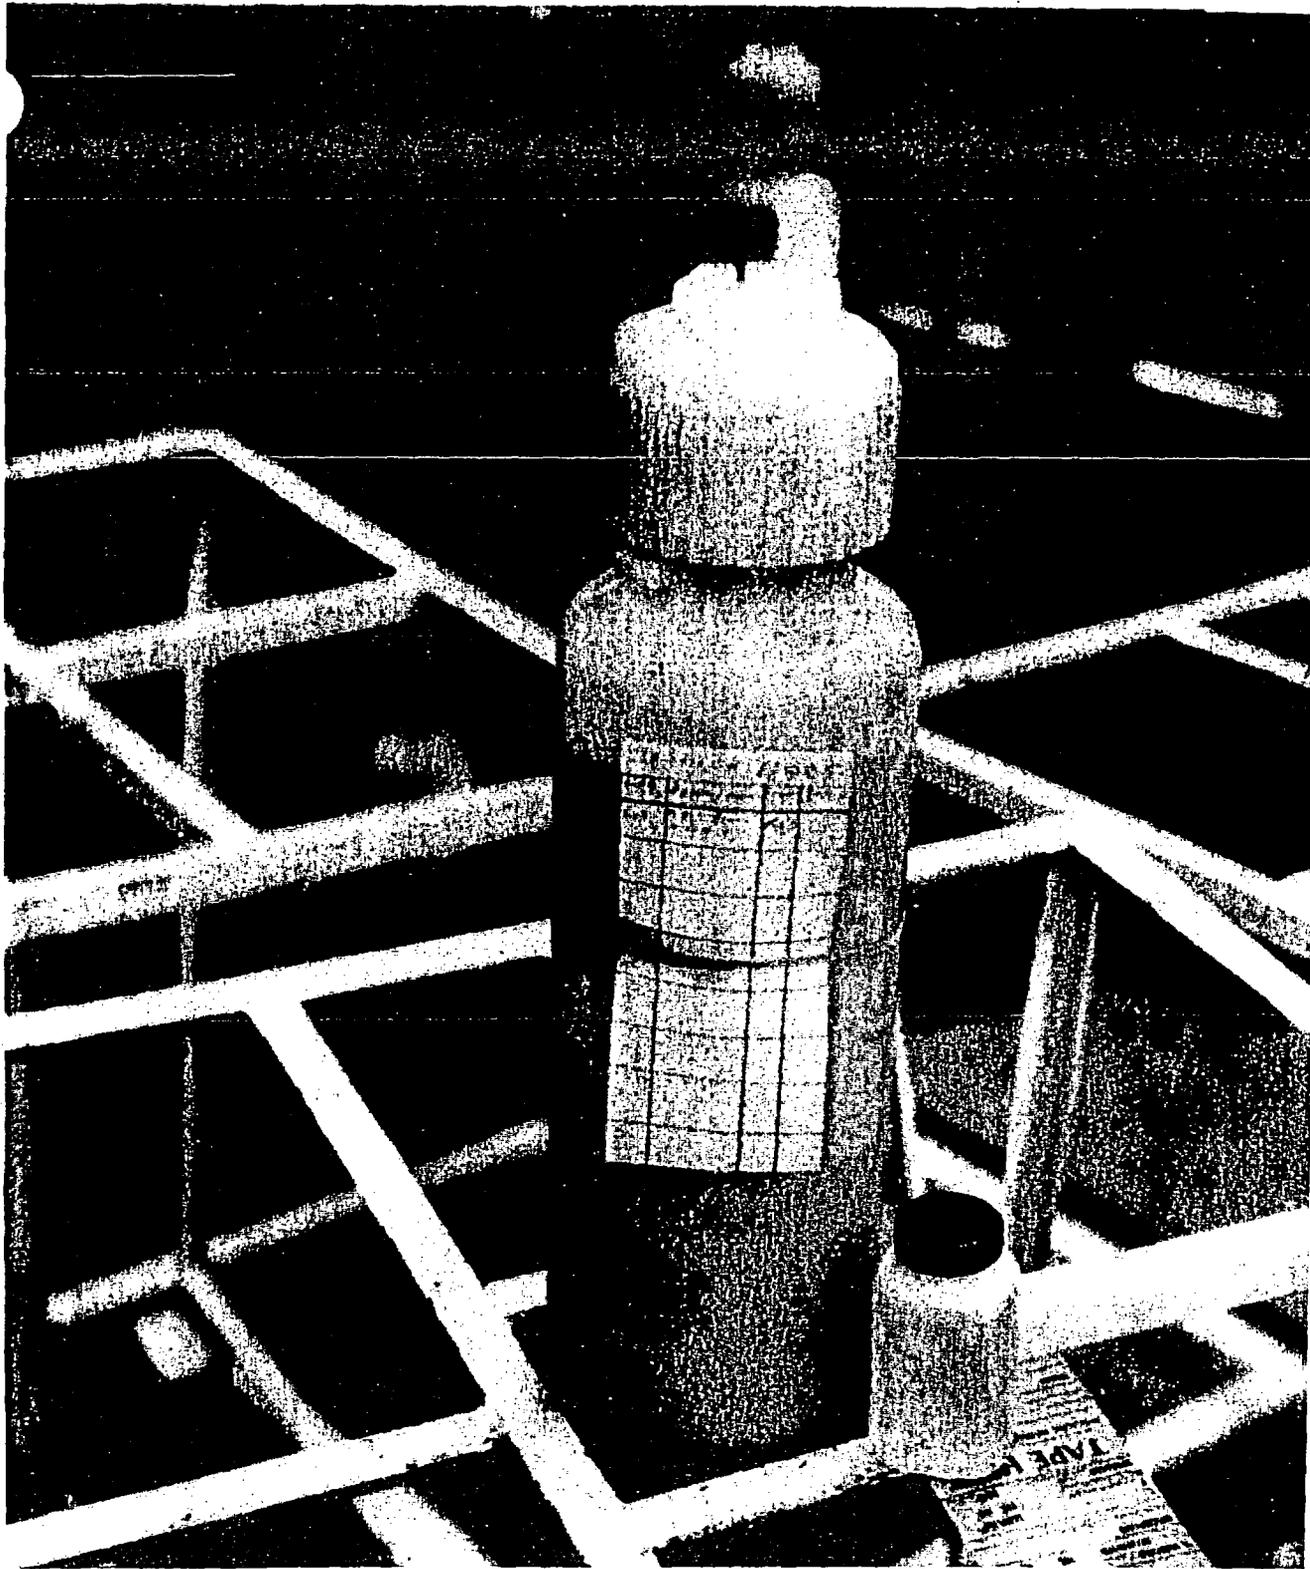
5. Bottle 11005 - This close-up shows the bottle in the "safe" cart nearest to the photographer in picture 4. It illustrates the method used for affixing the tag to the bottle, the type of tag used, the size of the sample bottle, and the way the sample tag is used.

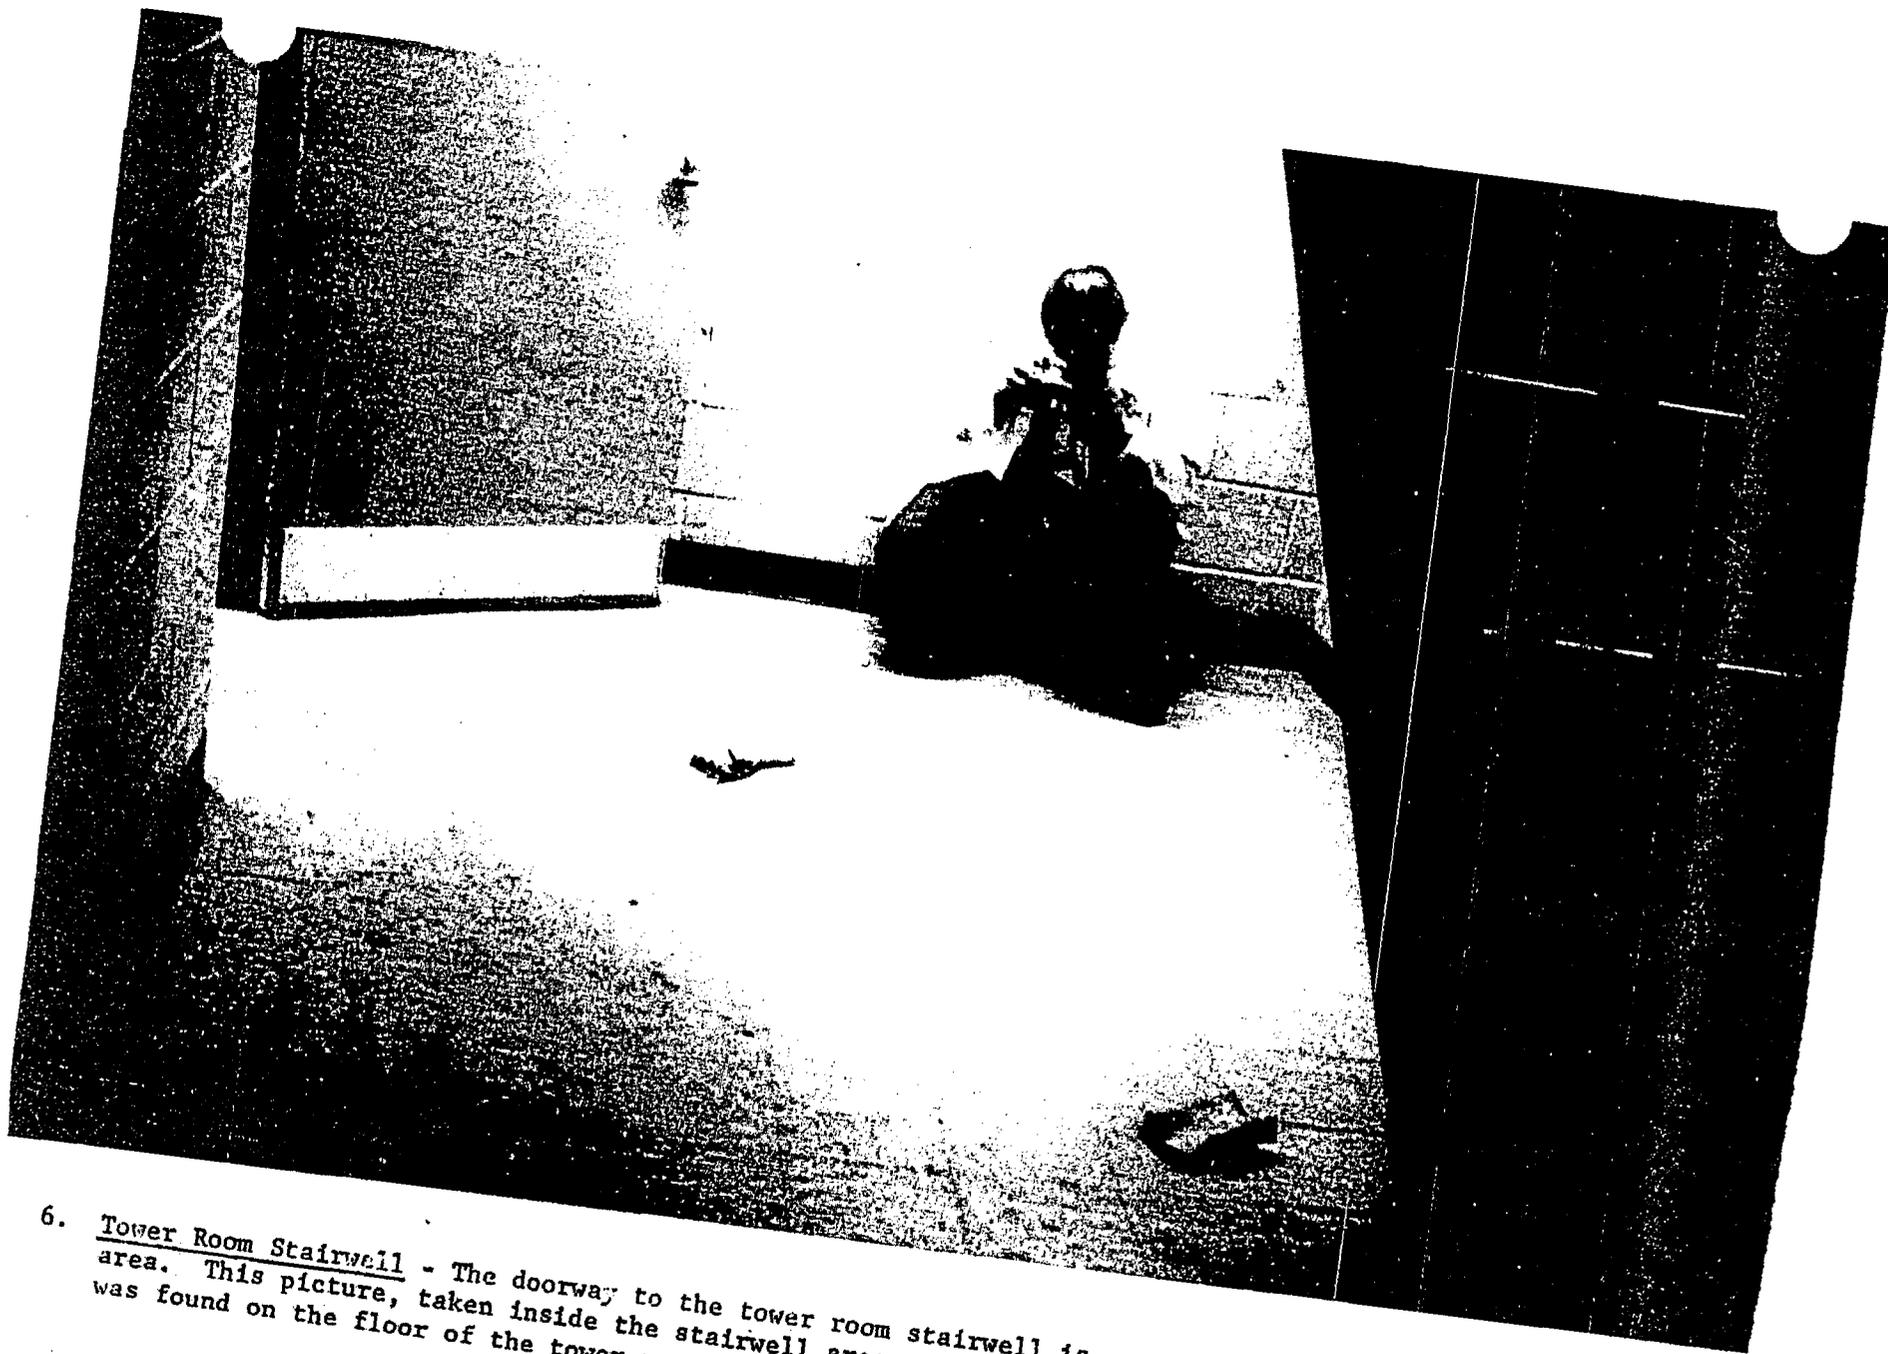
6. Tower Room Stairwell - The doorway to the tower room stairwell is north of the evaporator-precipitator storage area. This picture, taken inside the stairwell area, shows Mr. Lindberg taking a picture of Tag No. 1 which was found on the floor of the tower room stairwell. Two rubber gloves were also found on the floor.

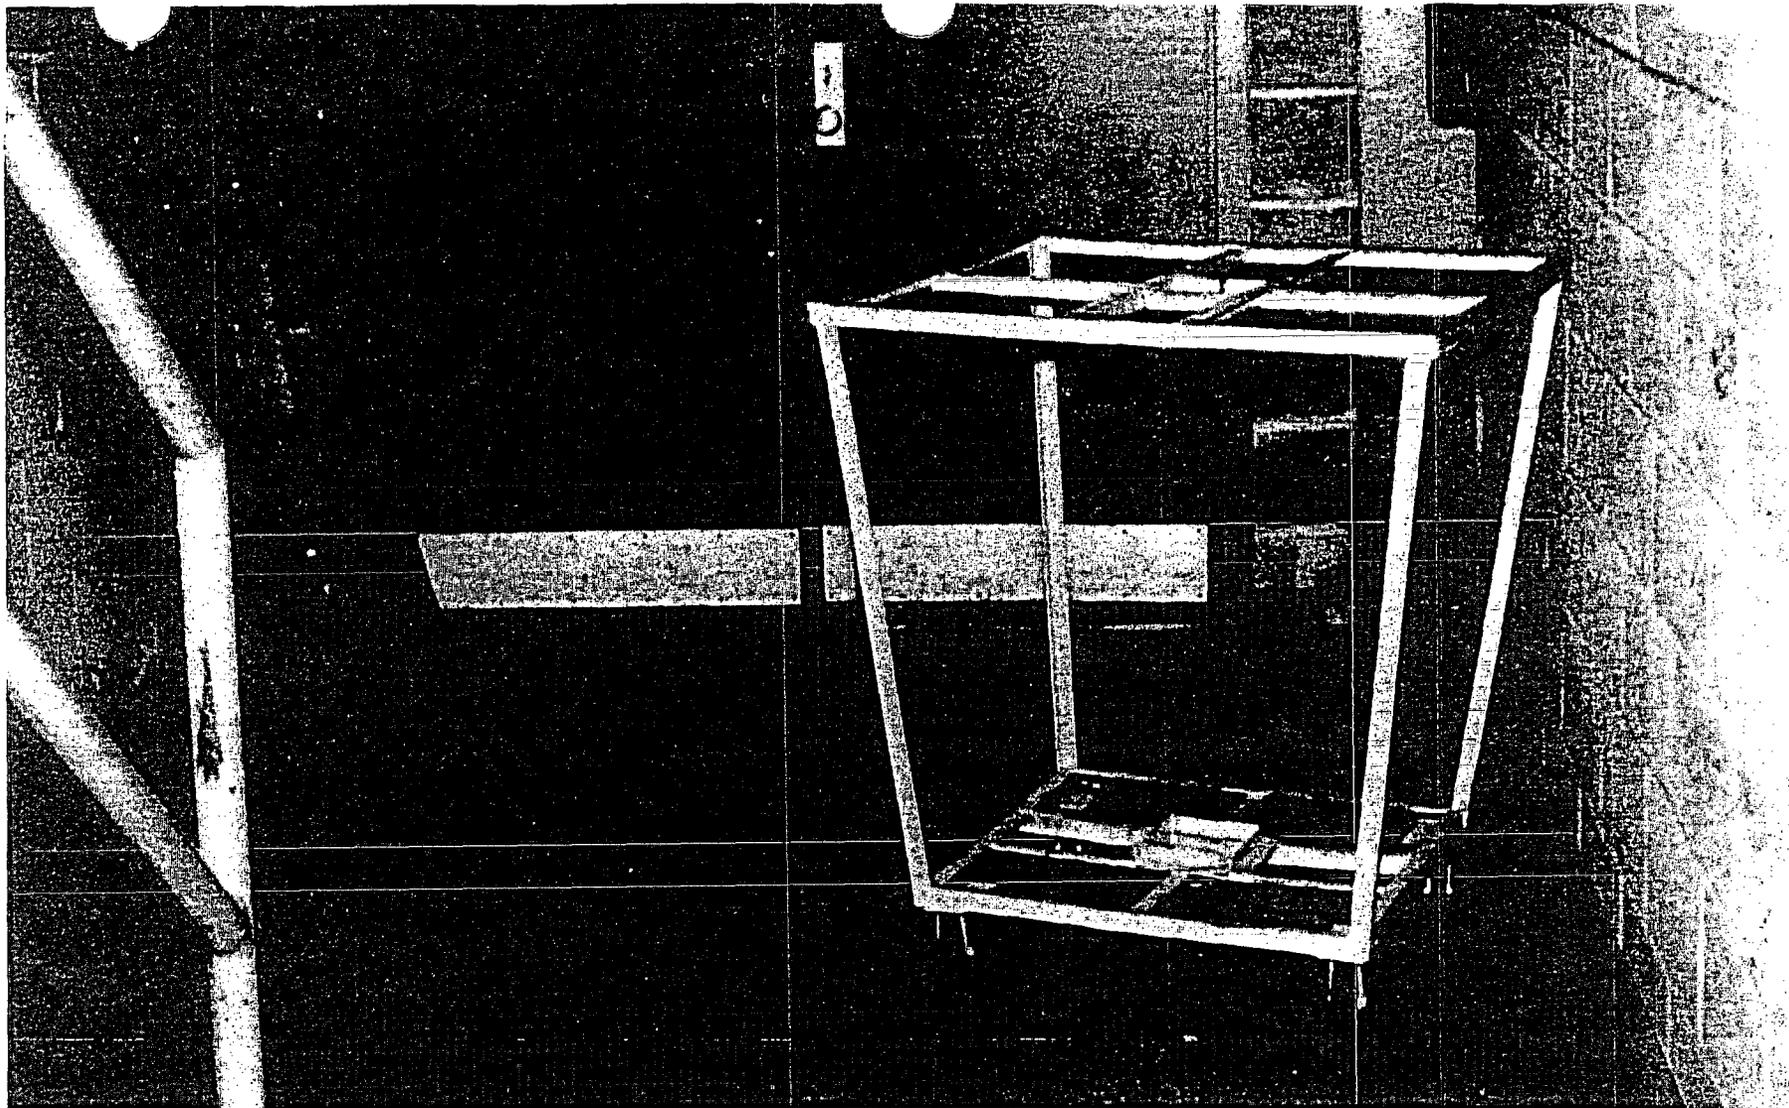
9. Empty "Safe" cart - This empty "safe" cart was found in the east portion of the first floor tower room stairwell and is presumed to have contained the 11 liter bottle of uranium solution that was carried to the third floor of the tower room.

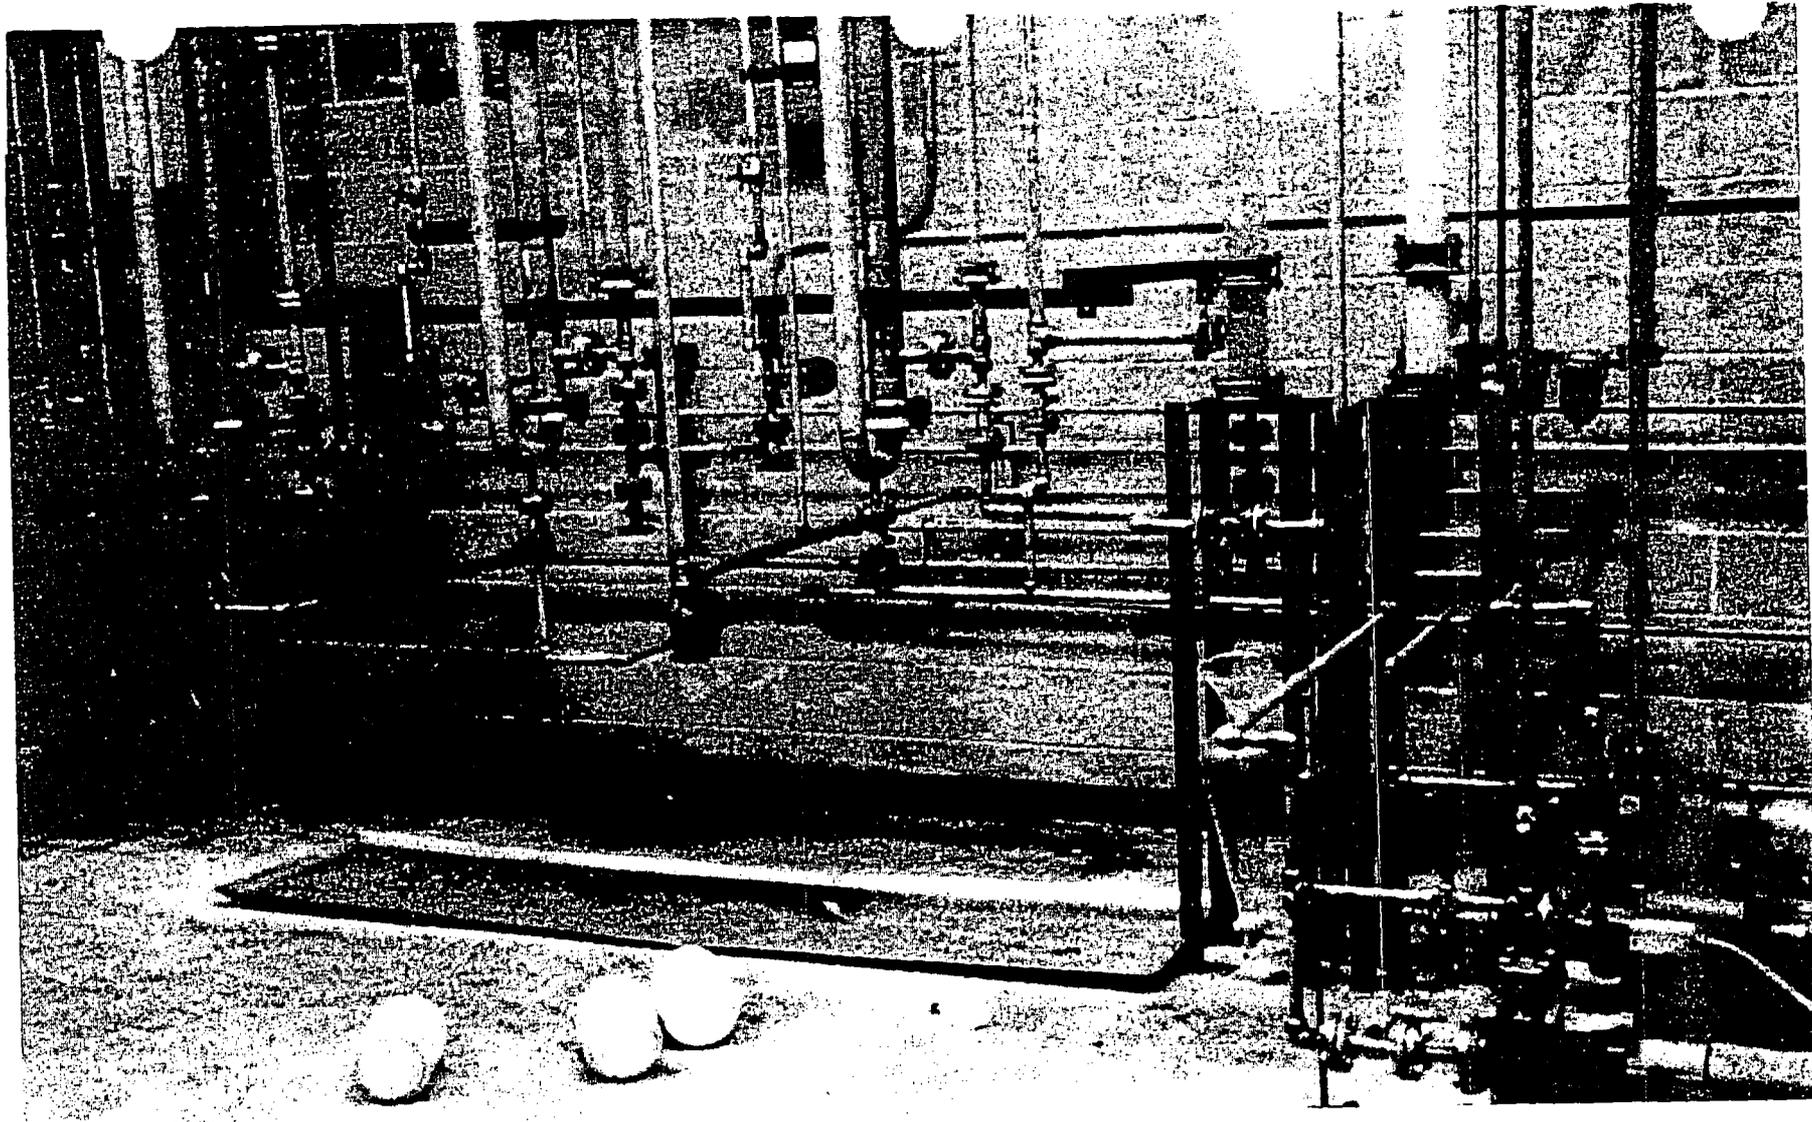
10. First Floor of the Tower Room - Looking north, three empty one-gallon bottles, a sponge, and a tag can be seen on the first floor of the tower room. The tag is about 2' west of pump 1-P-32 and was designated Tag No. 2. Directly in line with the two liter separatory funnel, but above it, is the bottom of the TCE (Trichloroethane) column, 1-C-10. Just to the right of the TCE column (east) is the organic wash column (1-C-9) which is still full of precipitate and solution that was involved in the nuclear incident.

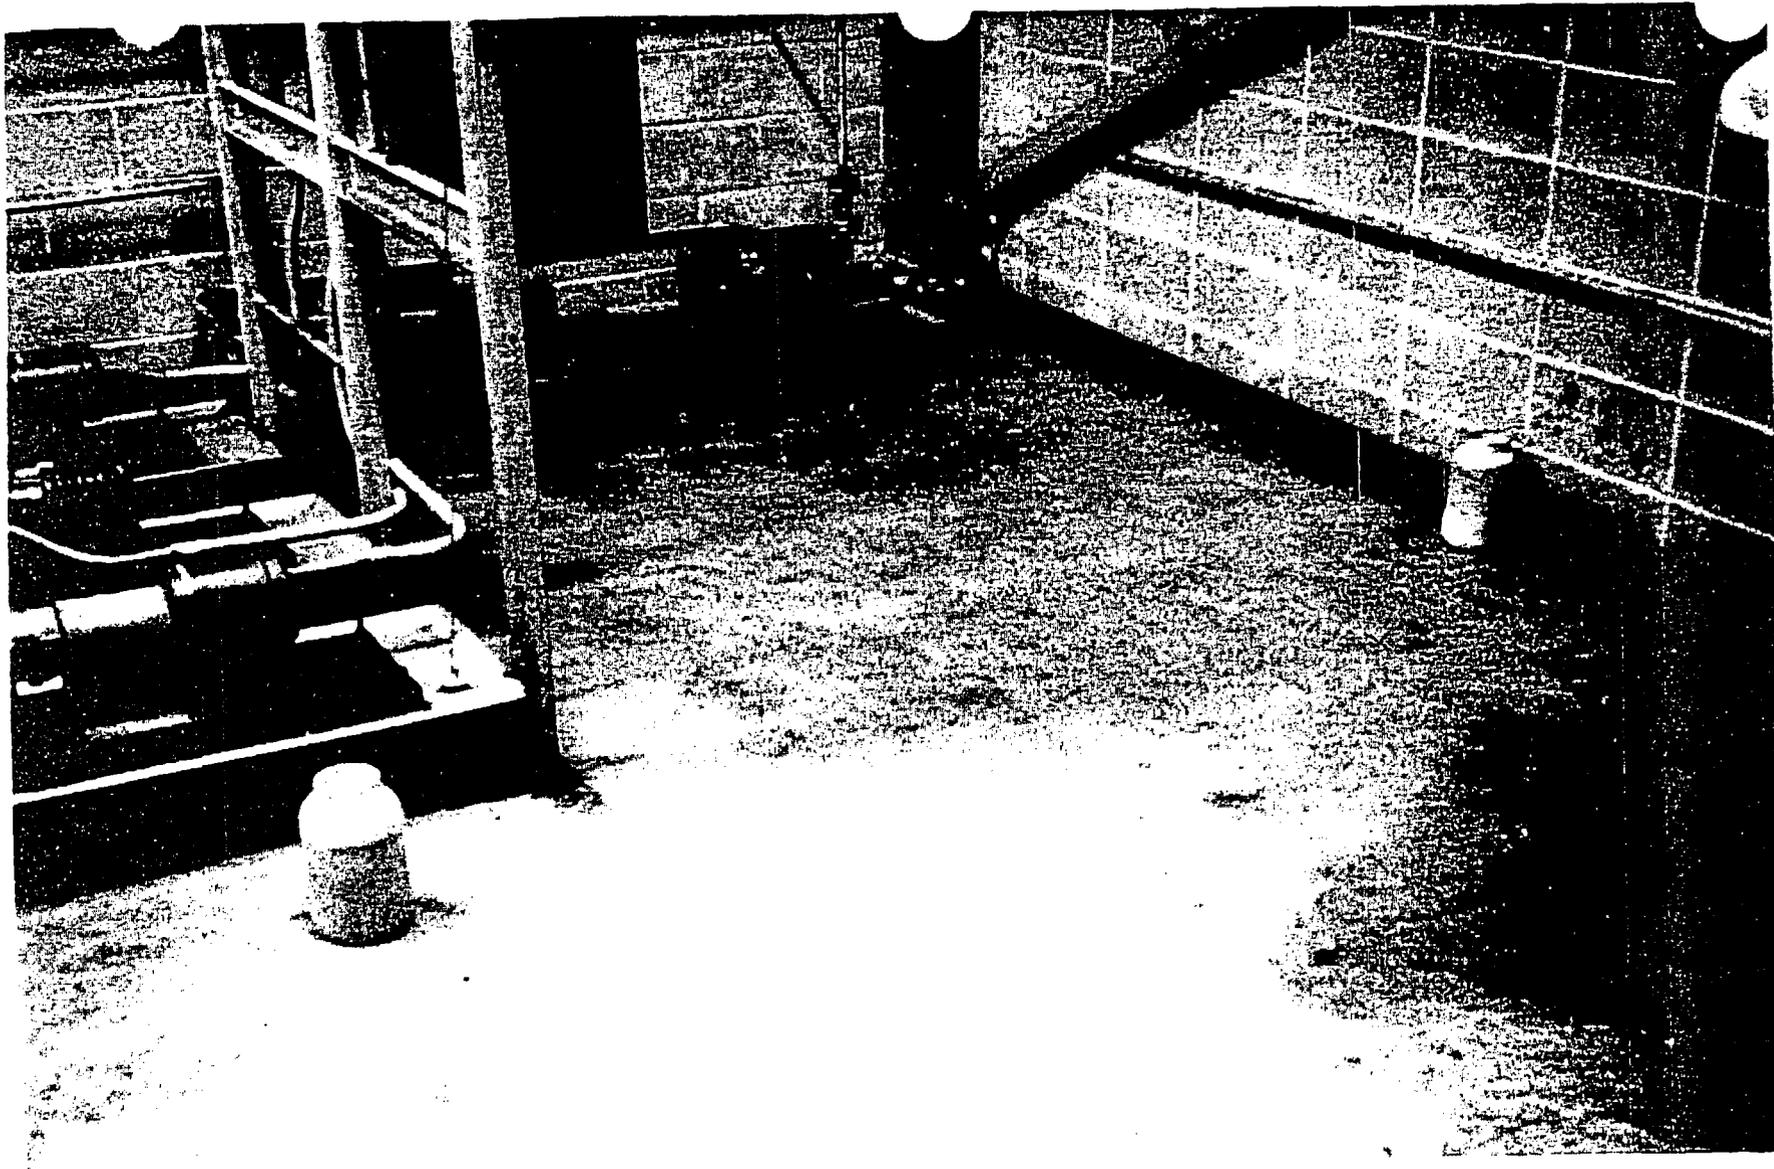
13. First Floor of the Tower Room - This shows the northeast portion of the first floor tower room. There is an open well above this area which goes to the top of the tower. Tag No. 3 was found on the floor, wetted with uranium solution that had splashed down the well from the third floor. The two one-gallon bottles contain solution that was drained from the 1-C-9 column before the incident material was drained from the sodium carbonate make-up tank (1-D-11) into the 1-C-9 column.

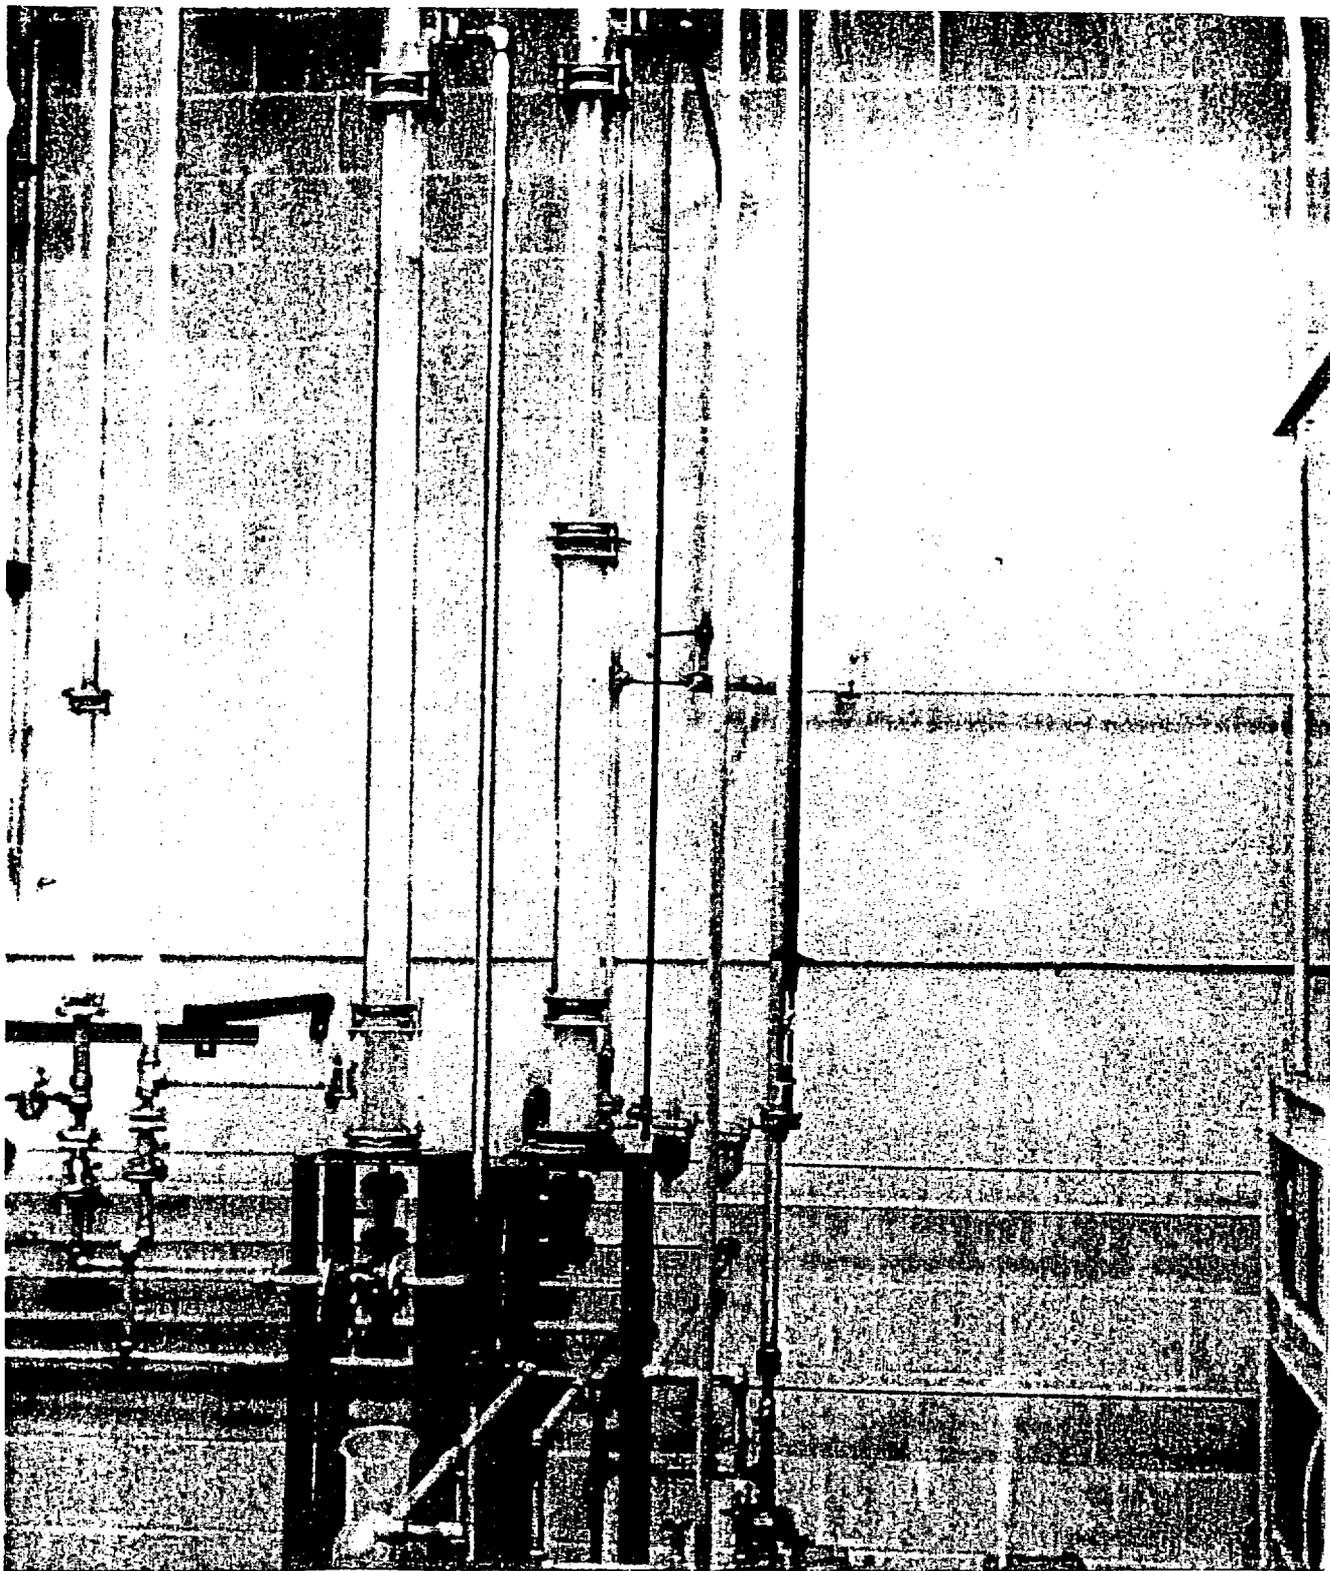
16. The TCE and Organic Wash Columns - This view of the columns shows the dirty TCE-aqueous interface of the TCE column (1-C-10) about a foot and a half from the overflow line, and the organic wash column (1-C-9) that is half full of precipitate. The organic wash column contains material involved in the nuclear incident.
