UNC RECOVERY SYTEMS

COMPLIANCE INVESTIGATION REPORT

Subject: UNITED NUCLEAR CORPORATION  
SCRAP RECOVERY FACILITY  
Wood River Junction, Rhode Island  
License No. SNM-777

Type "A" case - Criticality Incident

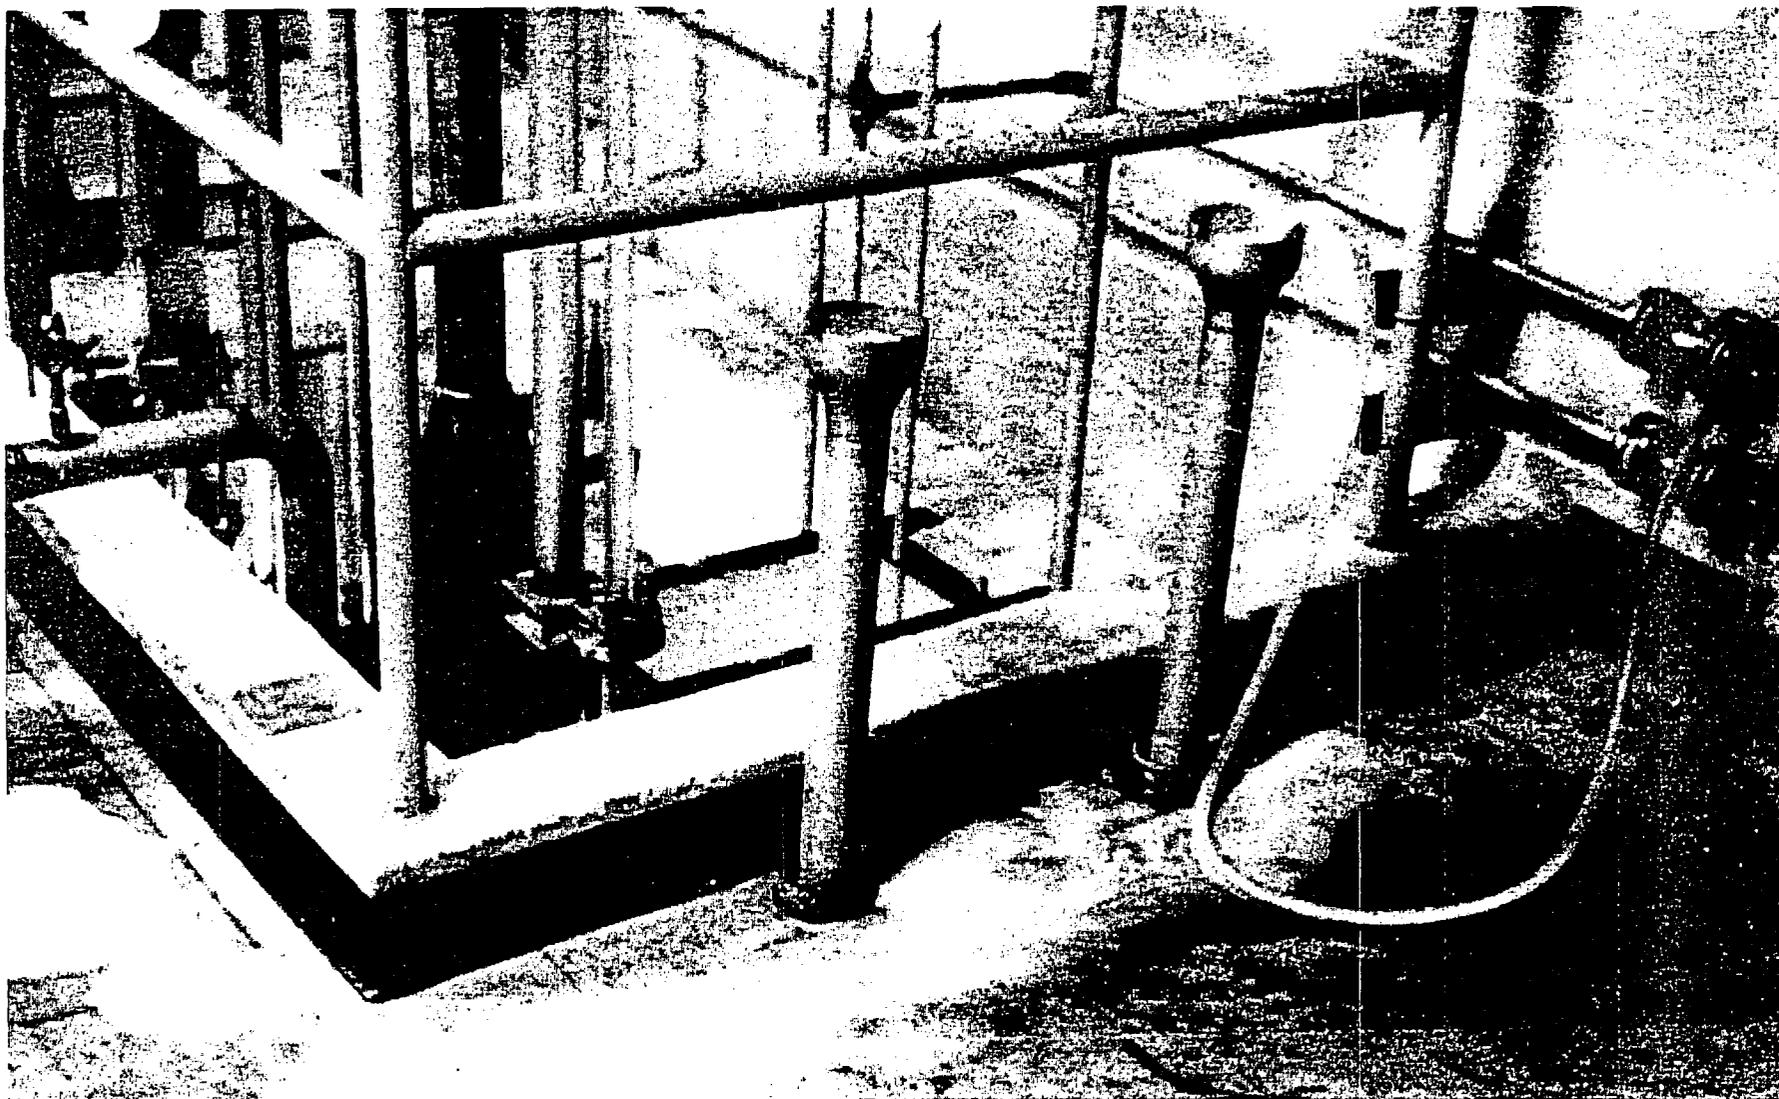
17. Second Floor of the Tower Room - This picture taken at the second floor level of the tower room, looking north, shows the funnels for columns 1-C-10 and 1-C-9 with the tygon tube that is connected to the 1/2" pipeline from the third floor sodium carbonate make-up tank. There is a spill of uranium precipitate and solution on the floor, that occurred when the tubing flipped out of the funnel. The 1-C-9 (organic wash) column funnel is the one closest to the north wall and the 1-C-10 (TCE) column funnel is nearest to the photographer.

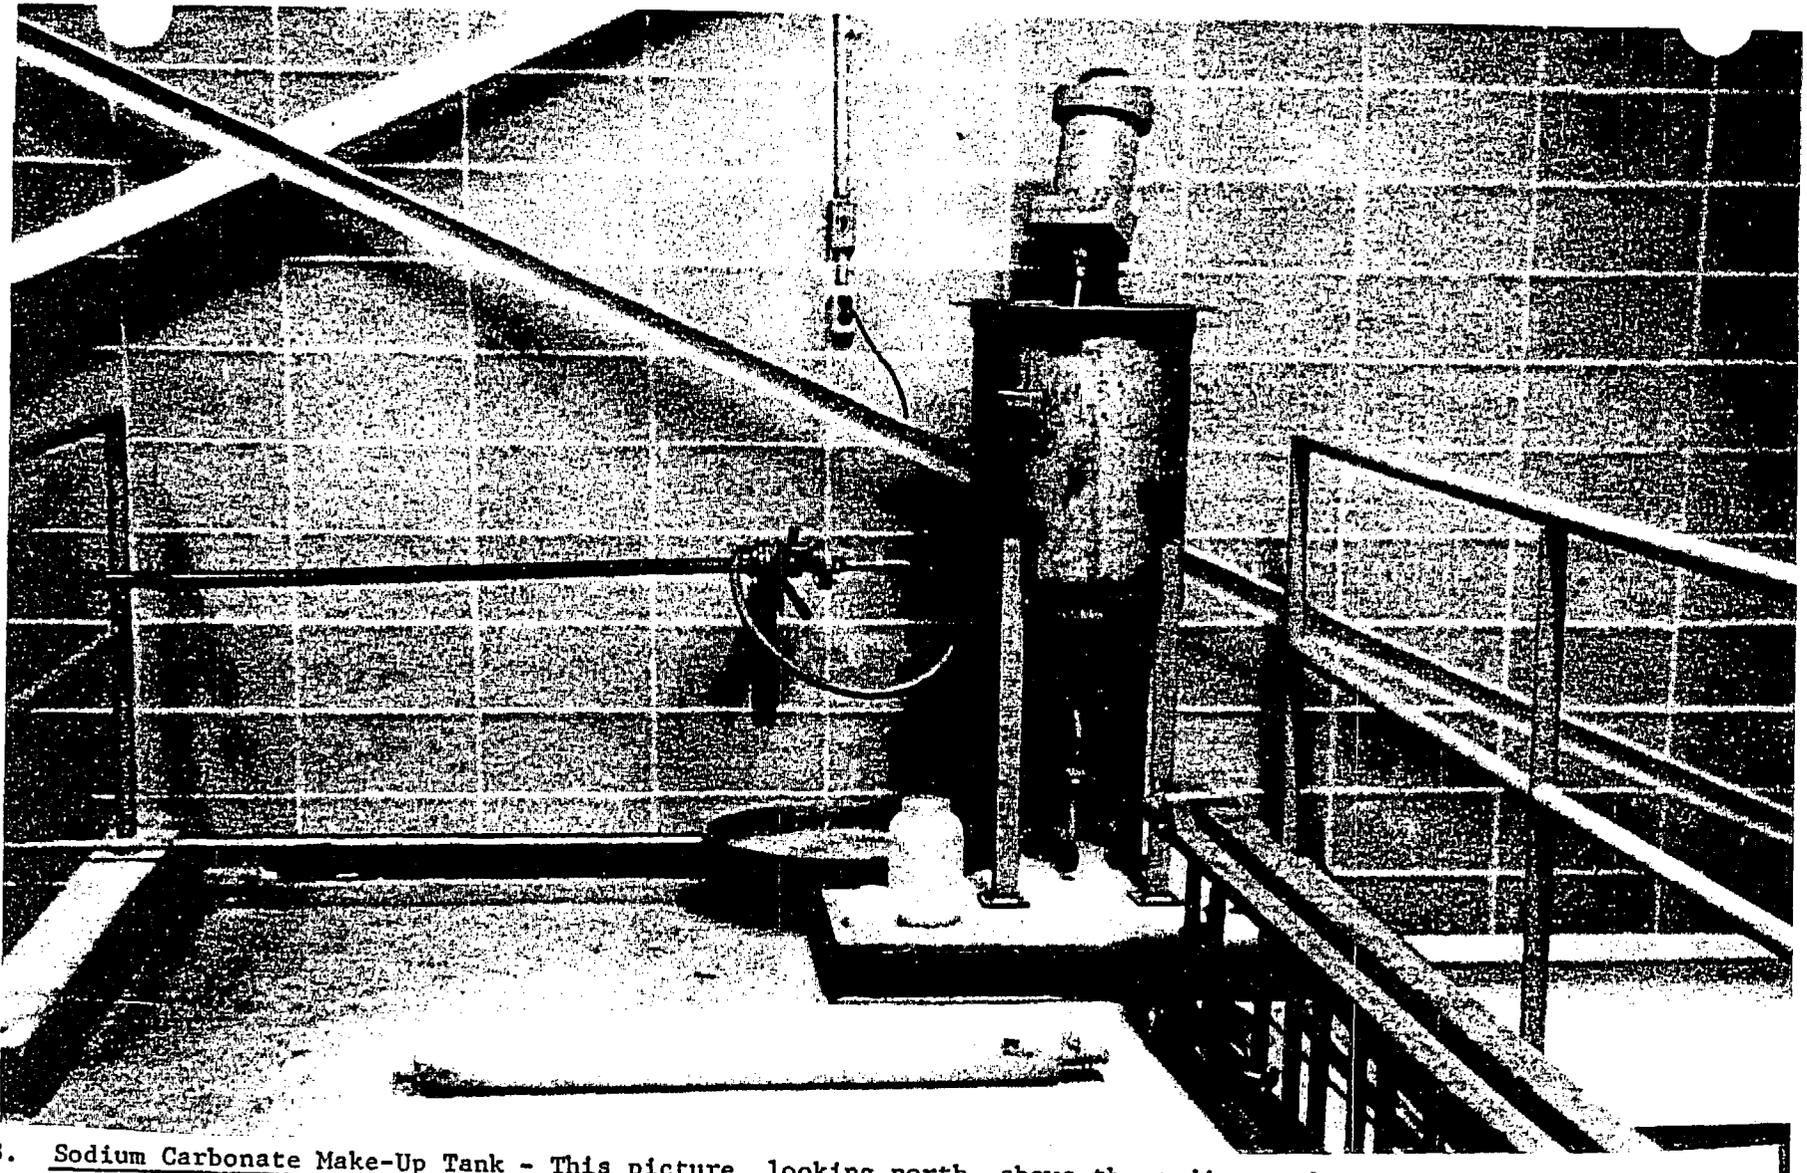
18. Sodium Carbonate Make-Up Tank - This picture, looking north, shows the sodium carbonate make-up tank (1-D-11) on the third floor of the tower room. This tank is the one where the nuclear incident occurred. The 11 liter bottle on the floor was initially found in the tank (about 2 hours after the incident occurred) with the bottom end facing west (to the left). The agitator was still running. Subsequently, the bottle was removed and the agitator turned off. The electrical outlet is just above the electrical outlet into which the ladder, the only place from the operator could stand while pouring solution from the 11 liter bottle into the tank, is on the platform, directly in front of the tank.

From examining a picture of the sodium carbonate make-up tank (1-D-11) it is apparent that the tank is reflected only on the north side by the concrete block wall and on the bottom by the floor. This system should have a high neutron leakage as it approaches criticality so the

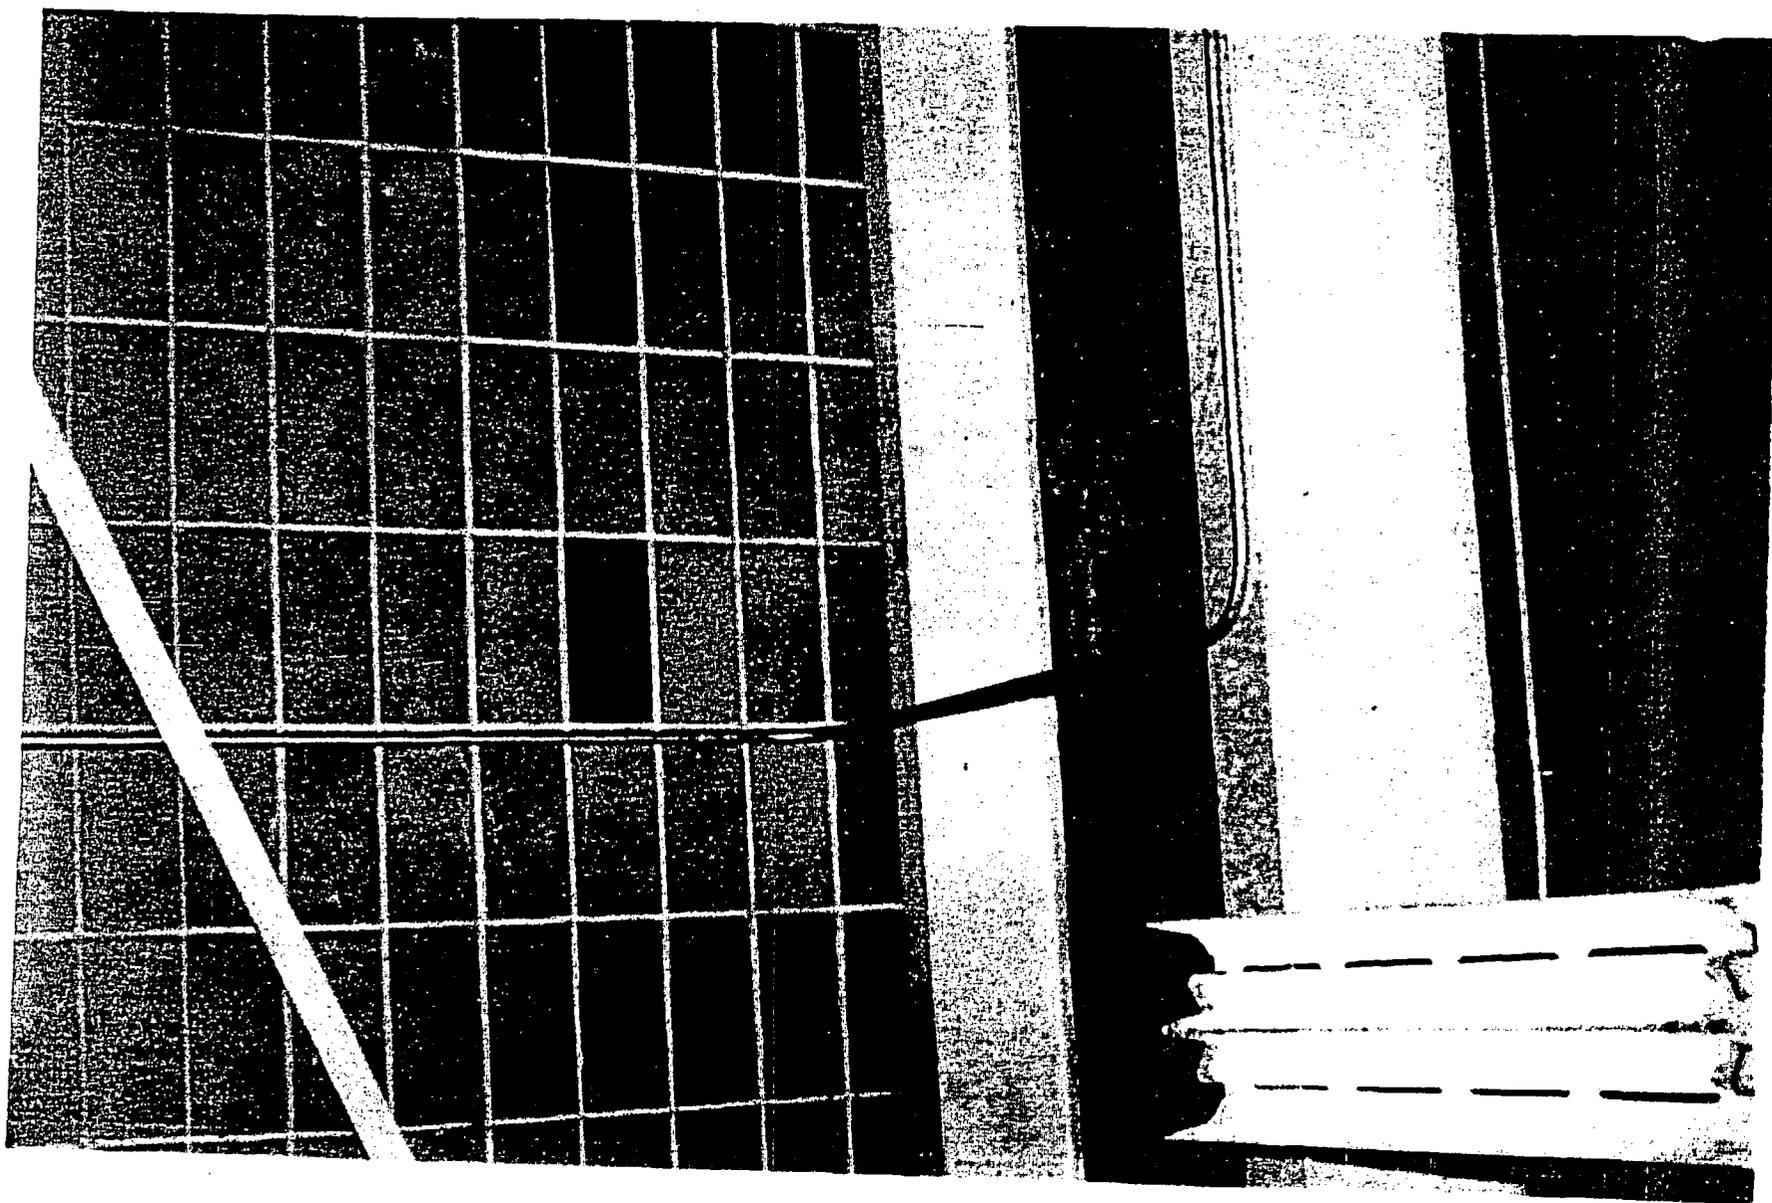
20. Ceiling of Third Floor Tower Room - This picture shows the fluorescent light fixture and ceiling of the third floor tower room. Uranium solution, plus some uranium precipitate, was expelled from the tank with sufficient force to splash it on the ceiling and light fixture. The ceiling is about 13-1/2' above the floor level.

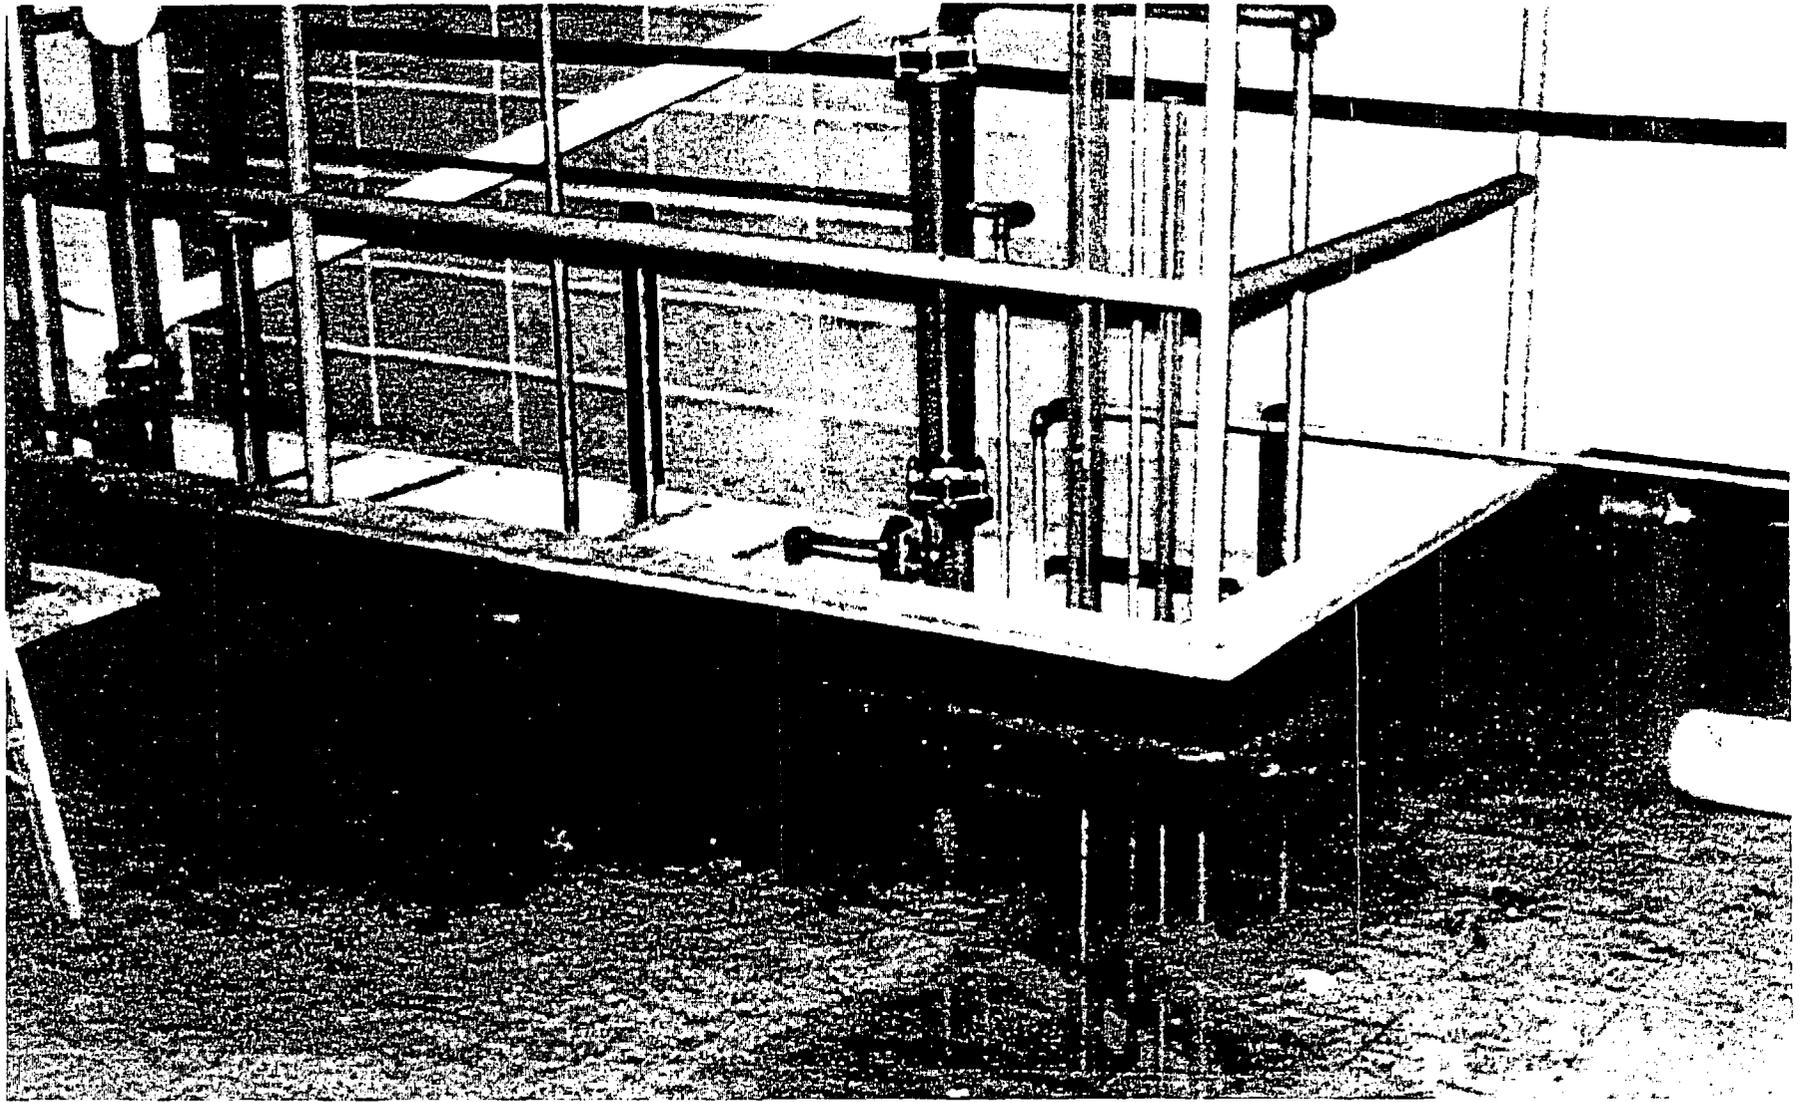
21. Solution on the Third Level Floor of the Tower Room - This picture taken on the third floor level of the tower room, shows part of the uranium solution that was expelled from the sodium carbonate tank. The solution had collected in a low spot of the tower room floor. The 11 liter bottle at the right edge of the picture is the same bottle shown in picture 18.

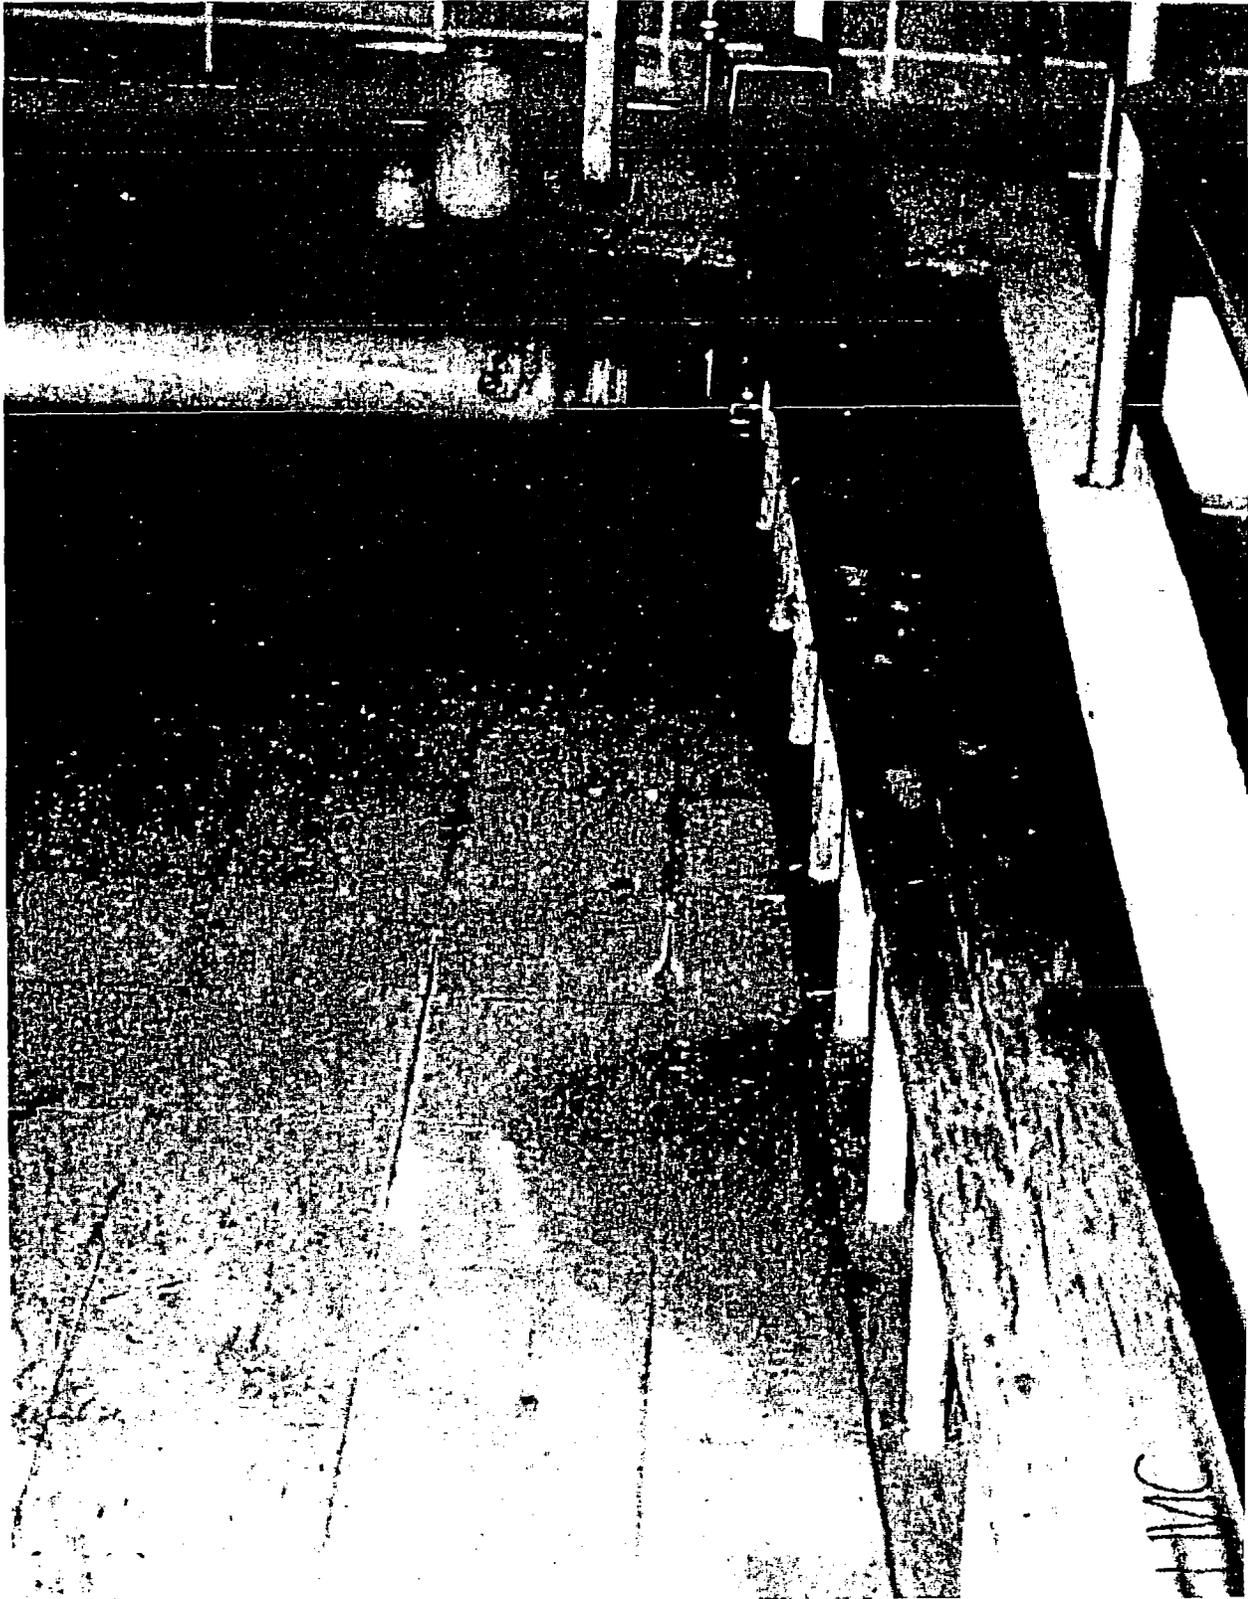
22. Solution on the Third Level Floor of the Tower Room - This picture shows the rest of the uranium solution (picture 21) that was found on the third level tower room floor. The 11 liter bottle at the top of the picture is the same bottle shown in picture 18.

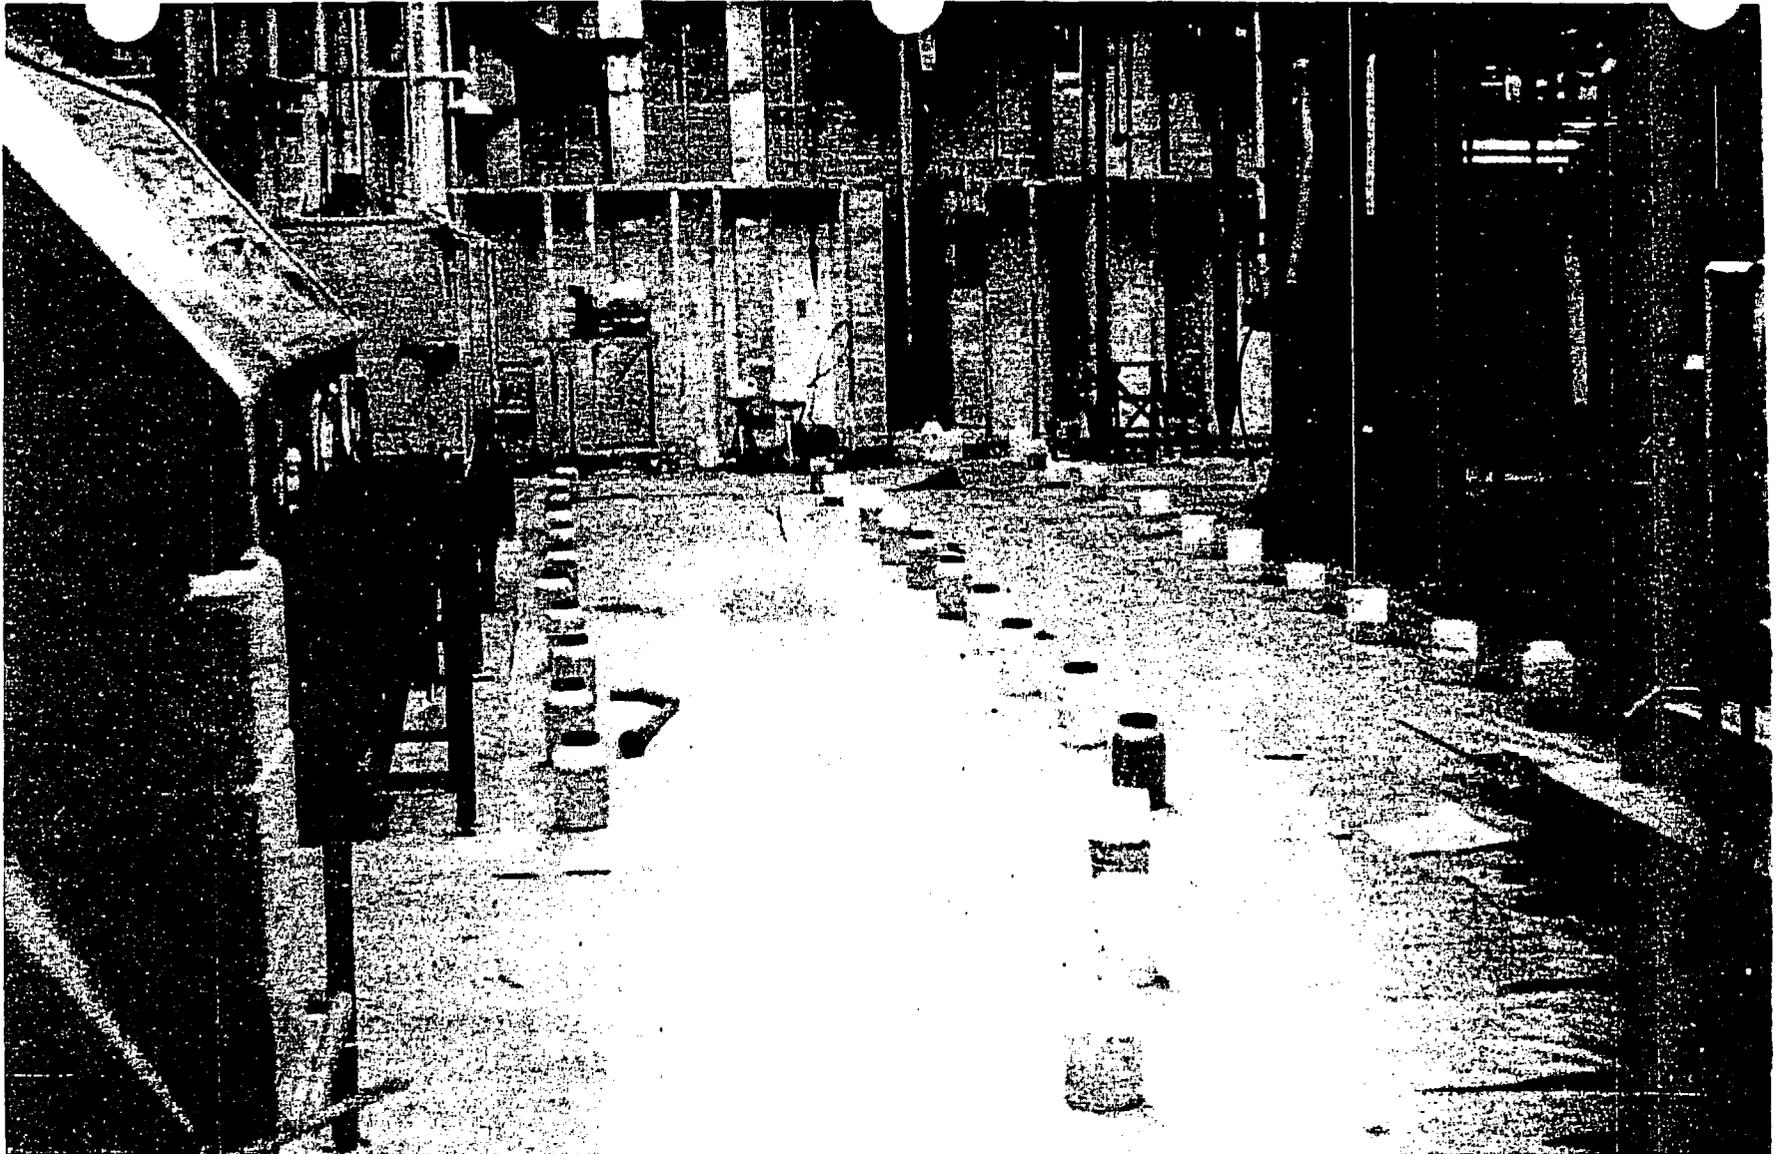
23. First Floor Process Area, Central Section - This picture was taken after decontamination work had been started and shows the area between the stainless steel dissolver (right) and the process hoods (left). The one gallon bottles on the floor contain both concentrated (up to 40 g/l) and low concentration (less than 5 g/l), uranium solutions from the decontamination effort. The tall hoods at the far (east) end of the area do not contain any process equipment as yet.

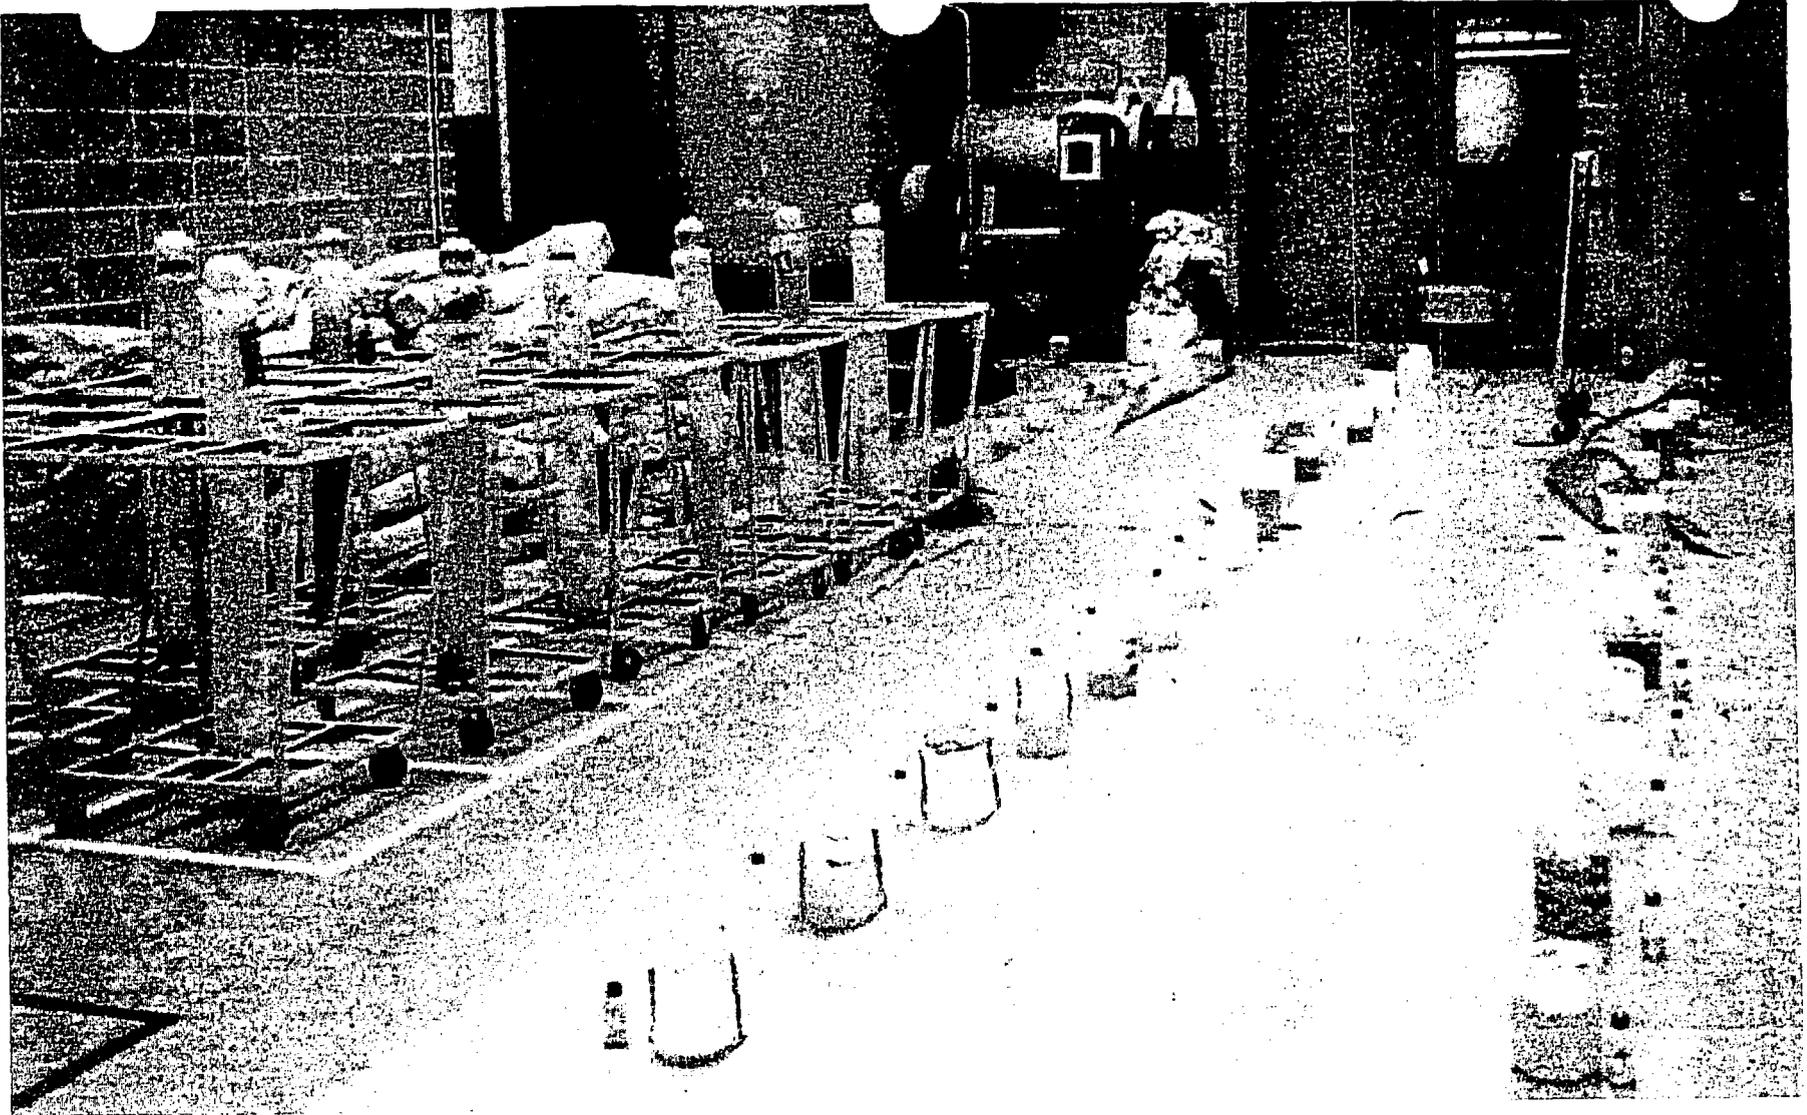
24. First Floor Process Area, North Section - This picture was taken after decontamination work had been started and shows the area north of the process hoods. The large tank in the top center of the picture (along the north wall) is the extractor feed tank (1-D-41) and east of it is the incinerator. Behind the partially open sliding door is the pickle liquor receiving area and the waste neutralization tanks. The one gallon bottles on the floor contain solutions that are primarily low concentration (less than 5 g/l) uranium solutions from the decontamination effort.
