REVISION	DATE	DESCRIPTION
FIGURE 5 GEOLOGIC CROSS SECTIONS A-A' B-B' AND C-C' REMEDIAL ASSESSMENT FANSTEEL, INC. MUSKOGEE, OKLAHOMA		
PREPARED FOR KIRKPATRICK & LOCKHART PITTSBURGH, PENNSYLVANIA		
APPROVED	JWH 12/27/93	
CHECKED	JWK/050483	
DRAWN	JWK/050483	
DRAWING NUMBER		
0111-E435

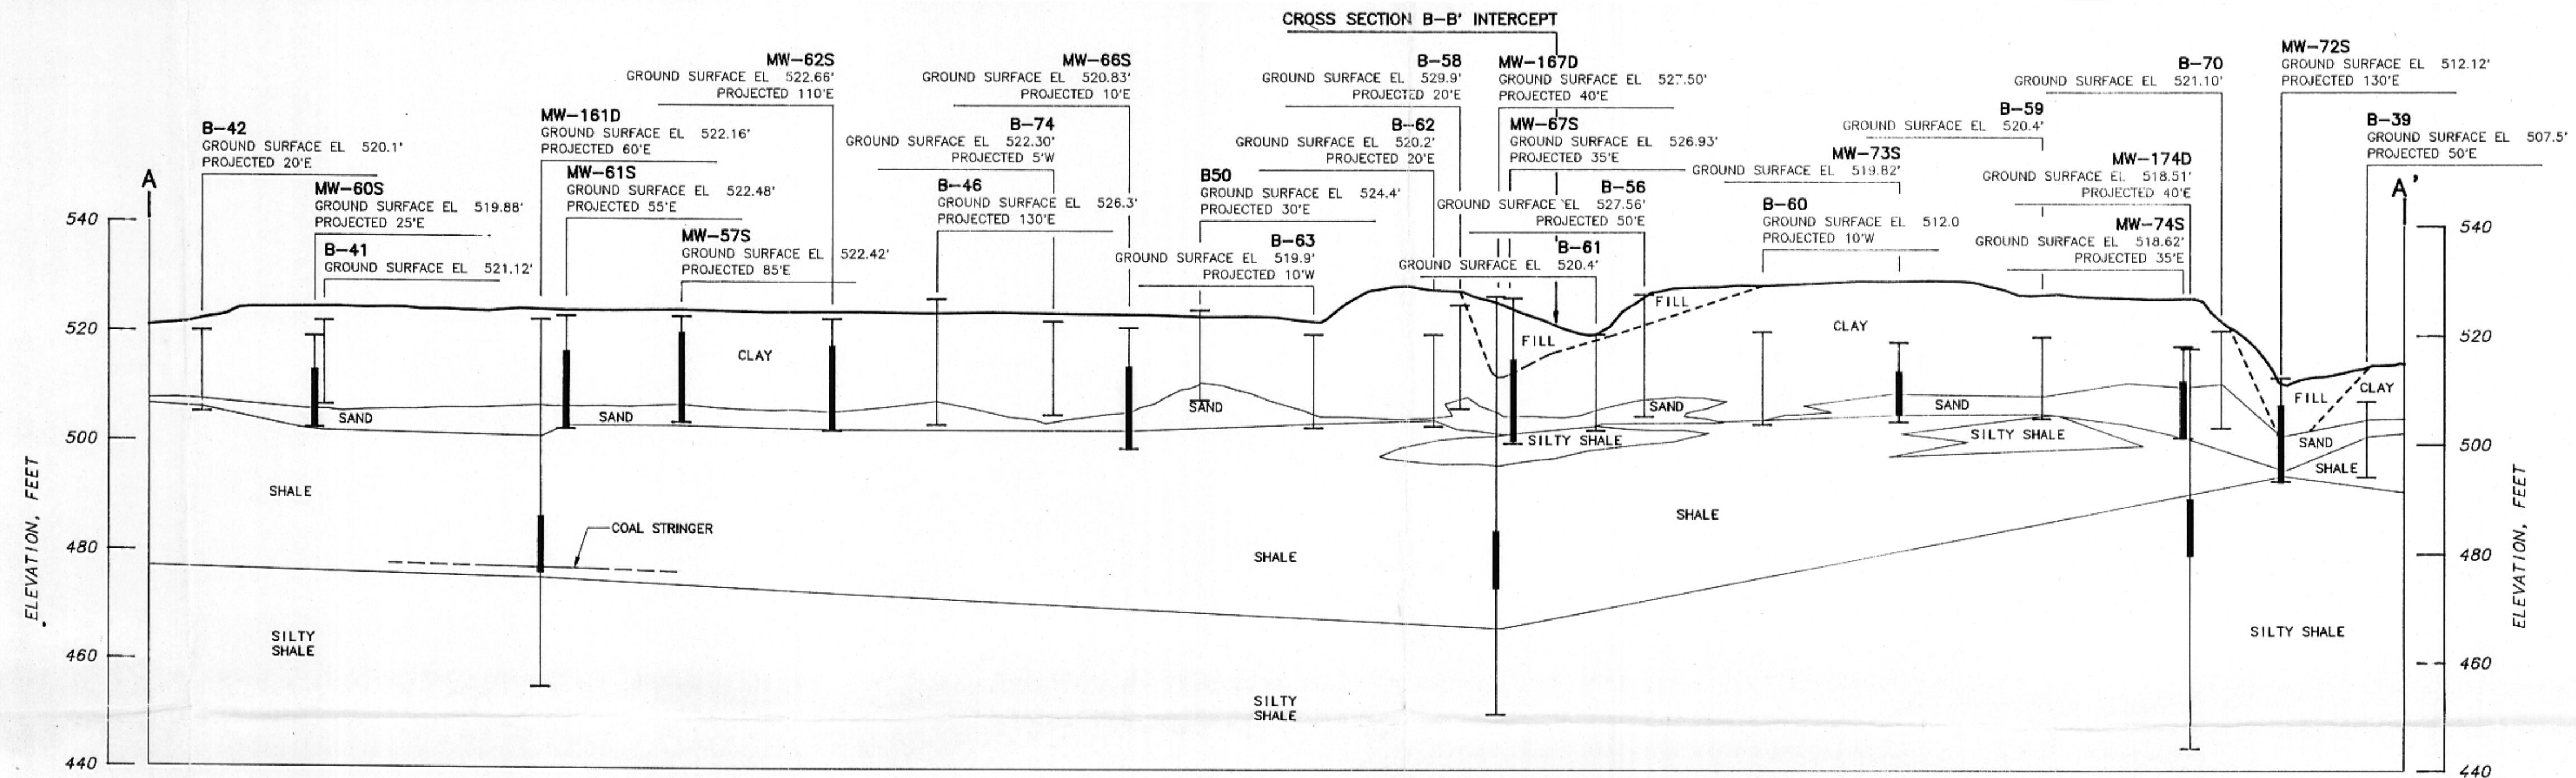
GEOLOGIC CROSS SECTION A-A'
(LOOKING WEST)

THESE CROSS SECTIONS DEPICT GEOLOGIC CONDITIONS AT SPECIFIC LOCATIONS SHOWN BASED UPON OBSERVATIONS OF MATERIALS ENCOUNTERED. GEOLOGIC STRATA AT OTHER LOCATIONS MAY DIFFER FROM CONDITIONS OCCURRING AT THESE SITES.
