Characterization Report for Vacuum Breaker 1 and Ditch East of Switchyard

Characterization Report for Vacuum Breaker 7

BASEMAP OF VB-7

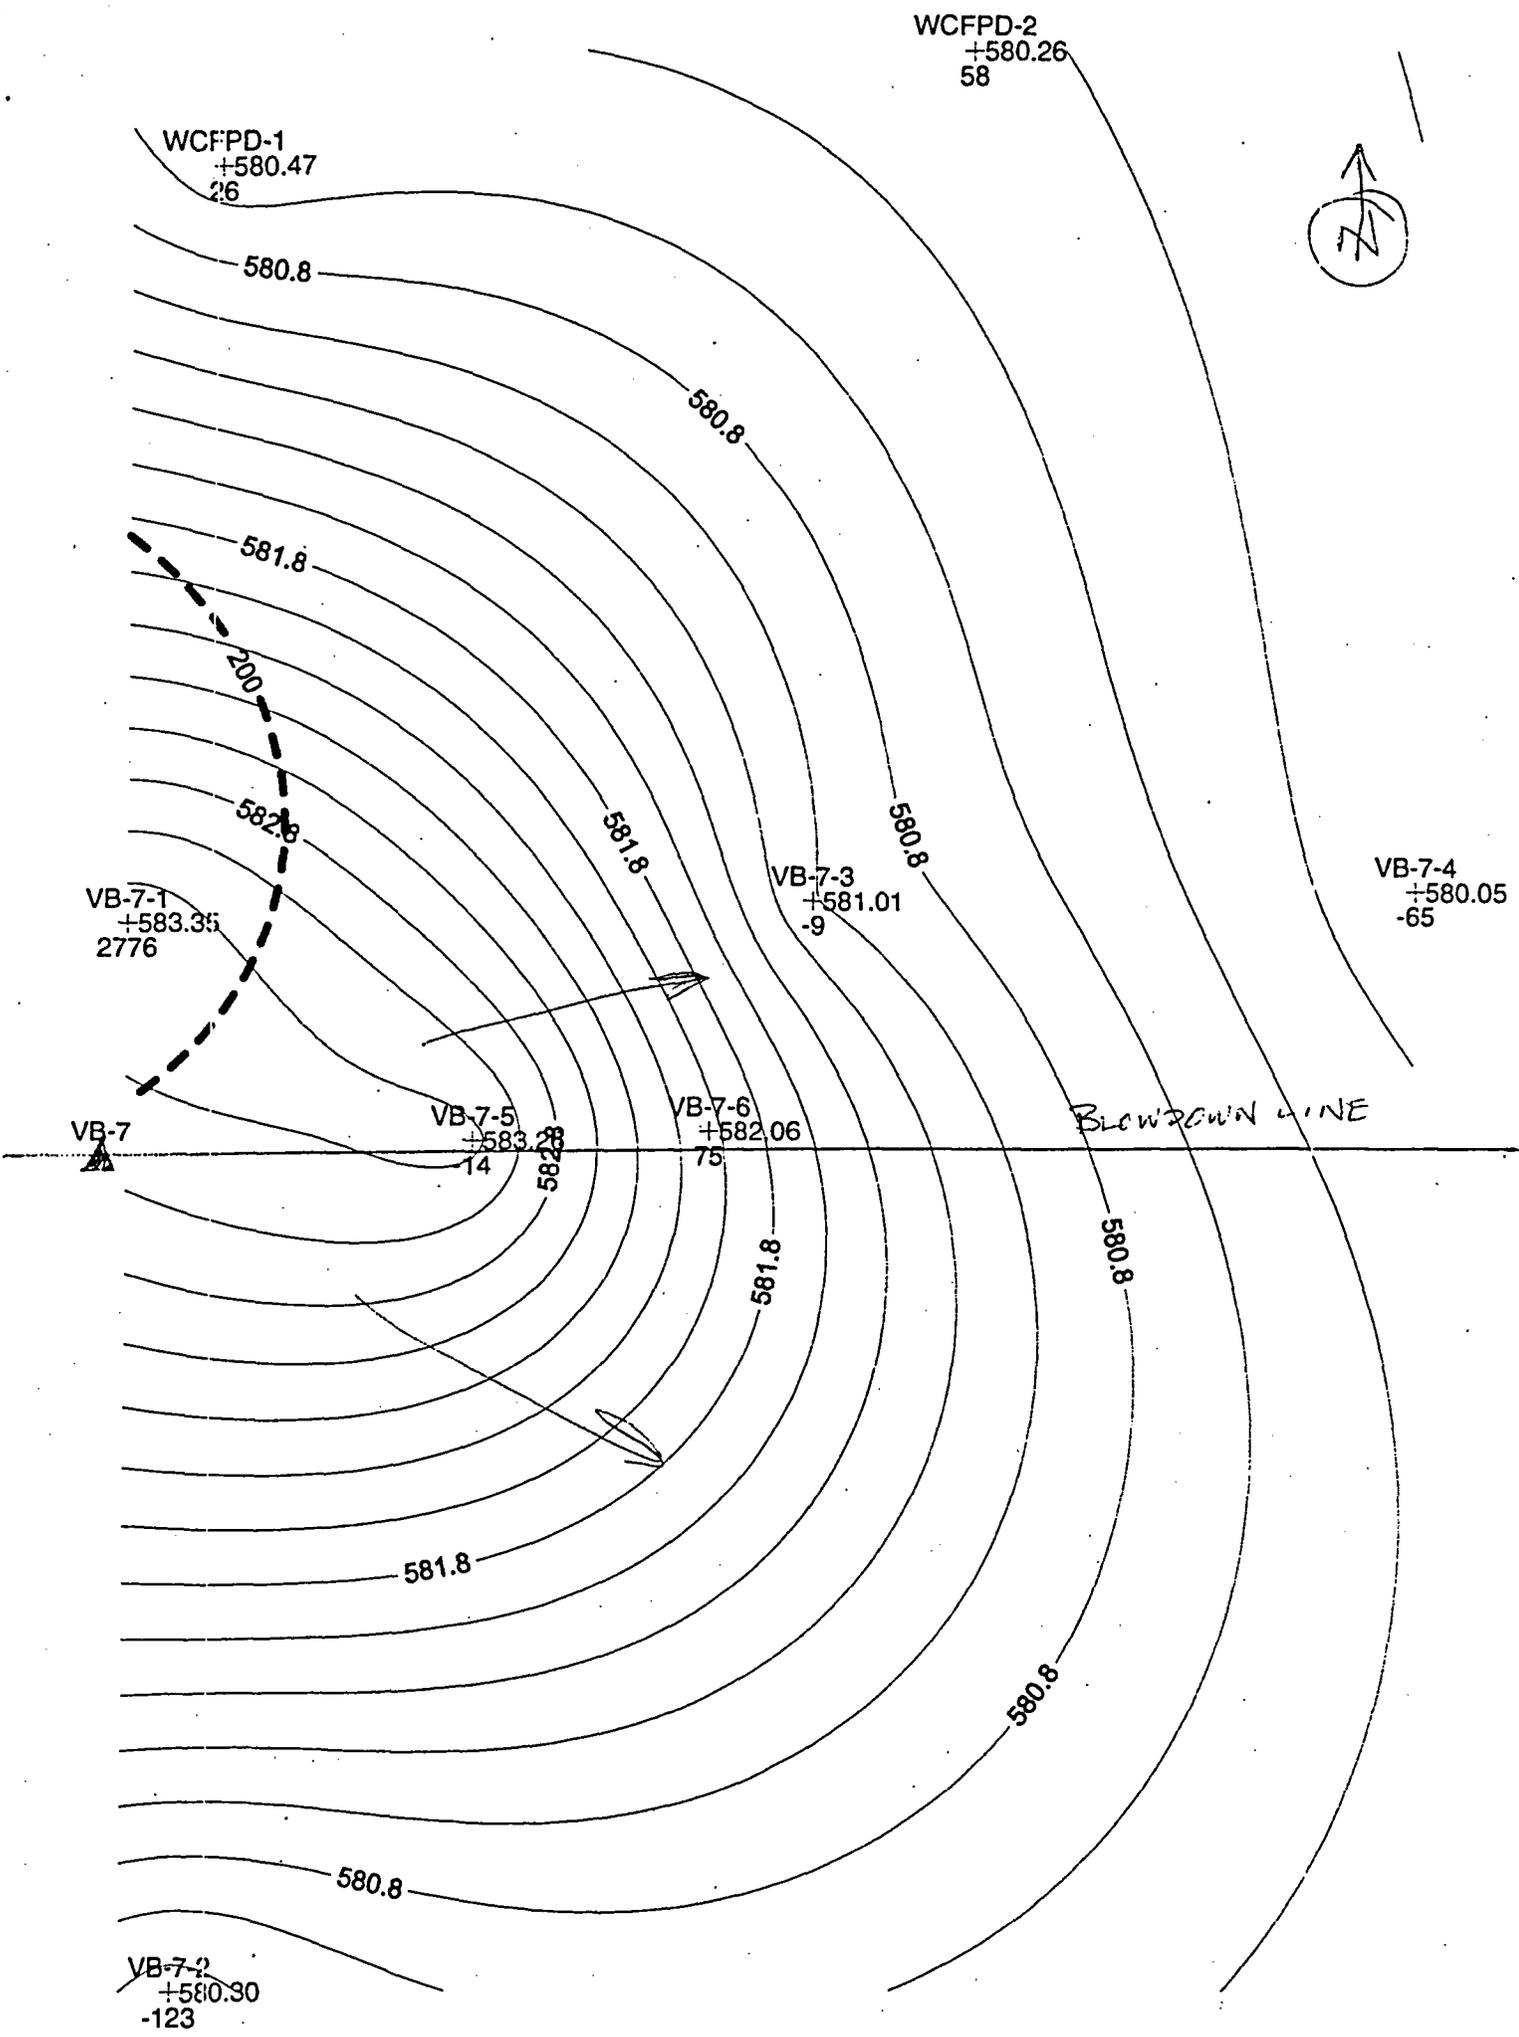
Vacuum breaker 7 on the blowdown line is located about 875 yards east of Essex road and 450 yards north of Smiley road on transmission tower right-of-way. This land is leased to a local resident for agriculture. Directly north of the right-of-way is property owned by the Will County Forrest Preserve District.

Hydraulic gradient lines are plotted on CRA figure Z. The ground water flow in the area of vacuum breaker 7 is northeast. CRA has determined that groundwater flow on site is 50 to 100 feet per year. Assuming this to be the same at vacuum breaker 7, water spilled at vacuum breaker 7 would be expected to flow northeast.

Again, CRA figure Z contains sample locations. Sample wells were drilled either to a depth of 15 feet or 25 feet in the down gradient direction from vacuum breaker 7. Additional sample wells were drilled to determine the extent of the expected plume. The samples and wells drilled to characterize a plume from vacuum breaker 7 were given identifiers of the form: VB7-X where X is a sequential number. The team placed wells on the expected streamline emanating from the vacuum breaker. Only one of these wells, a shallow one drilled 40' directly north of the vacuum breaker, yielded any significant tritium concentration. Well VB7-1 has about 2500 pCi/L.

Characterizing the plume with one data point presents a challenge to the accuracy. Since none of the deep wells had elevated tritium, the plume seems confined to the shallow groundwater. Also, there was no elevated tritium detected at VB7-3 which is located about 130' east of VB7-1 nor was there any tritium at WCFP-1, located 150' north of VB7-1. Therefore, it is reasonable to estimate the plume as being 120' long, 10' wide at the vacuum breaker, spreading to and remaining 50' wide at the property line, and 4' deep. The average concentration of plume is estimated at 1/3 the difference between the composite concentration of 41,600 and the concentration (2500) at the property line. For the part of the plume north of the property line, it is estimated at 1/3 the value (2500 pCi/L) at the property line. For sandy soils, the soil is estimated to contain 20% water. This yields a total tritium inventory of 2,682,000,000 picocuries.
