figure  
TRITIUM CONTOURS  
NOVEMBER 2005  
BRAIDWOOD STATION  
Braceville, Illinois

figure 1  
 SITE PLAN  
 AND WELL LOCATIONS  
 BRAIDWOOD STATION  
 Braceville, Illinois

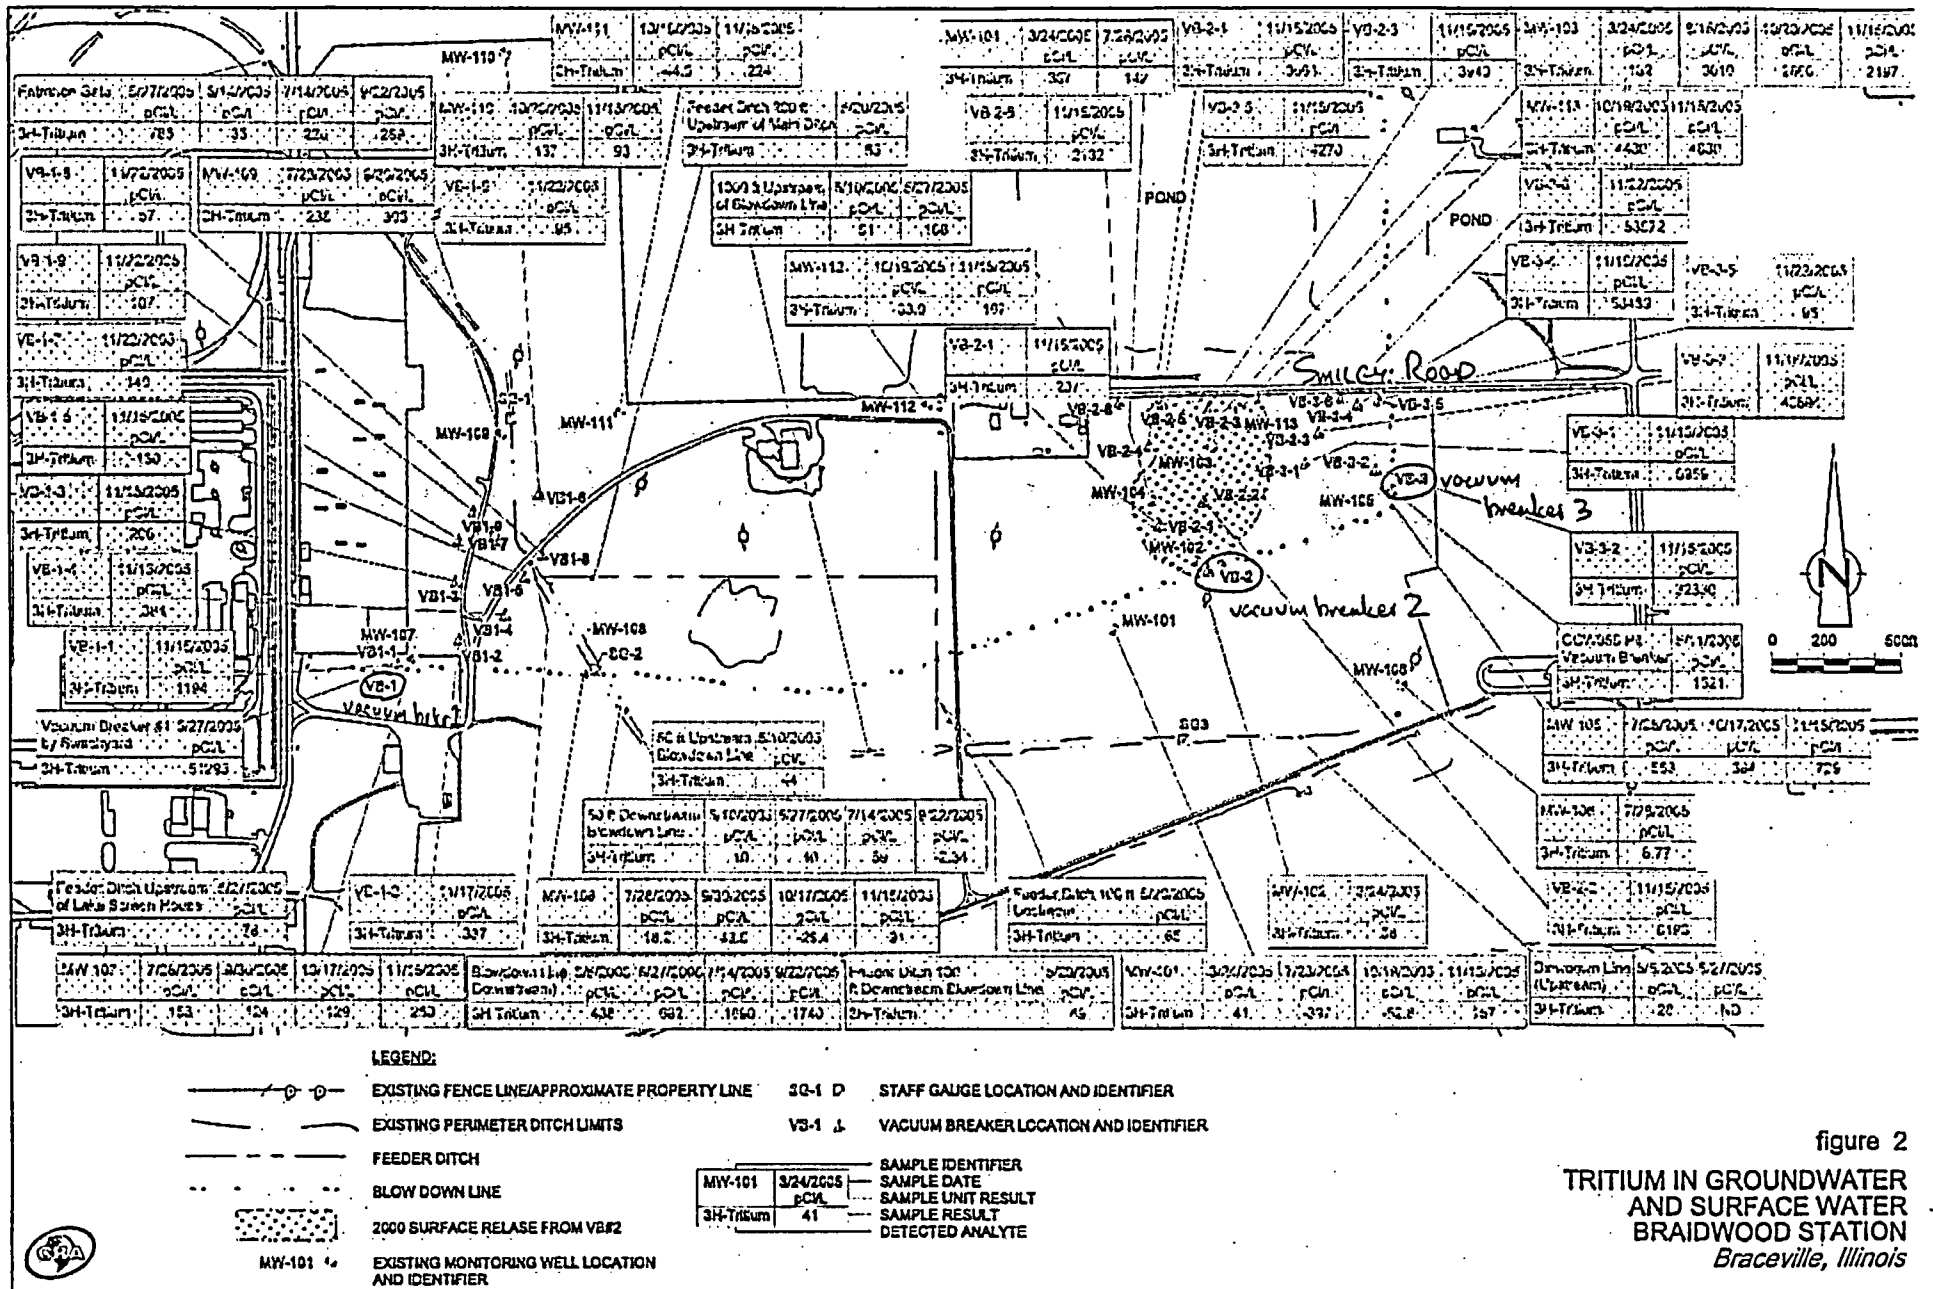
figure 2  
**TRITIUM IN GROUNDWATER  
 AND SURFACE WATER  
 BRAIDWOOD STATION**  
*Braceville, Illinois*

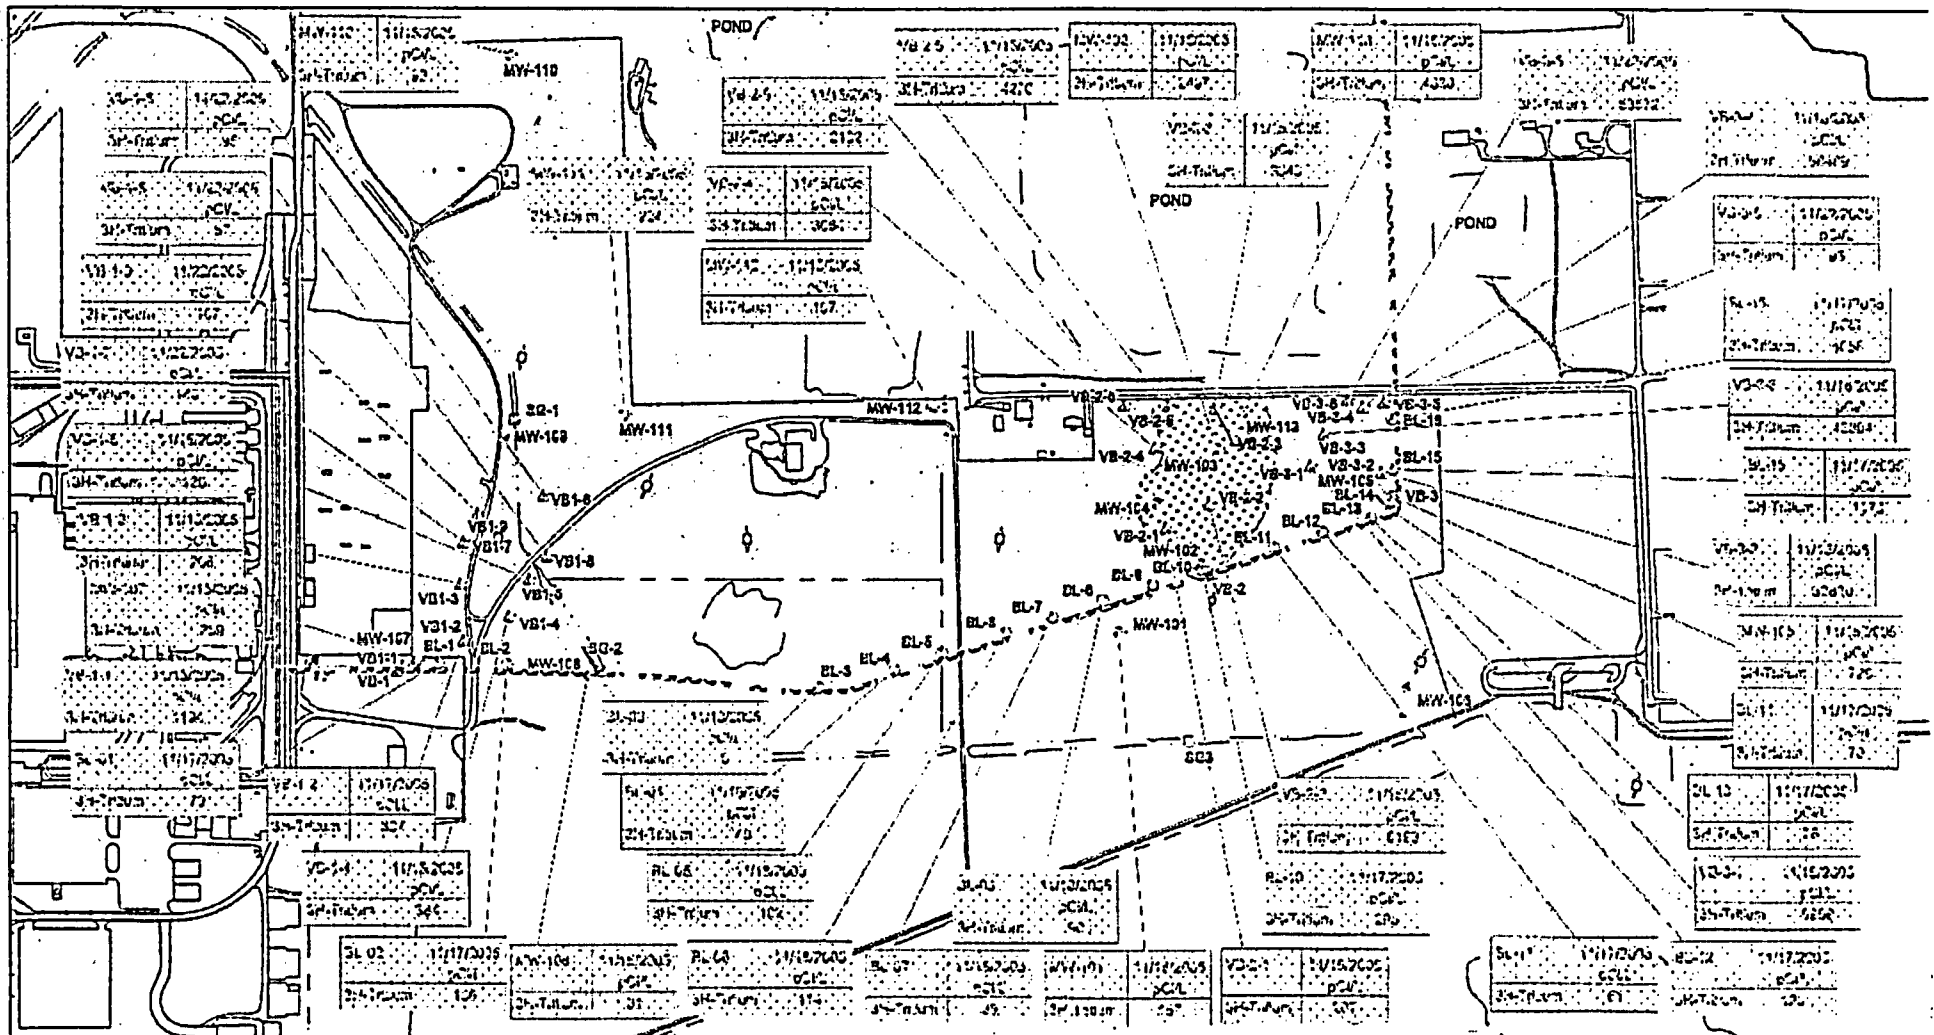
figure 3  
**TRITIUM IN GROUNDWATER**  
**NOVEMBER 2005**  
**BRAIDWOOD STATION**  
*Braceville, Illinois*
