Hydrological and Geological Features Contributing to a Seepage Event at Yucca Mountain

Paper Number H43A-03

2006 American Geophysical Union Annual Spring Meeting,

The occurrence of an unusual seepage event in the Exploratory Studies Facility (ESF) tunnel at Yucca Mountain (YM) in 2005 provides an opportunity to further understand the hydrological system associated with flow in fractured rocks and seepage into tunnels.

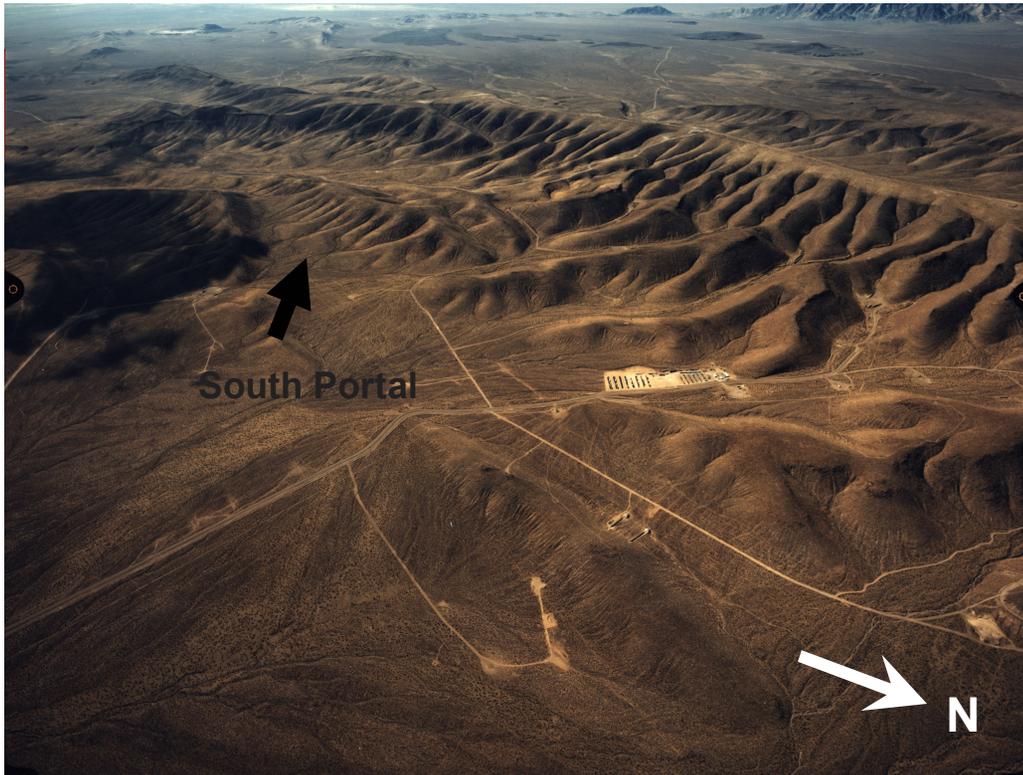
Figure 1. Photograph of east flank of YM looking southwest. Arrow indicates approximate location of south portal of ESF. Note the photograph was taken prior to construction of the ESF.

Yucca Mountain (Figure 1)

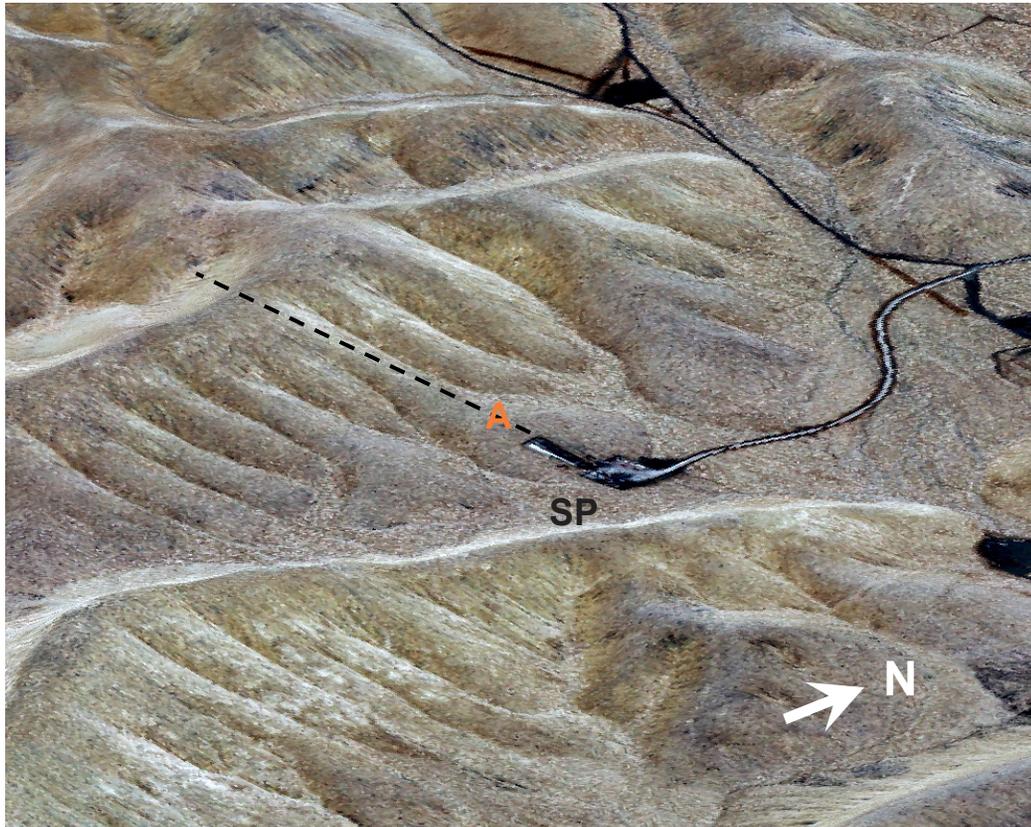
Figure 7. Location of South Portal (SP) and projected trace of ESF. The trace was only projected to top of the north-trending ridge; note that the tunnel continues to the west. Dirt roads and cleared areas have been photo-adjusted to be dark.

The geographic features at the ground surface above the seepage location are shown in Figures 7, 8, and 9. The trace of the south ramp of the ESF tunnel follows the top of a small, eastward-trending ridge top that terminates to the west at a north-trending ridge. An observation from Figures 7, 8, and 9 is that it appears there is only a small catchment area providing runoff to the seepage location; i.e., there is no local depression.

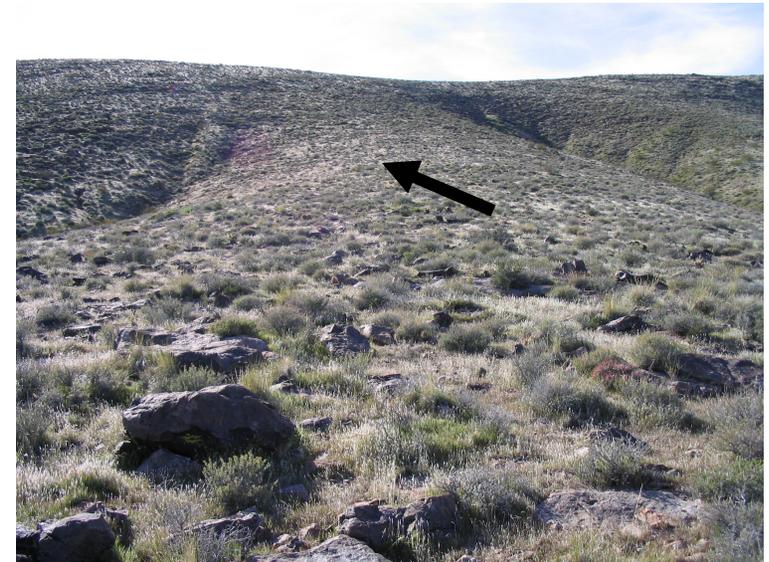
Figure 8. Photograph looking westward up the ridge from point A on Figure 6. Arrow points to approximate projected location of seepage in tunnel. At point of arrow, approximate distance between bottoms of washes is 90 m.
