Braidwood Unit 1  
Pressurizer Heater # 52  
Tube Leakage

Exelon/NRC Teleconference

May 31, 2006

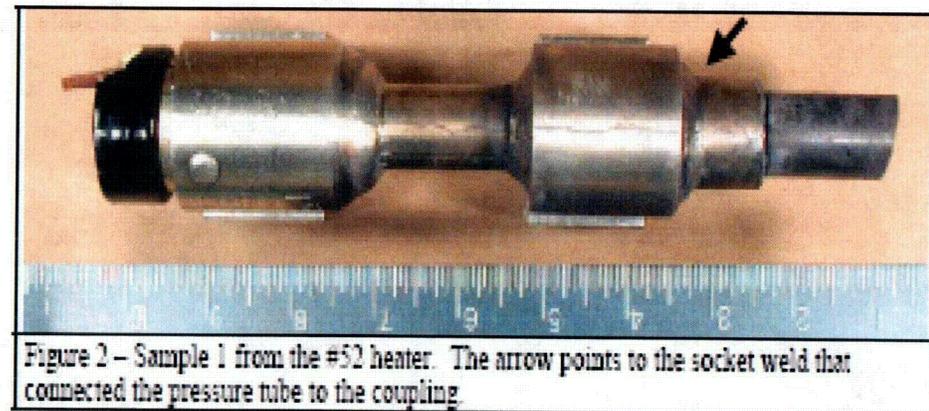
Figure 2 – Sample 1 from the #52 heater. The arrow points to the socket weld that connected the pressure tube to the coupling.
