SUBJECT: STAFF OBSERVATIONS OF TESTING FOR GENERIC SAFETY  
ISSUE 191 DURING APRIL 28, 2006, TRIP TO THE ALION  
HYDRAULICS LABORATORY

On April 28, 2006, the NRC staff traveled to the Alion Hydraulics Laboratory in Warrenville, Illinois, to observe generic testing associated with the resolution of Generic Safety Issue 191 (GSI-191). The objectives of the trip were to observe in-progress large-tank qualification testing of a modular strainer array simulating the proposed top-hat replacement suction strainer design for San Onofre Nuclear Generating Station (SONGS) and to familiarize NRC staff with Alion's testing capabilities. The trip was coordinated with a separate staff visit to Fauske & Associates (ADAMS Accession ML061720472) to observe work sponsored by industry to identify a replacement buffering agent for use in pressurized water reactor containment pools. The staff was informed before the trip that the SONGS testing had been delayed. However the staff continued with plans to visit the Alion Hydraulics Laboratory to observe preparations for the SONGS test and also to observe other test activities underway at the facility. The participating NRC staff members were Ralph Archit

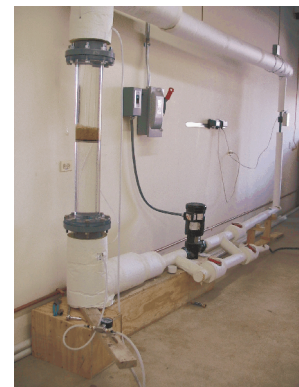
**Figure 2** Chemical Effects Loop

The vertical test loop that is intended to be used for chemical effects testing has a 16-gallon capacity, is compatible with a representative sump environment, and is capable of operating at up to a maximum temperature of 160°F (Figure 2). The laboratory had equipment for generating precipitates per the methodology outlined in WCAP 16530-NP, and loop testing was planned to evaluate the head loss effects of each precipitate. Alion personnel described their overall approach to plant-specific chemical effects evaluations. Debris bed type and thickness in the vertical head loss loop will be scaled for consistency with the full-scale testing. Head loss measured in the vertical test loop using plant-specific debris and plant specific environments (e.g., pH, temperature) will be used to develop a “bump-up” factor to be applied to existing large-scale array test results. Testing will be performed to compare head loss in representative containment pool environments with non-representative environments (e.g., deionized water).
