Localized Corrosion Initiation and Propagation Tests

Xihua (Shē-wǎ) He
*Center for Nuclear Waste Regulatory Analyses
Southwest Research Institute[®], San Antonio, Texas*

*NWTRB Workshop on Localized Corrosion
of Alloy 22 in Yucca Mt. Environments
Las Vegas, Nevada, September 25-26, 2006*

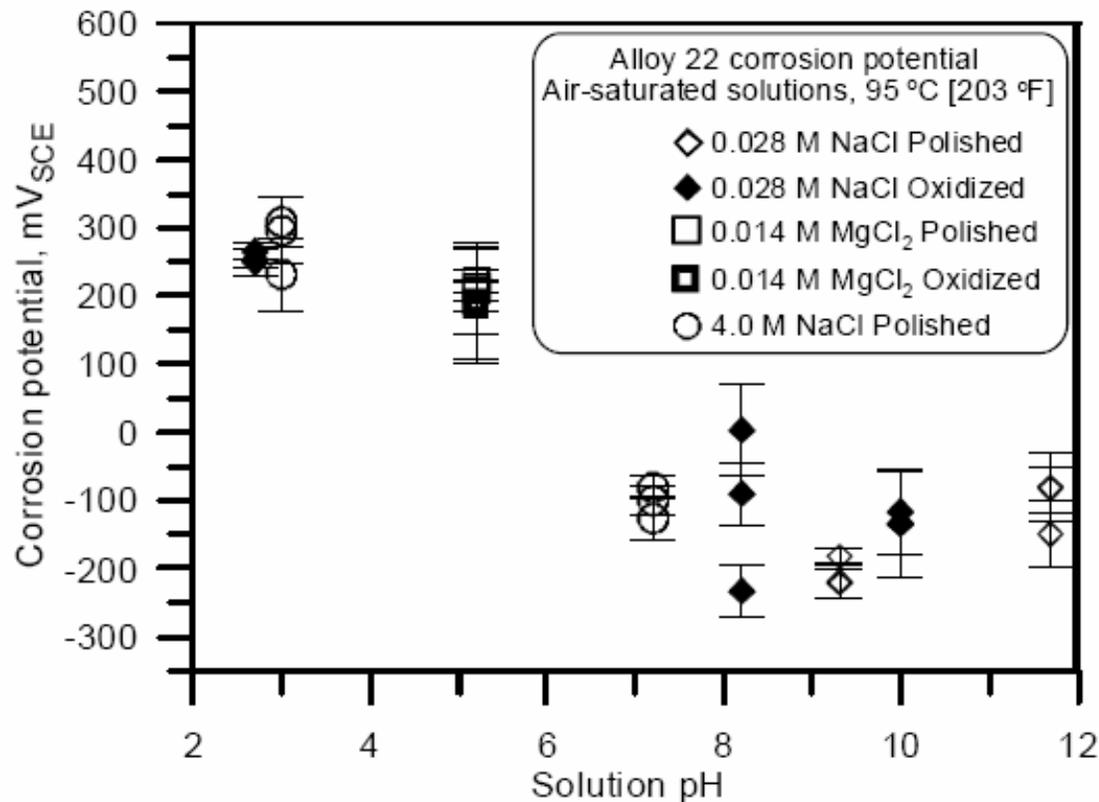
Localized Corrosion Initiation — Corrosion Potentials and pH

- E_{corr} in acidic condition was more than 300 mV greater than that in alkaline solutions

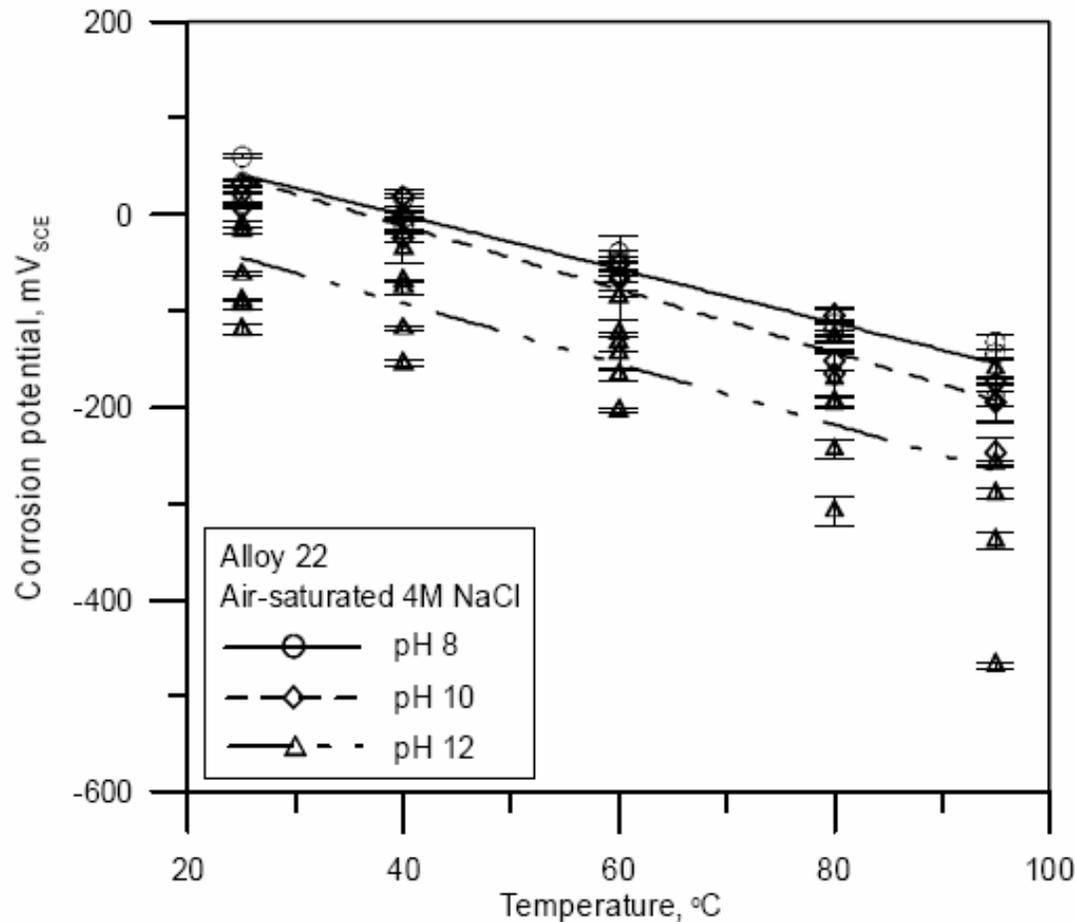
Corrosion Potentials and Temperature

- E_{corr} decreased with increasing temperature
- E_{corr} values at 25 °C were approximately 150 to 200 mV greater than the values at 95 °C

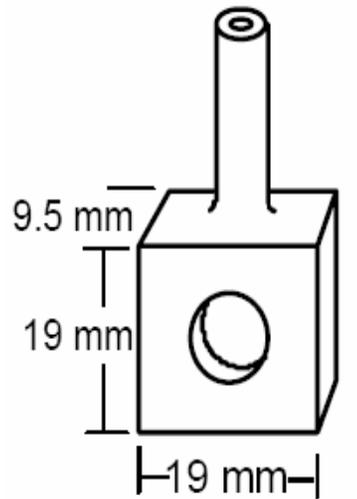
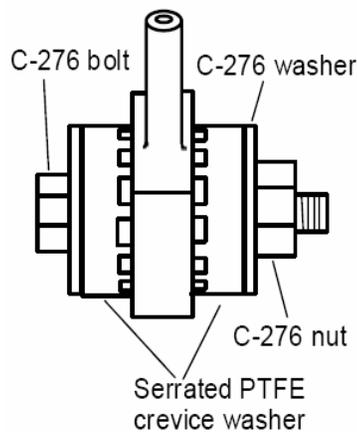
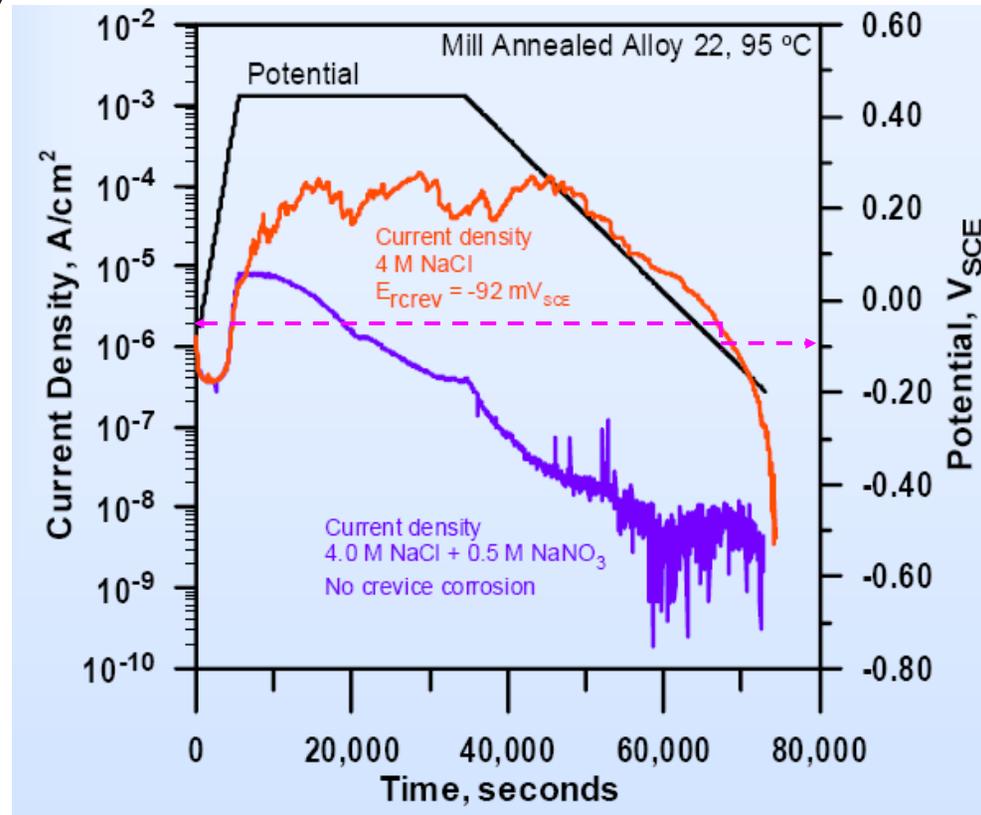
Multiple Crevice Assembly (ASTM G78)

Repassivation Potential Measurement Method

- Electrochemical tests used to measure repassivation potential for assessing crevice corrosion

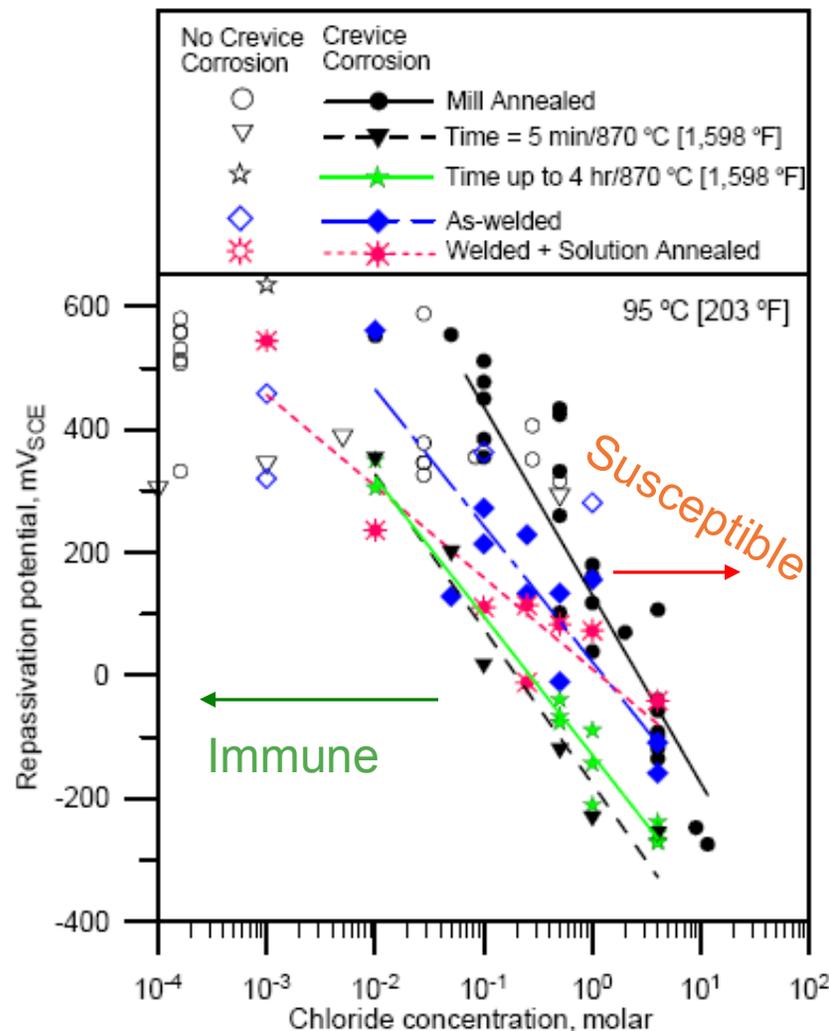
Repassivation Potentials and Effects of Fabrication Processes

- Repassivation potential used as critical potential for the long-term initiation of localized corrosion
- Crevice corrosion susceptibility increases with increasing chloride concentration
- Fabrication processes such as welding, postweld heat treatments, and thermal-aging increase crevice corrosion susceptibility

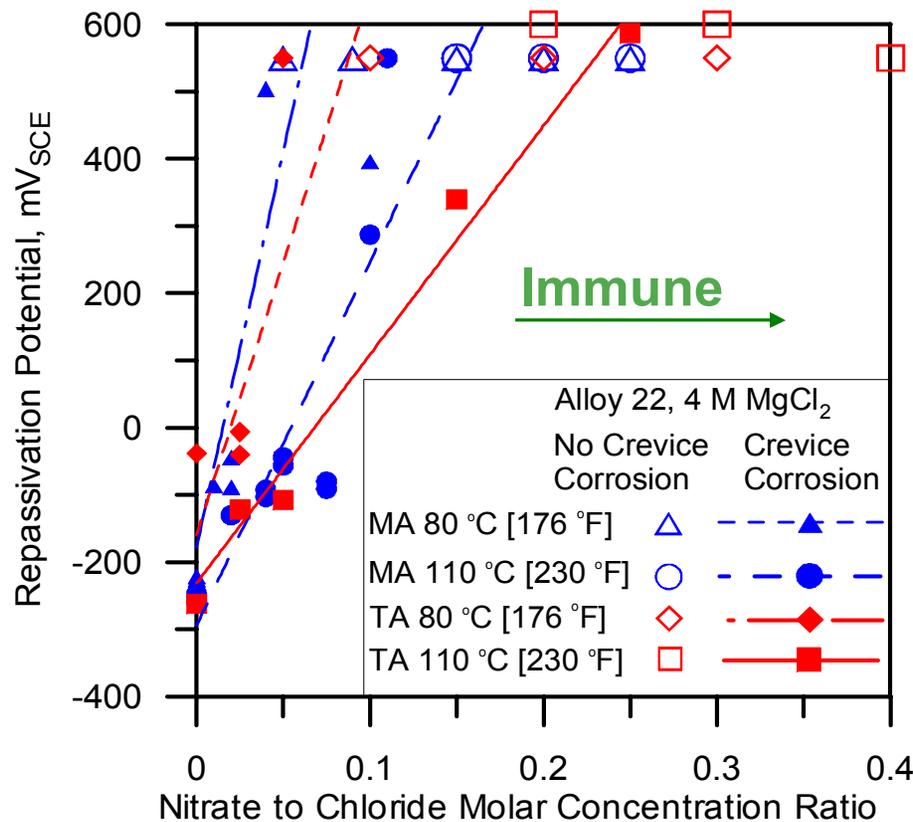
Repassivation Potentials and Nitrate to Chloride Concentration Ratios

At 110 °C

- [Nitrate]/[Chloride] > 0.1
no localized corrosion for mill-annealed
- [Nitrate]/[Chloride] > 0.3
no localized corrosion for thermally aged

At 80 °C

- [Nitrate]/[Chloride] > 0.1
no localized corrosion for mill-annealed
- [Nitrate]/[Chloride] > 0.1
no localized corrosion for thermally aged

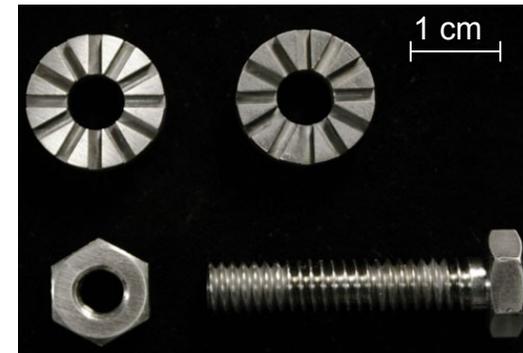
Serrated Crevice Washer, Bolt, and Nut

Protruding serrated plateaus

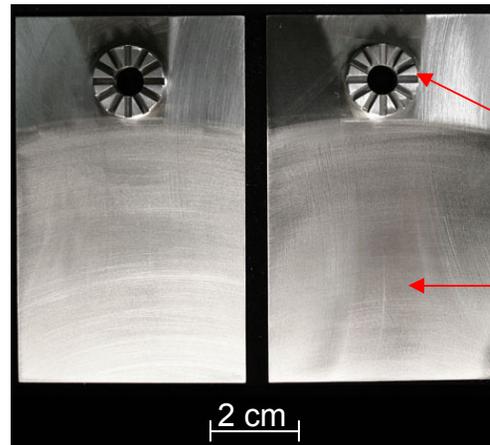
Large Titanium Grade 7 Washer

Flange to increase surface area

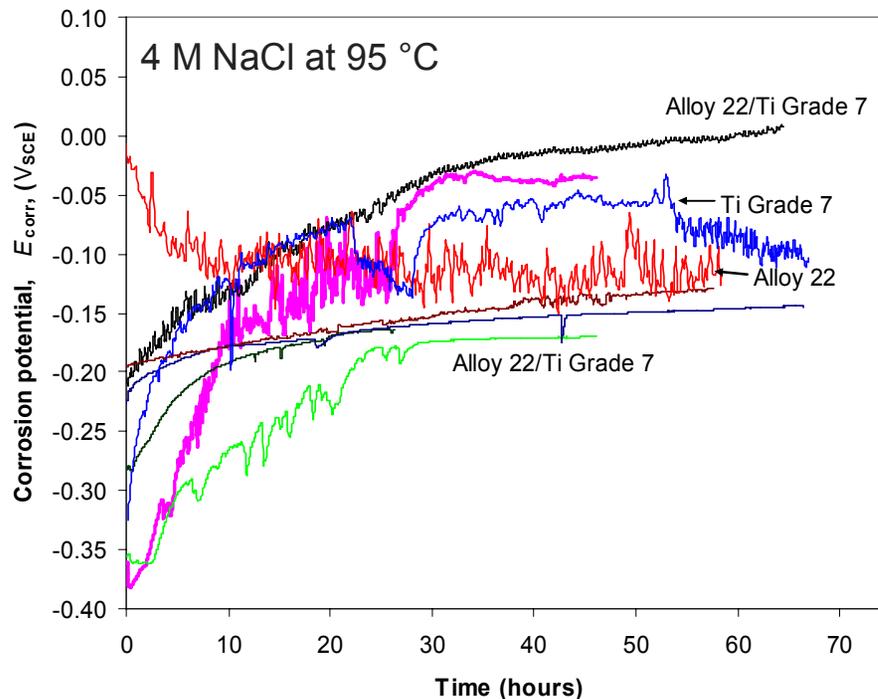
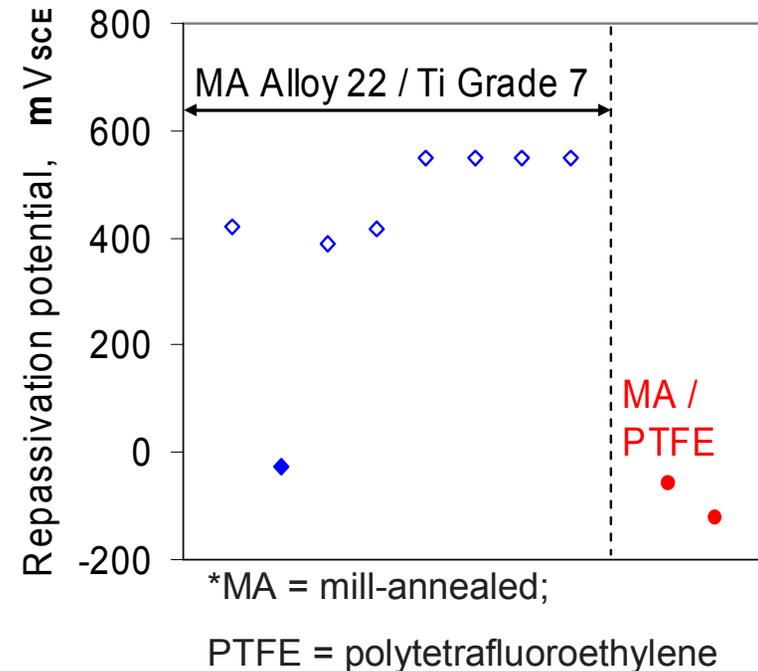
Corrosion of Alloy 22, Ti Grade 7, and Alloy 22-to-Ti Grade 7 Crevice Couples

- No effect of Alloy 22-to-Ti Grade 7 crevice couple on corrosion potential
- Alloy 22 crevice corrosion resistance was not degraded by forming crevices with Titanium Grade 7

- Crevice corrosion resistance was not degraded by dissimilar metal crevices

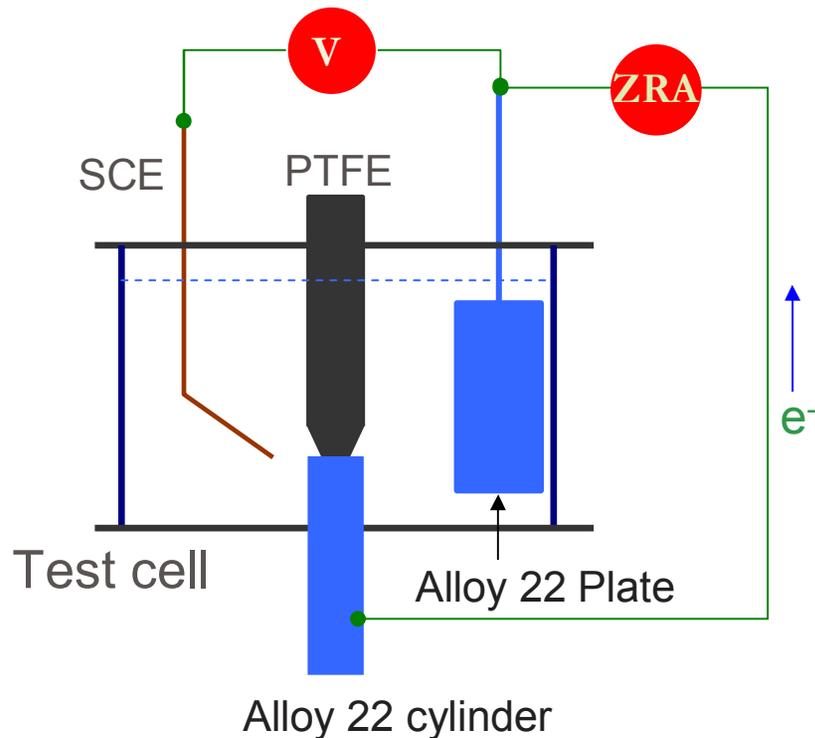
Single Crevice Assembly

- Solution: 5 M NaCl + 2×10^{-4} M CuCl₂
- Temperature: 95 °C
- Test time: 0.5 – 90 days

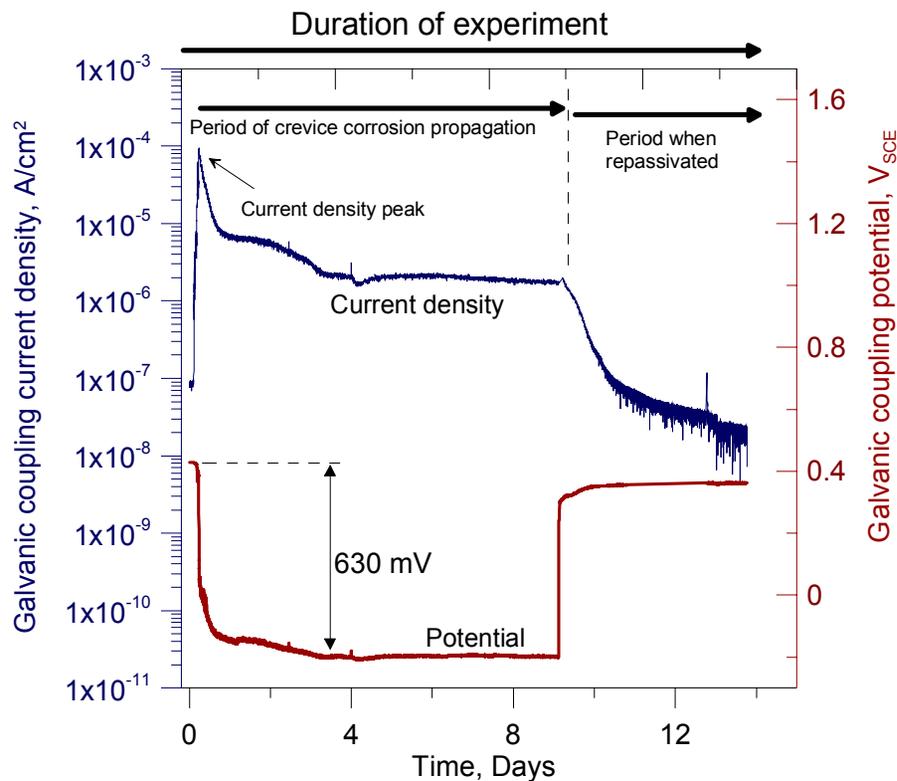
Initiation, propagation, and repassivation

- Strong stifling after initiation
- Arrest at 9 days and no re-initiation (Arrest refers to a stop in penetration, e.g. repassivation)

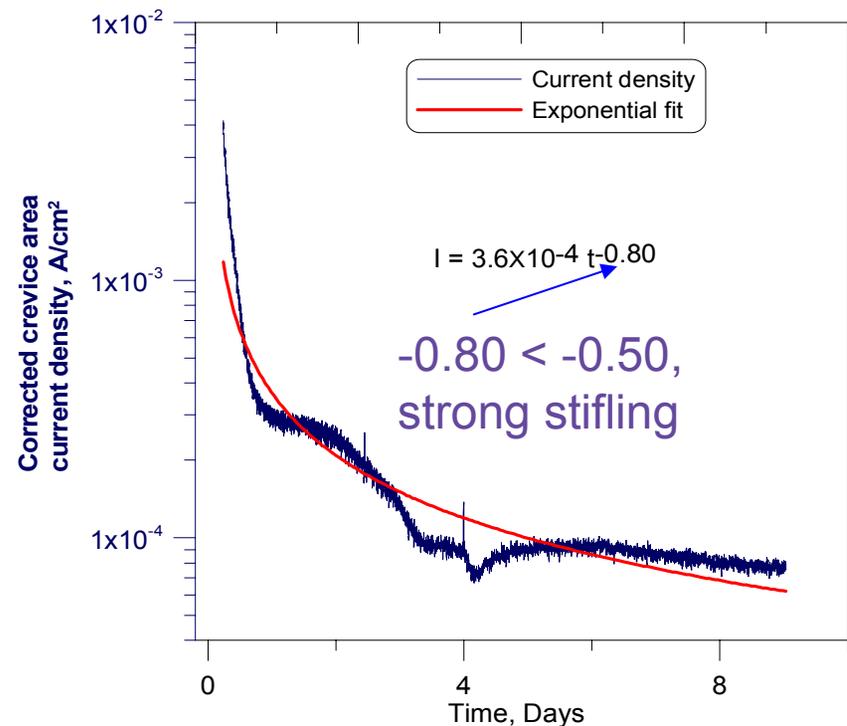
Current density decay

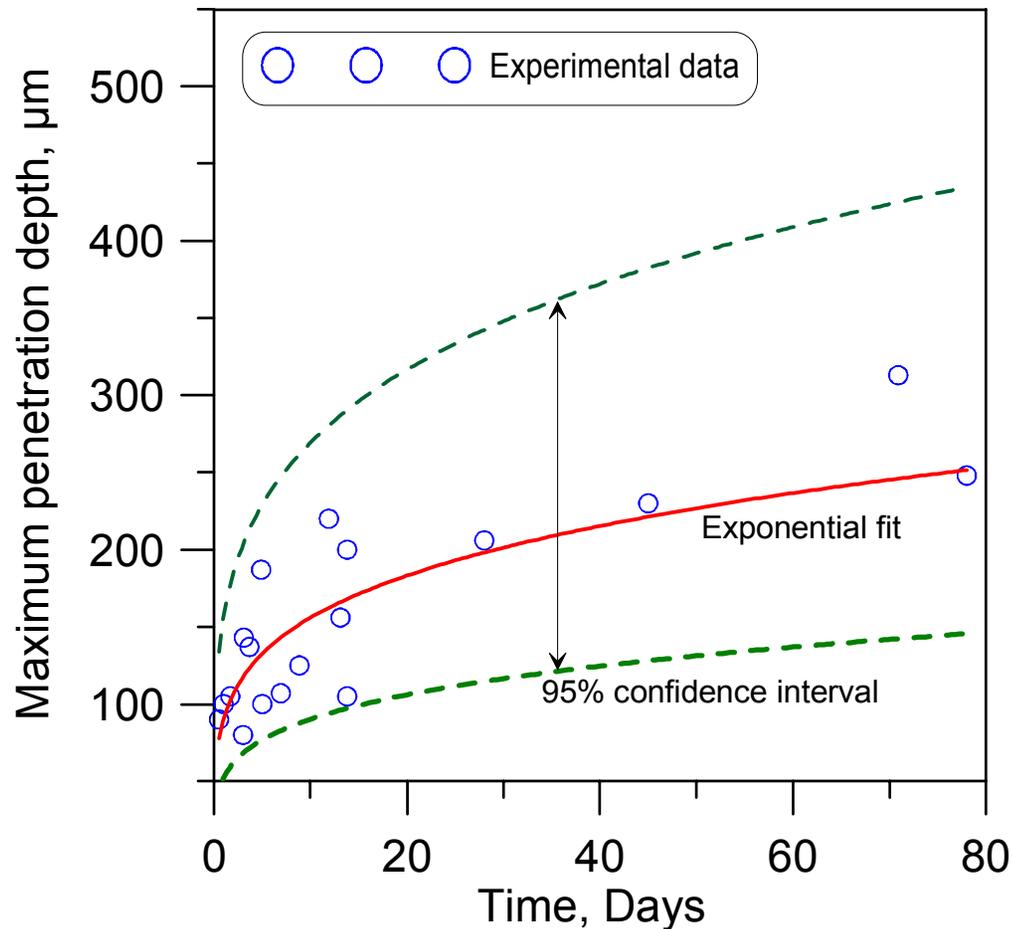
Crevice Corrosion Penetration Behavior

- Tests were conducted for specific time intervals

- Penetration depths were measured with an optical microscope

$$d_{\max} = 0.0912 t^{0.233}$$

- $0.233 < 0.5$, suggesting strong stifling tendency
