RE: St. Lucie Unit 2
Docket No. 50-389
120-day Post Outage Steam Generator Report
Technical Specification 4.4.5.5.c

Pursuant to Technical Specification 4.4.5.5.c and 6.9.2, attached is the SL2-16 120-day post outage steam generator special report for indications found in the tubesheet region (including the expansion transition) of the St. Lucie Unit 2 steam generators.

In accordance with Plant Technical Specification (TS) Section 4.4.5.5.c., this special report provides information concerning indications found in the tubesheet region (including the expansion transition) of the St. Lucie Unit 2 steam generators (SG).

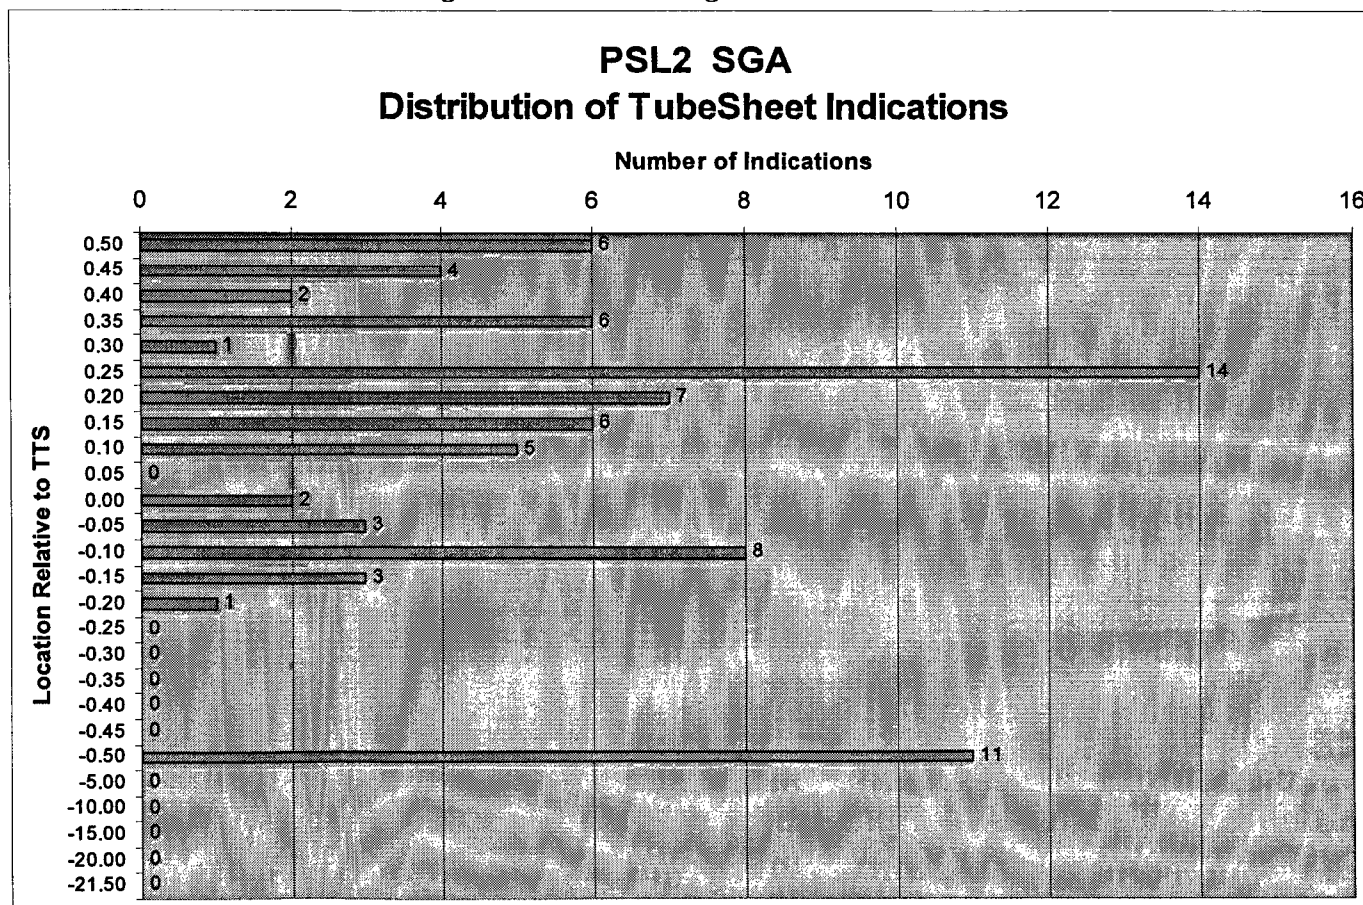
Figure 1 - SL2-8 through SL2-16

Figures 1 and 2 provide the cumulative number of indications detected in the tubesheet region as a function of elevation within the tubesheet for SG 2A and 2B respectively as required by TS 4.4.5.5.c.2. The period of time in which degradation has been experienced in the tubesheet region at St. Lucie Unit 2 extends from SL2-8 through SL2-16. The total cumulative indications found in the tubesheet region during this period is 79 in SG 2A and 92 in SG 2B.

(TTS – Top of Tubesheet)
