Enclosed is the diagram and closeout survey of the Cardiac Imaging and Stress Rooms, which were located on the 1st floor of Radiology. All values for ambient exposure rates and removable contamination were below levels permissible for Nonrestricted use. Please release these areas for unrestricted use.

POCONO MEDICAL CENTER
Close-out Survey Cardiac Imaging and Stress Testing Rooms

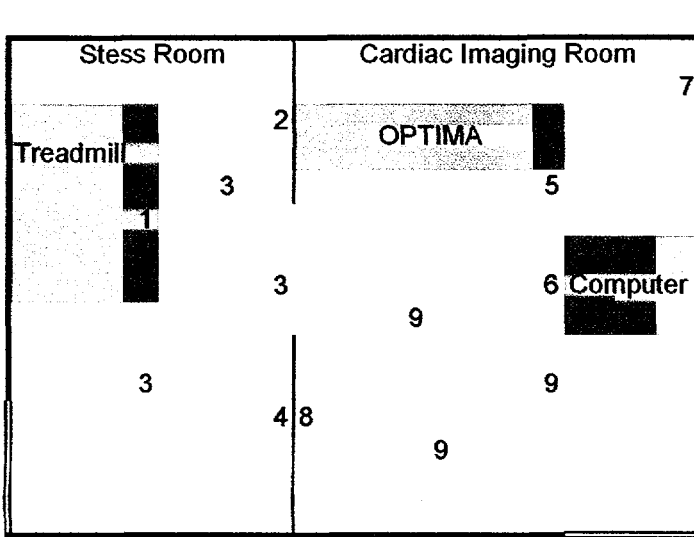
Location		mR/hr	cpm	dpm
1	Treadmill	0.02	582	0
2	Console	0.02	591	5
3	Floor	0.02	566	0
4	Sink	0.02	583	0
5	Camera Area	0.02	599	14
6	Desk Top	0.02	612	30
7	Counter Top	0.02	593	7
8	Counter Top	0.02	622	42
9	Floor	0.02	593	7
	Background	0.02	587

Radiology Main Hallway

Area Description
Optima Camera Area
Stress Mill and Room
