**SOURCE PRODUCTION AND EQUIPMENT CO., INC.**  
**113 Teal Street St. Rose. Louisiana 70087**

**CONSOLIDATED APPLICATION**  
**for**  
**NRC CERTIFICATE OF COMPLIANCE**  
**USA/9263/B(U)**

**Model SPEC-150**  
**Type B(U) Radioactive Material Package**  
**April 22, 1999**

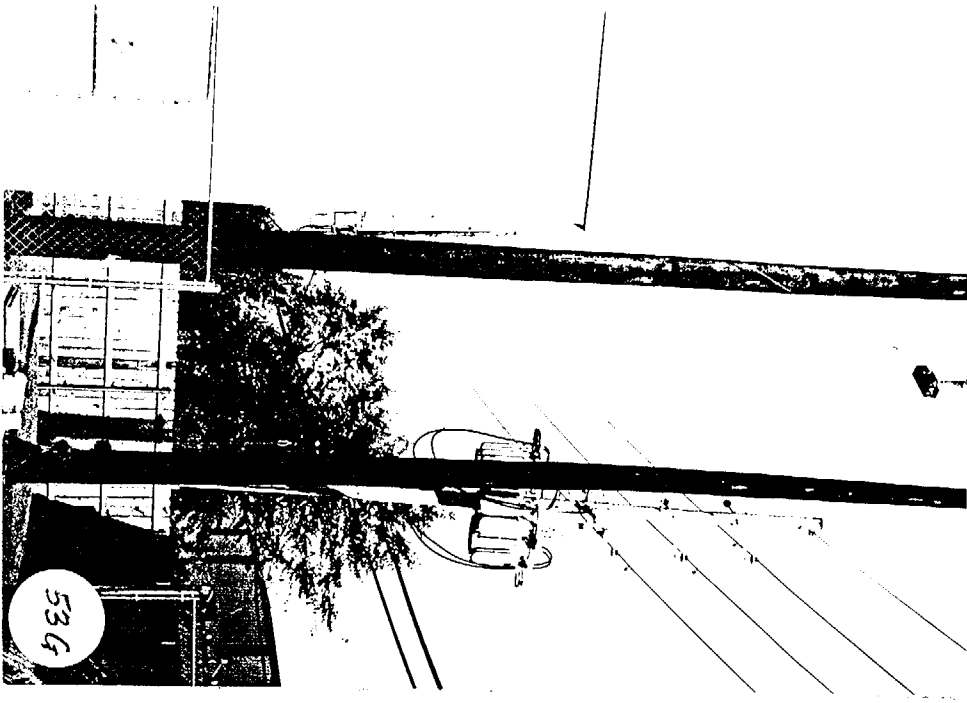
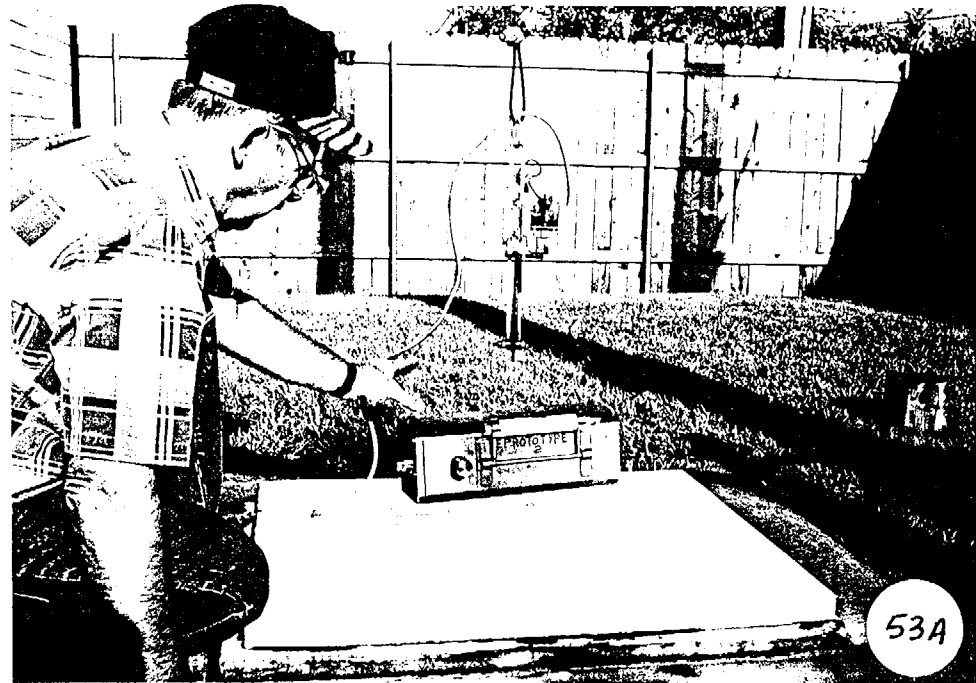
53 I

The point of impact for this test was the right side of the SPEC-150 test device. The intent was to inflict the maximum amount of force to shift the depleted uranium shield to the right side of the device and cause the source assembly to partially withdraw. The device was suspended from the left side to orient the center of gravity directly over the point of impact. See Photographs 53A, 53B and 53G. Upon impact the lock cap and the control attachment boss separated from the device. See Photograph 53C. The source connector was exposed, but not damaged. See photographs 53D and 53E. The radiation level at the lock end of the model SPEC-150 increased slightly, but not significantly, due to the secondary scattered radiation resulting from the loss of the lock cap. There was no other increase in radiation levels in any direction from the SPEC-150 package and there was no loss of radioactive content. All exterior TMJ joints remained intact and the source remained fully secured within the SPEC-150. See photograph 53D. The device remained in the locked position. Damage to the housing consisted of superficial scratches and denting to the right side of the device. See Photographs 53F and 53H. The imprint of the device on the drop target depicts the right side point of impact. See photograph 53I.

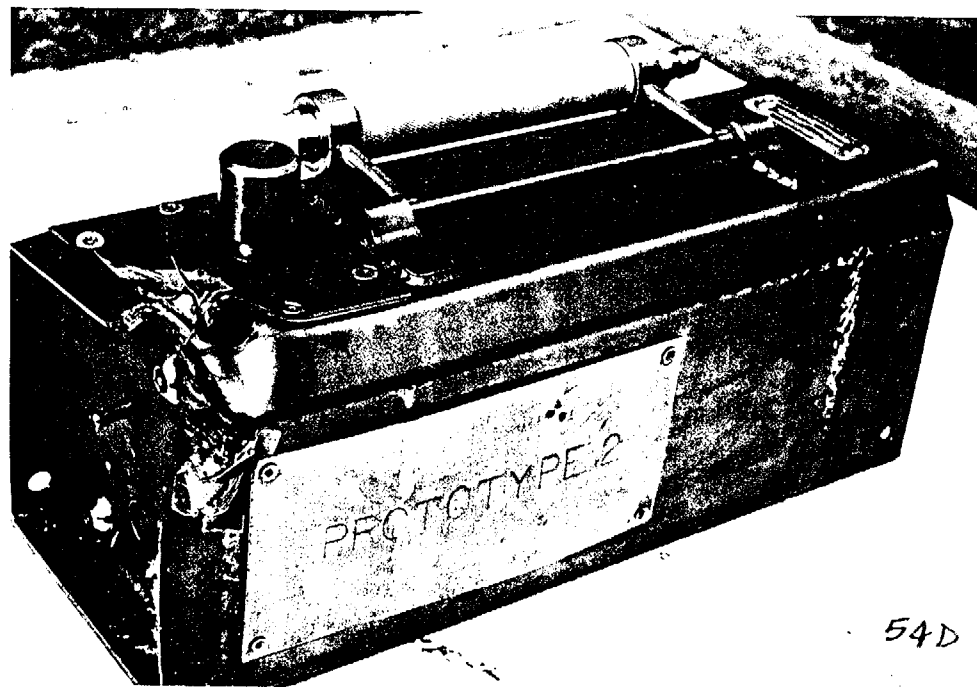
54D

The point of impact for this test was located at the top right corner at the lock end of the SPEC-150 test package. The intent was to cause the maximum amount of damage to separate the ASM/Lock Module from the device thus removing the source assembly from the shield. The device was suspended from a single wire attached to the diagonally opposite corner at the outlet end of the package to position the center of gravity directly over the point of impact. See photographs 54A and 54B. The top right corner of the housing distorted inward and upward approximately one inch. One of the six ASM lid screws (on the right side closest to the lock end) sheared off. See photograph 54C and 54D. The source connector remained

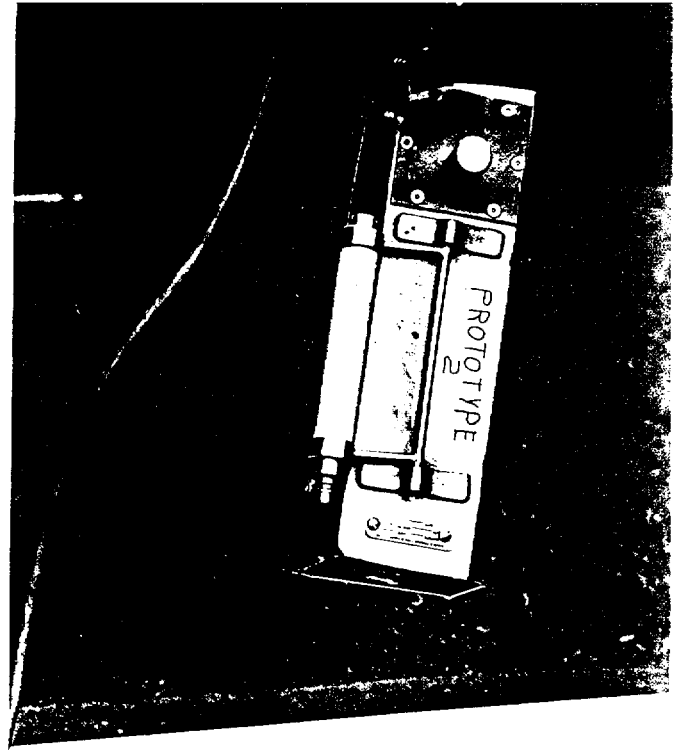
55D	Third 9 meter drop - Side Flange Dented
55E	Third 9 meter drop - Side Flange Dented
55F	Third 9 meter drop - Outlet panel
55G	Third 9 meter drop - Top of housing
56A	Fourth 9 meter drop - Orientation
56B	Fourth 9 meter drop - Orientation
56C	Fourth 9 meter drop - Outlet panel screws shear
56D	Fourth 9 meter drop - Outlet panel screws shear
56E	Fourth 9 meter drop - Outlet panel distortion
56F	Fourth 9 meter drop - Source remained locked
56G	Fourth 9 meter drop - Source remained locked
57A	Puncture test- Set up
57B	Puncture test- Set up
57C	Puncture test- No damage

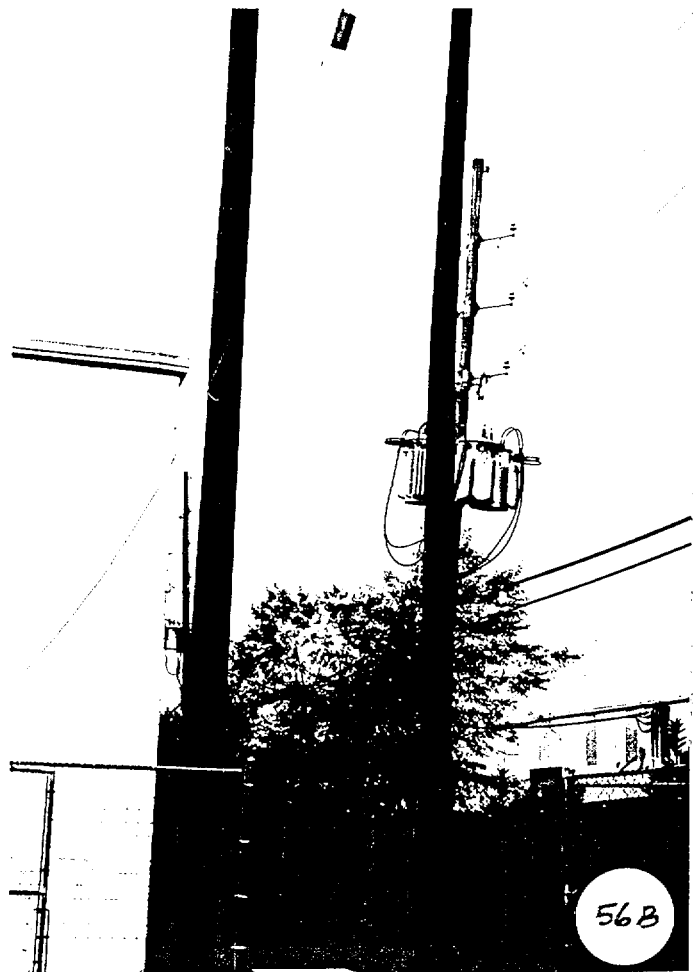
56B

The point of impact for the fourth drop test was the bottom left corner at the outlet end of the device. See photographs 56A and 56B. The lower left and upper right outlet end panel screws sheared off. See photographs 56C and 56D. The previously damaged TMJ weld seam that joins the outlet end plate to the bottom plate opened more, the end plate buckled outward more, and the depleted uranium shield shifted further toward the outlet end causing bottom of the outlet end plate to distort outward approximately an additional 7/8 inch. See photographs 56C, 56D and 56E. The bottom left corner at the outlet end dented inward approximately ½ inch. See photographs 56C and 56D. The TMJ welded joints that join the outlet end plate to the device housing split upward three inches on both left and right sides. See photographs 56C, 56D and 56E. The ASM/lock module shifted toward the outlet end of the device. The source remained locked and undamaged. See photographs 56F and 56G. The radiation level at the lock end of the device increased

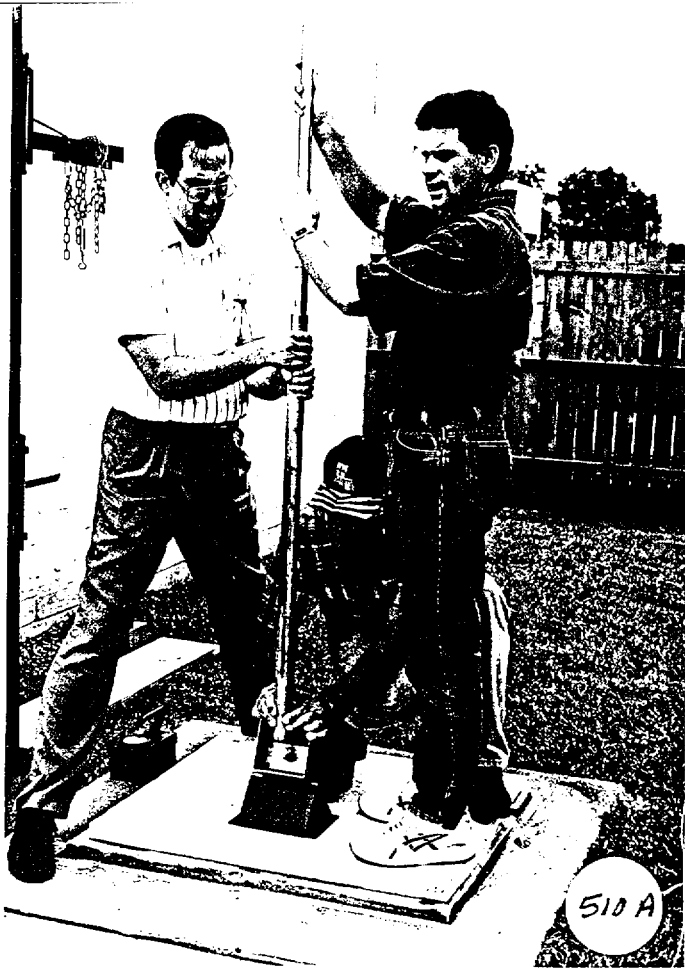
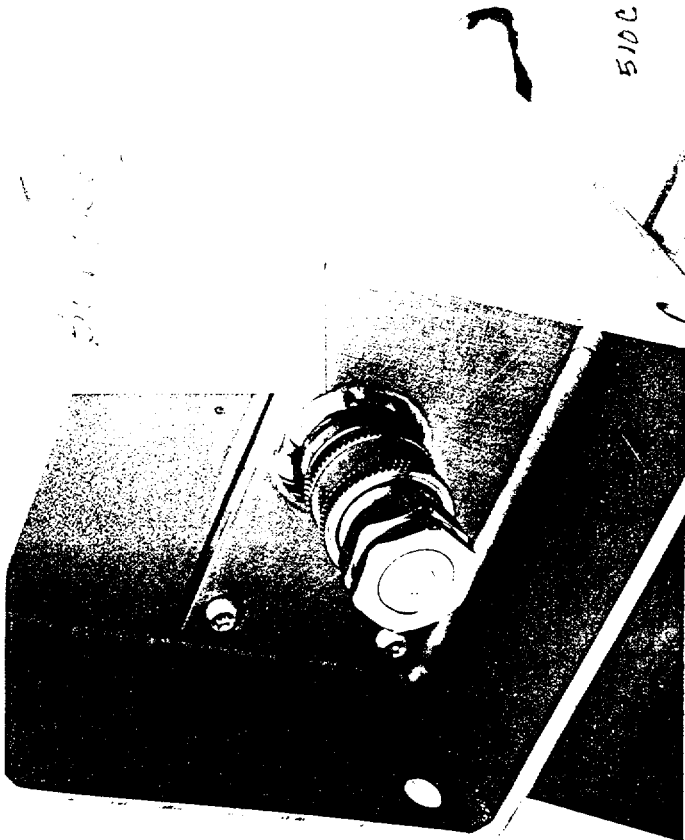
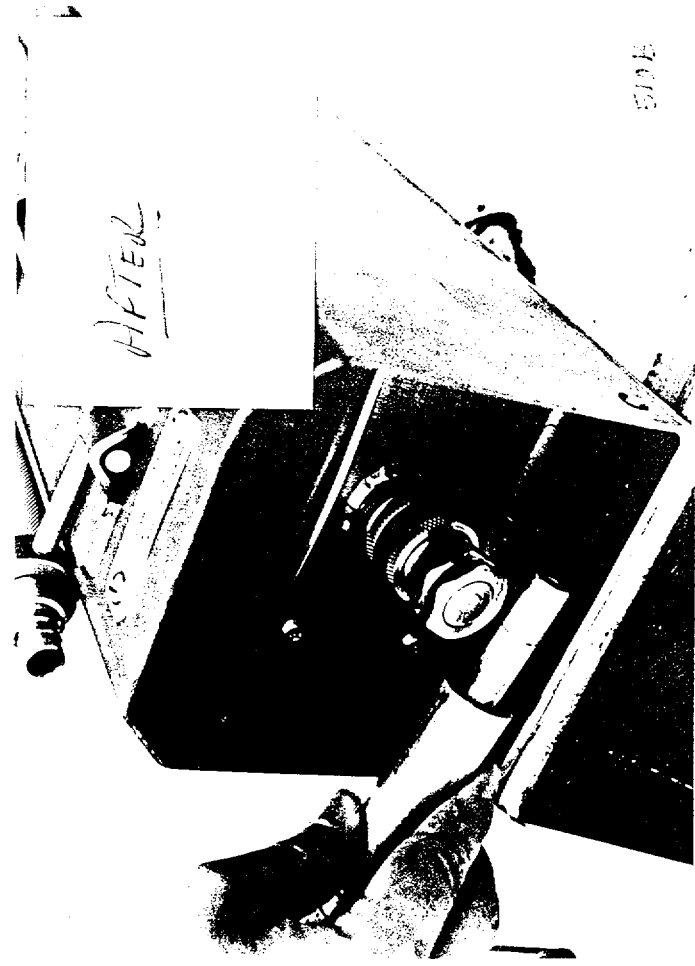
**Penetration Test  
Prototype #4**

510A	Penetration - Set up
510B	Penetration - Safety plug and outlet nipple intact
510C	Penetration - Safety plug and outlet nipple intact
511A	Additional weight added to handle
511B	Additional weight added to handle
513A	First 9 meter drop - Orientation
513B	First 9 meter drop - Orientation
513C	First 9 meter drop - Orientation
513D	First 9 meter drop - Height of drop
513E	First 9 meter drop - Corner damage
513F	First 9 meter drop - Corner damage
513G	First 9 meter drop - Corner damage
513H	First 9 meter drop - Superficial damage to side
513I	First 9 meter drop - Opposite corner damage
514A	Puncture test - Set up
514B	Puncture test - Set up
514C	Puncture test - Set up
514F	Puncture test - Set up
514D	Puncture test - Impression of target pin
514E	Puncture test - Impression of target pin
515A	Second 9 meter drop - Set up
515B	Second 9 meter drop - Set up
515I	Second 9 meter drop - Set up
515J	Second 9 meter drop - Set up

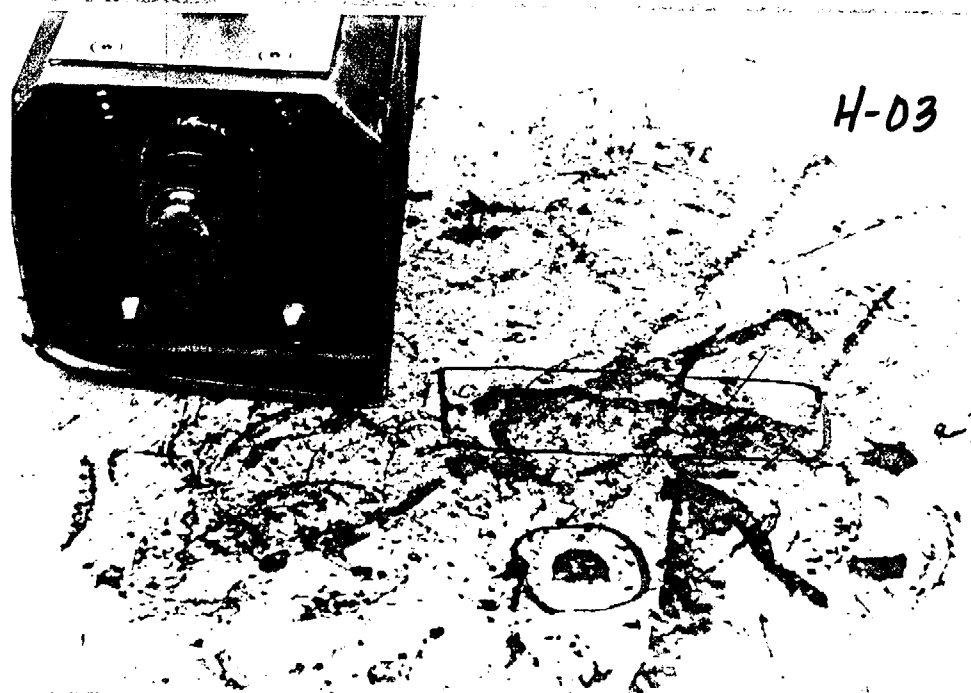
The test package was suspended from two points at the outlet end with the center of gravity positioned directly over the lock cap. See Photographs G-09 through G-11. Photograph G-12 shows the package positioned 30 feet above the target. Photographs H-01 through H-04 show the damage from the 1st 30-foot drop test on the lock cap. With the possible exception of the source assembly release plunger (which was the point of impact of the previous 30-foot drop test in August 1994) the lock cap is the point of impact most likely to damage the lock. The lock is located inside the lock module which is located behind the lock end plate of the package. There is no direct access to impact the lock itself. The lock cap is located slightly off of the geometrical center of the lock end of the package and was the initial point of impact. The test dented the end of the lock cap in approximately 1/4 inch. See Photograph H-02. The impact damaged the lock cap threads and prevented it from being able to be removed from the package. The end of the bottom plate was the secondary point of impact. Photograph H-03 shows the marks of the lock cap and bottom edge on the target outlined in red colored borders. Besides superficial scratches there was no measurable additional damage to the bottom edge. See Photograph H-04.

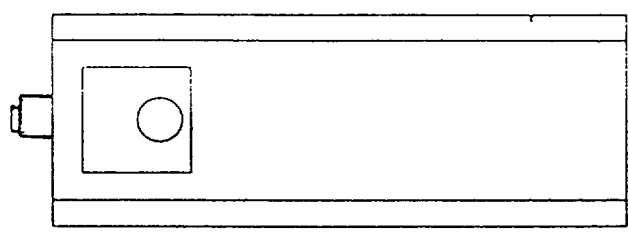
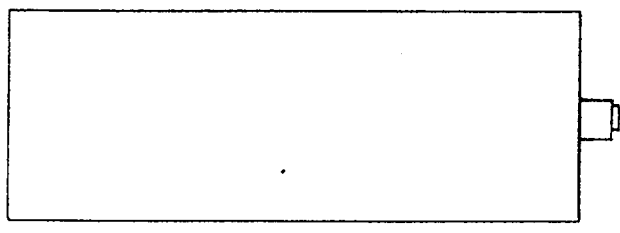
PROTOTYPE #2  
1ST 9 METER DROP  
POINT OF IMPACT;  
DIRECTLY ON RIGHT SIDE

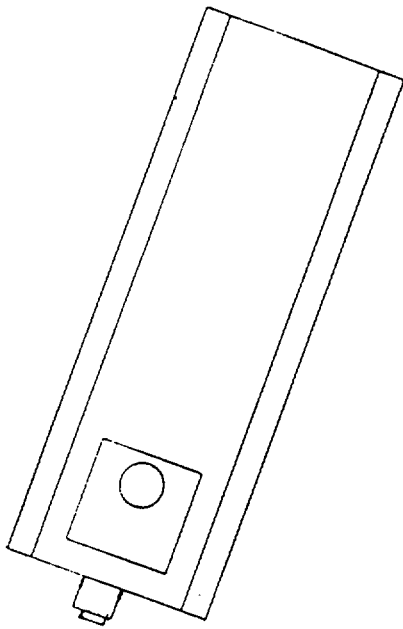
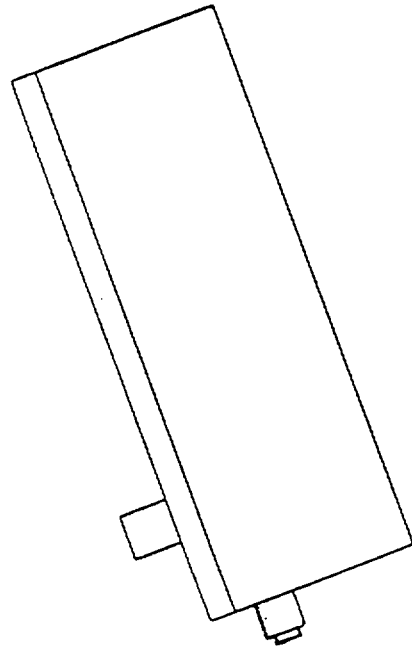
PROTOTYPE #2  
3RD 9 METER DROP  
POINT OF IMPACT;  
RIGHT SIDE EDGE AT THE OUTLET END

The point of impact of the third drop test was intended to be the right bottom corner at the outlet end. See photographs 55A and 55B. During the drop the device rotated slightly due to windy conditions. This caused the point of impact to be the right side edge (flange) at the outlet end which included the bottom right corner. See photograph 55D. The flange dented inward approximately ½ inch along the entire length of the right side. See photographs 55D and 55E. The depleted uranium shield shifted toward the outlet end of the device approximately 3/8 inch. The four screws holding the outlet end panel to the outlet end plate remained intact. See photograph 55F. The outlet end plate buckled outward and the end of the safety plug was dented causing the safety plug to be jammed in place. The device housing was bent upward slightly at the top right corner at the outlet end. See photographs 55D and 55G. The TMJ welded joint that joins the outlet end plate to the bottom plate was split along the entire length. See photograph 55F. The source remained in the locked position. The radiation level at the top center surface of the device after the 3rd drop increased from 0.24 mSv (24 millirem) per hour to 0.8 mSv (80 millirem) per hour.

(NOTE: THE INTENDED POINT OF IMPACT WAS THE RIGHT/BOTTOM CORNER AT THE OUTLET END. DUE TO WIND CONDITIONS THE DEVICE SLIGHTLY ROTATED DURING THE DROP AND CAUSED THE IMPACT POINT TO BE THE RIGHT SIDE EDGE AT THE OUTLET END.)

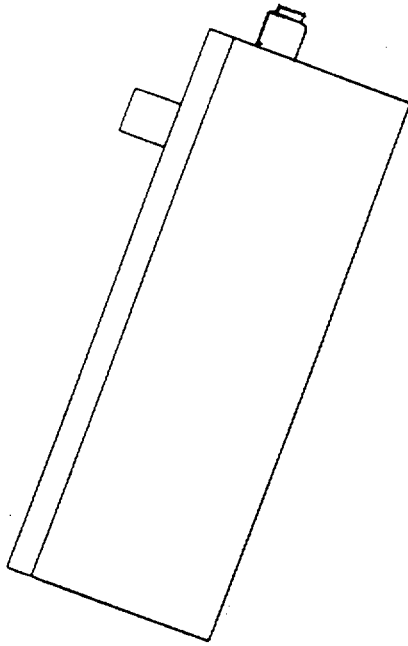
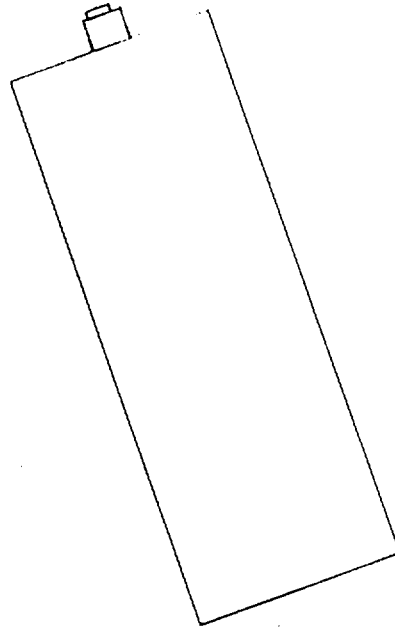
PROTOTYPE #2  
4TH 9 METER DROP  
POINT OF IMPACT;  
BOTTOM/LEFT CORNER AT THE OUTLET END

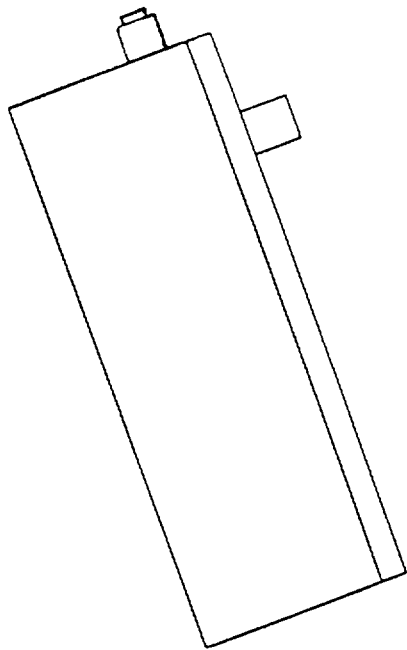
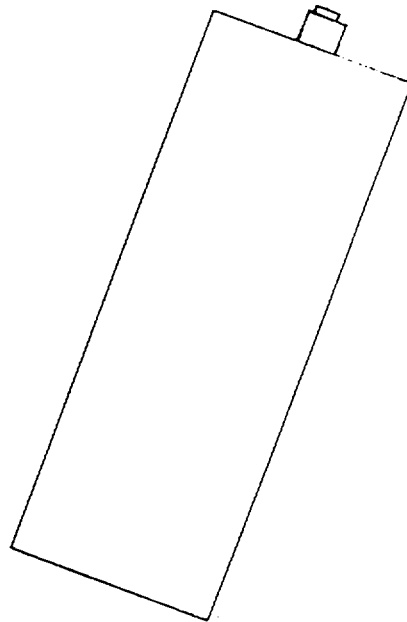
PROTOTYPE #4  
1ST 9 METER DROP  
POINT OF IMPACT;  
RIGHT/BOTTOM CORNER AT OUTLET END

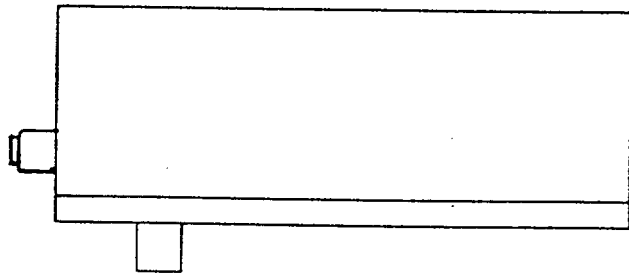
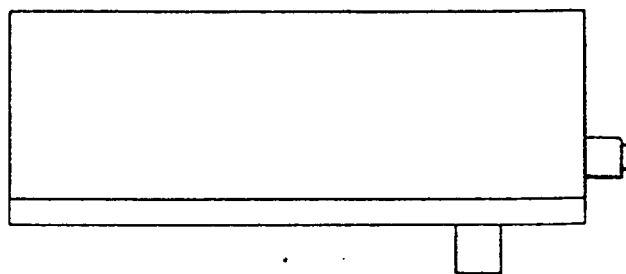
PROTOTYPE #4  
2ND 9 METER DROP  
POINT OF IMPACT;  
DIRECTLY ON TOP

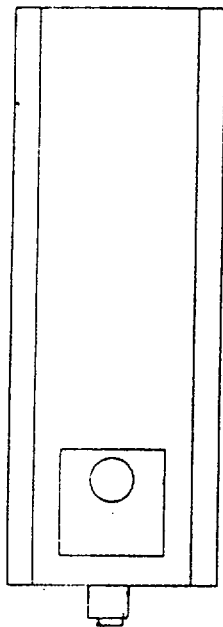
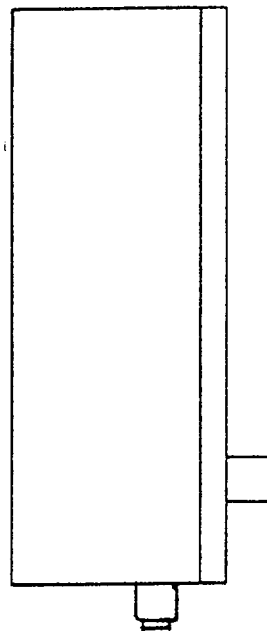
PROTOTYPE #4  
3RD AND 4TH 9 METER DROPS  
POINT OF IMPACT;  
DIRECTLY ON LOCK END (LOCK CAP, SOURCE LOCK AND DEVICE LOCK)

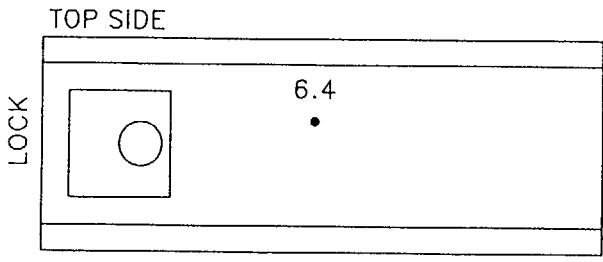
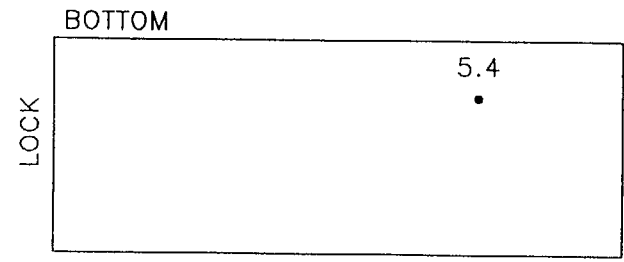
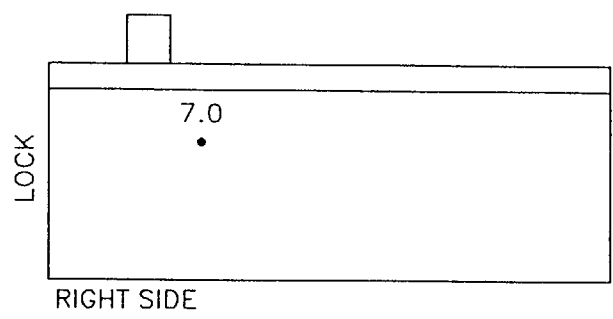
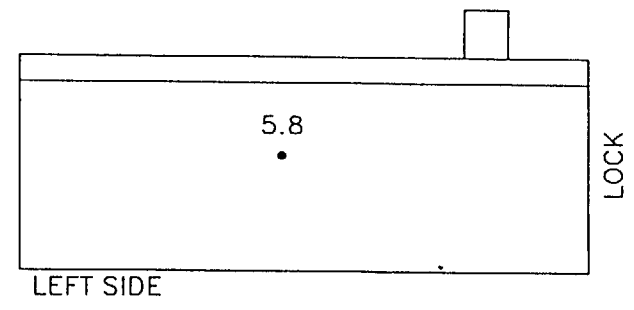
FILE: SRP1294A

SPEC-150 EXPOSURE DEVICE  
 PROTOTYPE #4 RADIATION PROFILE: POST-DROP

SURVEY DATE 12-17-94 (AFTER 5 EA. 4 FOOT DROPS)  
 SURVEY METER MODEL GS1000A S/N 1771 CAL. DATE 12-5-94  
 CALIBRATION VERIFIED 12-17-94  
 CURIES 8 SOURCE MODEL G-60 SOURCE S/N AH2503

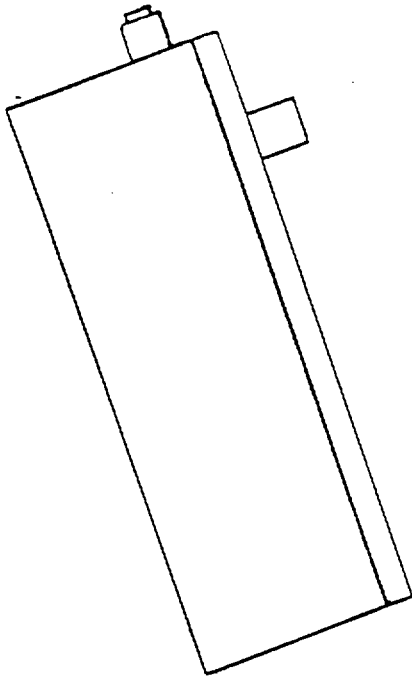
**SPEC-150 Serial Number 500**  
**30' Drop Test 6/26/97**  
**Point of Impact: Right/Bottom Corner at Outlet End**

The point of impact for SPEC-150, s/n 500, was based on an analysis of the design and extensive past experience testing numerous prototype SPEC-150 and SPEC 2-T packages. The orientation and point of impact was selected to cause the maximum damage to the package based on the maximum potential for shield movement. Essentially, the SPEC-150 is a depleted Uranium shield weighing approximately 35 lb. enclosed in a rectangular GTAW welded Titanium enclosure. The shield is retained in the enclosure by tabs or "ears" cast integrally with the shield. One of these tabs is attached to the outlet end plate. The other end tab is attached to the intermediate bulkhead within the enclosure toward the lock end. The mechanism securing the radioactive source assembly in the center of the depleted Uranium shield is attached to the lock end of the enclosure. An impact causing the shield to shift toward the outlet end of the camera, while preserving the integrity of the securing mechanism, would result in the source capsule being displaced from the fully shielded position within the depleted Uranium shield. As defined above, this would result in maximum damage.

Dropping the package with the impact point at the outlet end bottom edge or at one of the outlet end bottom corners allows for a larger potential displacement of the shield, especially if the center of gravity of the package is located approximately over the impact point to reduce package rotation at impact. Additionally, this orientation allows the reaction from the shield to bear directly on the end plate near the weld joint. Prototype packages have been dropped repeatedly and demonstrate greatest physical damage when dropped on one of the outlet end corners. Since the package housing is symmetrical in this axis, either corner may be chosen. Based on these factors the package was oriented so as to impact with the center of gravity over the outlet end bottom right corner, as viewed from the lock end of the package (See Photograph A2)(See Orientation Sketch, Appendix 4. 4).

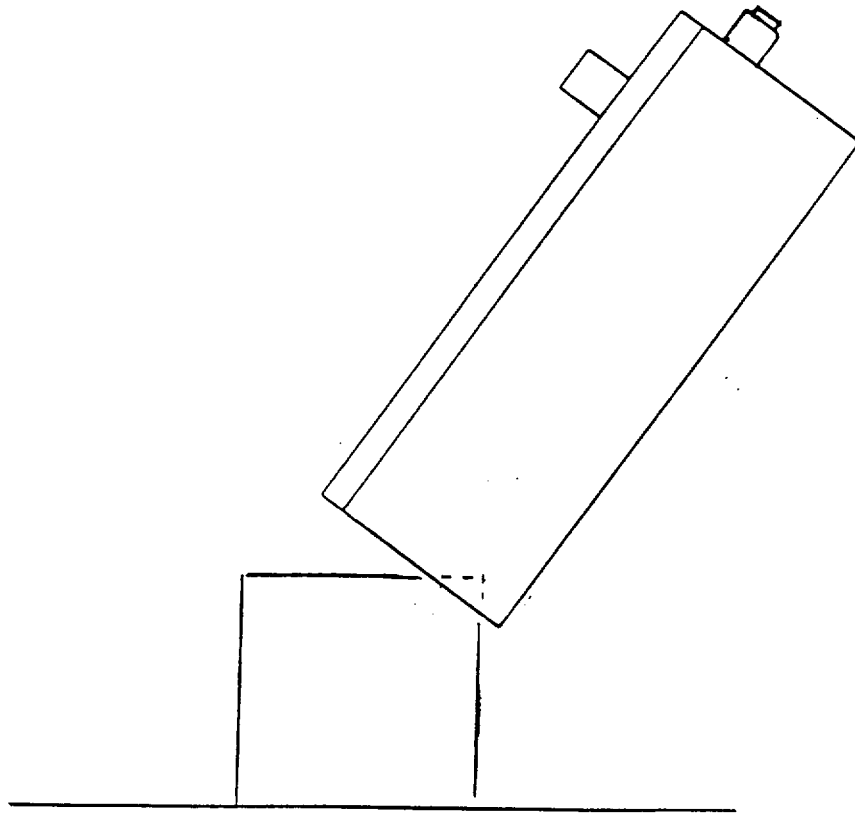
**SPEC 150 Serial Number 500**  
**Puncture Test 6/26/97**  
**Point of Impact: Safety Plug**

A model SPEC-150 prototype was subjected to the impact of a 1-1/4 inches diameter steel cylinder weighing 13 lbs falling a distance of 40 inches. The point of impact was directly on the safety plug which is located at the outlet end of the device. See photograph 510A. The safety plug is the weakest structural point on the device that would also cause the most significant increase in radiation level if it were to break off. IAEA Safety Series No. 6 Regulations for the Safety Transport of Radioactive Material 1985 Edition (As Amended 1990) states in Paragraph 537(b) that the normal condition of transport test should not result in more than a 20% increase in surface radiation levels. The impact caused the outlet end panel to bend downward slightly. The safety plug and outlet nipple remained intact. See photographs 510B and 510C. There was no increase of radiation levels. The penetration test did not result in loss of radioactive contents from the package, increase radiation levels nor reduce the effectiveness of the model SPEC-150 package.

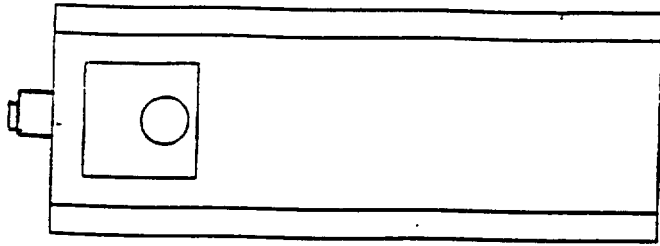
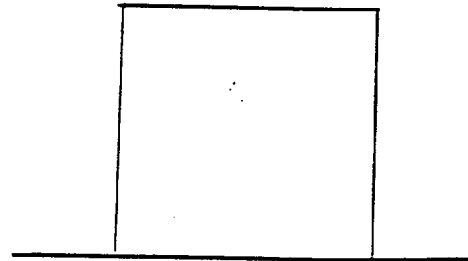
**Puncture Test 6/26/97**

**Point of Impact: Right Side**

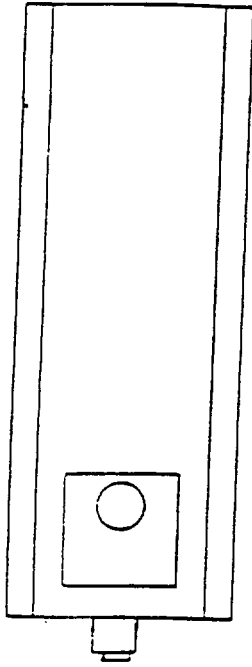
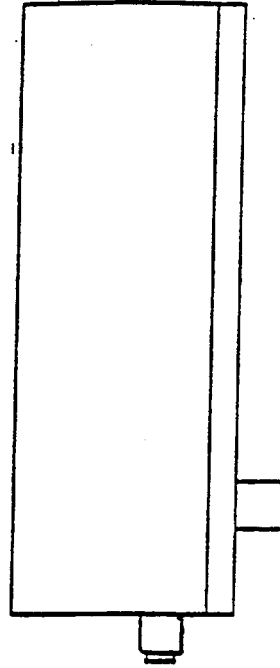
**SPEC 150 Serial Number 500**  
**Puncture Test 6/26/97**  
**Point of Impact: Directly on Lock Cap**

Lock End: The upper right corner dented inward 1/4 inch, no other damage. The lock cap is intact and operates properly.
