Subject: Transmittal of the *Verification Monitoring Report for the Naturita, Colorado, Processing Site*

# Verification Monitoring Report for the Naturita, Colorado, Processing Site

**Verification Monitoring Report  
for the Naturita, Colorado,  
Processing Site**

January 2007

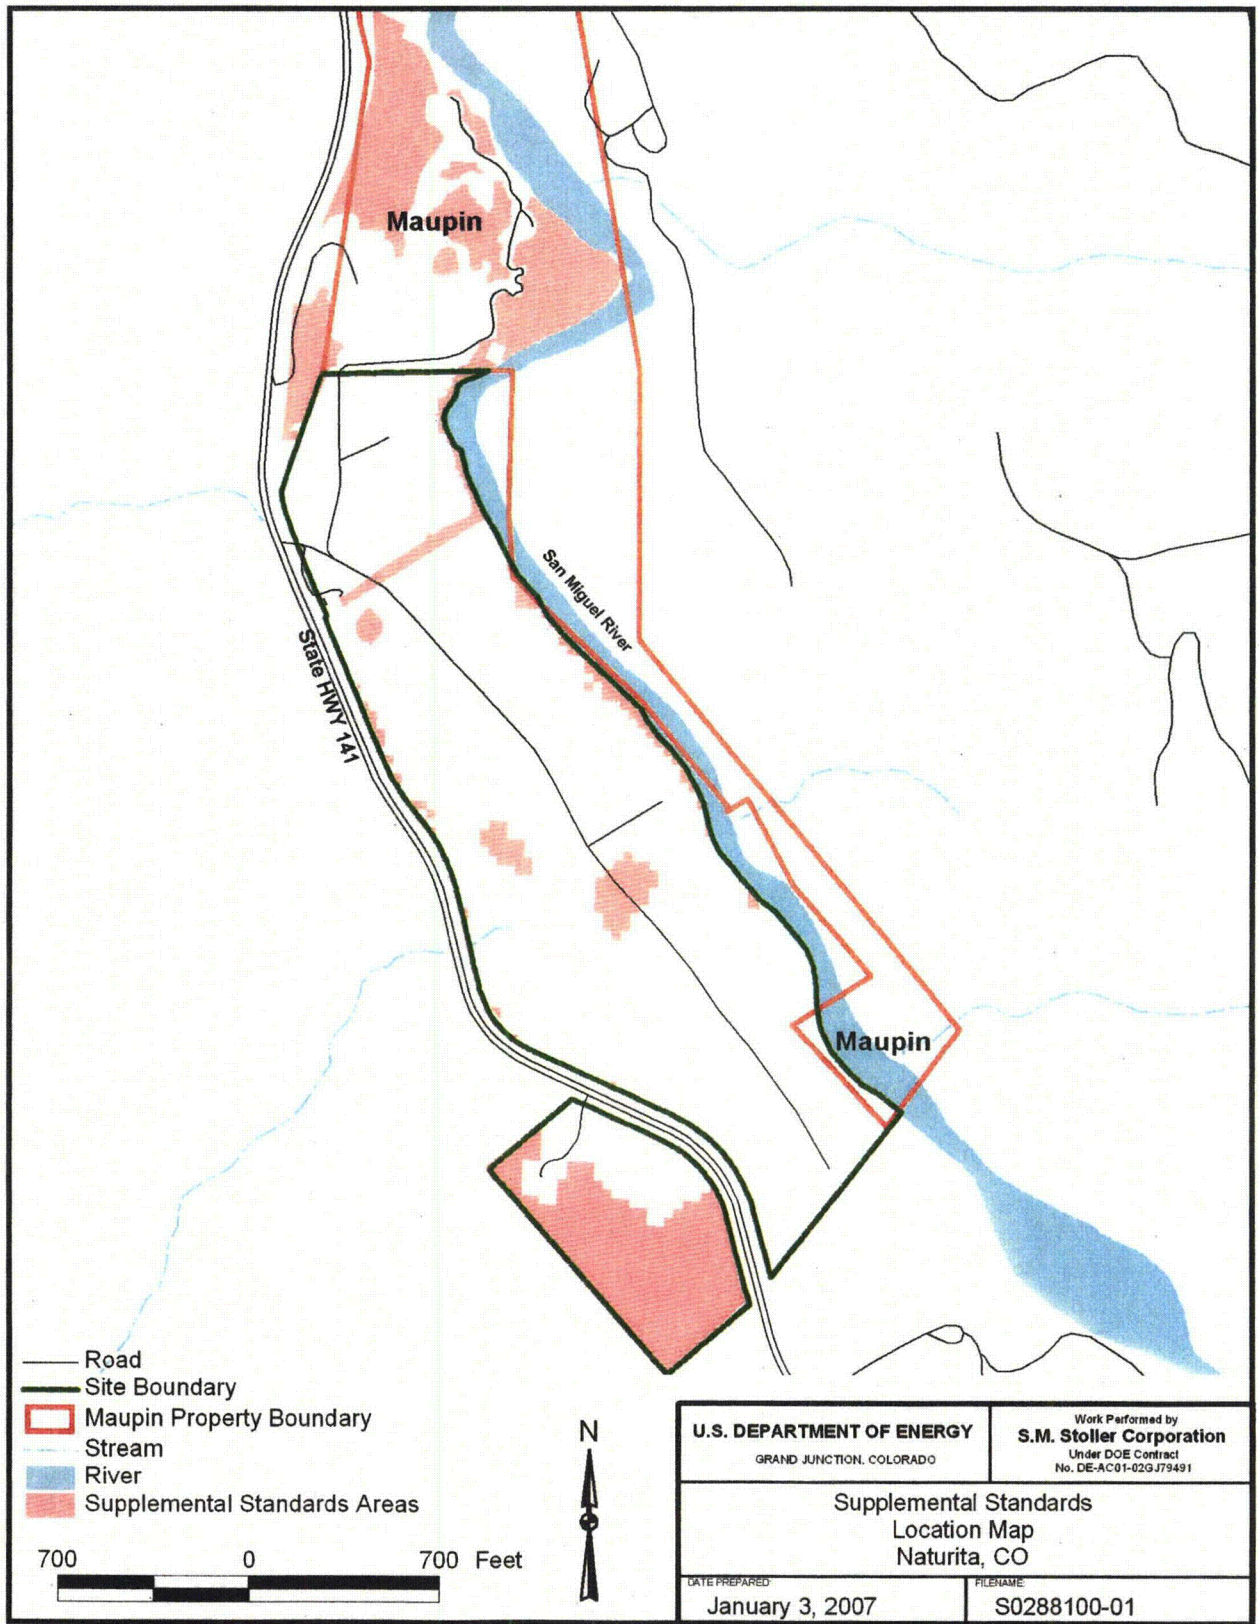
Figure 2. Supplemental Standards Location Map at the Naturita Site

As noted previously, supplemental standards were applied to soils over a significant portion of the site and an adjacent vicinity property. The persistence of uranium and vanadium in these areas represents a potential continuing source of ground water contamination. Despite this, concentrations of uranium and vanadium have declined over time (see Appendix C, Time-Concentration Plots for Uranium and Vanadium). It is probable that concentrations will continue to decline until soil and ground water interactions reach equilibrium; at that time ground water concentrations will probably level off.

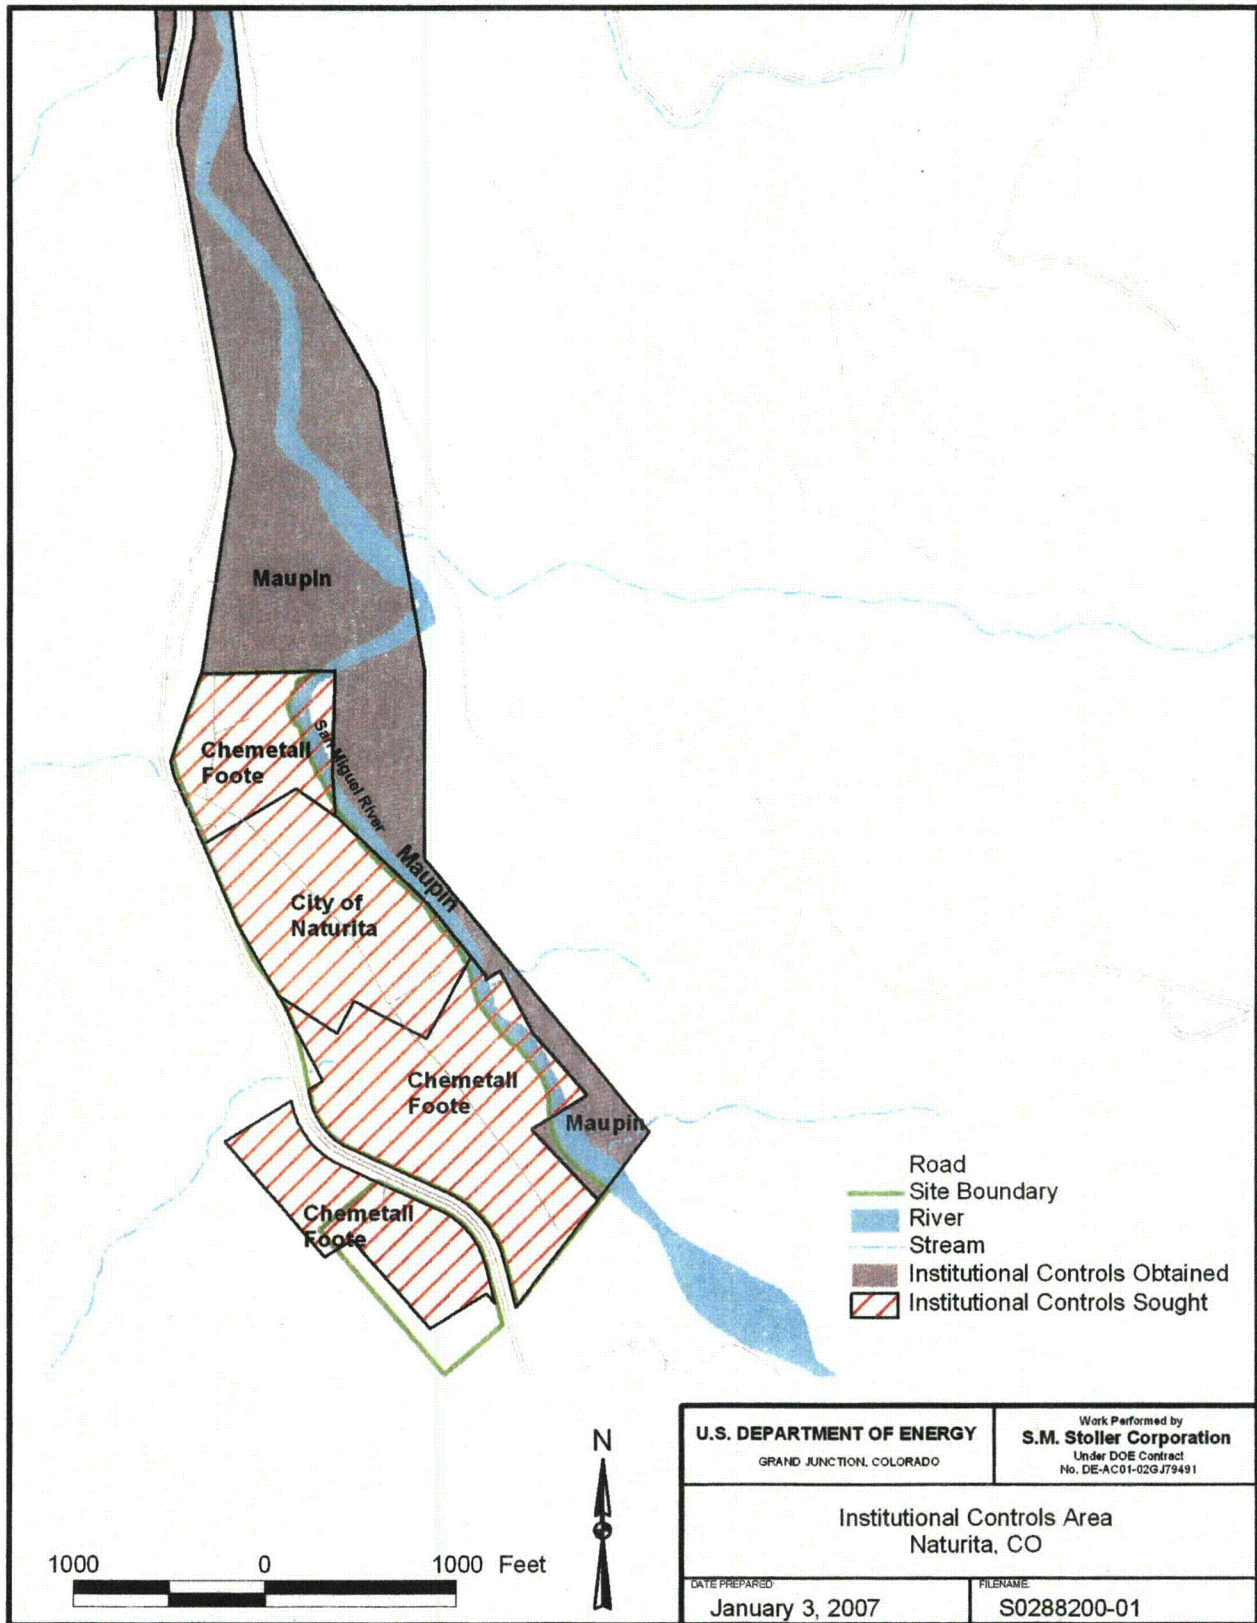
Figure 3. Institutional Controls Area, Naturita, Colorado

Institutional controls have been or will be placed on ground water that is currently contaminated or may be potentially affected in the future. On the basis of Colorado Senate Bill 01-145 that passed in July 2001, perpetual environmental covenants can be created that place restrictions on land use, including drilling and pumping of ground water from that land, where remedial actions have been completed and contamination has been left in place. The covenant is between the property owner and the State of Colorado. These covenants are legally enforceable restrictions on land use and therefore meet the definition of institutional controls under the Uranium Mill Tailings Radiation Control Act. Such an environmental covenant will prohibit domestic use of contaminated ground water until it can be demonstrated that contaminant concentrations have reached regulatory limits.

In July 2002, the Maupin family signed an environmental covenant with the Colorado Department of Public Health and Environment prohibiting the use of alluvial ground water for drinking purposes. For this consideration, DOE provided a domestic water well to replace the beneficial use of ground water being denied as a result of this institutional control. Similar environmental covenants to prevent use of alluvial ground water are being negotiated with all other landowners for properties affected by site-related contamination. This will ensure protectiveness of human health and the environment for as long as necessary. Figure 3 shows the total area to be covered by this type of institutional control. It extends along the floodplain on either side of the San Miguel River for approximately 3,600 feet downgradient of the site to the Calamity Bridge.

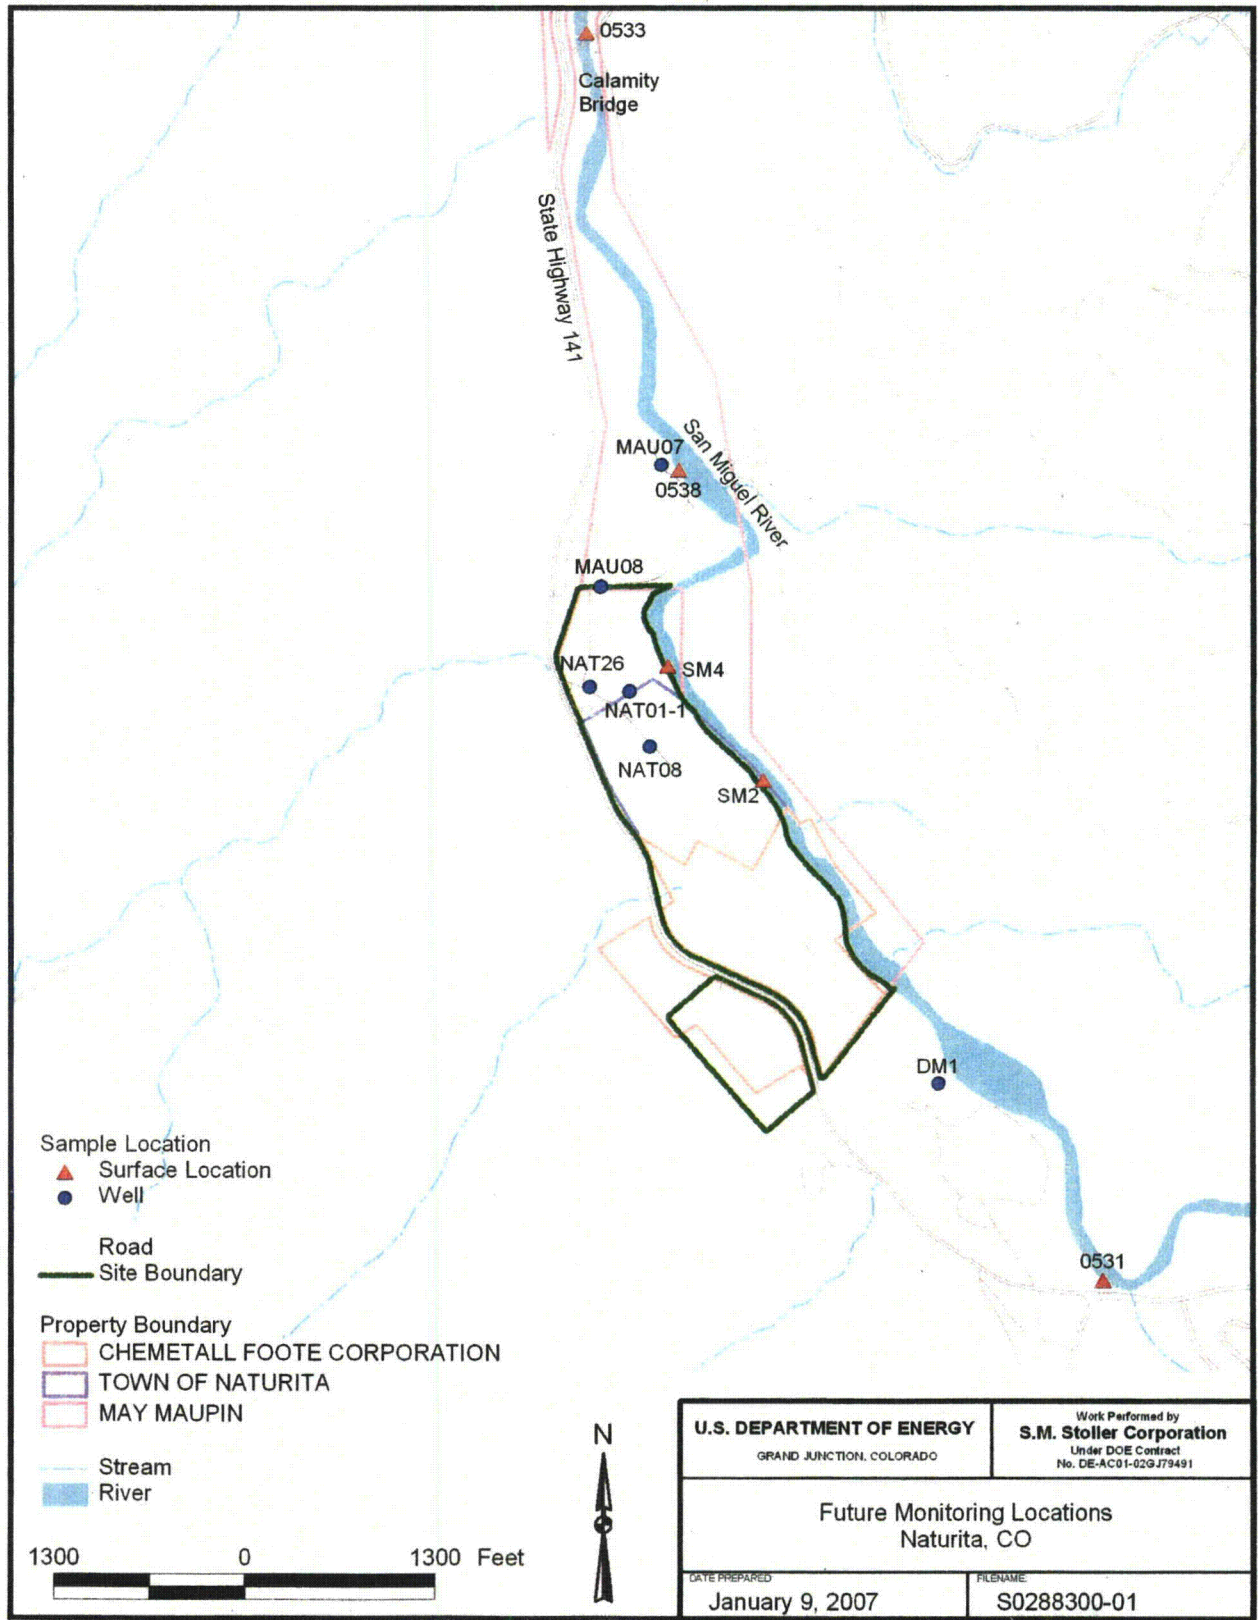
Figure 4. Monitoring Locations at the Naturita Site

Monitoring is planned to ensure continued protection of human health and the environment. Monitor wells DM1, NAT01-1, NAT08, NAT26, MAU08, MAU07, and surface locations 0531, 0533, 0538, SM2, and SM4 will be monitored for uranium and vanadium (Figure 4). DM1 is a background ground water location. If this well is removed by expansion of the gravel mining operation, a suitable location will be selected for installation of a new background well.

Surface location 0531 is upgradient on the San Miguel River; 0533 is the downgradient location on the San Miguel River; and 0538 is the seep on Maupin property. SM-2, crossgradient of the uranium plume, and SM-4, crossgradient of the vanadium plume, were added at the recommendation of Montrose County officials.

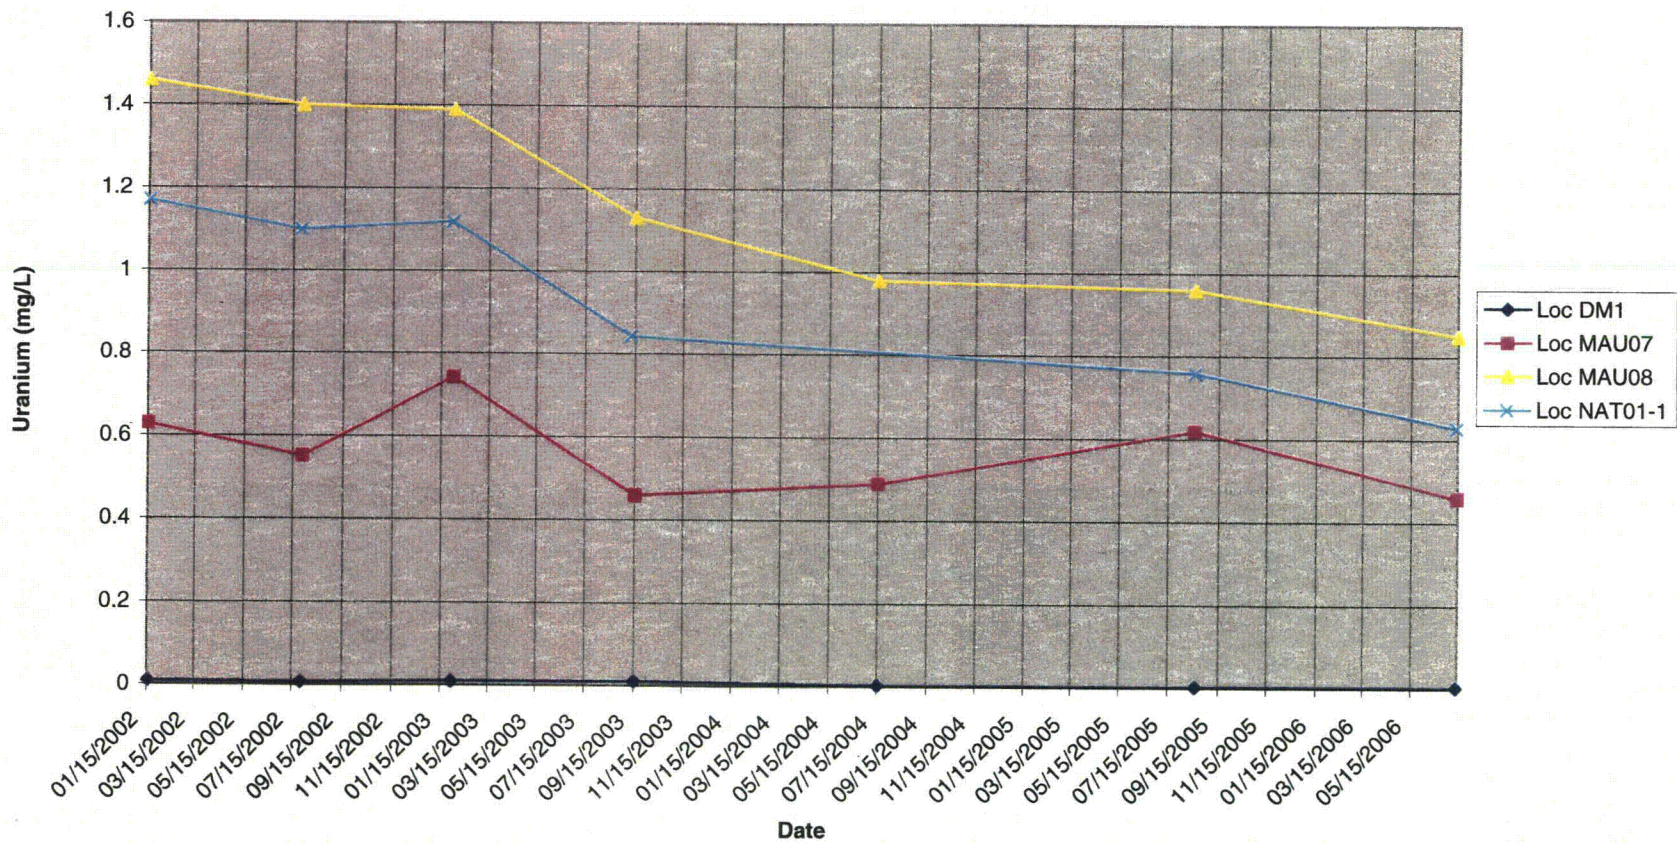
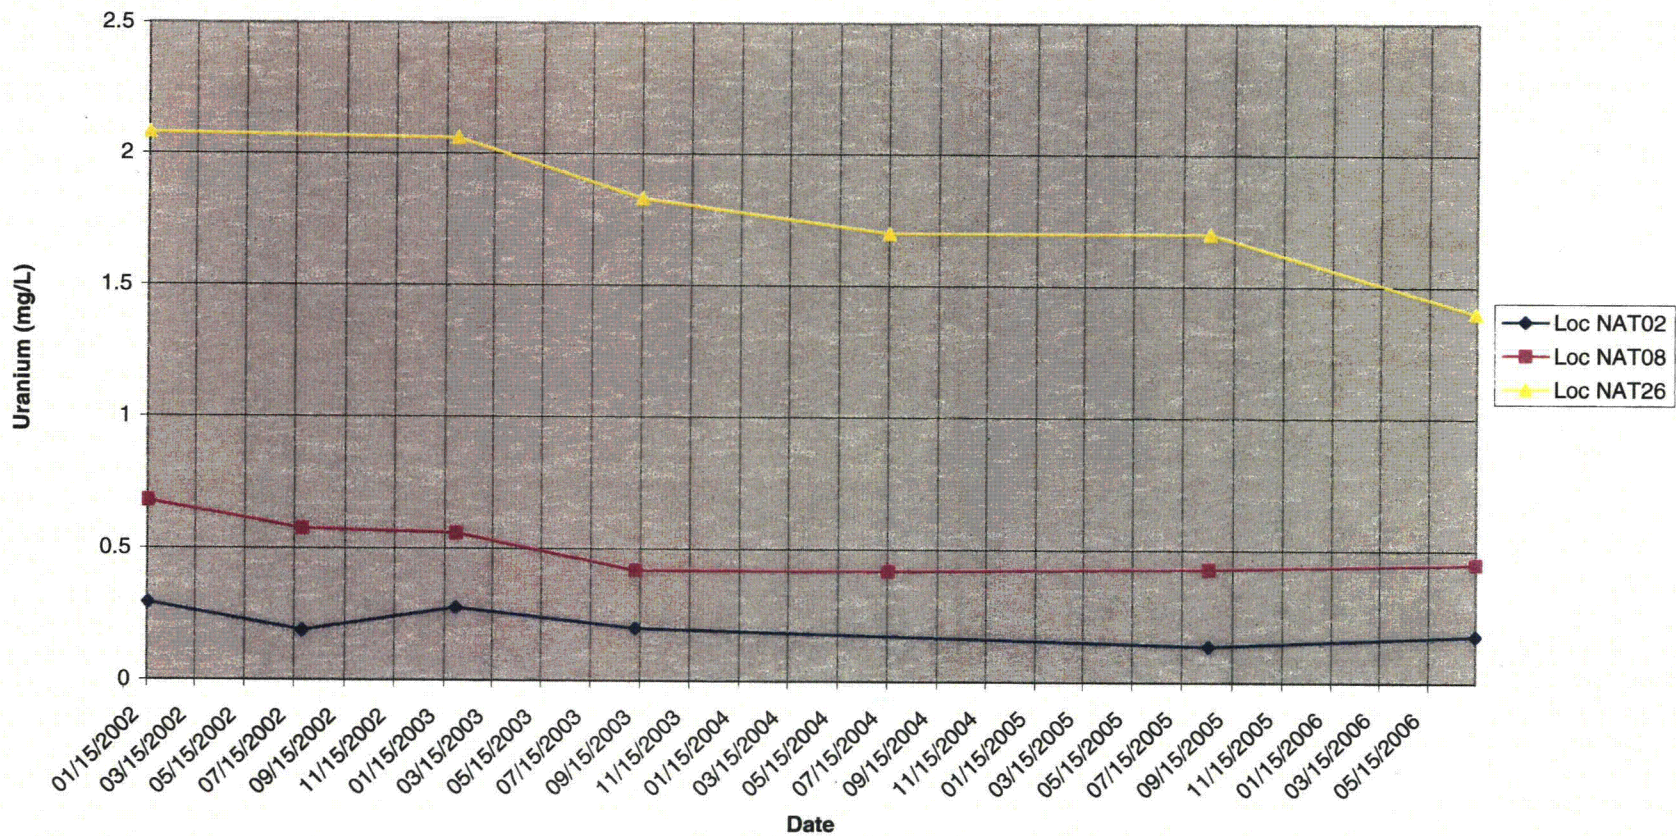
## Uranium Concentration

Based on most recent sampling results, uranium concentrations in ground water ranged from 0.0048 mg/L in background well DM-1, which is upgradient from the former tailings area, to 1.4 mg/L in well NAT26. Concentrations in all wells except DM-1 exceed the UMTRA maximum concentration limit of 0.044 mg/L. Vanadium concentrations ranged from below the detection limit (<0.0002 mg/L currently; earlier detection limits were 0.01–0.04 mg/L) to a maximum value of 2.8 mg/L in well NAT08. Location NAT08 is the only location at which elevated vanadium has been observed; recent concentrations have declined by about half at this location over the monitoring period.

Monitoring conducted since the completion of surface remediation indicates that concentrations of uranium and vanadium in ground water have been on the decline. This is despite the fact that a persistent drought in the western U.S. has resulted in increases in ground water concentrations at similar sites. Concentrations have remained well below the proposed alternate concentration limits for protection of surface water. Ground water data for 2006 are presented in Appendix A; time-concentration plots for uranium and vanadium for the entire monitoring period are included in Appendix C.
