March 14, 2007

This explanation accompanies a sketch faxed from Karl Feintuch (USNRC PM) to Tony Browning (DAEC) to obtain crack data as part on an independent assessment of UT data (TAC MD4630)

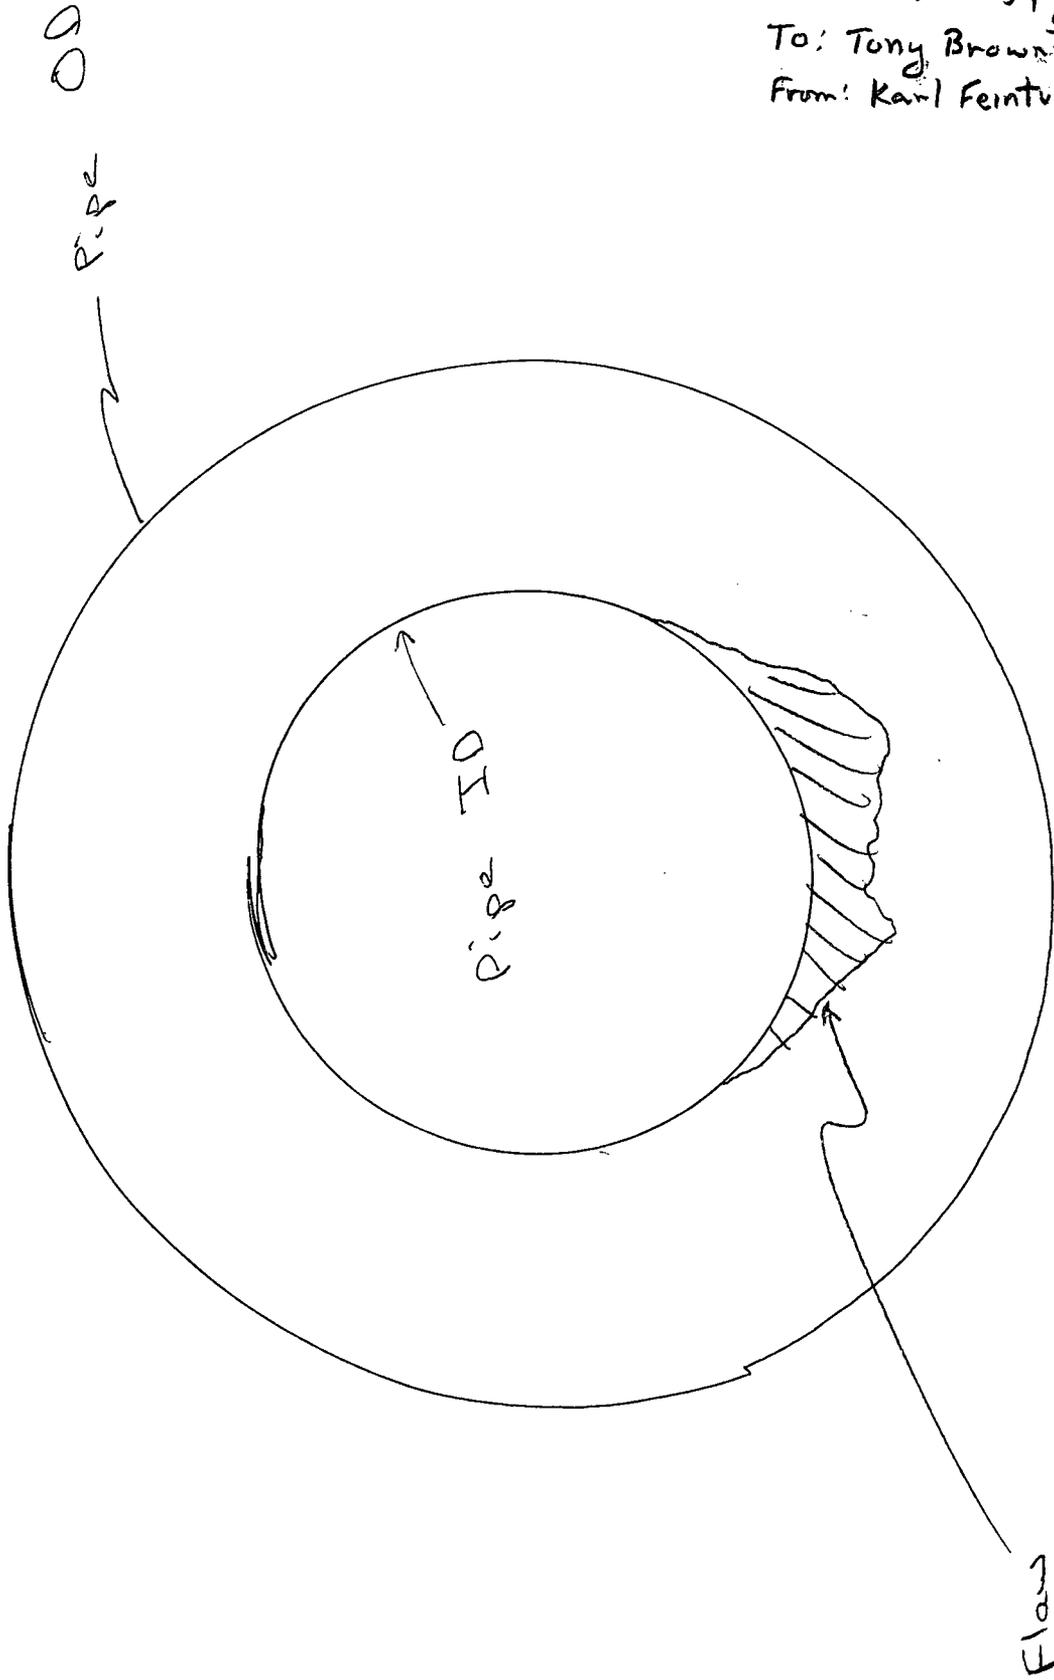
The "picture" of a "flaw profile" shows the length and depth of the flaw around the circumference of the pipe.

There are many ways to show a flaw profile. The one sketched is one way (although what is desired is a scale showing the length and depth of the flaw). Other ways to show a flaw profile would be, starting at one end of the flaw, to show the depth of a cross-section and then incrementally go along the length of the flaw providing the thru-wall depth at each location. For example, for slices taken at 0.02" increments, the crack could be characterized as:
