NUREG/CR-2607
SAND82-0431
RP

FIRE PROTECTION RESEARCH PROGRAM FOR THE
U. S. NUCLEAR REGULATORY COMMISSION
1975-1981

Donald A. Dube
Systems Safety Technology Division

Date Published: April 1983

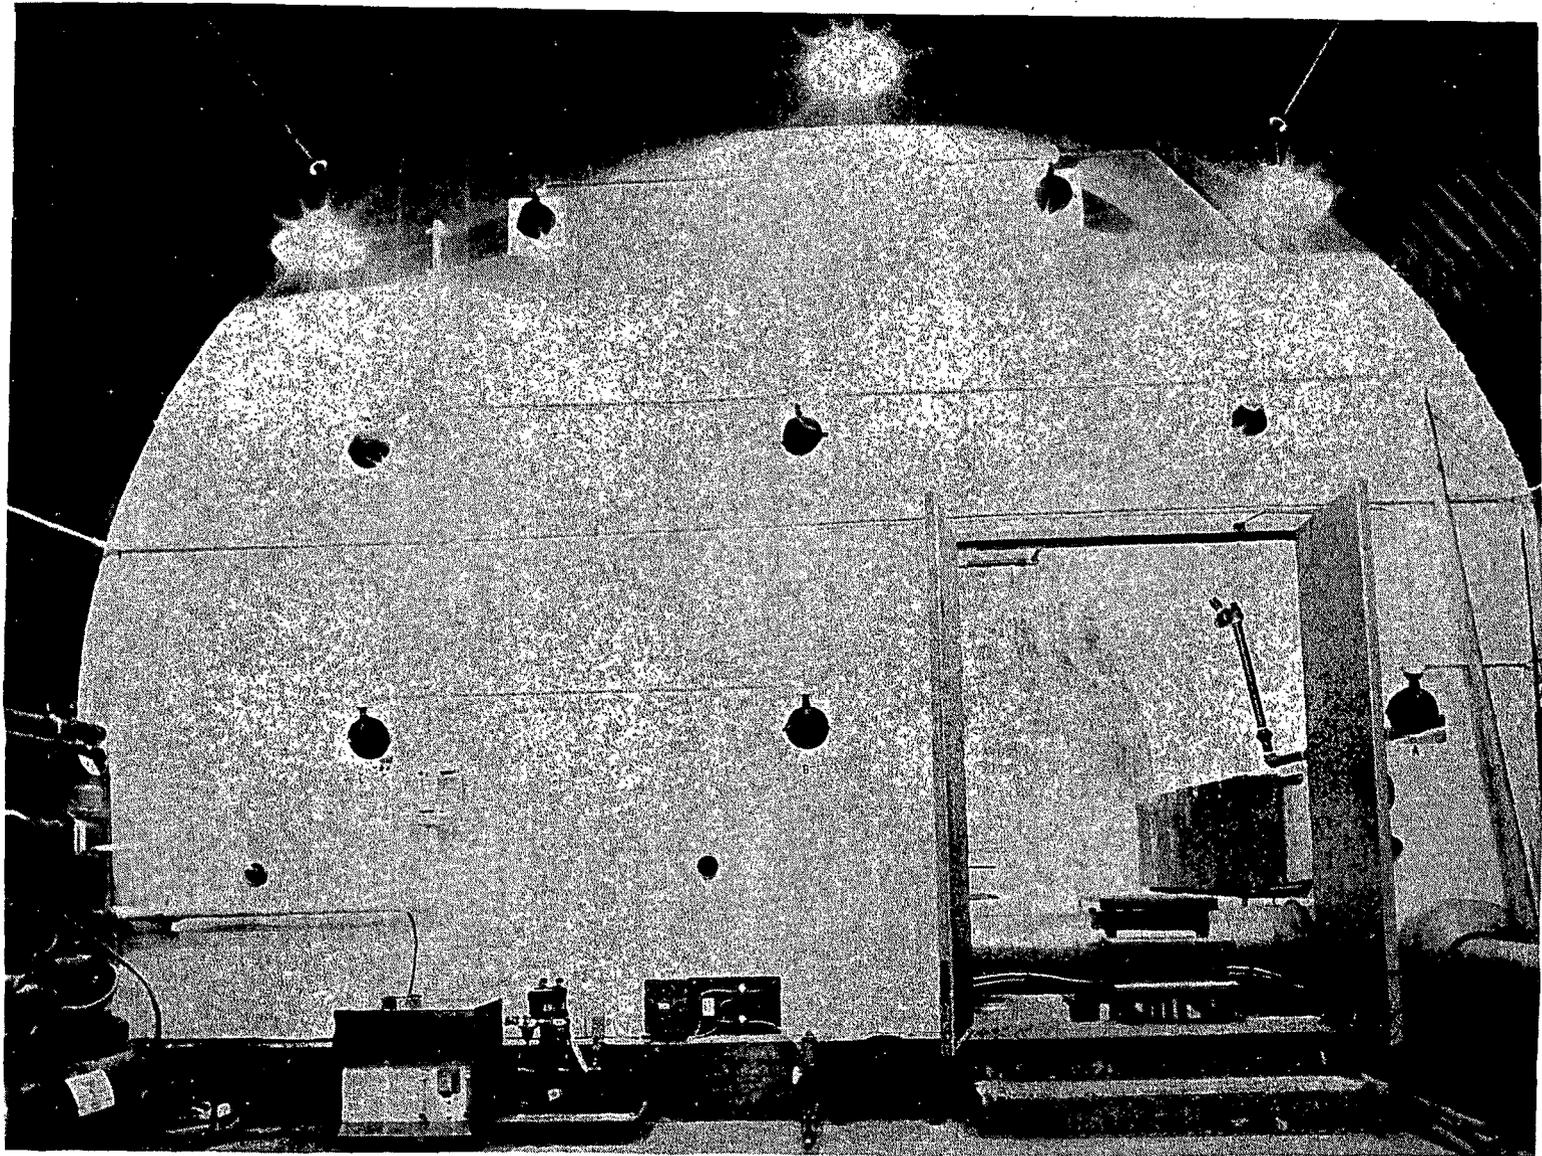
Figure 1

Outside View of Fire Test Facility

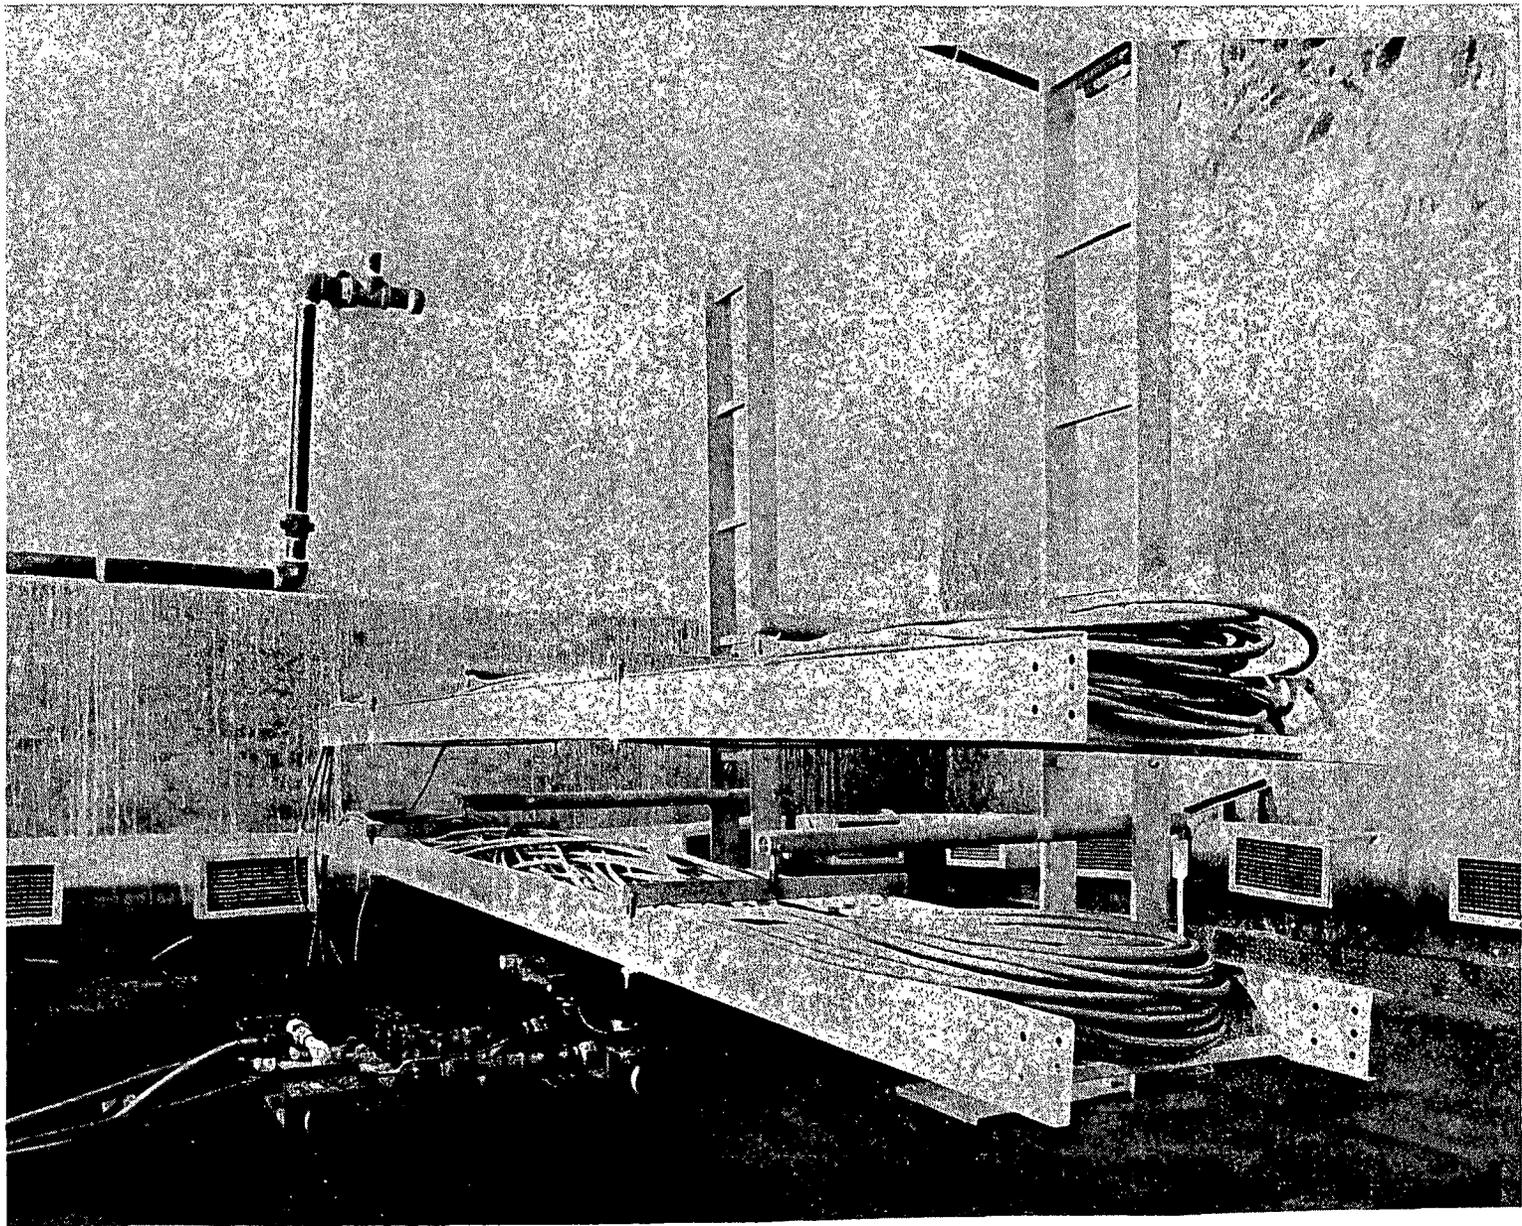
Figure 2

Inside View of Fire Test Facility

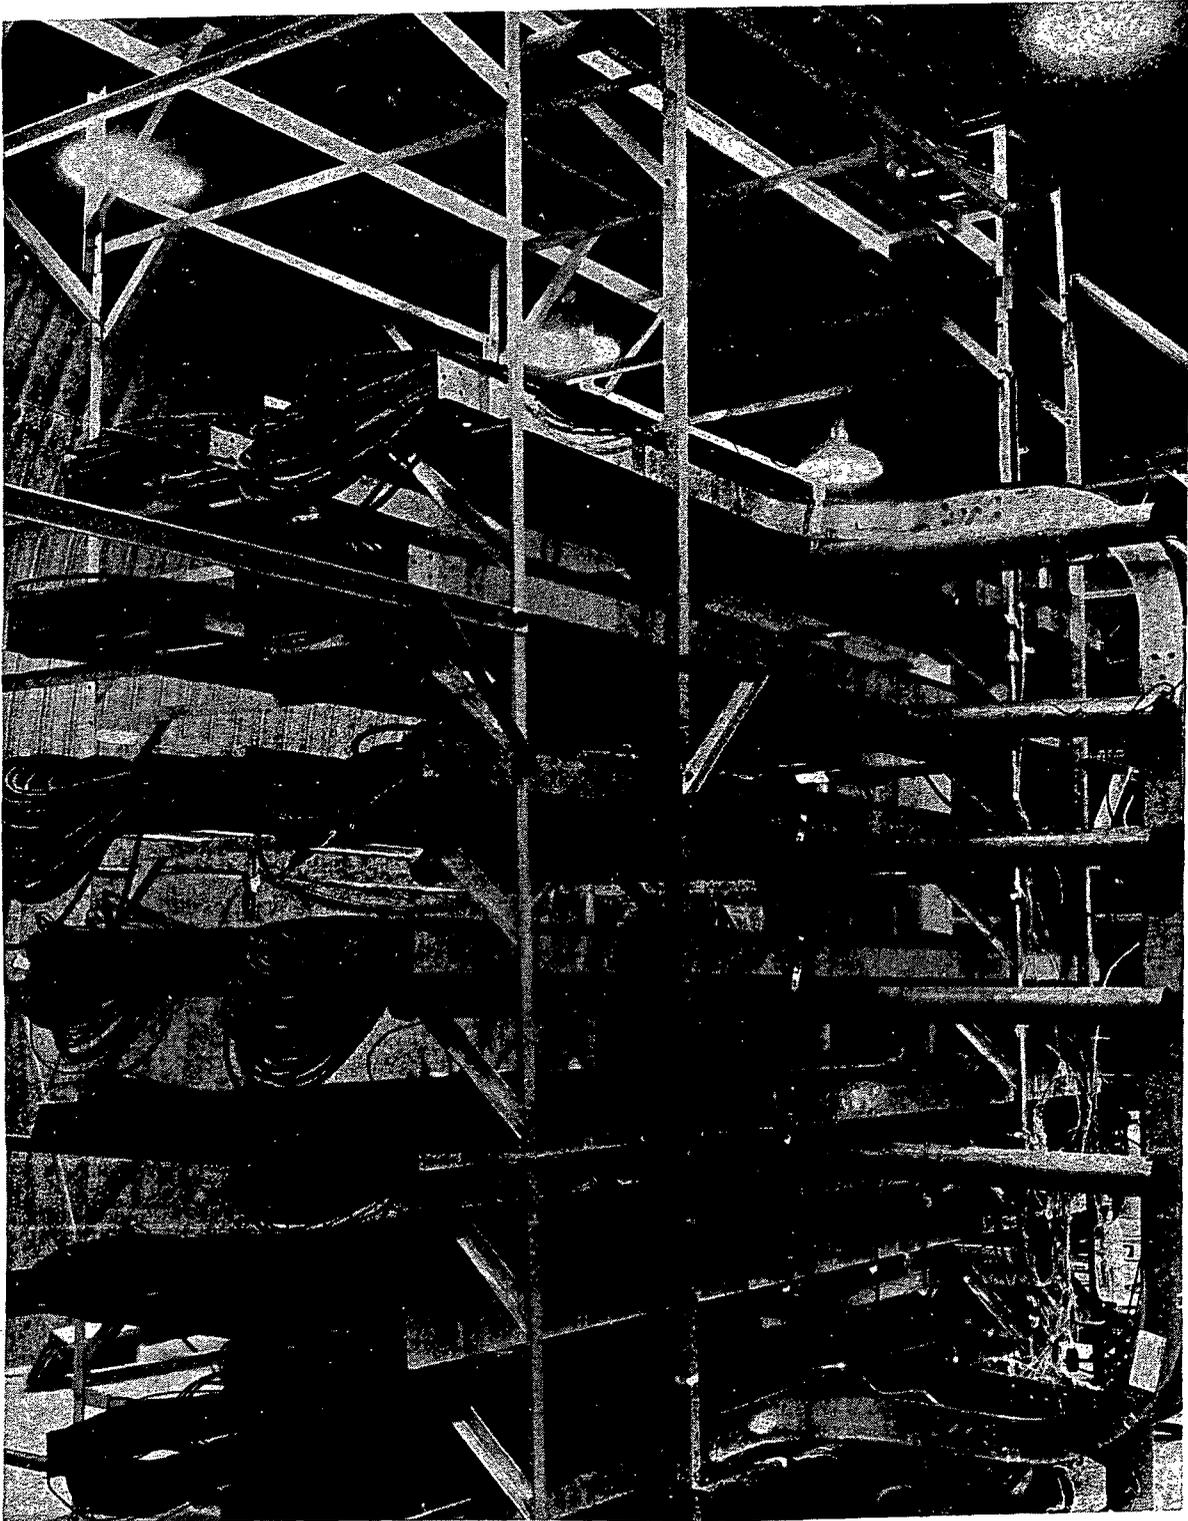
Seventeen Tray Arrangement

The third phase involved three tests, each consisting of two vertical stacks (total of 14 trays) for one safety division, and three trays for the second division. The spacing conformed to Regulatory Guide 1.75. A mixture of one-conductor and three-conductor No. 12 AWG cross-linked PE cables was used. Short circuits and fires occurred between 94 and 105 amps. Once again, electrical damage was confined to the ignition tray and the fire did not propagate. Figure 5 illustrates the test configuration for the phase three tests as well as the July 6, 1977 exposure test described below.

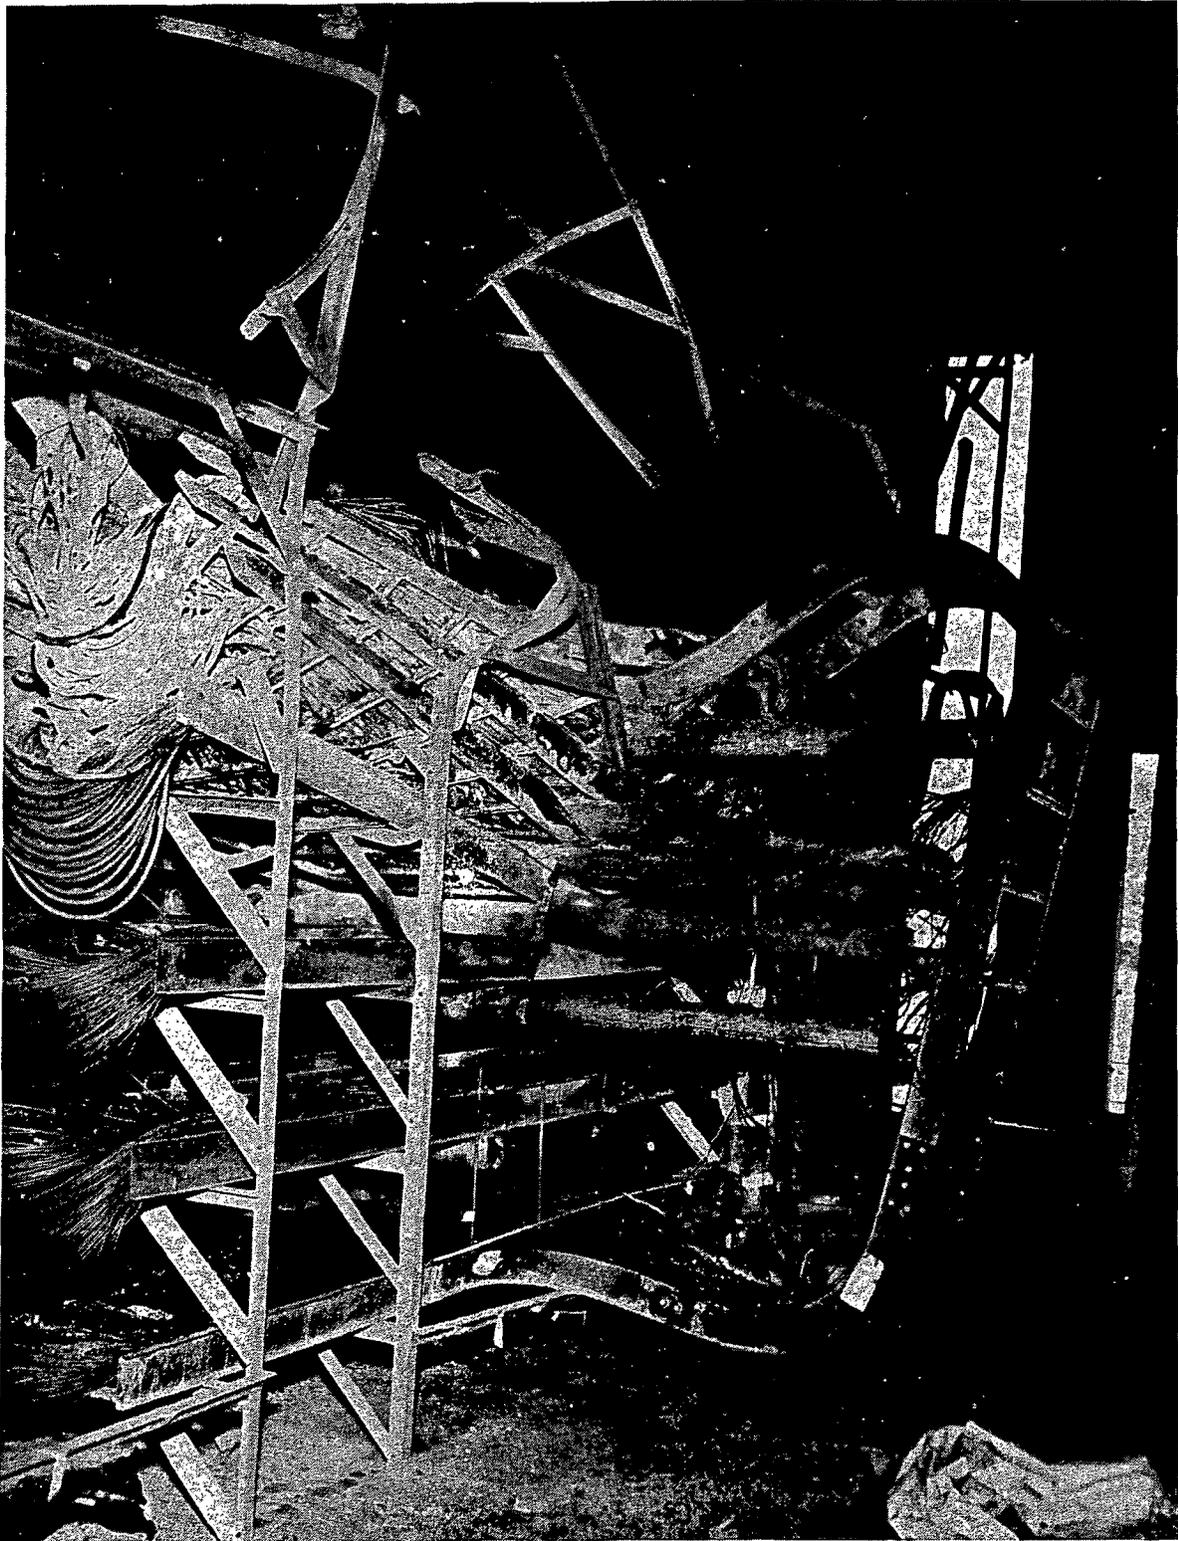
Figure 6

Post-Test Results of July 6, 1977 Test

A 5-minute exposure to standardized (IEEE-383 ribbon type) propane burners produced a fully developed fire within a single cable tray. Optimized parameters for this type of fire were obtained in a series of 12 single-tray tests performed earlier. A barrier was placed over the donor tray until after the propane burners were turned off and was then removed to allow the single-tray fire, with only the cable as fuel, to act as a propagation source. The fire not only propagated through the closely stacked trays of one division but also ignited the cables in the redundant safety division. The after effects of the test are shown in Figure 6. This illustration is a bit deceiving in that the cable tray supports were made of aluminum rather than steel, and hence were more susceptible to structural damage resulting from high temperatures. The important point to make is that the fire propagated from the ignition tray up through the first safety division and to the second safety division.

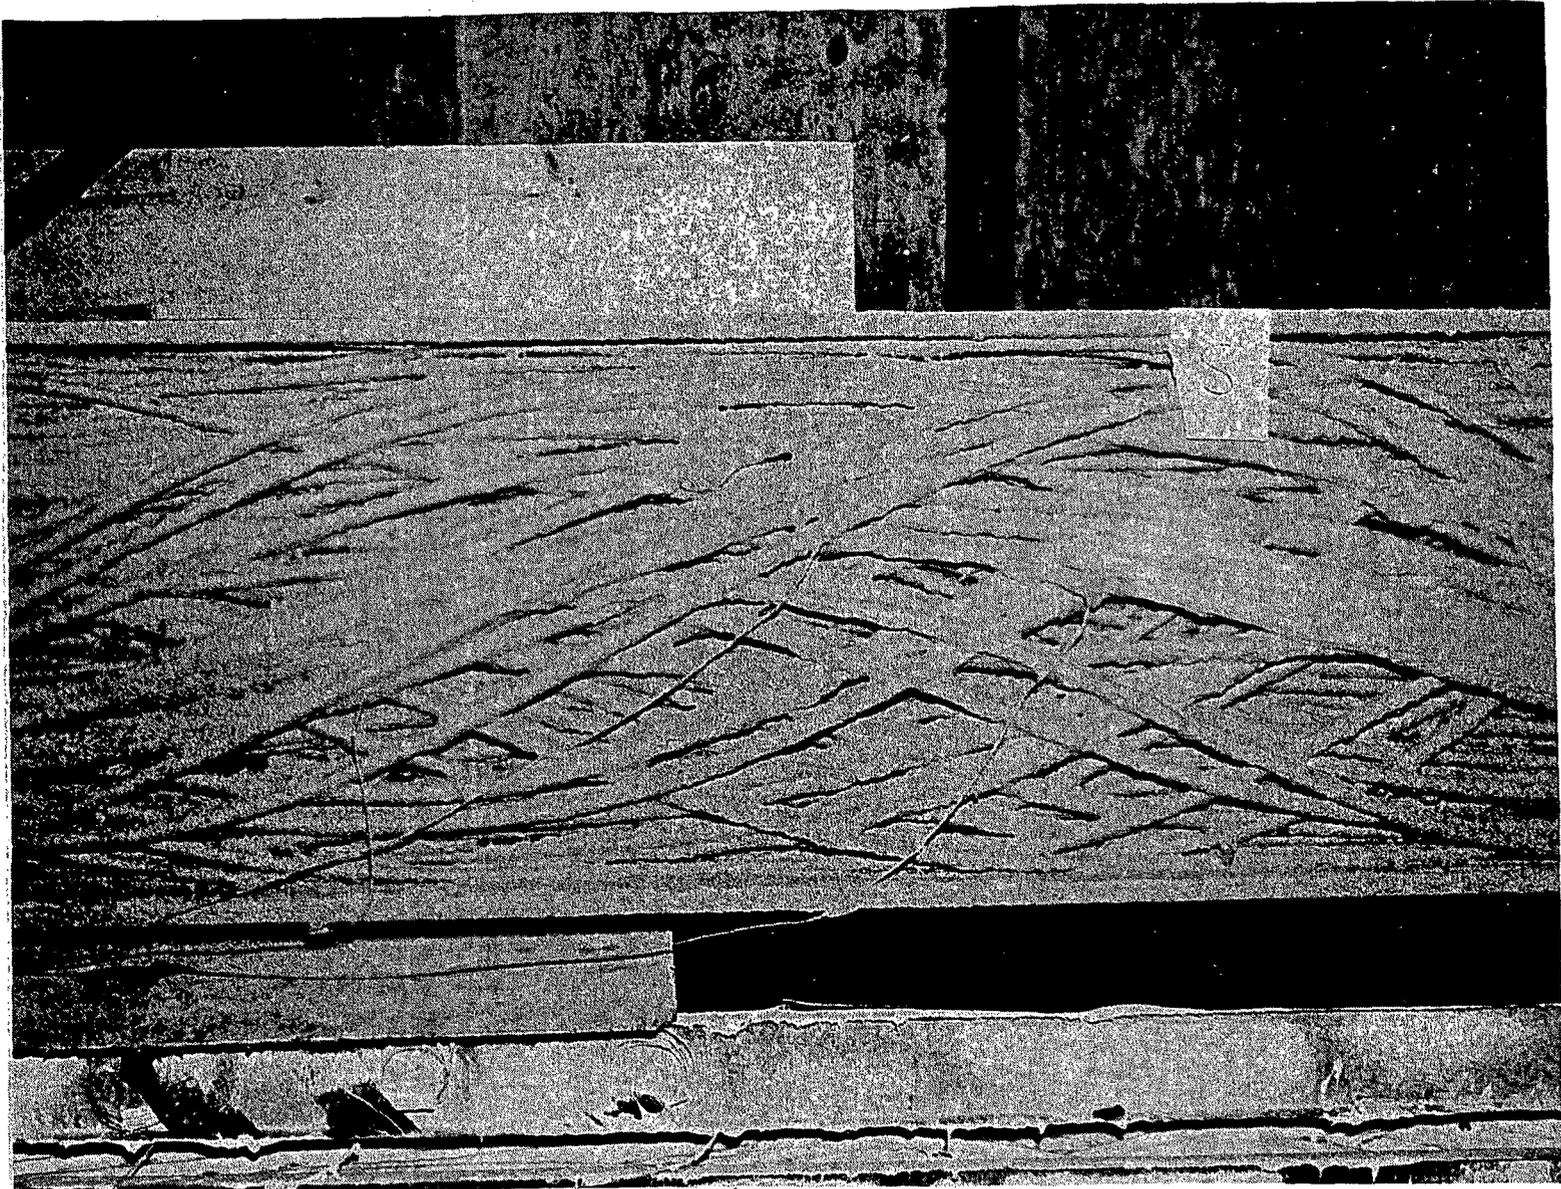
Figure 7

Coating "C" Prior to Test 33

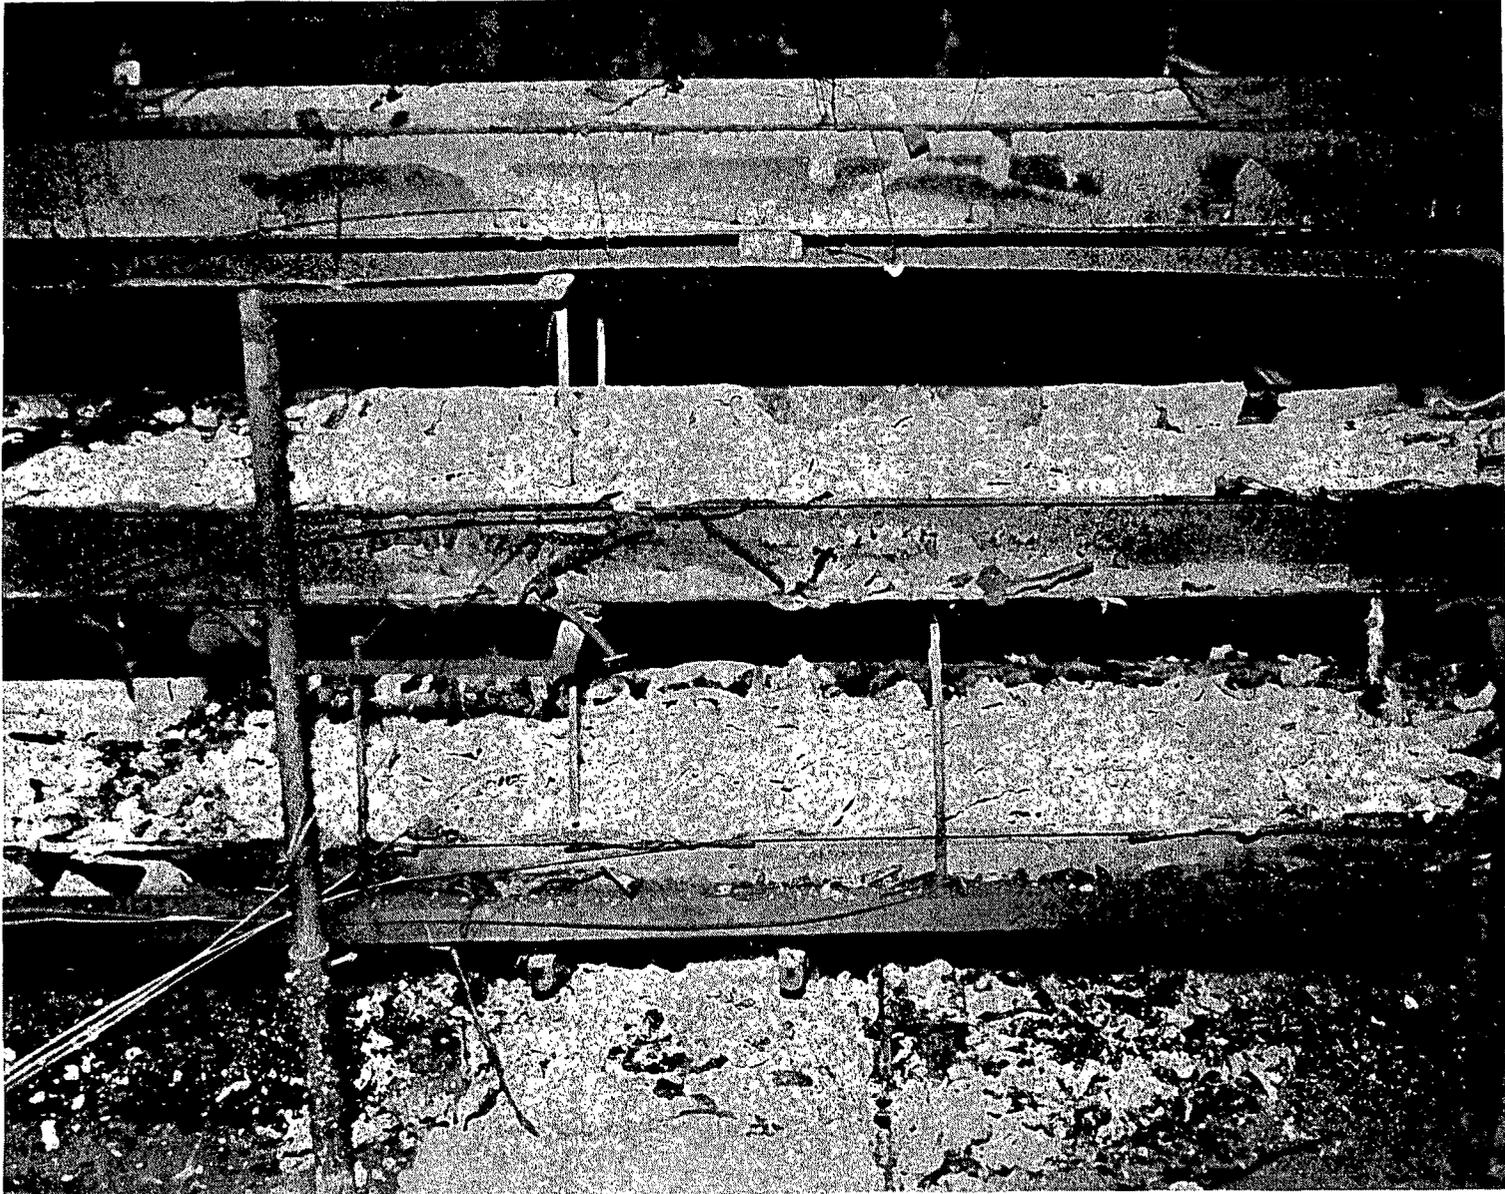
Figure 8

Results of Test 33 Using Coating "C"

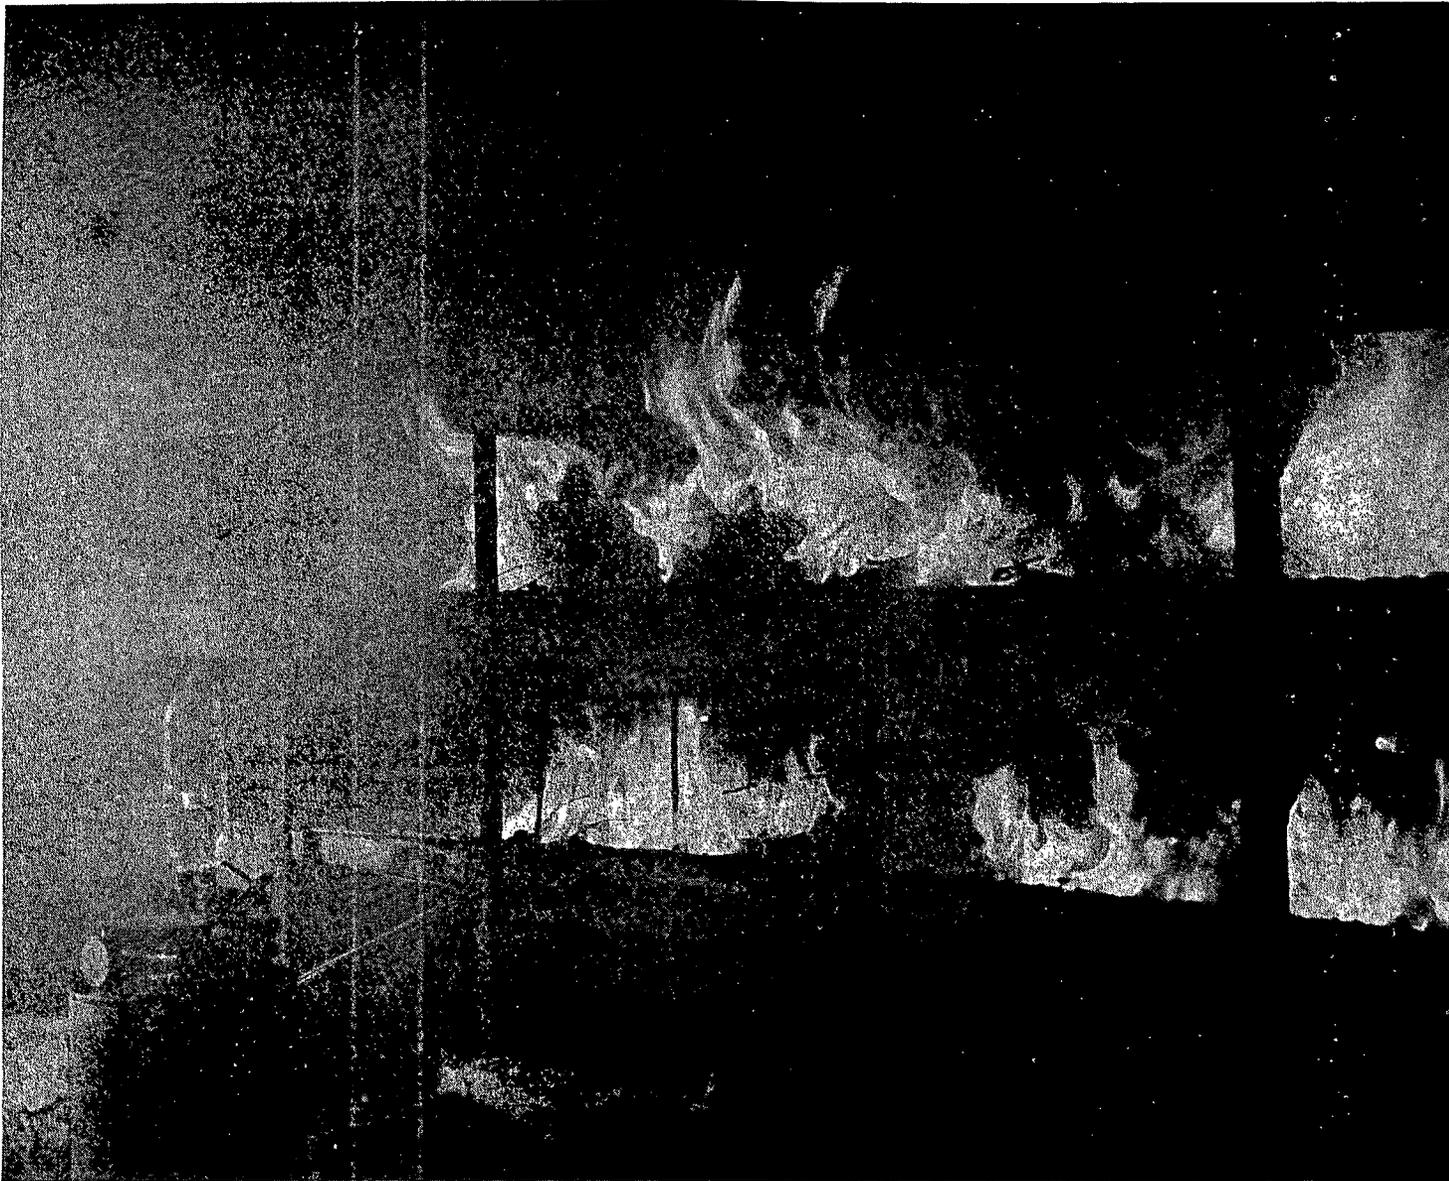
Test 47 Diesel-Fueled Fire

Another series of tests used the two-tray configuration previously described. However, the ignition source was a diesel-fueled fire which burned for about 13 minutes before self-extinguishing. Another important difference is that no barrier was placed between the trays so that both trays might be exposed to the diesel fire. Five tests were conducted altogether. The rankings of the relative performance of the cable coatings was in good agreement with single-tray and two-tray tests. Figure 9 shows the intensity of the fire during Test 47 (Coating C, unqualified cable in an open ladder configuration). Detailed results can be found in References 25 and 26.

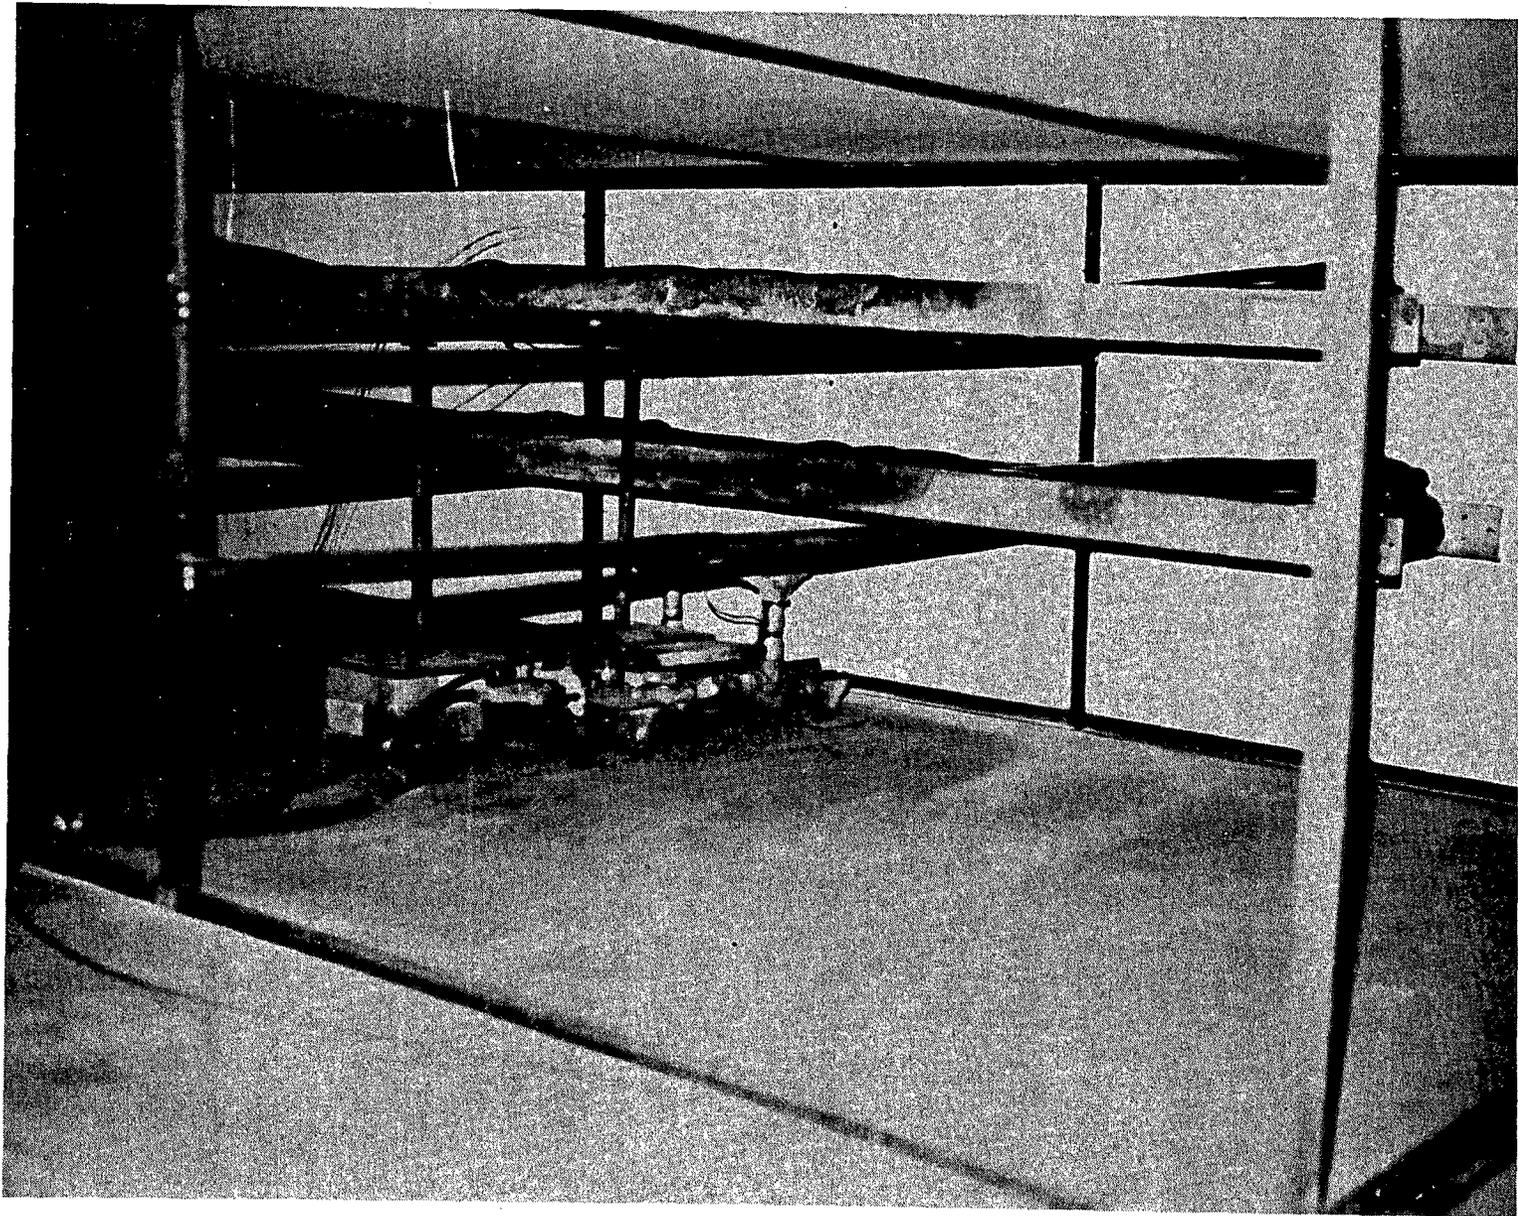
Figure 11.

Corner Effects Test Arrangement

Originally, it was planned to have concrete walls and ceilings provide a corner to simulate the usual conditions found in a nuclear power plant. A review of fire literature and a brief investigation led to the conclusion that a corner made of ceramic fiber boards would be little different from a concrete corner for the duration of the test fire.³⁰⁻³² This construction was used for ease of assembly and economy. Six 4 x 8 foot (1.2 x 2.4 m) ceramic fiber boards 1 in. (2.54 cm) thick were arranged as shown in Figure 11 to form a corner above and beside two horizontally oriented cable trays, with the top tray 10.5 in. (26.7 cm) above the other.

Six tests were run in this series, three each with the IEEE-383 qualified and unqualified cable. The three distances from the ceiling to the top tray were 10.5, 18, and 120 in. (0.27, 0.46, and 3.05 m). The wall distances to the edge of the tray were 5, 10.5, and 60 in. (0.13, 0.27 and 1.52 m).

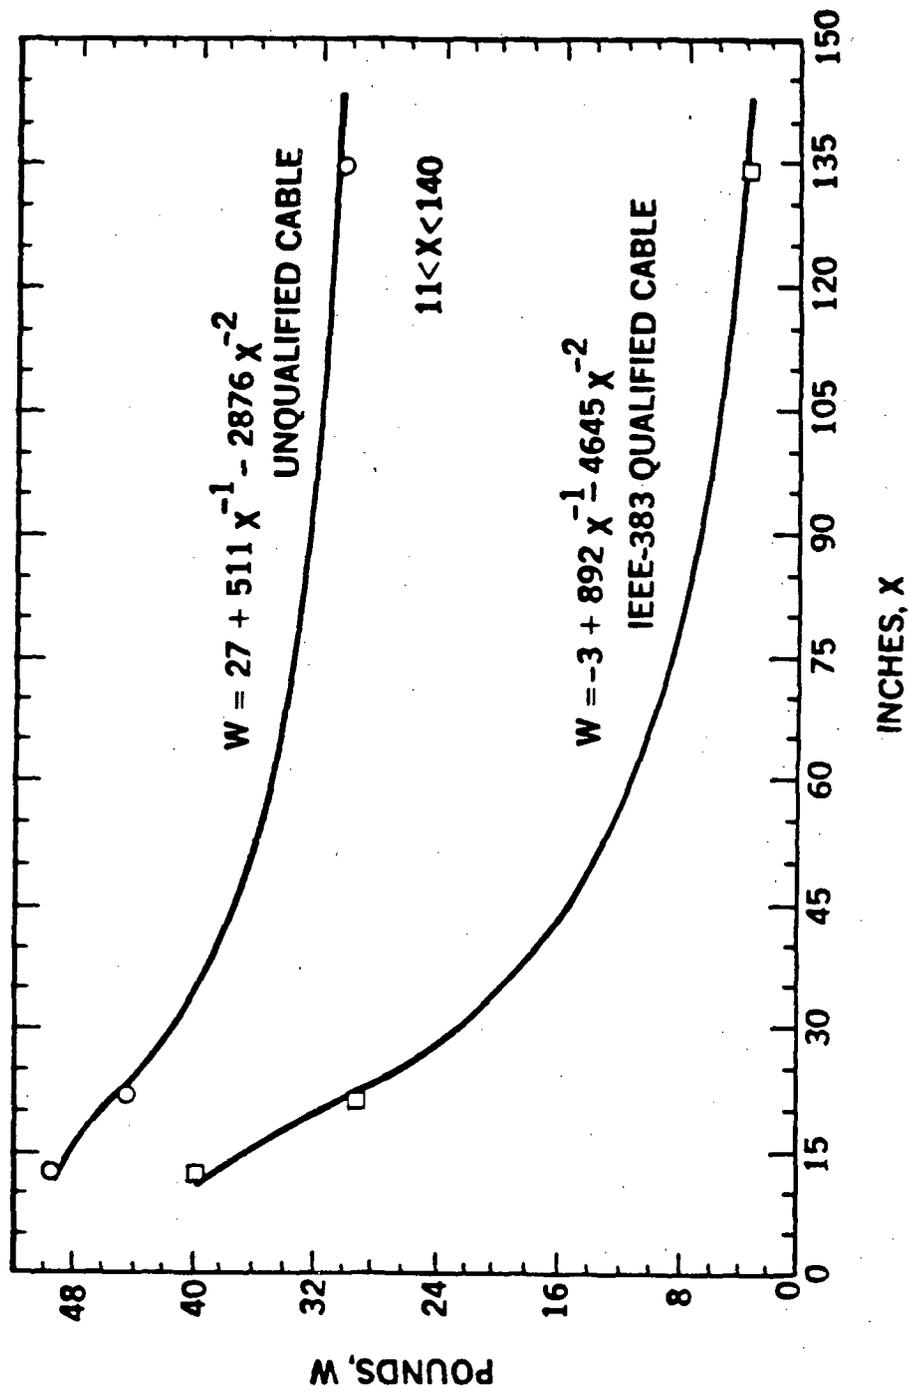
Figure 12
 Cable Weight Loss as Function of Corner Distance

An inverse relationship was found between fire intensity and wall/ceiling distance in these corner effects tests. Beyond a diagonal distance (from tray edge to corner) of 6 ft (1.8 m) there was little effect.

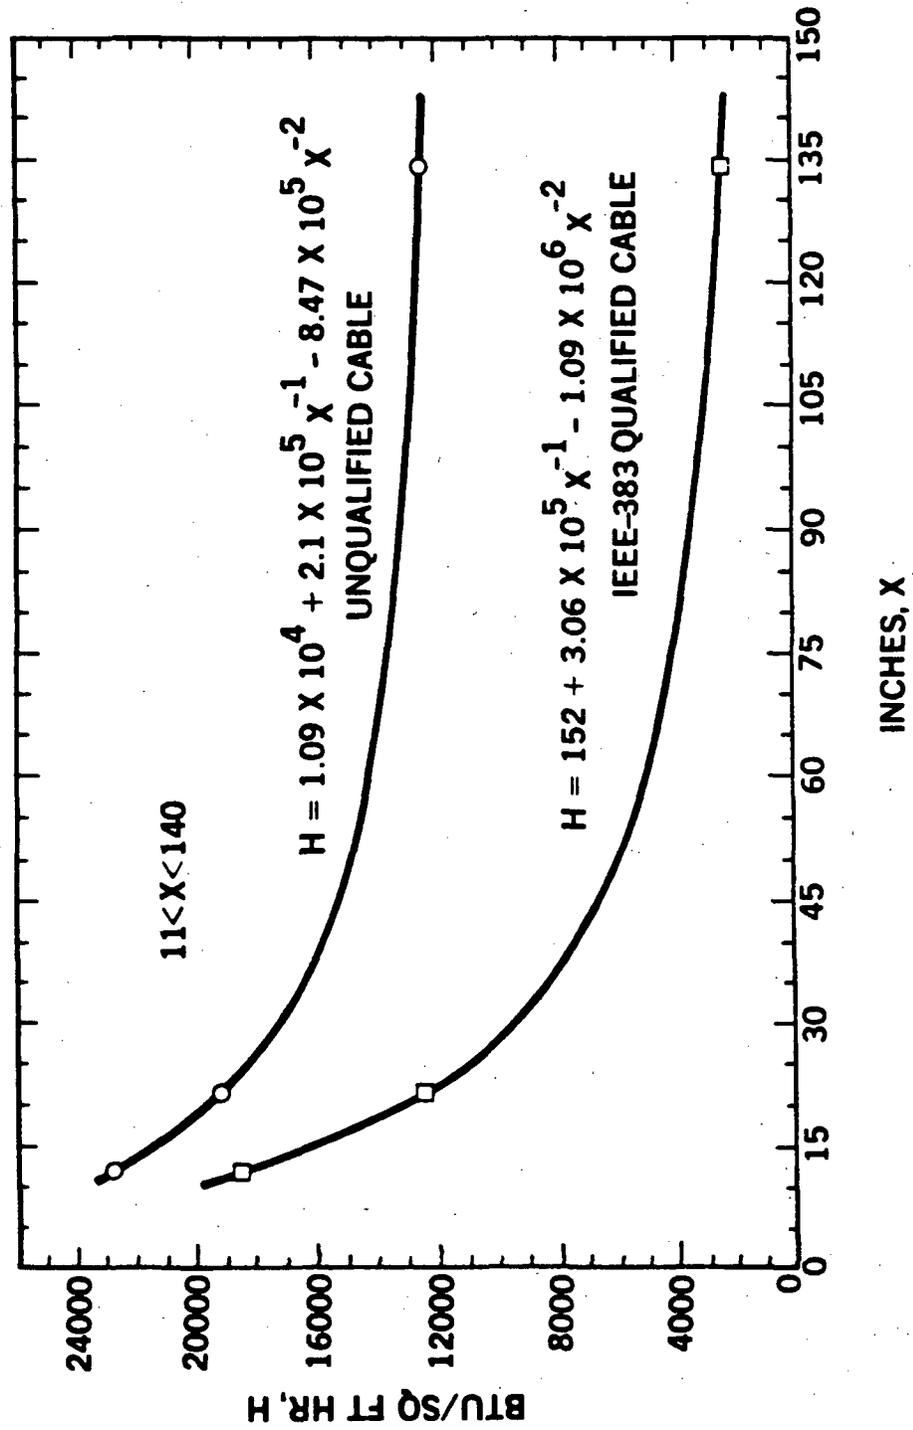
Figure 13
 Maximum Heat Flux From Cable Tray Fire as
 Function of Corner Distance

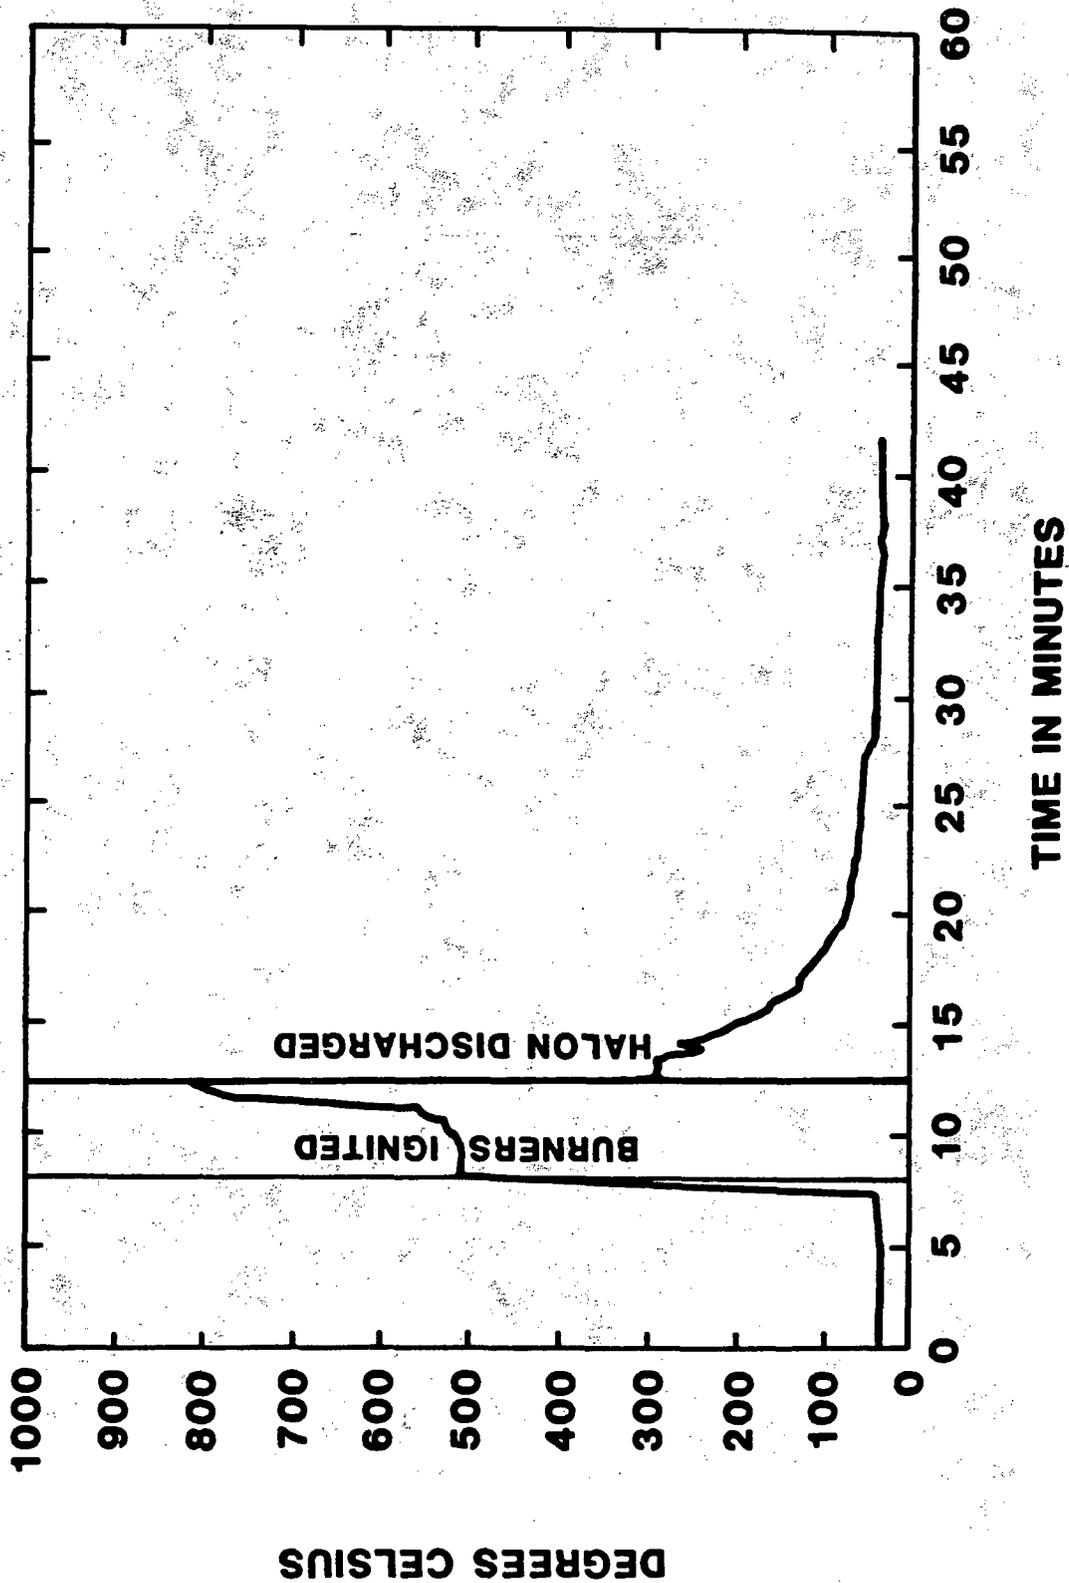
Figure 16

**TEST #61 UNQUALIFIED CABLE, HORIZONTAL TRAYS, 16 MIN HALON SOAK
LOWER BARRIER TEMPERATURE**

Temperature Drop in Flaming Region

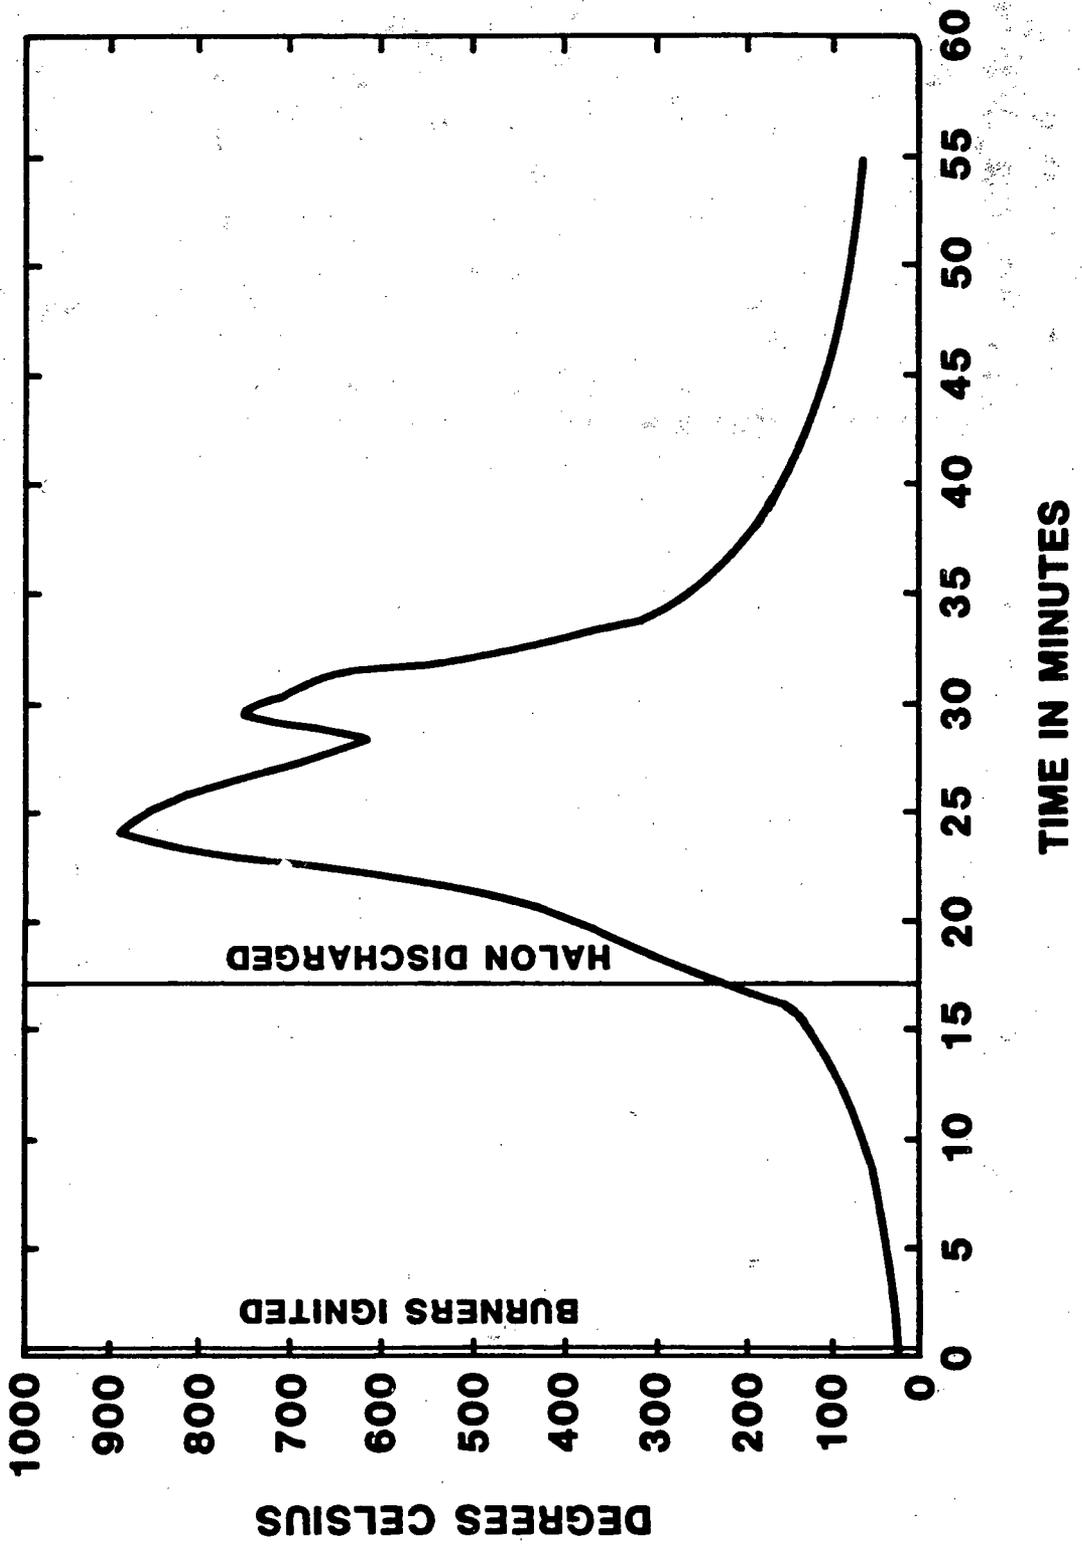
Figure 17

**TEST # 60, IEEE-383 CABLE, HORIZONTAL TRAYS, 4 MINUTE HALON SOAK
ACCEPTOR TRAY CENTER TEMPERATURE**

Indication of Deep-Seated Fire and Reignition of Cables

3. No flammable concentrations of unburned hydrocarbons were pyrolyzed during the Halon soak time in any of the tests.
4. A time limit on the Halon's ability to permanently extinguish a cable tray fire may have emerged. While a 10-minute interval of Halon soak was enough to extinguish a fire in a horizontally oriented tray filled with qualified cable, a 4-minute interval was inadequate for this task.
