NUREG/CR-2607
SAND82-0431
RP

FIRE PROTECTION RESEARCH PROGRAM FOR THE
U. S. NUCLEAR REGULATORY COMMISSION
1975-1981

Donald A. Dube
Systems Safety Technology Division

Date Published: April 1983

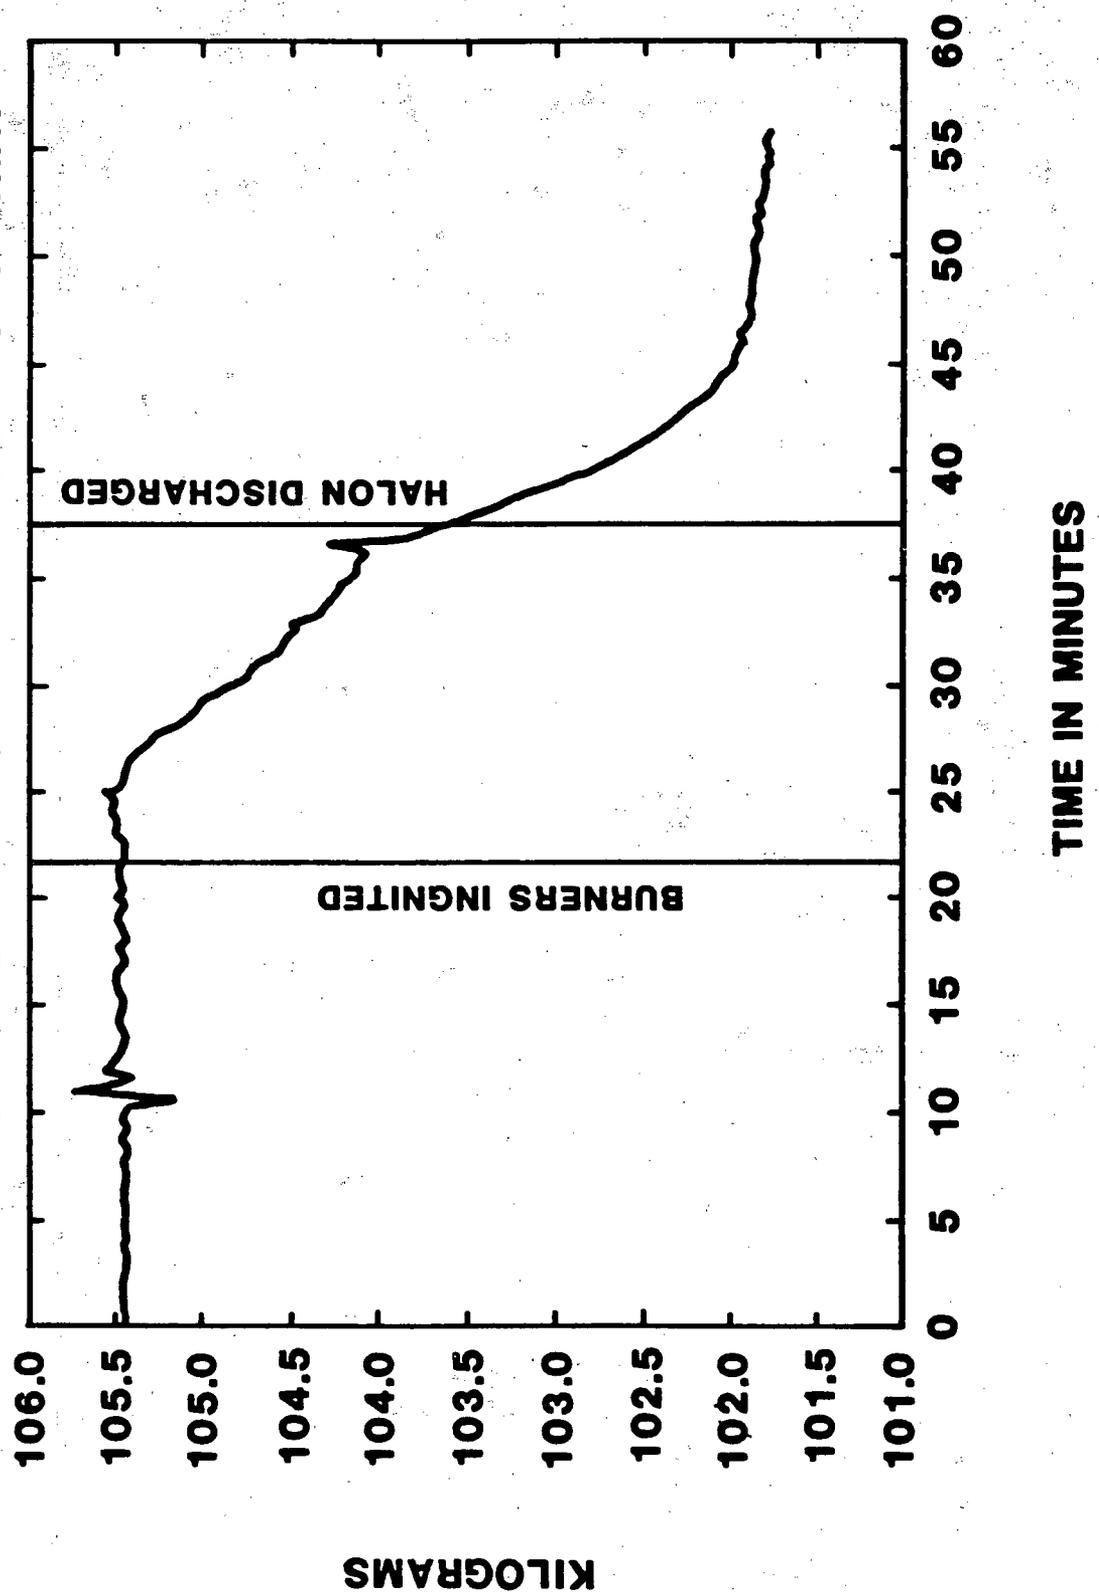
Figure 18
Mass Loss in Presence of Halon

**TEST #57, IEEE-383 CABLE, HORIZONTAL TRAYS,
10 MINUTE HALON SOAK, TOTAL MASS OF DONOR TRAY**

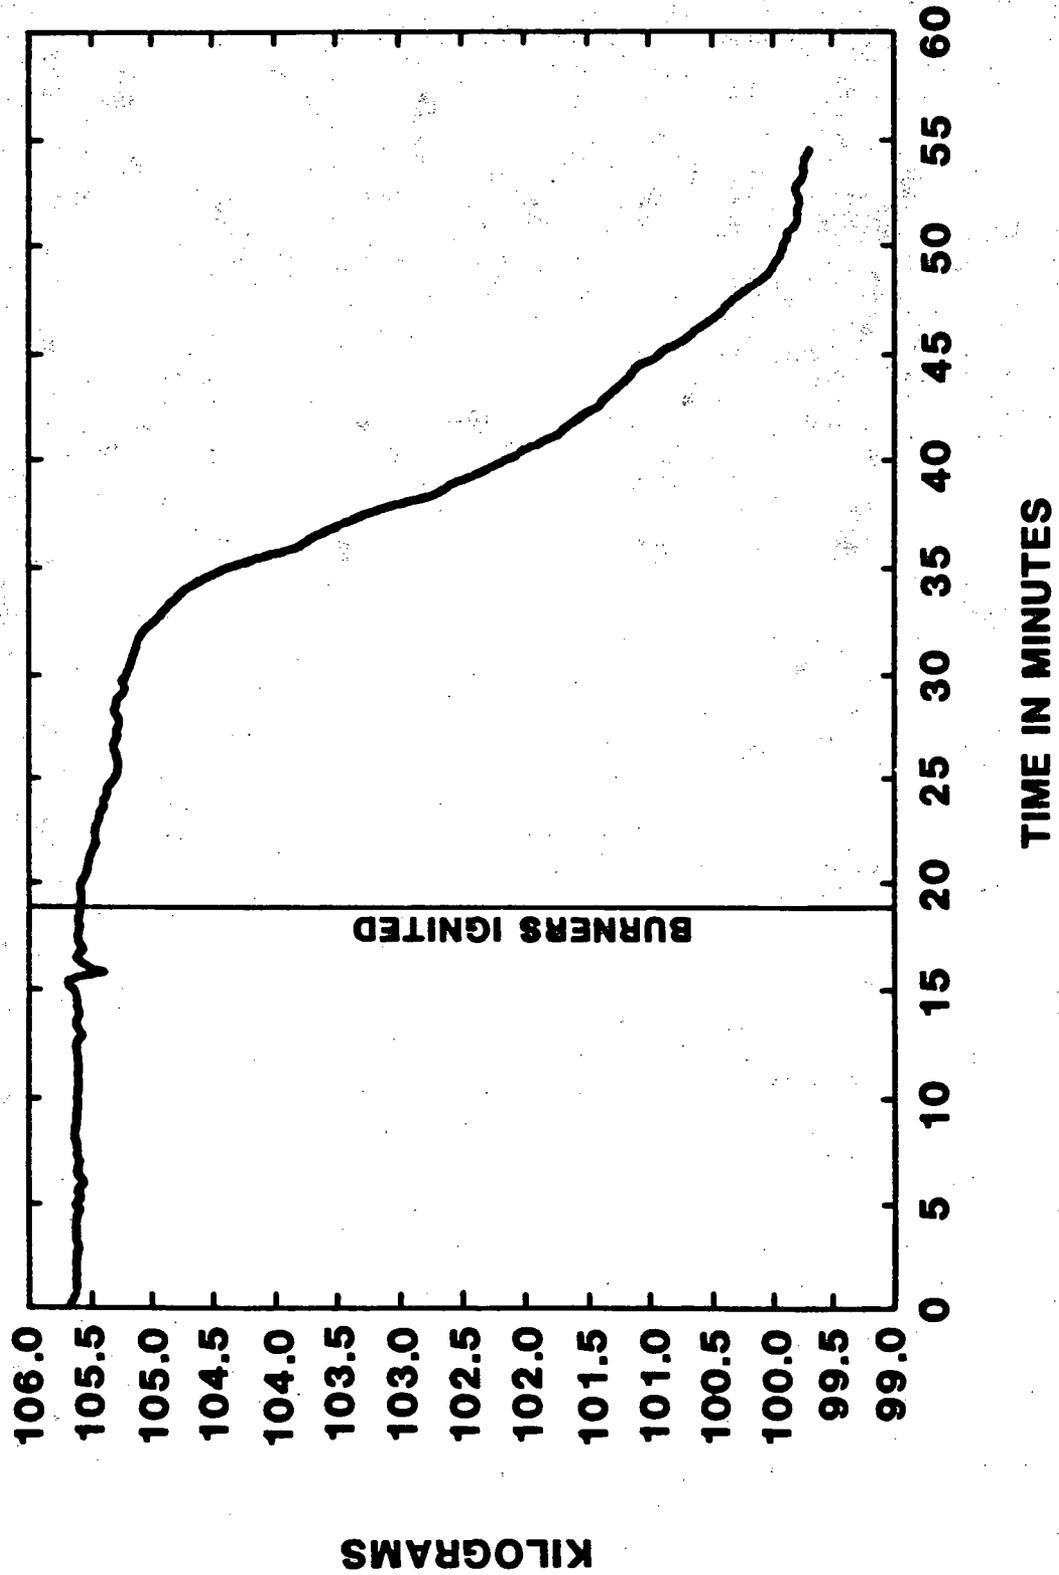
Figure 19

**TEST #59, IEEE-383 CABLE, HORIZONTAL TRAYS, NO HALON SOAK
TOTAL MASS OF DONOR TRAY**

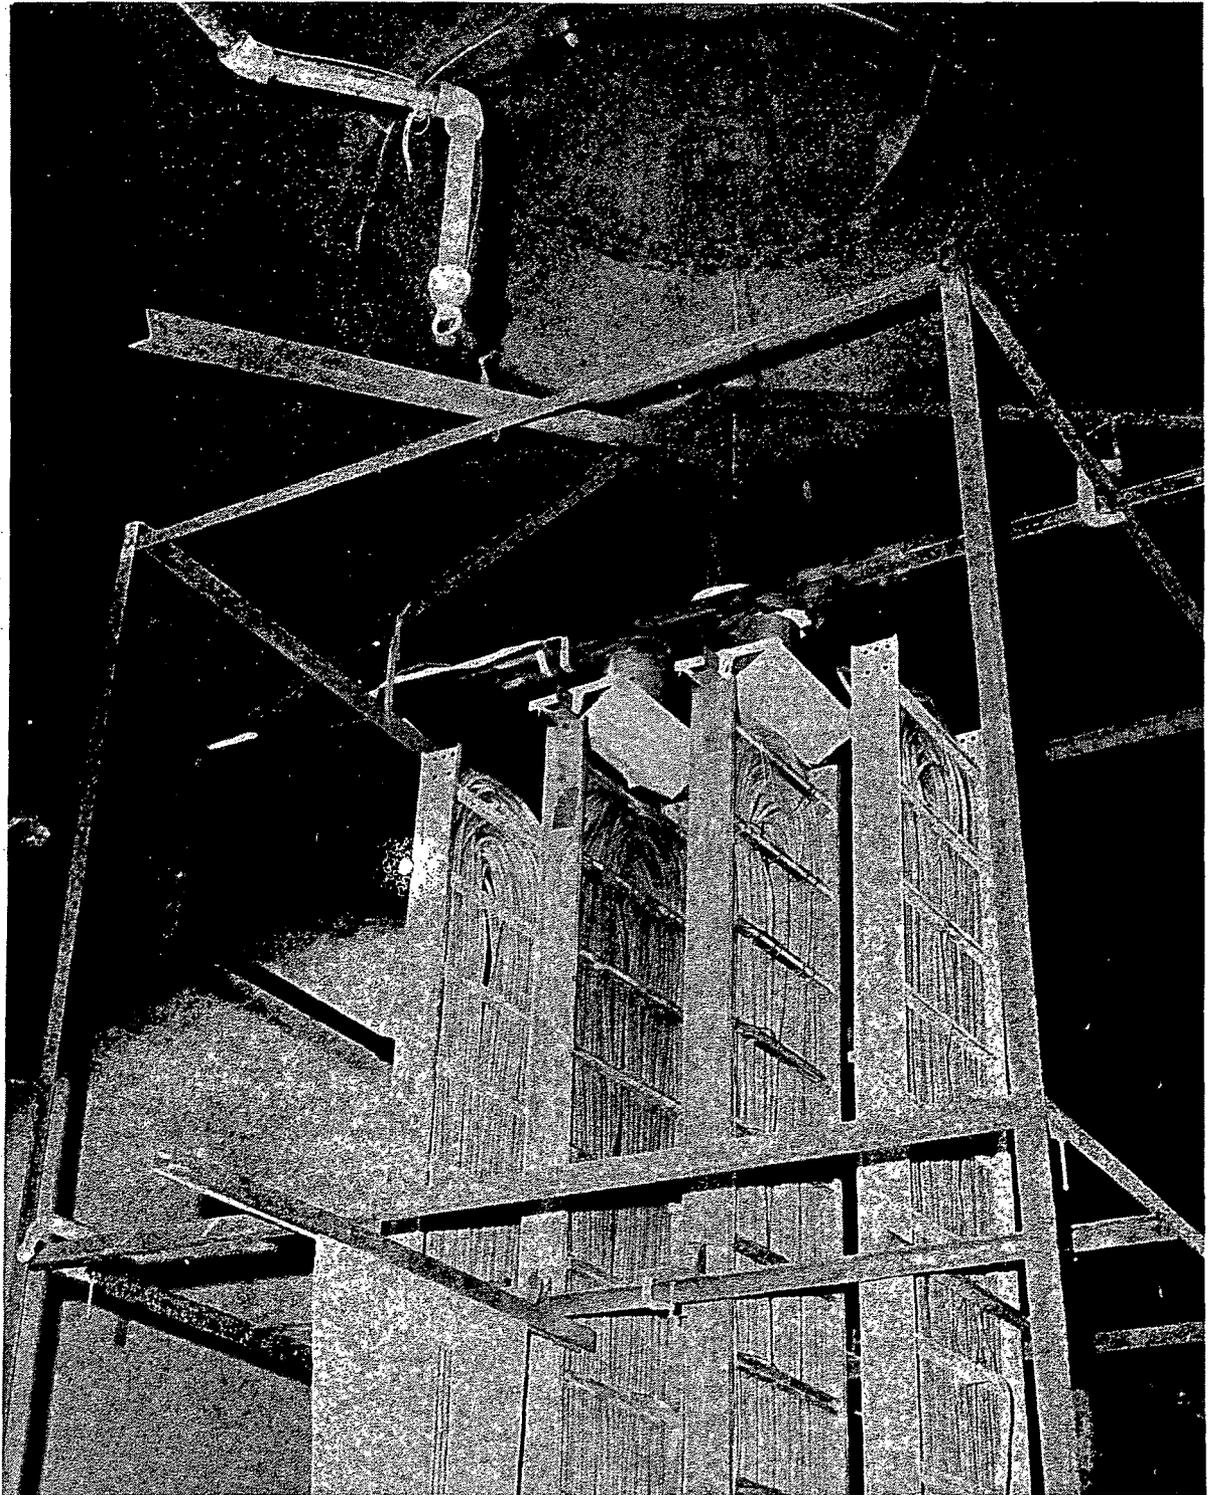
Figure 20

Water Sprinkler Test Arrangement
(Vertical Configuration)

The water sprinklers were successful in extinguishing all cable trays fires in the configurations tested. Suppression was more effective in the vertical configuration, with 4 to 5 minutes of suppression an adequate amount of time for vertical trays but marginally adequate for horizontal tray fires. Short circuits occurred quite readily in the acceptor tray when the water was discharged, but the cause of the shorts is uncertain.

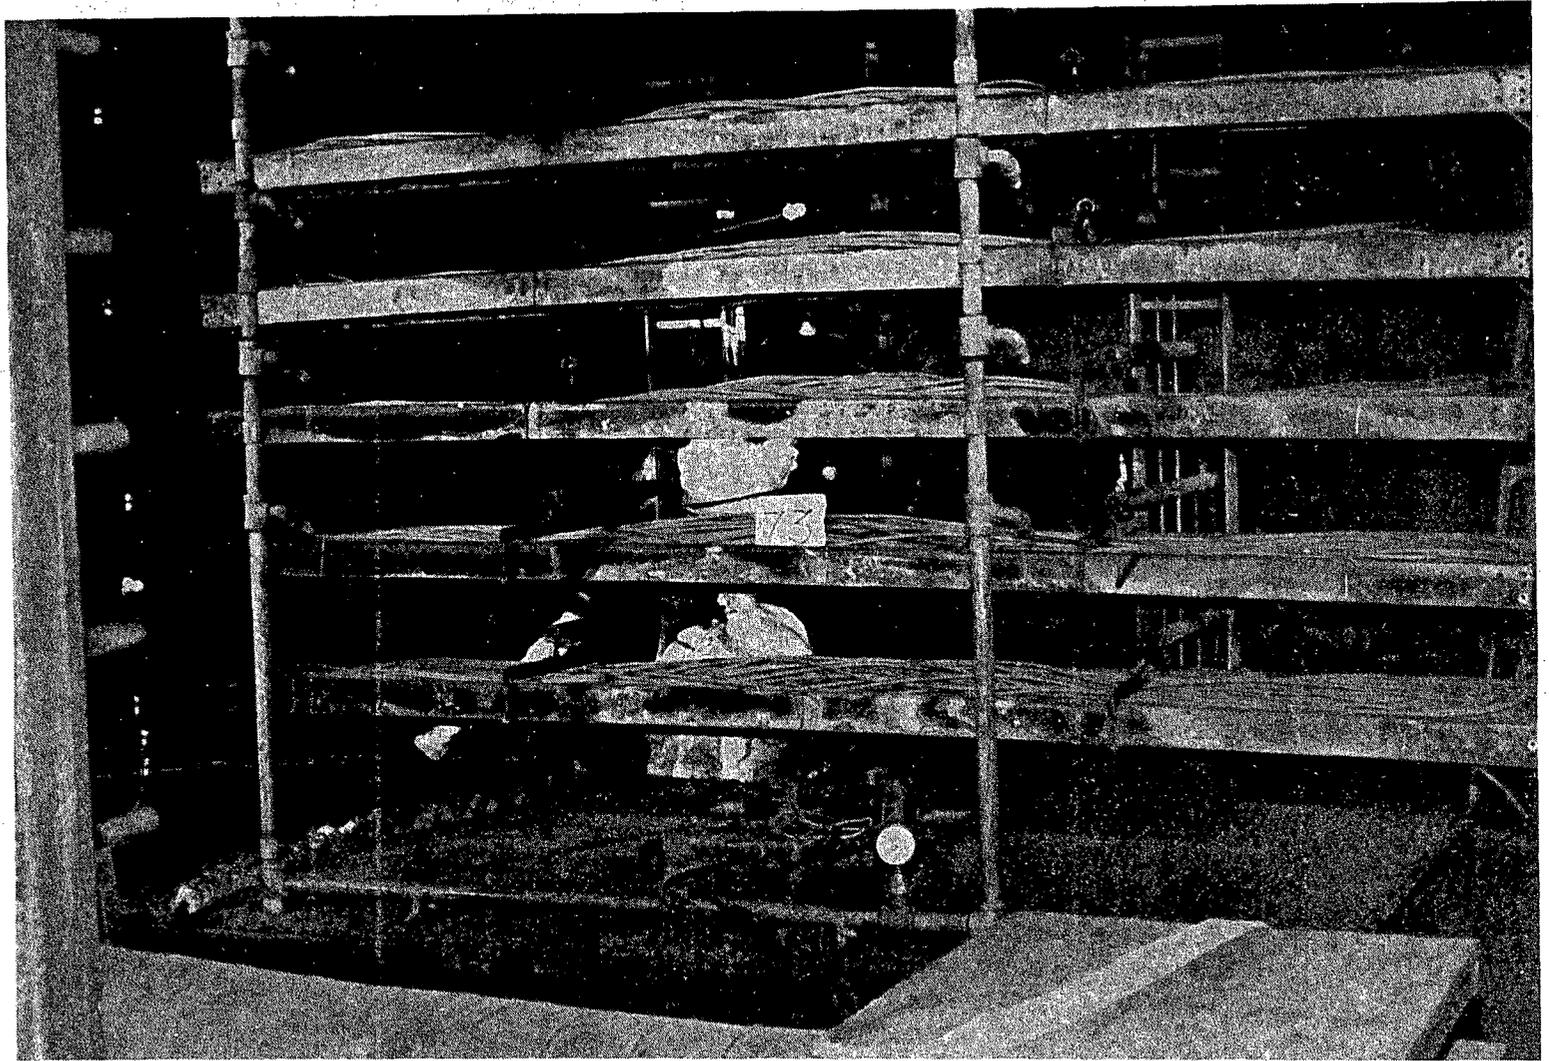
Figure 21

Directed Water Spray Test Arrangement
(Horizontal Configuration)

Another series of water tests was conducted to determine the effectiveness of directed water sprays in suppressing cable tray fires. Tests were conducted in both the vertical and horizontal configurations, and with both IEEE-383 qualified and unqualified cables. A total of five, 12-ft (3.7-m)-long cable trays filled to 25 percent were used in each test. Unlike the Halon and water sprinkler suppression tests, the intention in these tests was to obtain fully developed fires in four of the five cable trays before manually activating the water suppression system. Although no final report on these tests has been issued as yet, the results are briefly summarized here. Table IX lists the tests performed to date and the results.

Flat, fan-type spray nozzles were used. A uniform distribution of spray was provided over an angle of 100°. The orifice size was 7/64 in. (2.8 mm) and each of the ten nozzles used in all the tests provided 2.7 GPM (0.17 l/s) at a static pressure of 81 psig (5.6×10^5 Pa), or a flow density of 0.3 GPM per ft² (12.2 l/min-m²) of cable tray surface area. These values are in compliance with NFPA 15 standards for identified fire hazards.⁴

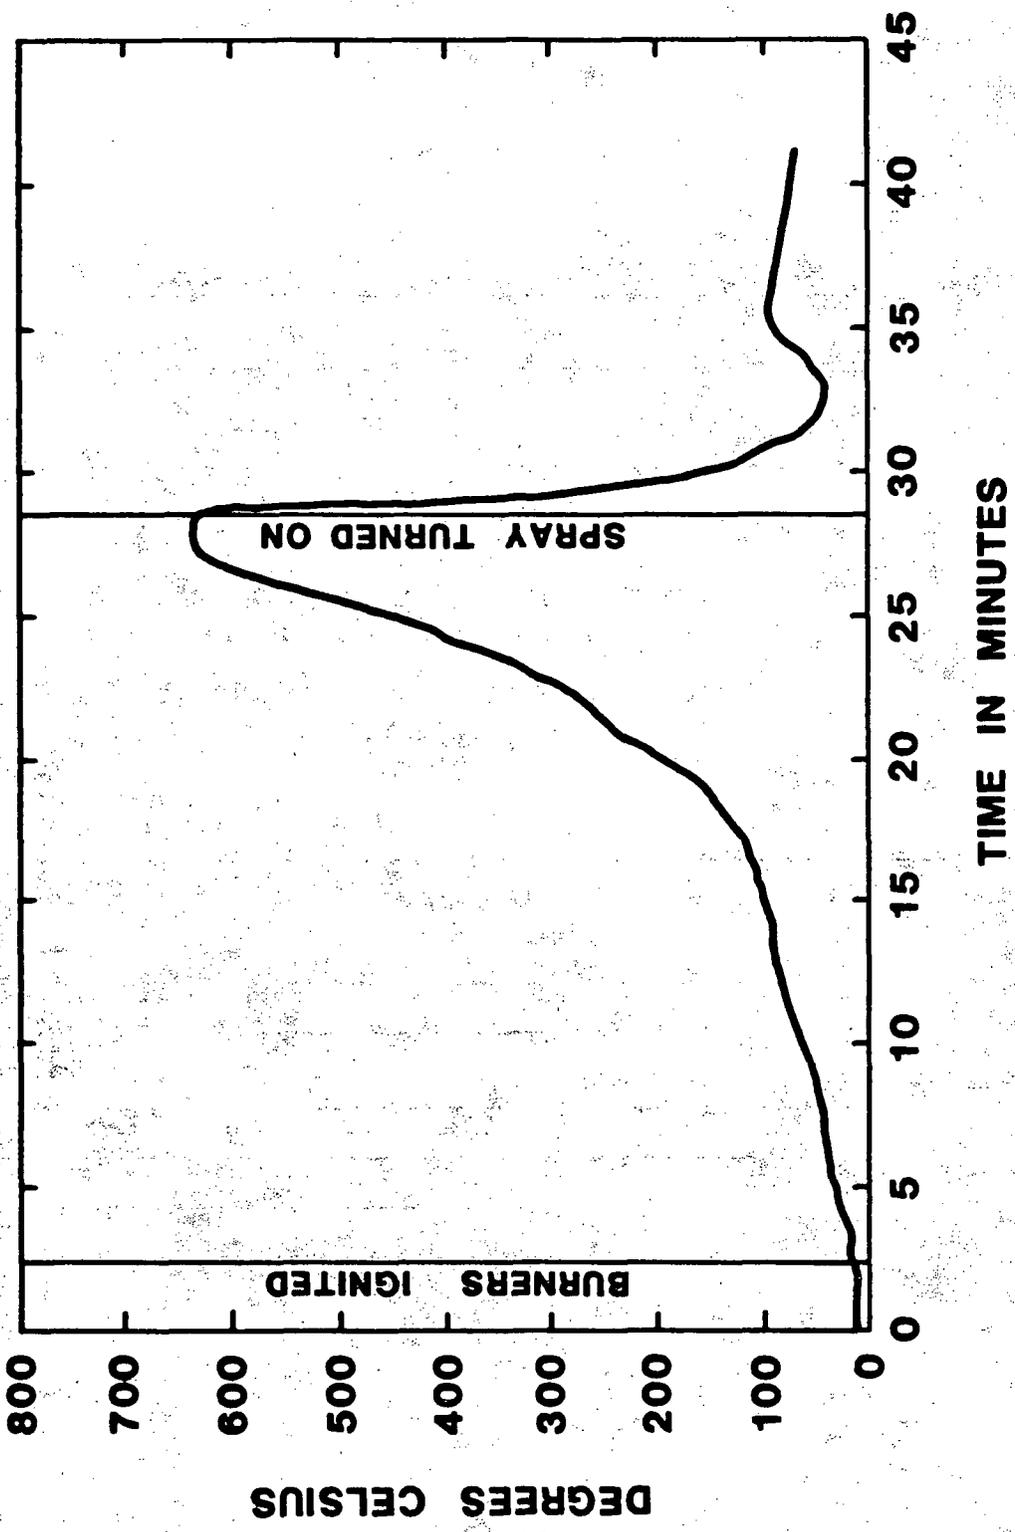
Figure 22

**TEST NO. 75, 5 TRAY VERTICAL ARRANGEMENT, IEEE-383 QUALIFIED CABLES
5 MINUTE WATER SPRAY, TRAY 2 TEMPERATURE (126 INCHES UP FROM BOTTOM)**

Indication of Effectiveness of Directed Water Spray

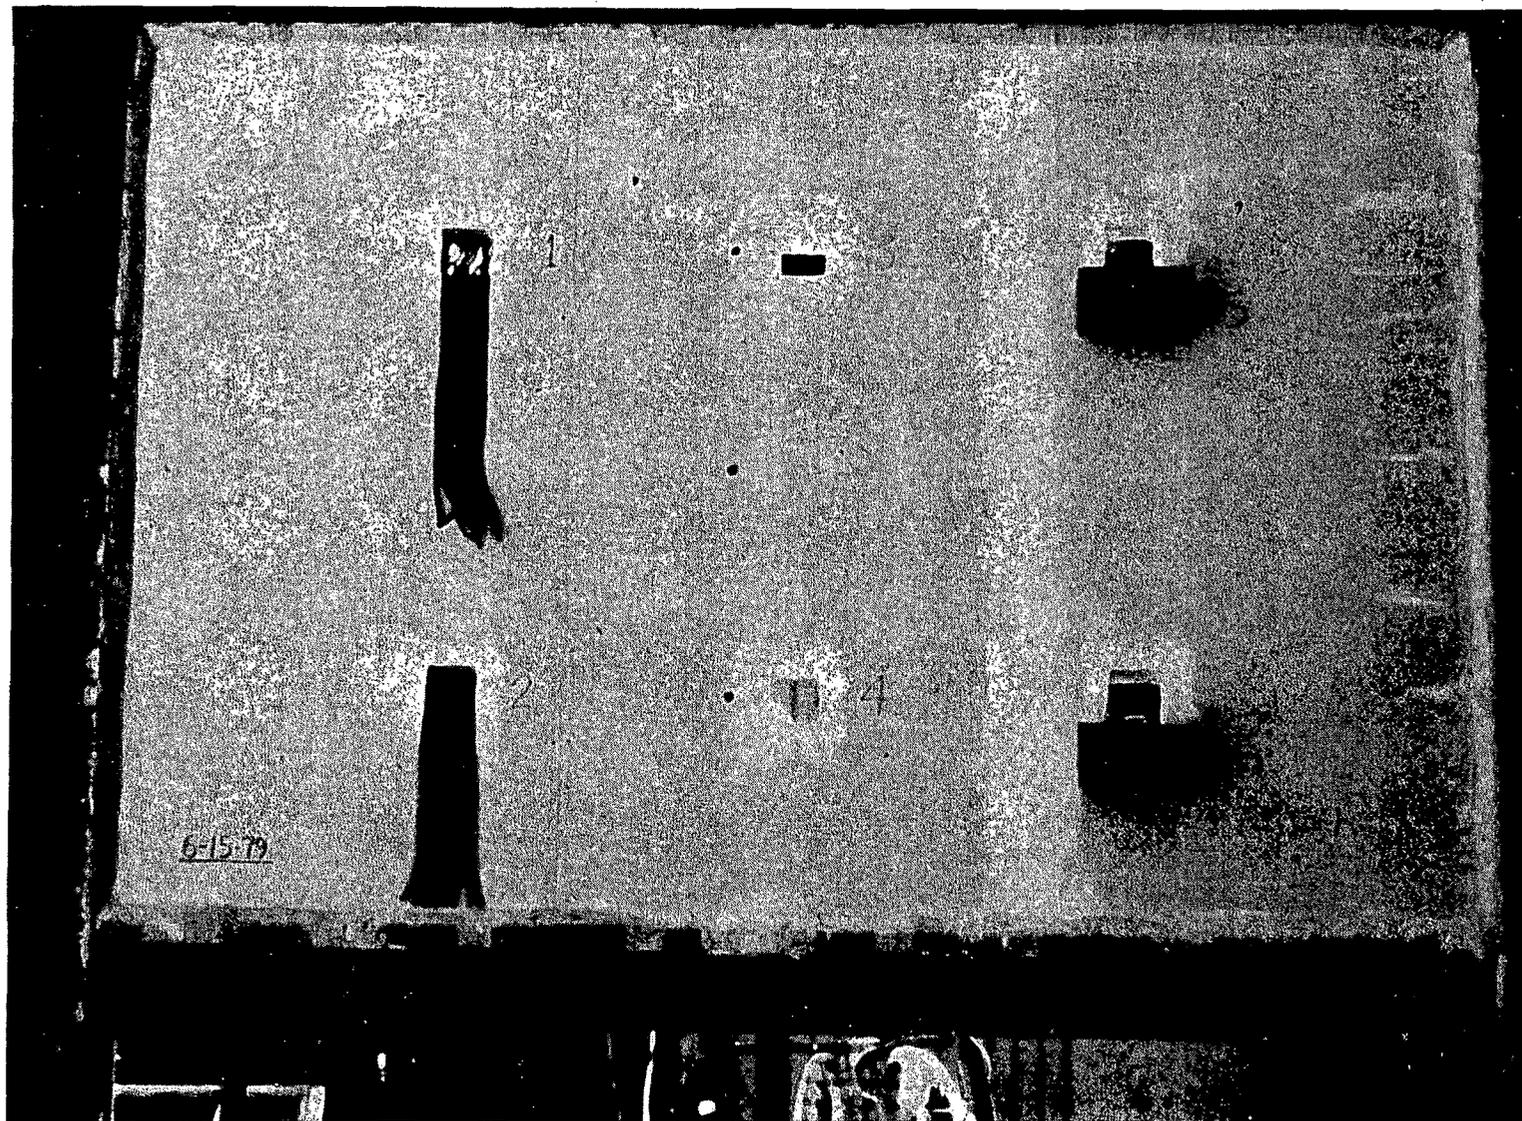
Figure 24

Each of the three experiments employed identical walls (see Figure 24). The walls consisted of a 76 mm (3 in.)-thick, phenolic impregnated, paper honeycomb core covered on each side with three layers of 13 mm (1/2 in.)-thick gypsum wall board. The finished walls were 0.152 m (6 in.) thick, 2.44 m (8 ft-0 in.) high and 3.66 m (12 ft-0 in.) in length. A total of six penetrations were introduced into each wall. The penetrations measured 0.152 m x 0.152 m (6 in. x 6 in.) and were symmetrically arranged. The conditions present at each of the penetrations during the experiments are summarized in Tables XI to XIII.

Large-Scale Penetration Seal Tests at U-C Berkeley

The large-scale vertical furnace used in these experiments consists of a reinforced concrete frame lined with refractory material. The furnace opening is 3.66 m (12 ft-0 in.) wide and 3.35 m (11 ft-0 in.) high. The furnace is fired by 44 burners using natural gas fuel. The burners can be operated in either a premixed or diffusion mode. During these experiments the burners were operated in a premixed mode. The 44 burners are arranged so that the furnace temperature can be maintained in accordance with the standard temperature-time curve as specified by ASTM Designation E-119.

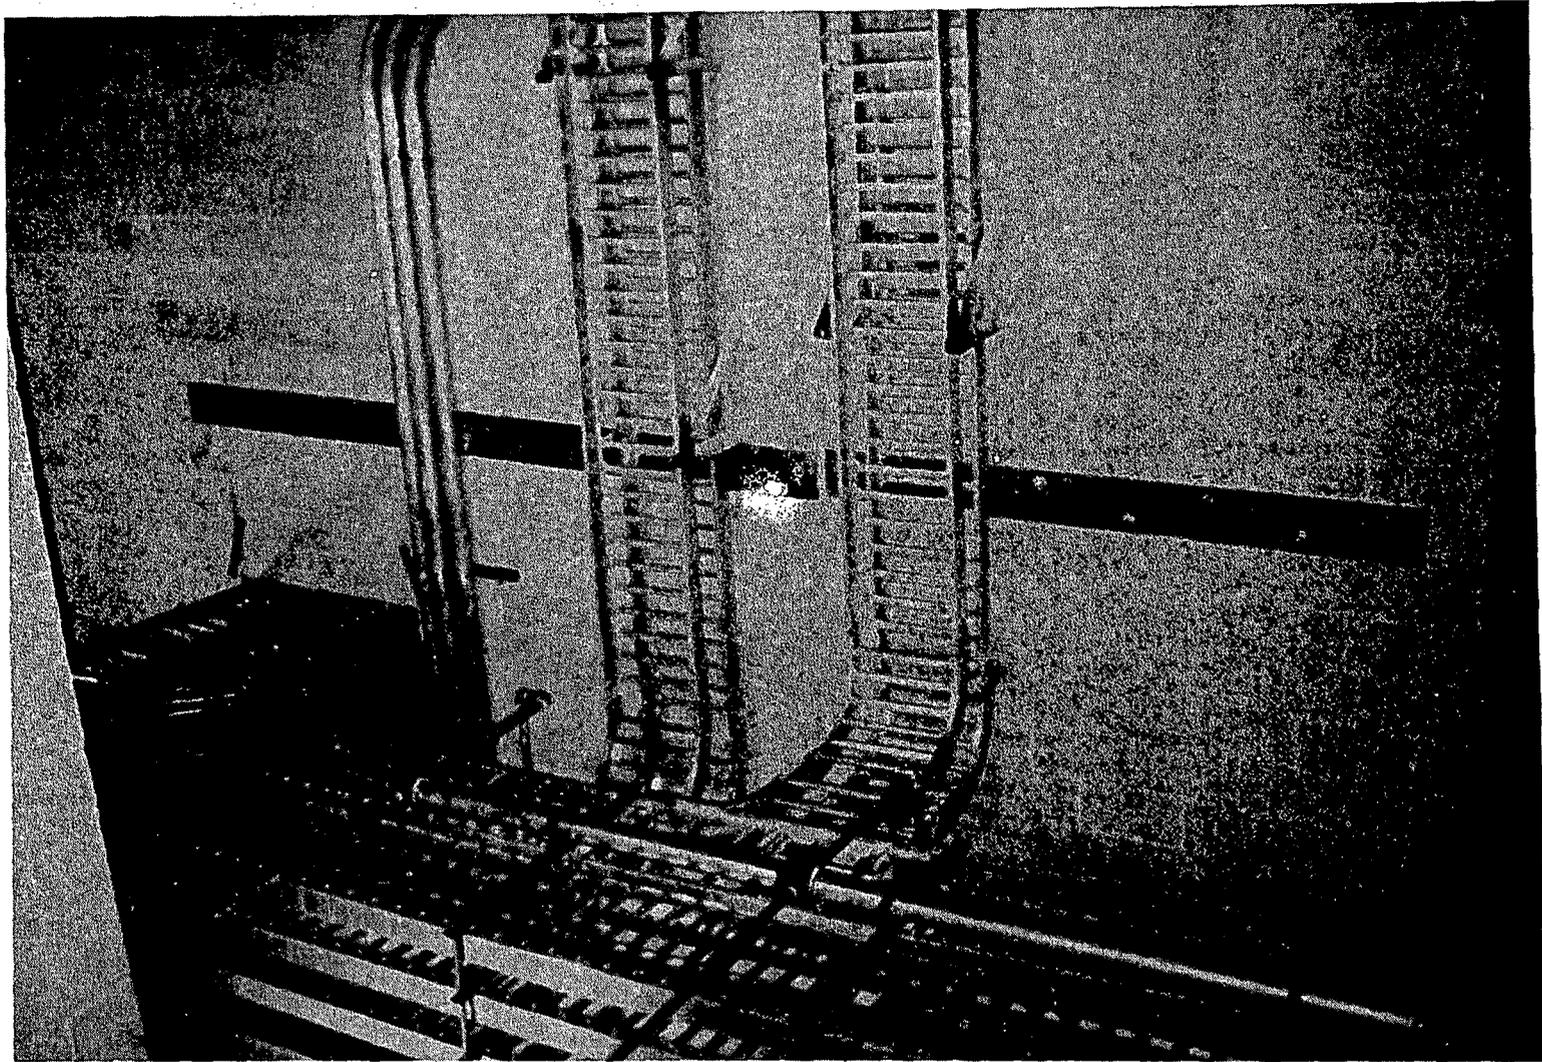
Figure 25
Upper Portion of Browns Ferry Replication
Test Setup

A full-scale replication type experiment was conducted at Underwriters Laboratories to assess the performance provided by a specific fire protection configuration designed in accordance with NRC fire protection guidelines and found acceptable to the staff.⁴¹ The experimental configuration was constructed to replicate several cable trains and the fire protection system for an area in the Browns Ferry Reactor Building (elevation 593 ft, Area p to q and R6 to R7, Unit 1). In this area there are many electrical circuits in cable trays and conduits, water pipes, and other equipment used in operating the plant. Of specific concern is the group of electrical circuits located along the north wall near the centerline for this area. At this location is a group of vertical cable trays and conduits (see Figure 25). One of these cable trays and one conduit contains Division II safety circuits, while another conduit contains Division I safety circuits.

The fire protection for this area consists of detection systems, a suppression system, flame retardant cable coating, and steel cable tray covers. The detection system

includes ionization type ceiling mounted smoke detectors and line type cable tray mounted heat detectors. The suppression system is an automatic water spray system which is activated upon signals from both smoke and heat detectors from one fire protection zone within this area. Most cables in trays are protected with a flame retardant coating. TVA specifications allow installation of ten cables or less within a tray without application of the coating. When there are more than ten uncoated cables in a tray, the entire uncoated cable bundle is to be protected with the coating. Although TVA specifications require a minimum 1/8 in. (3.2 mm) dry thickness of coating, cables in this area are protected with an approximate 1/4 in. (6.4 mm) dry thickness of coating.

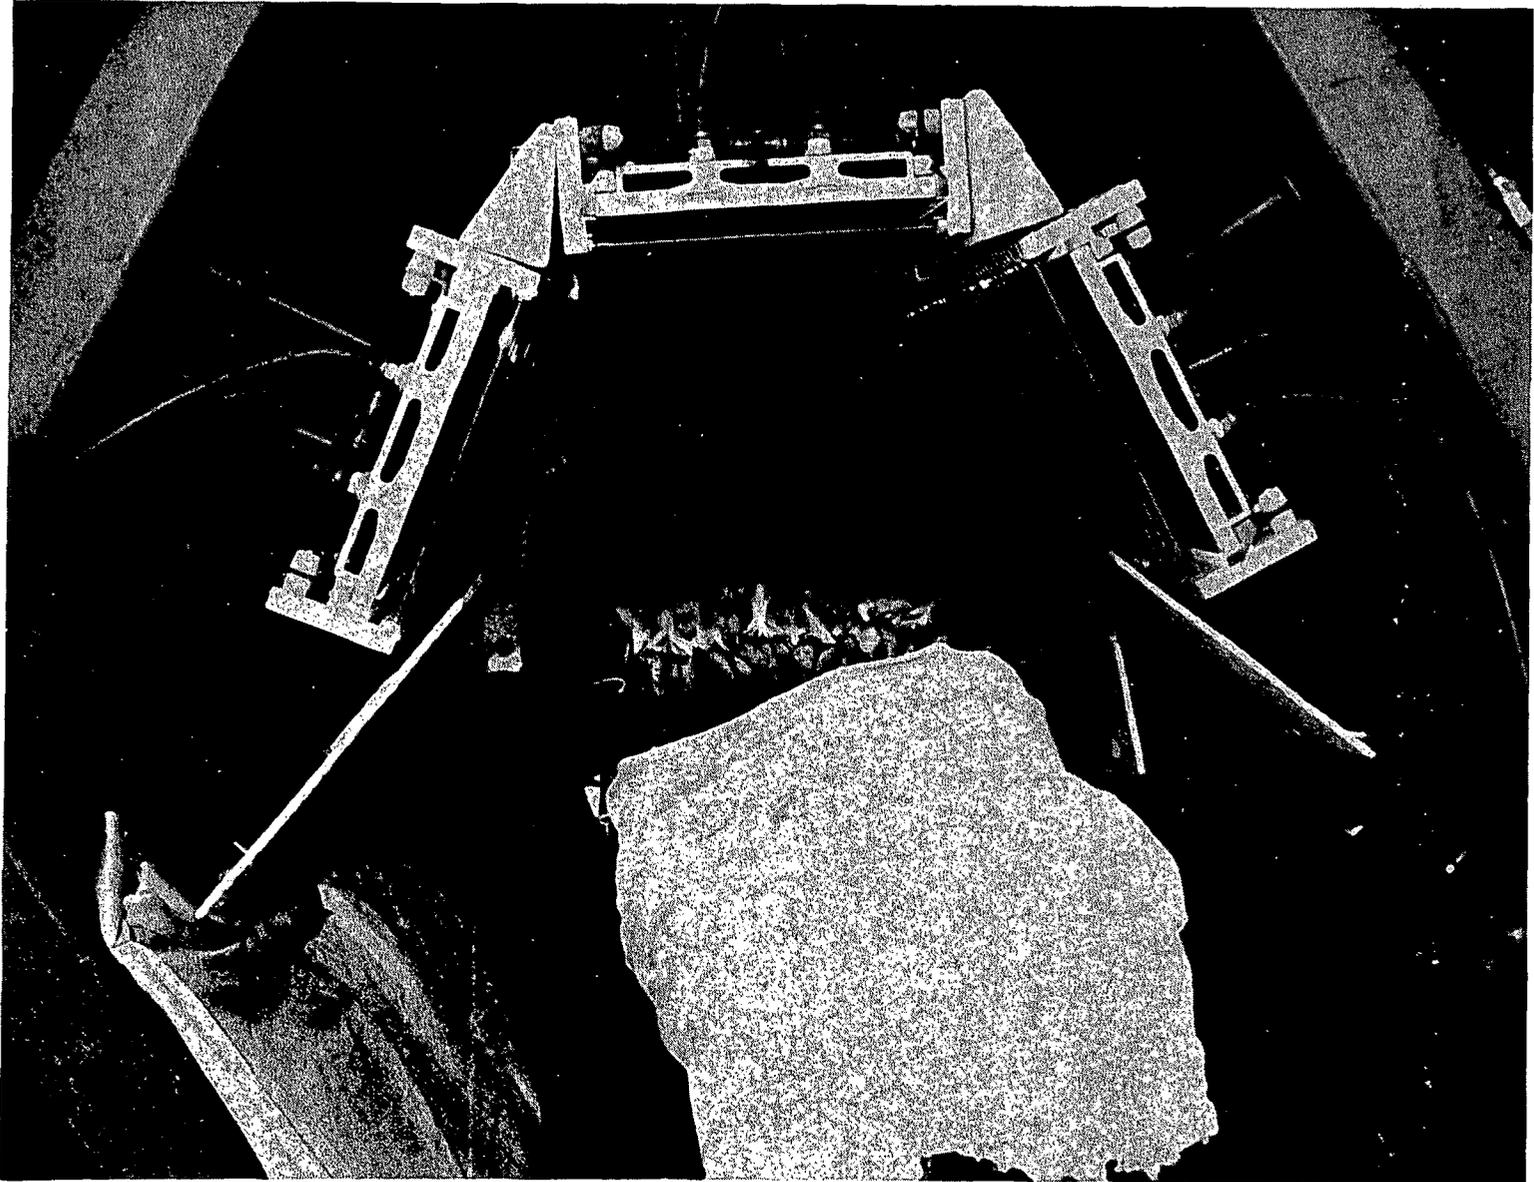
Figure 26

Full-Scale Radiant Heat Test

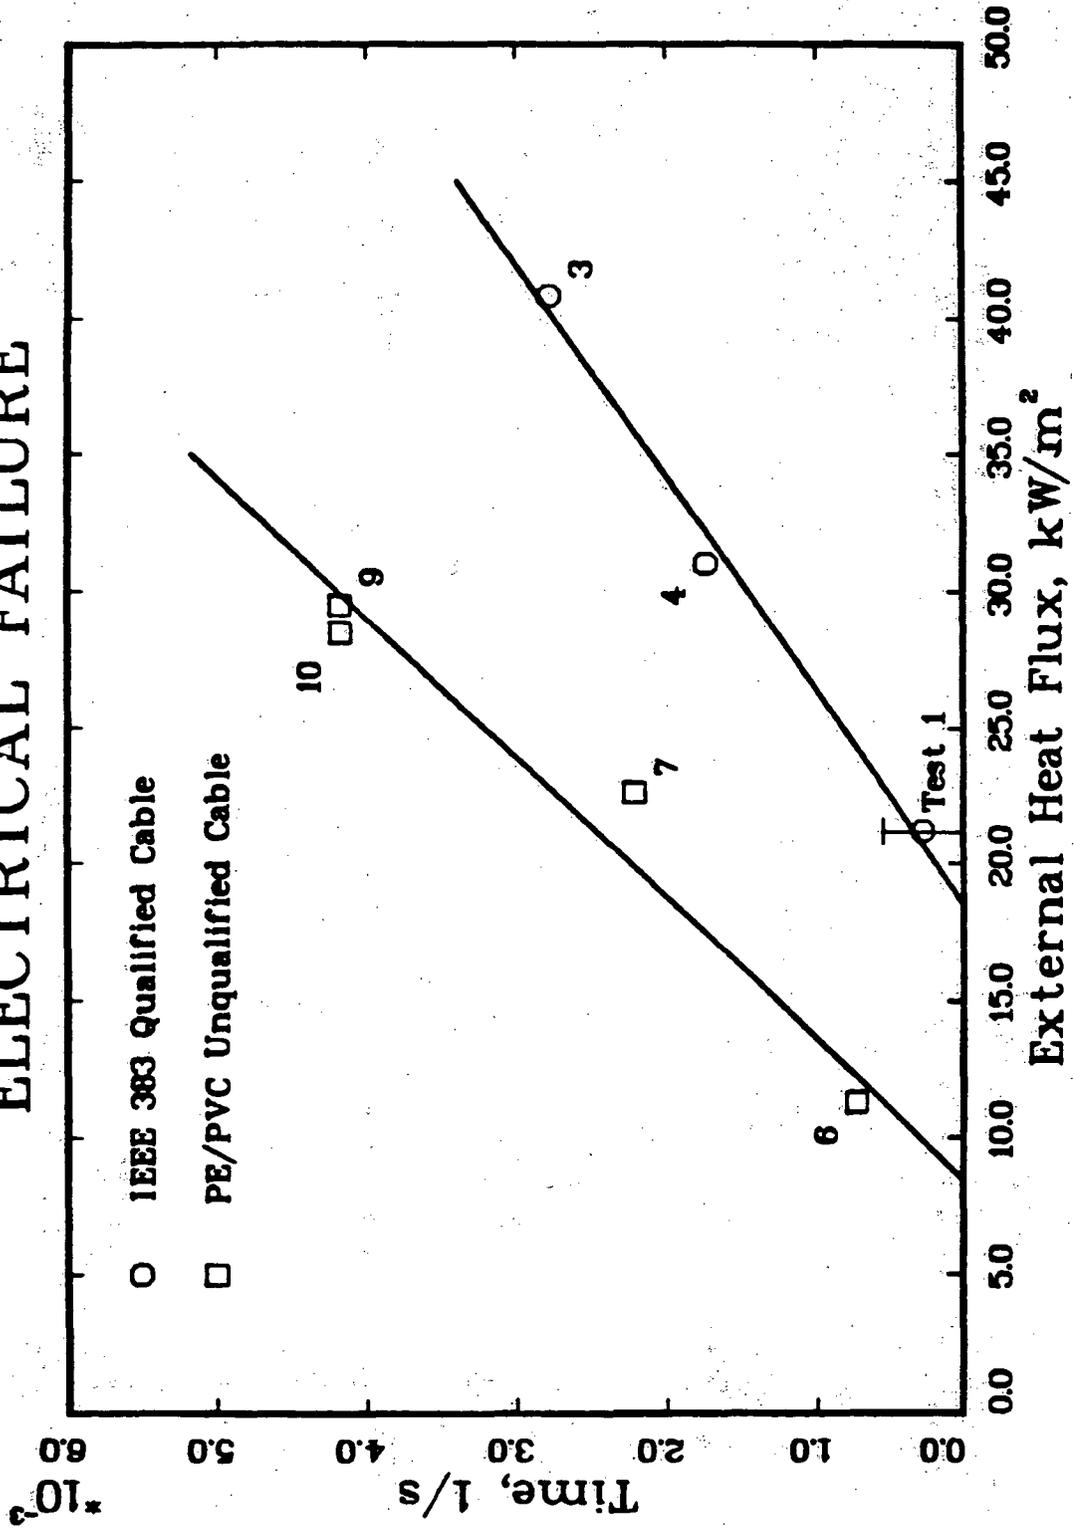
Figure 27

Correlation Between Time to Electrical Failure and External Heat Flux

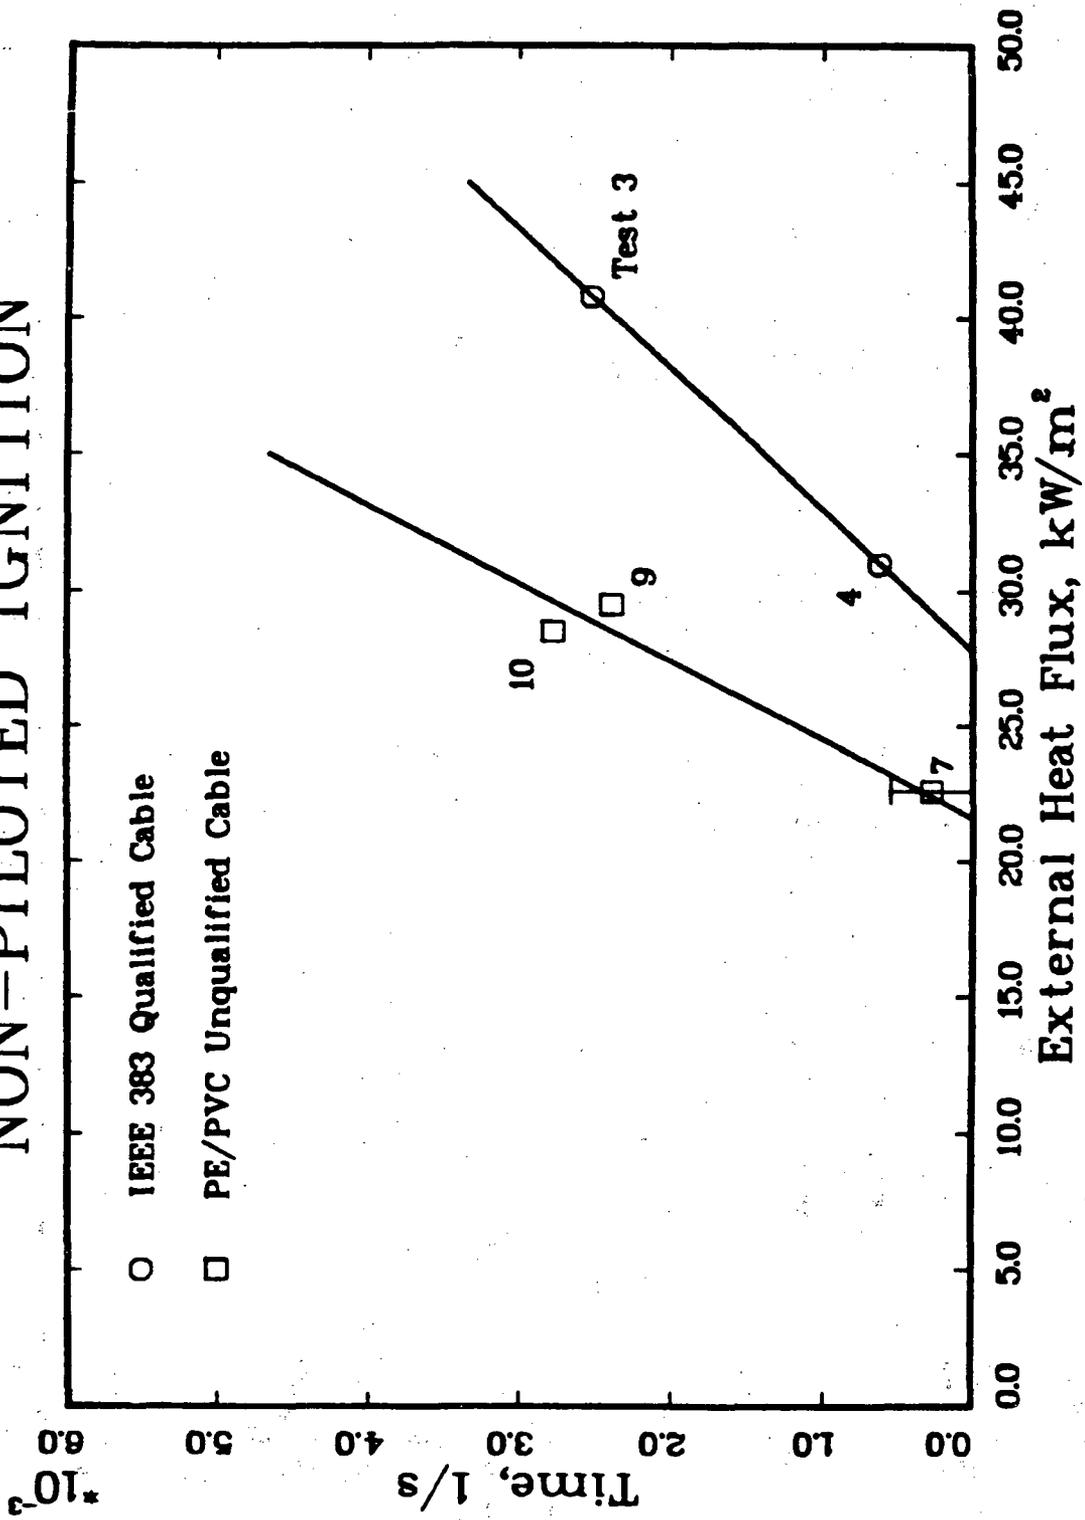
Figure 28.

Correlation Between Time to Non-Piloted Ignition and External Heat Flux

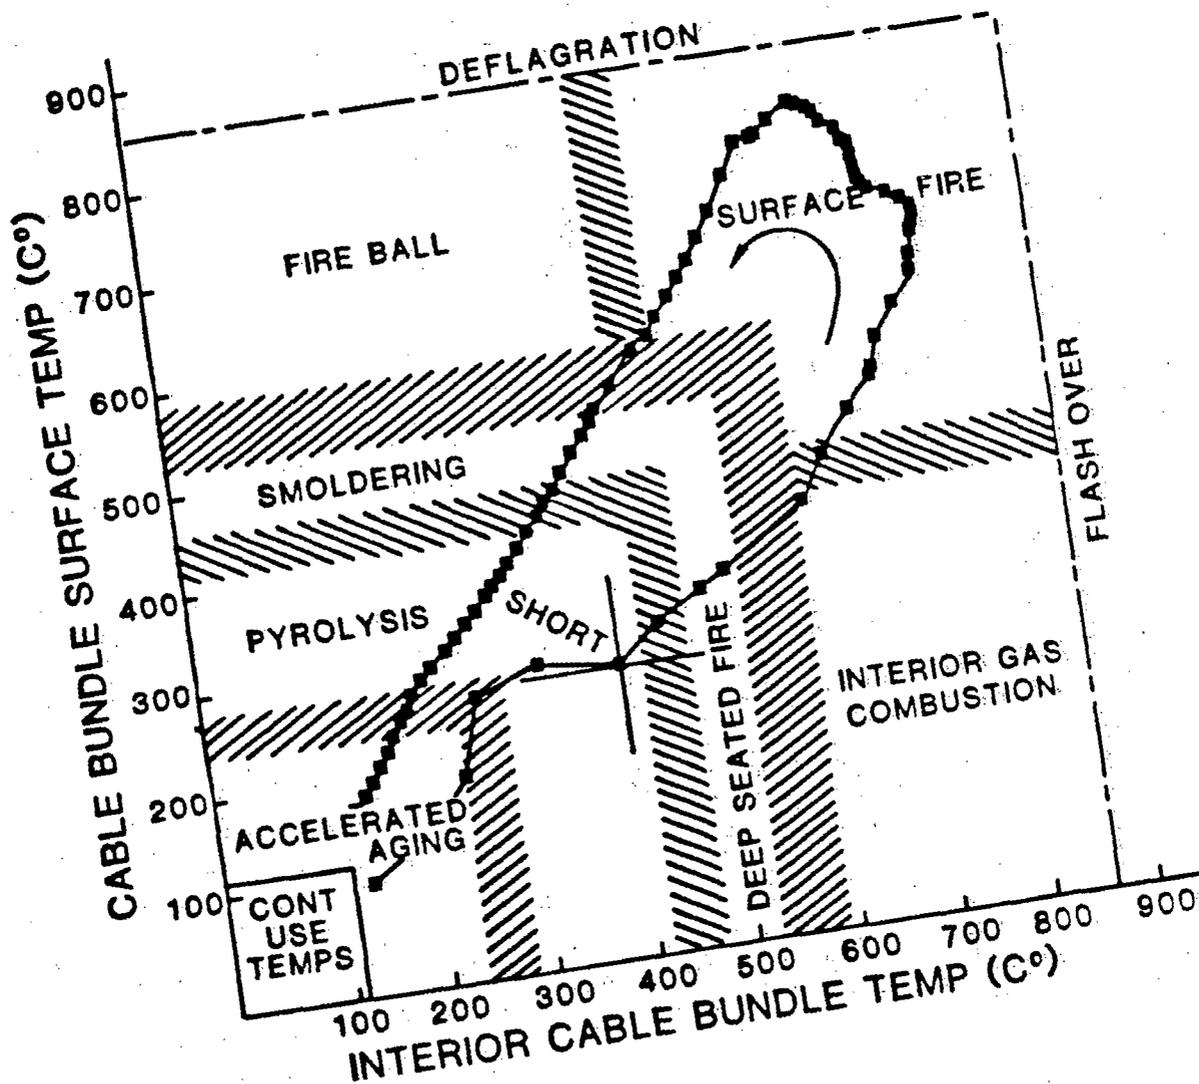
Figure 29
Temperature Profile on Burn Mode Matrix
for Pre-IEEE-383 Cable Test

The burn modes for electrical cable fires are by nature divided into oxygen-sufficient and oxygen-starved categories upon the evolution of pyrolytic gases. The temperature limits for the various modes are dependent on the composition of the combustible material used for the insulation in the different types of electrical cables and are determined by abrupt increases in temperature rise rates.

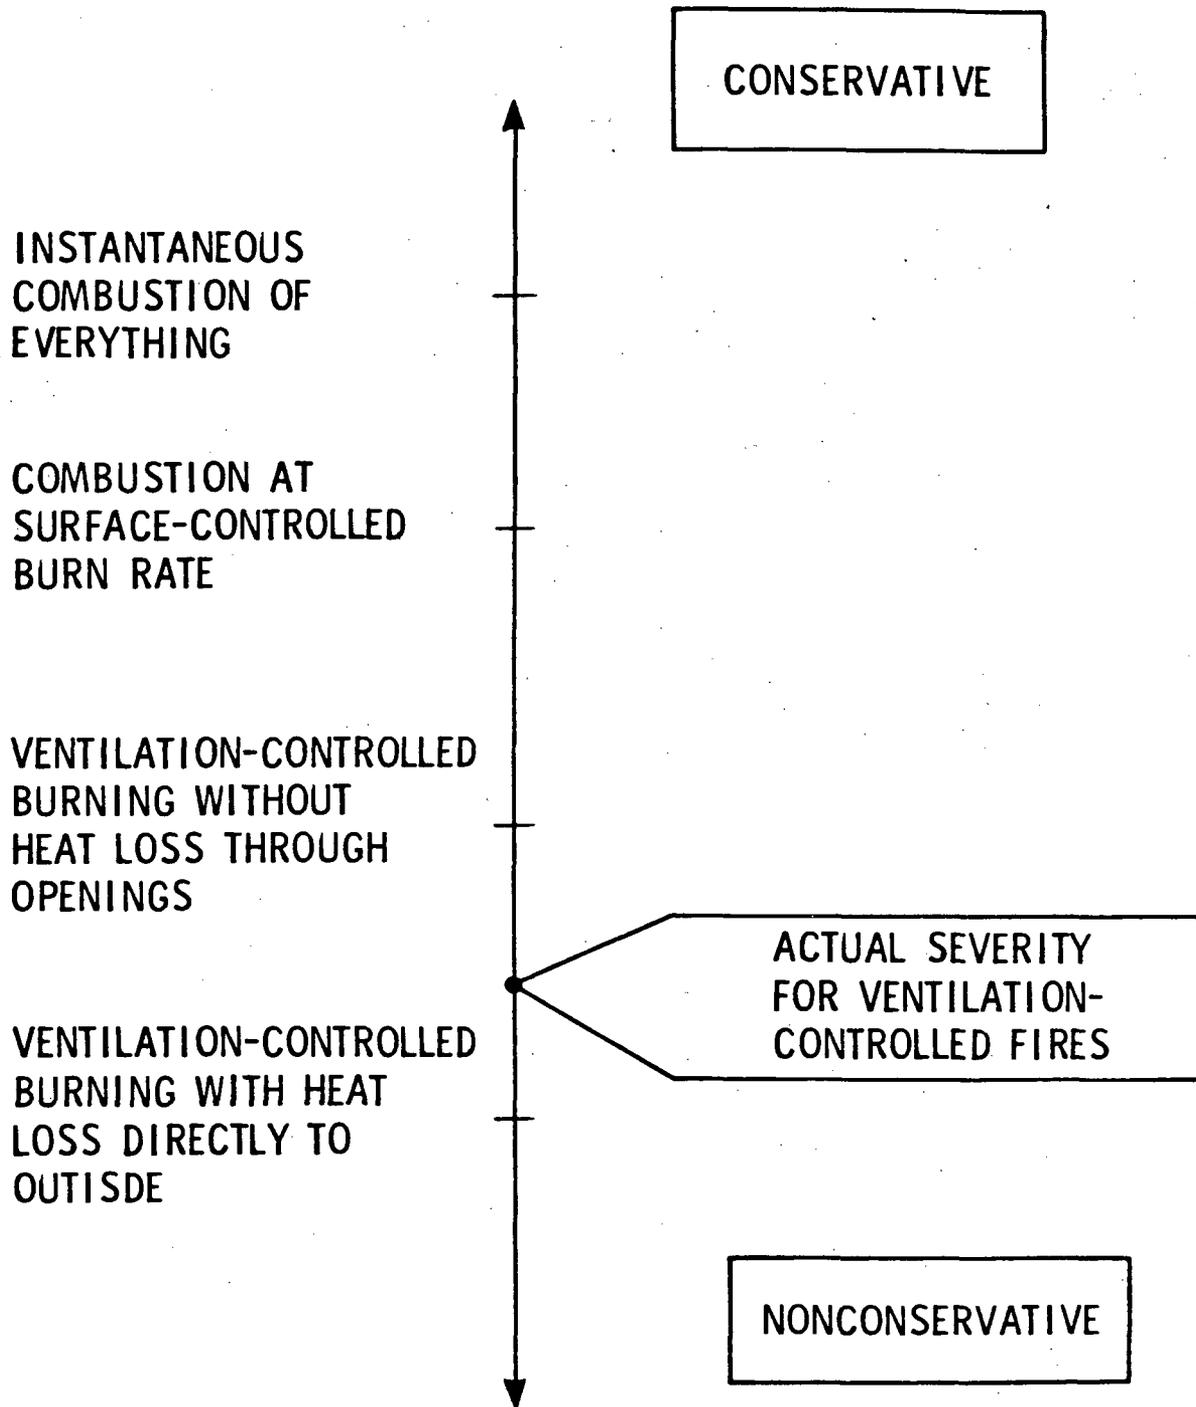
Figure 30

Comparison of Models for Assessing Fire Severity
in Nuclear Power Plants
