**Assessment of Hydrogeologic Conditions and  
Need for Long-Term Groundwater Monitoring  
at the Former Durita Uranium Mill, Naturita, Colorado**

**Assessment of Hydrogeologic Conditions  
and Need for Long-Term Groundwater Monitoring  
at the Former Durita Uranium Mill, Naturita, Colorado**

Gene Peters and Randall Fedors

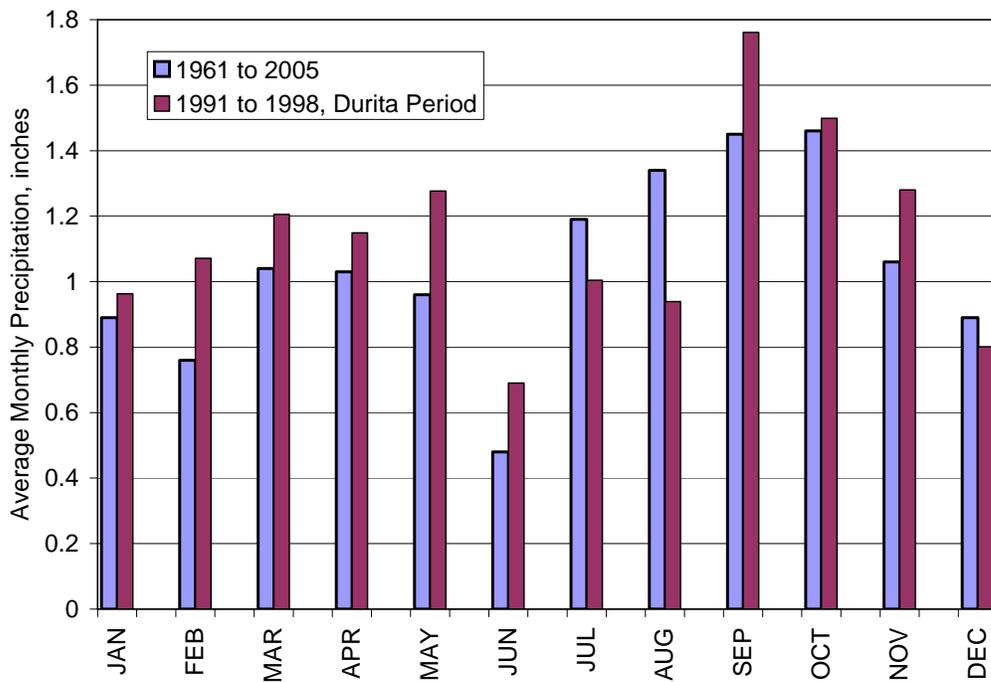
**Figure 5. Average precipitation for entire period of record for Uravan and for period of water level monitoring at Durita (1991 to 1998)**

Monthly values (**Figure 5**) suggest that precipitation occurs throughout the year, though June is moderately drier and late summer into early winter is moderately wetter than the other months. The presence of fall and winter precipitation is generally important in semiarid climates because evapotranspiration rates are reduced during these seasons, thus leading to the most prominent period for recharge. In the groundwater section, we will describe our search for indications of a seasonal signal in recharge as recorded in water levels in monitoring wells.

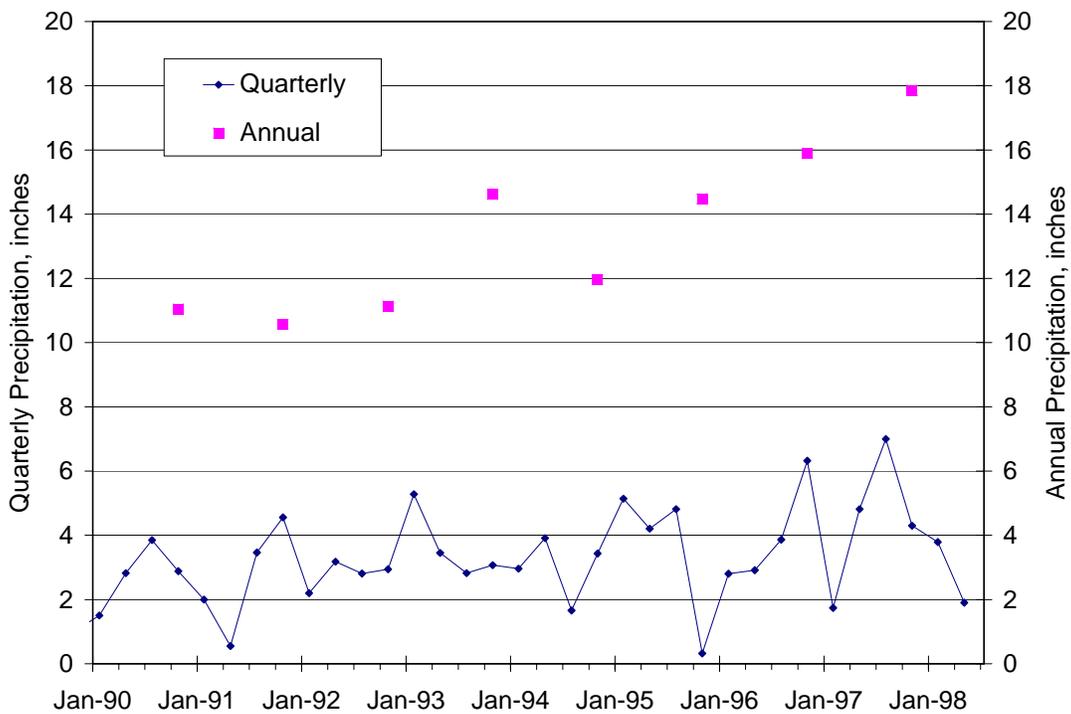
**Figure 6. Quarterly and Annual Precipitation Data from Uravan NOAA Meteorological Station for the Period of Interest for Durita**

Annual and quarterly values of precipitation at Uravan, our analog for Durita weather, are plotted in **Figure 6**. A prominent feature illustrated by the annual values, though difficult to distinguish in the quarterly data, is the trend of increasing precipitation for the later part of the period (1995 through 1998). In the groundwater section, we will also describe our search for indications of an increasing trend for recharge as recorded in water levels in monitoring wells for the 1995 through 1998.

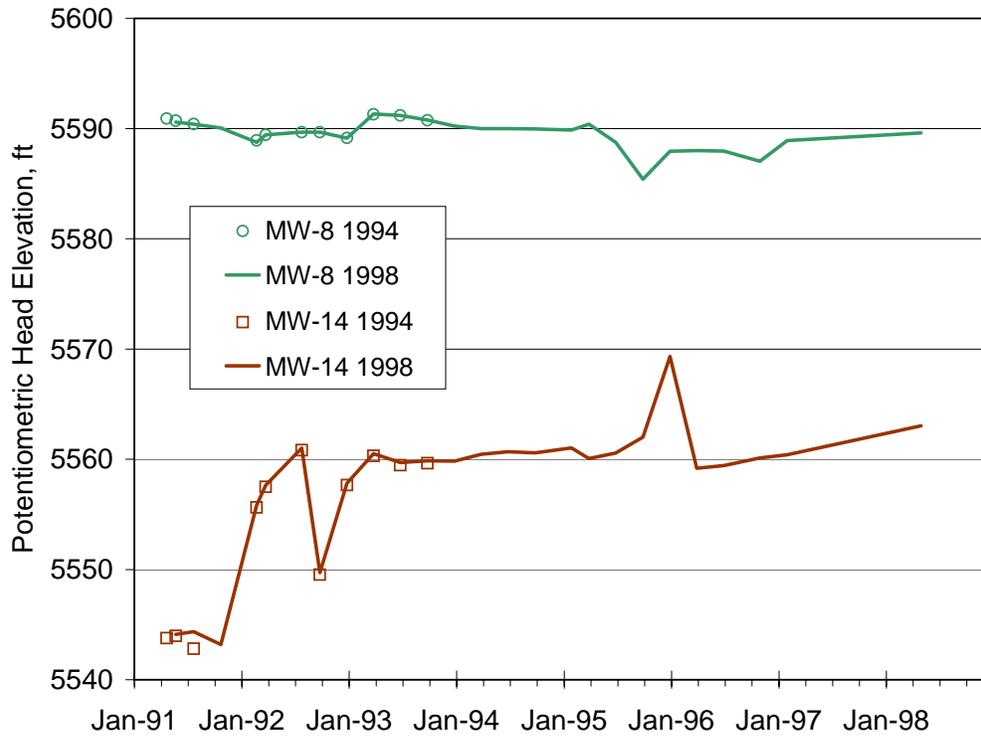
**Figure 8. Potentiometric Heads for Upstream Boreholes From Two Data Sources, Hecla (1998) and Studios Solutions (1994)**

Two points on the reliability of the data warrant discussion. The first point concerns the two reports contained data from 1991 to 1993 (Hecla 1998; Studios Solutions 1994). The first point is that the two data sources were not consistent; the differences are illustrated in Figures 8 and 9. Monitoring wells MW-9, MW-10, and MW-11 have noteworthy inconsistencies in early data. The second point is that the earlier report contained references to ground surface and borehole collar data elevation errors that required a new survey. MW-8 and MW-9 were resurveyed and found to have ground and casing heights off by as much as 3 feet. It was not clear from documentation if the data were revised to reflect the new survey information.

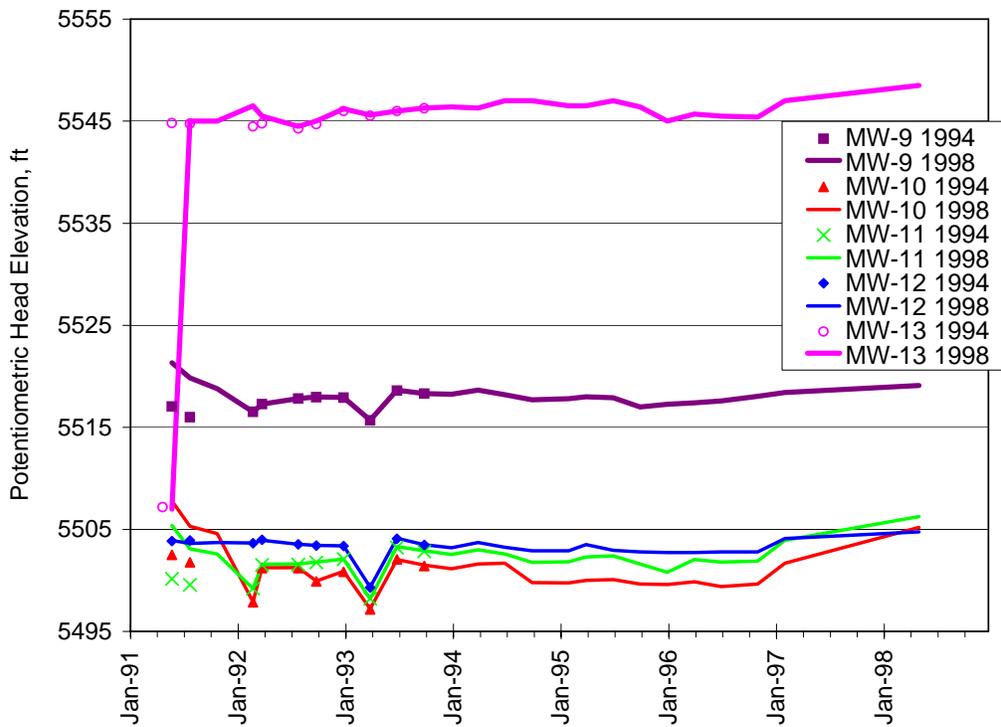
**Figure 9. Potentiometric Heads for Downstream Boreholes From Two Data Sources, Hecla (1998) and Studios Solutions (1994)**

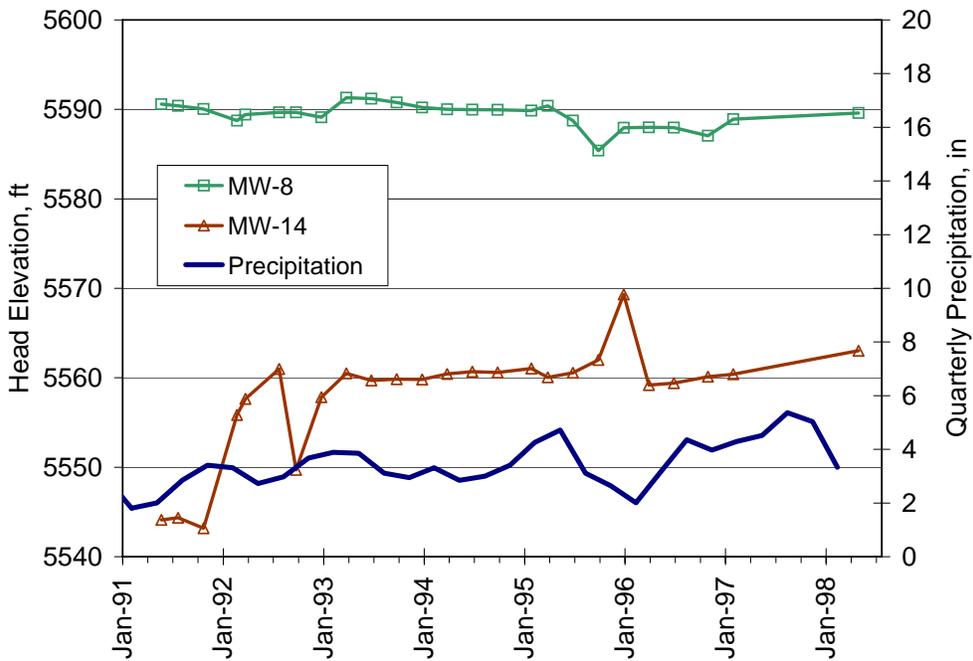
**Figure 10. Smoothed Quarterly Precipitation Overlaid on Potentiometric Head Data for Upstream Wells**

Temporal variations caused by climate stresses are evident when precipitation patterns are overlaid on the water level data (Figure 10 and 11). Two prominent observations are evident. First, a seasonal precipitation pattern is tracked by the water levels, particularly the downgradient (MW-10, MW-11, MW-12) and cross-gradient wells (MW-9 and MW-13). There is a significant dampening of the precipitation signal, and a slight delay in the propagation of the signal. The second prominent observation is that all the wells show an increase in water levels corresponding to the wetter years of 1996 and 1997. The aquifer response to the increased precipitation varies across the site from +1 to +5.5 ft from Nov 1996 to Jan 1998. Note that this period only has three measurements, so seasonal signals are lost. The spatial variation in the seasonal pattern supports a local source for the recharge, rather than an upslope recharge where the sand units intersect the ground surface (related to the synclinal structure). For example, MW-9 and MW-10 are closely spaced with MW-9 upgradient from MW-10. These two wells show the largest and smallest increases over the 1996 to 1998 period; MW-9 increased by 1.0 ft and MW-10 increased by 5.5 ft.

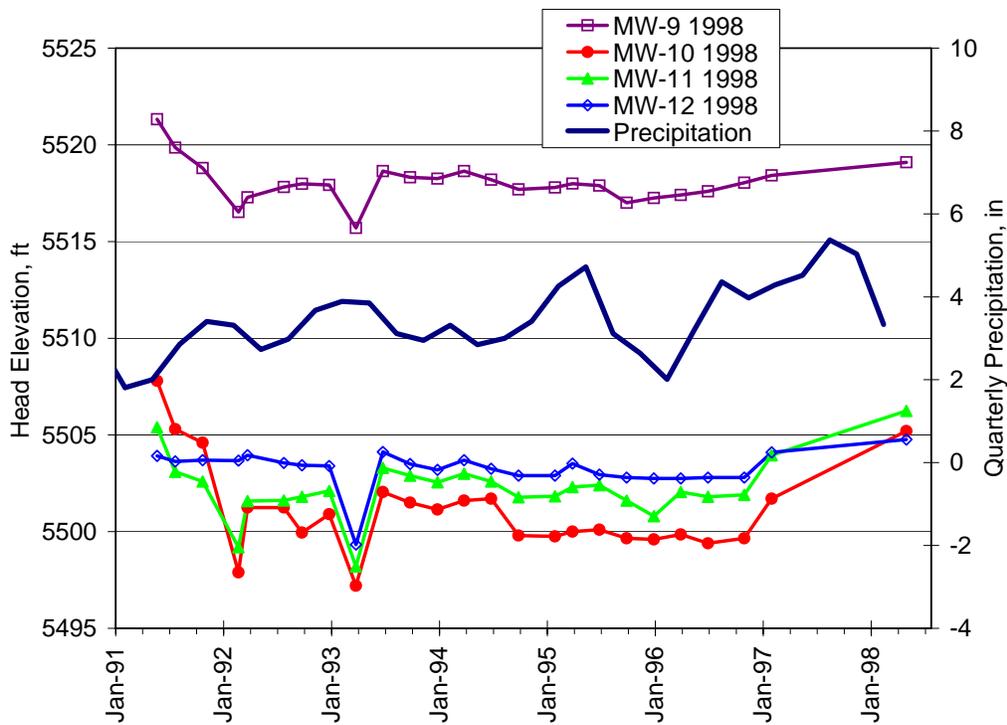
**Figure 11. Smoothed Quarterly Precipitation Overlaid on Potentiometric Head Data for 4 of the 5 Downstream Wells boreholes**

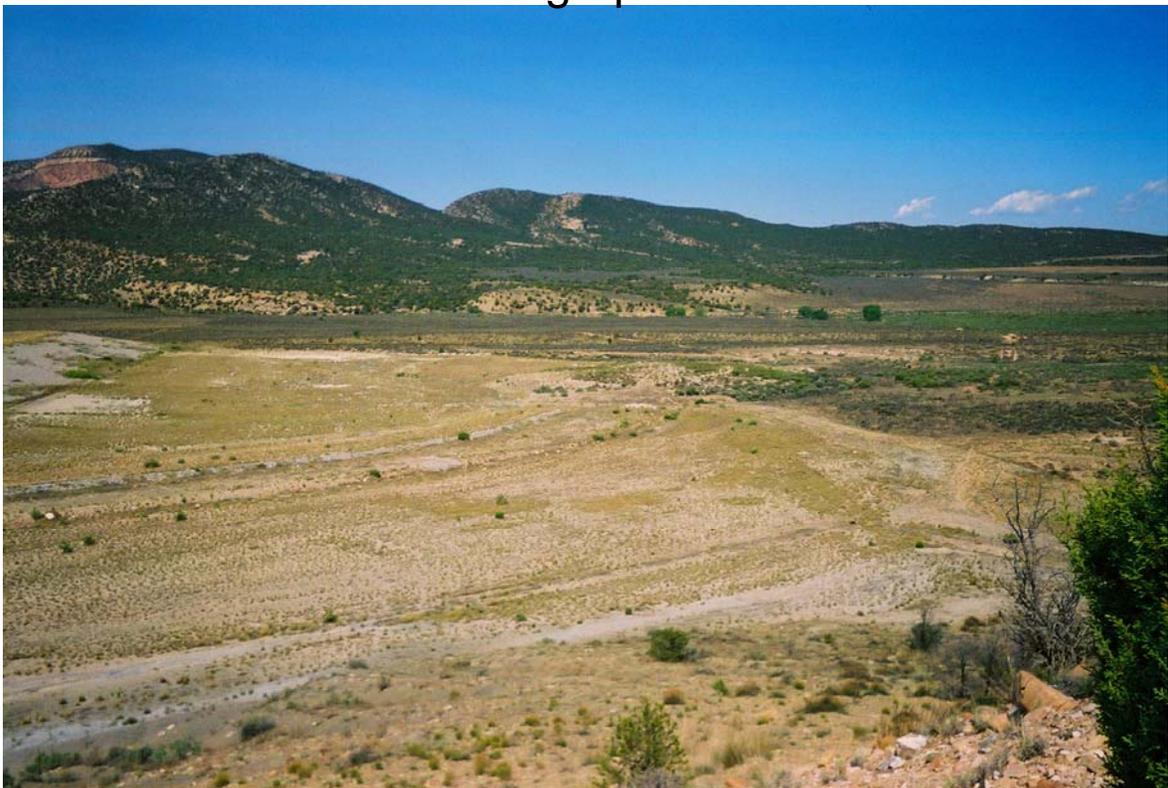
Photograph 24A

24A	View from top of Mancos Hill, facing west. The northern edge of Leach Tank 201 visible in left mid-ground. The former mill area and raffinate pond complex are present in the center of the photo. The central diversion (run-off) channel runs from lower left through the center of the photo.
25A	View from top of Mancos Hill, facing south to southeast. Northern edge of Leach Tank 203 visible in center. Barren area in center of photo likely is former ore processing area, in which tailings from Naturita site (located c. 2.5 miles northeast of Durita site) were agglomerated with H <sub>2</sub> SO <sub>4</sub> before placement in leach tanks.
20A	Shallow bench excavated into lower one-third, south side, of Mancos Hill. Pen for scale, pen cap oriented upward. Excavation depth approximately 1.5 feet below grade. Salt-related, friable induration visible at ground surface (note absence of vegetation) in upper portion of photo. Surficial material is heavily weathered, small (<1.0-in) shale fragments; original texture absent.  At base of excavation, original structure and texture preserved, but rock friable and easily disaggregated. Vertical and subvertical joints are prominent and frequent. Iron staining and calcite present on bedding planes in joints. White material is crystalline CaCO <sub>3</sub> present in friable veins and lenses, oriented from vertical to horizontal. Calcite crystals exhibited long, slightly curved acicular form; where present as vein filling, exhibited crystal growth from both sides, meeting in center.

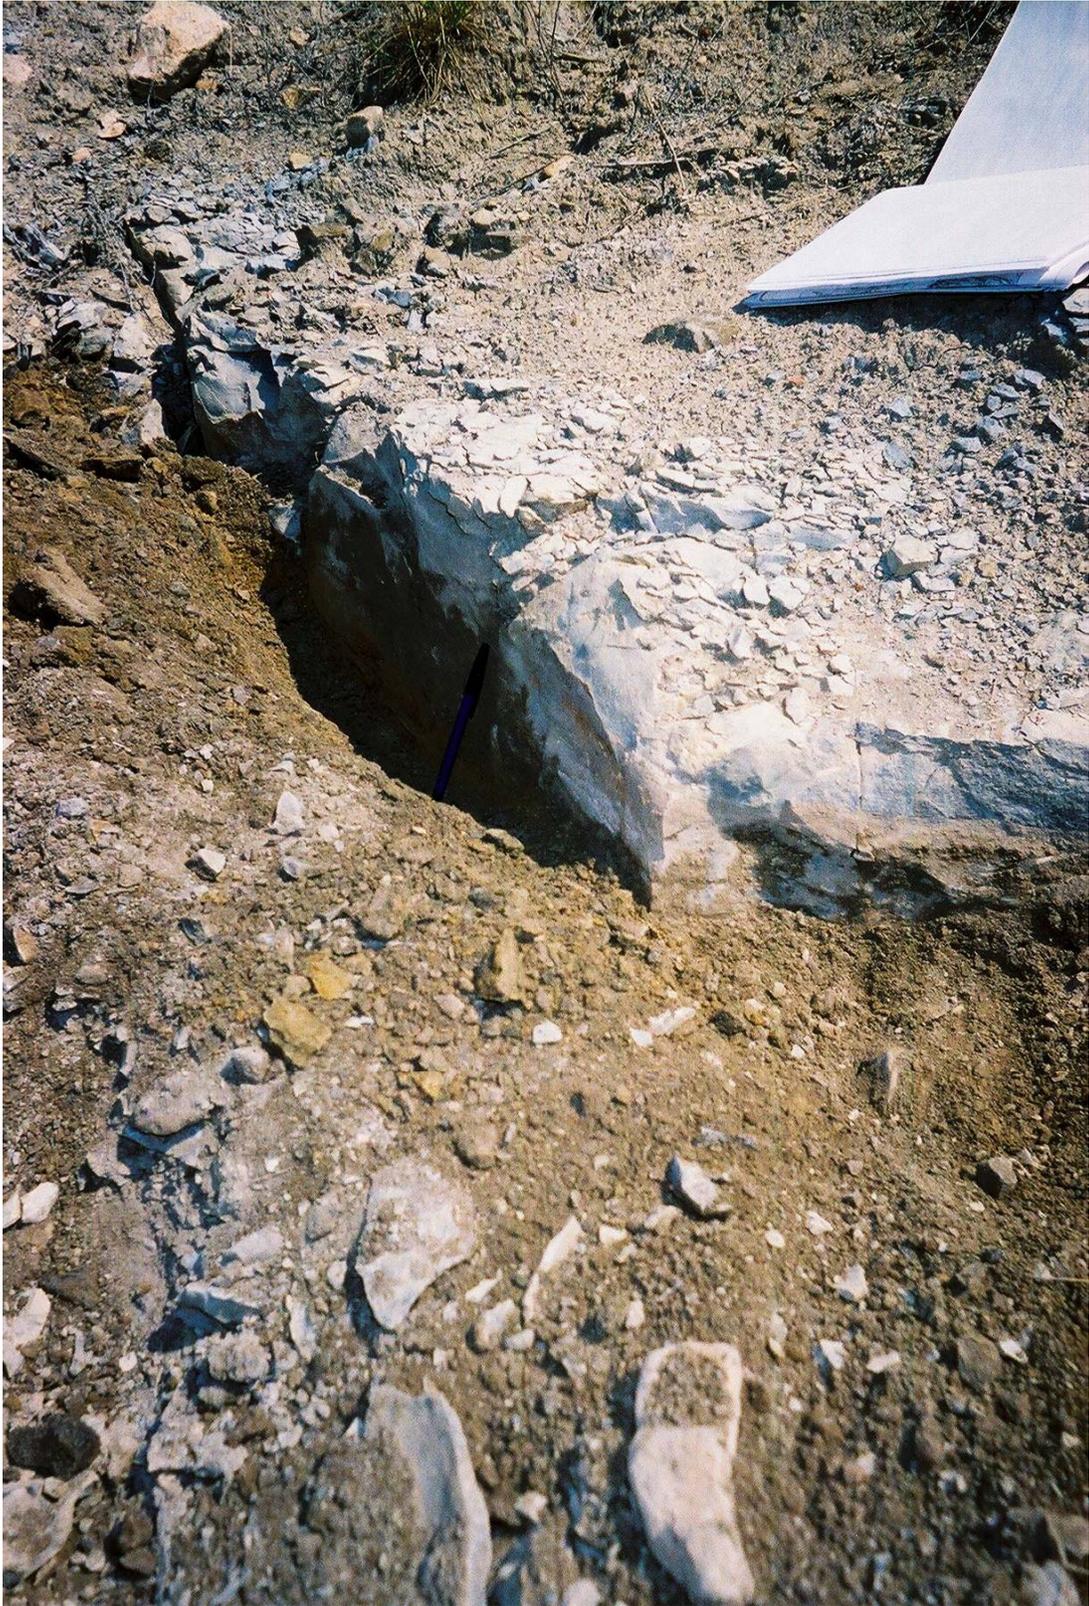
Photograph 17A

- 17A Photo of shallow excavation at base of Mancos Hill, west side, facing northeast. Clipboard for scale. Excavation was of more resistant layer visible in Photo 17A. Note rapid change from heavily weathered surficial material to more competent claystone/shale. Note north-south and east-west intersecting joint sets.

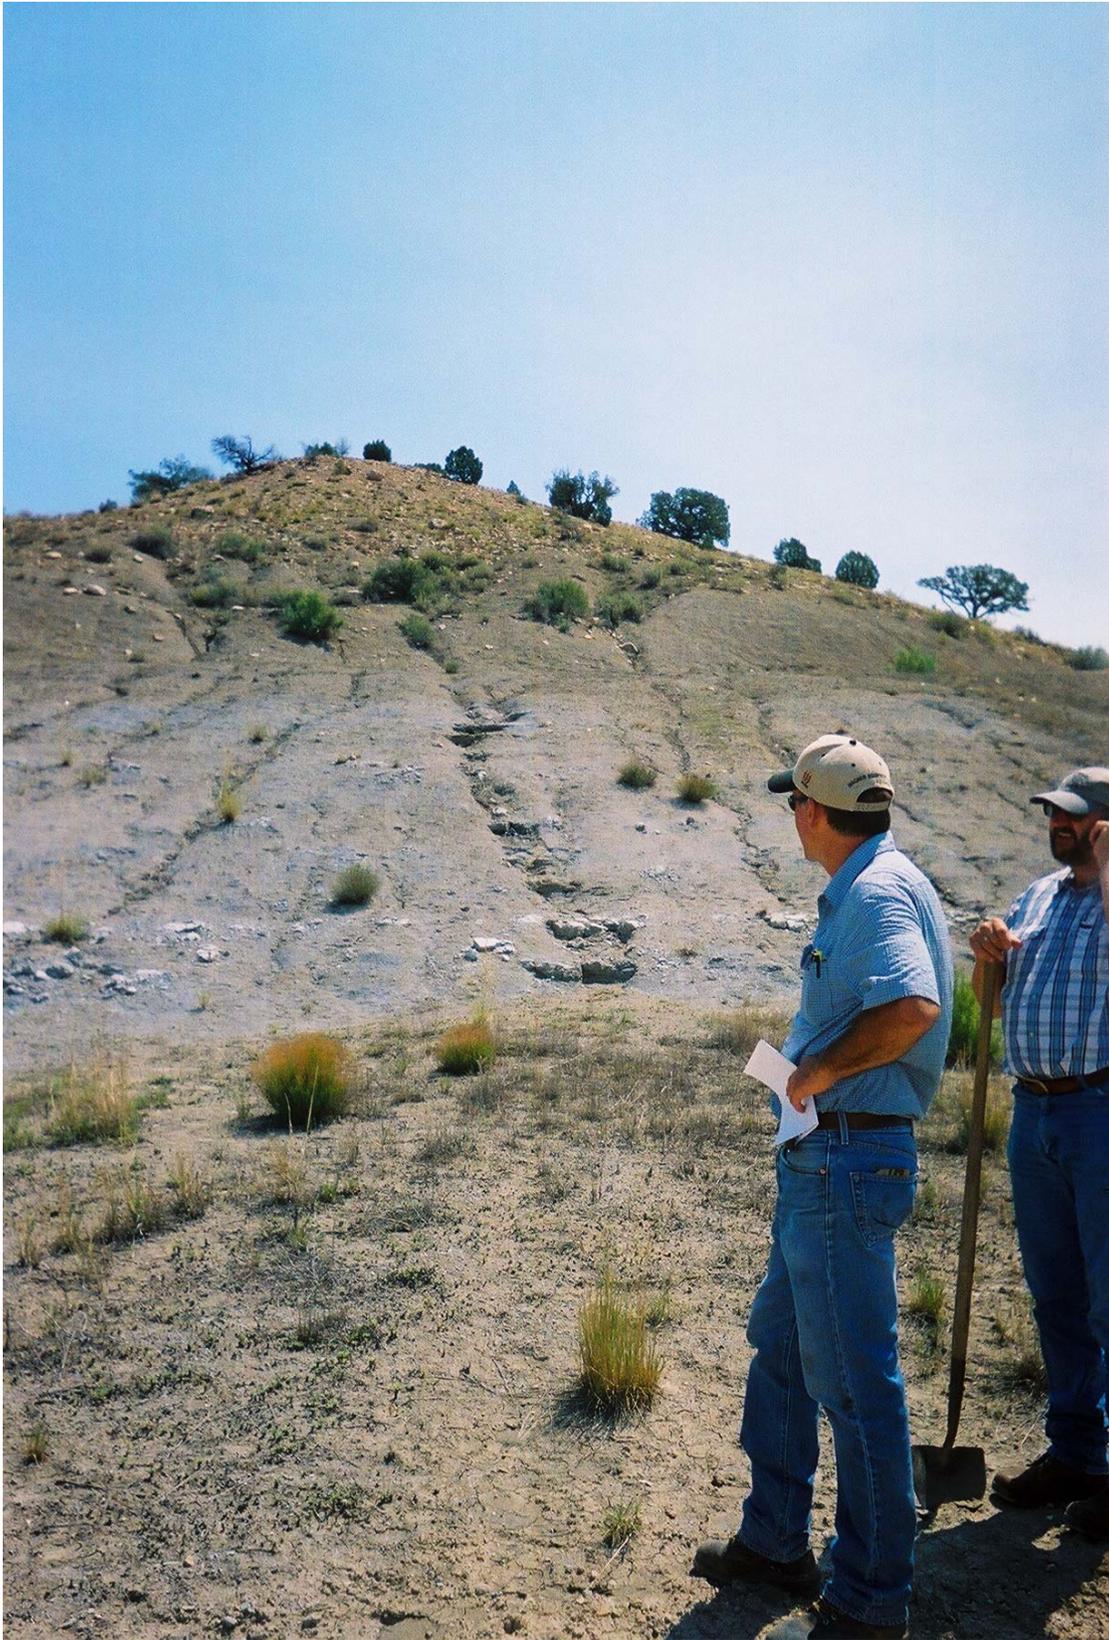
Photograph 16A

- 16A Photo of base of Mancos Hill, north and northwest sides. Absence of vegetation may be related to reclamation activities, though no processes are reported to have occurred in this immediate area. Note prominent drainage rills, which are absent on other sides of Mancos Hill, exposing several layers of more competent, resistant claystone/shale. Visible in upper portion of photo, near top of Mancos Hill are much larger rock fragments of sandstone, ranging up to cobble-sized. Ground surface, in foreground of photo, more clay-rich; note desiccation cracks. Visible in photo are Earl Reams (left, of Ream Construction, representing Hecla) and Ed ???, DOE contractor.

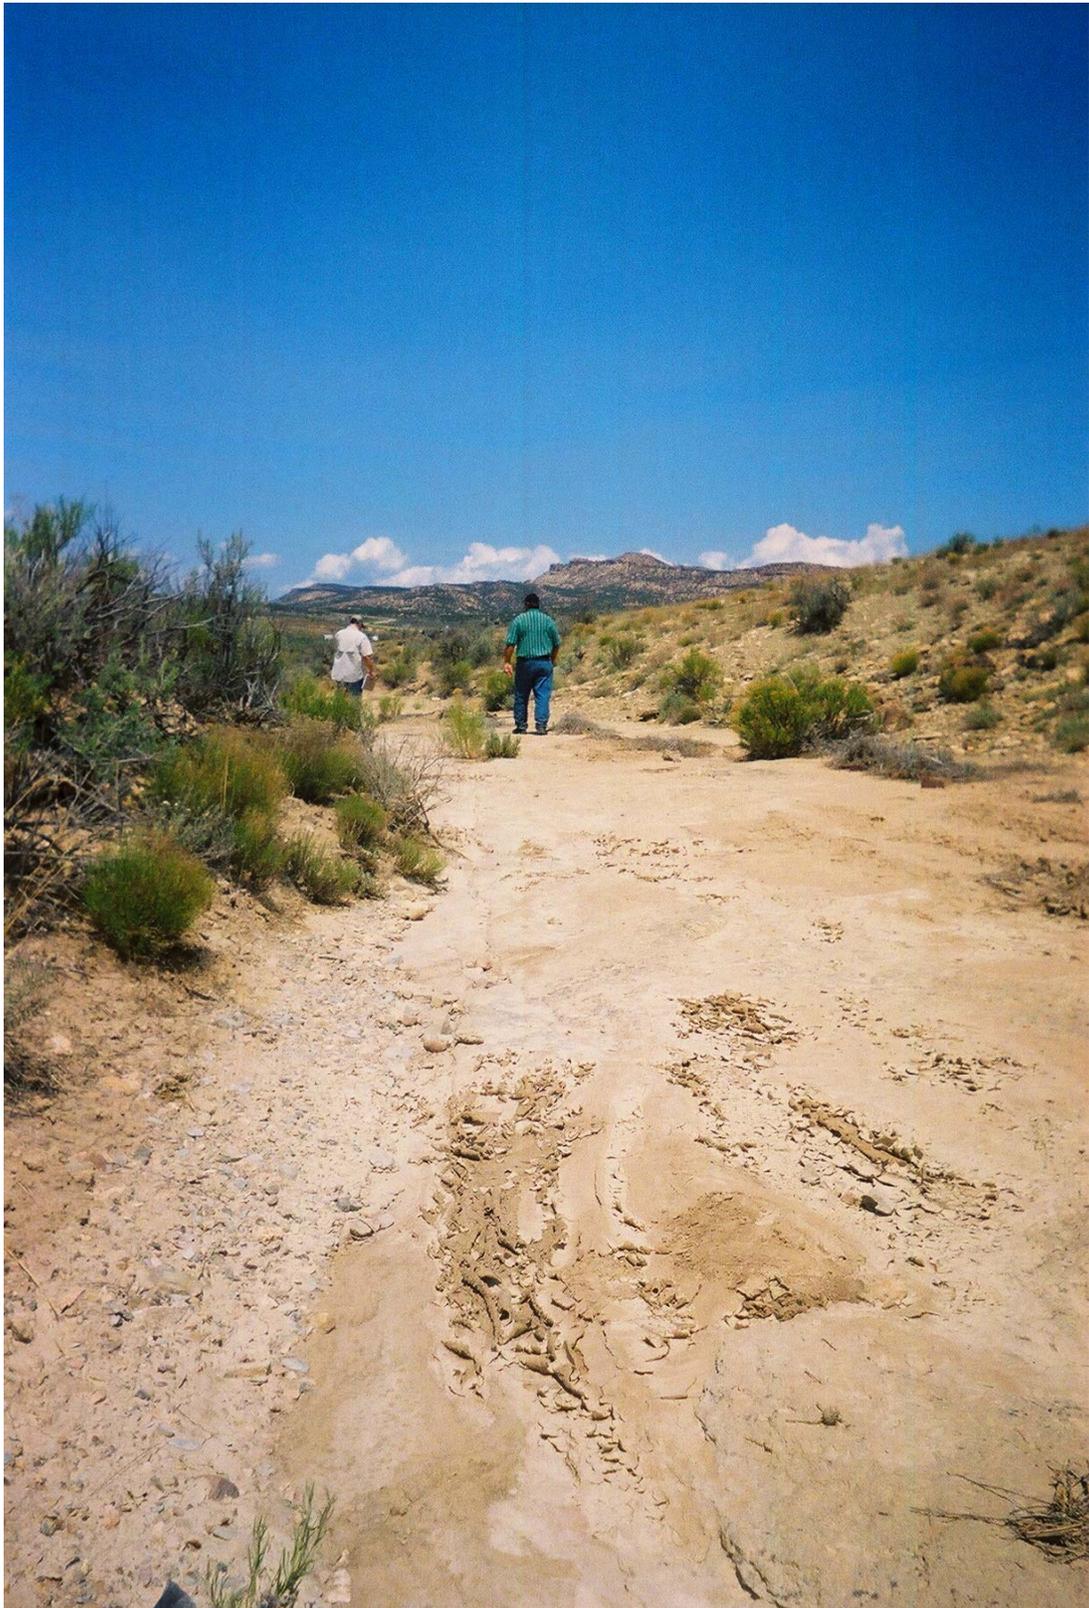
Photograph 14A

- 14A Photo of dry tributary channel to Dry Creek, north of site boundary, off northeast corner of site. This channel leads to the cataract area depicted in subsequent photos. Channel may be fracture-controlled, based on several long (10-meter scale) vertical to subvertical fractures evident in channel bed, with orientation parallel to channel trace. Note fine-grained material present in channel bed, exhibiting very prominent desiccation cracks and fragment curling.

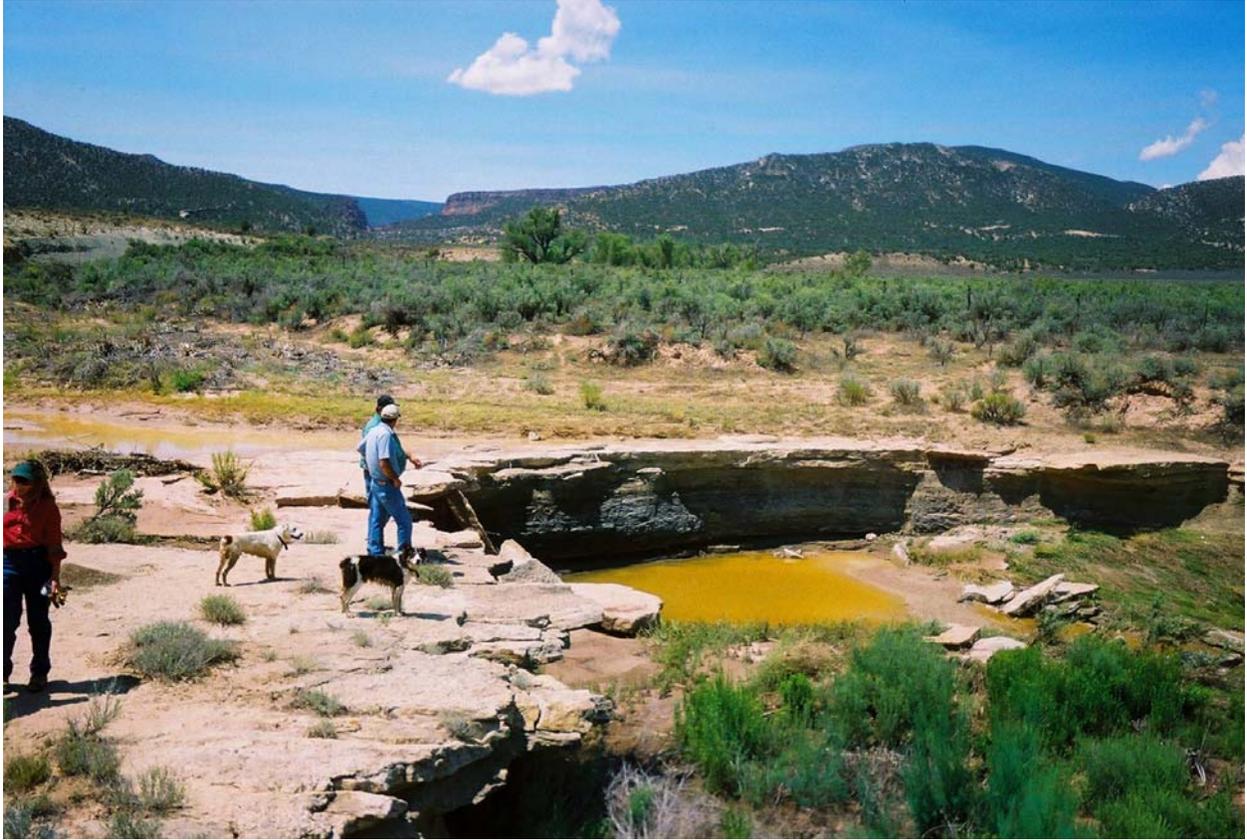
Photograph 12A

- 12A View of upper cataract area facing east-northeast, approximately 1,660 feet north of site, close to centerline of site. Dry Creek not flowing, but with large pools several feet deep in areas. Note resistant sandstone caprock layer controlling cataract, underlain by easily eroded shale layers, suffering extensive block failure and headward erosion. Likely represents the general interbedded contact between the Mancos and Dakota units. Standing water on left represents principal channel for Dry Creek. Individual in lower left standing in area of dry tributary channel in which photo 12 A was taken. Several large joints visible at ground surface.

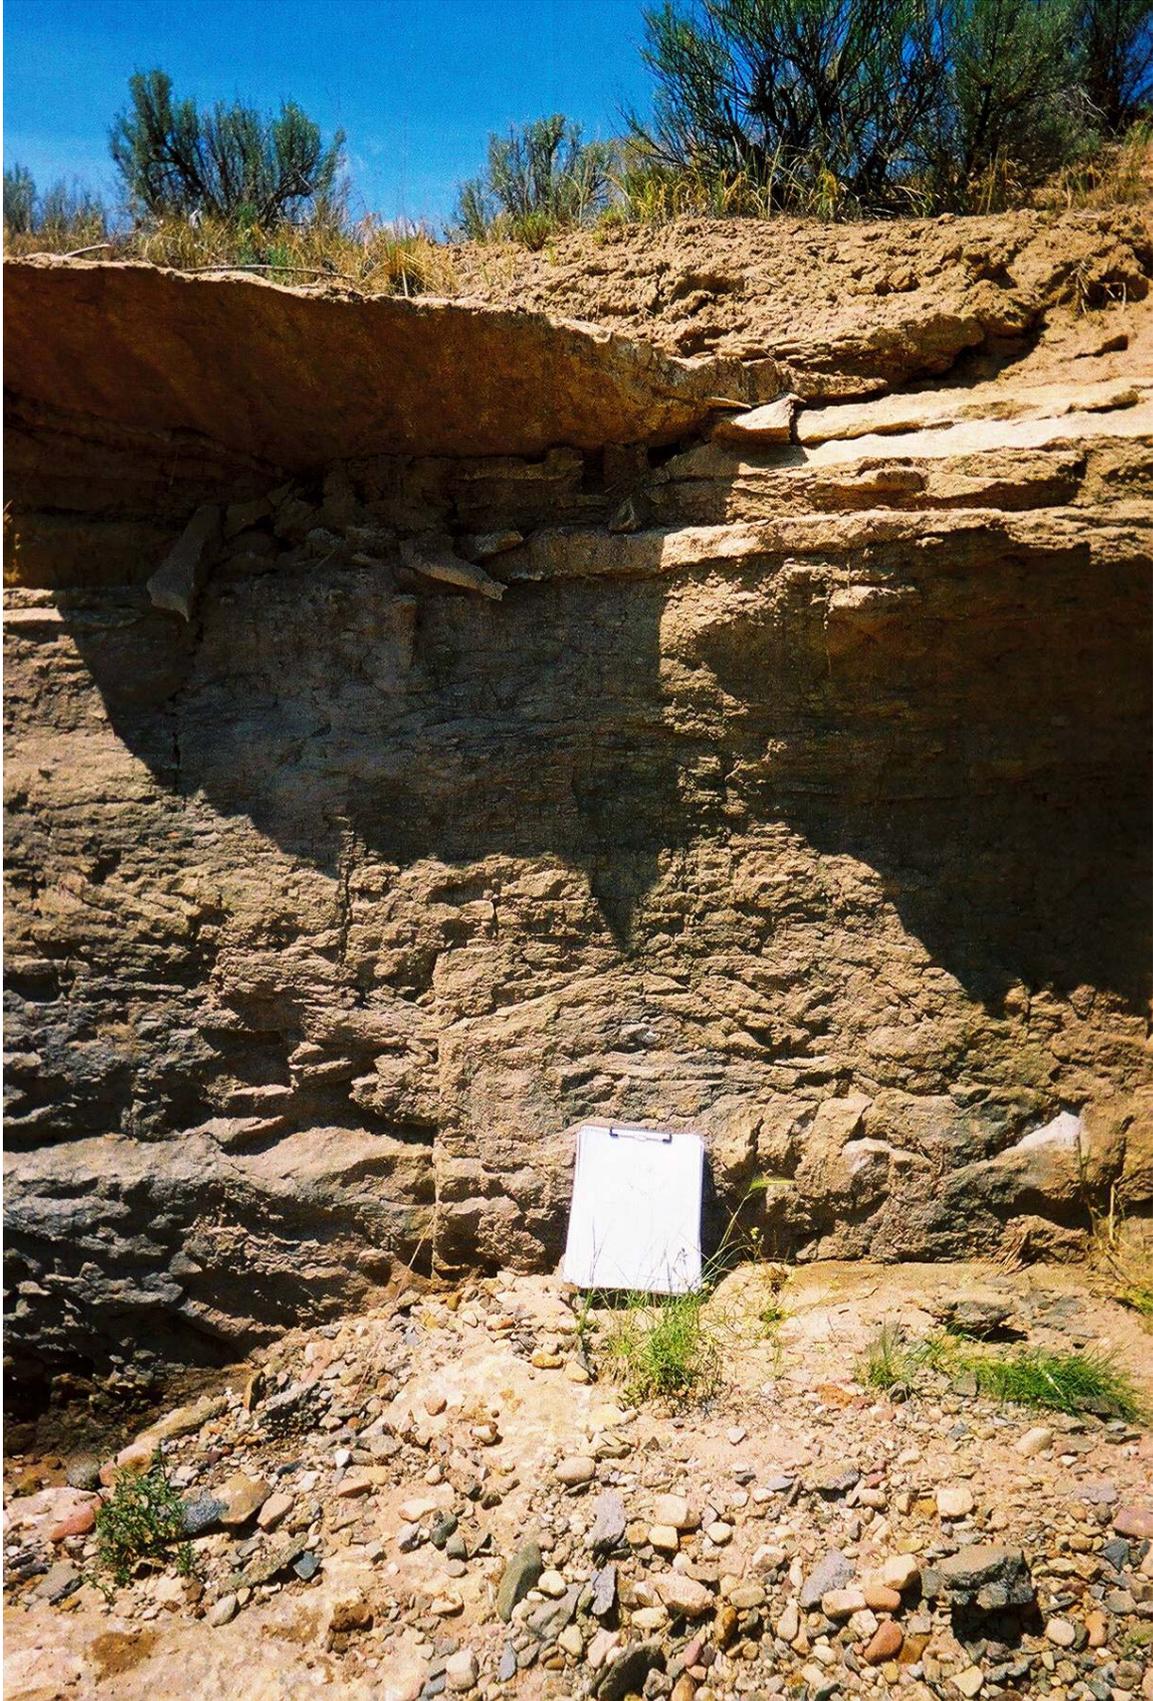
Photograph 11A

- 11A View of cross section exposed in upper cataract area, facing approximately southwest. Clipboard for scale. Note extensive weathering in layers below sandstone caprock layer, with extensive vertical joints and fractures.

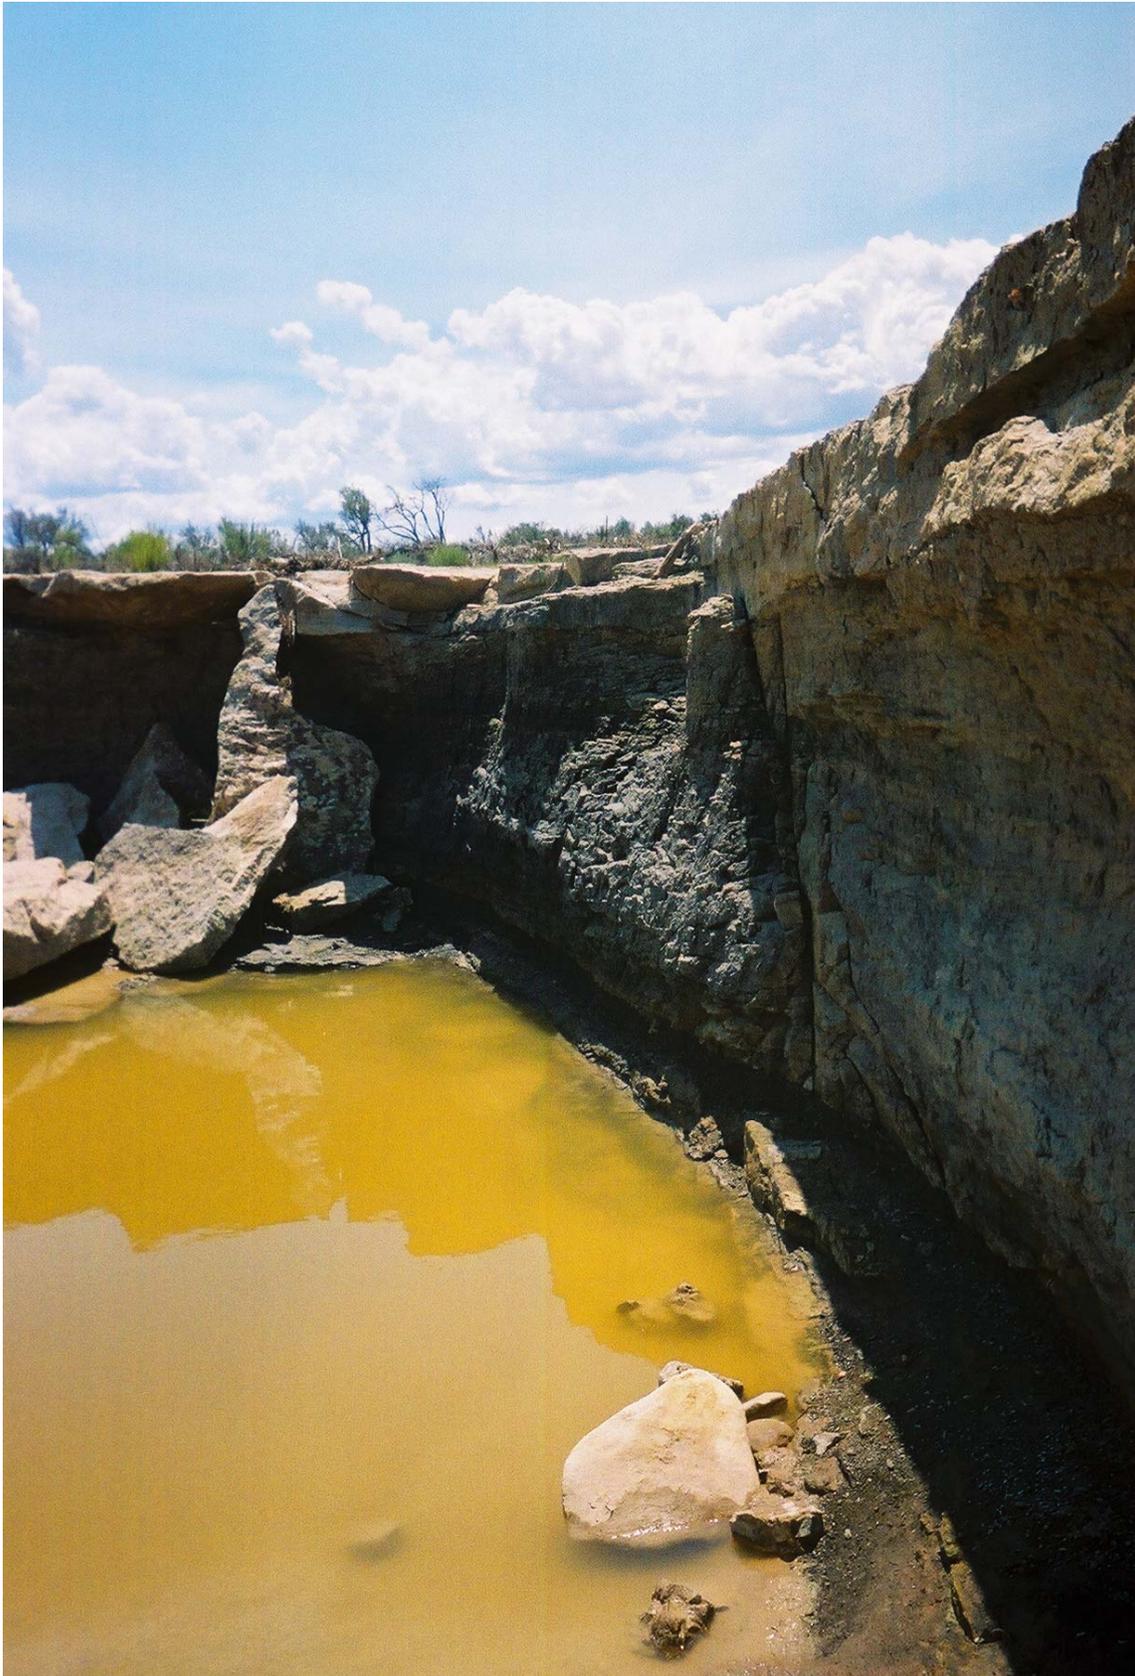
Photograph 10A

- 10A View of cross section exposed at upper cataract area, facing approximately southeast. Note large, vertical fracture extending into plane of photo.

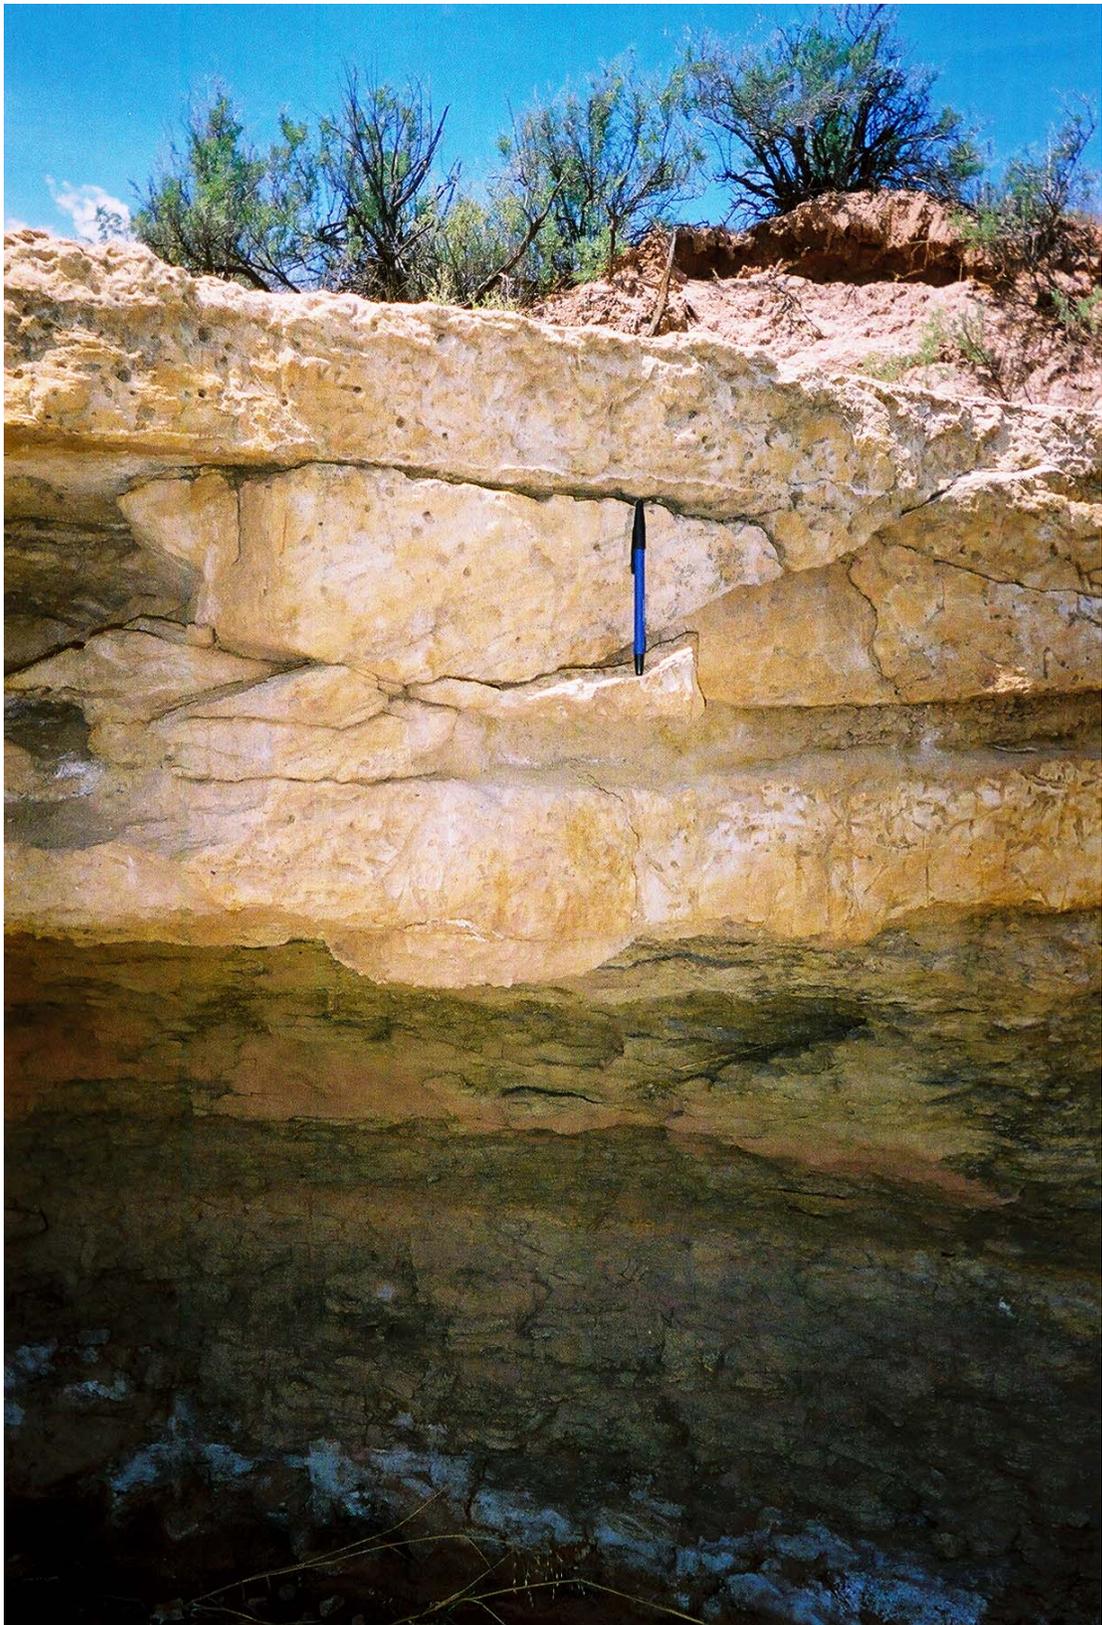
Photograph 09A

- 09A Closer view of sandstone caprock layer at upper cataract area. Pen for scale; cap oriented upward. Note horizontal to subhorizontal joints and bedding planes, cross-stratification, and considerable bioturbation in sandstone. Iron staining and calcite present.

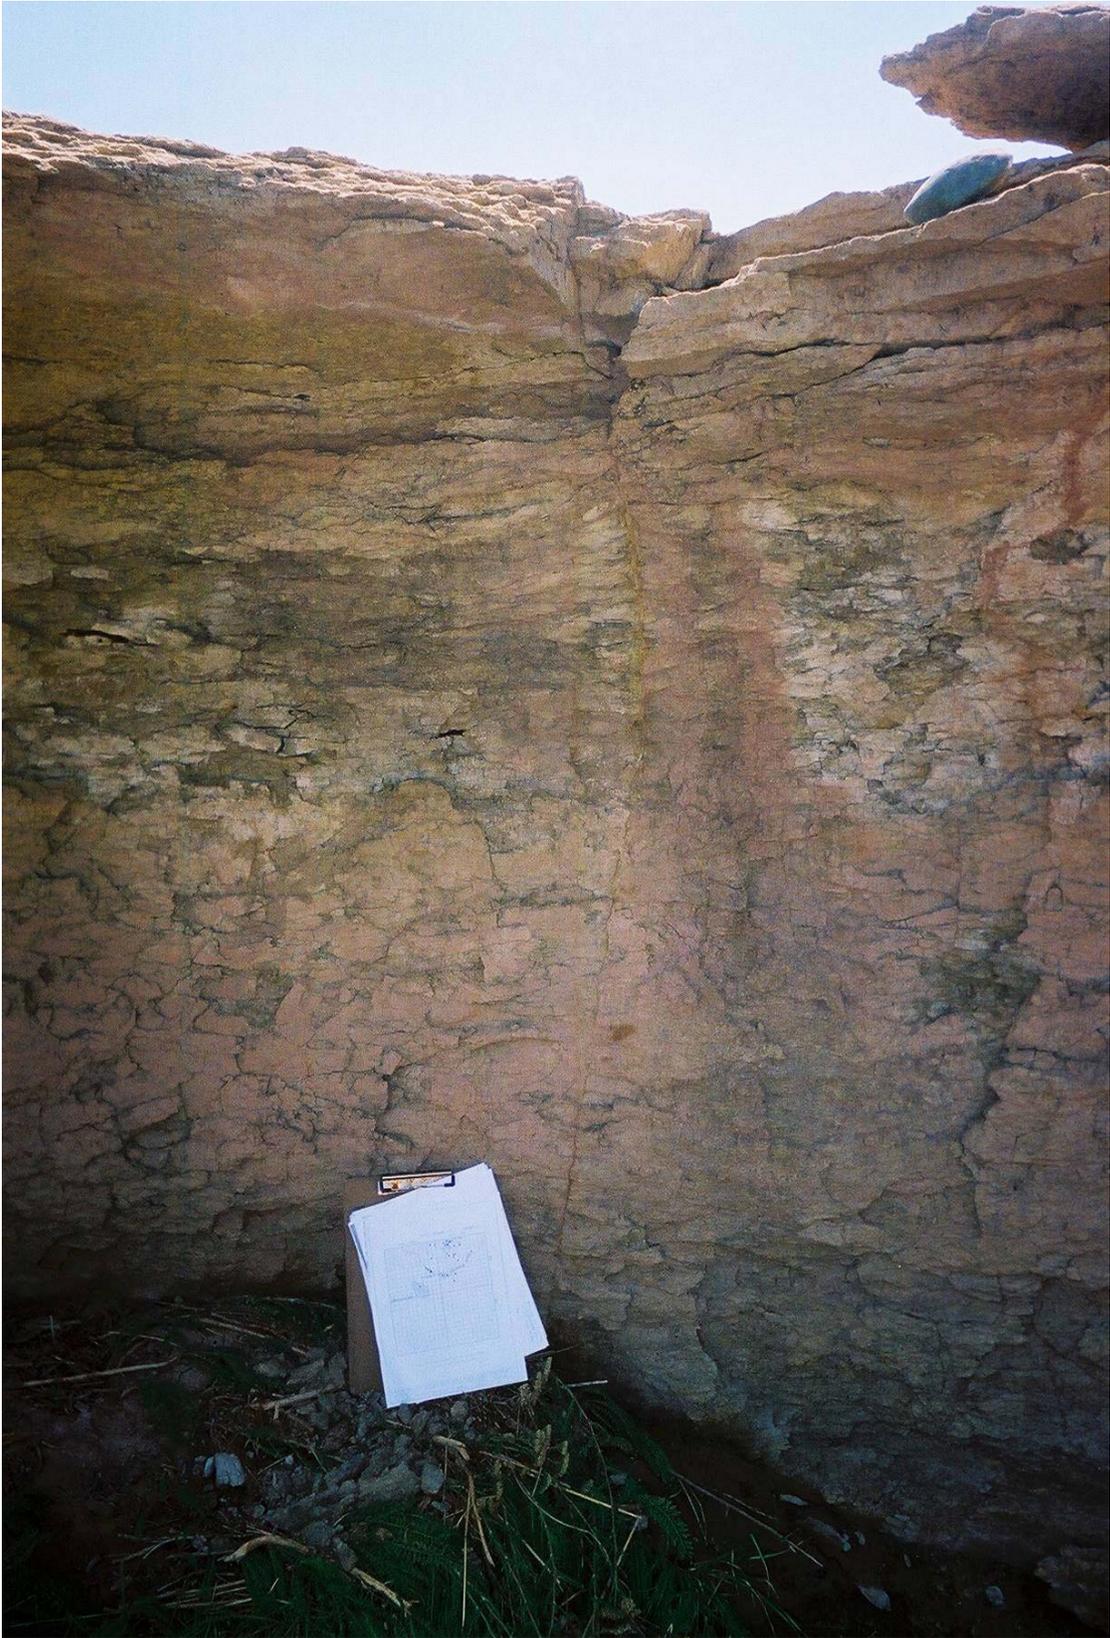
Photograph 08A

- 08A Cross section exposed at southeast portion of upper cataract. Note subvertical continuous, iron-stained joint in center of photo. Clipboard for scale.

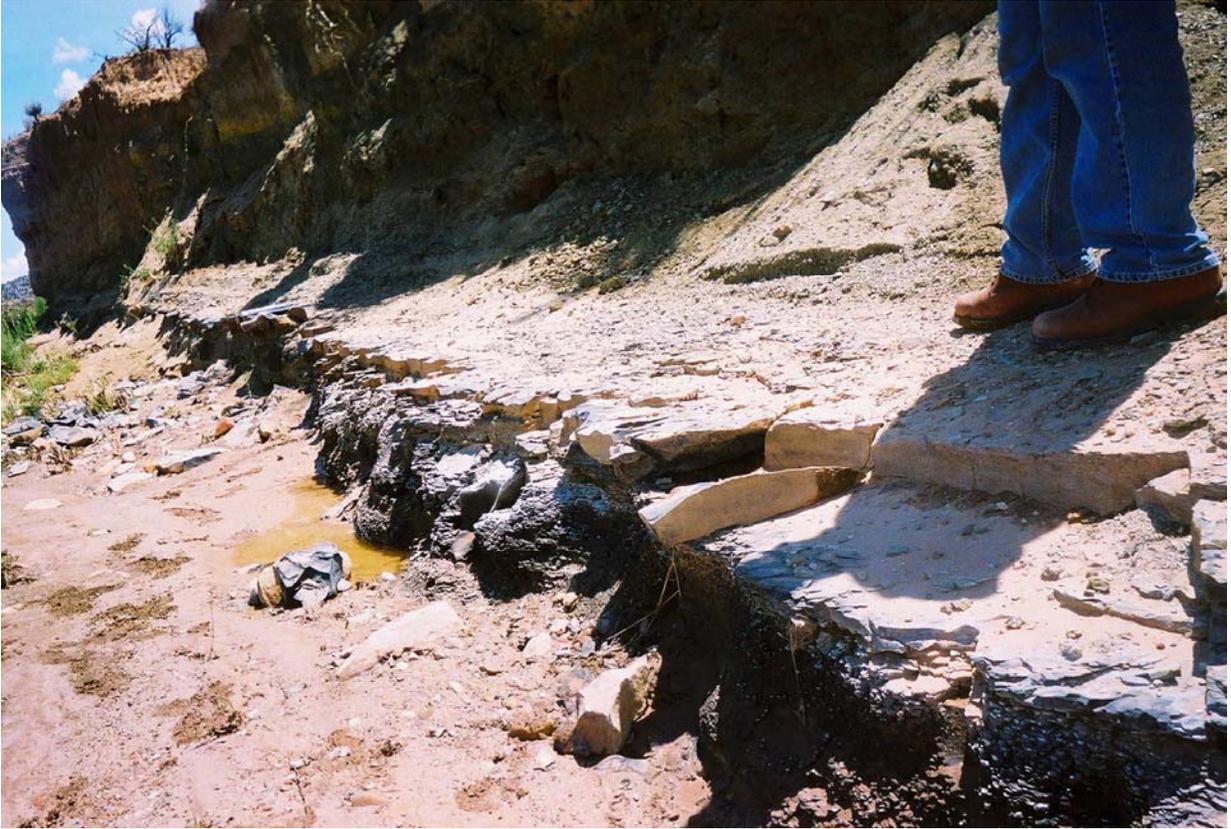
Photograph 02A

- 02A Closer view of claystone/shale bench in Photo 03A; same features evident.
- 01A View of alluvium in upper portion of section exposed in Photo 03A. Note root penetration and prominent horizontal soil change center of photo. Possible paleo-surface. Calcite present and increasing in proportion towards bottom of upper soil horizon. Pen for scale; cap oriented upward.
