**Assessment of Hydrogeologic Conditions and  
Need for Long-Term Groundwater Monitoring  
at the Former Durita Uranium Mill, Naturita, Colorado**

**Assessment of Hydrogeologic Conditions  
and Need for Long-Term Groundwater Monitoring  
at the Former Durita Uranium Mill, Naturita, Colorado**

Gene Peters and Randall Fedors

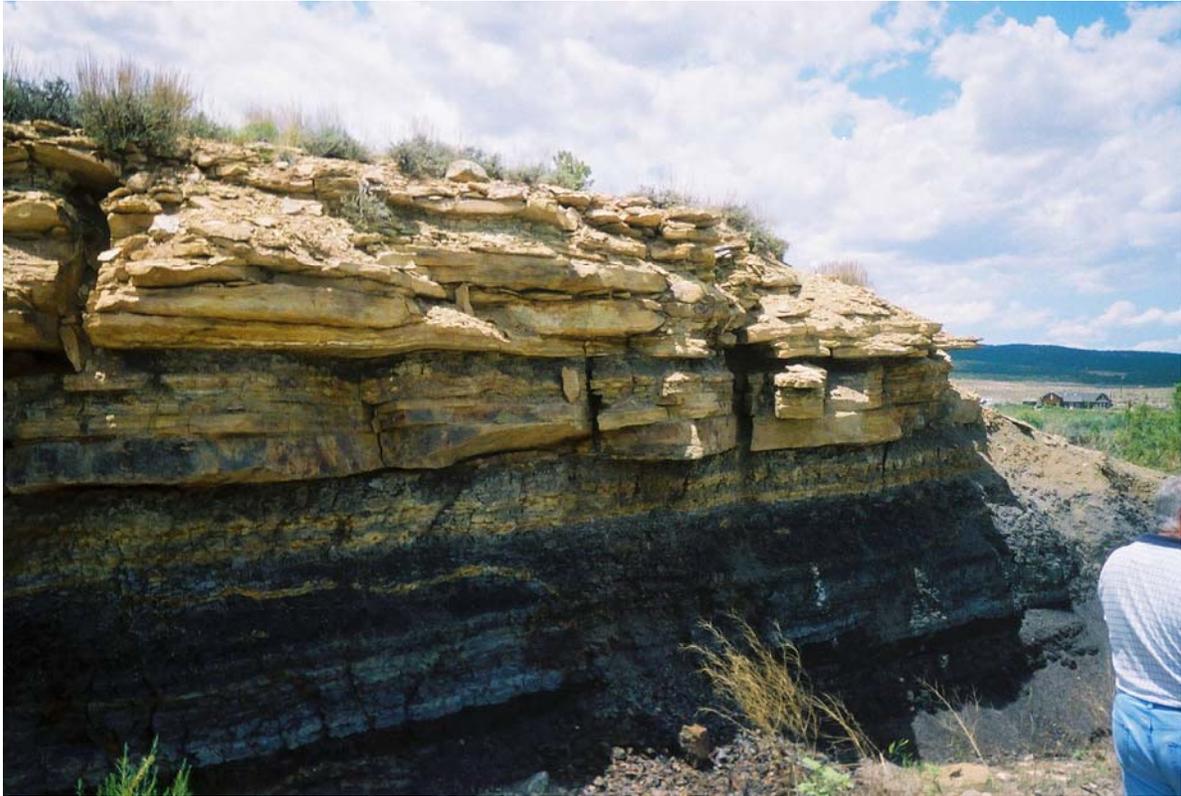
Photograph 0A

- 0A View of road cut on west side of access road, facing west-northwest, approximately 2,000 feet north of site. Coke Oven Ranch buildings visible in right-center portion of photo. Upper portion of cut exposes Mancos/Dakota interbeds. Note prominent fractures oriented northwest into plane of photo, some with apertures of several inches. Darker layer near base of section is near-anthracite coal layer, diagnostic of Dakota Formation.

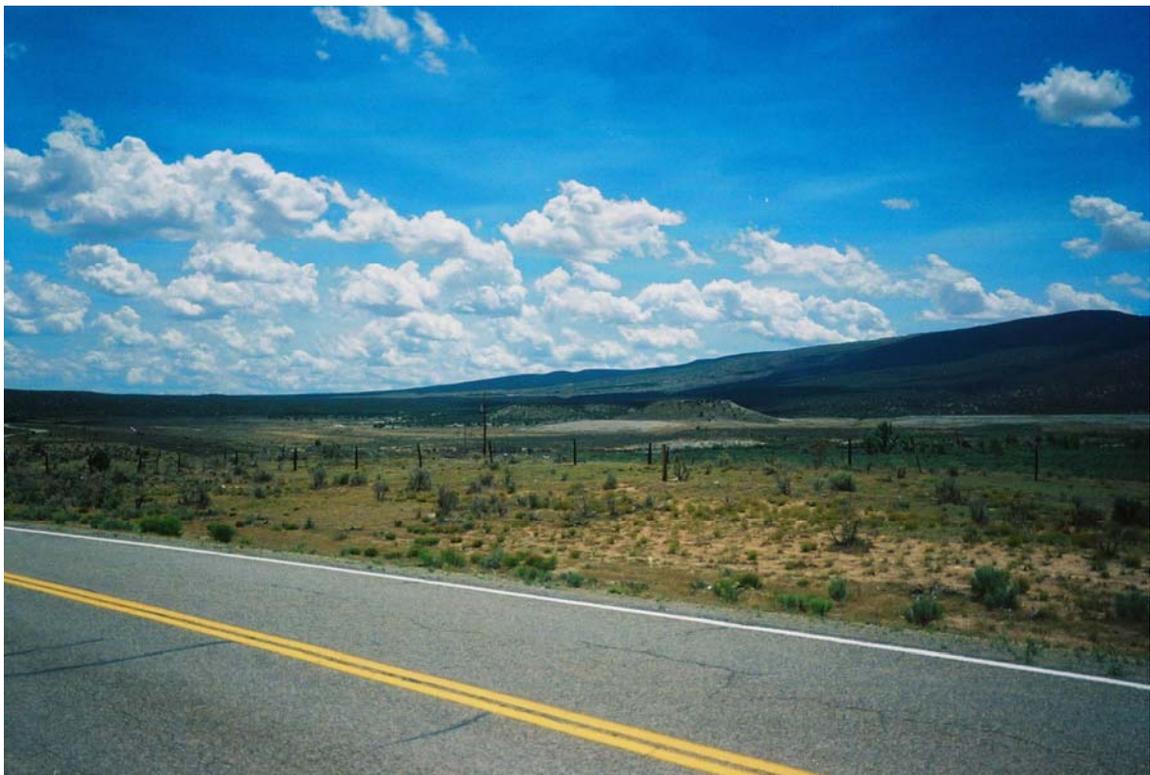
Photograph 00A

- 00A View of site from Highway 90, facing southeast. Mancos Hill visible slightly right of center of photo.
